# National Transportation Safety Board

ERA23FA247

## **MATERIALS LABORATORY**

Location: Lake Worth, Florida  
Date: May 26, 2023  
Vehicle: Cessna 172P, N3KV  
Investigator: Heidi Kemner (AS-ERA)

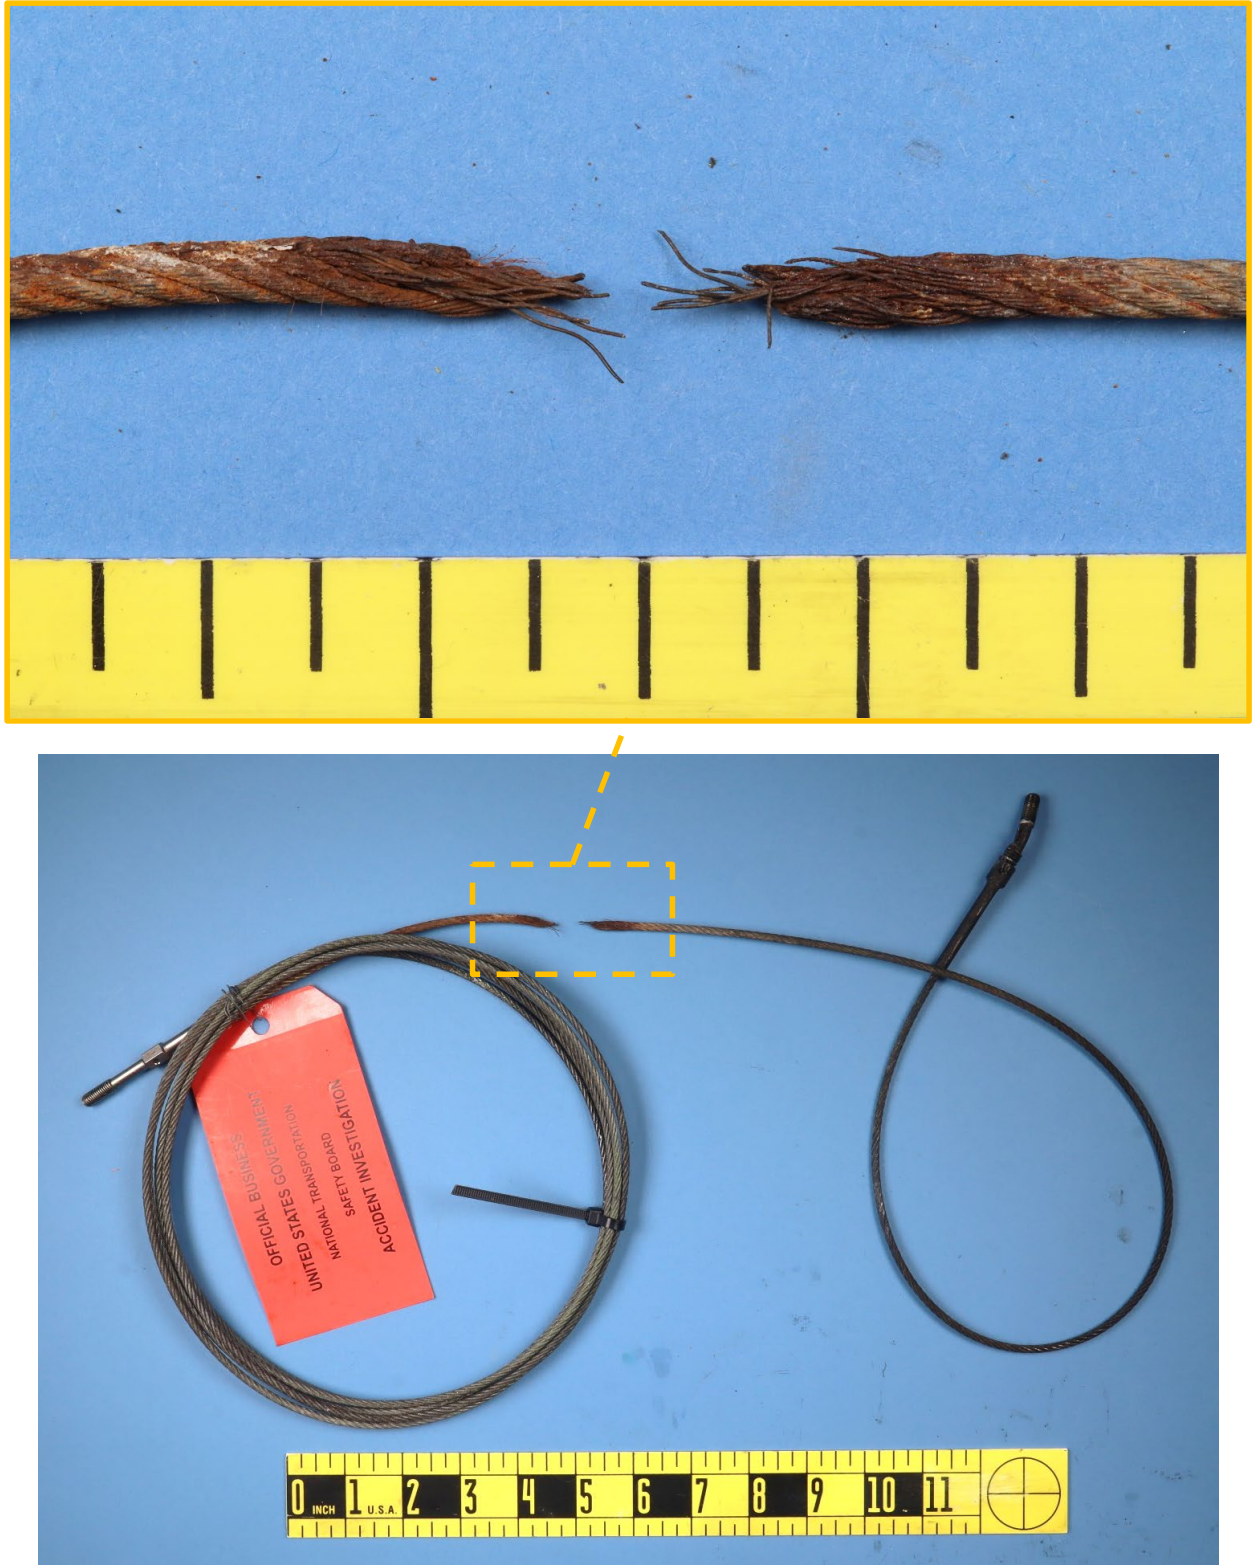
The separated aileron cable pieces were submitted in two bags, one labeled "attached to R wing" and the other labeled "connected inside fuselage". The R wing cable piece had separated approximately 24 inches from the fitting end. The cable attached to the fuselage end was secured in a coil. The cable is shown in Figure 1, with a close-up of the separation visible in the top image. The cable strands remained bundled, and the separated ends of the cable tapered to points, with only a few wires splayed outwards. The cable in the vicinity of the separation was coated in reddish-brown colored deposits consistent with corrosion.

**Figure 1.** (Bottom) Macro photo showing the submitted cable pieces. (Top) Close-up photo showing the separated ends of the cable pieces.

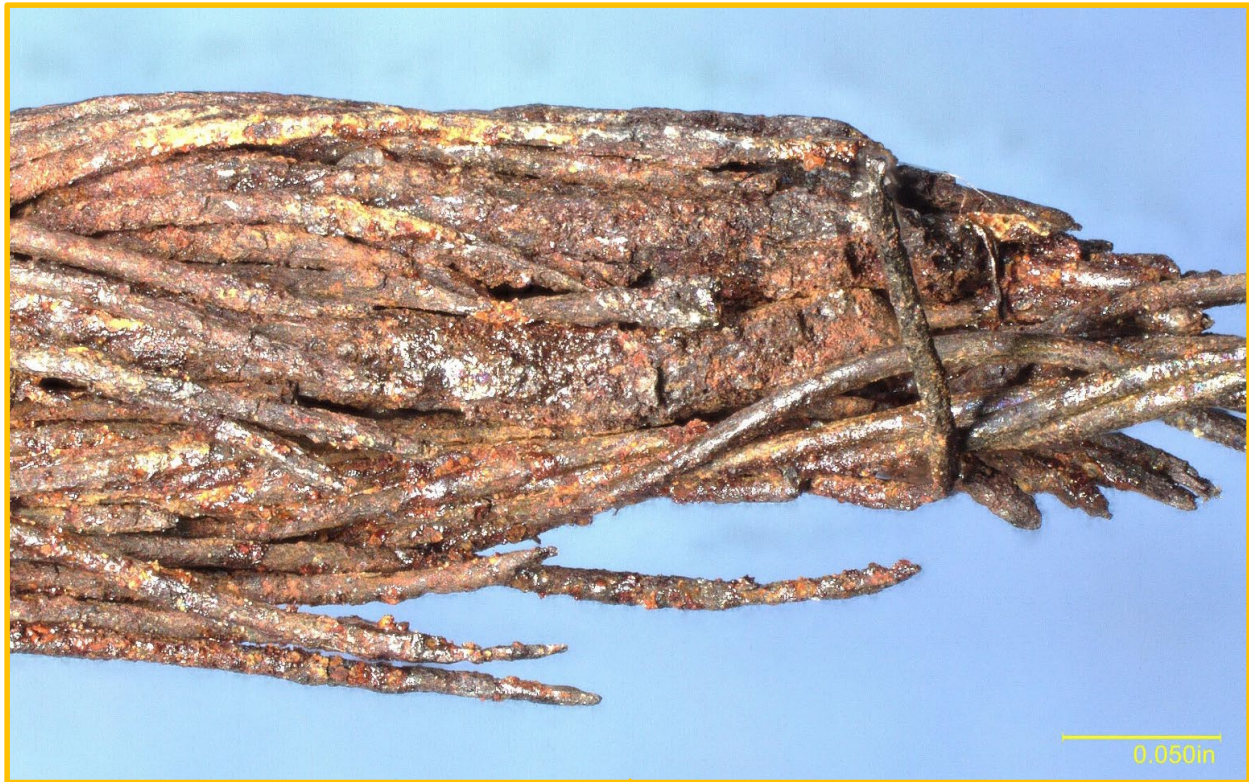
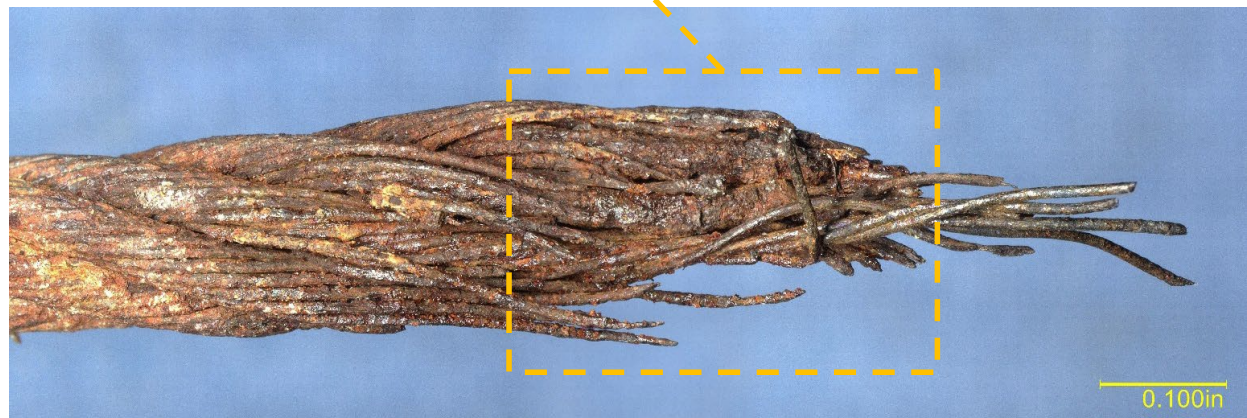
Digital microscope images show the reddish-brown deposits of the separated end of the R wing cable piece in Figure 2. Very thick deposits made the strands look like solid pieces and appeared to hold the bundled wires together. Approximately 2 inches from the end of the separation was sectioned from the R wing cable piece. The sectioned piece was iteratively cleaned by soaking in Evapo-Rust® (CRC Industries, Horsham PA) heavy rust remover in an ultrasonic bath. Figure 3 shows digital microscope images of the sectioned piece after cleaning. A few wires had uneven, localized thinning either at the separated ends or along the length of the wire. Pockmarks consistent with corrosive attack were observed on the surfaces of numerous wires. Some of the wire ends had necked down, with cup-cone fractures visible, while other wires had no thinning and angled fractures at the ends.

**Figure 2.** Digital microscope images of the separated end of the R wing cable piece in the as-submitted condition.

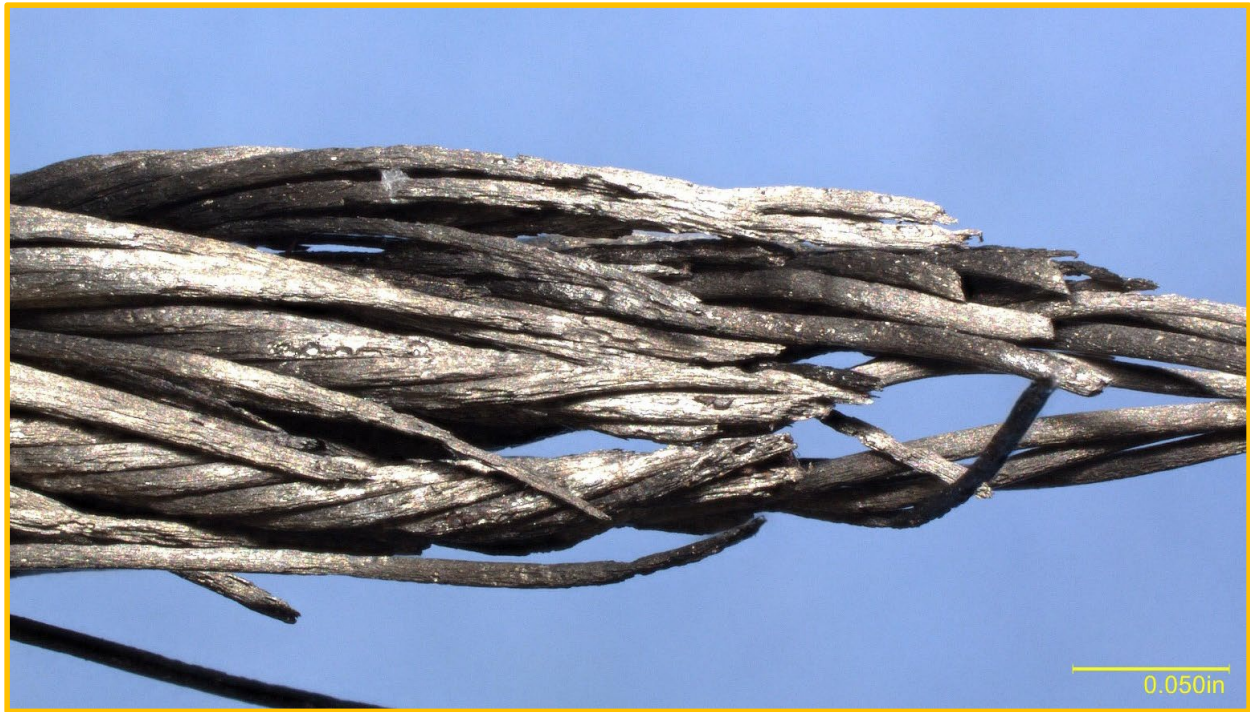
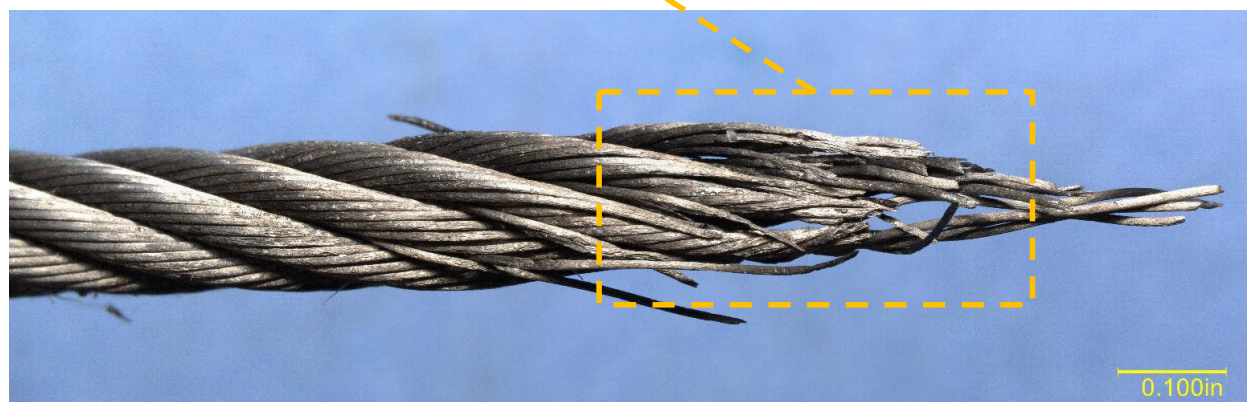
**Figure 3.** Digital microscope images of the separated end of the R wing cable piece after cleaning.

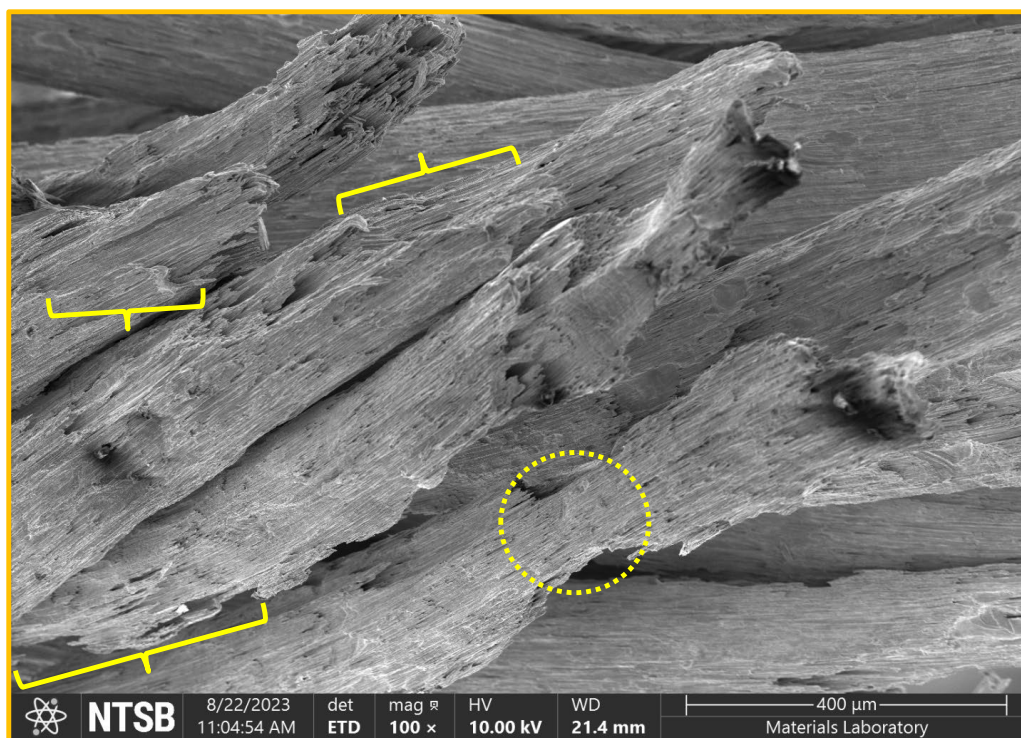
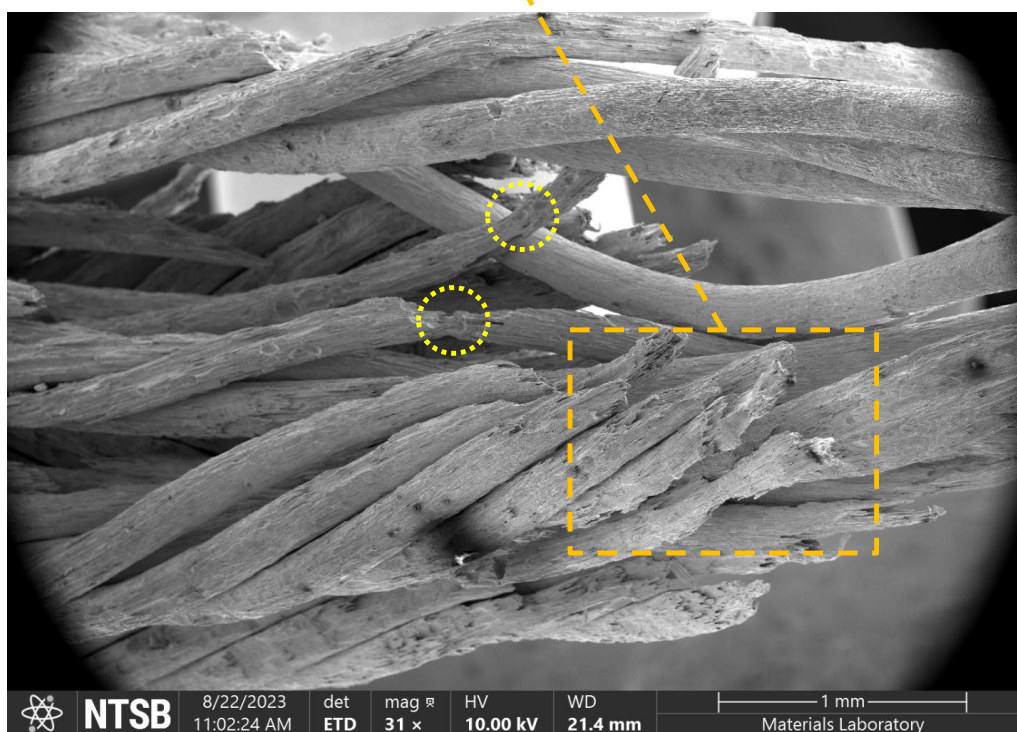
The cleaned sectioned piece from the R wing cable end was examined using a scanning electron microscope (SEM). The outer diameter (OD) surfaces of the wires had a layered woody appearance, with some areas shedding material layers, as indicated by the yellow brackets in Figures 4 and 5. The uneven, localized thinning observed in some wire cross-sections (yellow dotted circles) resulted from substantial shedding of material. Pockmarks were observed on the surfaces of most wires. The woody appearance, shedding material, and pockmarks were all consistent with corrosive attack.

The angled fracture surfaces visible on some wires in Figures 4 and 5 had the same layered woody appearance as the wire OD surfaces. The similarities indicate those wires likely fractured in tension due to embrittlement and weakening from corrosive attack. A few necked down wires are shown in Figures 6 and 7. The cup-cone fractures on the necked down wires had dimpled features consistent with ductile tensile overstress on the majority of the fracture surfaces. Pockets of layered woody features consistent with corrosive attack were visible between the dimpled features. Figure 8 compares a fracture surface fully covered in layered woody features with a cup-cone fracture surface that has only pockets of layered woody features (yellow arrows) interspersed in majority dimpled features (blue arrows).

**Figure 4.** SEM images of the separated end of the R wing cable piece after cleaning. The yellow brackets indicate areas where material is shedding in layers from wires. Uneven, localized thinning in wire cross-sections resulting from material shedding is indicated by yellow dotted circles.

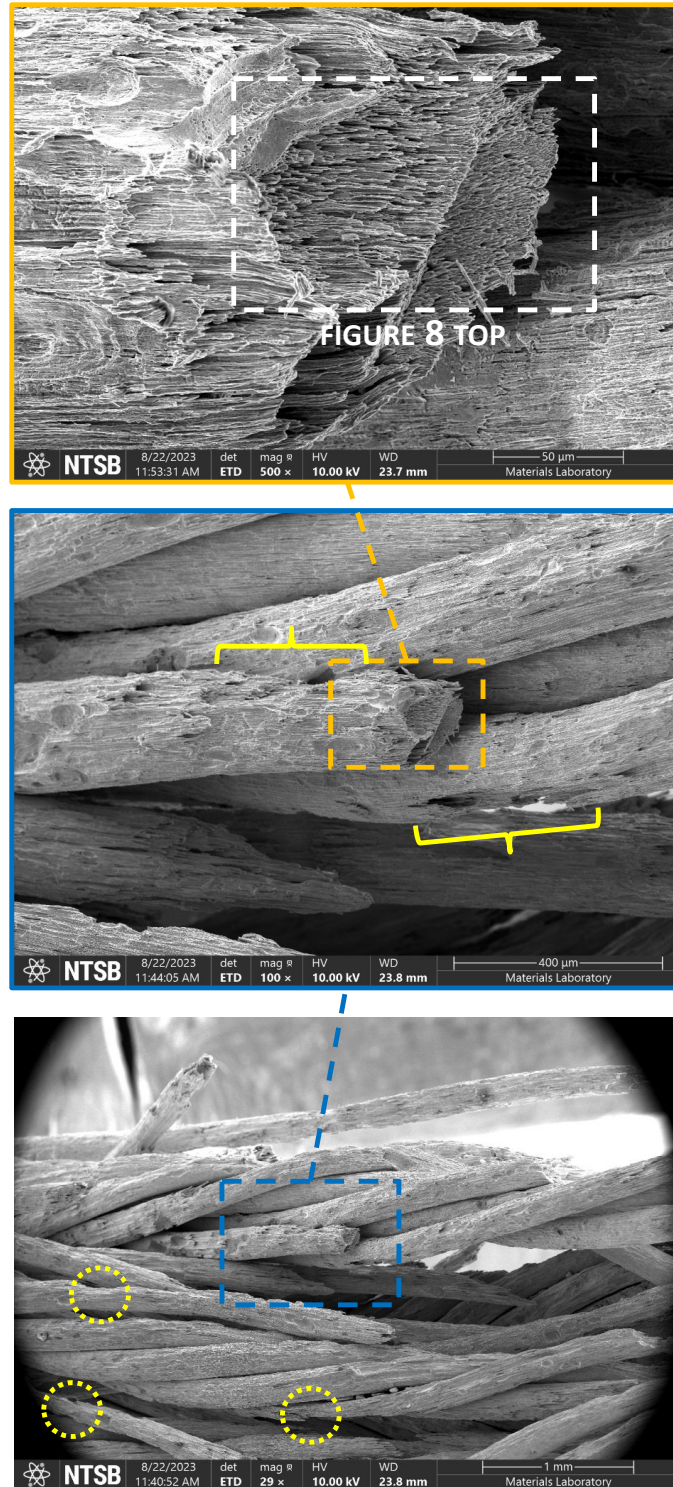
**Figure 5.** SEM images of the separated end of the R wing cable piece after cleaning. The yellow brackets indicate areas where material is shedding in layers from wires. Uneven, localized thinning in wire cross-sections resulting from material shedding is indicated by yellow dotted circles.

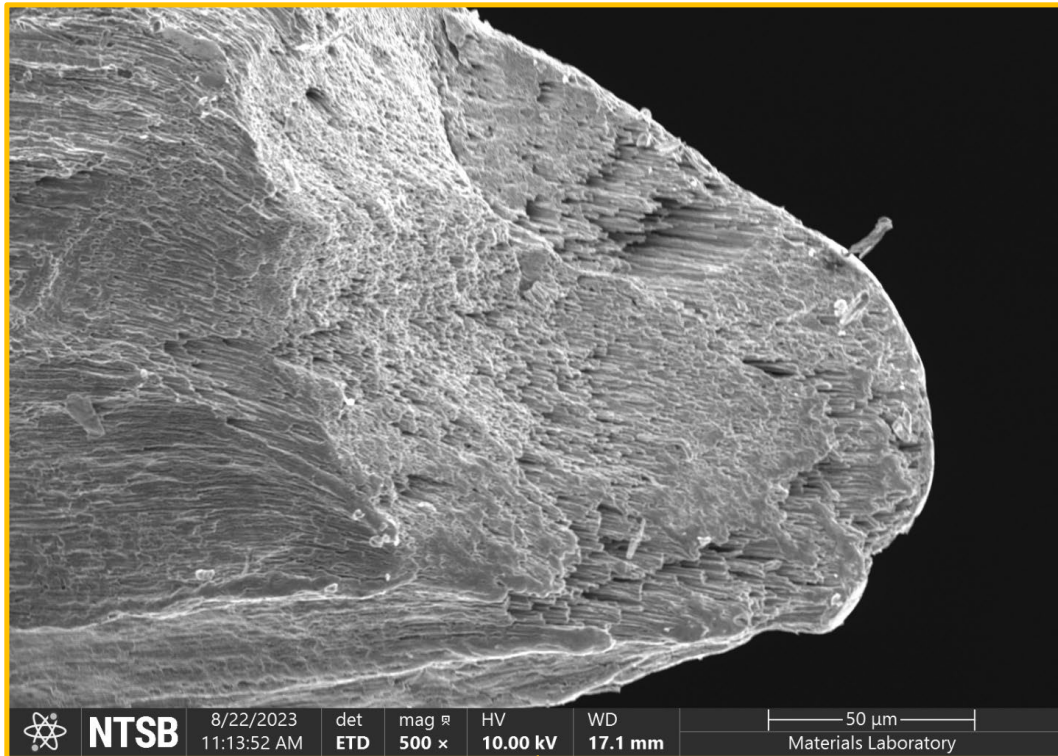
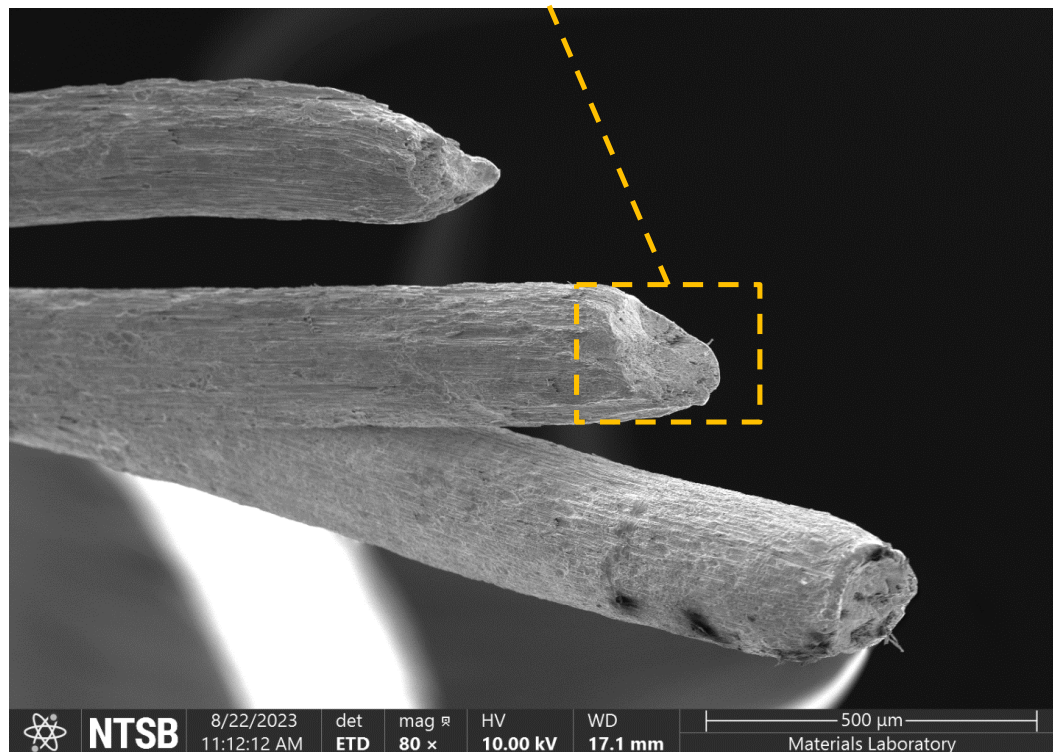
**Figure 6.** SEM images of wires with necking and cup-cone fractures observed in the separated end of the R wing cable piece after cleaning.

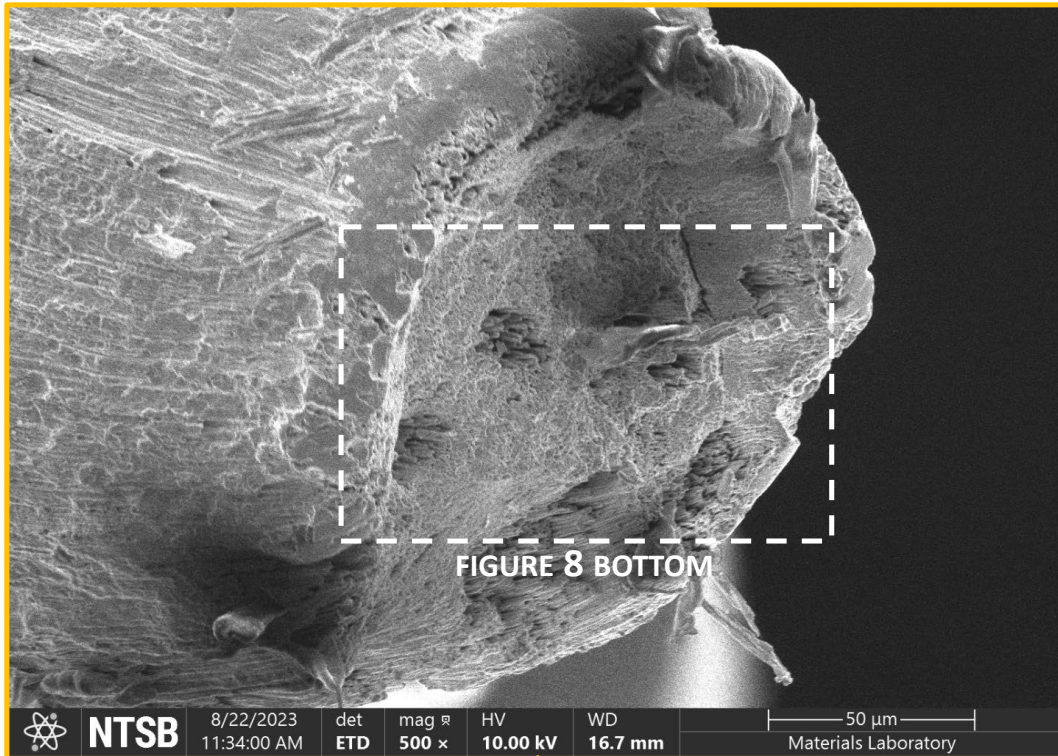
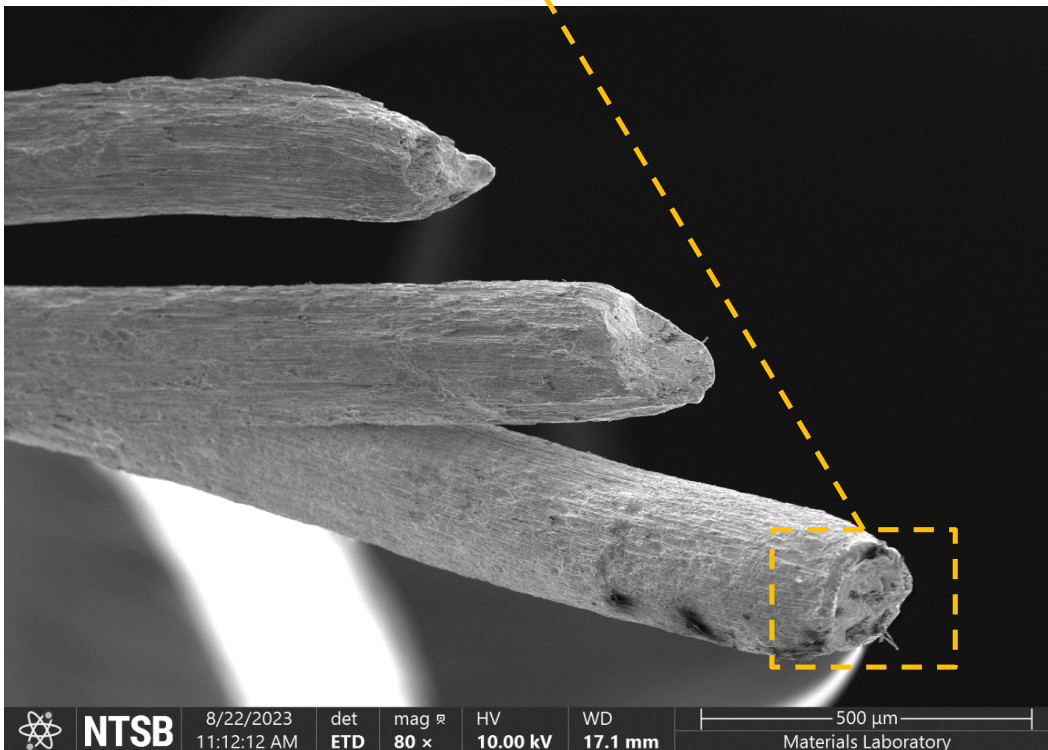
**Figure 7.** SEM images of wires with necking and cup-cone fractures observed in the separated end of the R wing cable piece after cleaning.

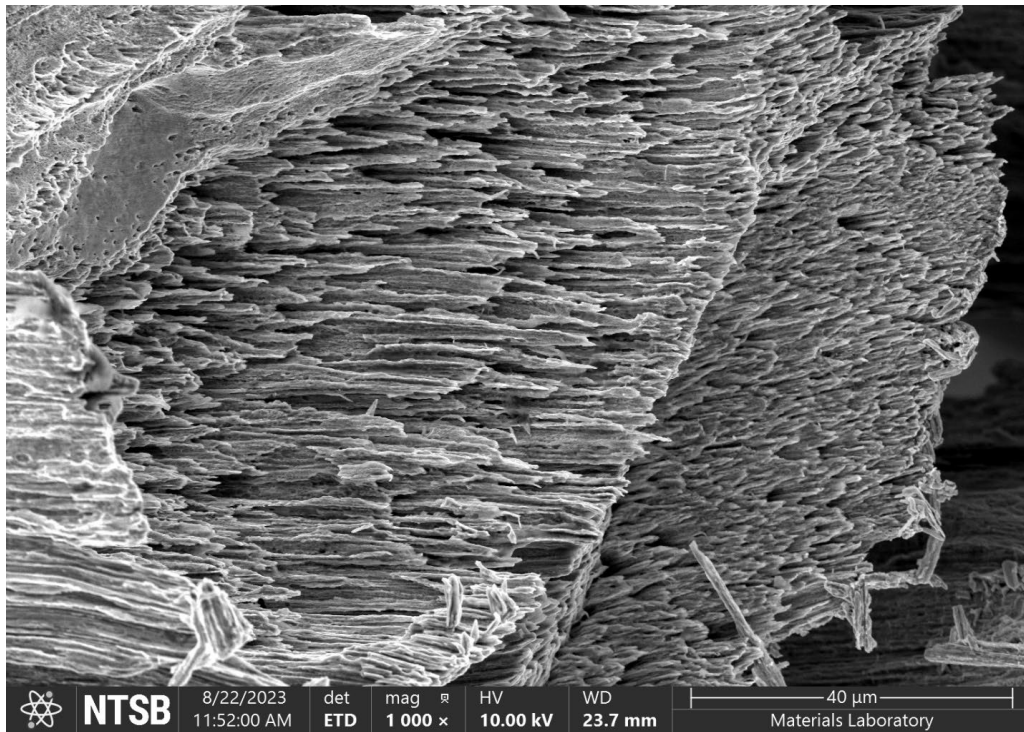
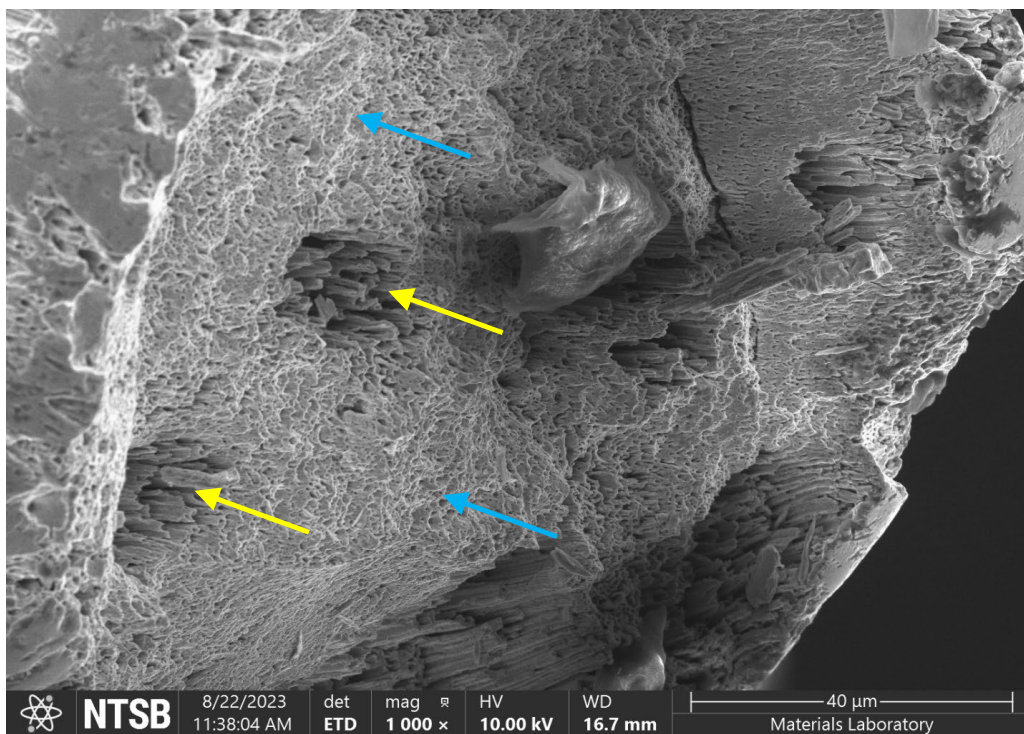
**Figure 8.** SEM images comparing a wire that had an angled fracture surface (top) and a wire that had a cup-cone fracture surface (bottom) in the separated end of the R wing cable piece after cleaning. The pockets of layered woody features (yellow arrows) from corrosive attack were observed interspersed with dimpled features (blue arrows) from ductile tensile overstress on the cup-cone fracture surface.
