**MEMORANDUM FOR RECORD**

**Subject:** ERA23FA249

**Contact:** NTSB Materials Laboratory E-mail report from NTSB Subject Matter Expert

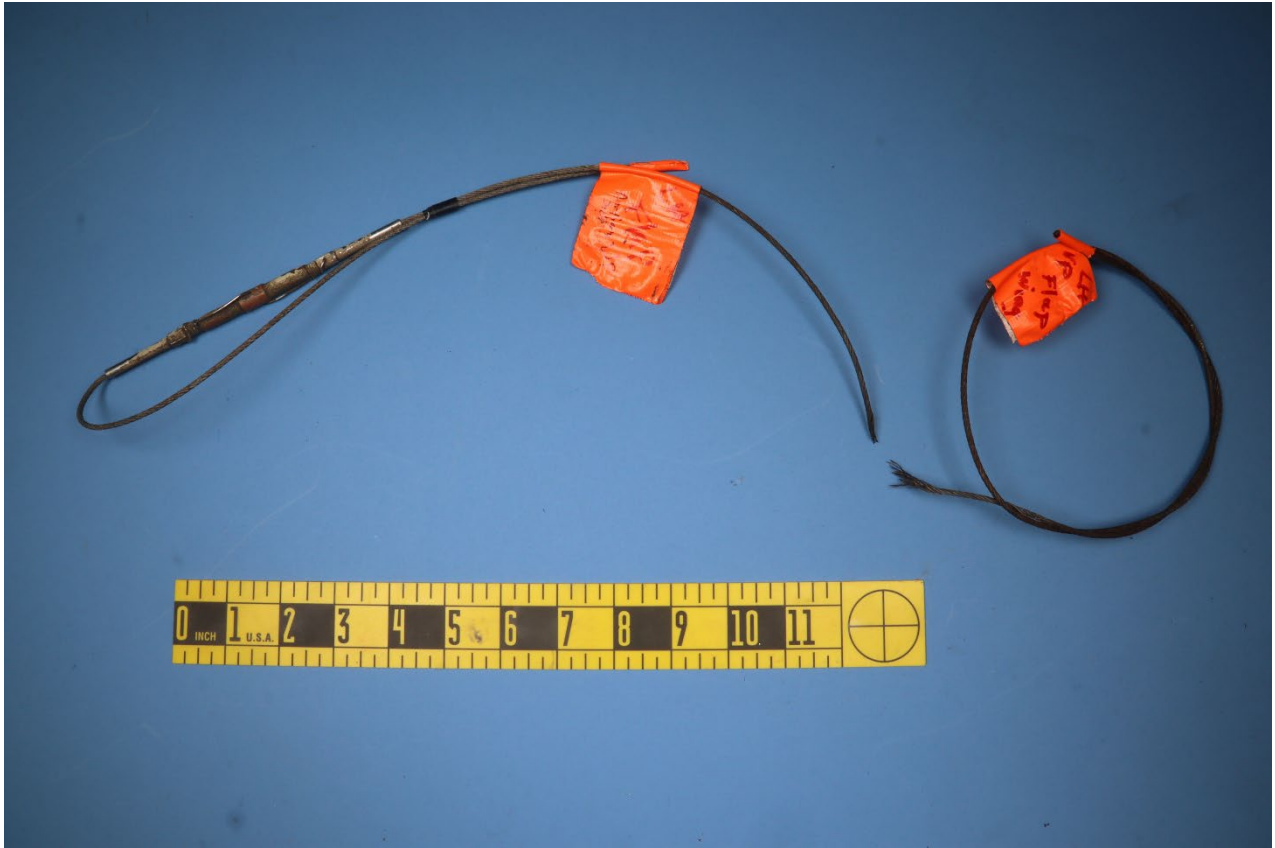
As part of the investigation, while on-scene, the left flap up cable was fractured at the upper door post in the area of a pulley. The two ends of the fractured cable were retained for retained for examination by the NTSB Materials Laboratory.

**Figure 1 IMG-0031 View of the Submitted Sections of the Fractured Left Flap Up Cable**

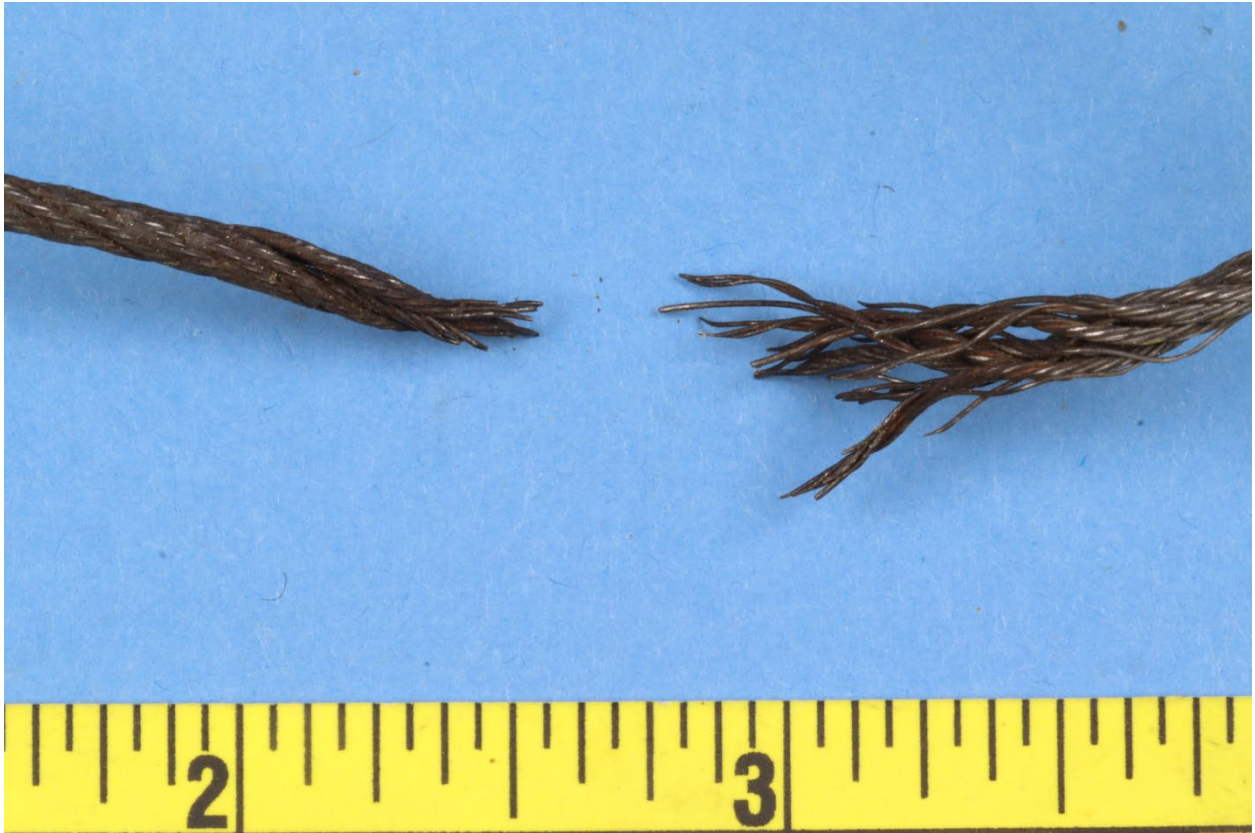
According to the e-mail reported from the NTSB Materials Engineer subject matter expert, "There was a separation in the submitted cable ('IMG\_0031'). The separated cable ends were lightly cleaned using methanol and inspected with a 5-50x stereomicroscope. At the location of the separation, one half of the fractured cable had wires that had unwound, while the other half had wires that remained bundled in their strands ('IMG\_0032'). Flat areas were observed on the outer diameter of the cable ('End 1 S (30x)' and 'End 2 S (20x)') that were consistent with rubbing against another object for some time. There was thinning of the separated wire ends adjacent to the area with the external rub, ('End 1 fracture surfaces S (50x) and 'End 2 fracture surfaces S (40x)'), as well as lesser amounts of thinning on a few internal wires due to rubbing contact between contacting wires. The fracture surfaces of the wires were silver colored and appeared fresh. Several of the fractured wires with thinning appeared to have flat fracture surfaces consistent with fatigue. The remaining majority of wires displayed necking and cup-cone macro features consistent with ductile overstress on their fractured wire ends."

**Figure 2 IMG\_0032. View Showing the Condition of each Fractured End of the Cable**

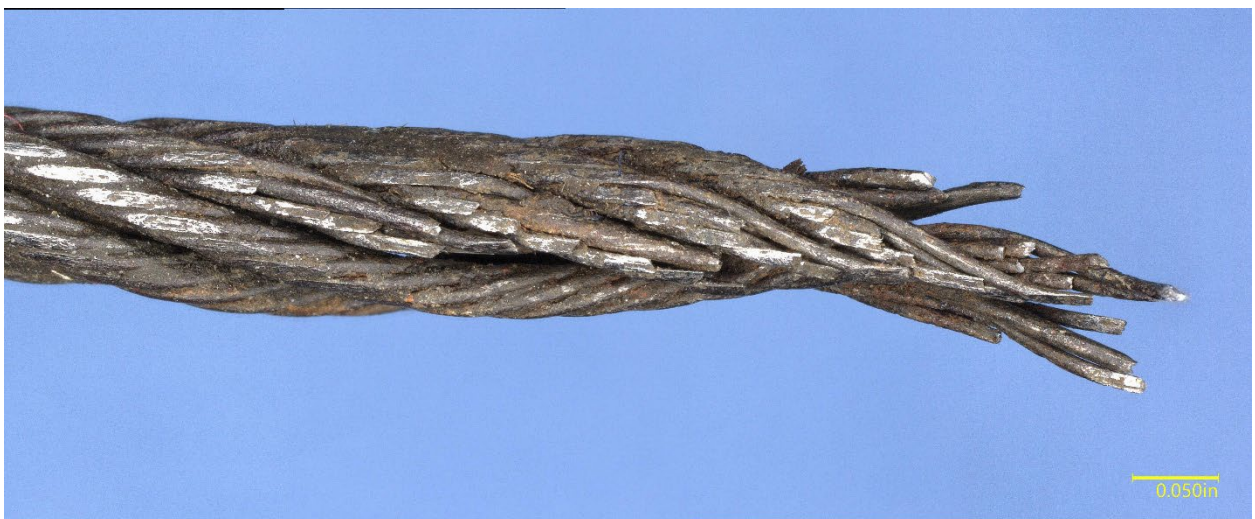
**Figure 3 End 1 S (30X) View Showing Flat Areas on Cable Strands**

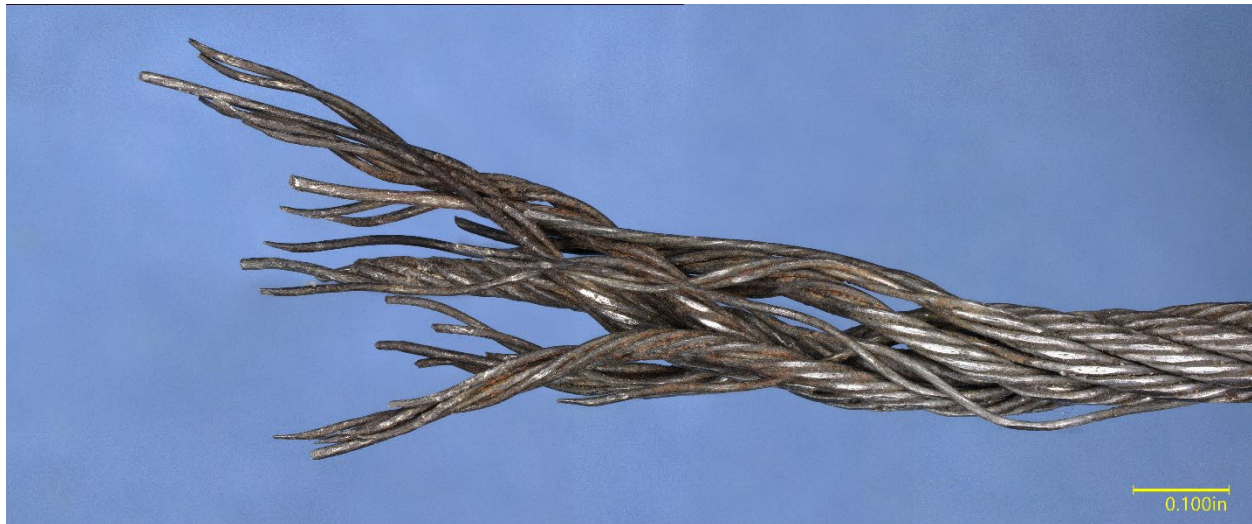
**Figure 4 End 2 S (20X). View Showing Flat Areas on Cable Strands**

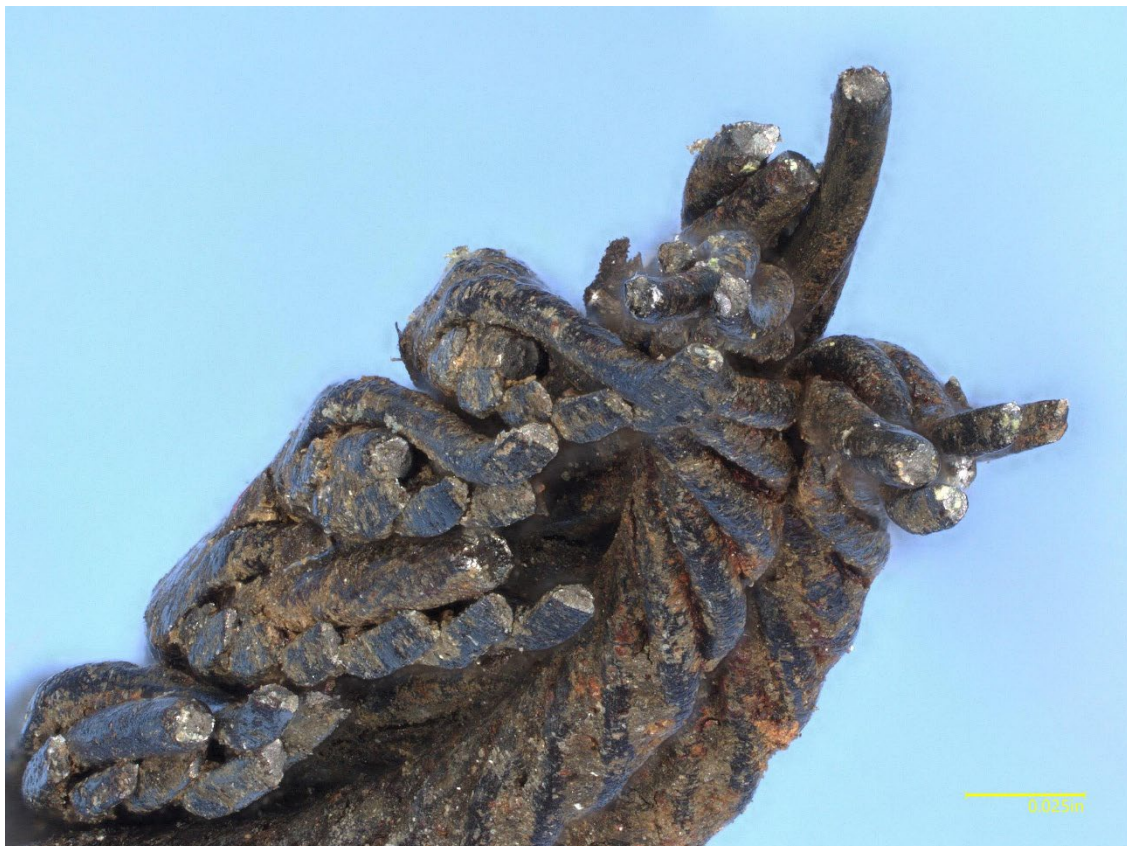
**Figure 5 End 1 Fracture Surfaces S (50X). View of thinning of Cable Strands Adjacent to Area with External Rub**

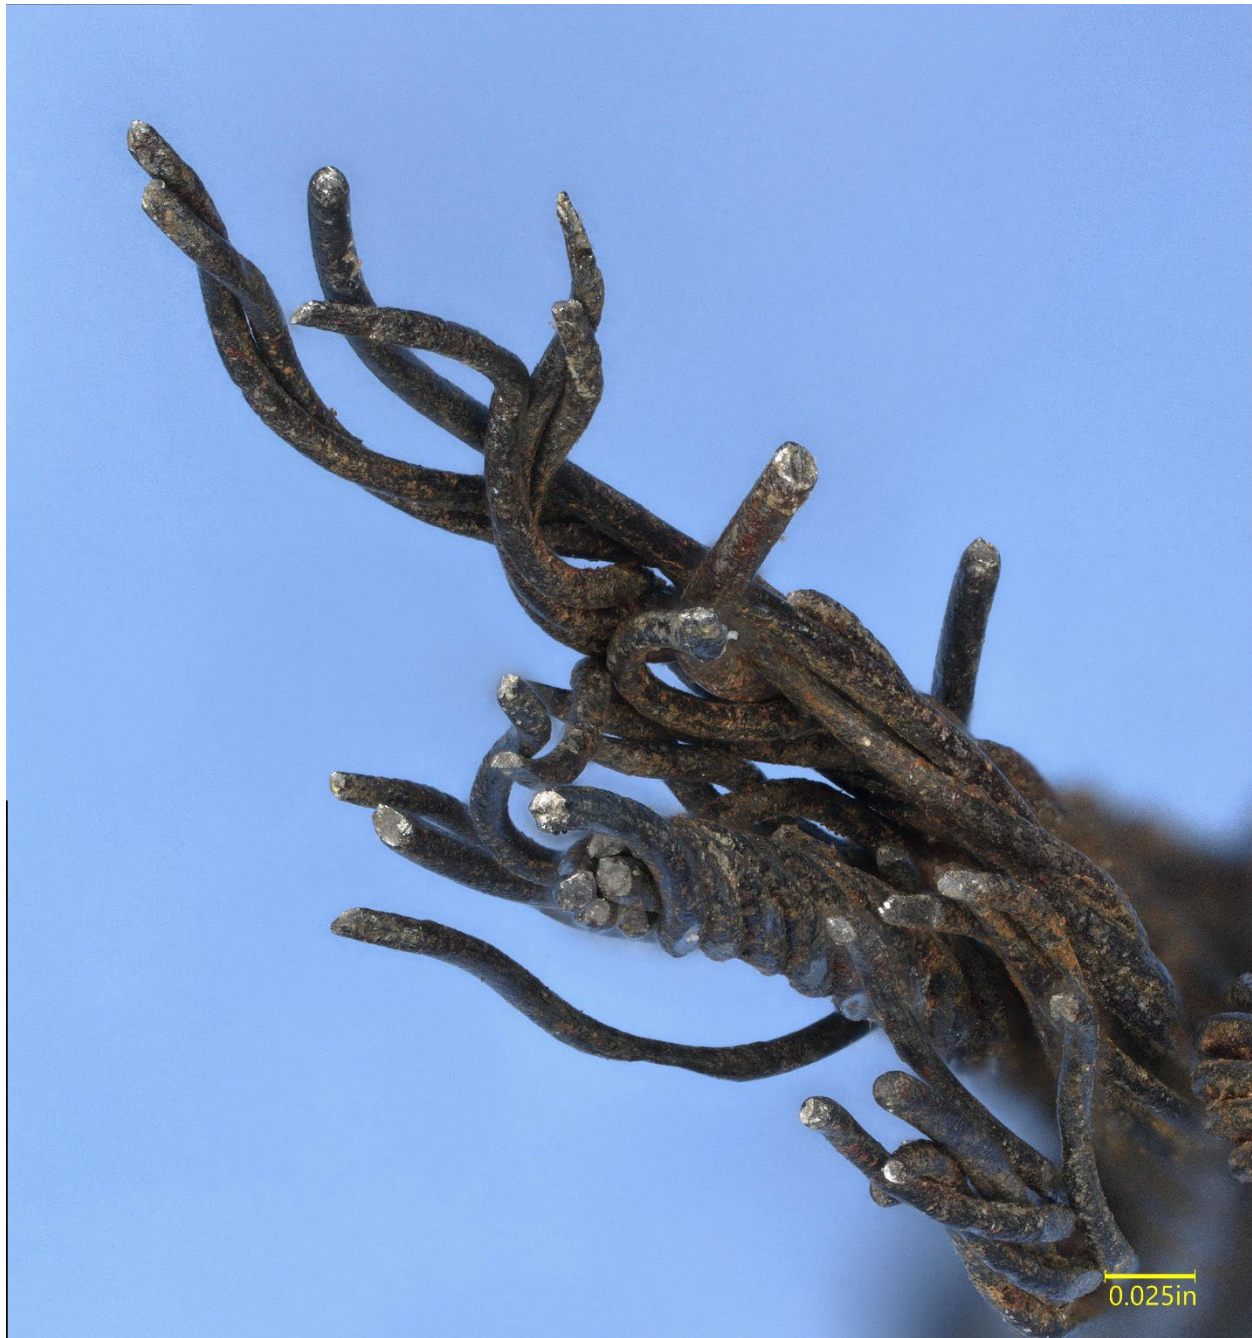
**Figure 6 End 2 Fracture Surfaces S (40X). View Showing the Ends of the Fractures Strands**
