# National Transportation Safety Board

ERA23FA249

## **WRECKAGE EXAMINATION SUMMARY**

Location: Plymouth, New York  
Date: May 28, 2023  
Time: 1452 EDT  
1852 coordinated universal time (UTC)  
Airplane: N8775X, Cessna 182D

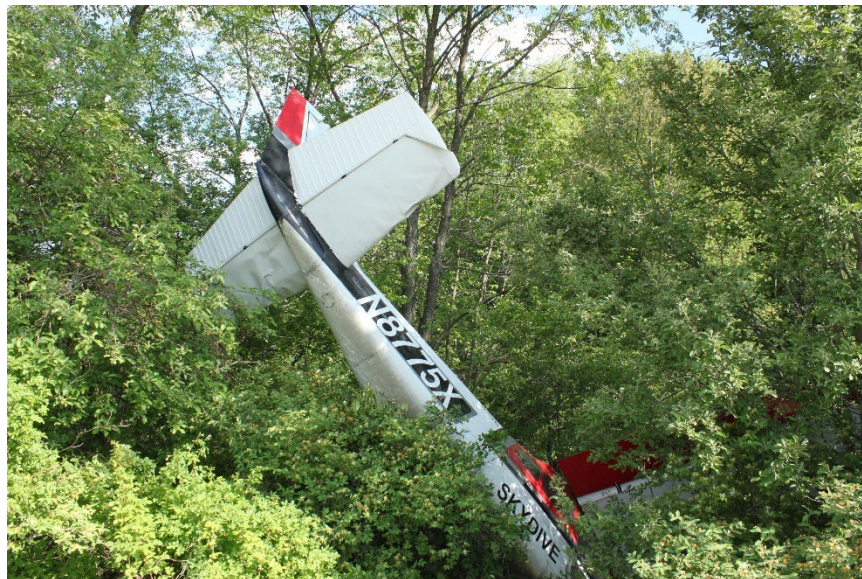
Examination of the accident site revealed the wreckage came to rest at 42.570059° north latitude and -75.547635° west longitude. The airplane came to rest on a magnetic heading of about 189° on a slight downsloping terrain and was in a 49° nose-low and tail high attitude (Figure 2). It was also in a right wing high attitude; the left wing was separated at the wing root and was in close proximity to the main wreckage.

**Figure 2 Right Side View of the Wreckage At the Accident Site**

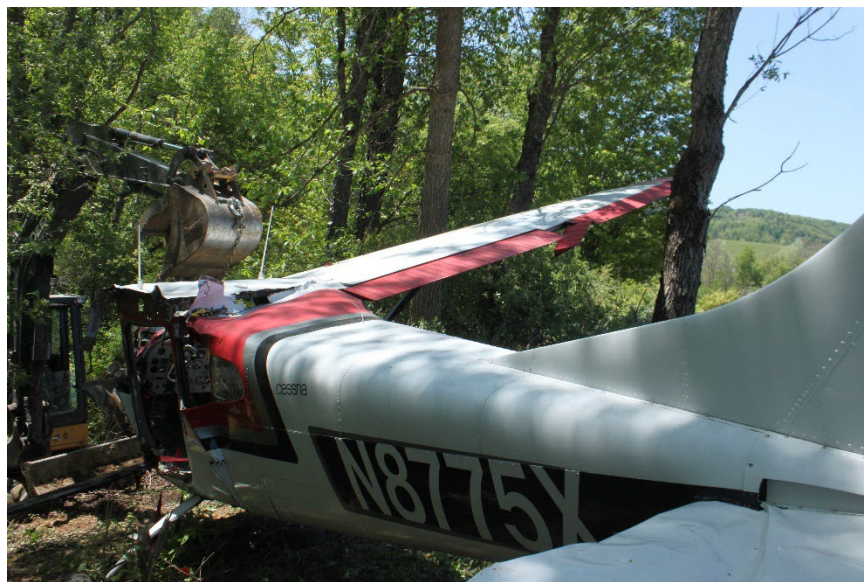
The left side of the fuselage just aft of the left main landing gear exhibited compression buckling (Figure 3) which continued to the bottom. The aft empennage exhibited minimal damage.

**Figure 3 Left Side View of the Fuselage and Aft Empennage**

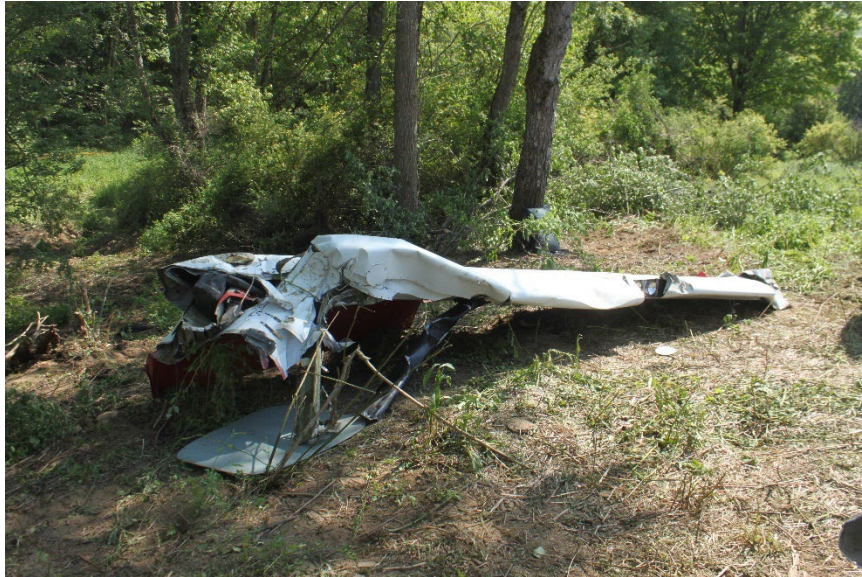
Examination of the left wing which was structurally separated but found in close proximity to the resting position of the wreckage revealed it exhibited extension damage to the leading edge from about the landing light inboard (Figure 4).

Further examination of the left wing revealed the flap and aileron remained attached. The lift strut exhibited overload fracture about 3 ft outboard of the lower attach point. An impact mark was noted on the leading edge inboard of the pitot tube. Another impact mark was noted on the leading edge near wing station 154 associated with tree contact. The impact mark near

the pitot tube was associated with the airplane being in a left bank of about 30°. No fuel was found in the breached bladder tank.

**Figure 4 Frontal View of the Separated Left Wing Following Extraction From The Resting Position**

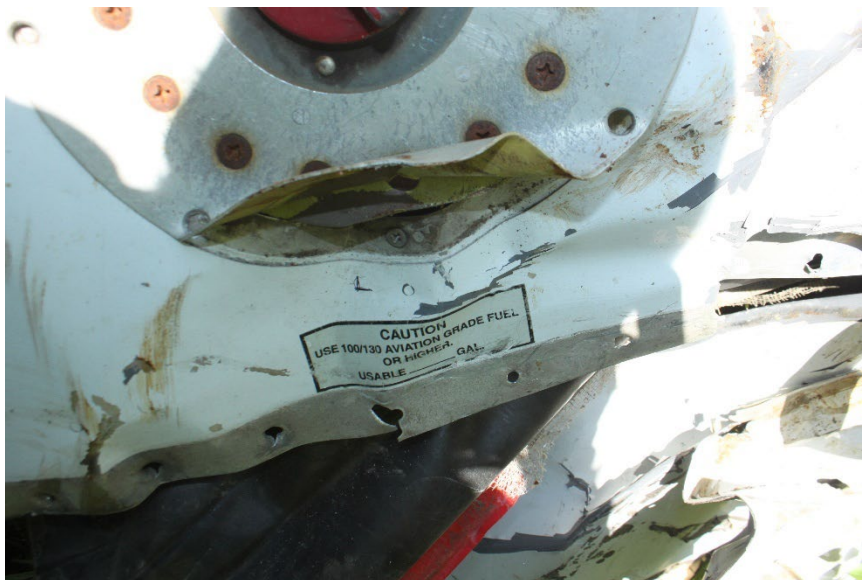
A vented fuel cap was installed and it checked satisfactory. The fuel tank placard did not have usable fuel capacity (Figure 5). The fuel transmitter moved freely to the up and down stop positions. No evidence of fuel staining aft of the fuel filler cap was noted.

**Figure 5 View of the Placard Adjacent to the Left Fuel Filler Cap**

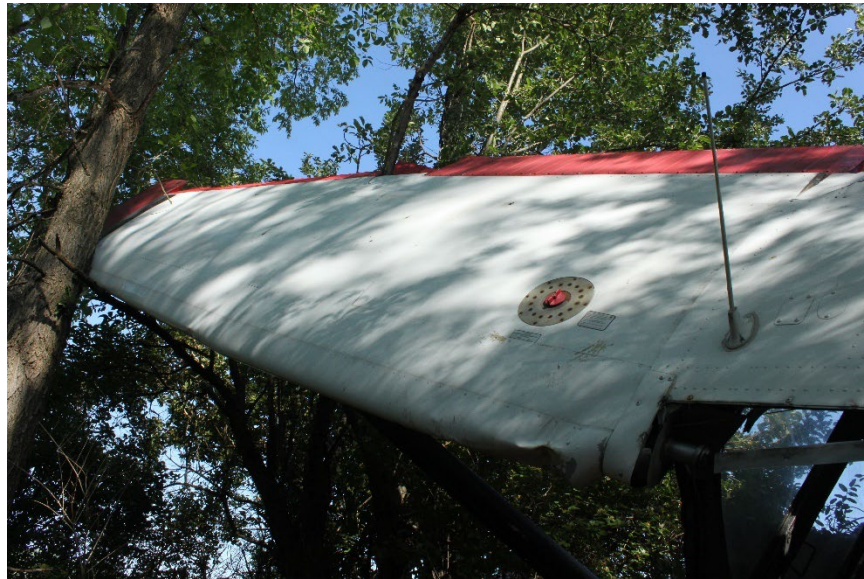
Examination of the right wing which remained structurally attached (Figure 6) revealed it contained 25 ounces of blue colored fuel consistent with 100 low lead. The lift strut remained attached at both ends. A vented fuel cap was in place and it checked satisfactory; there were no fuel stains aft of the fuel cap. The flap and aileron remained connected; the flap appeared to be retracted. A placard by the fuel cap does not specify the total capacity or usable capacity (Figure 7). The fuel transmitter moved freely to the up and down stop positions.

**Figure 6 Upper View of the Right Wing**

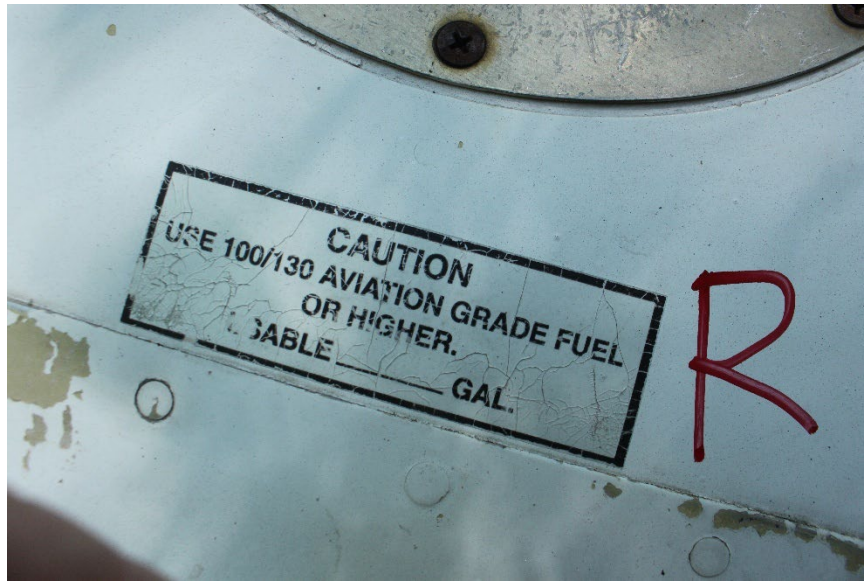
**Figure 7 View of the Placard Adjacent to the Right Fuel Filler Cap**

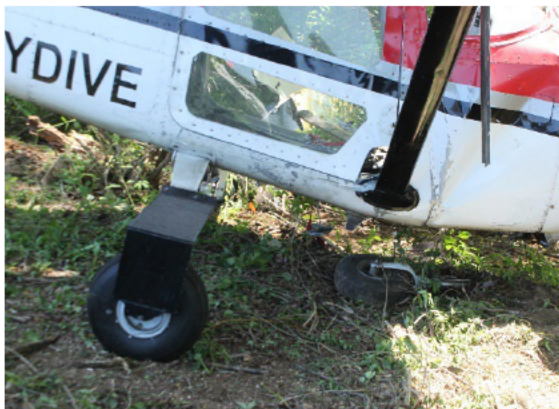
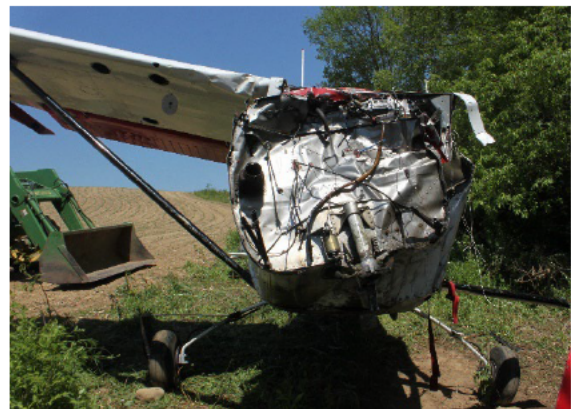
Both main landing gear remained attached but the nose landing gear wheel assembly and lower strut was separated from the nose gear strut assembly (Figures 8 and 9).

**Figure 8 View of Right Main Landing Gear and Separated Nose Wheel Assembly and lower Strut**

**Figure 9 Frontal View Showing Both Main Landing Gears and Nose Gear Strut Assembly**

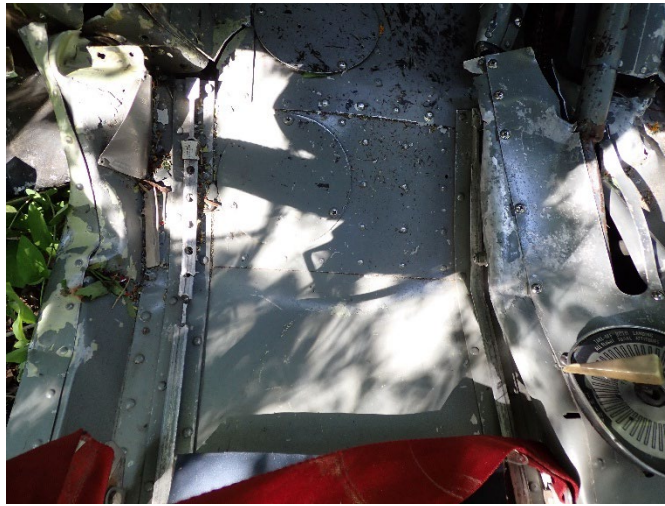
The left and right floors of the cockpit exhibited extensive compressive buckling. The instrument panel was also distorted. The upper skin of the center section of the wing was heavily distorted on the left side. The pilot's inboard and outboard seat tracks were displaced up on the forward ends and several areas of the outboard seat track with the seat pin lock holes were fractured (Figure 10).

**Figure 10 View of Pilot's Floor and Seat Tracks**

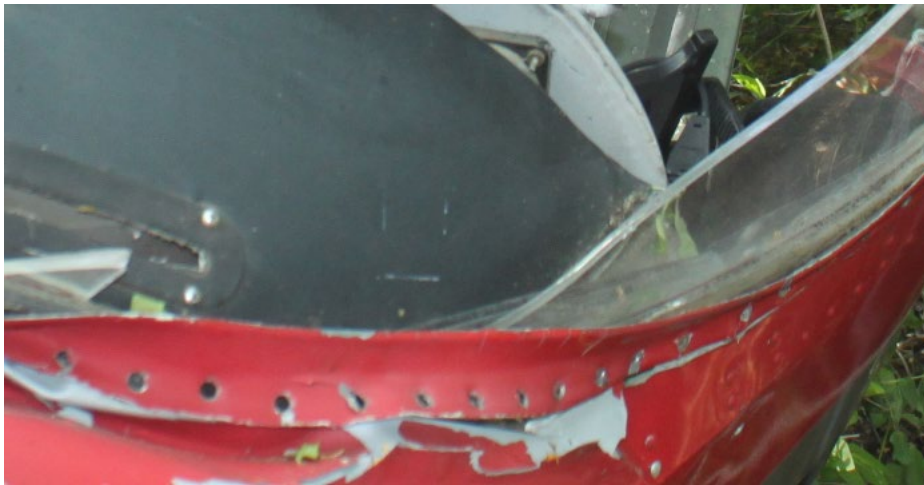
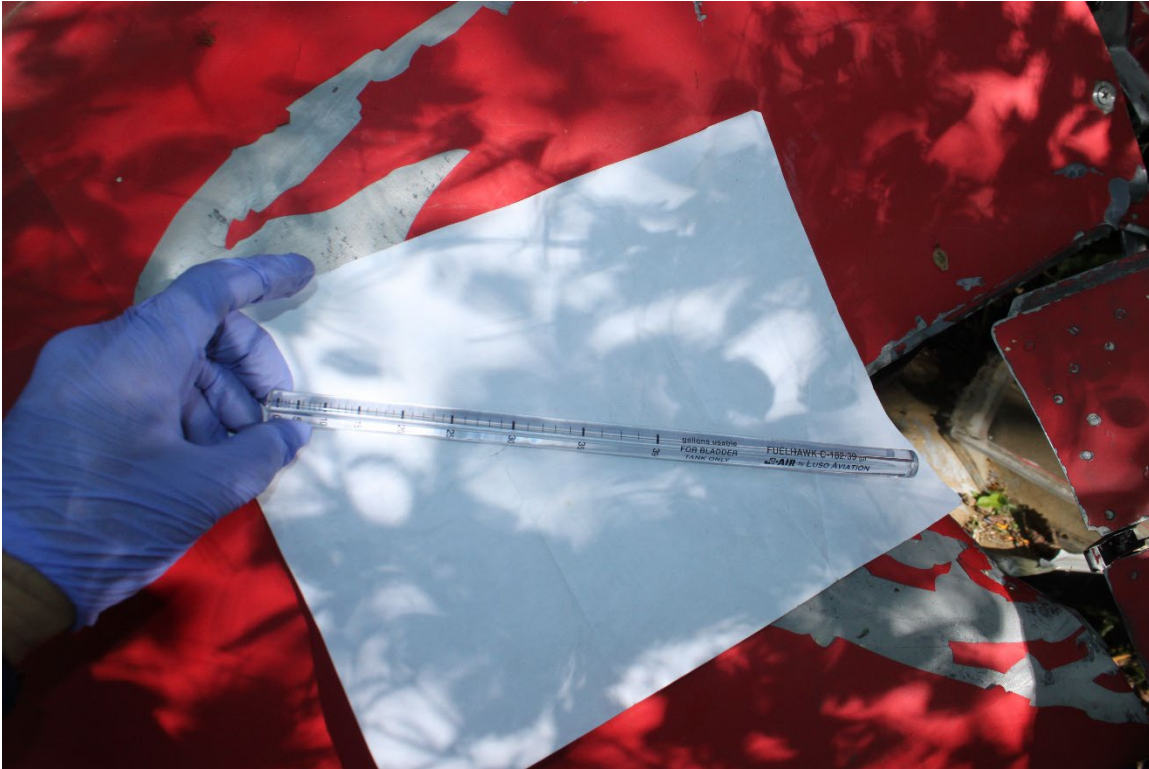
A fuel dipstick was found on the glareshield on the left side near the pilot's corner (Figures 11 and 12). It was marked with "gallons usable FOR BLADDER TANK ONLY", "FUELHAWK C-182/39 gal." and "AIR by Luso Aviation." It had numerical markings of 0, 5, 10, 15, 20, 25, 30, 35, and 39. Between the 0, 5, 10, 15, 20, 25, 30, and 35 numerical markings were 4 individual lines while there were only 3 individual lines between 35 and the 39 numerical markings.

**Figure 11 View of Location Where Dipstick Found**

**Figure 12 View of the Dipstick Recovered in the Wreckage**

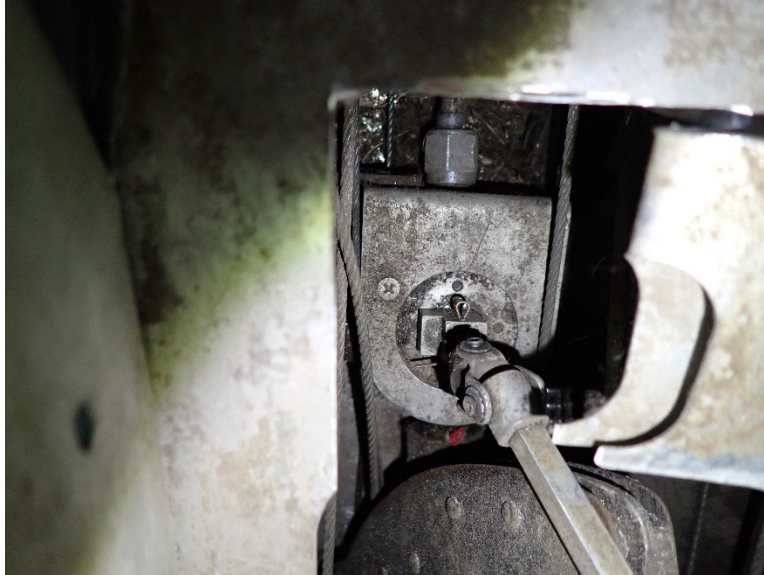
Examination of the fuel selector valve revealed it was in the left fuel tank detent. Following removal of the fuel selector valve from the system no fuel was noted at any of the inlet or outlet ports or lines. Also, no fuel stain was noted on the interior surface of the skin beneath the area of the fuel selector valve (Figure 13).

**Figure 13 View of the Interior Skin Beneath the Fuel Selector Valve**

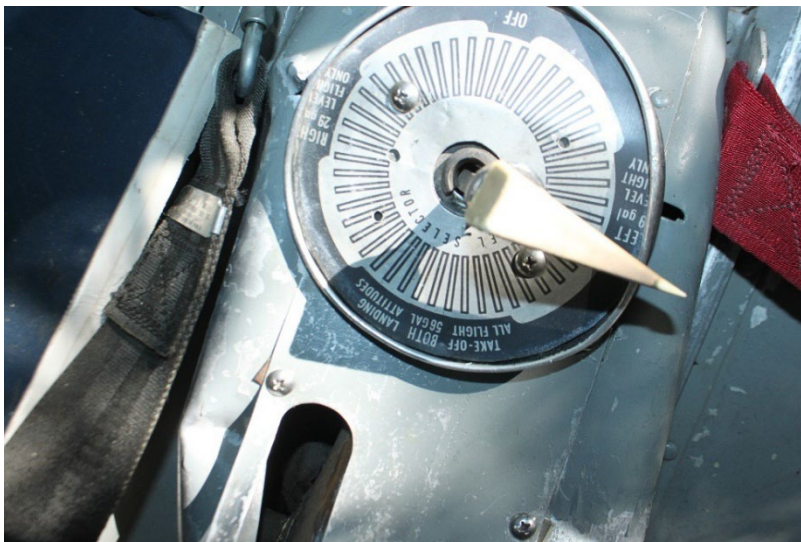
Inspection of the placard adjacent to the fuel selector valve revealed it specified that the "BOTH" position had 56 gallons useable fuel available for "ALL FLIGHT ATTITUDES" while the individual left and right fuel tank positions had 29 gallons useable fuel available for "LEVEL FLIGHT ONLY" (Figure 14).

**Figure 14 Placard Adjacent to Fuel Selector Valve**

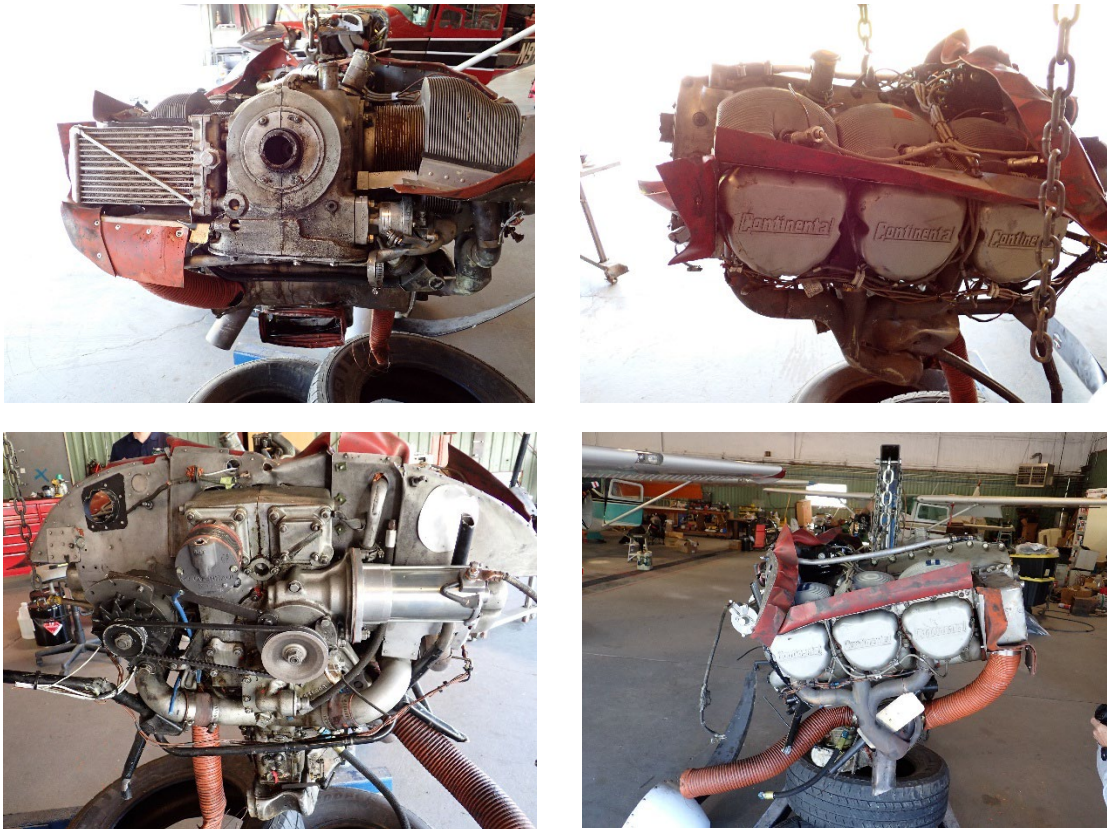
Examination of the engine following recovery (Figure 15) was performed by placing a splined shaft in the vacuum pump drive pad. Rotation of the crankshaft in the direction of rotation was performed for 720° and crankshaft, camshaft and valve train continuity was confirmed. During rotation of the crankshaft the upper spark plugs from all cylinders were removed from the cylinders but then re-connected to the leads and during rotation of the crankshaft spark was noted at all upper spark plugs. The oil level was above 12 quarts but the engine was slightly canted aft. The oil screen was clean but did contain some carbon particles. Following separation of the propeller governor the drive shaft rotated freely and the governor pumped oil that was inside the unit.

**Figure 15: Front, Left, Rear, and Right Side Views of the Engine**

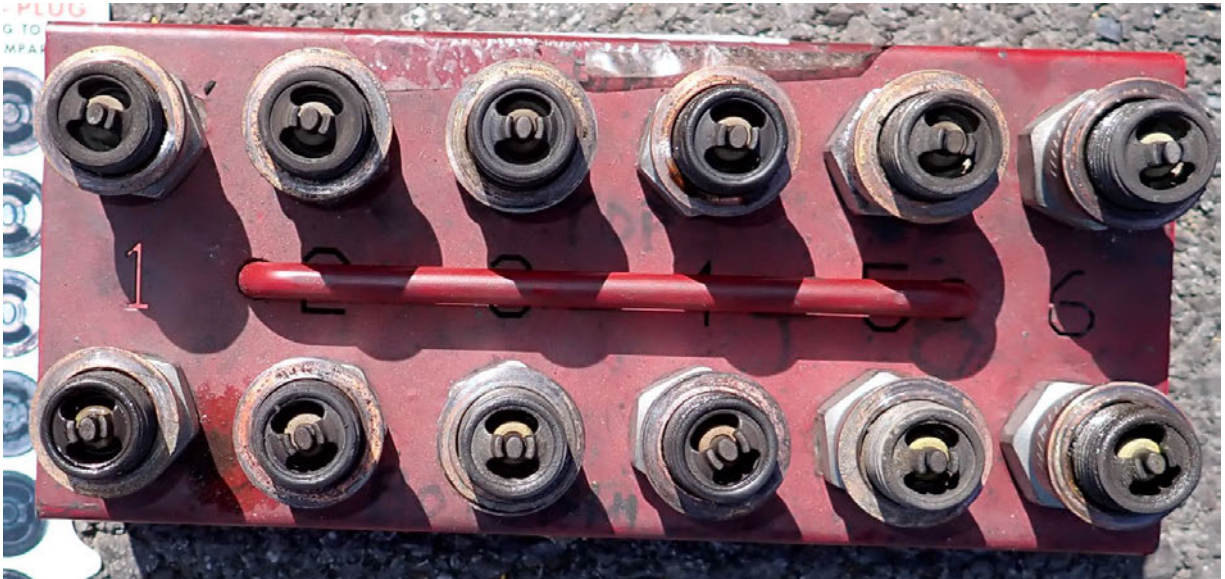
Examination of the spark plugs revealed all were Champion RHM40E massive electrode. All spark plugs exhibited worn out -normal of the center and ground electrodes<sup>2</sup> and normal color (Figure 16). All center electrodes were football shaped.

**Figure 16 View of the Spark Plugs**

Examination of the air induction, exhaust, and lubrication system revealed no evidence of preimpact failure or malfunction. Minor out of tolerance conditions were noted to a few of the spark plugs but there was no evidence of preimpact failure or malfunction of the ignition system.

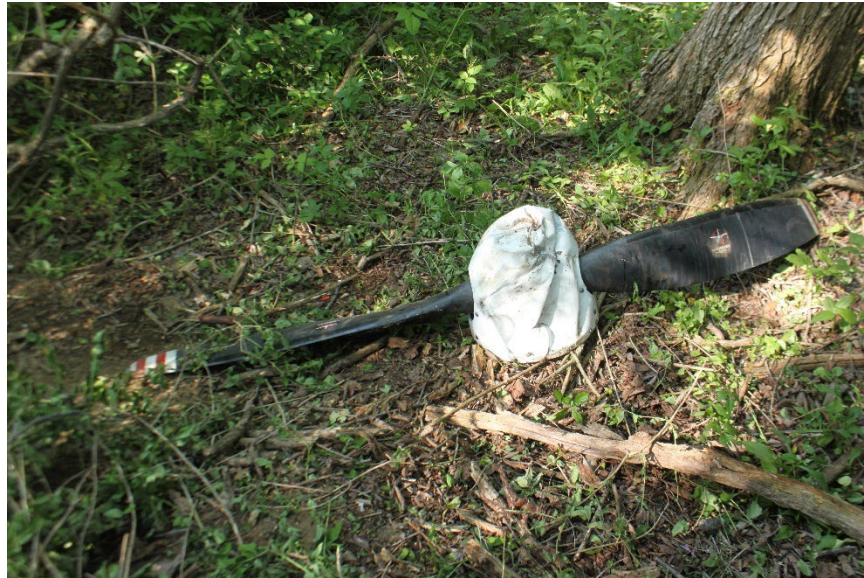
The crankshaft flange fractured and remained attached to the propeller hub flange. The assembly was found in very close proximity to the main wreckage (Figure 17). One blade was bent about 30° beginning about 11 inches from the hub. Chordwise scratches were noted on the blade face, or cambered side of the blade. Abrasion was noted near full span of the blade on the leading edge. The propeller blade was in an abnormal position inside the hub and could not be moved with hand pressure. The leading edge appeared

to be twisted towards low pitch beginning about midspan. The other blade exhibited very slight contact to the leading edge and appeared to be in a normal position in the hub.

**Figure 17 View of the Separated Propeller with Attached Crankshaft Flange**
