## Air Safety Investigations Aircraft Incident/Accident Technical Report

| Aircraft Incident/<br>Accident Information | Year: 1955 | Make: Cessna | Model: 180 |
| | Serial number: 31976 | | Registration: N3178D |
| Senior Air Safety Investigator: Ernest C. Hall | | Report #: ASI-23-BF-T | Report date: 10-23-23 |

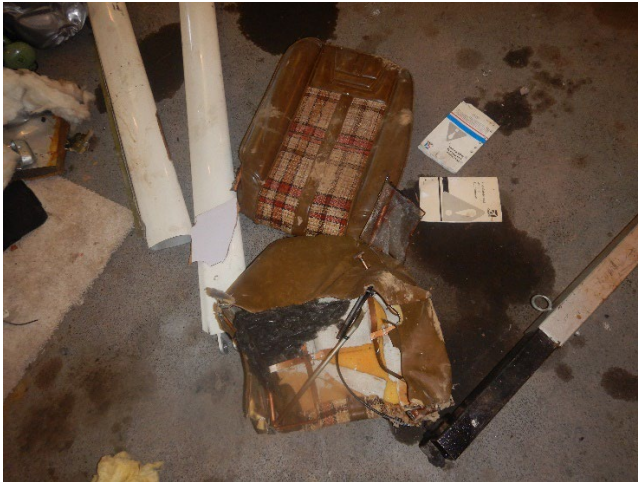
#1 Seat – ASI-23-BF-122

| Restraint System Information | | | | | | |
|---|---|---|---|---|---|---|
| 1 | Yes | 2-Point | Undt | Partially cut | Non-OEM | Yes |

| Seat Condition Information | | | | | |
|---|---|---|---|---|---|
| 1 | Forward facing | Partially | Partially | Partially | Partially |

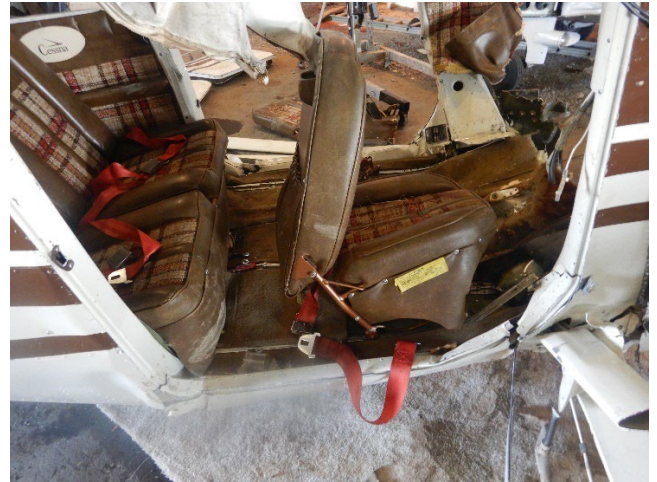
#2 Seat – ASI-23-BF-105

| Restraint System Information | | | | | | |
|---|---|---|---|---|---|---|
| 2 | Yes | 2-Point | Undt | Intact | Non-OEM | No |

| Seat Condition Information | | | | | |
|---|---|---|---|---|---|
| 2 | Forward facing | Partially | Partially | Partially | Partially |

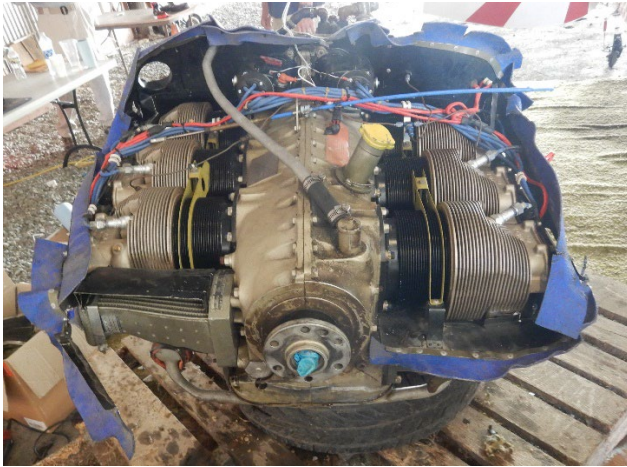
Cropped – Front Engine – ASI-23-BF-131

The engine exhibited minimal impact damage. Cylinder #5 valve cover had a hole in the side, the starter separated from its attachment point, and the oil pan had a hole at the drain plug. The throttle control cable remained attached to the carburetor throttle control arm that was separated from the carburetor. The carburetor control linkage was actuated, and fuel sprayed out of the accelerator pump jet.

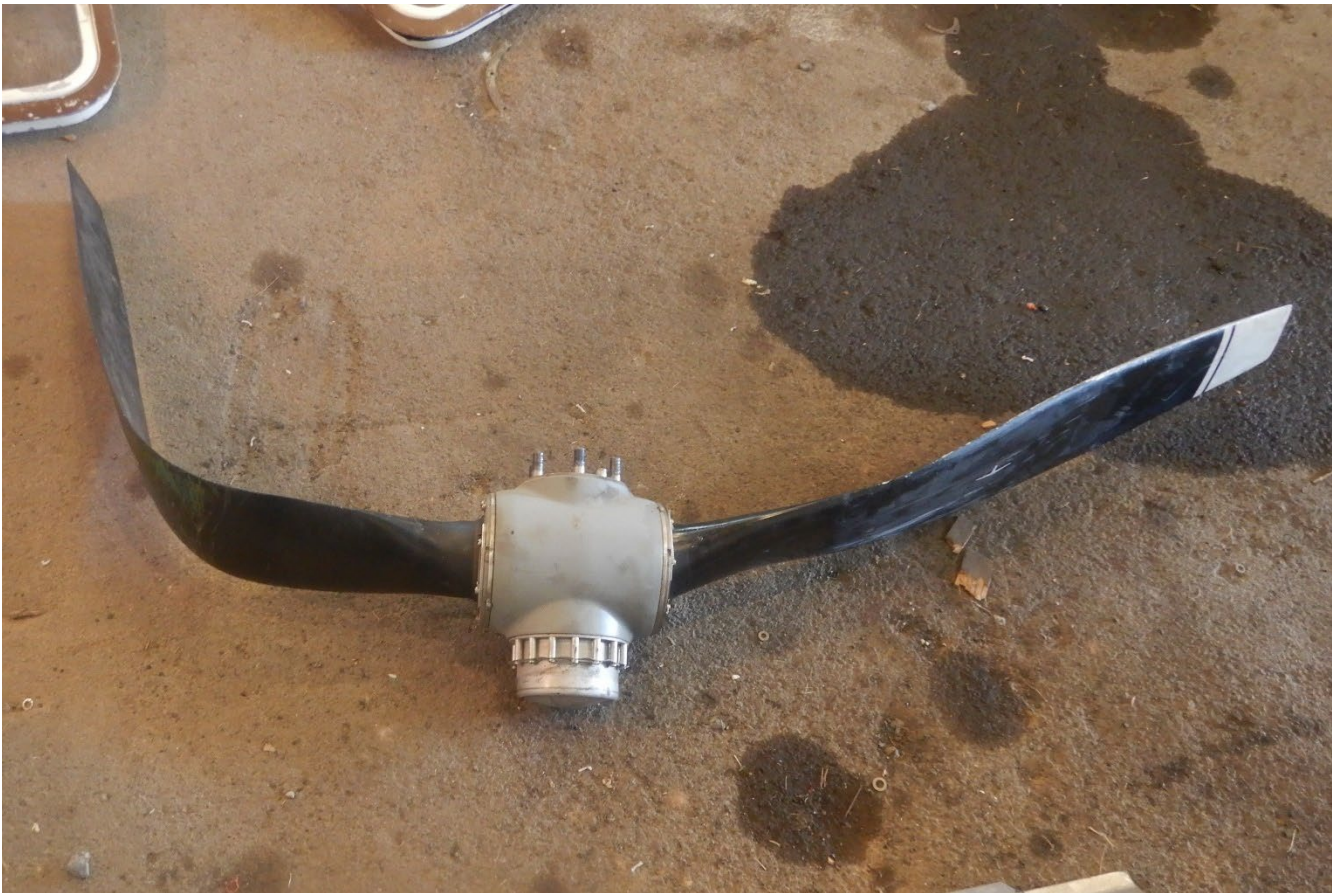
Cropped – McCauley Propeller – ASI-23-BF-124

The McCauley 2-bladed constant speed propeller remained attached to the engine crankshaft propeller flange. One blade was bent aft to the non-camber side about 11" from the root. The other blade exhibited a slight twist and bend aft to the non-camber side.

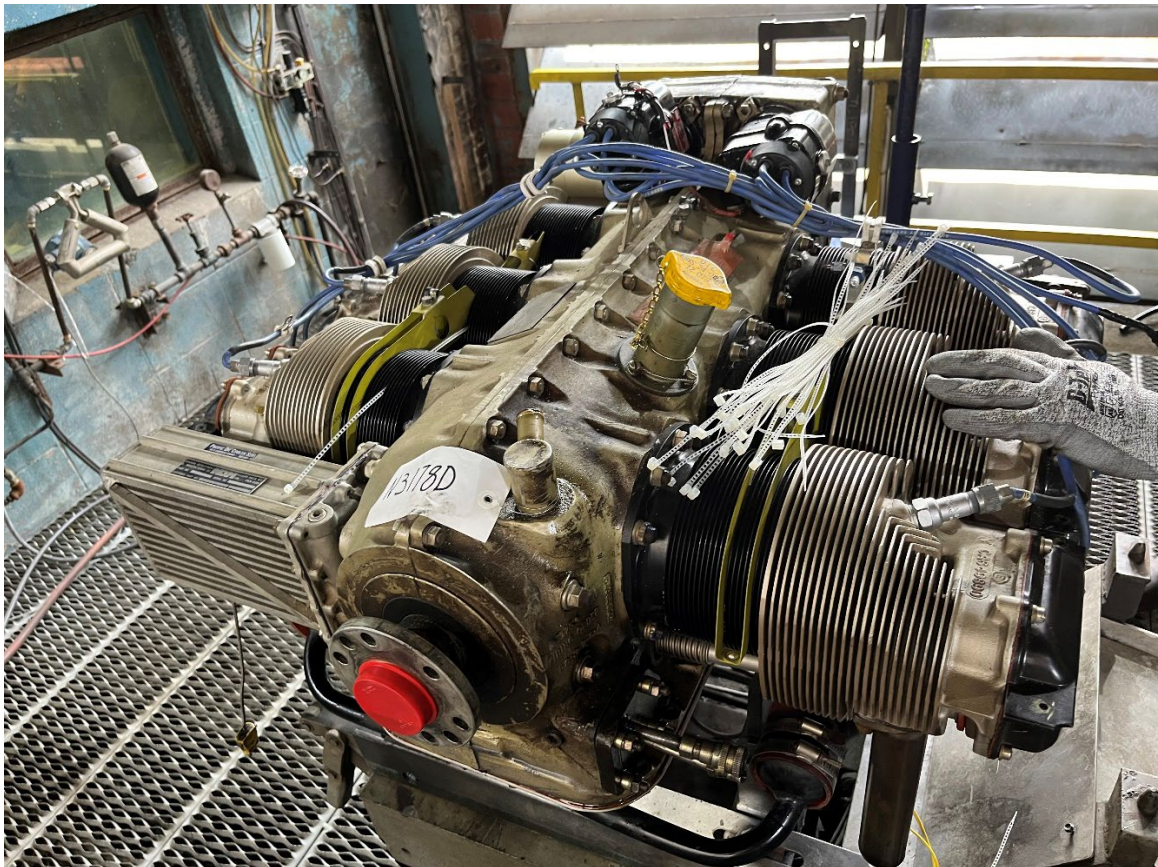
ASI-23-BF-171 – Engine in Test Stand

On 08-24-23, engine S/N 45748-5-J was uncrated and prepared for run testing at Continental Aerospace Technologies analytical testing facility. The impact damaged air induction system was replaced with a like system. The impact damaged oil cooler was replaced with a suitable replacement. It was noted when the original oil cooler was removed that the gasket had been installed backwards, partly blocking the oil passage. The original carburetor, magnetos, ignition harness, and spark plugs were used in the test run. During the test run the engine produced 2,450 RPM at 27.7 inches of manifold pressure (Max 2,550 RPM).
