# National Transportation Safety Board

ERA23FA256

## **AIRWORTHINESS**

Group Chair's Factual Report

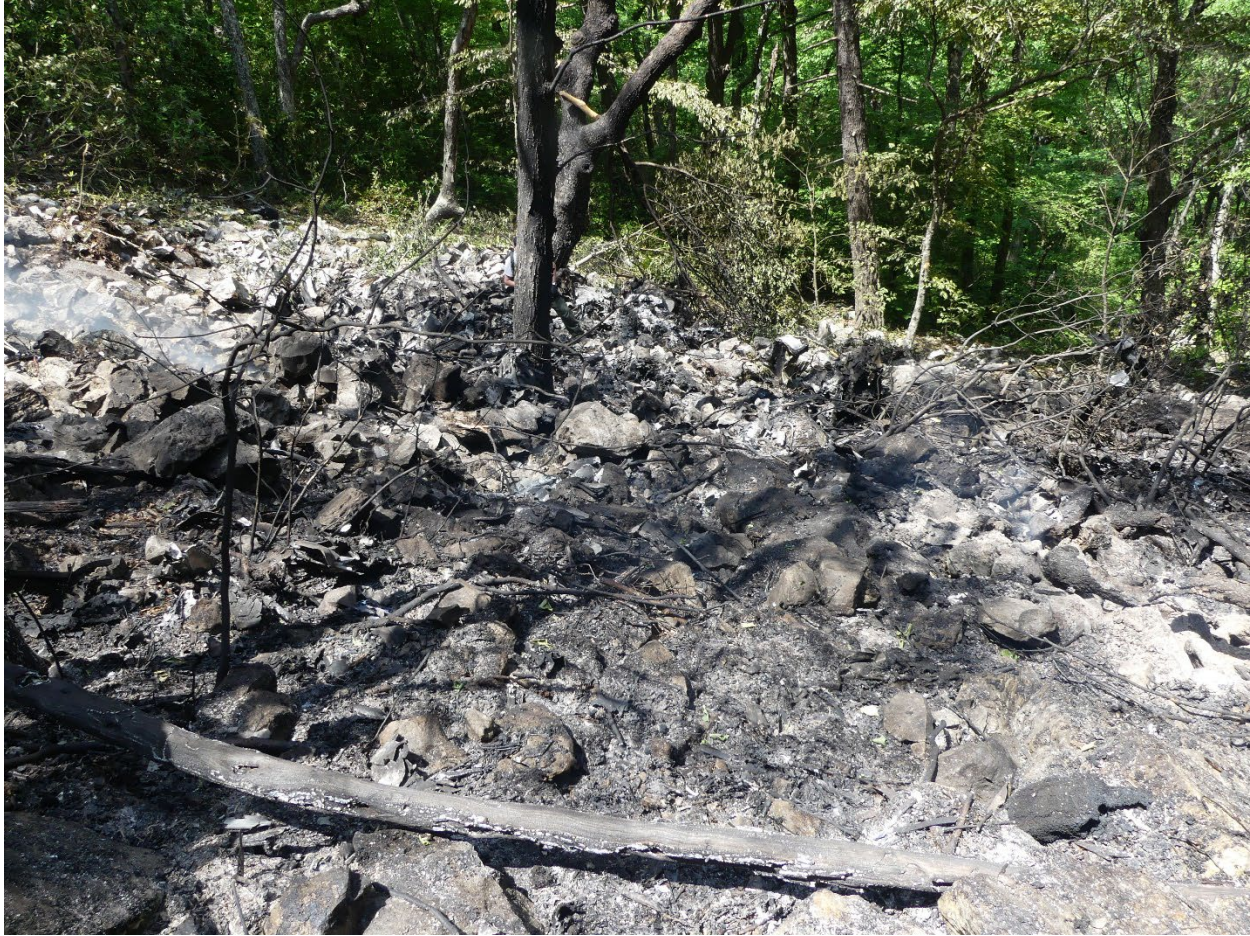
**Figure 11.** Accident scene.

The airplane impacted steep rocky terrain about 1.5 miles north of the Montebello VOR (see Figure 11). The debris field was condensed in a very small area consistent with the aircraft impacting the ground at a nearly vertical angle. The near vertical angle was determined based on the angle that the tree limbs surrounding the debris field were severed. The wreckage was extremely fragmented and scattered around a main crater. A post impact fire occurred. One engine was generally intact and was located approximately 100 feet downhill from the impact crater. The other engine was fragmented and located in the debris field. The following components were located in the debris field: left main landing gear assembly, both thrust reverser structure, tail structure with a portion of the elevator, a section of rudder, pieces of both ailerons on opposite sides of debris field, flap tracks, four wing attachment points, pieces of control cable from the tail, pieces of avionics boxes, seat frames and seat track, wing skin and portions of the wet wing structure.

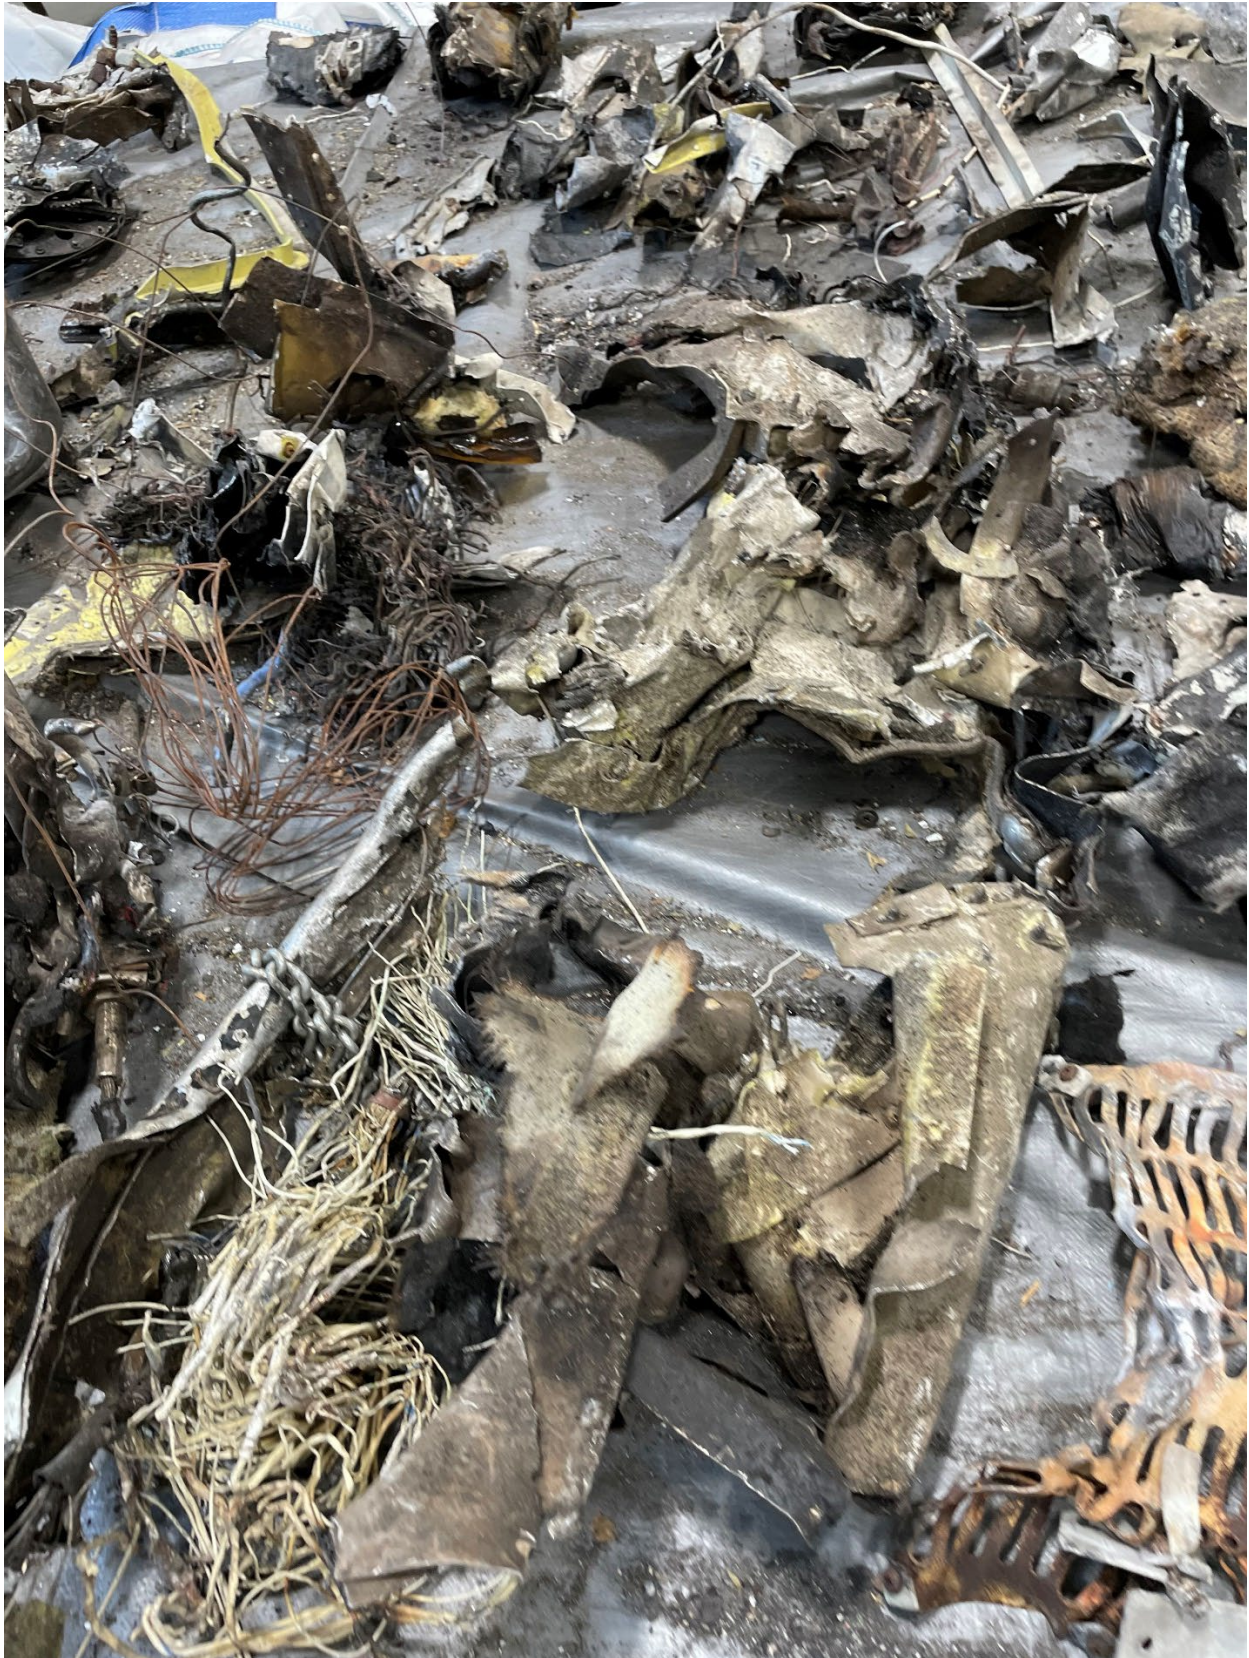
**Figure 13.** Representative picture of wreckage debris.

The group met at Anglin Air Recovery Services' facility in Clayton, DE on 6-7 September 2023 to examine the wreckage recovered from the accident site. The group examined eighteen bags of wreckage looking for the CVR, pressurization, bleed air, oxygen, and flight control components. The aircraft data plate was recovered (see Figure 12). The wreckage was highly fragmented (see Figure 13). No components of the CVR were found.

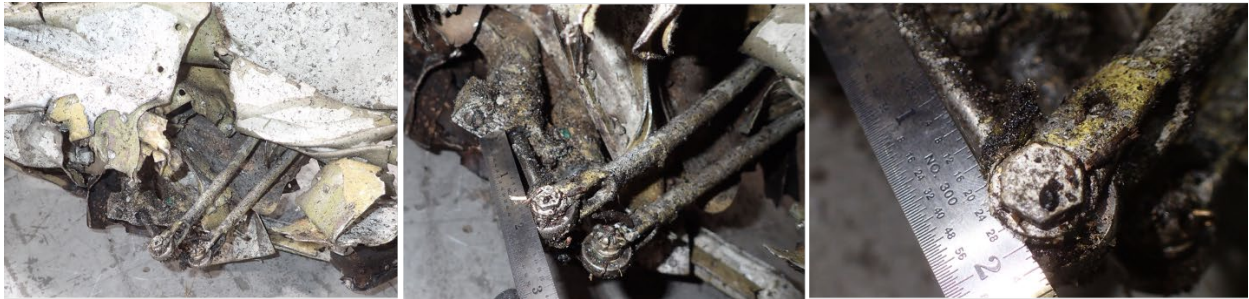
**Figure 15.** Photos of left elevator trim actuator.

The left elevator trim was measured at 1.7 inches, which corresponds to 5 degree tab up trim (see Figure 15). The right elevator trim actuator was 1.8 inches, which corresponds to 6.5 degrees tab up (see Figure 16). The right elevator trim actuator rod was bent 90 degrees and sustained heavy impact related damage.

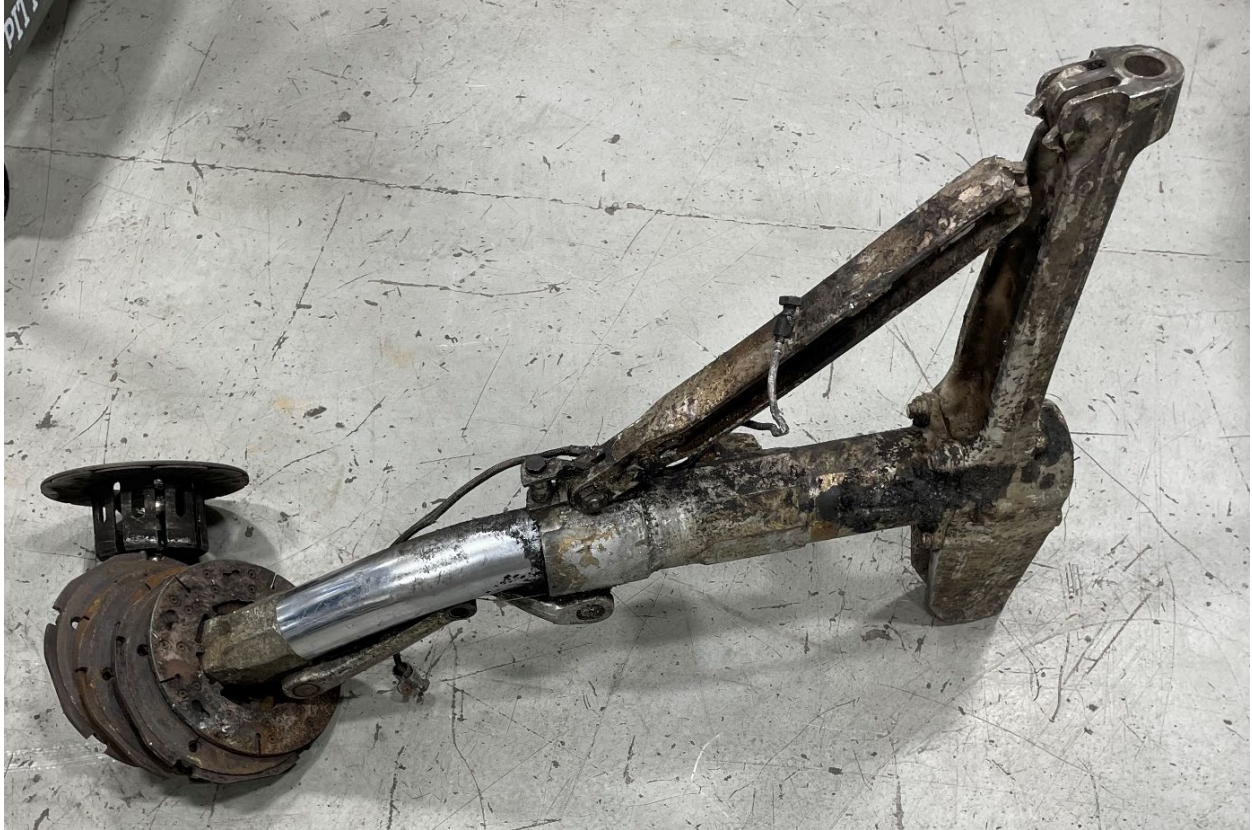
**Figure 19.** Left main landing gear.

The left main landing gear was located (see Figure 19). One main landing gear wheel and one main landing gear actuator were located but their position could not be determined.

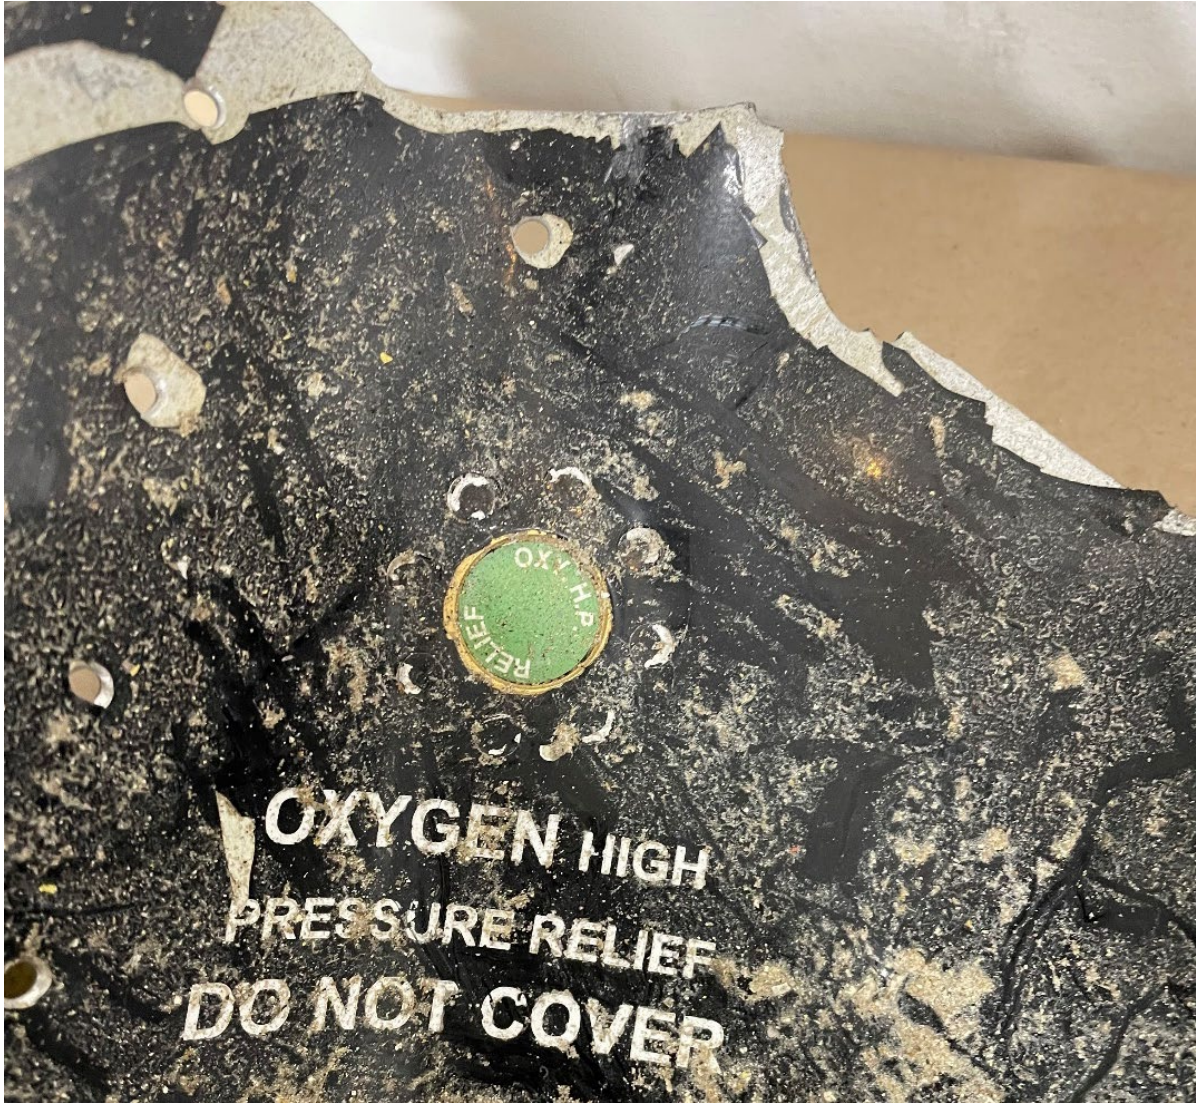
**Figure 20.** Photo of oxygen high pressure relief valve overboard discharge indicator.

The oxygen high pressure relief valve overboard discharge indicator and a fragment of structure was located (see Figure 20). The oxygen high pressure relief valve overboard discharge indicator was intact. Bleed air flow valve and sections of ducting were located in the debris.

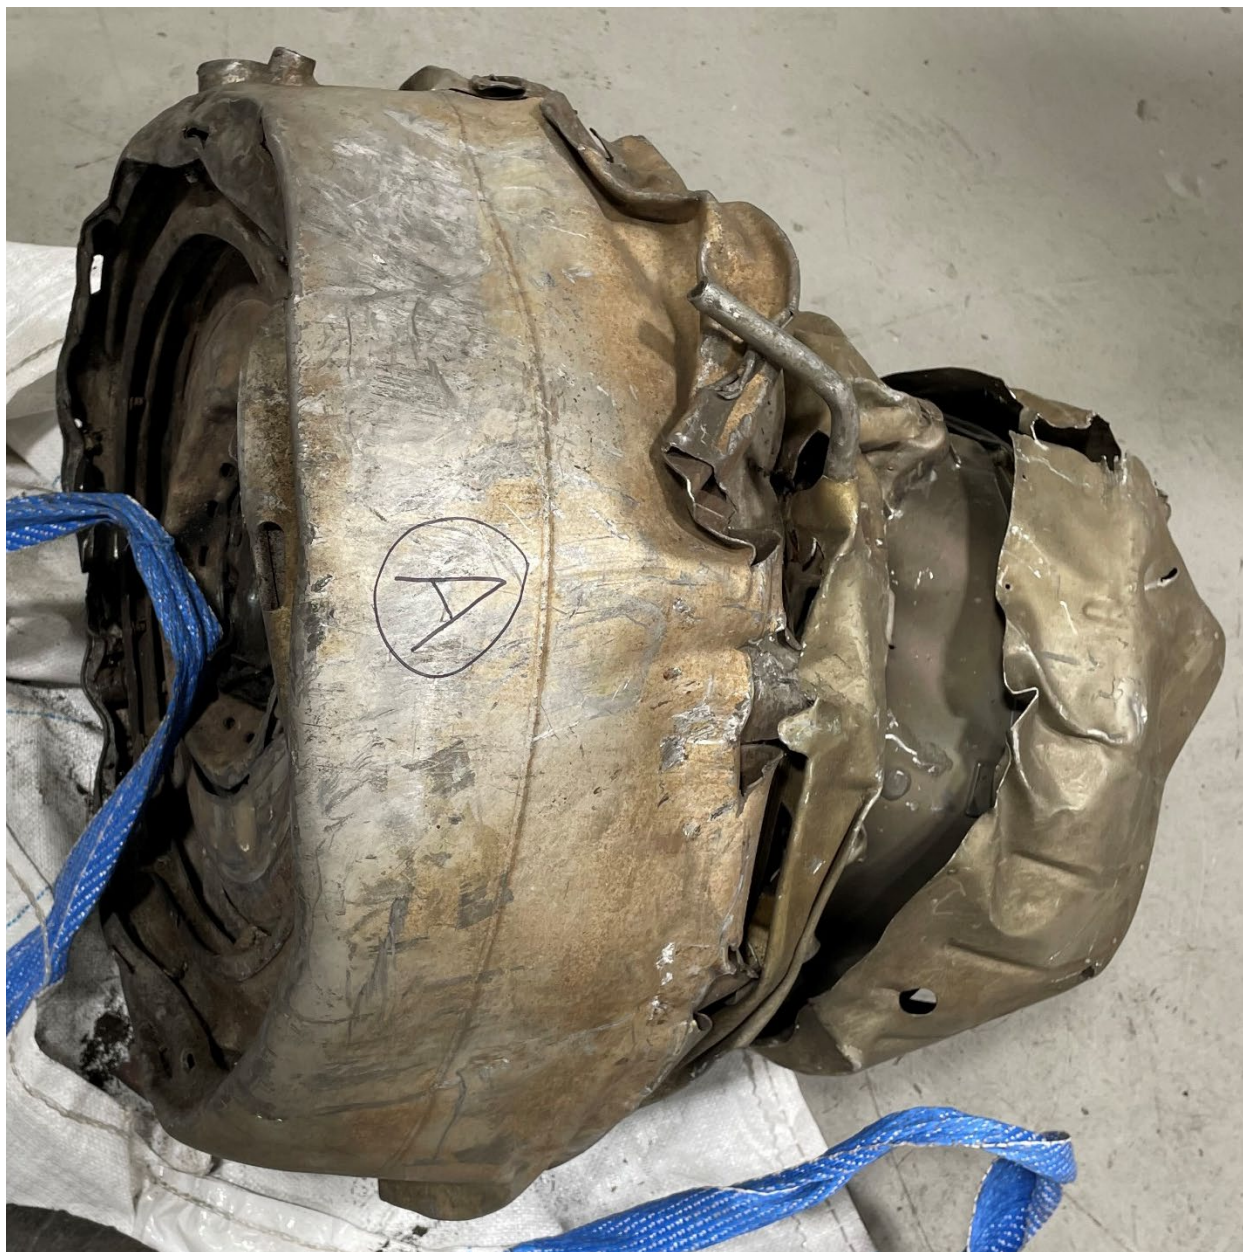
**Figure 23.** Photo of engine A.

The following observations of engine A (see Figure 23) were noted:

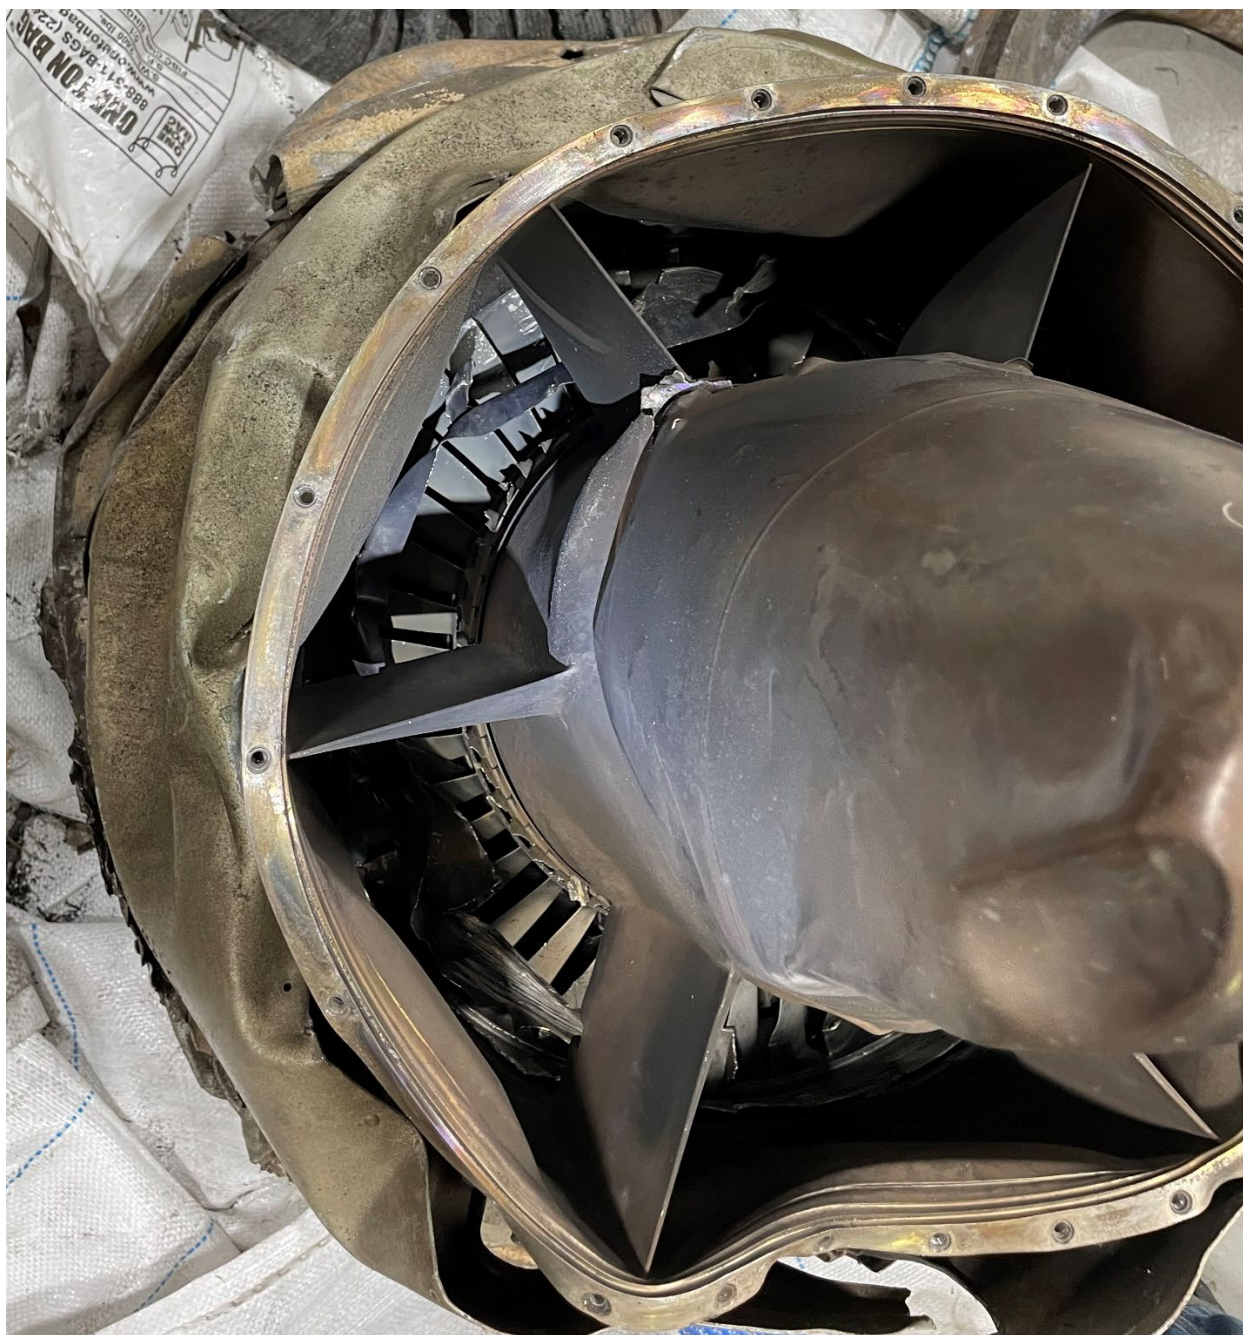
**Figure 24.** Photo of engine A second stage LPT.

- Aft looking forward, all the second stage low pressure turbine (LPT) blades were fractured at their platforms. Scoring was observed on the second stage blade tip shroud (see Figure 24).

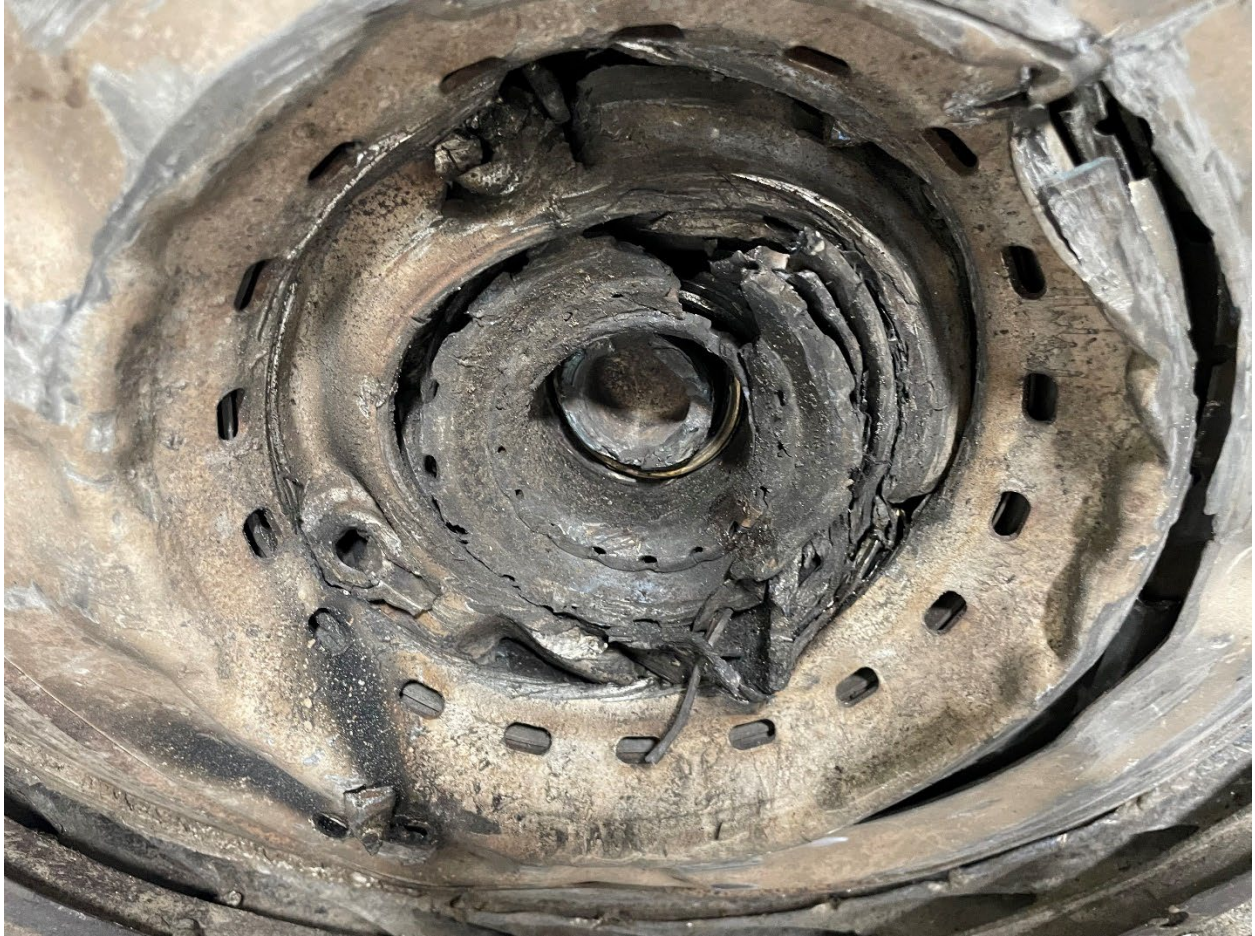
**Figure 25.** Photo of engine A compressor diffuser.

- The compressor diffuser was buckled, and rotational scoring was observed. Both HP and LP shafts were fractured and separated (see Figure 25).
- The high pressure compressor (HPC) impeller was separated and showed signs of rotational scoring. About 1/5 of the impeller exducer was fractured and was missing. The majority of the impeller blades were fractured and were missing at the root. Some remaining blades were bent over, opposite direction of rotation. The bevel gear for the accessory drive was fractured (see Figure 26).

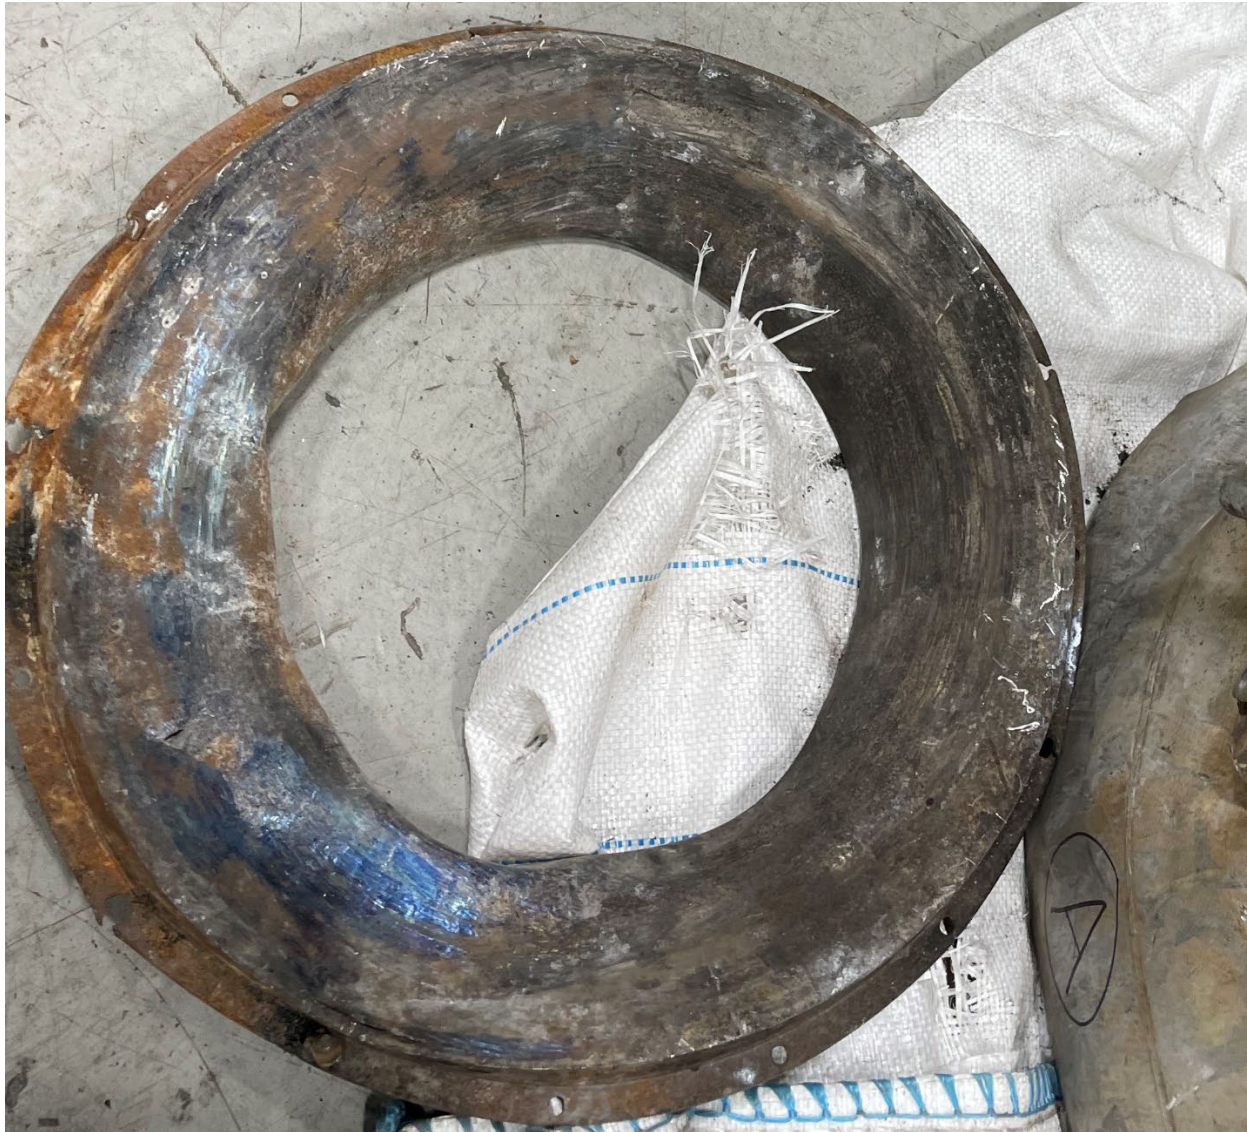
**Figure 27.** Photo of engine A HPC impeller shroud.

- The impeller shroud was deformed and evidence of 360 degree rotational scoring and blueing was observed (see Figure 27).

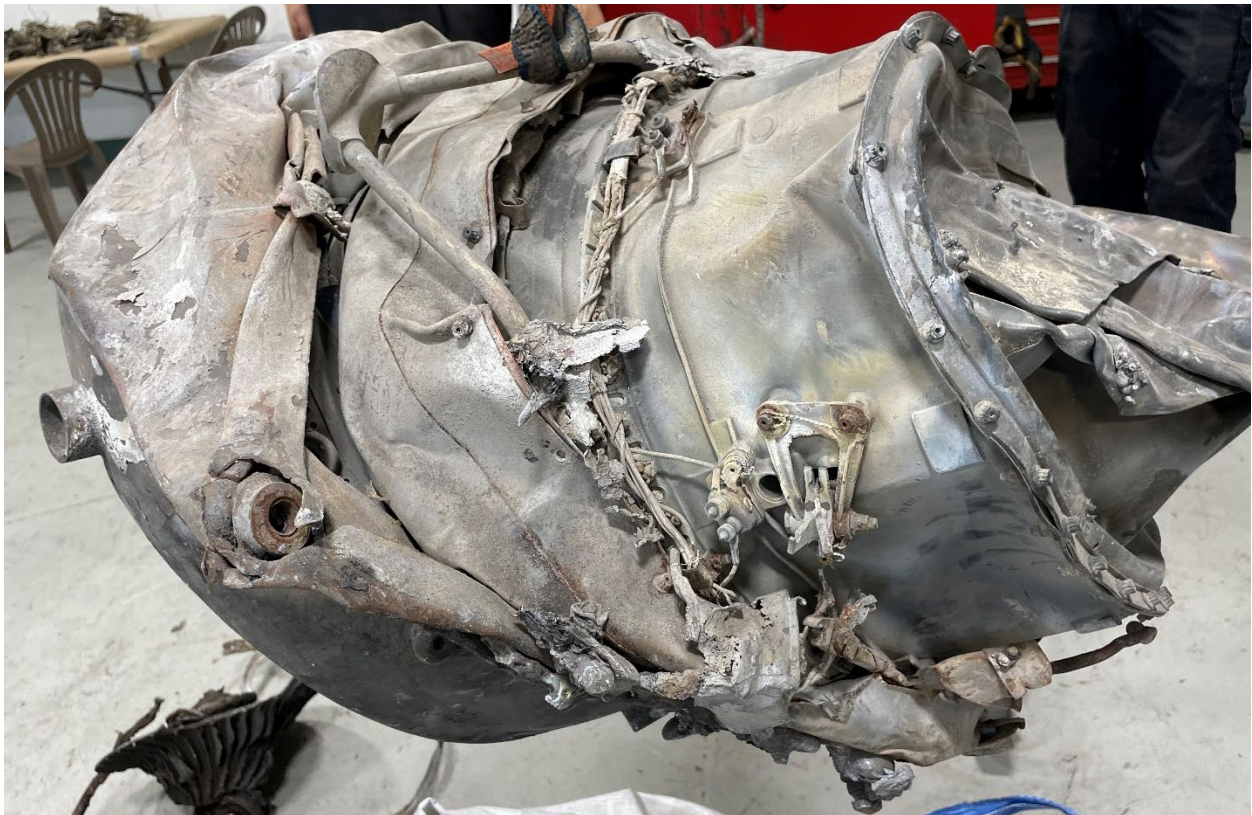
**Figure 28.** Photo of engine B.

The following observations of engine B (see Figure 28) were noted:

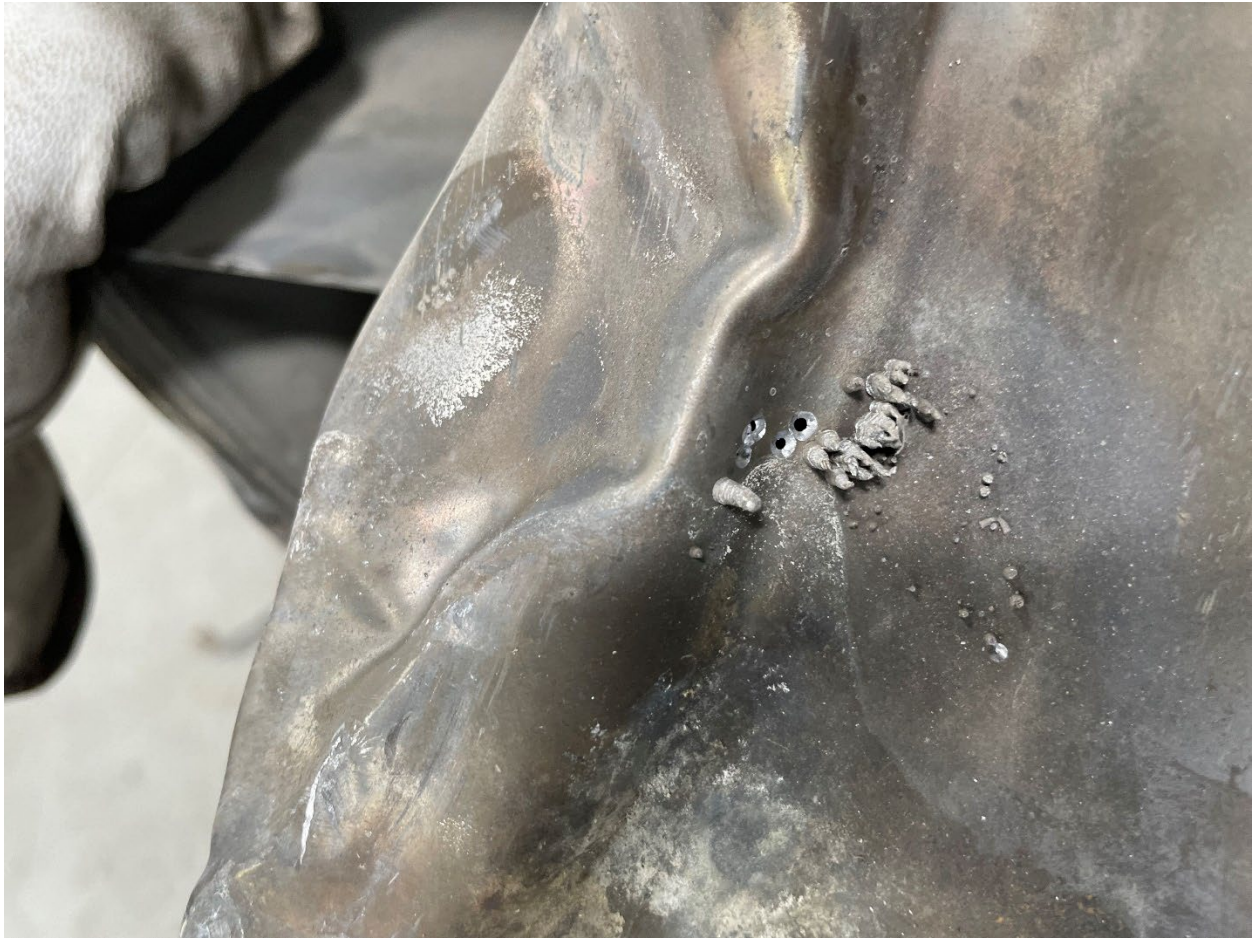
**Figure 29.** Photo of engine B exhaust nozzle.

- Aft looking forward, the exhaust nozzle was attached and deformed. There were holes observed on the exhaust nozzle, with evidence of foreign material and melted deposits near the holes (see Figure 29).
- The exhaust center cone and support struts were present.
- The second stage LPT blades were fractured and separated at the platforms (see Figure 30). The LPT module appeared displaced aft. About half of the second stage LPT vanes were fractured and exhibited trailing edge impact damage. First stage LPT blades were fractured at the platform or were separated and missing.

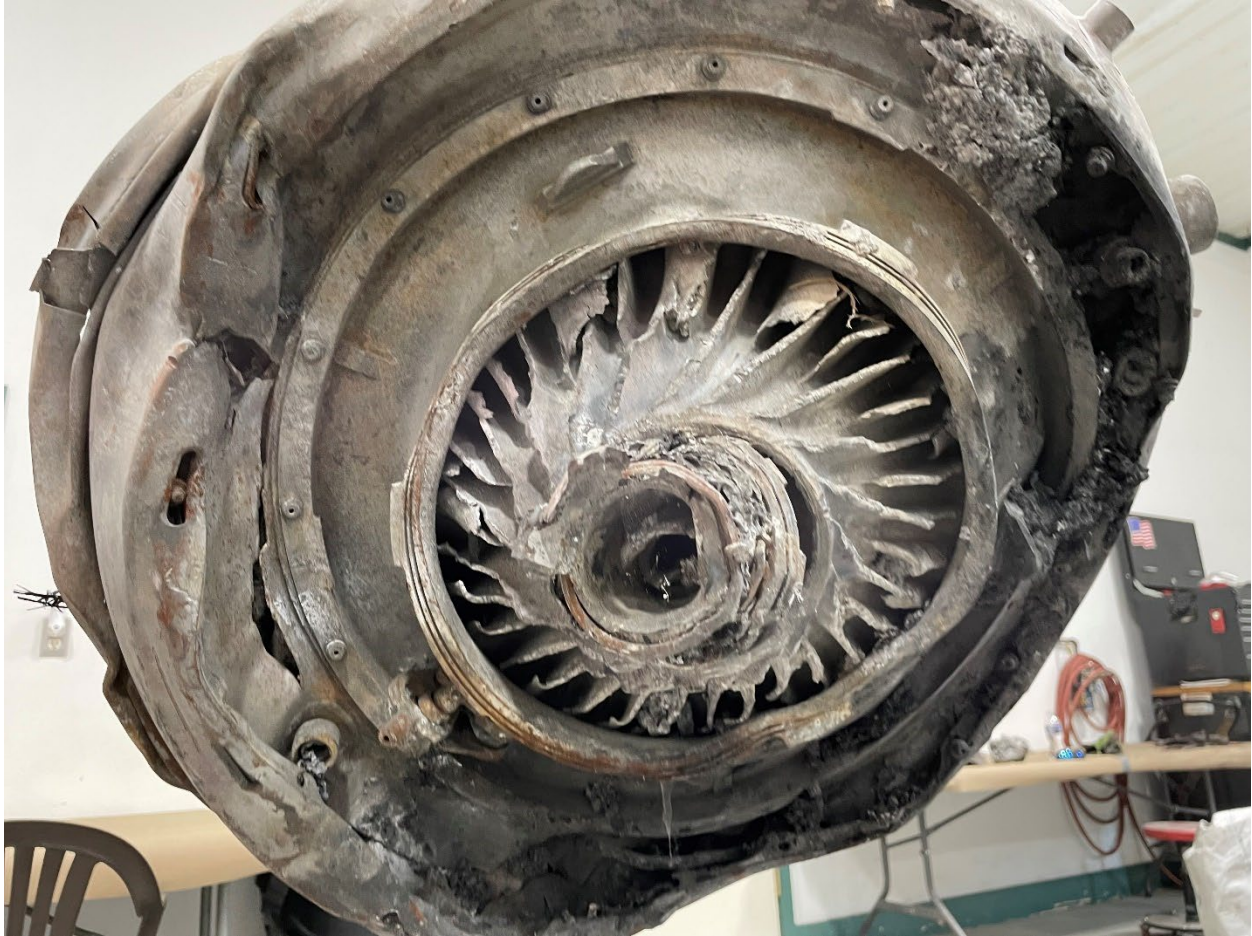
**Figure 31.** Photo of engine B compressor impeller.

- The HPC impeller remained on the shaft. The majority of the blades were fractured at the root and missing. The remaining blades were bent opposite direction of rotation (see Figure 31).
- The HP and LP shafts were fractured forward of the impeller.
- The engine case had partially separated due to impact related damage, allowing a view of the combustor and the HPT rotor (see Figure 32). The HPT blades were missing.
- The HPC impeller shroud was deformed. It showed marks of rotational scoring (see Figure 33).
