**Wreckage Examination  
NTSB Accident Number  
ERA23FA258**

| Location: | Jamestown, NY |
| Date: | June 6, 2023 |
| Aircraft: | Cirrus SR22T |

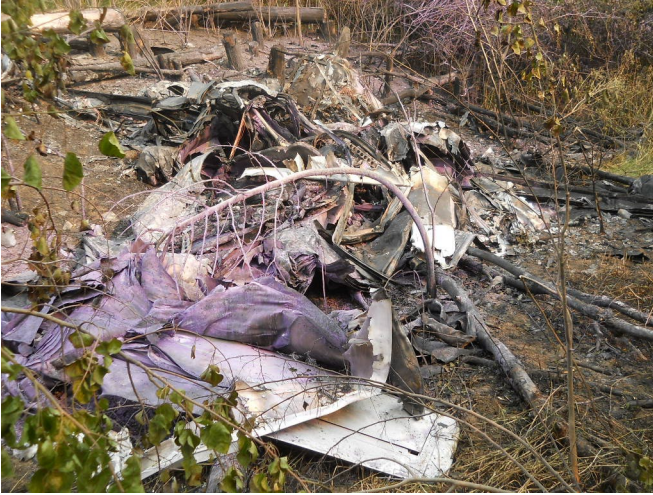
The wreckage came to rest upright, oriented north, and was mostly consumed by fire. No debris path was observed, and the CAPS was recovered next to the wreckage. The four corners of the airplane were identified. The empennage remained attached and was partially consumed. The RDM sustained thermal damage, but was recovered from the empennage. The forward cockpit section and instrument panel were destroyed. Both wing ailerons and flaps had separated and were partially consumed. Flight control cable continuity was confirmed from the cockpit to all control surfaces. Measurement of the flap actuator corresponded to 50% flap extension. Measurement of the elevator trim motor corresponded to a neutral trim position.

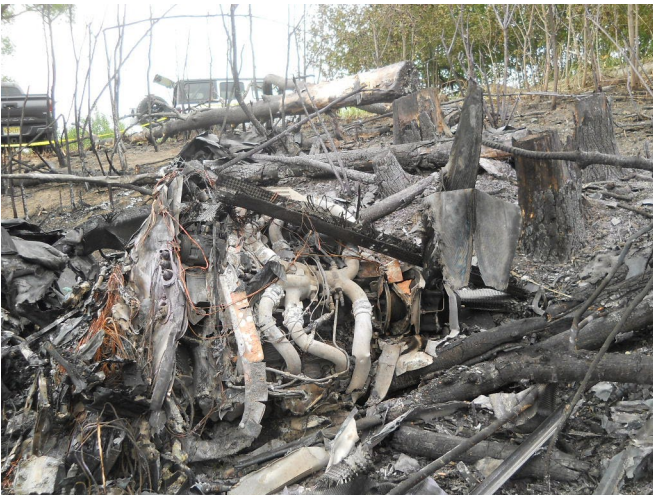
The propeller hub remained attached to the engine. Two composite blades separated, and one remained attached. The engine was retained for further examination.
