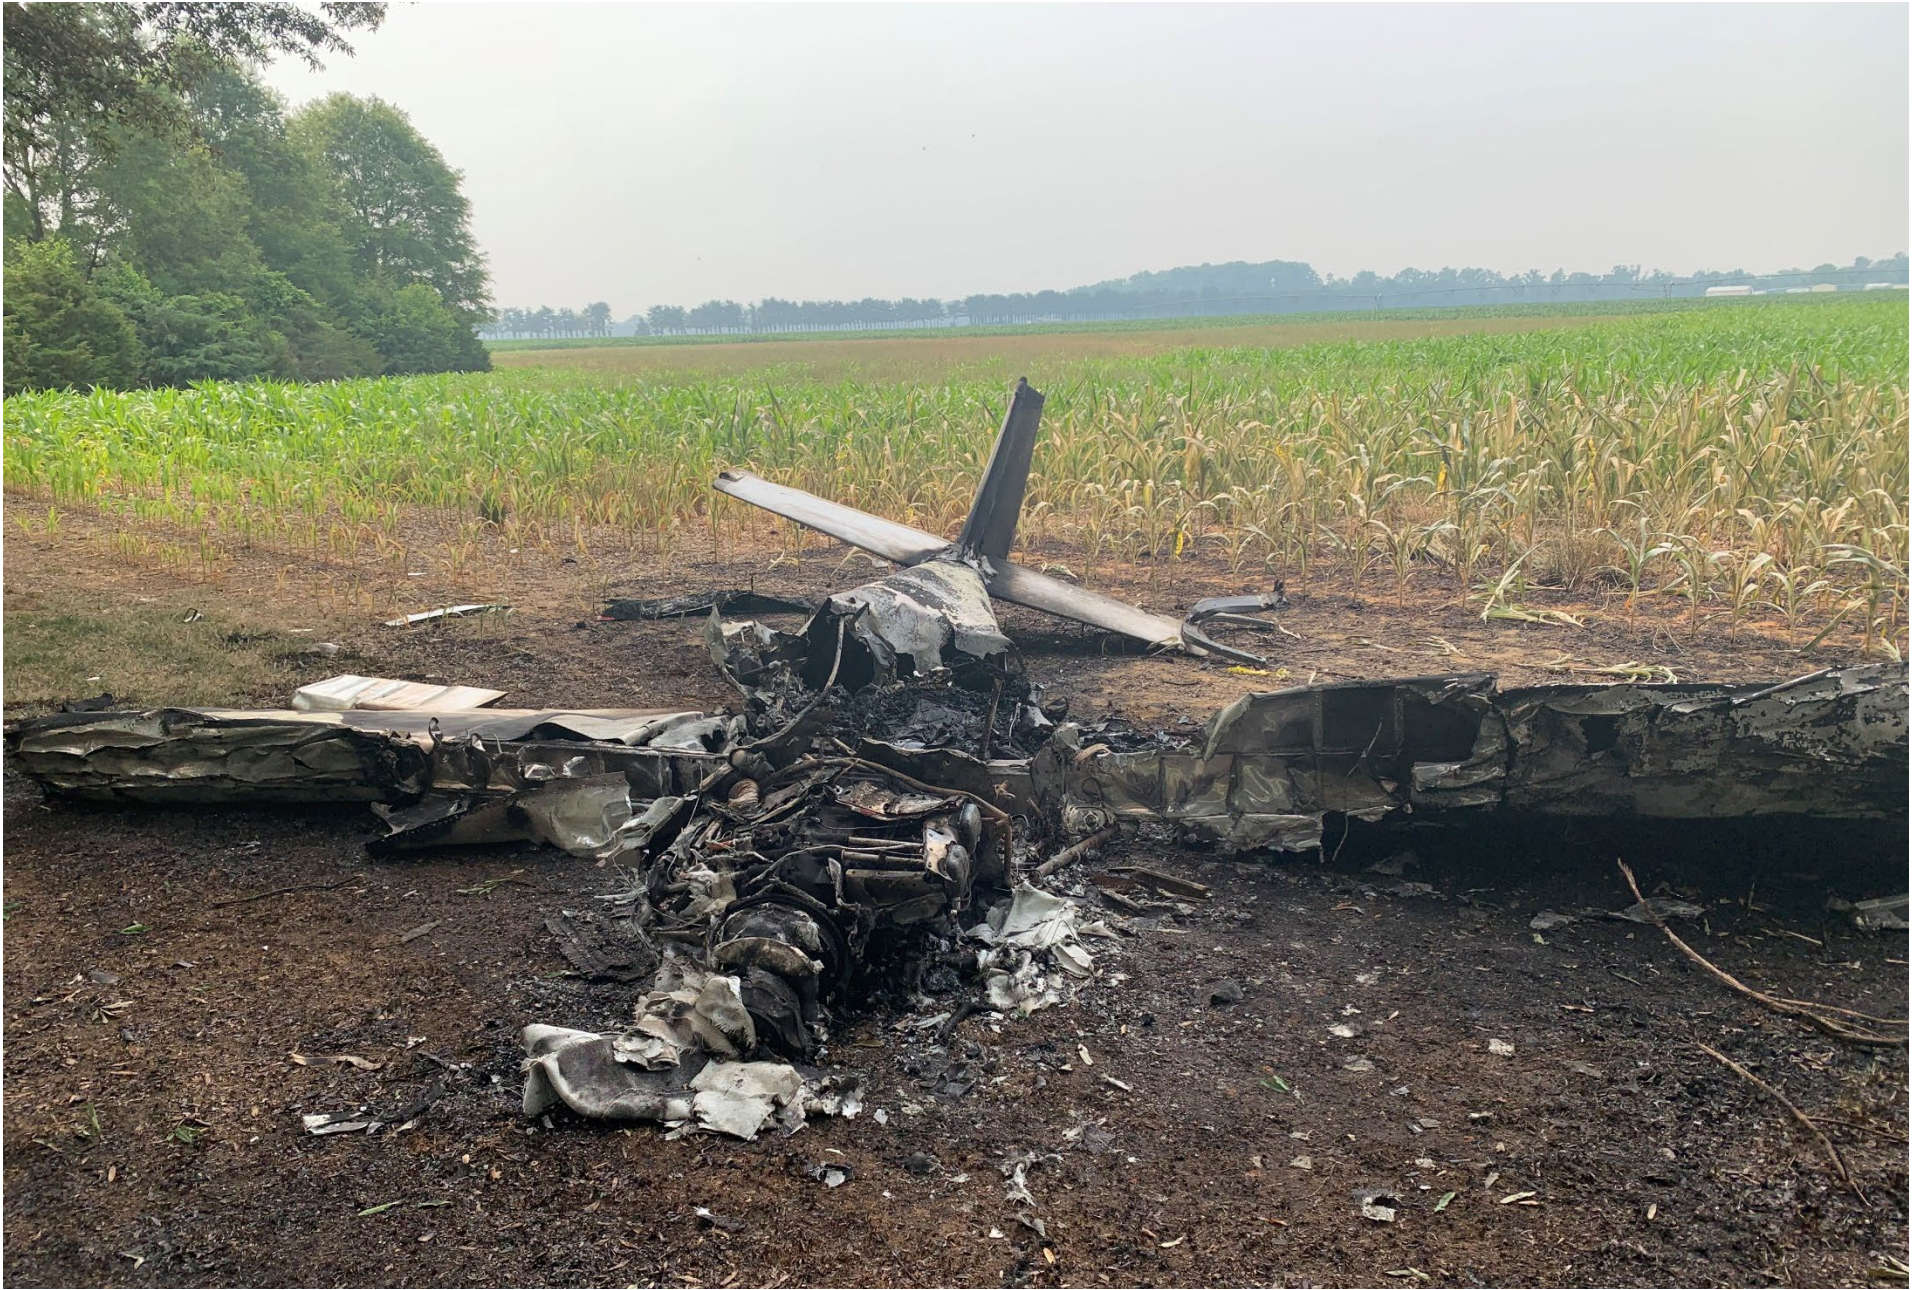
**Photo 1 – Main wreckage, front view**

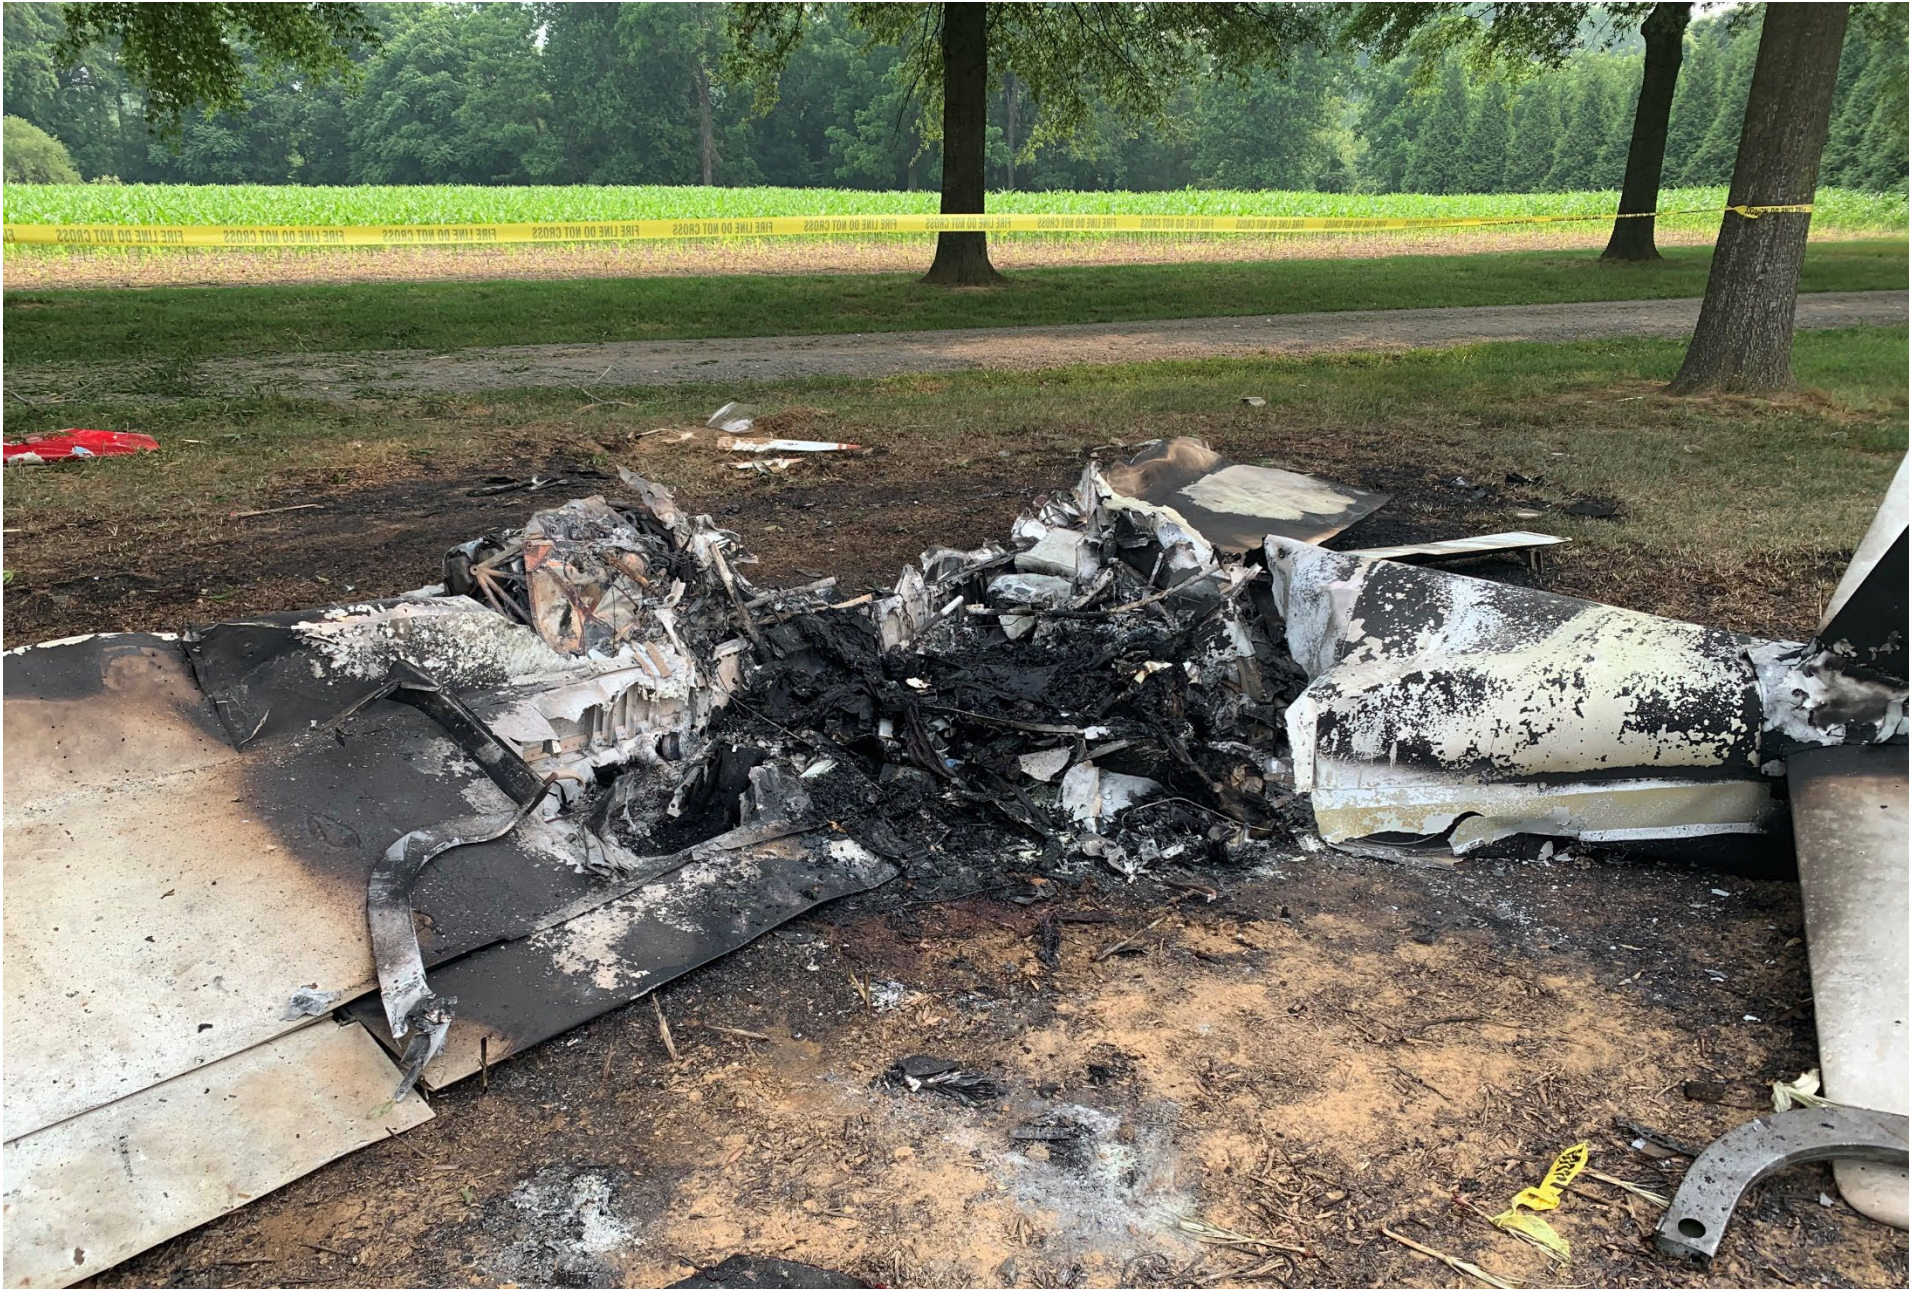
**Photo 2 – Main wreckage**

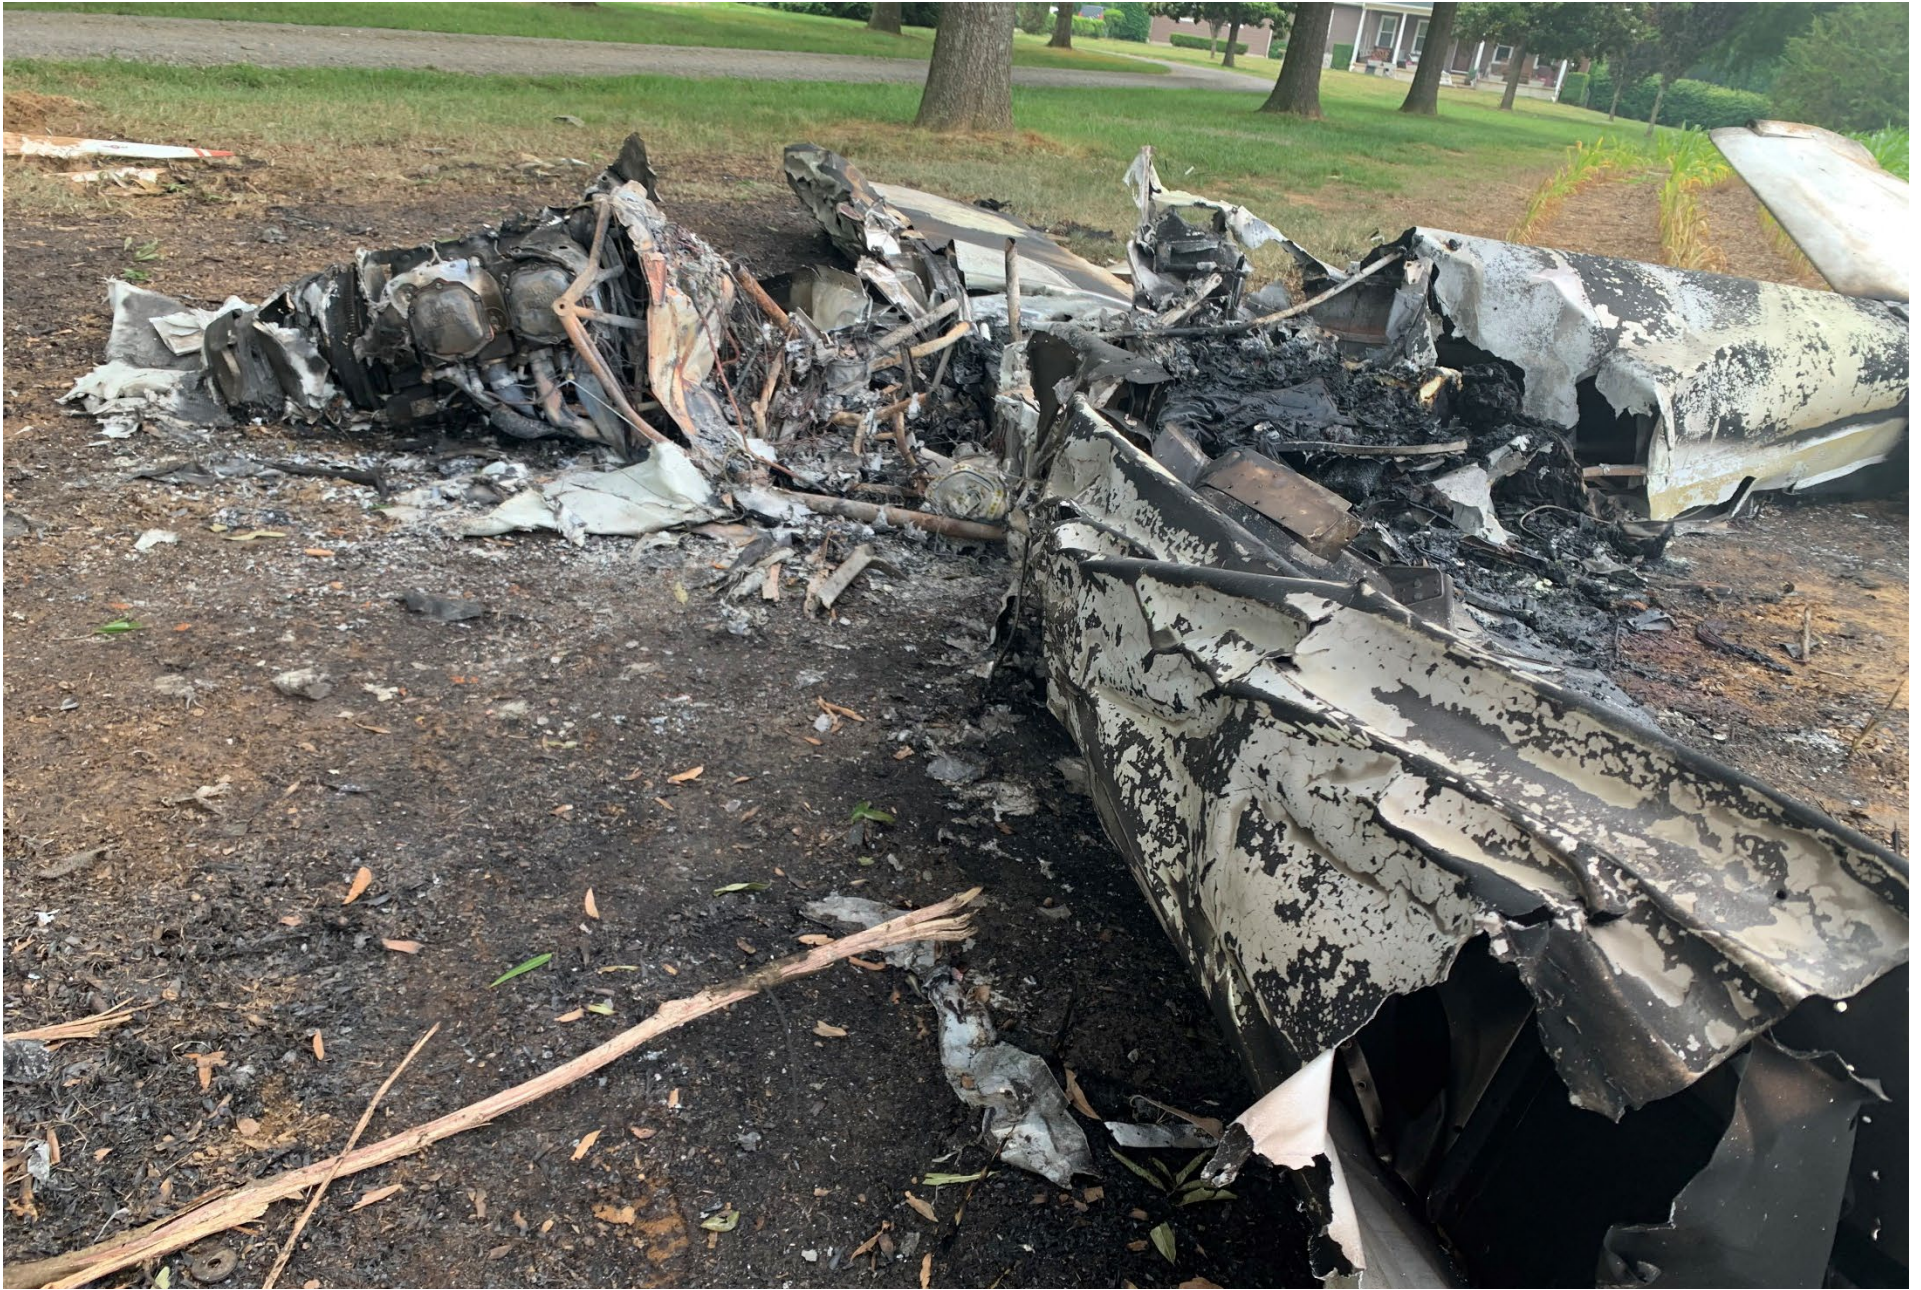
**Photo 3 – Main wreckage, view from left wing, note accordion crushing on leading edge**

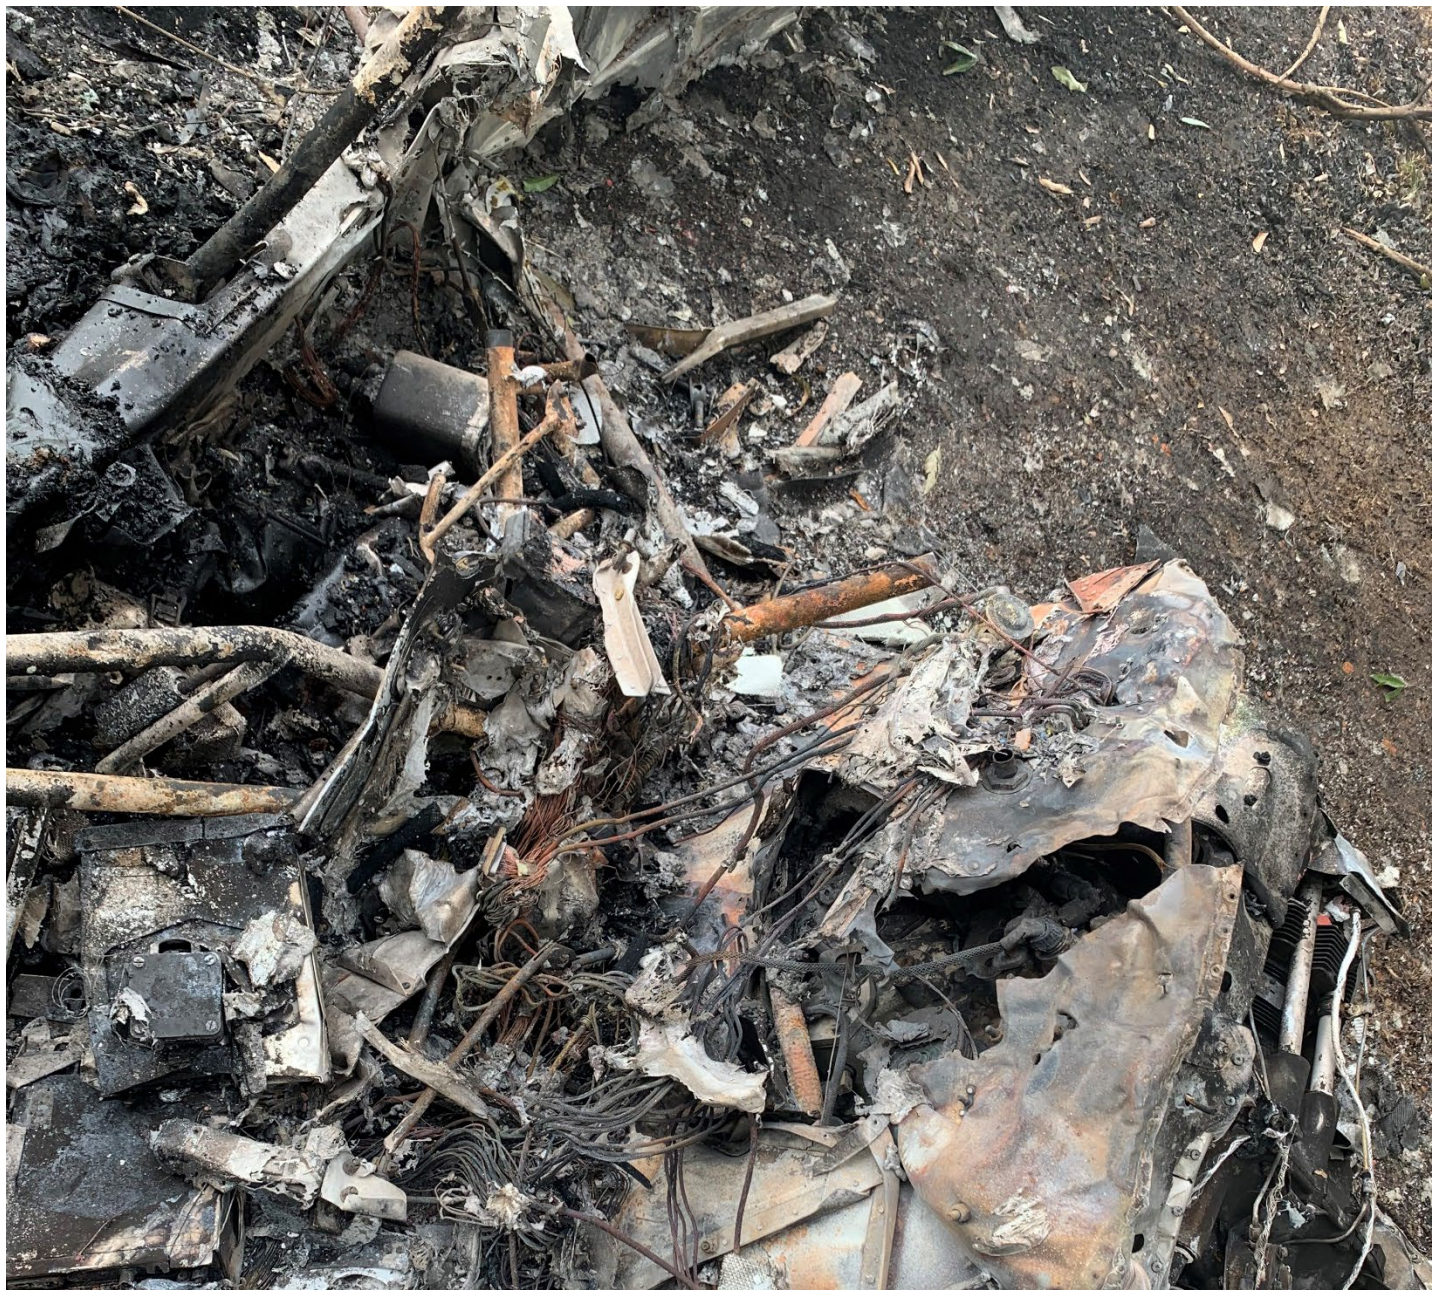
**Photo 4 – Instrument panel**

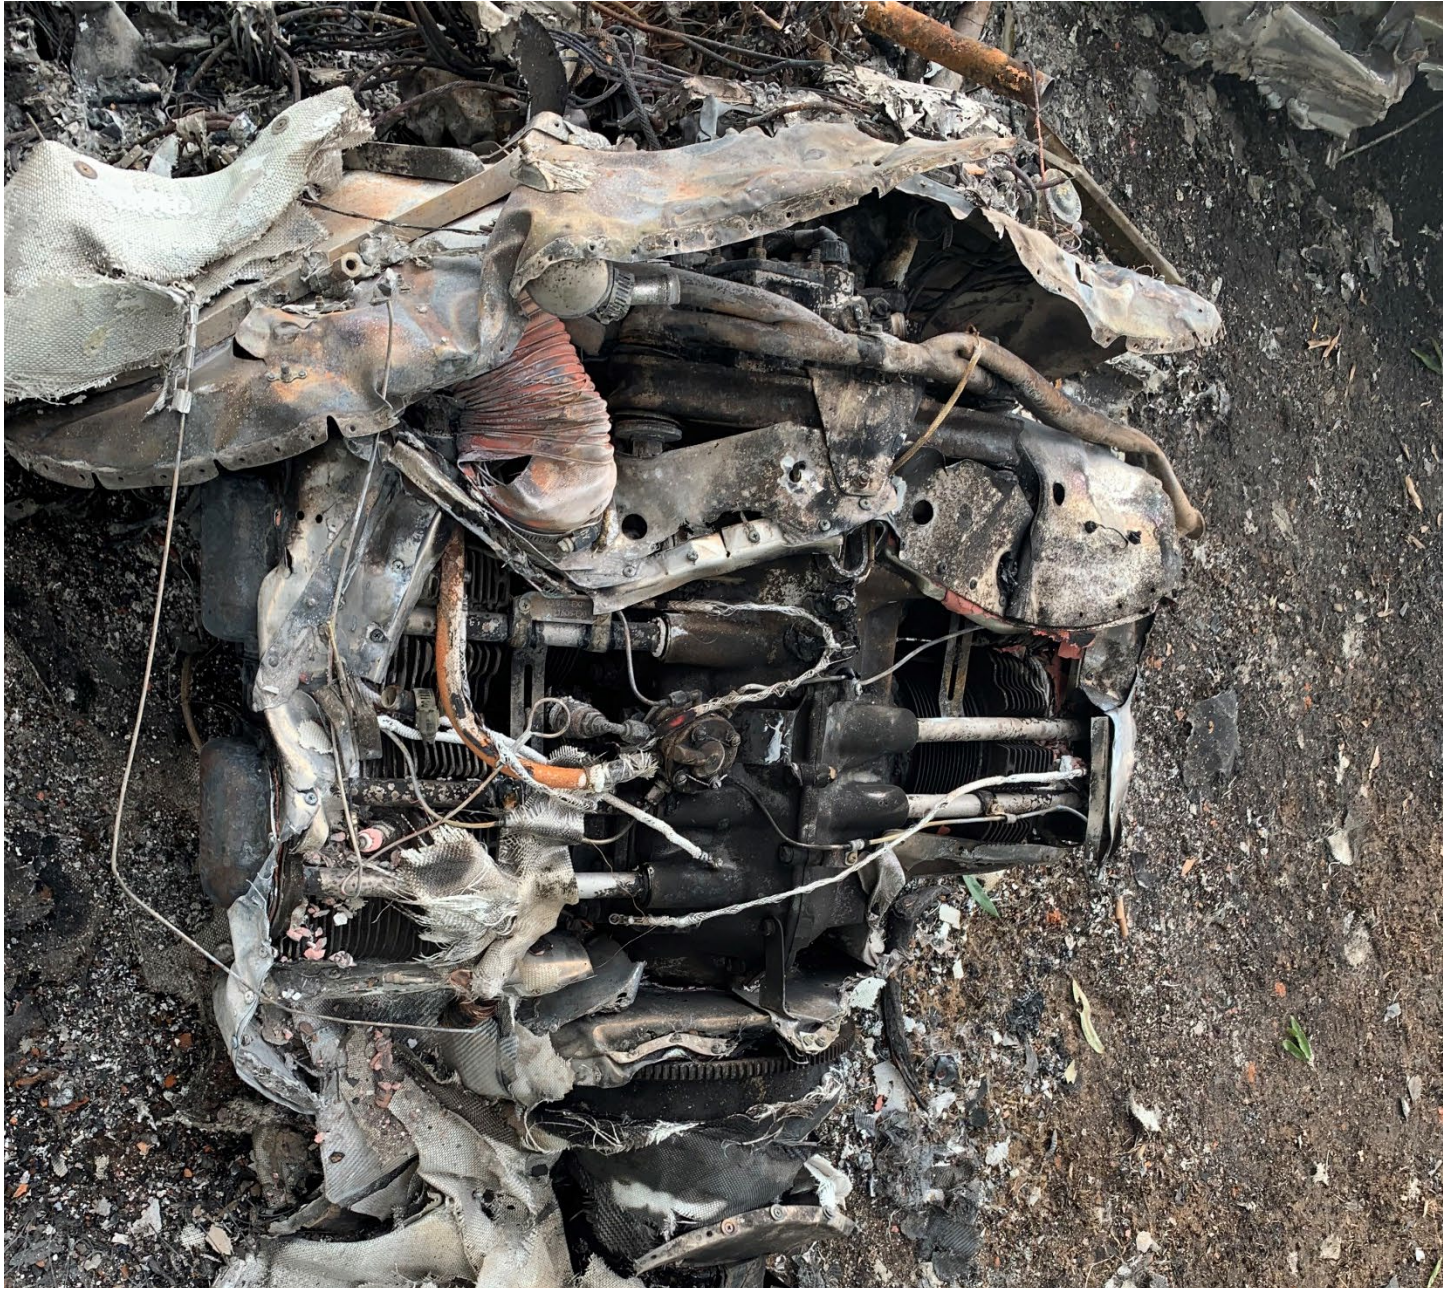
**Photo 5 - Engine**
