# National Transportation Safety Board

ERA23FA266

## **MATERIALS LABORATORY**

Factual Report 23-095

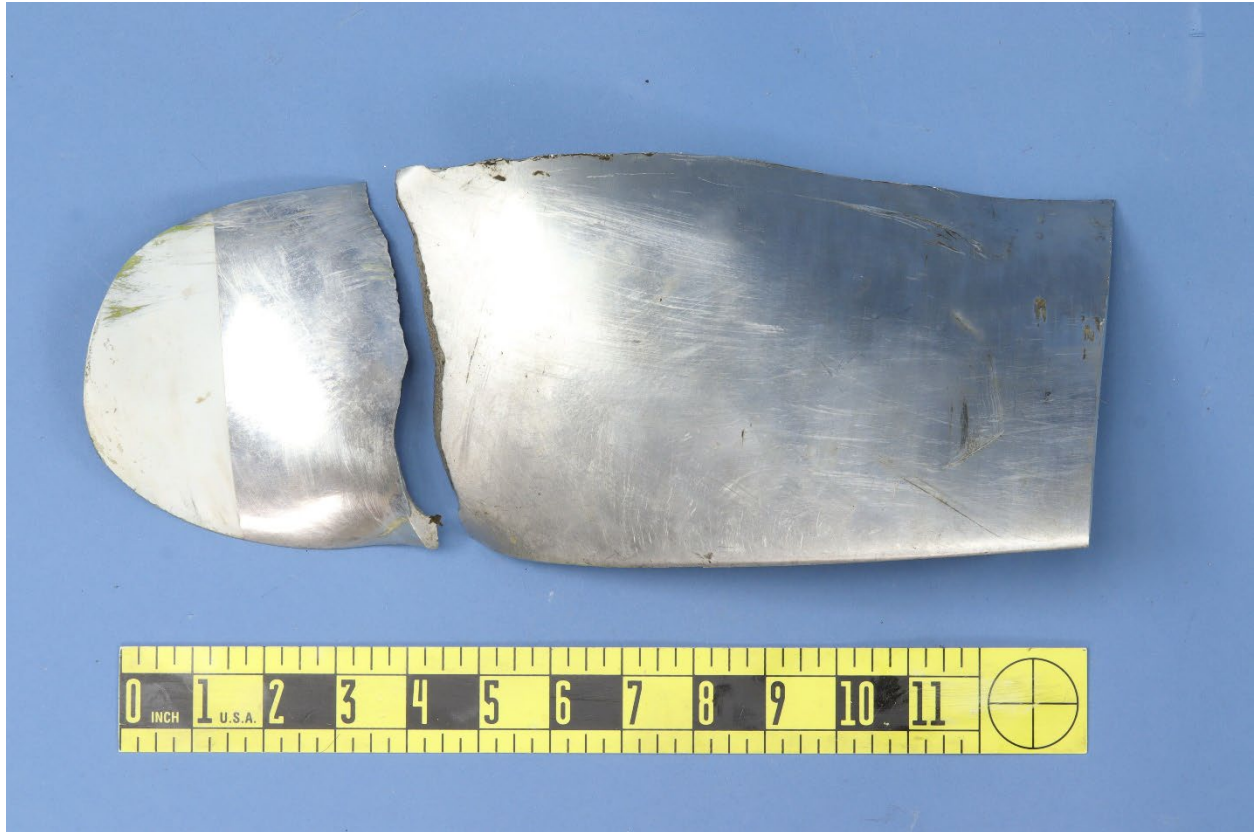
Outboard portion of a Hartzell propeller tip and a section of the propeller blade it separated from (Figure 1).

**Figure 1.** Portion of the propeller tip and propeller blade as received.

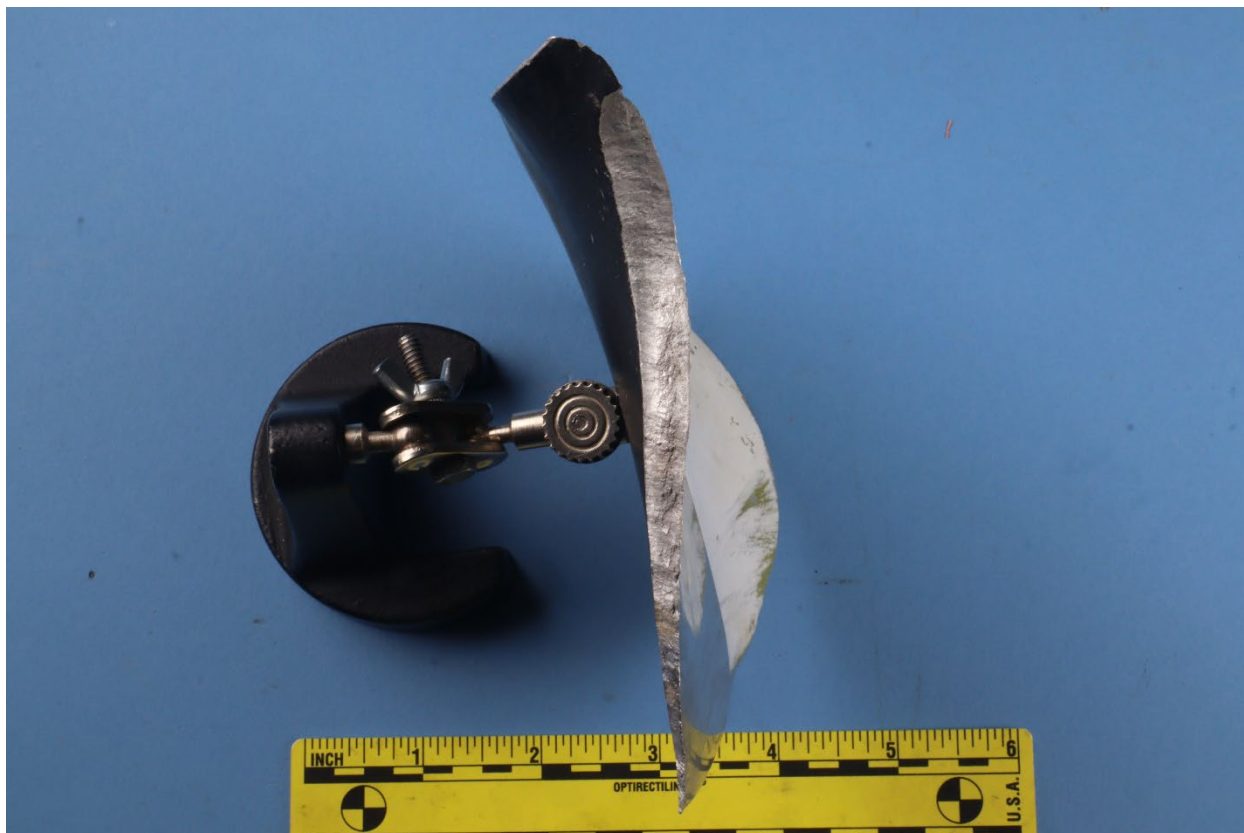
The portion of the propeller tip that separated from the propeller blade was approximately 4 inches long. The fracture surface on this portion of the propeller tip exhibited slant fractures consistent with an overload fracture (Figure 2). On the leading edge of the propeller tip an indentation was observed consistent contact damage (Figure 3). The propeller tip also exhibited some scuff marks on the pressure side. The portion of the propeller tip exhibited plastic deformation in opposing directions as can be seen in both figures 2 and 3. The deformation and fracture surface found on the portion of the propeller tip are consistent with damage caused due to impact.

**Figure 2.** Fracture surface of separated propeller tip.

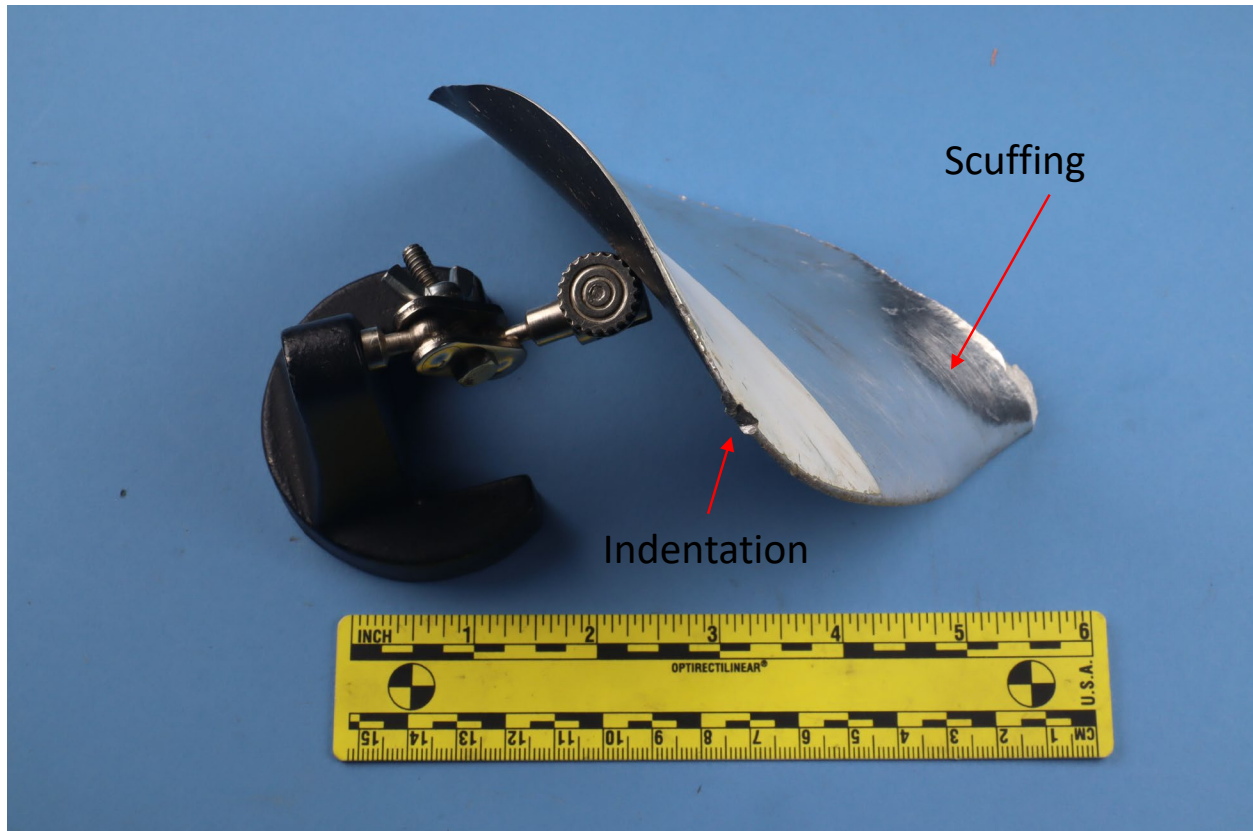
**Figure 3.** Indentation on outboard leading edge of the propeller tip.

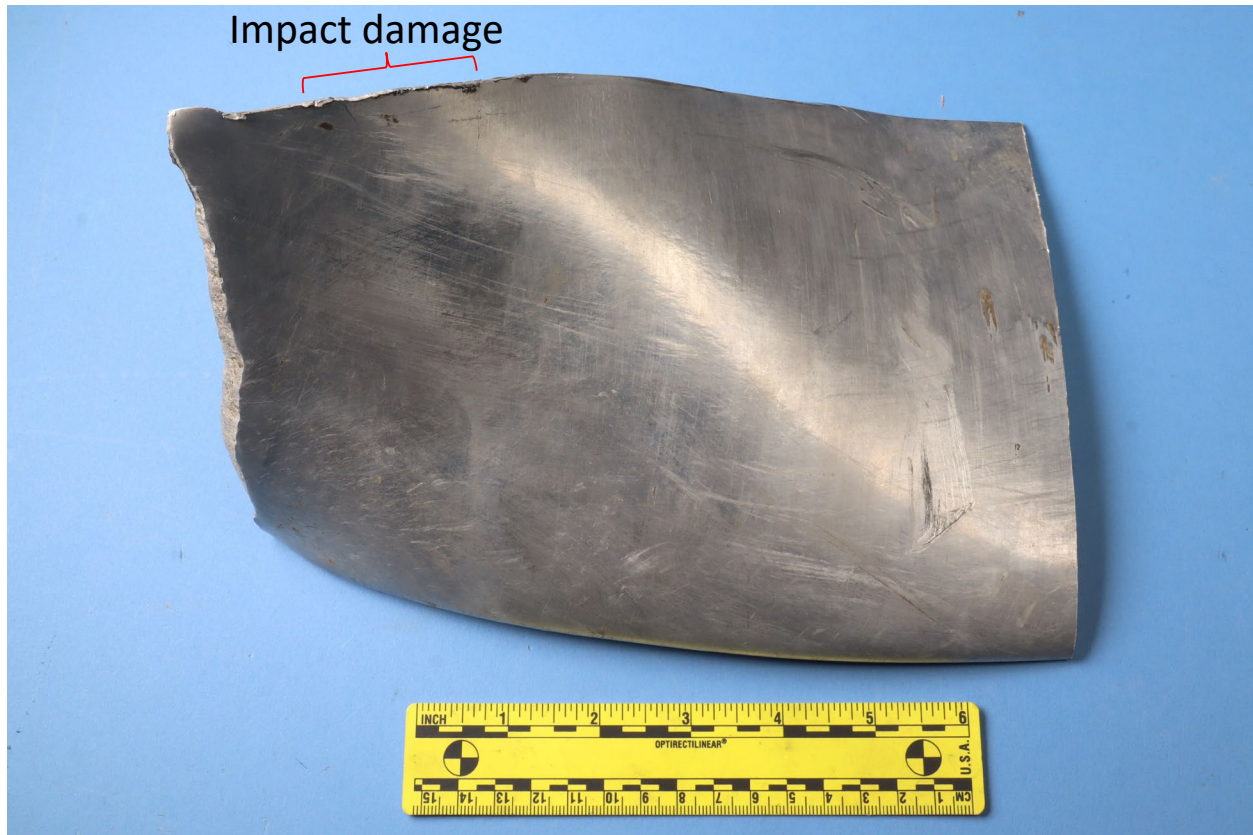
The portion of blade adjacent to the separated portion of the propeller tip exhibited some scratches and scuffing on the top pressure side (Figure 4). There was also an area of impact damage along the trailing edge of this portion of blade.

**Figure 4.** Portion of the propeller blade adjacent to the separated tip.
