# National Transportation Safety Board

ERA23FA266

## **ACCIDENT ON SITE EXAM**

Location: Windsor Airport (63NY), Youngstown, NY  
Date: June 11, 2023  
Time: 1506  
1906 (UTC)  
Airplane: Harmon Rocket, N85TP

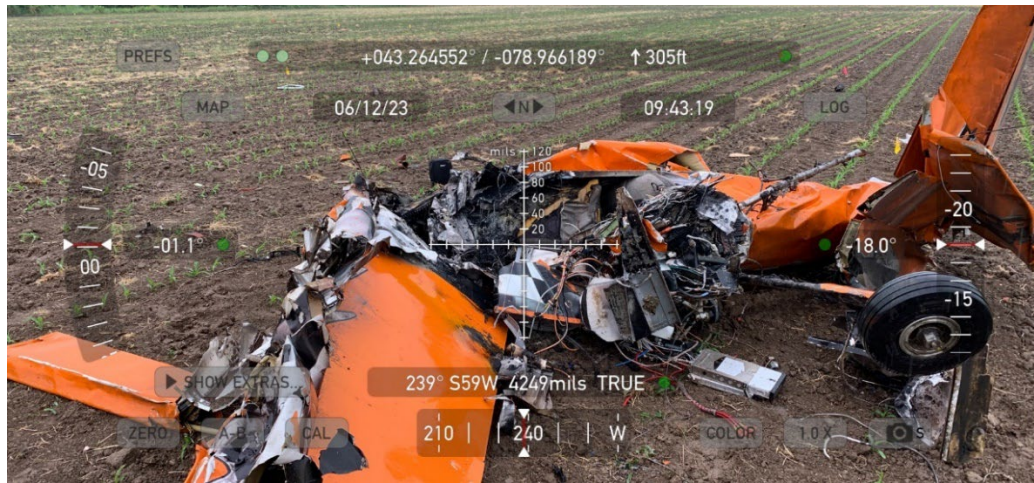
Windsor Airport (63NY) Youngstown, New York USA 400 feet from departure end of runway 36. Trees, 2 lane paved road, trees and corn farmland, level and muddy. Rain. Accident site was spread out over 450 feet from initial tree impact to the engine. Initial impact contained aluminum and fiberglass pieces of wreckage, an aileron, and misc. pieces of the airframe. The airplane entered a second row of trees before the wing tanks were compromised and there was a fire to the airplane that was quickly extinguished. Elevation was 300 feet. Lat/log 43.264321° / -78.966362° (figure 1) There were numerous branches and large diameter trees that exhibited features consistent with propeller slicing.

**Figure 1 Accident site with location/direction details.**

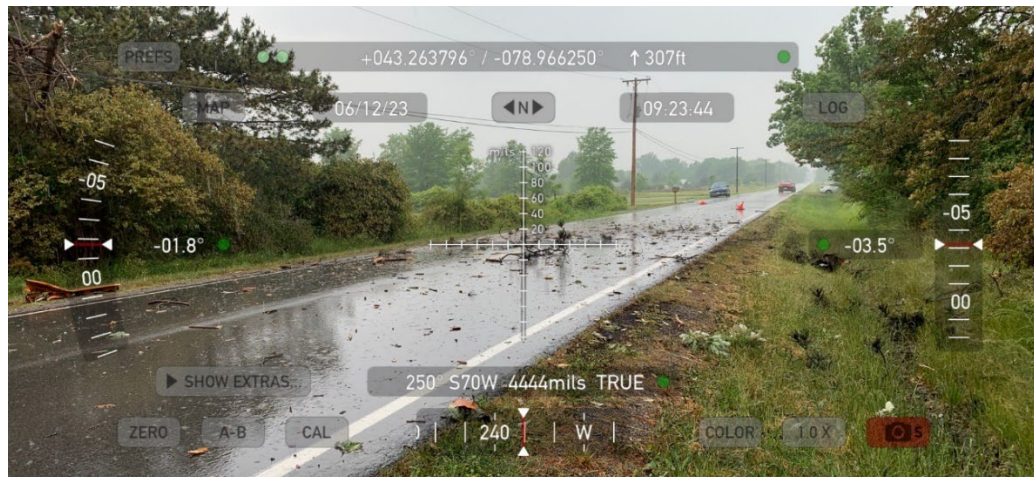
**Figure 2 Wreckage path across road. Path is from left to right.**

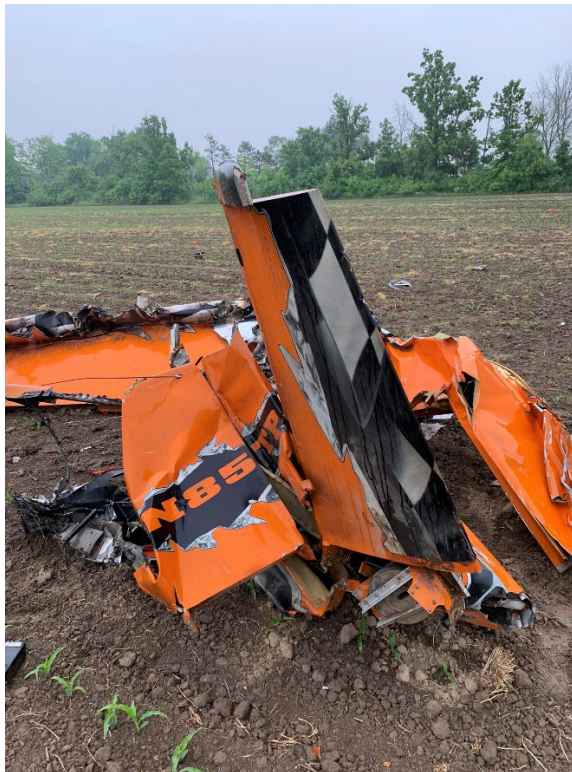
All tail control surfaces were damaged and installed in their respective locations and moved manually with corresponding cable movement. A hole was cut into the fuselage to observe all control tubes. No anomalies or other irregularities were discovered. Rudder continuity was established from the rudder-to-rudder pedals. Stabilizer continuity was established from the stabilator to the main cabin area through overload breaks in the control rods.

**Figure 3 View of empennage looking forward.**

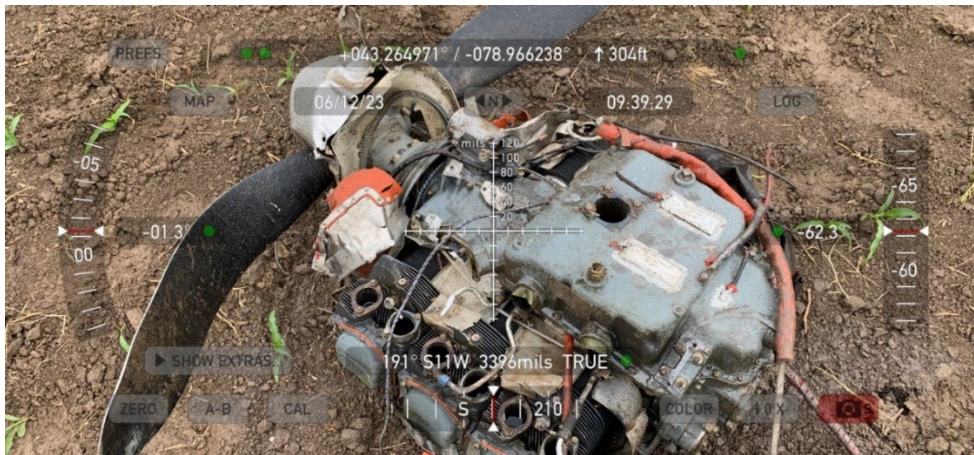
The powerplant is a six-cylinder, air cooled, direct drive, horizontally opposed, carbureted, naturally aspirated engine with a rating of 260HP @ 2700RPM. The Lycoming IO-540-B4B5, Serial Number L-7798-40 was severely impact damaged.

There was no evidence of fire damage to the engine, but it was subjected to extreme impact loads.

**Figure 4 View of right bottom of the engine as discovered in the field.**

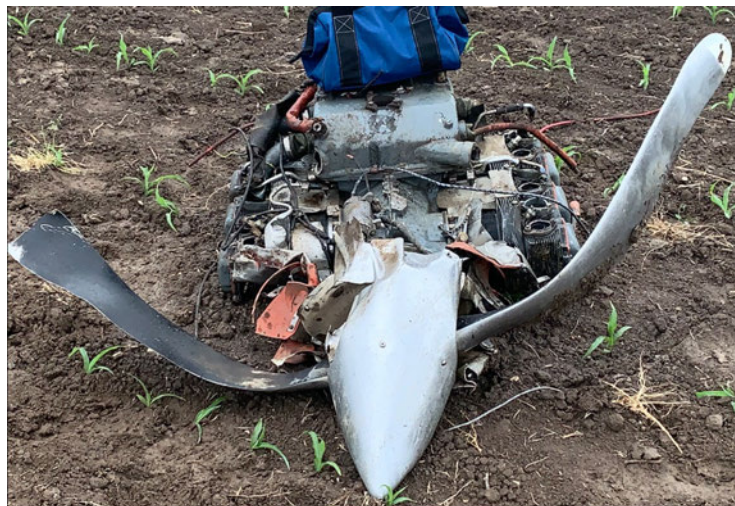
Examination of the propeller revealed the 2-blade, Hartzell (HC-C2YK1BF) metal constant-speed propeller was missing a 5-inch section of blade that according to witnesses, had separated and landed on the concrete adjacent to the hanger with 1 witness stating that it came off before the impact.

Both blades were polished and showed evidence of chordwise scraping and one blade exhibited a wave bent through the entire span; this was the blade missing the tip. There was s-bending and significant leading edge gouges. The propeller remained attached to the flange and the propeller spinner was crushed. The propeller tip and a 10-inch portion of the blade that was cut off with a hot saw will be sent to the NTSB materials laboratory for examination.

**Figure 5 Hartzell propeller exhibiting signs of s bending and polishing.**
