ERA23FA270

## INVESTIGATION PHOTOGRAPHS

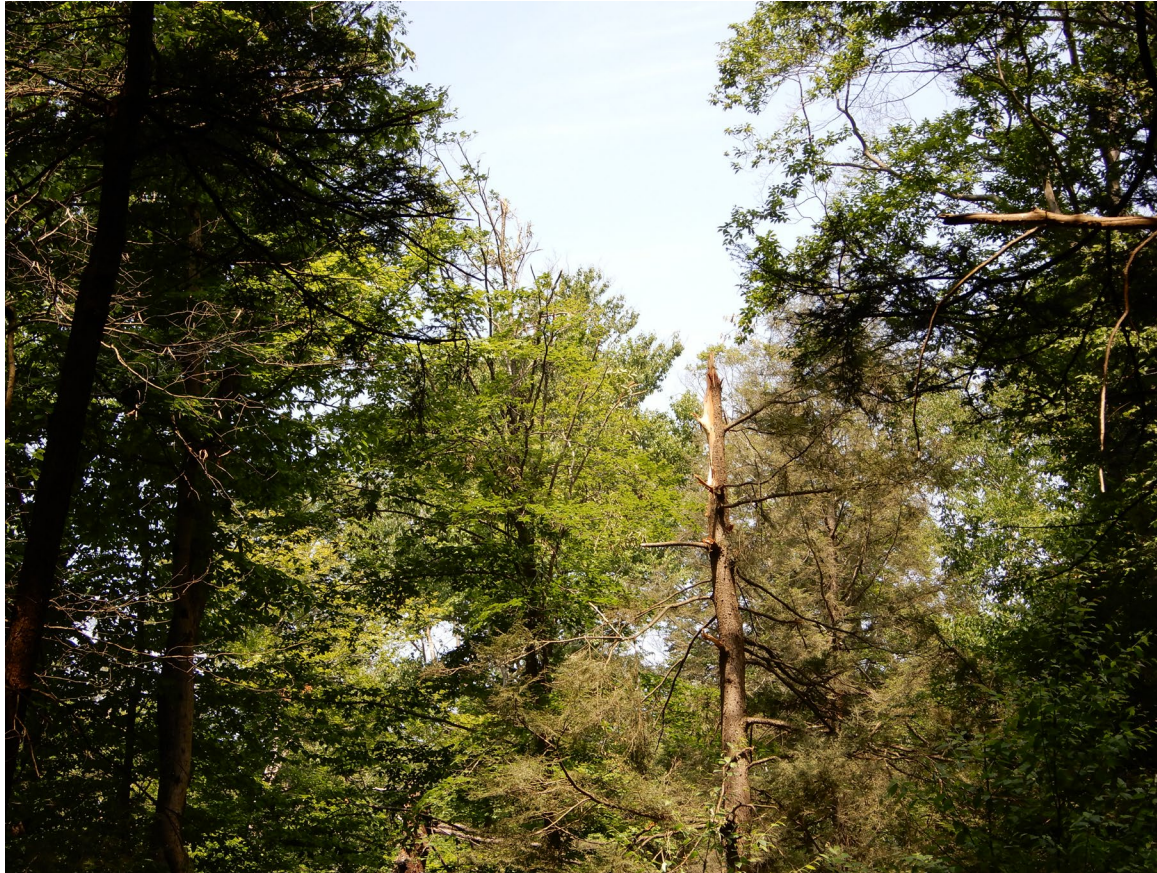
**Photograph 1 - Initial Impact Point (NTSB Photo)**

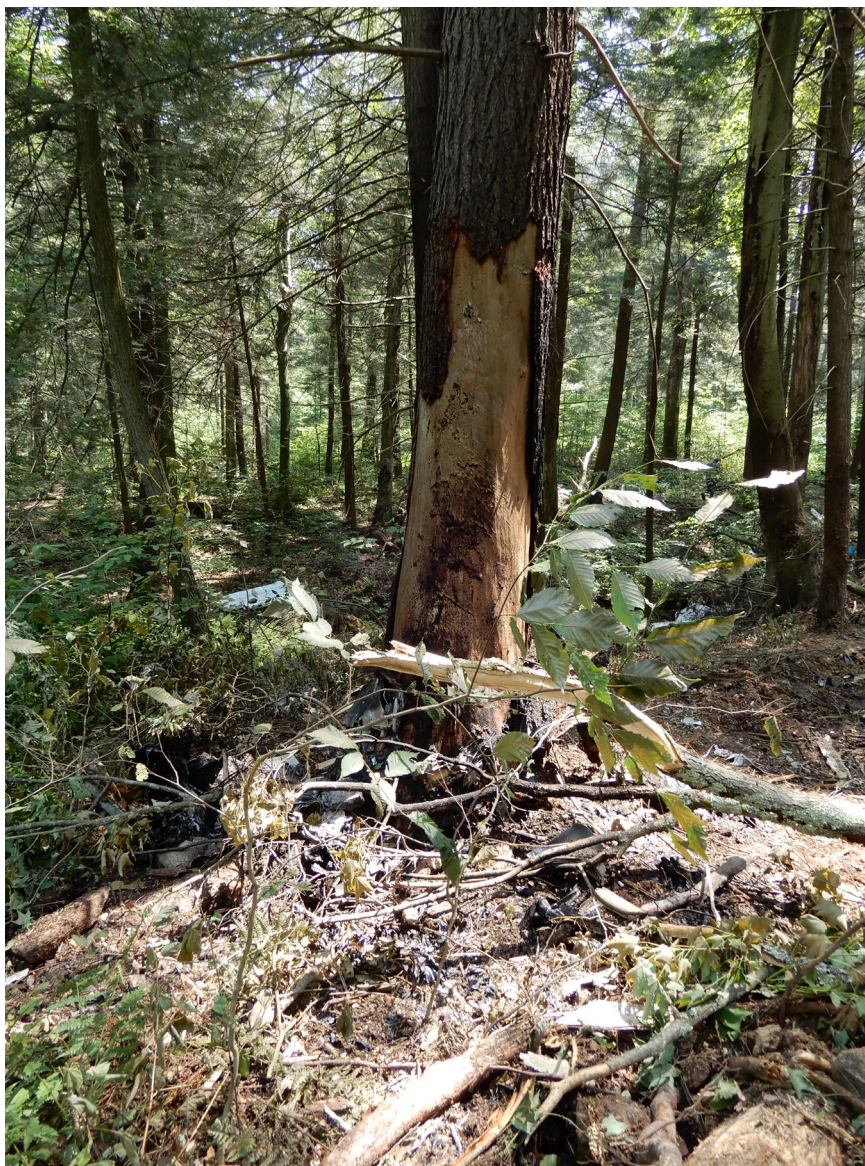
**Photograph 2 - Initial Ground Impact (NTSB Photo)**

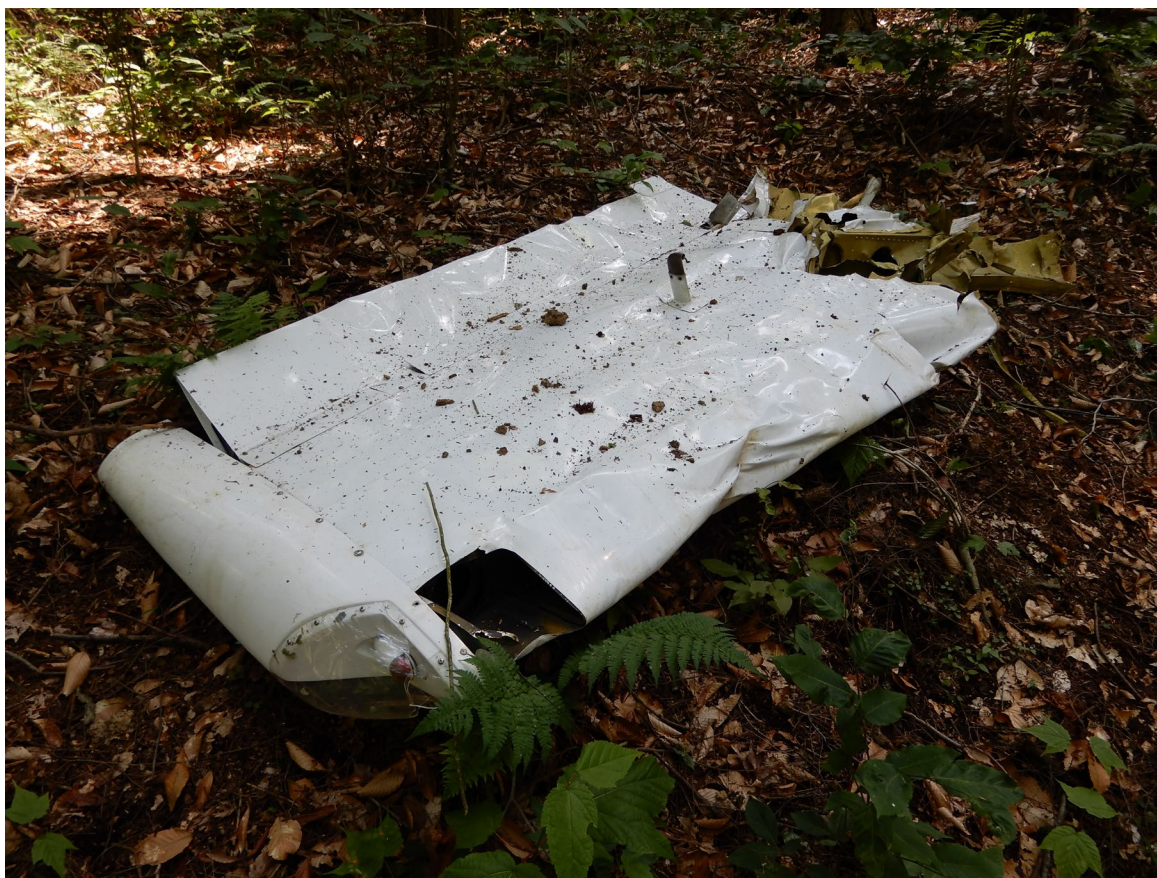
**Photograph 3 - Left Wing Outboard (NTSB Photo)**

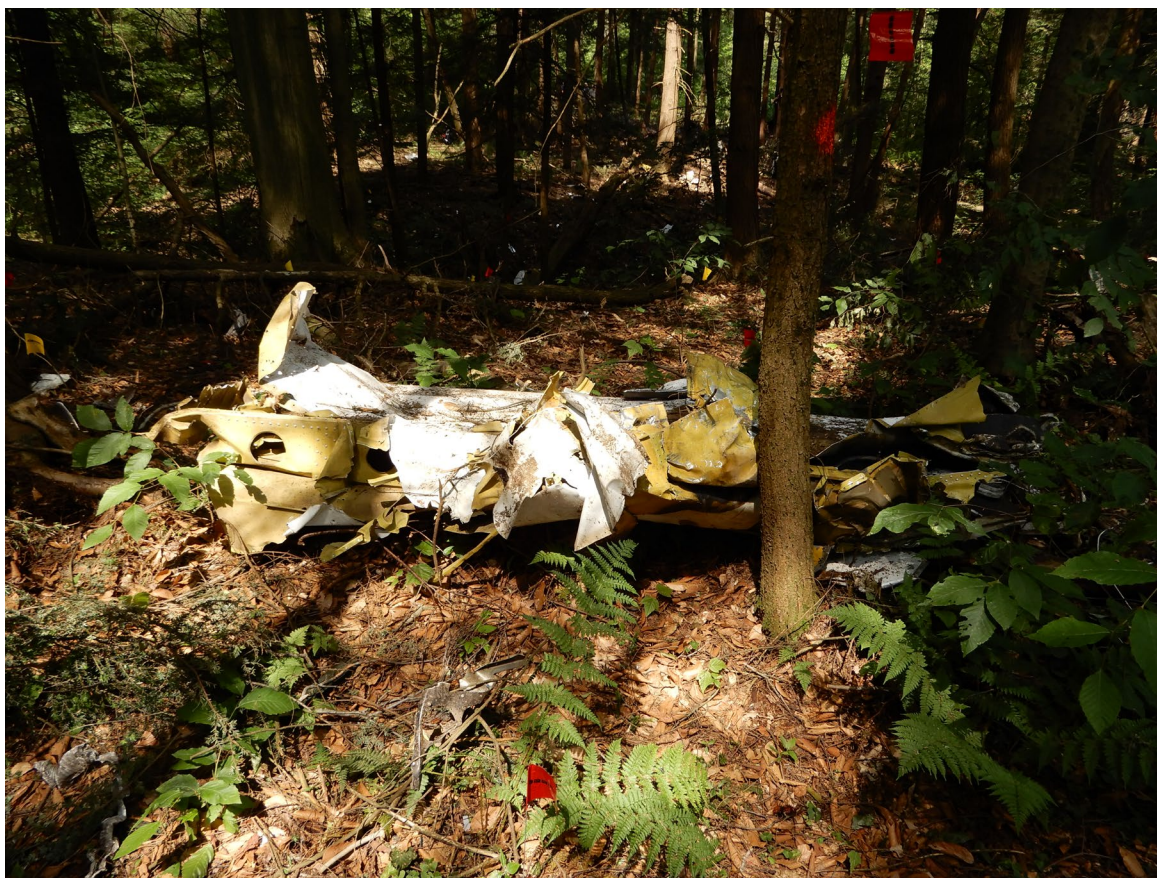
**Photograph 4 - Right Wing (NTSB Photo)**

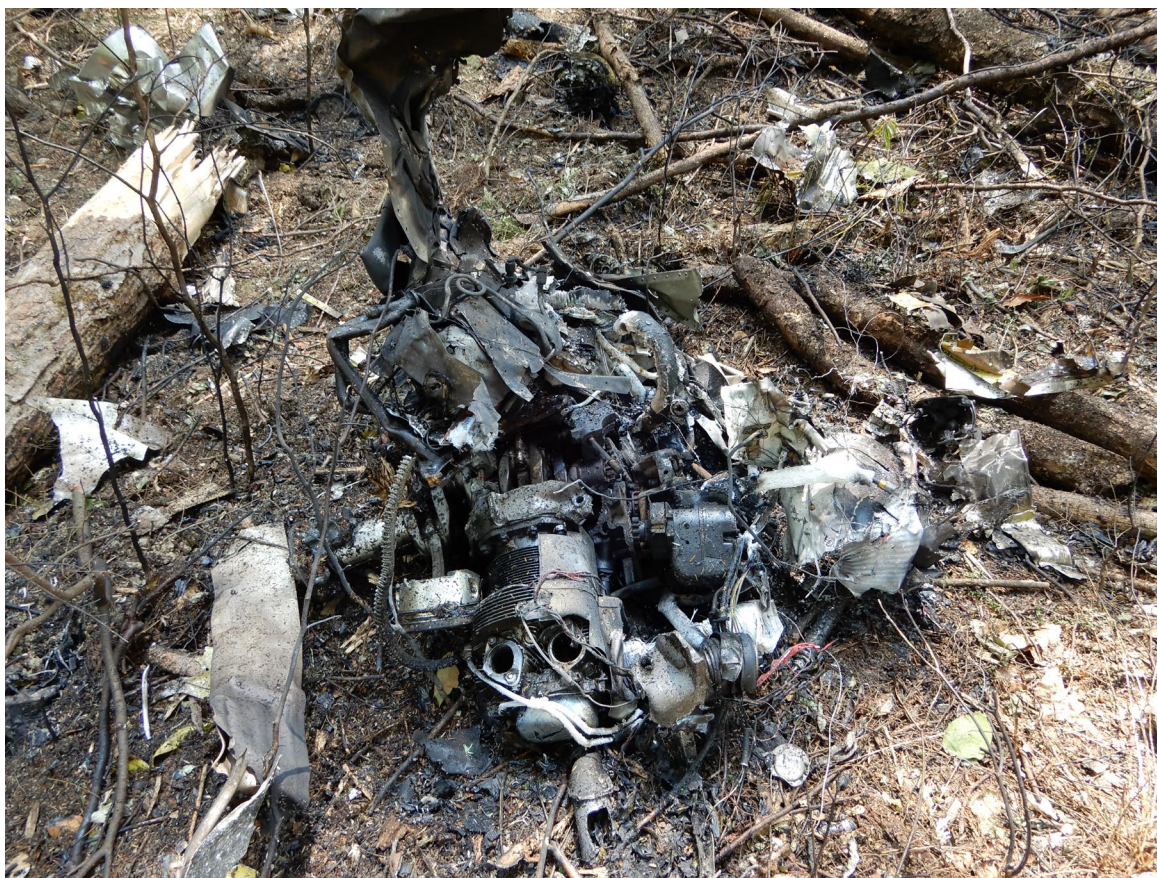
**Photograph 5 - Left Engine (NTSB Photo)**

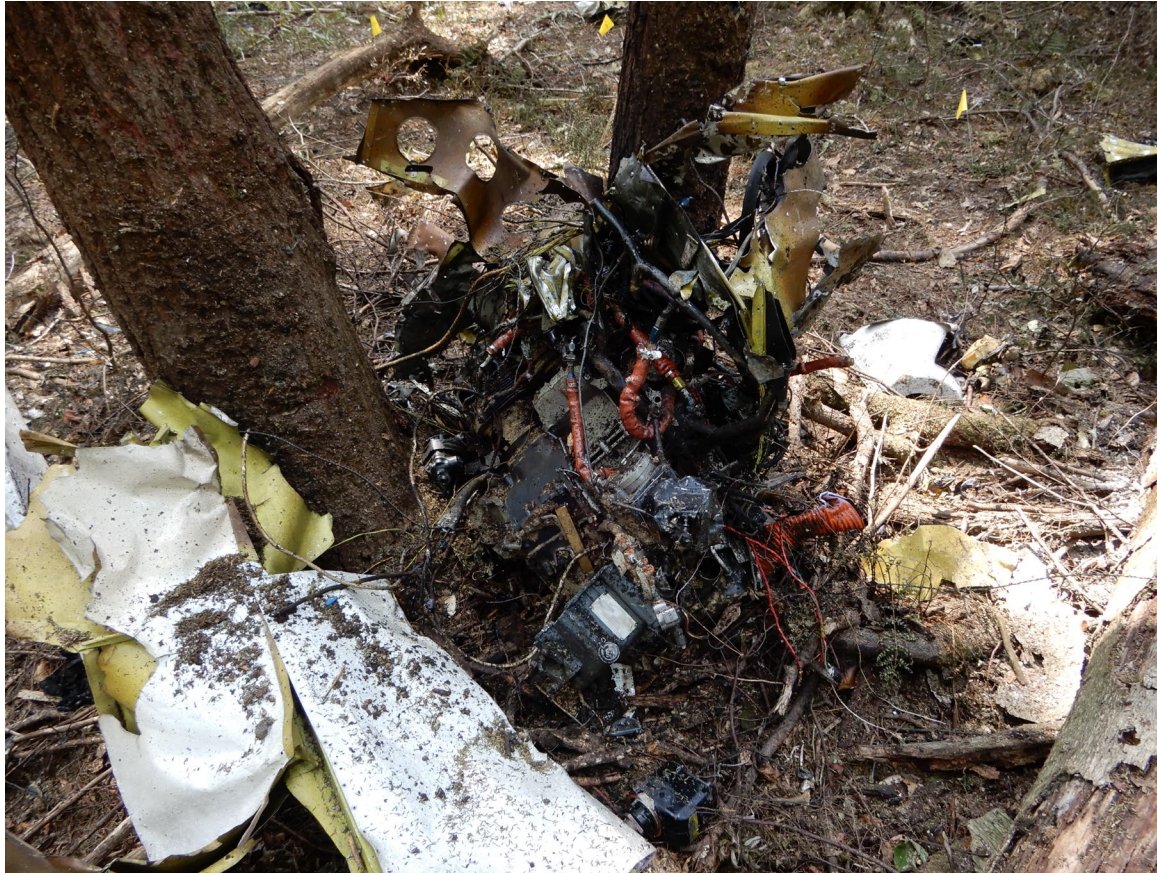
**Photograph 6 - Right Engine (NTSB Photo)**

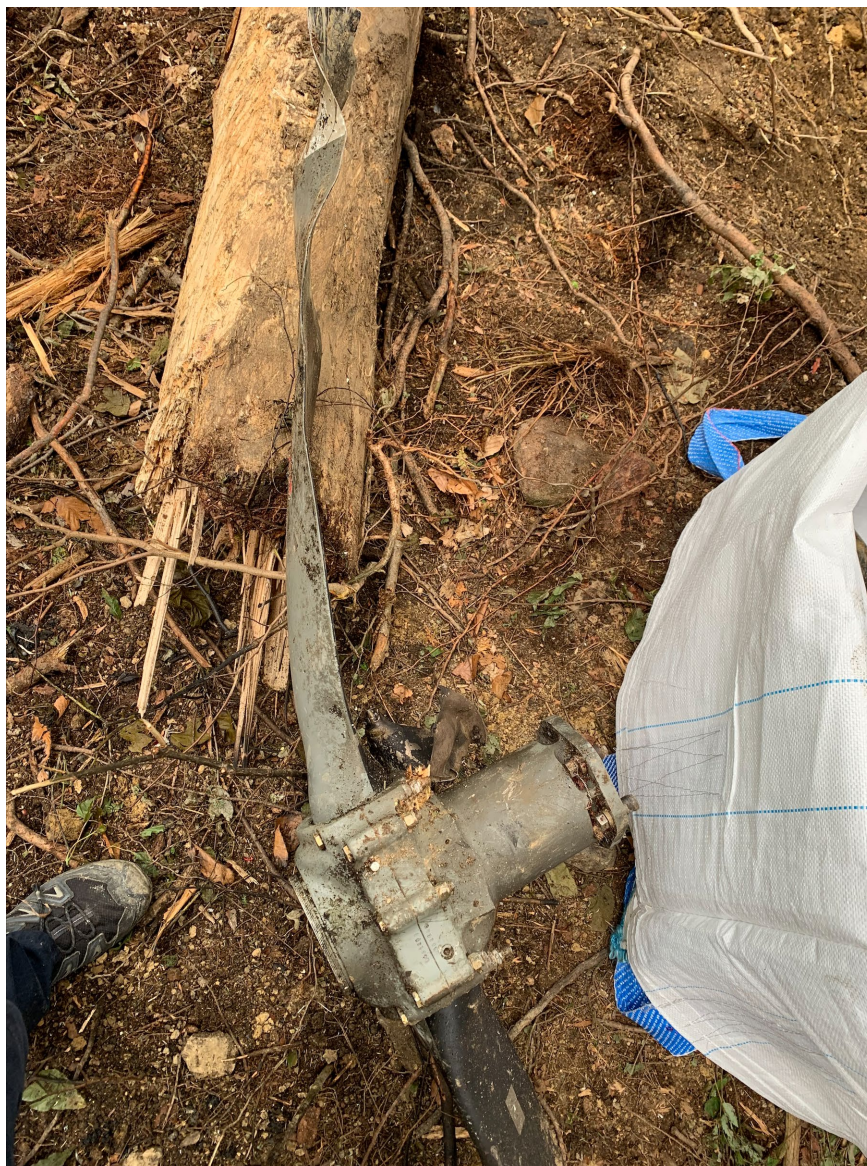
**Photograph 7 - Left Propeller (NTSB Photo)**

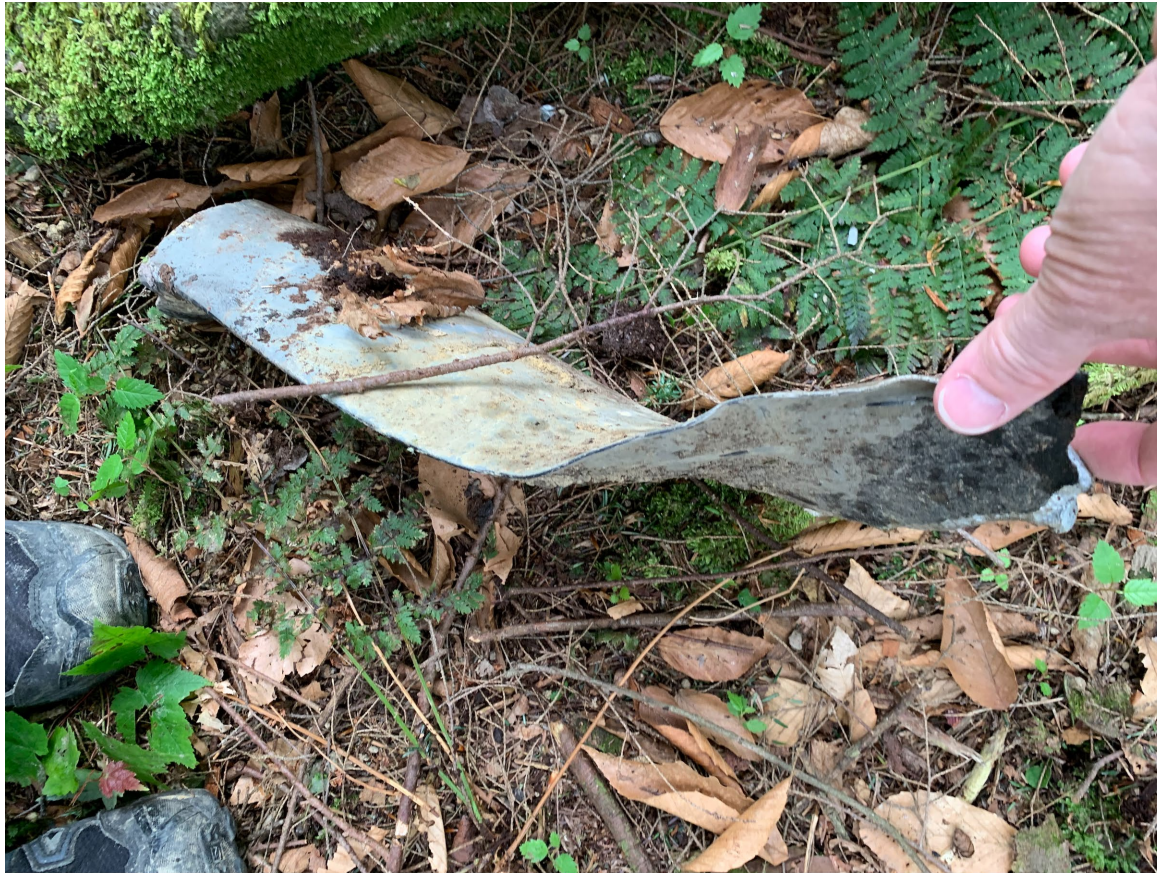
**Photograph 8 - Right Propeller Blade (NTSB Photo)**

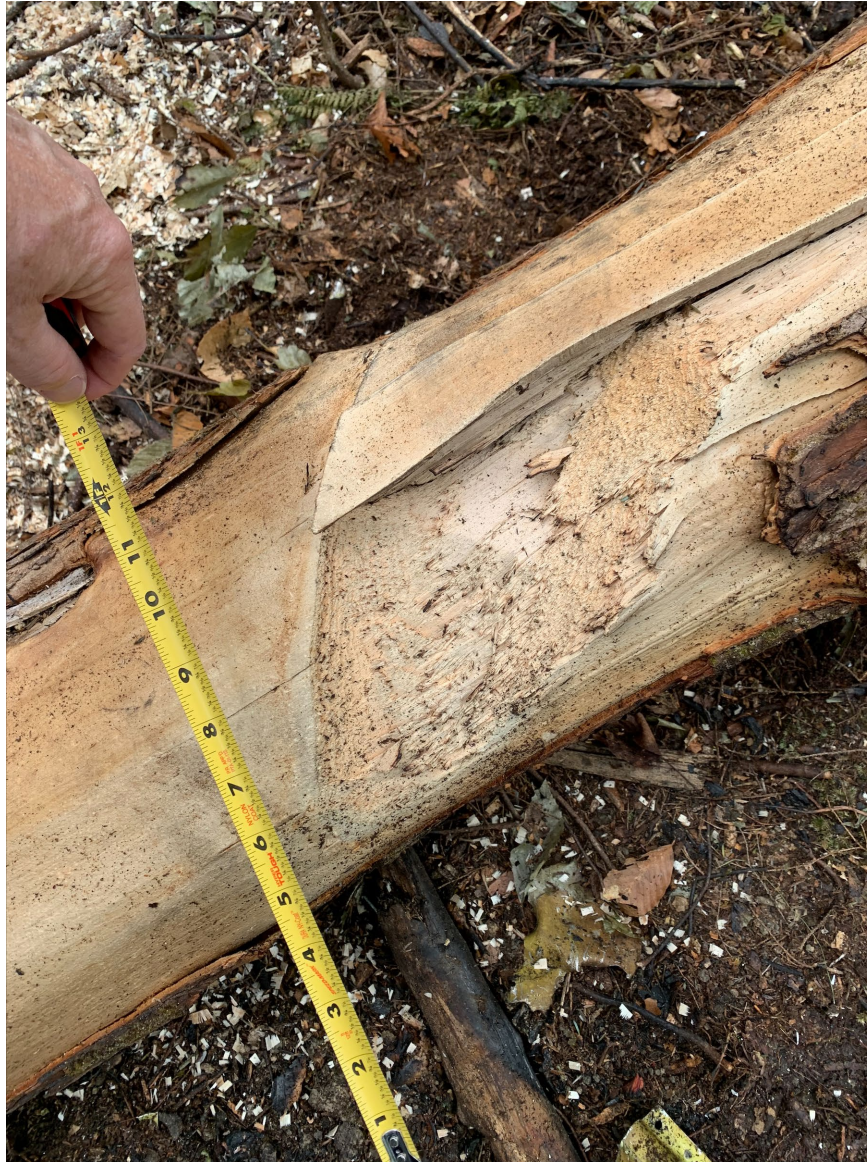
**Photograph 9 - Propeller Blade Damage to Tree (NTSB Photo)**

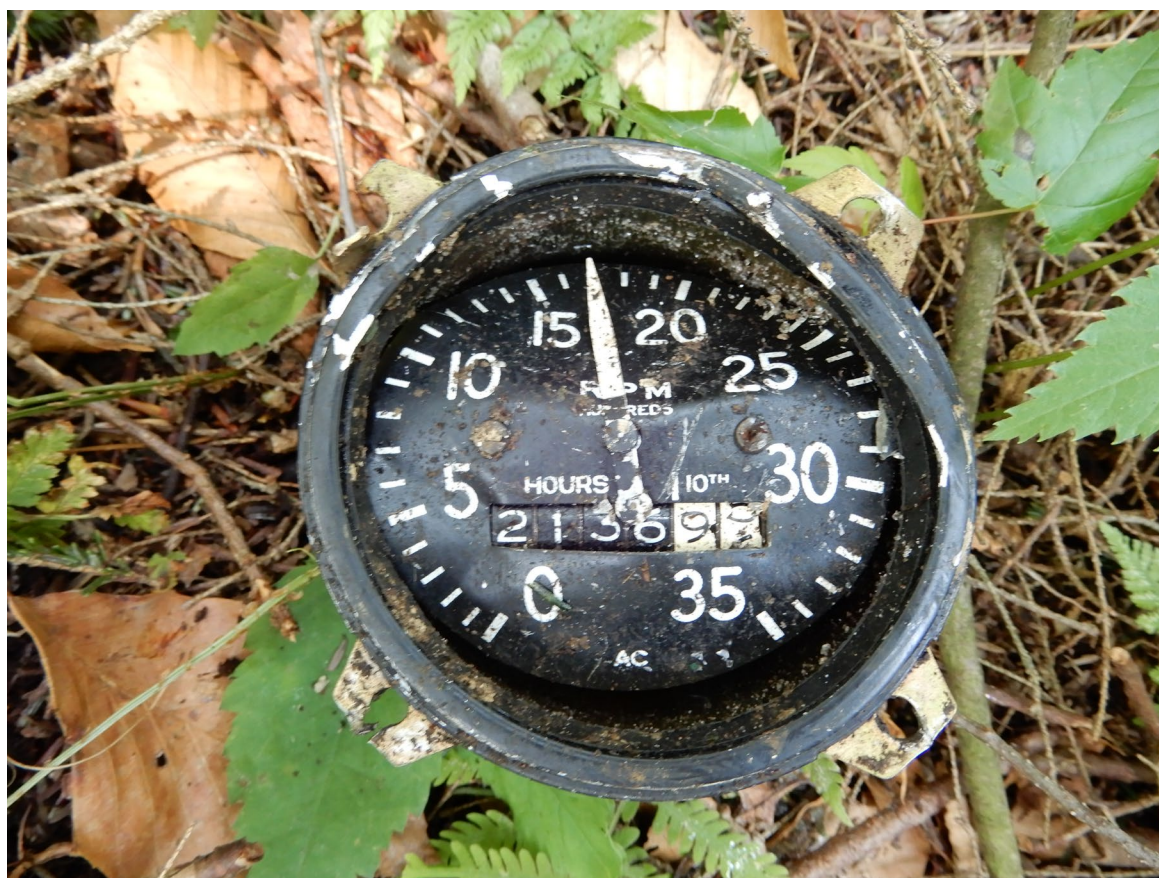
**Photograph 10 - Engine Tachometer (NTSB Photo)**

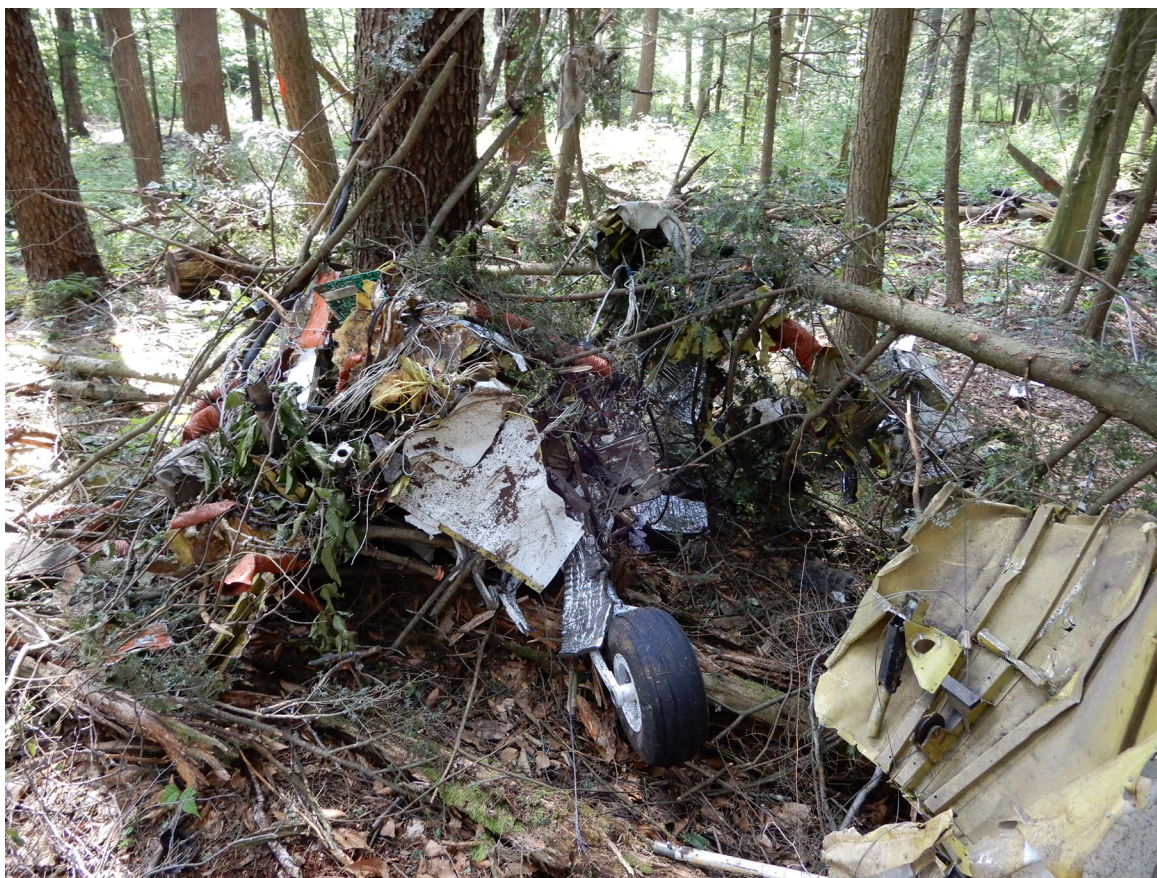
**Photograph 11 - Forward Fuselage and Cockpit (NTSB Photo)**

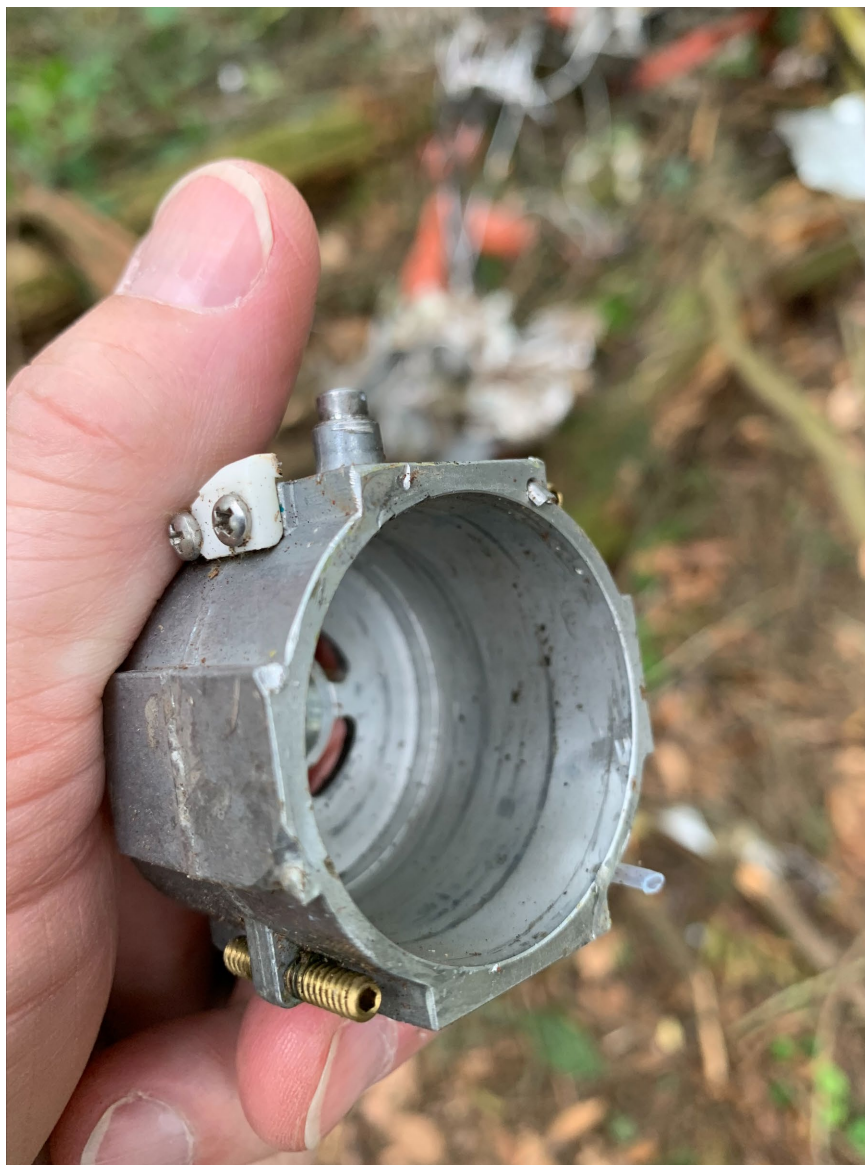
**Photograph 12 - Attitude Gyro Case (NTSB Photo)**
