**WRECKAGE EXAMINATION**  
**NTSB Accident Number**  
**ERA23FA273**

| Aircraft: | Mooney M20R |
| Registration | N13LV |

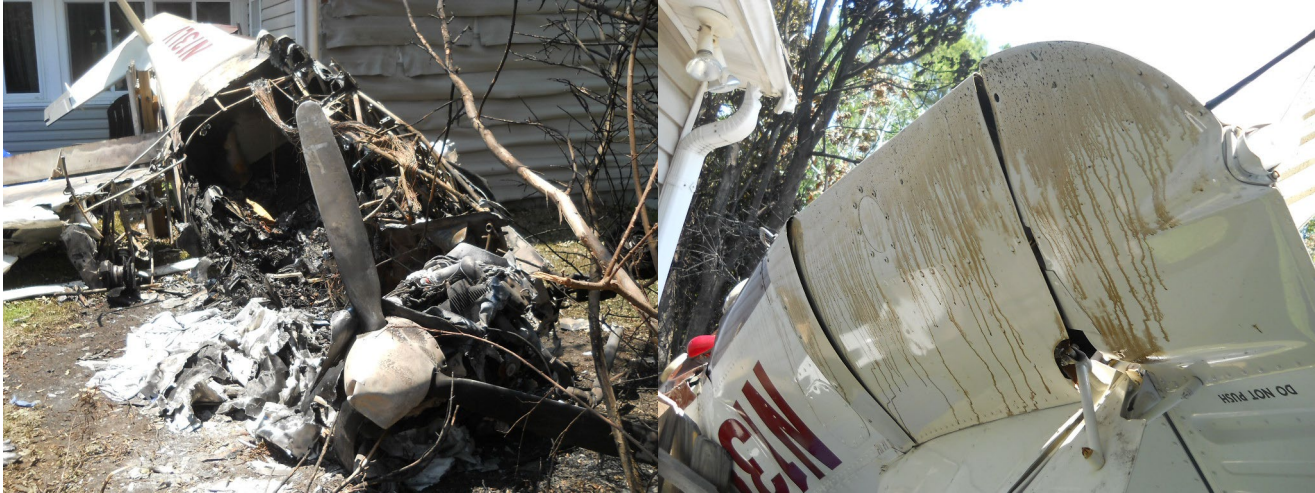
The wreckage came to rest in a residential yard, near the left rear side of the home, and a postcrash fire ensued; however, it did not ignite the home. The wreckage was laying on its right side, oriented about a 090° magnetic heading. An approximate 125-ft debris path was observed, beginning with the right aileron suspended in an approximate 40-ft tree, on a northwest course to the main wreckage. The left wing remained partially attached to the fuselage. The aileron and flap remained attached to the left wing. The flap was observed in an extended position; however, the flap control in the cockpit could not be identified. The right wing had separated and was resting underneath the left wing. The right aileron and flap had separated from the right wing. The flap was recovered near the right wing and the aileron was recovered from the tree. The landing gear was observed in an extended position. The empennage remained intact and oil streaks were noted on the underside. Flight control continuity was confirmed from the cockpit via push-pull tubes to all flight control surfaces, except for the separated right wing, where aileron continuity was confirmed to the wing root. The cockpit and cabin were consumed by fire.

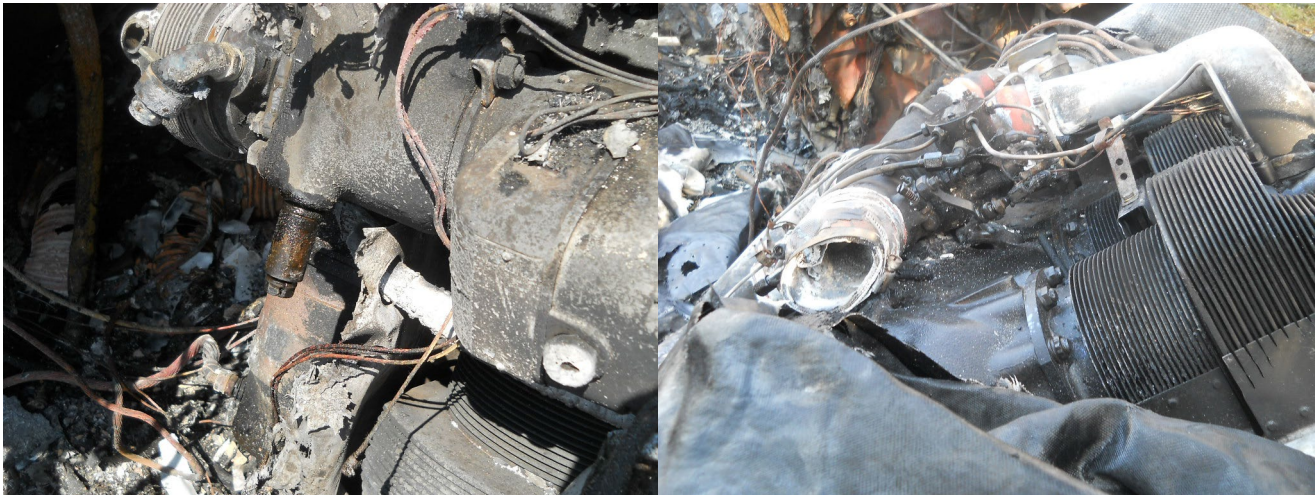
The engine came to rest inverted, and the propeller remained attached to the engine. An oil sump accessory port plug was observed loose, with oily blue stained baffling material resting below it. Additionally, the No. 4 connecting rod had protruded through the top of the engine case. A check of the oil dipstick revealed no measurable oil in the engine.
