ERA23FA273

## INVESTIGATION PHOTOGRAPHS

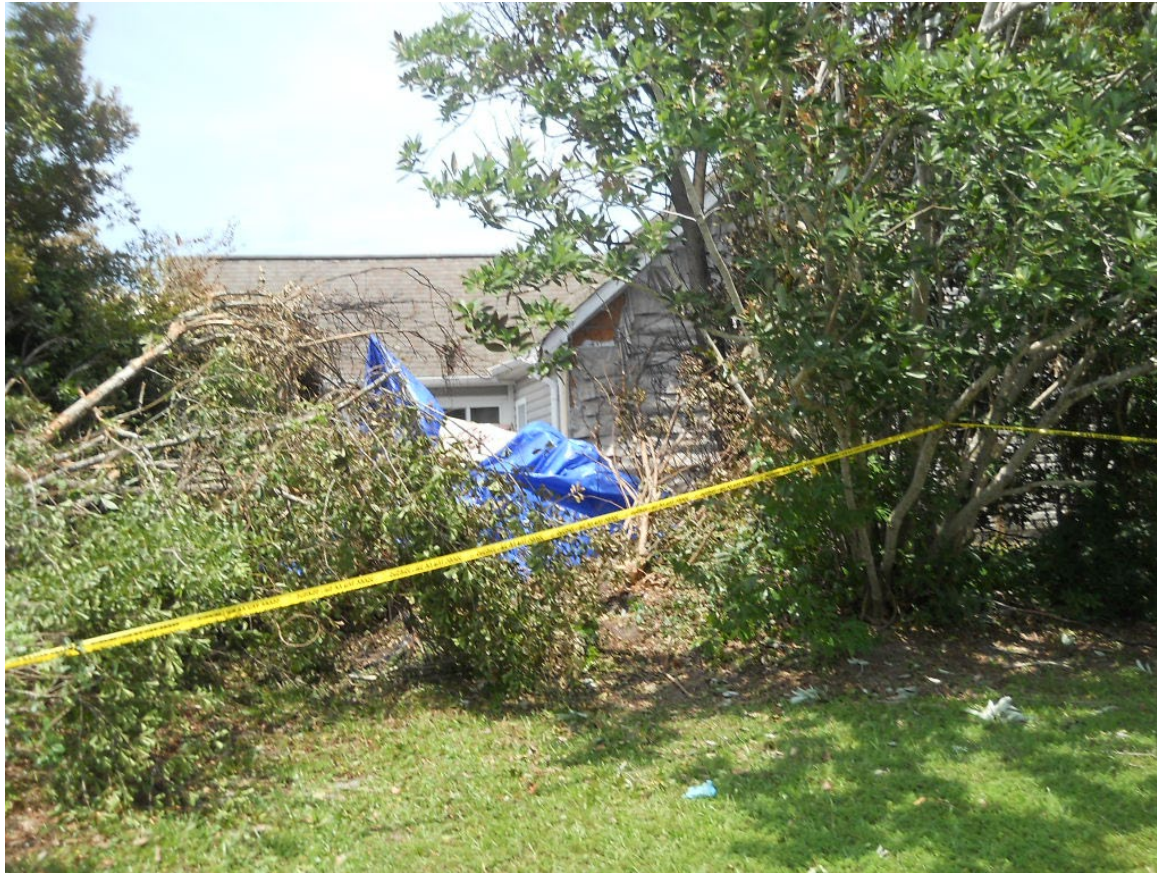
**Photograph 1 - Accident Site**

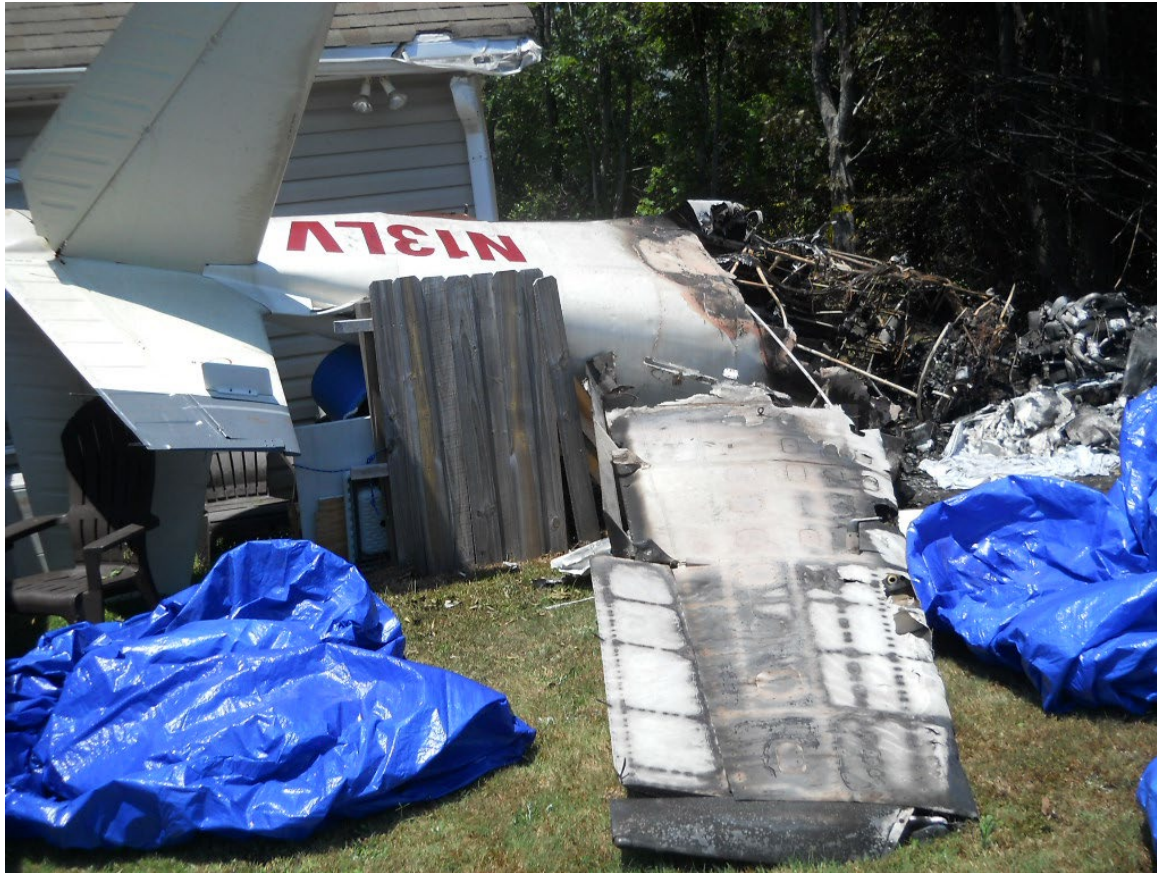
**Photograph 2 - Main Wreckage**

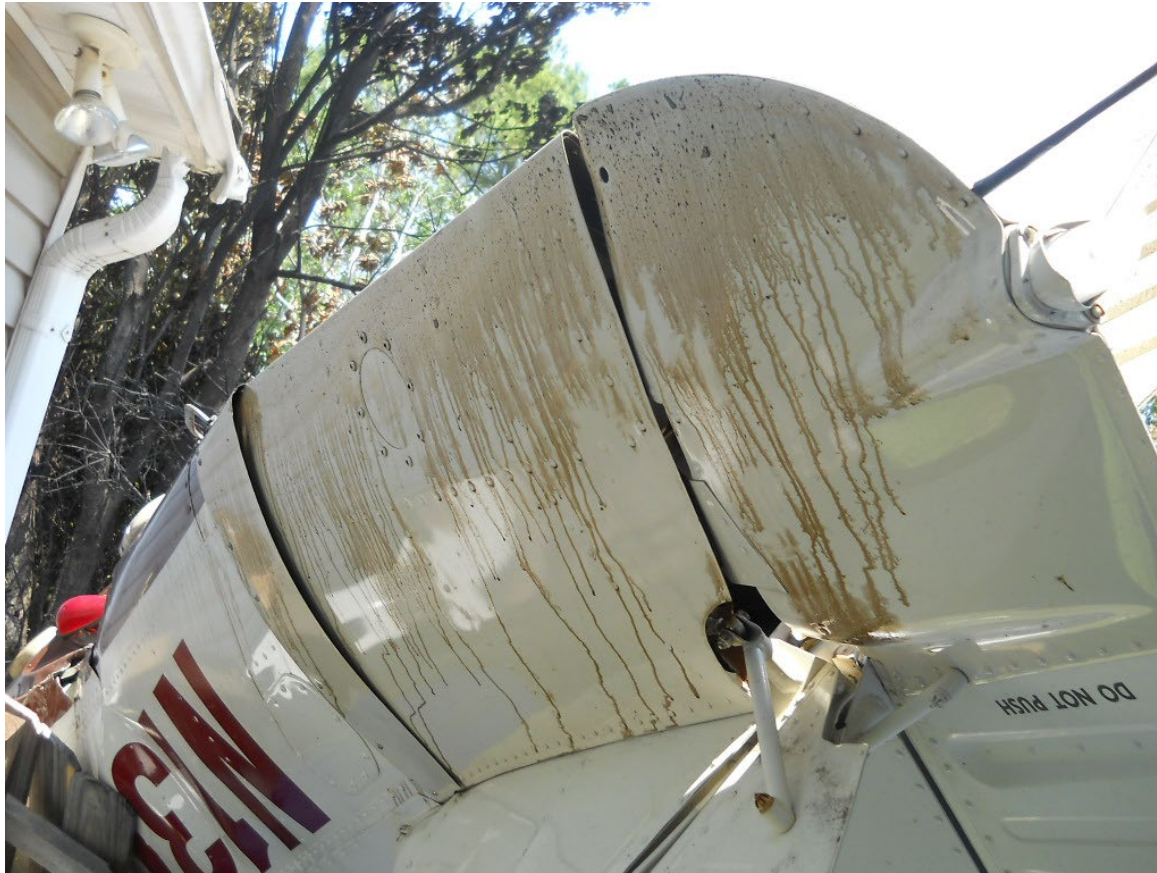
**Photograph 3 - Oil Streaks on Empennage**

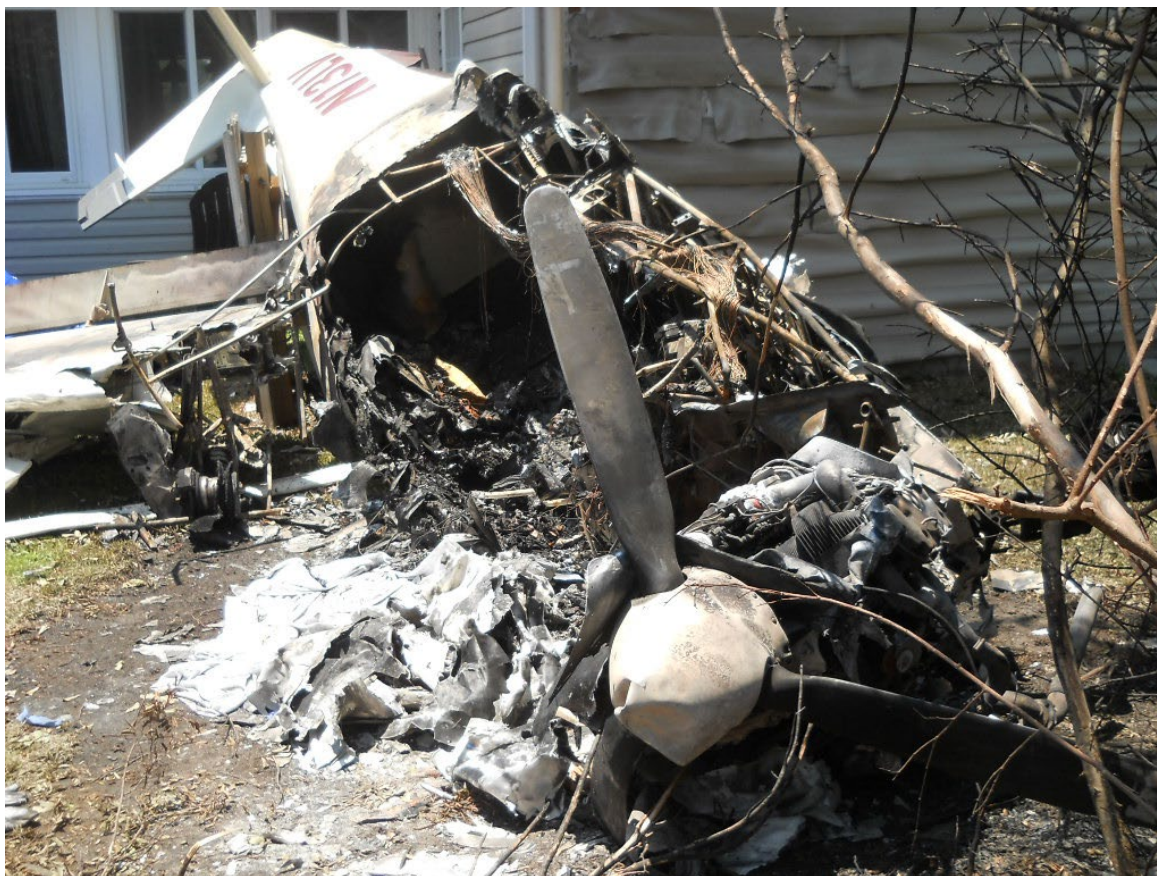
**Photograph 4 - Engine And Propeller**

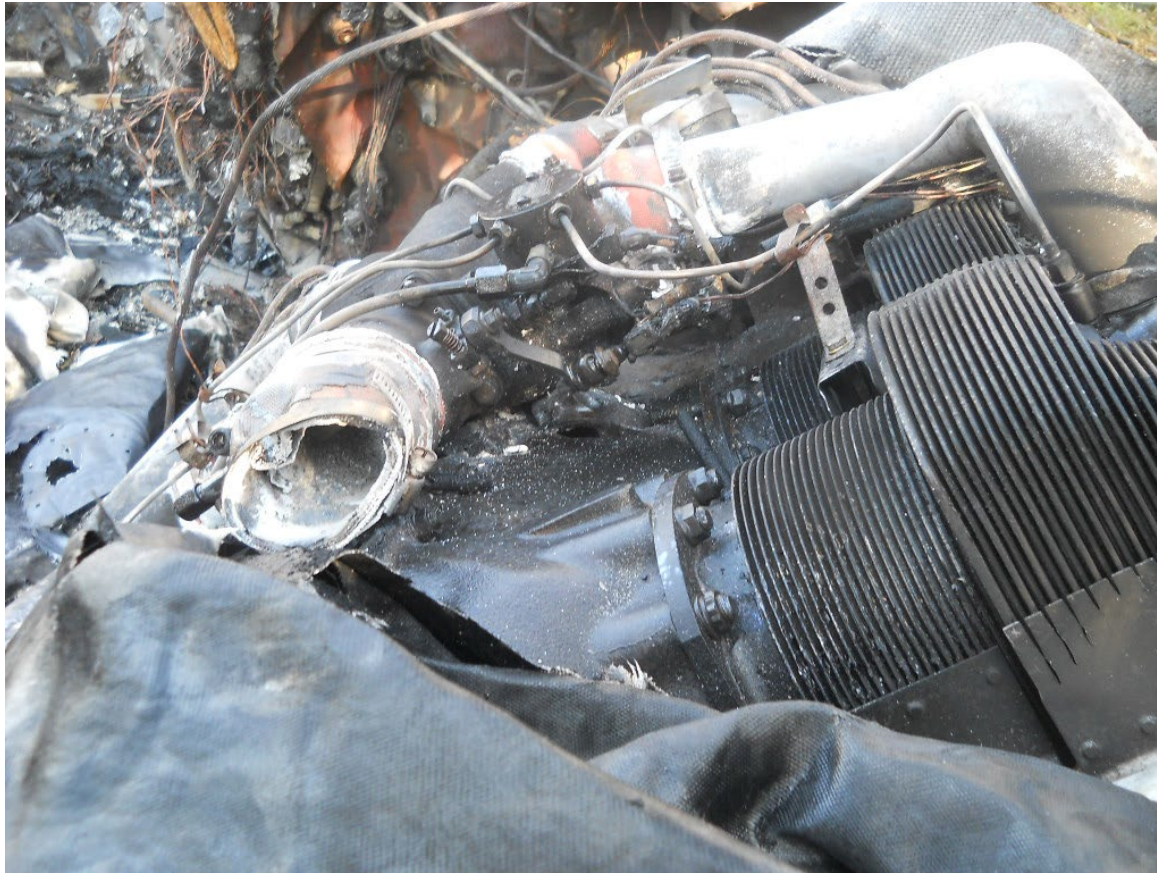
**Photograph 5 - Hole in Top of Crankcase**

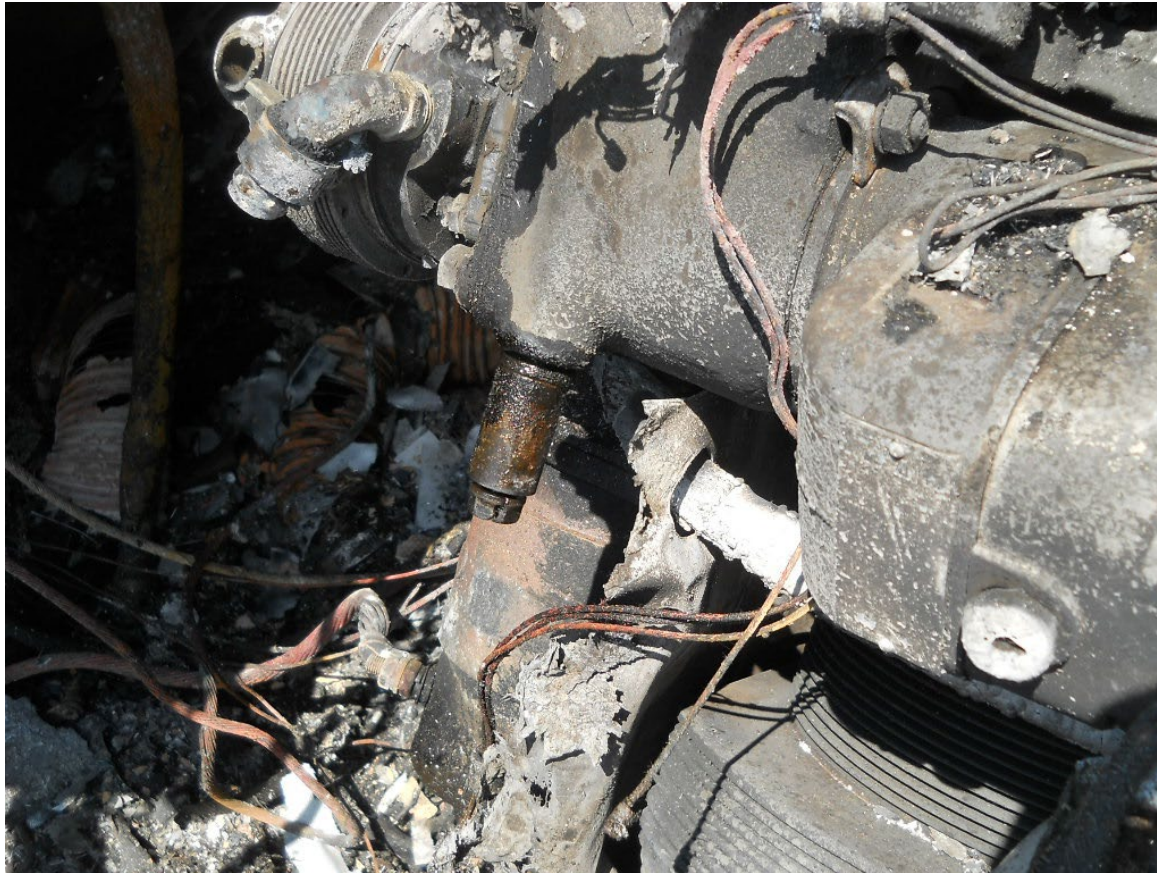
**Photograph 6 - Loose Oil Sump Accessory Port Plug**

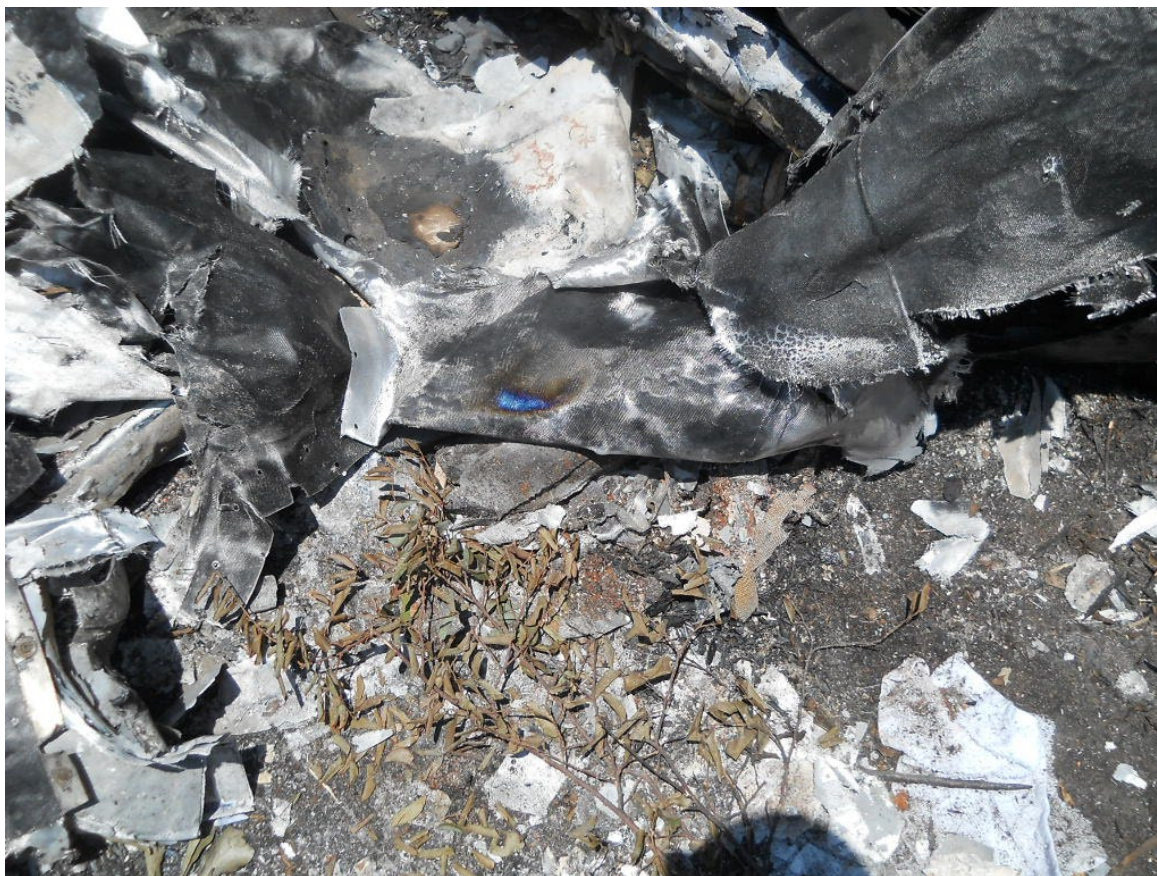
**Photograph 7 - Blue Staining Below Engine**
