# National Transportation Safety Board

ERA23FA313

## **PROPELLER GOVERNOR EXAMINATION**

Location: Churchville, MD  
Date: July 25, 2023  
Time: 1906 EDT  
2306 UTC  
Airplane: Piper PA-28R-200; N34PT

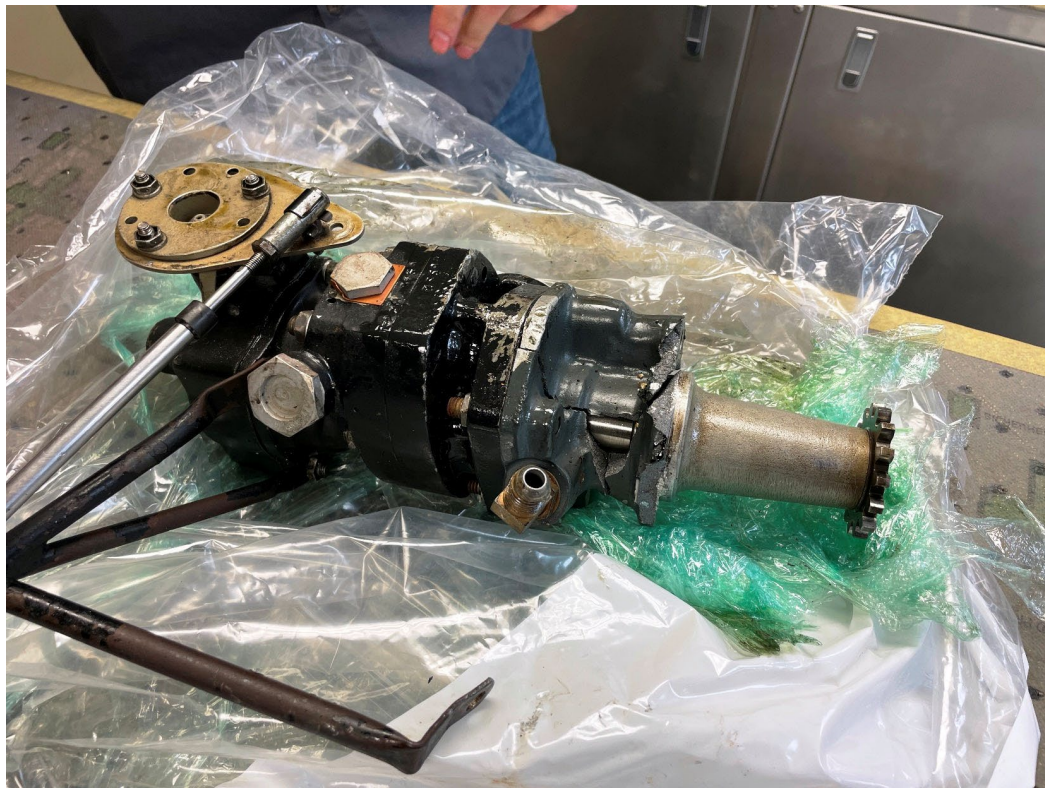
The Lycoming drive adaptor, a portion the Piper control cable and cable support truss were still attached to the governor. The drive adaptor was damaged by impact forces and only rotated approximately 180° before binding. Once the control cable and drive adaptor were removed, the control arm and governor pump shaft/drive gear moved freely by hand force. The governor external and internal surfaces were wet with oil but there was no measurable amount of residual oil in the pump. The high rpm stop post on the control arm was bent and partially fractured. The governor head had some gouging/wear due to contact with surrounding components.

**Photo 1: Overview of governor as received. (Hartzell Photo)**

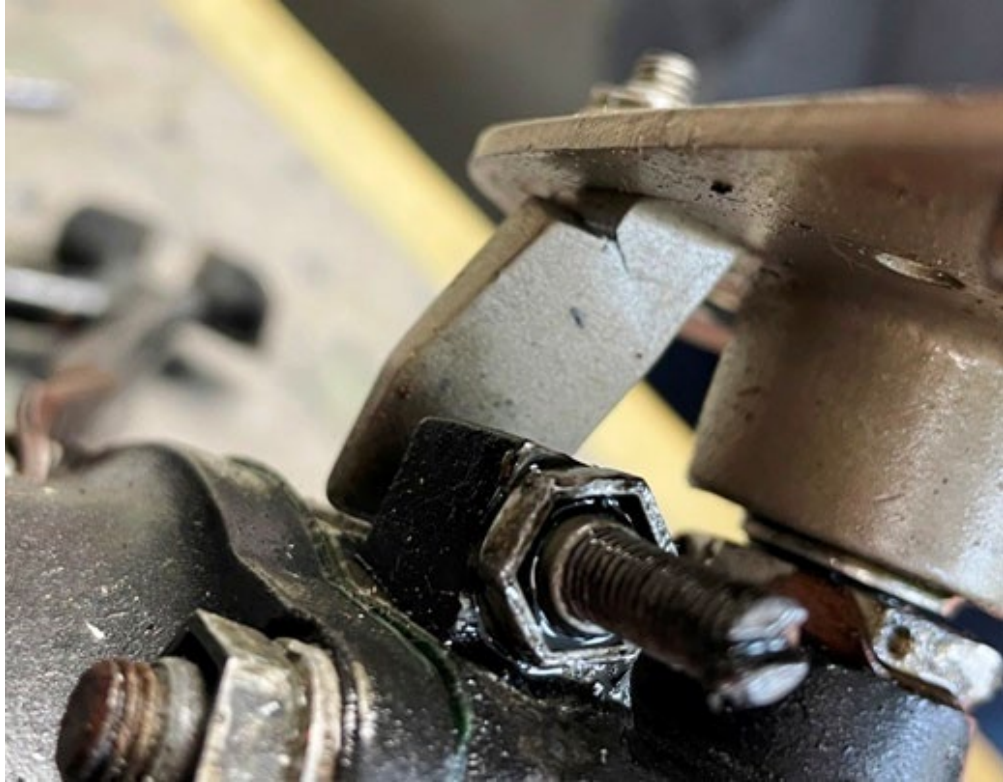
**Photo 2: View of bent/fractured high RPM stop post. (Hartzell Photo)**

**Control Shaft & Head -** The control head had gouging on the external surface. The high RPM stop post was bent and partially fractured. The control shaft appeared to have some bend at the shaft end, but it did not affect function.

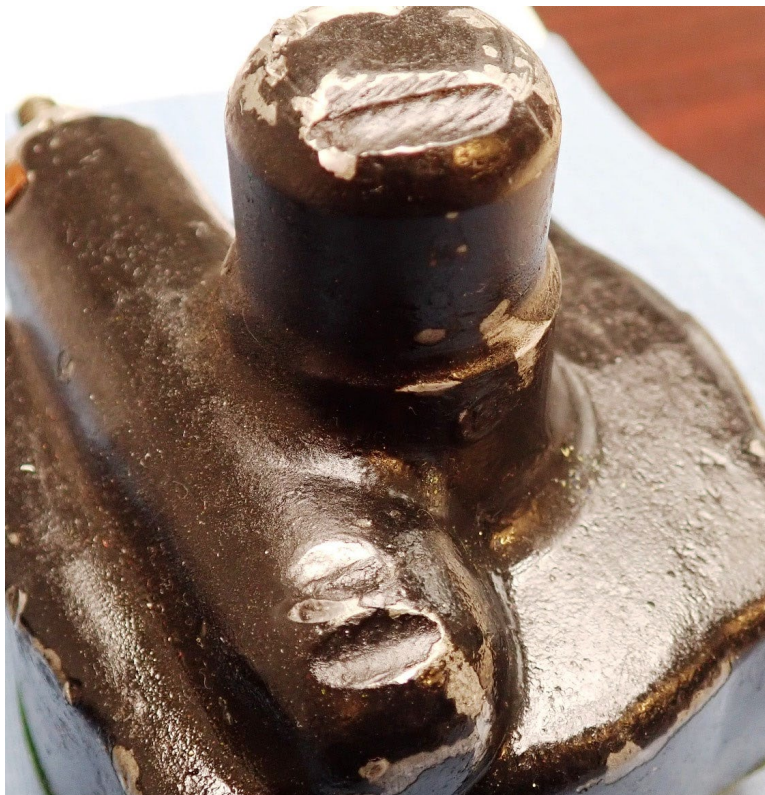
**Photo 3: Gouging/wear on the governor head. (Hartzell Photo)**

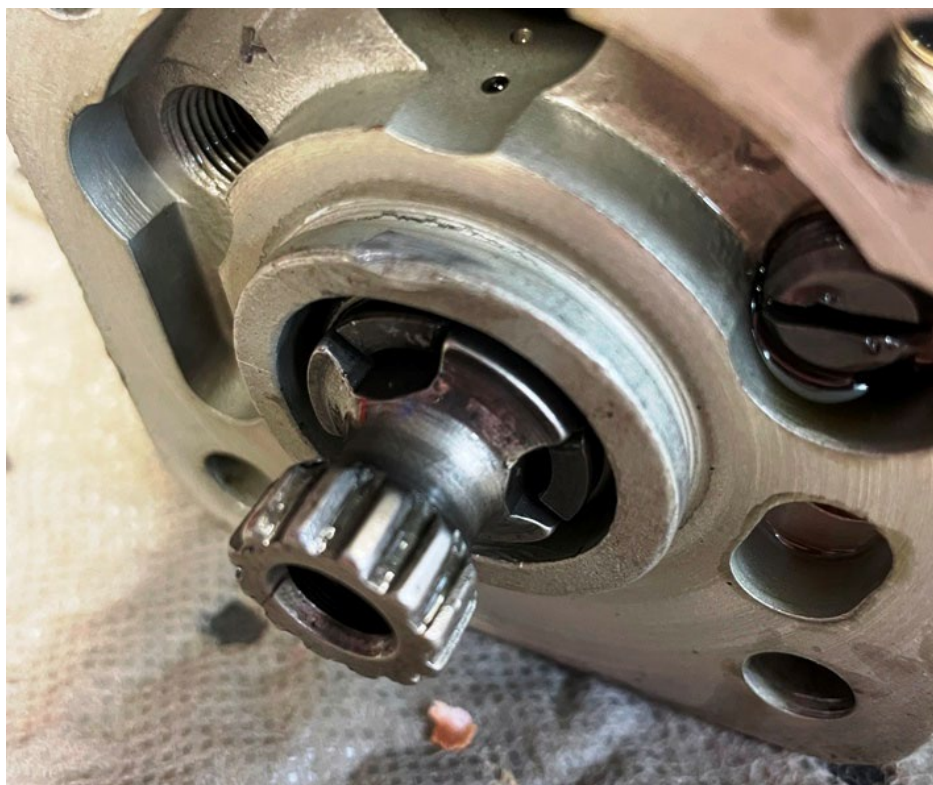
The Piper control cable and Lycoming drive adaptor were removed. There was impact damage to the governor pilot flange; a dent/deformation as well as a visible crack in the base radius. The mounting flange/surface had some impact damage along one edge, but it did not prevent leak-free seating on the test stand using a new gasket. The removed gasket/screen did have a small amount of foreign debris near a corner on the inlet side of the screen. The debris appeared to be a hard, black/grey, polysulfide sealant. There was also some metallic debris in the drive bore that appeared to be from the Lycoming drive adaptor impact damage.

**Photo 4: View of impact damage to the governor pilot flange. (Hartzell Photo)**

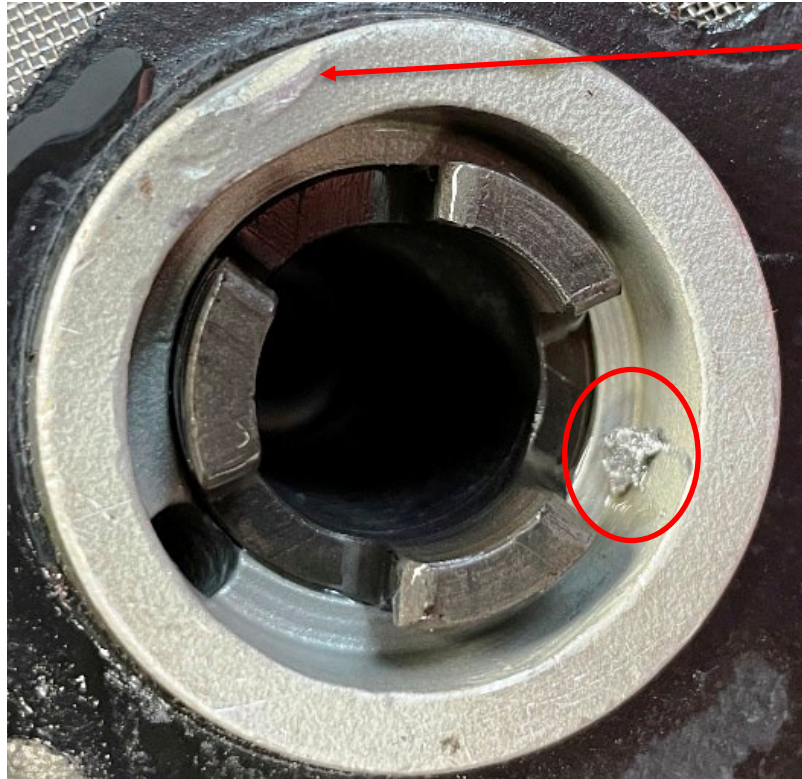
**Photo 5: Metallic debris in the drive bore. (Hartzell Photo)**

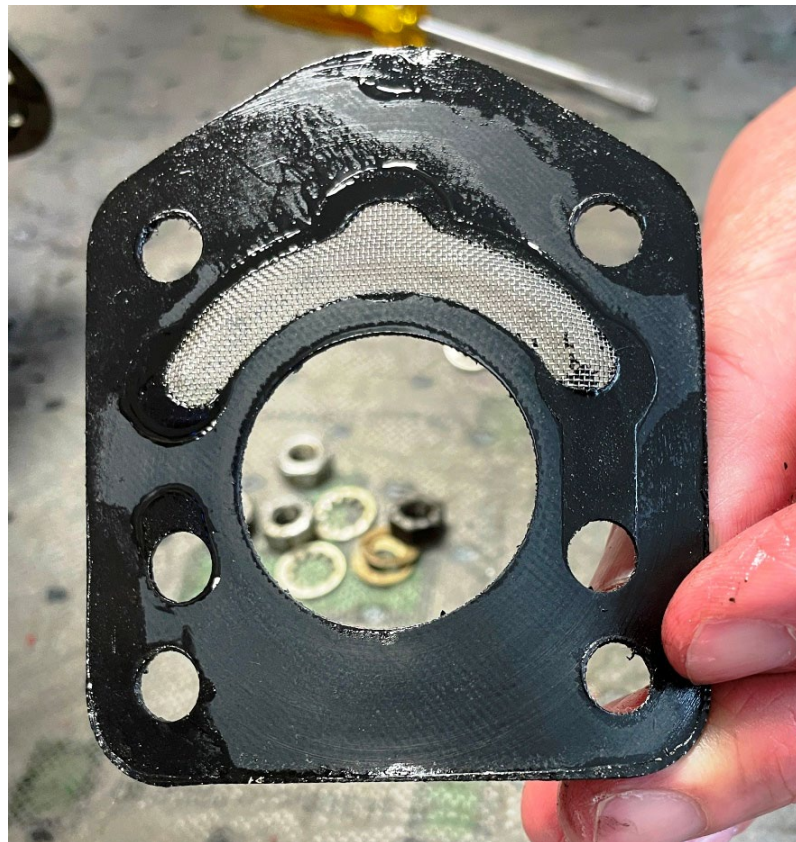
**Photo 6: Base and gasket/screen as received. (Hartzell Photo)**

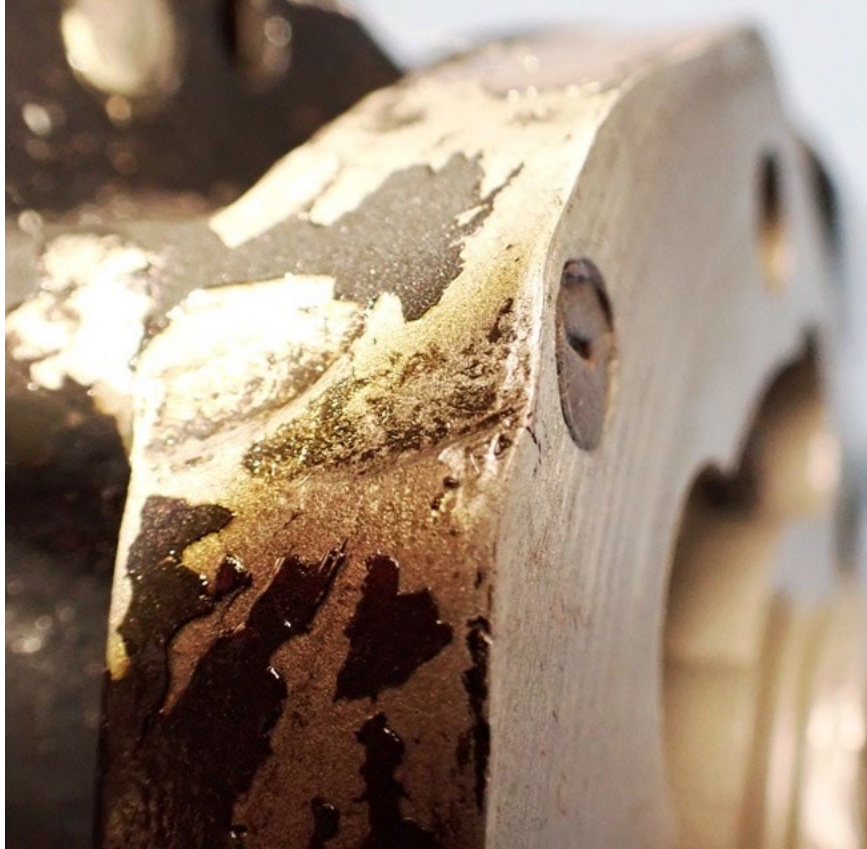
**Photo 7: Governor mounting flange impact damage on edge. (Hartzell Photo)**

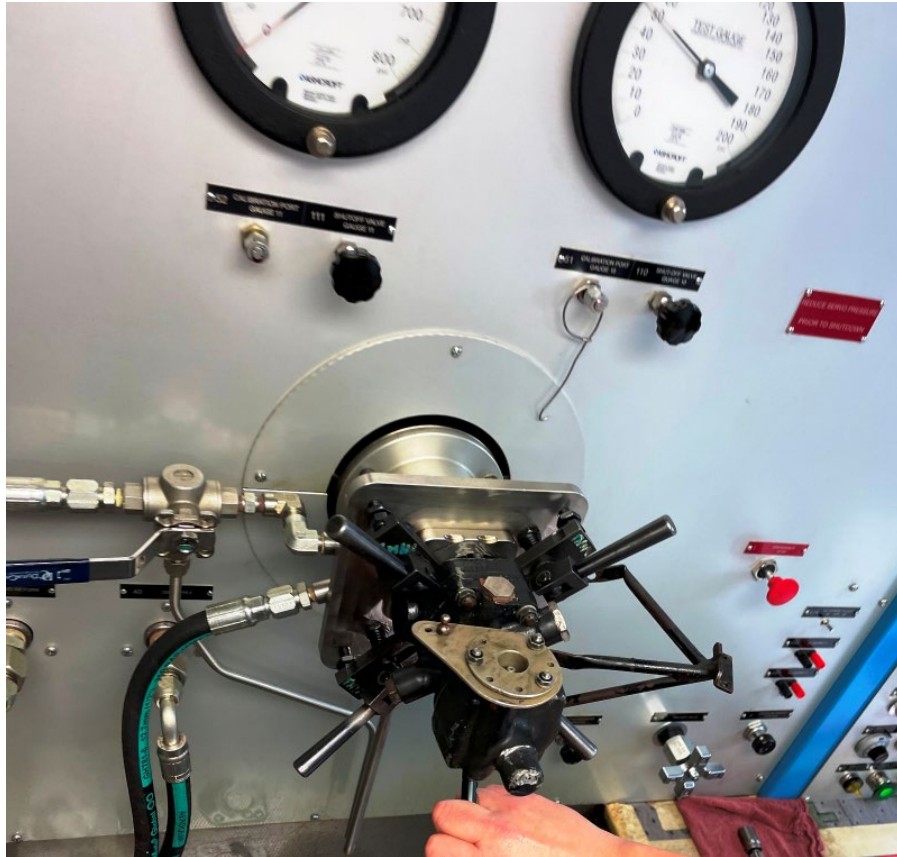
1. Pressure relief setting was 266 psi vs. a requirement of 275-300 psi.
2. Pump capacity flow rate was approximately 7.7 quarts at 1755 RPM vs. a requirement of 8-12 quarts/min.
3. Leakage rate was 17-18 oz. vs. a maximum limit of 8 oz./min.
4. With the high RPM stop visually positioned the RPM was 2330 RPM at 115°F oil temperature vs. a requirement of 2330 +/- 10RPM.
5. There was no external leakage noted.

**Photo 8: View of the governor installed on the test stand. (Hartzell Photo)**

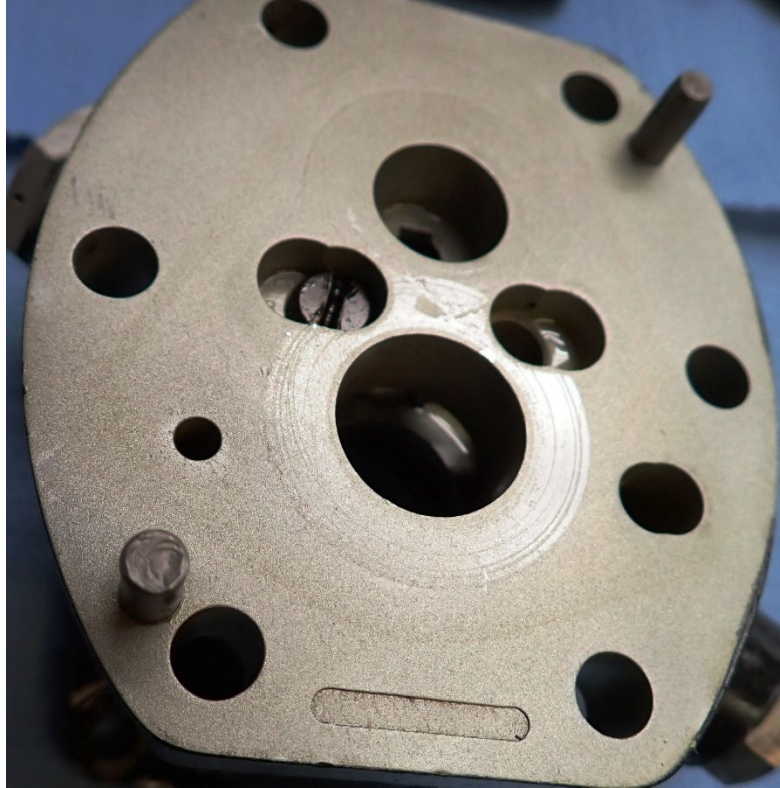
The governor was disassembled to investigate the reasons for the lower relief pressure, flow rate and high leakage. The only abnormal wear was some rotational scoring between the drive gear and body and between the flyweight unit and body. Otherwise, there were no unusual visual discrepancies noted, nor any debris found on any internal components during the disassembly and inspection of the governor.

**Photo 9: Rotational scoring on body from drive gear. (Hartzell Photo)**

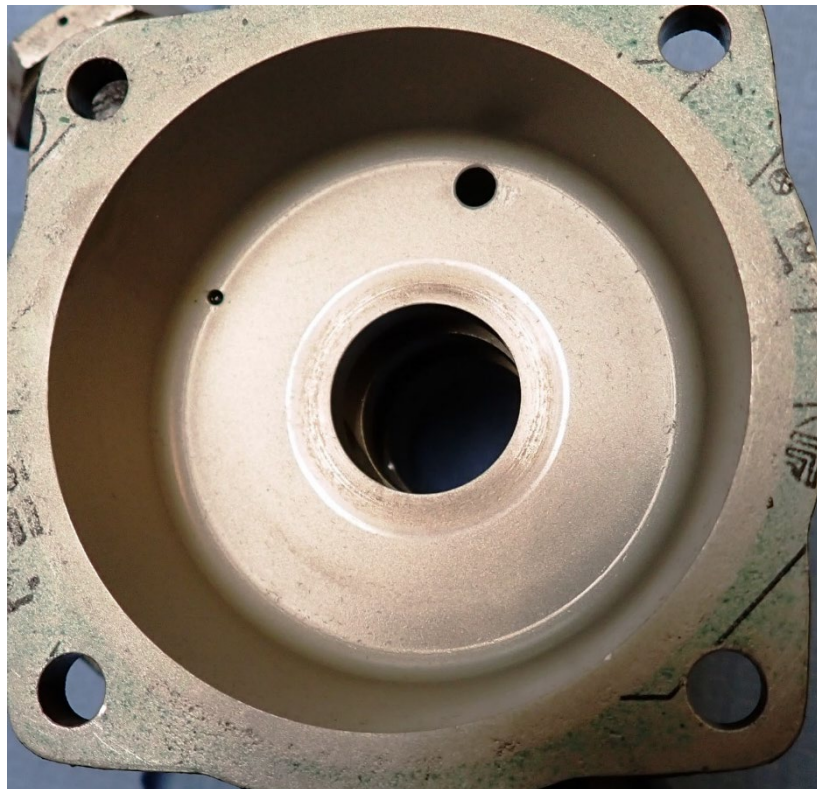
**Photo 10: Rotational scoring on the body from flyweight unit. (Hartzell Photo)**

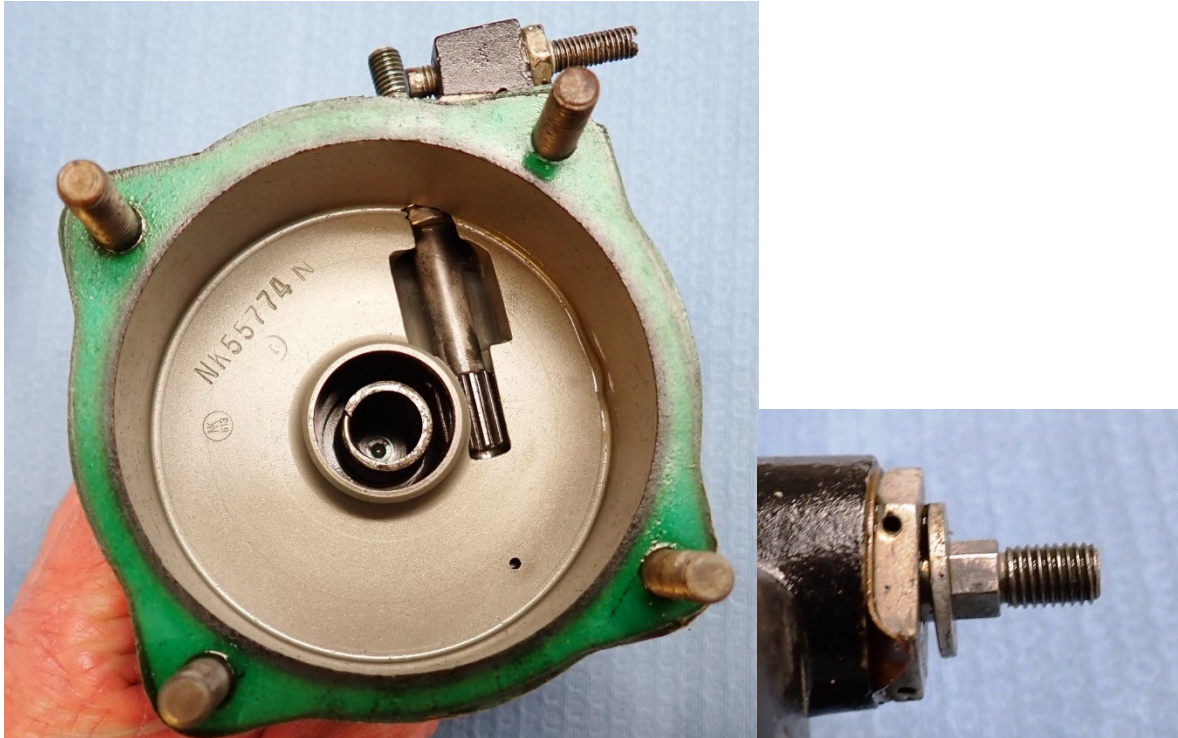
**Photo 11: Control shaft and head. (Hartzell Photo)**

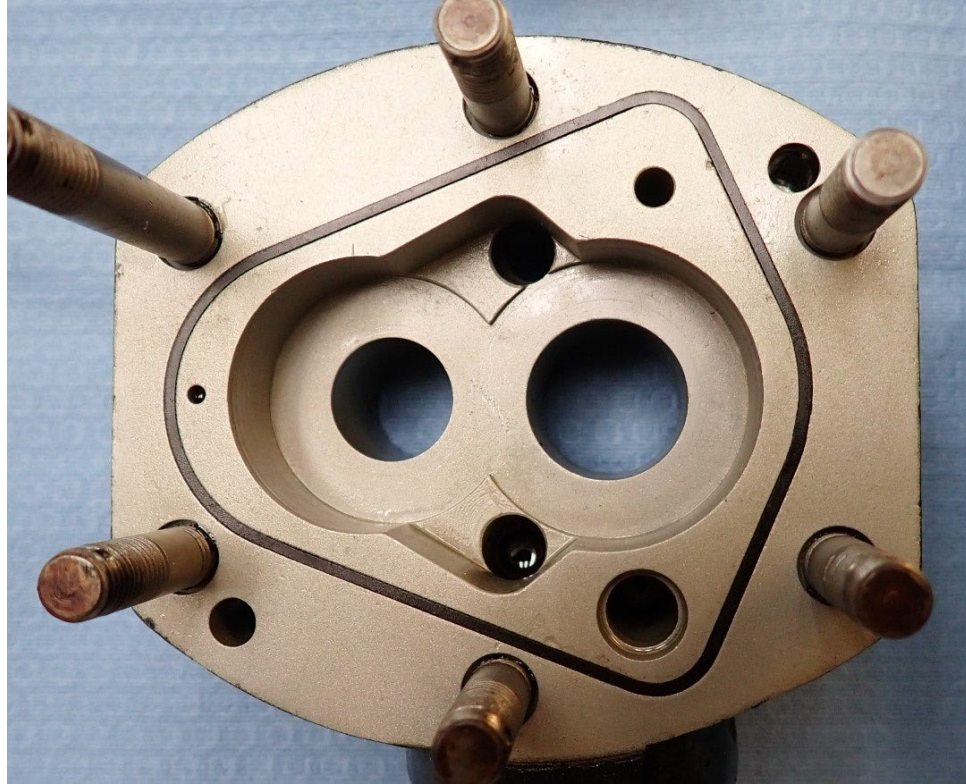
**Body -** The drive gear shaft bore was oversized (0.8758 vs. 0.8756 maximum).

**Photo 12: Governor oil pump body. (Hartzell Photo)**

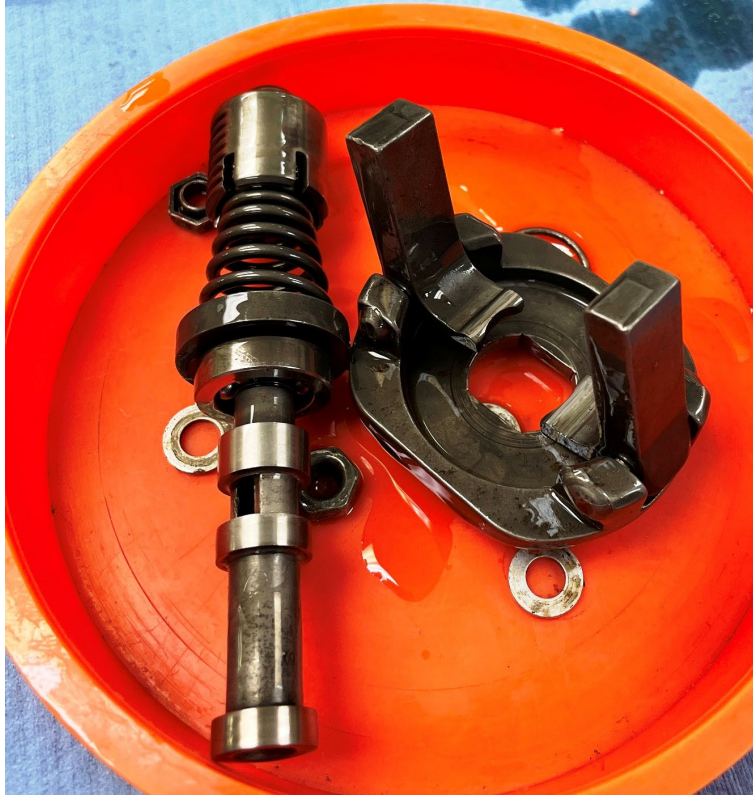
**Spool and Relief Valve** - The spool diameter was undersized (0.5610 vs. 0.5614 minimum) and the relief valve plunger was slightly undersized on one measurement (0.4981 vs. 0.4985).

**Photo 13: Governor spool, speeder spring, and flyweight unit components. (Hartzell Photo)**

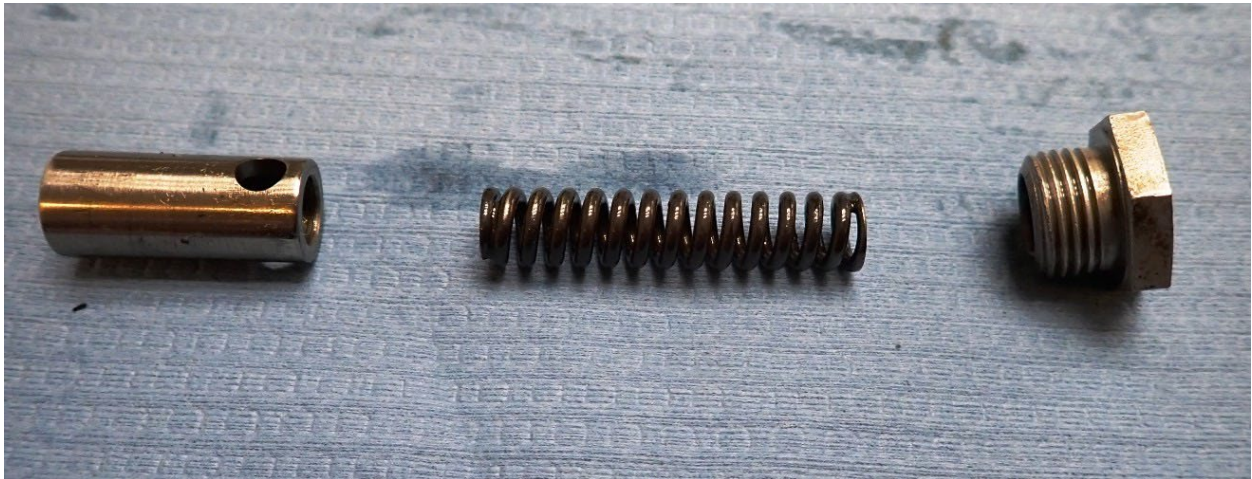
**Photo 14: Pressure relief valve components. (Hartzell Photo)**

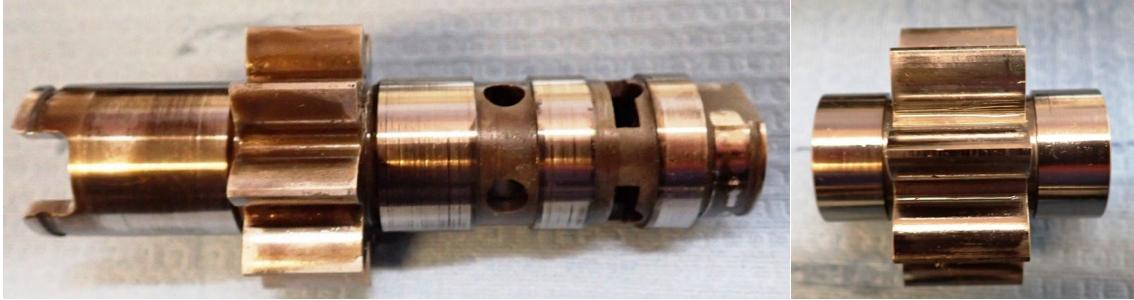
**Drive/Pump Gears -** Serviceable, no discrepancies noted.

**Photo 15: Governor oil pump gears. (Hartzell Photo)**
