# National Transportation Safety Board

ERA23LA313

## **WRECKAGE EXAMINATION**

Location: Churchville, MD  
Date: July 25, 2023  
Time: 1906 EDT  
2306 UTC  
Airplane: Piper PA-28R-200; N34PT

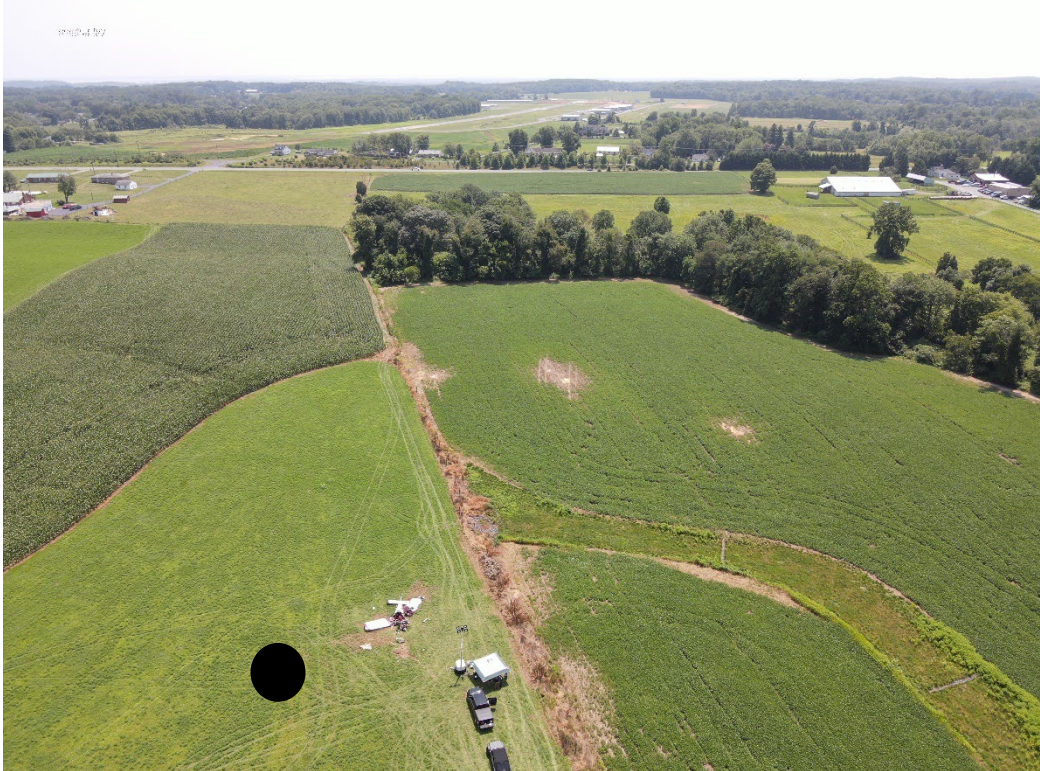
**Photo 1: Accident site with the airport of departure in the background. (HCSO Photo)**

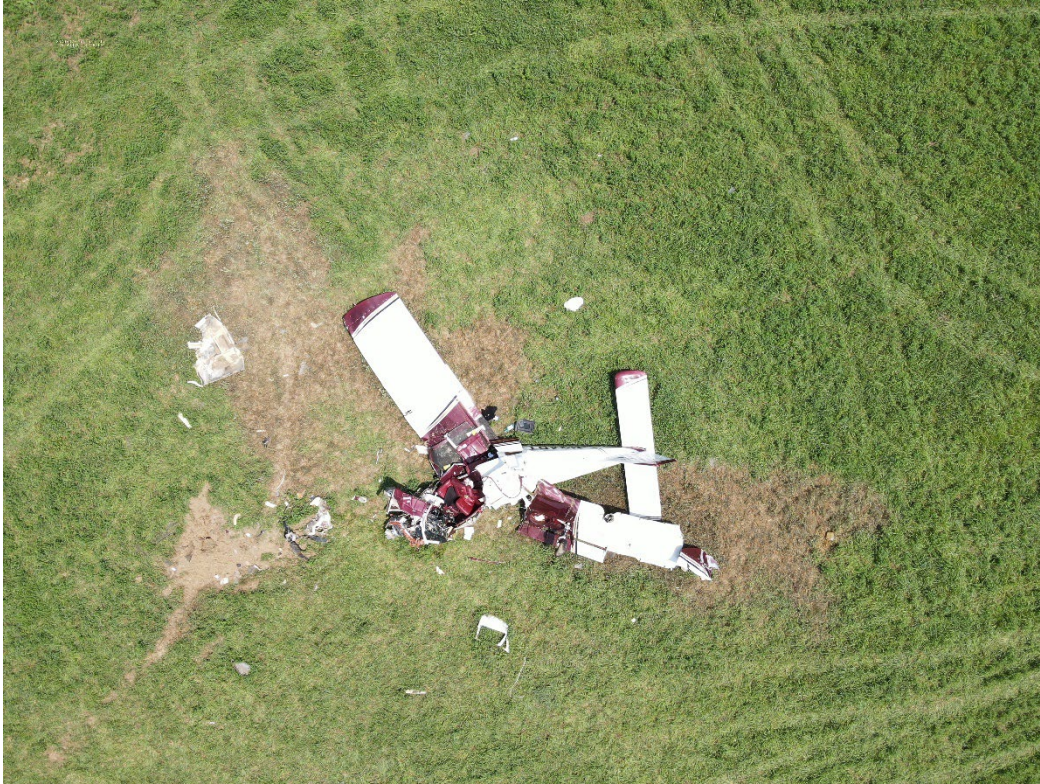
**Photo 2: Accident site as viewed from above. (HCSO Photo)**

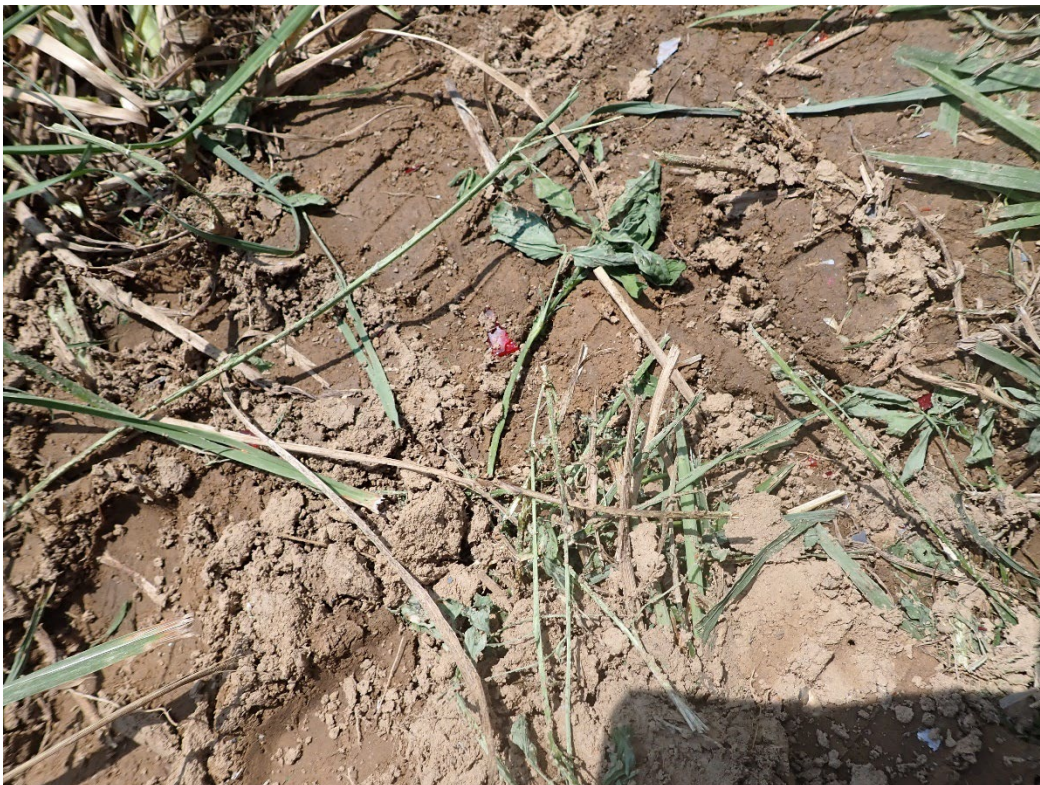
The airplane came to rest on a heading of about 350°, and an elevation of 386 ft in a cut hay field. There were multiple ground impact scars, the initial ground impact scar had remnants of a red light glass. There was a large ground impact scar about 20 ft. from the initial ground impact scar. The

**Photo 3: Initial impact ground scar with red lens glass.**

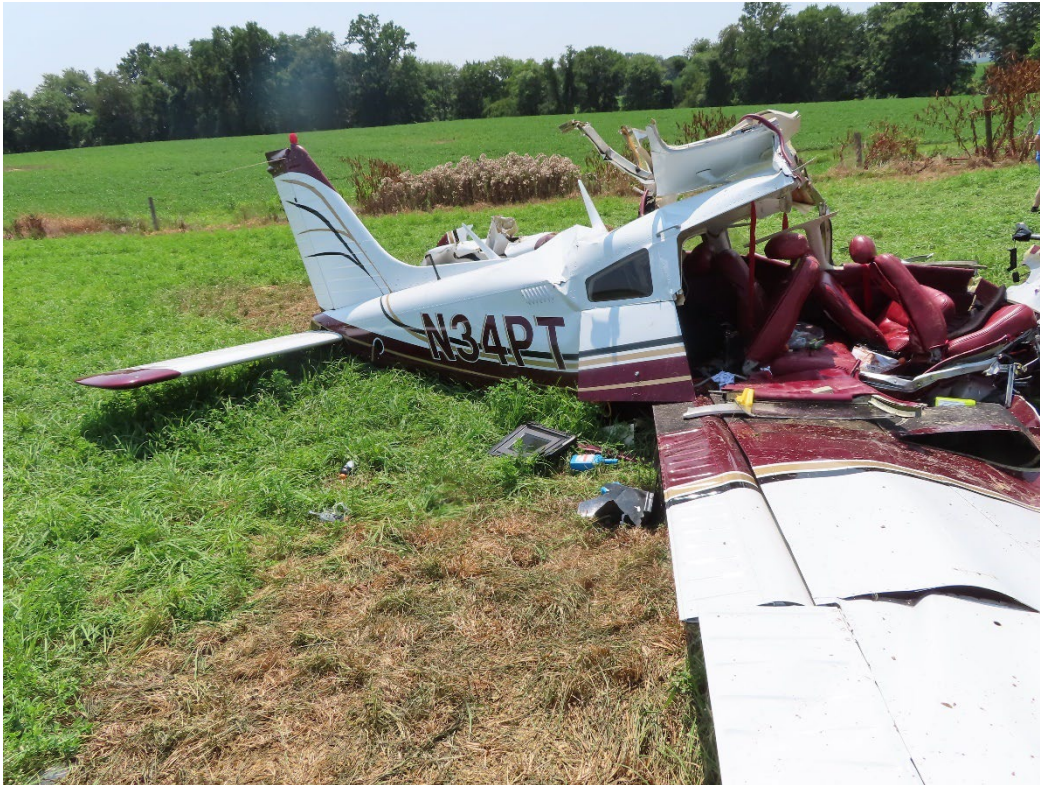
The fuselage was impact crushed aft and the top of the fuselage was peeled back. First responders did not cut the wreckage to remove the pilot.

**Photo 4: Right side of the fuselage. (Piper Photo)**

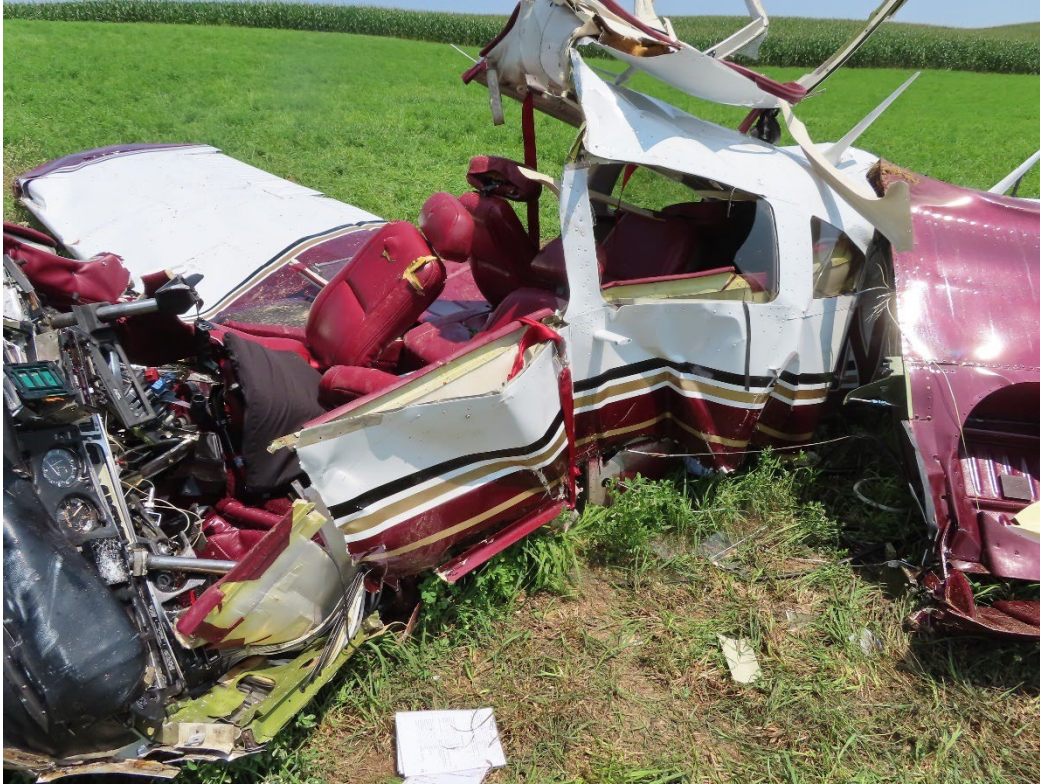
**Photo 5: Left side of the fuselage. (Piper Photo)**

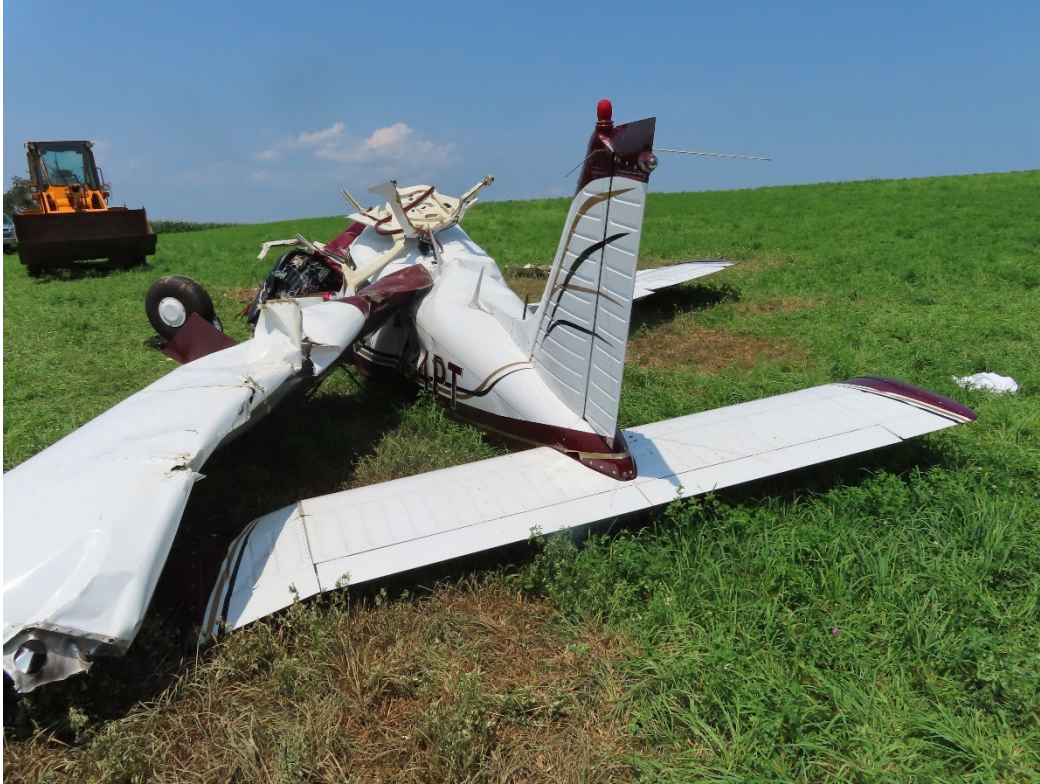
The stabilator remained attached at all attachment points, there was impact damage to the left stabilator tip. Control continuity was confirmed from the stabilator flight control surface to cables in the cockpit. The stabilator trim tab remained attached at all attachment points and was slightly nose up when the jack screw was measured. The vertical stabilizer and rudder were not damaged. Control continuity was confirmed from the rudder control surface to the rudder pedals in the cockpit. The beacon light remained attached to the top of the vertical stabilizer and was not damaged.

**Photo 6: View of the empennage. (Piper Photo)**

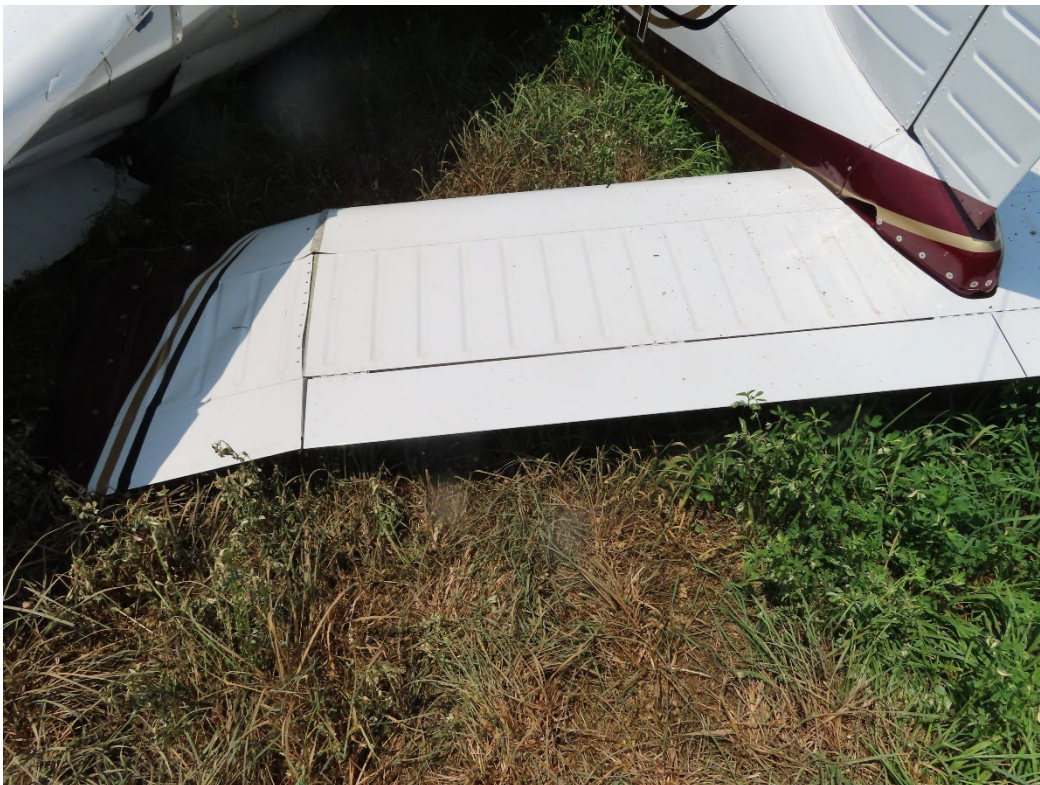
**Photo 7: View of damage to the left stabilator tip. (Piper Photo)**

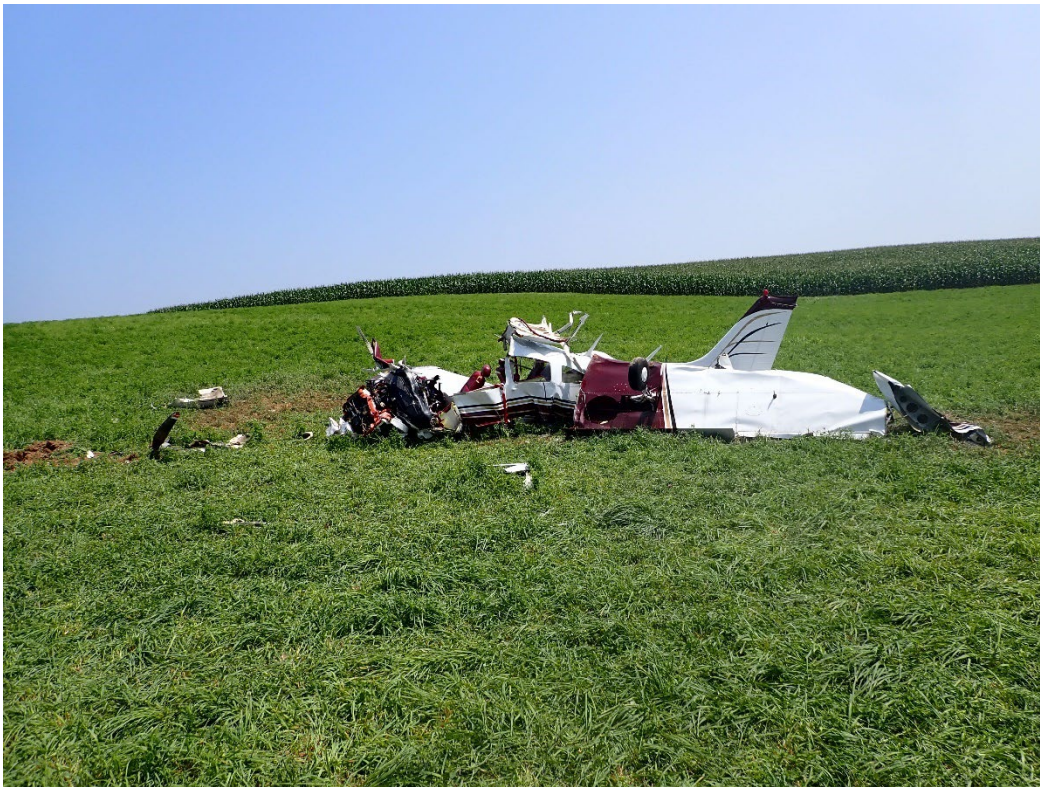
The left wing remained attached to the fuselage by one aileron control cable and was rotated towards the tail with the bottom facing up. All spars in the left wing were impact separated and exhibited overload fractures. The leading edge of the left wing was impact crushed aft along the entire length. The left aileron remained attached at all attachment points and exhibited impact damage. Both left aileron cables were attached at the bell crank and the bell crank was impact separated in the wing. The left aileron primary control cable remained intact through the wing and into the fuselage. The left aileron through cable was impact separated and exhibited unraveling and broom straw overload fracture. The left flap remained attached at all attachment points and exhibited impact damage, however it was separated from the control rod. The left wingtip was impact separated and the red navigation light lens was shattered.

**Photo 8: View of the left wing.**

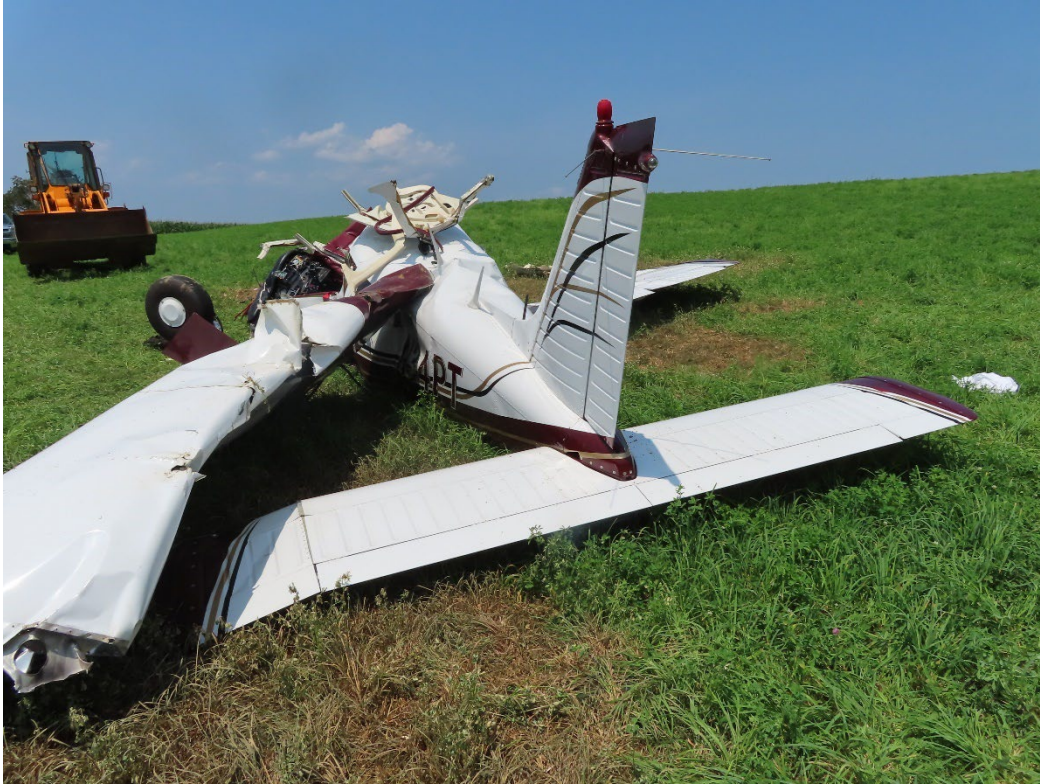
**Photo 9: View of crush damage to the leading edge of the left wing. (Piper Photo)**

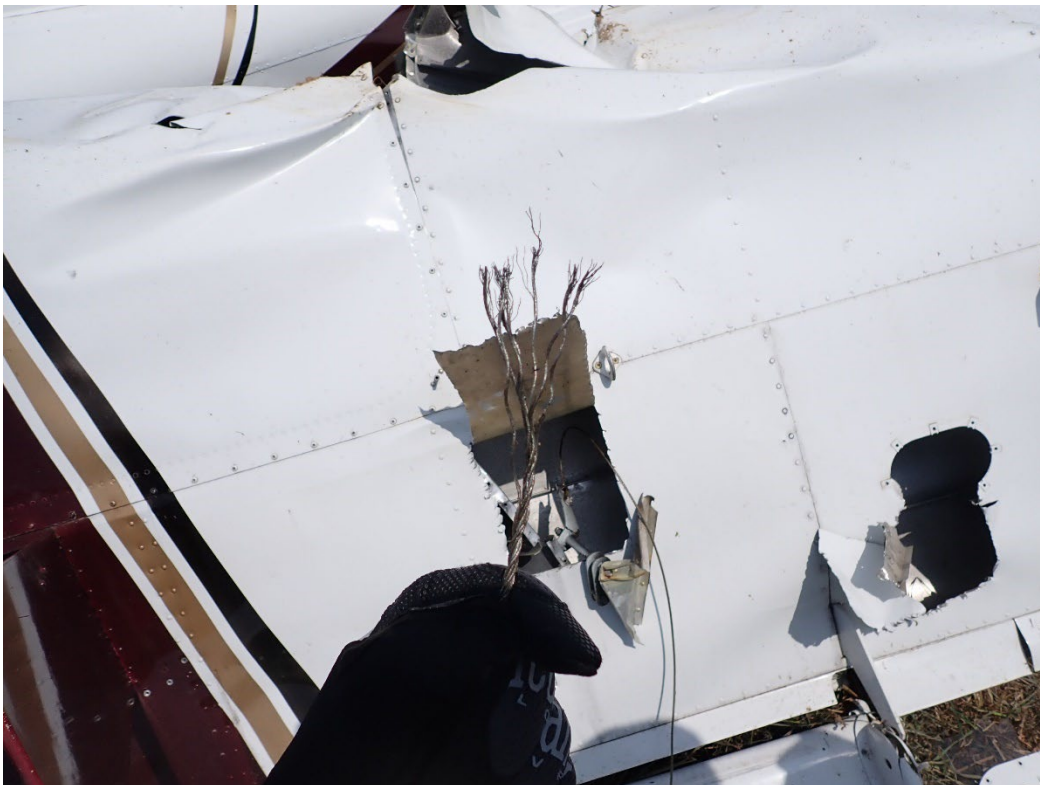
**Photo 10: Aileron through cable end that was attached to the left aileron bell crank.**

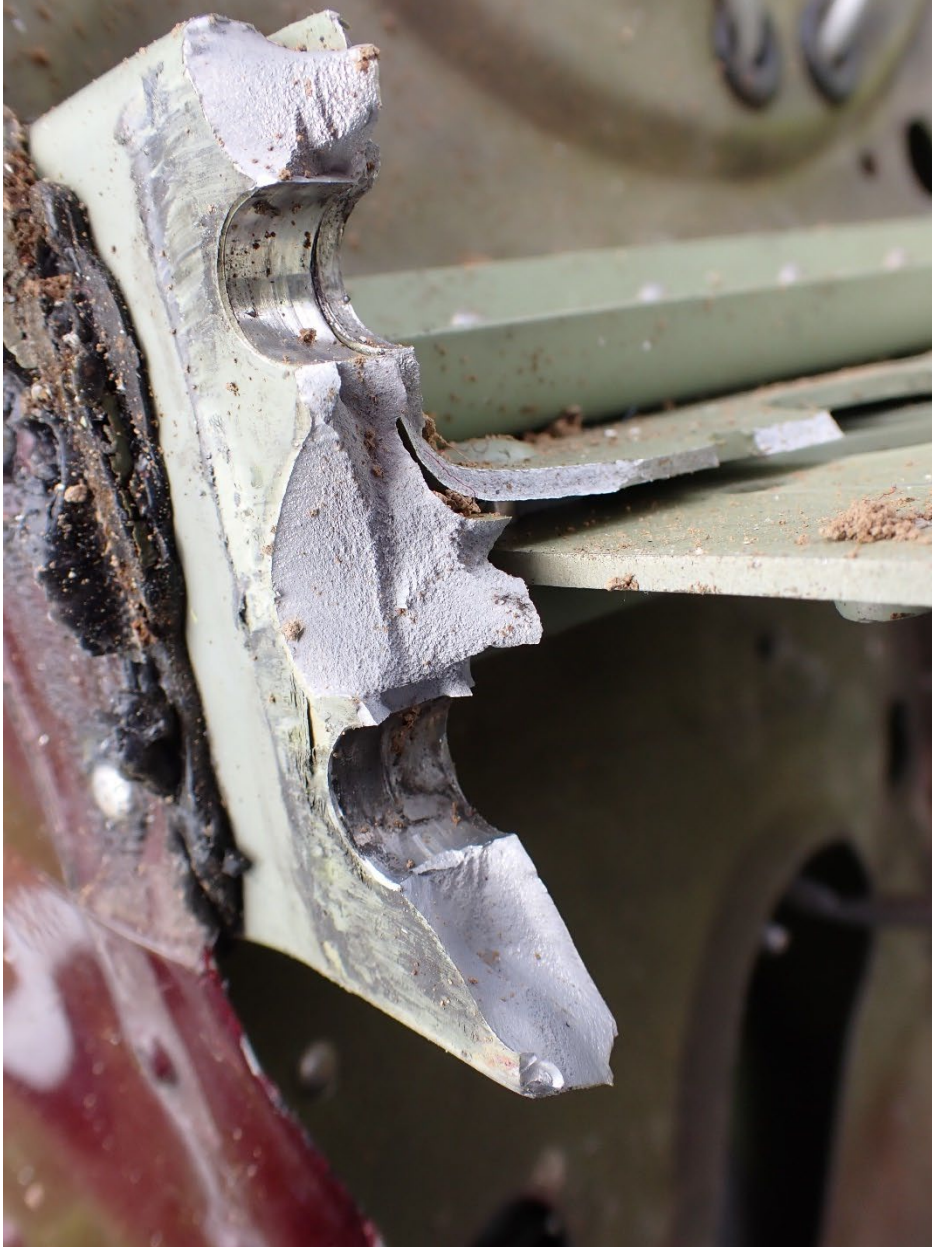
**Photo 11: Left main spar fracture.**

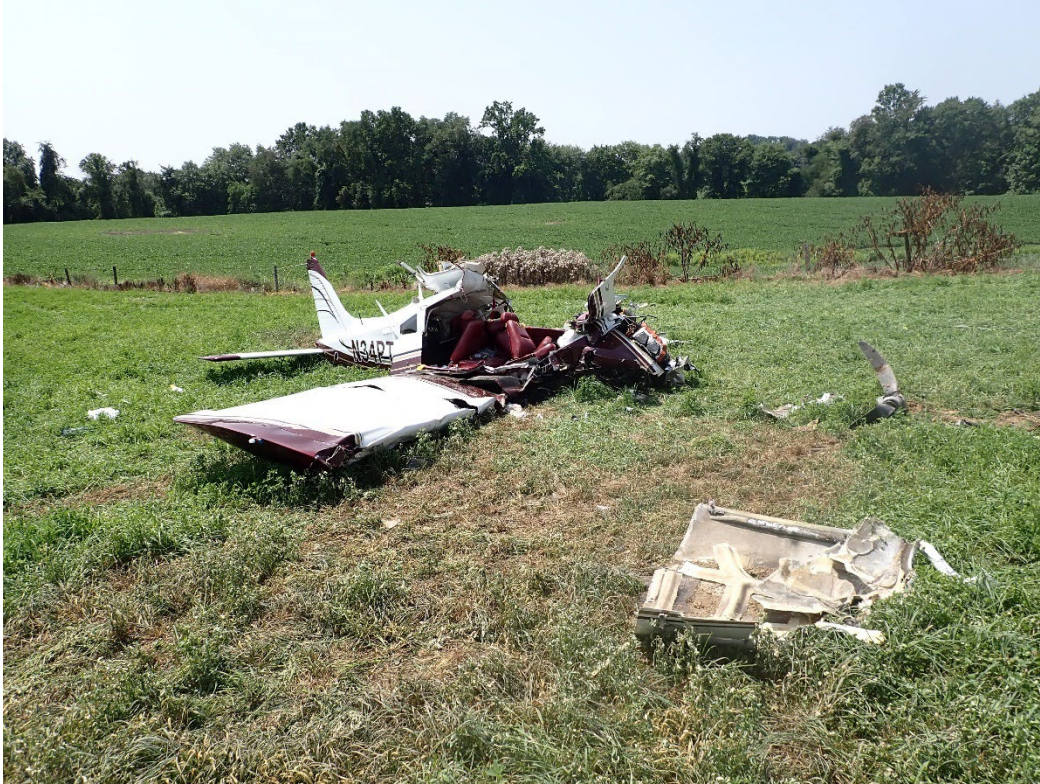
The right wing remained attached to the fuselage at all attachment points. The leading edge was impact crushed aft along the entire length. The right aileron remained attached at all attachment points. The right aileron cables remained attached to the bell crank and the bell crank remained attached in the wing. The right aileron primary cable was continuous to the control yoke and the right aileron through cable was impact separated and exhibited a broom straw overload fracture. The right flap remained attached at all attachment points and was in the extended position. Control continuity was confirmed from the flight control surface to the control yoke. The right wingtip remained attached, and the green navigation lens remained intact.

**Photo 12: View of the right wing leading edge.**

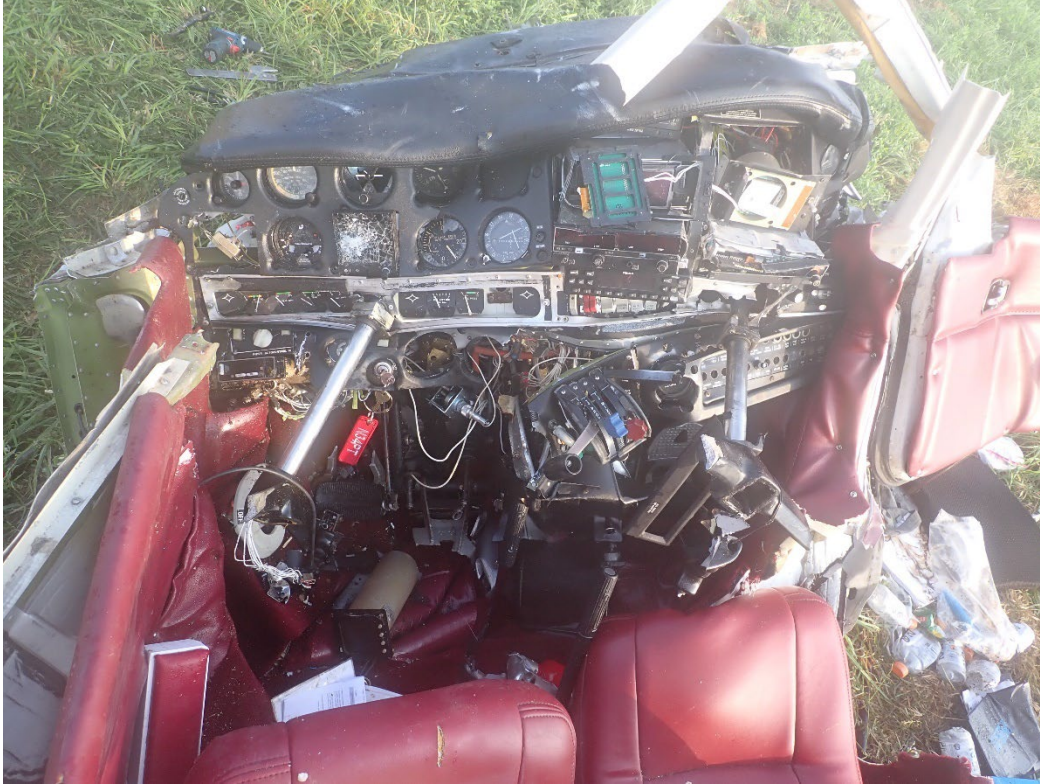
The landing gear handle was found in the down position. The flap handle was found in the flaps fully extended position, this was confirmed by counting the chain links from the flap handle to the gear on the flap torque tube. The ignition key remained in the ignition and was in both position. The vertical speed indicator was frozen showing a 1500 ft/min rate of descent. The throttle control lever was found about halfway between full throttle and idle. The propeller lever was found about a third of the way up from the bottom stop. The mixture lever was found about a quarter of the way up from the bottom stop. The left rudder pedals were fractured, and the right rudder pedals were intact. Both control yoke hand holds were impact separated. The left control yoke was impact fractured down and both control yokes were pulled from the instrument panel. The magnetic compass was impact separated and found near the large ground impact scar.

**Photo 14: View of the cockpit.**

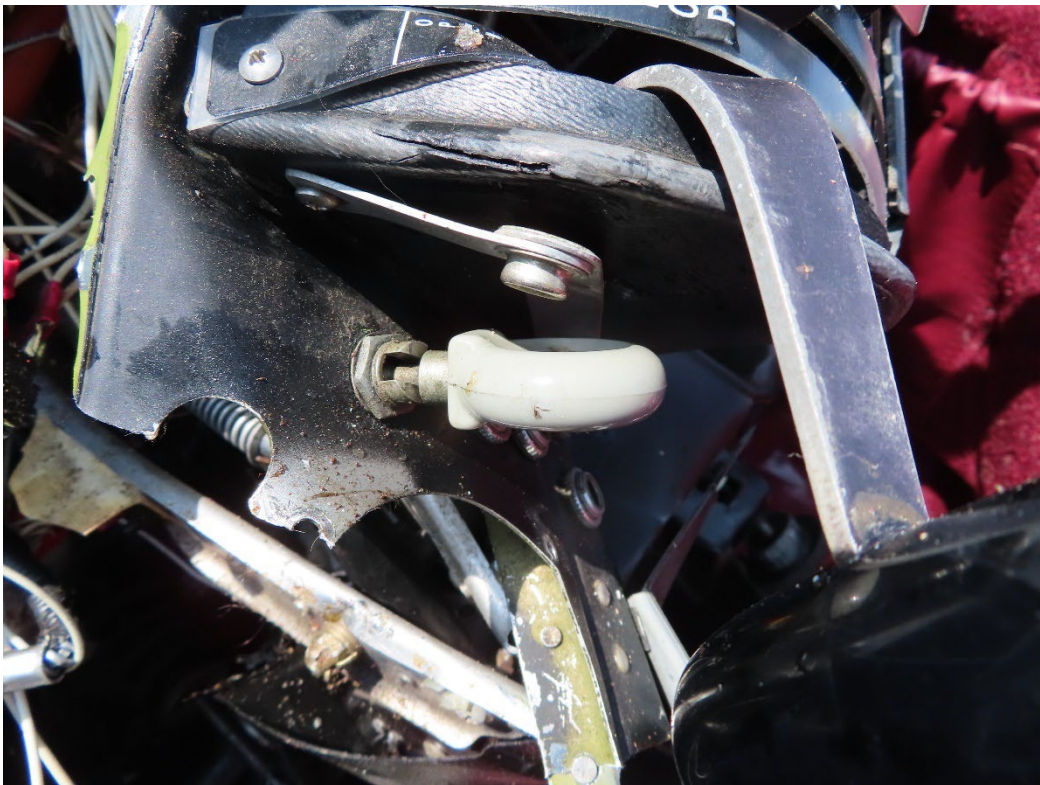
**Photo 15: Landing gear handle. (Piper Photo)**

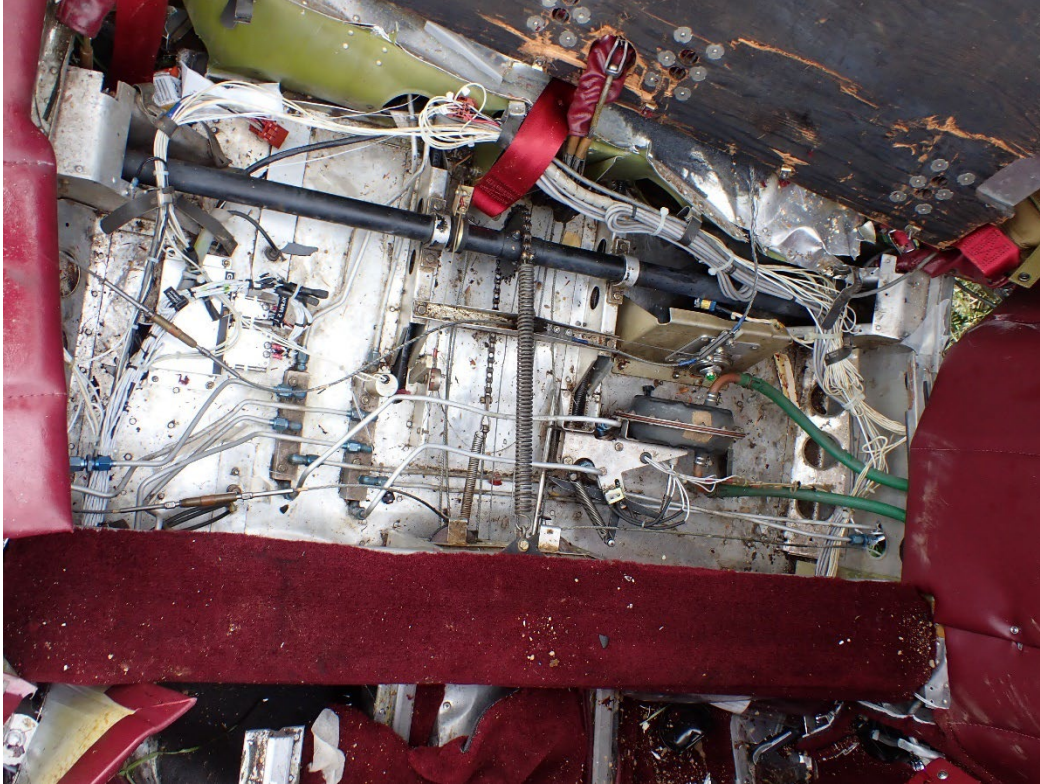
**Photo 16: View of the flap chain attached to the flap torque tube.**

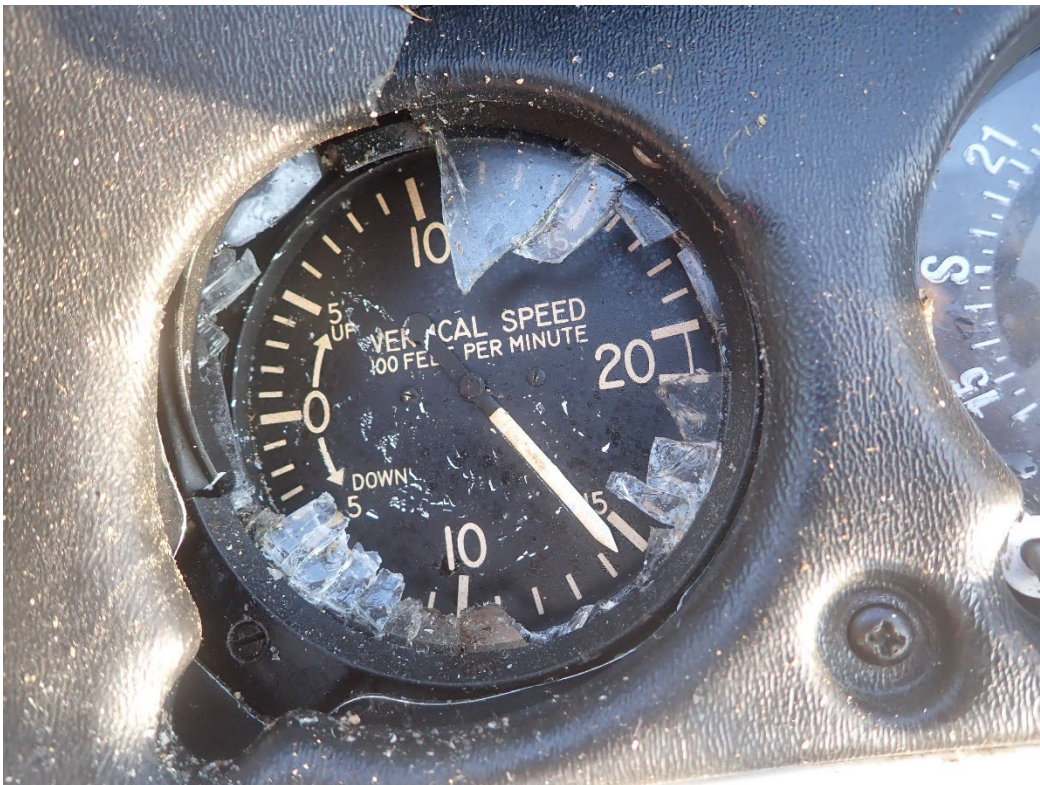
**Photo 17: Vertical Speed Indicator.**

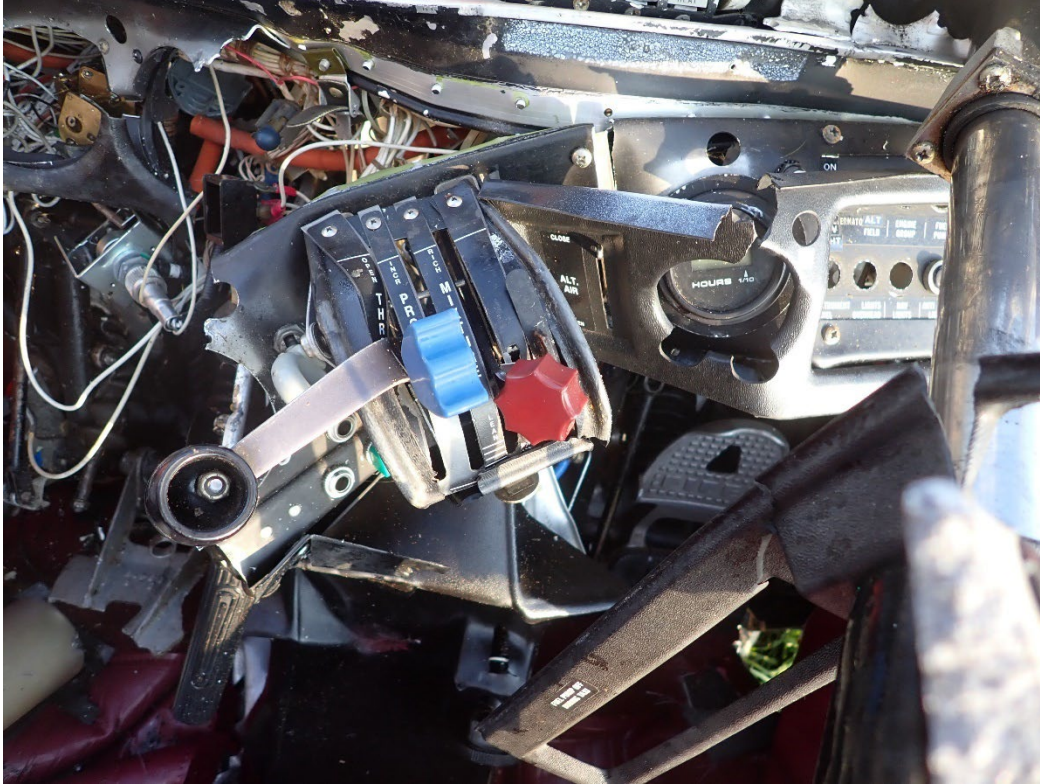
**Photo 18: View of the throttle quadrant.**

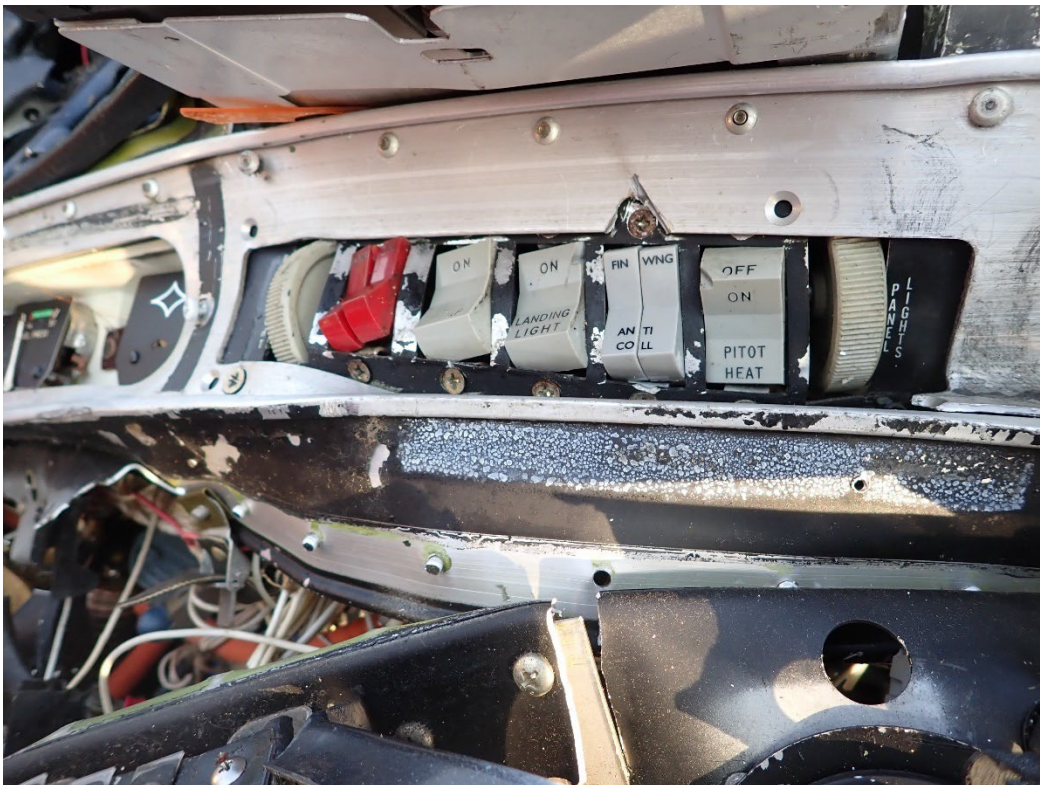
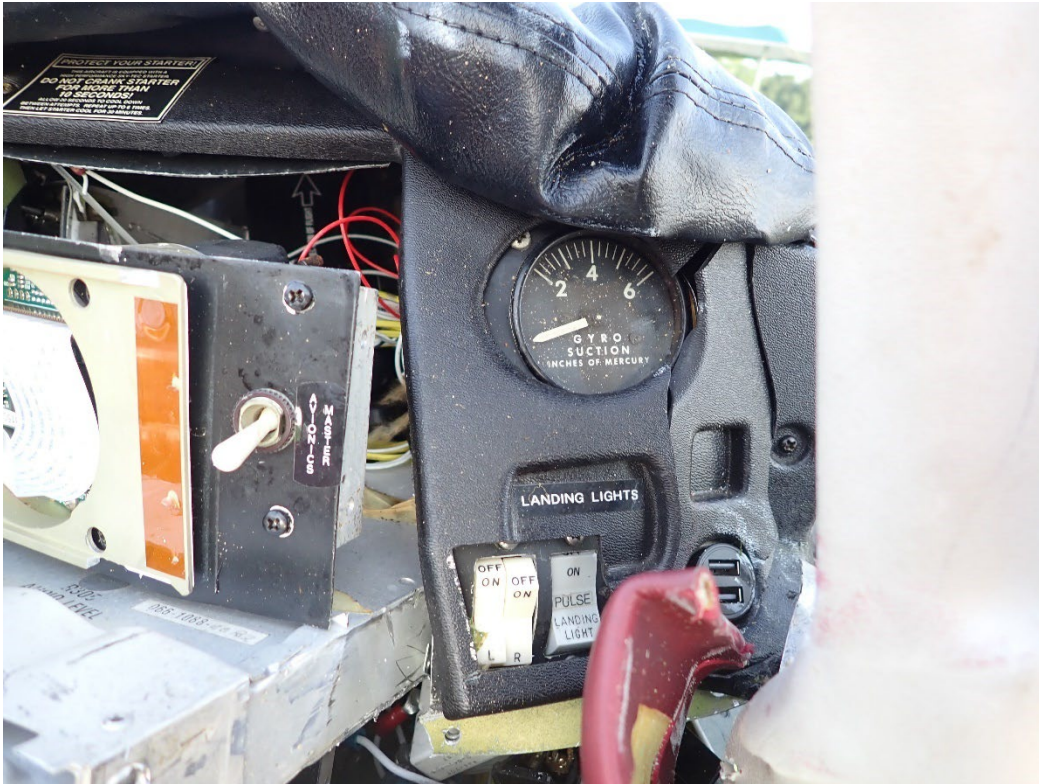
- Landing Lights Panel
  - L – ON
  - R – OFF
  - PULSE – ON
- Avionics Master – OFF
- Master – ON
- Pitot Heat – OFF
- Anti – Collision Lights – ON
- Landing Light – ON
- Fuel Pump – ON
- Master – ON

**Photo 19: View of cockpit switches.**

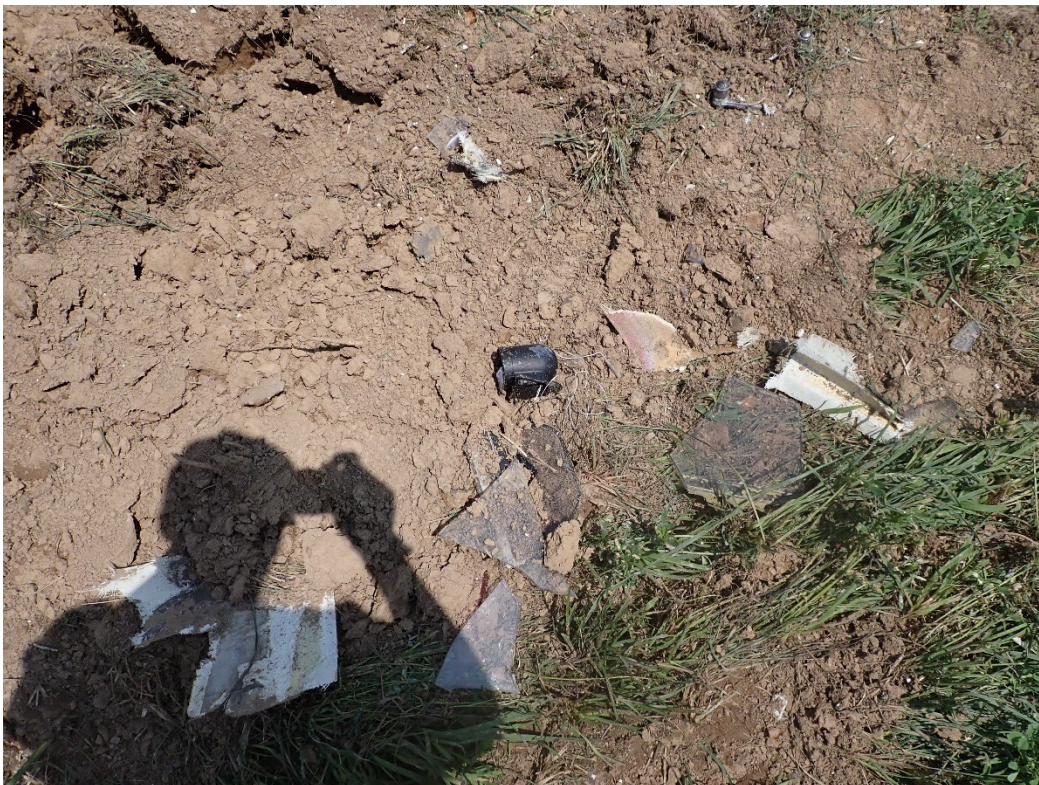
**Photo 21: View of the magnetic compass impact separated from the glareshield.**

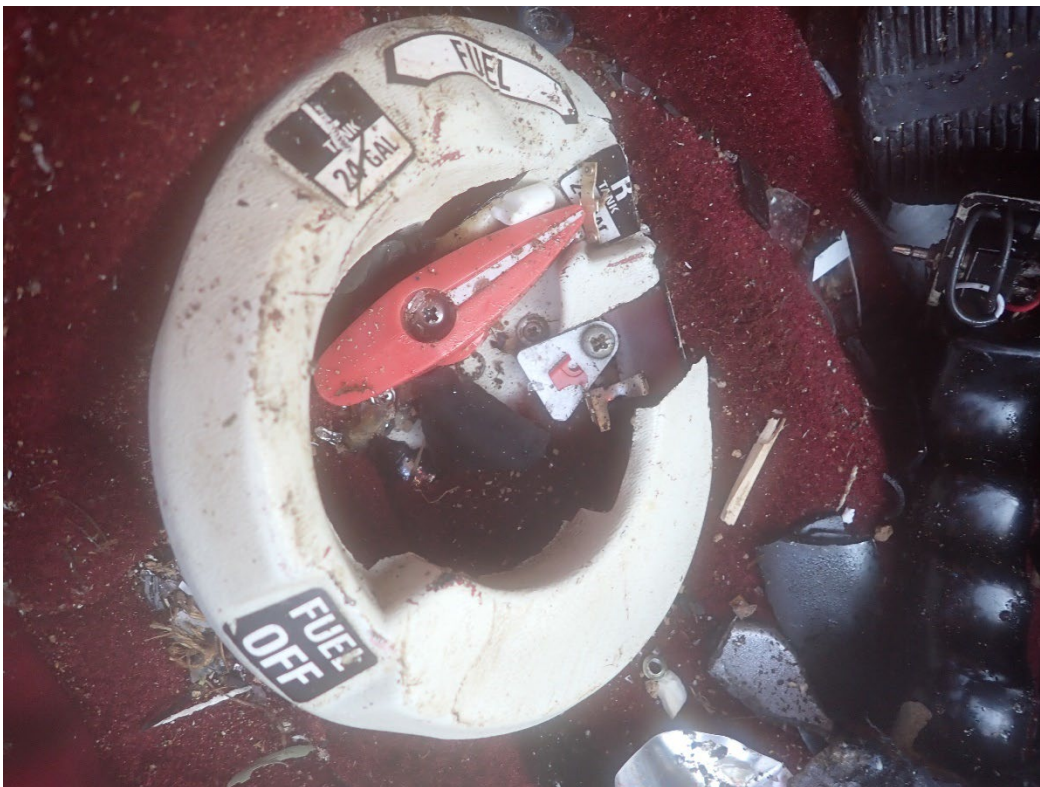
Both fuel tanks were breeched, and both fuel caps remained seated in place. There was a residual smell of aviation fuel. The fuel selector was in the right position. Fuel was found in the fuel selector and the fuel lines from the fuel selector toward the engine. The electronic fuel boost pump remained attached at all attachment points and was undamaged. Fuel was collected from the fuel boost pump and tested with water finding paste, no water was detected. The fuel strainer screen was free of debris.

**Photo 22: Fuel selector.**

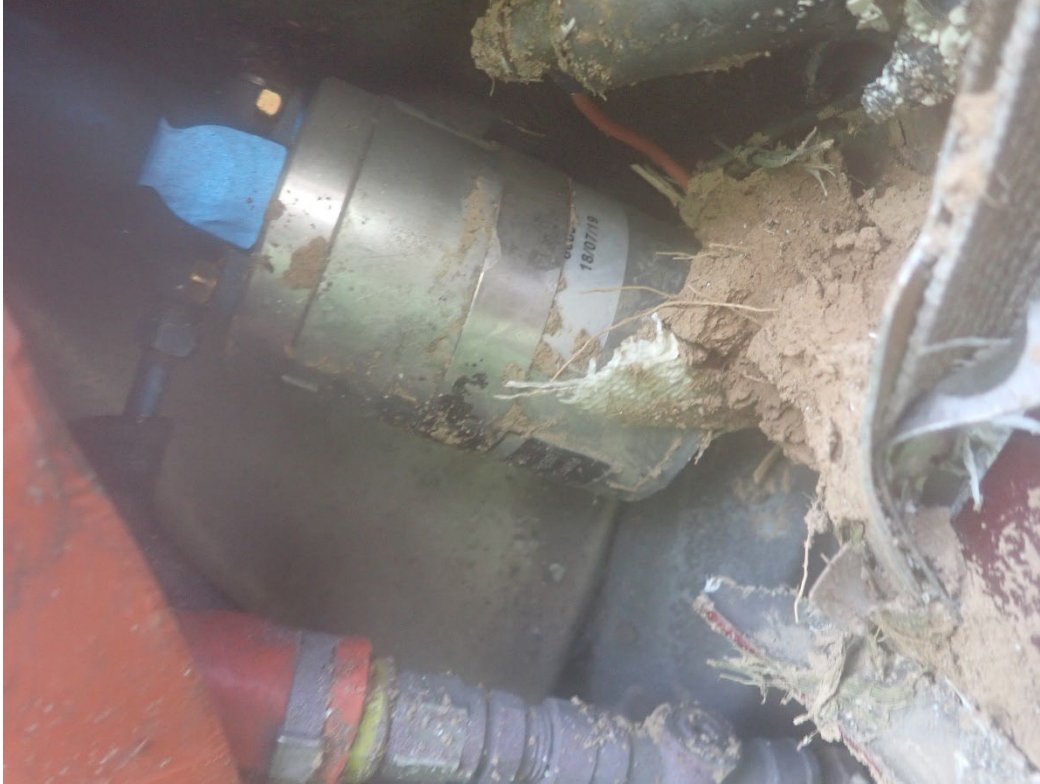
**Photo 23: Electric fuel pump.**

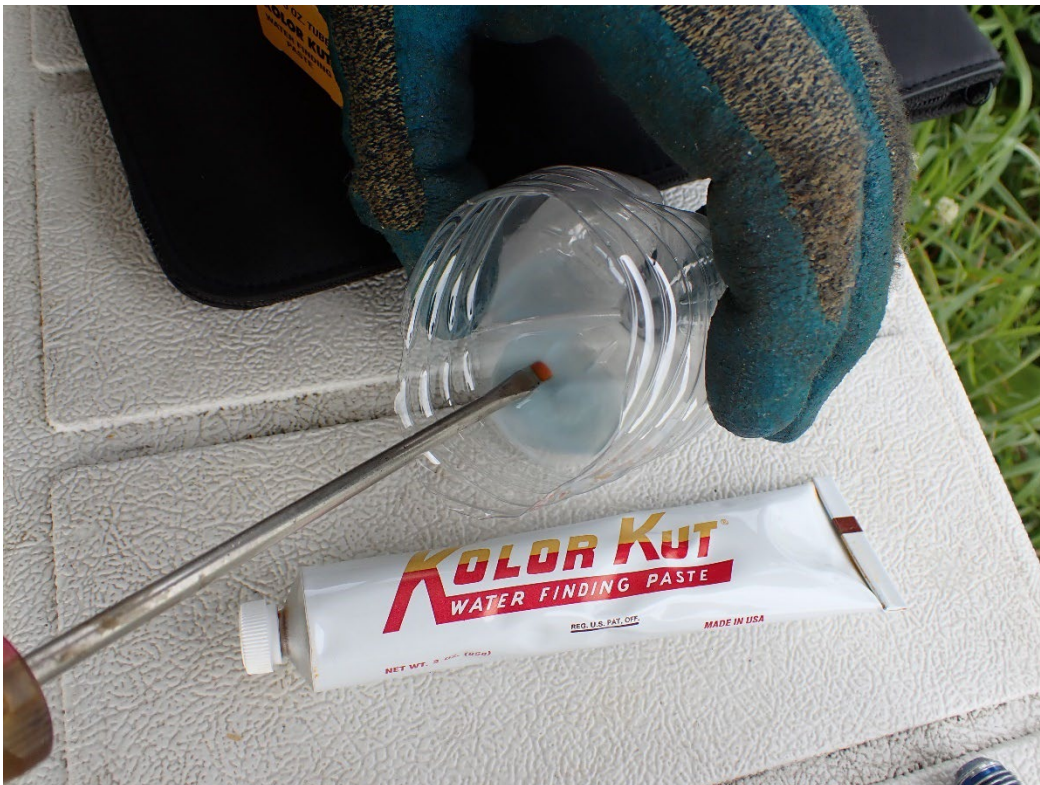
**Photo 24: Fuel being tested with water finding paste.**

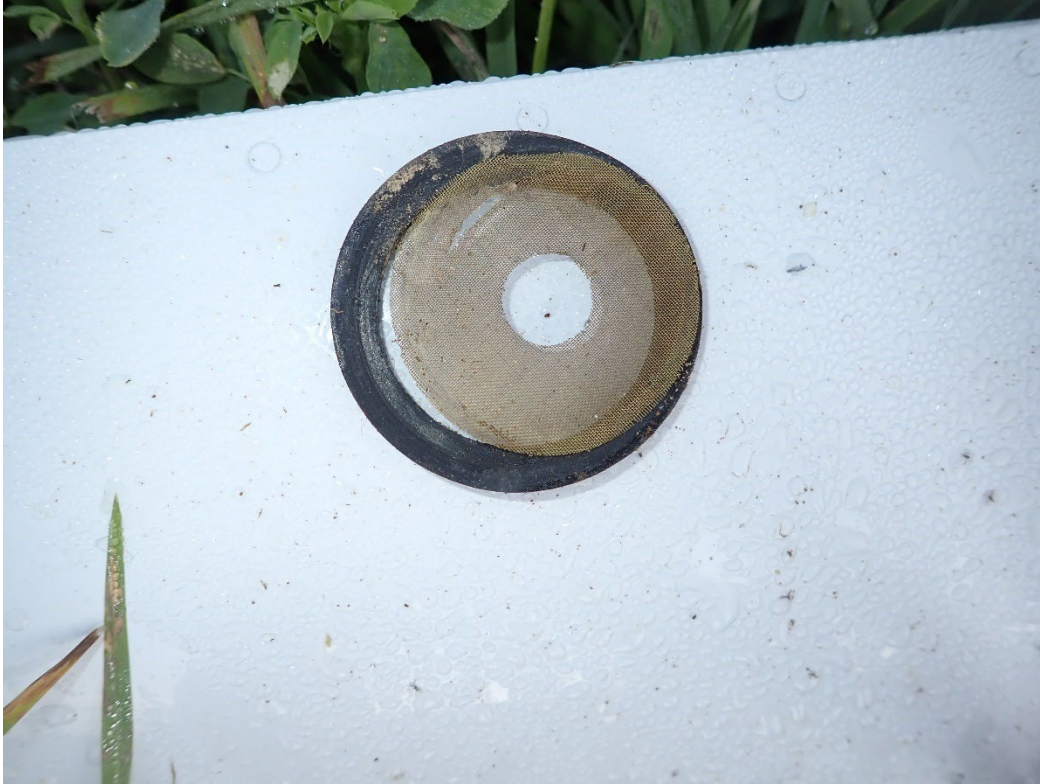
**Photo 25: Fuel strainer screen.**

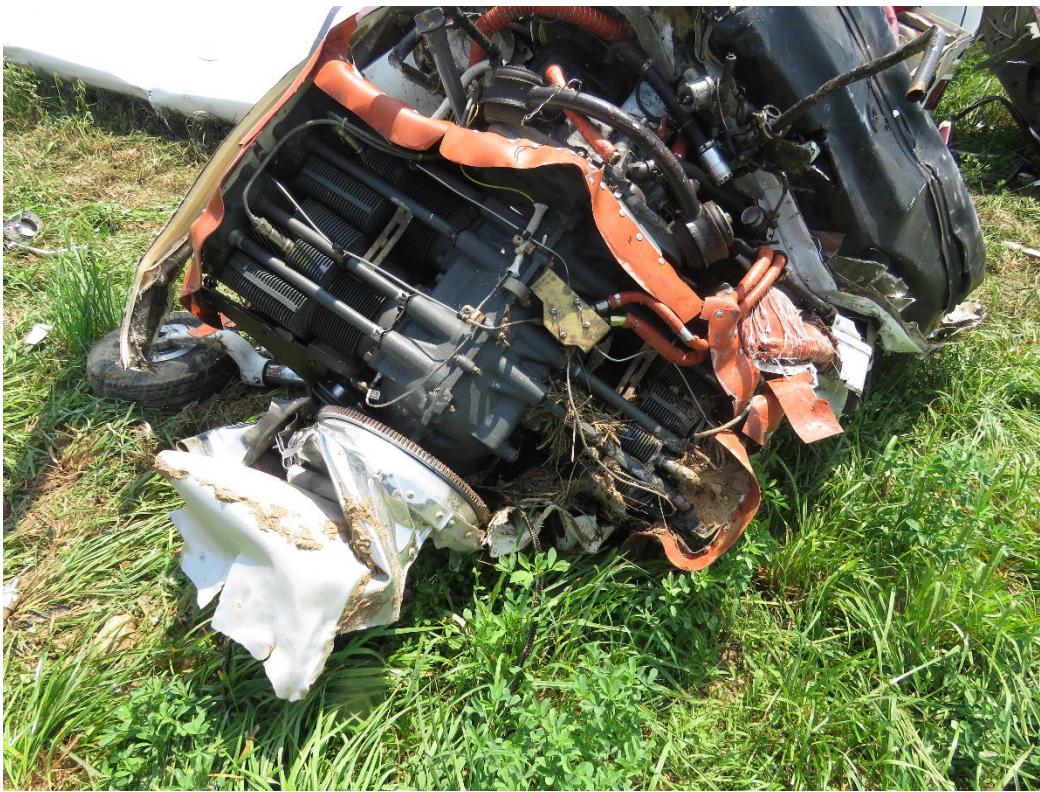
The engine model was a Lycoming IO-360-C1C, serial number L-10191-51A which had accumulated about 1273 hours of time in service since the last overhaul. The engine remained attached to the fuselage at all engine mounts. The top spark plugs, and rocker box covers were removed to facilitate crankshaft rotation. Compression and suction were confirmed on all cylinders using the thumb method when the crankshaft was rotated through 720° of rotation by hand using a tool in an accessory drive pad. Crankshaft and valvetrain continuity were confirmed when the crankshaft was rotated through 720° of rotation by hand using a tool in an accessory drive pad.

**Photo 28: View of the engine. (Lycoming Photo)**
