# National Transportation Safety Board

ERA23LA313

## **WRECKAGE EXAMINATION**

Location: Churchville, MD  
Date: July 25, 2023  
Time: 1906 EDT  
2306 UTC  
Airplane: Piper PA-28R-200; N34PT

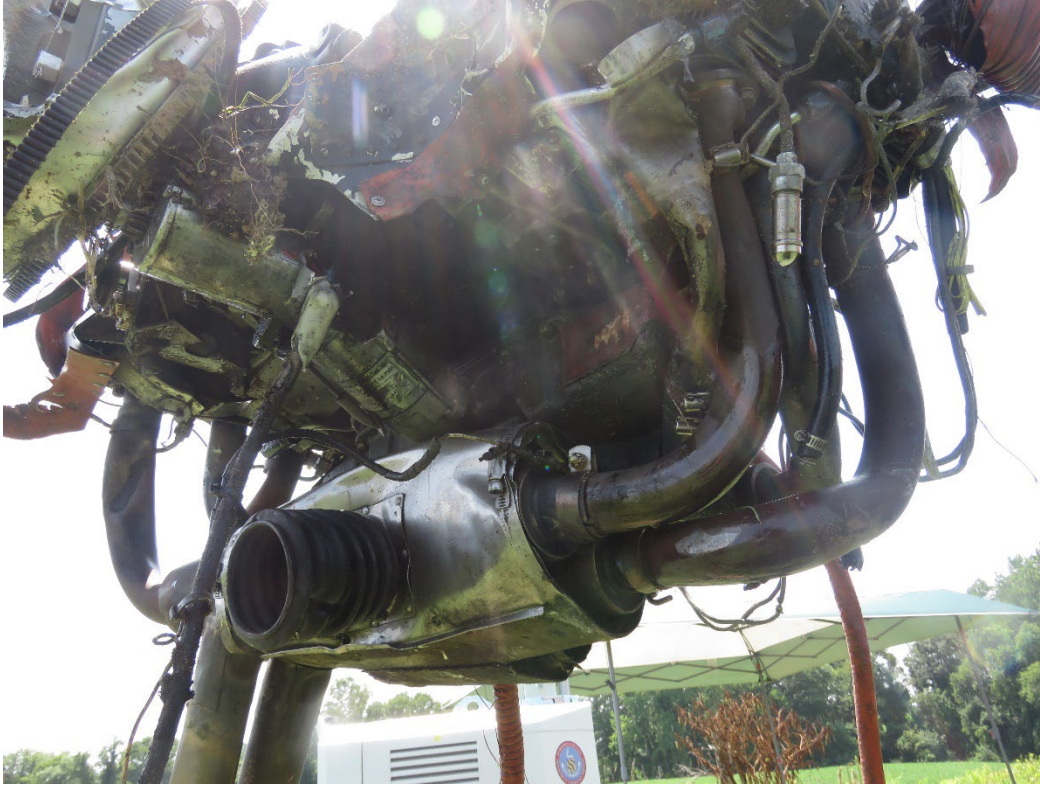
The exhaust stacks remained attached to the cylinder heads and were displaced slightly aft. The induction pipes for cylinders 2 and 4 were crushed by impact energy forces and pushed aft. The induction air filter was examined and was not obstructed.

**Photo 30: Intake and exhaust stacks. (Lycoming Photo)**

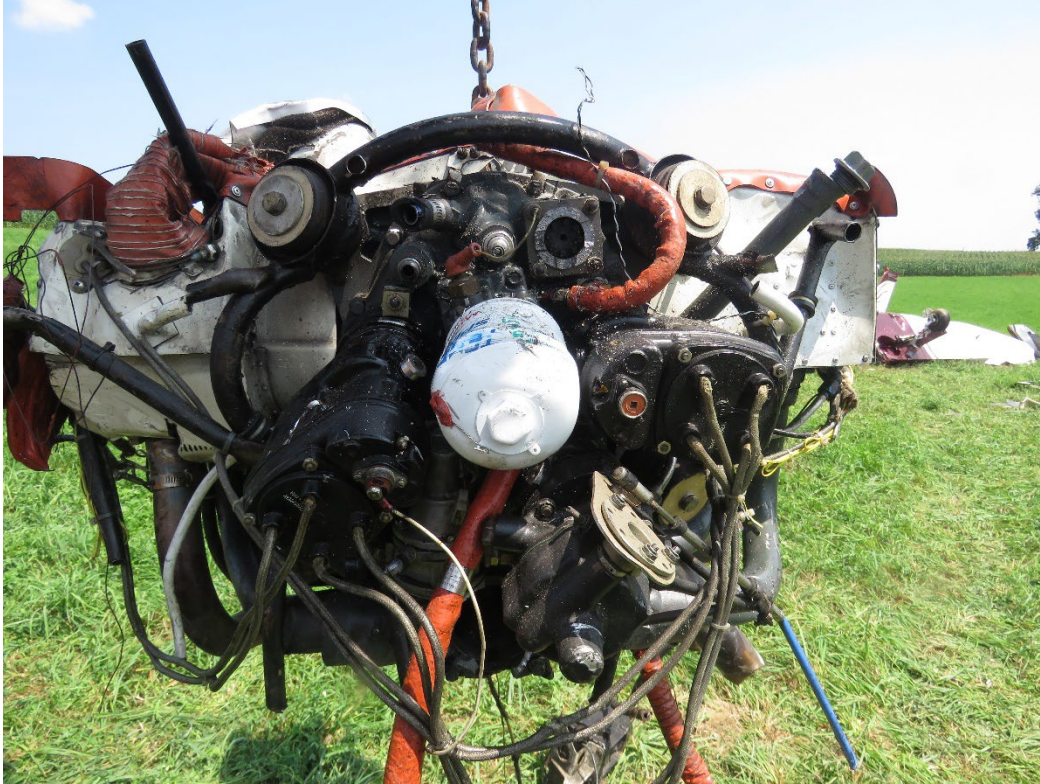
The right magneto remained attached to the engine, the left magneto was separated from the mounting flange surface. Both magnetos sparked on all leads when the drive gear was rotated by hand. Both impulse couplings snapped as expected.

**Photo 31: View of the magnetos. (Lycoming Photo)**

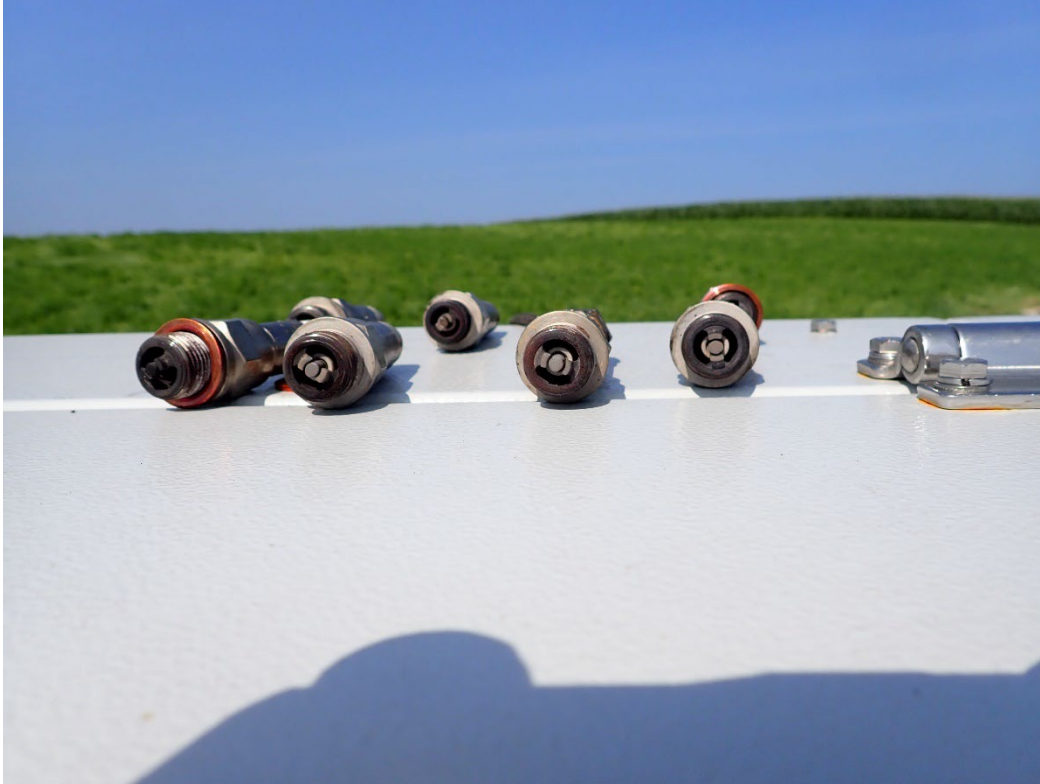
The spark plugs remained installed in their respective cylinder heads and were undamaged, except the No. 2 bottom spark plug which was destroyed by impact forces. The spark plugs displayed coloration consistent with normal engine operation when compared to the Champion Aviation AV-27 Check-A-Plug chart.

**Photo 32: View of spark plugs.**

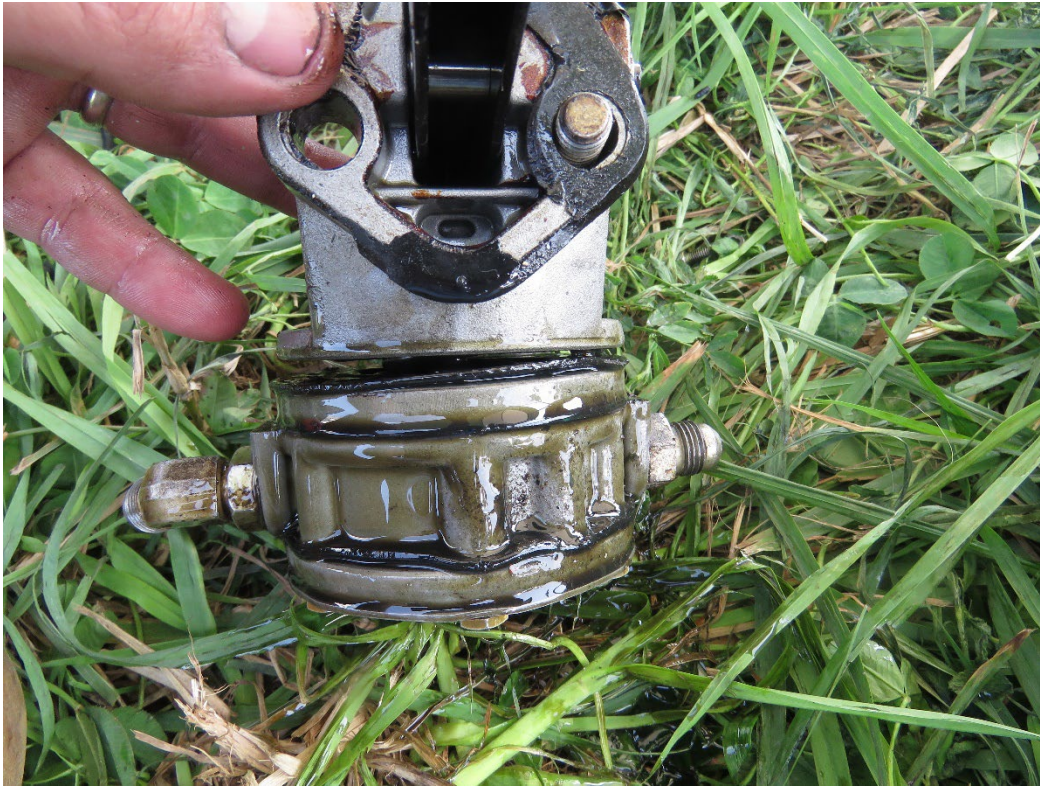
Fuel was found in the lines from the firewall to the engine driven fuel pump and in the lines from the engine driven fuel pump to the fuel injector. There was fuel in the flow divider. The engine driven fuel pump remained attached to the engine at all attachment points. The fuel injector was impact separated from the engine and remained attached through fuel lines. The throttle control cable was continuous from the cockpit to a cut made to facilitate recovery, from the cut to the control rod end, the control rod was bent, and impact separated at the control rod head. The mixture control cable was continuous from the cockpit to the fuel injection servo. The fuel injector inlet screen was examined and found no debris. The flow divider remained secured to the top of the engine and was undamaged. The unit was opened for further examination and liquid consistent with aviation fuel was present within the manifold and the diaphragm was undamaged. The fuel injector nozzles remained secured in their respective cylinder heads and appeared undamaged. The injector nozzles were not removed.

**Photo 33: Engine driven fuel pump. (Lycoming Photo)**

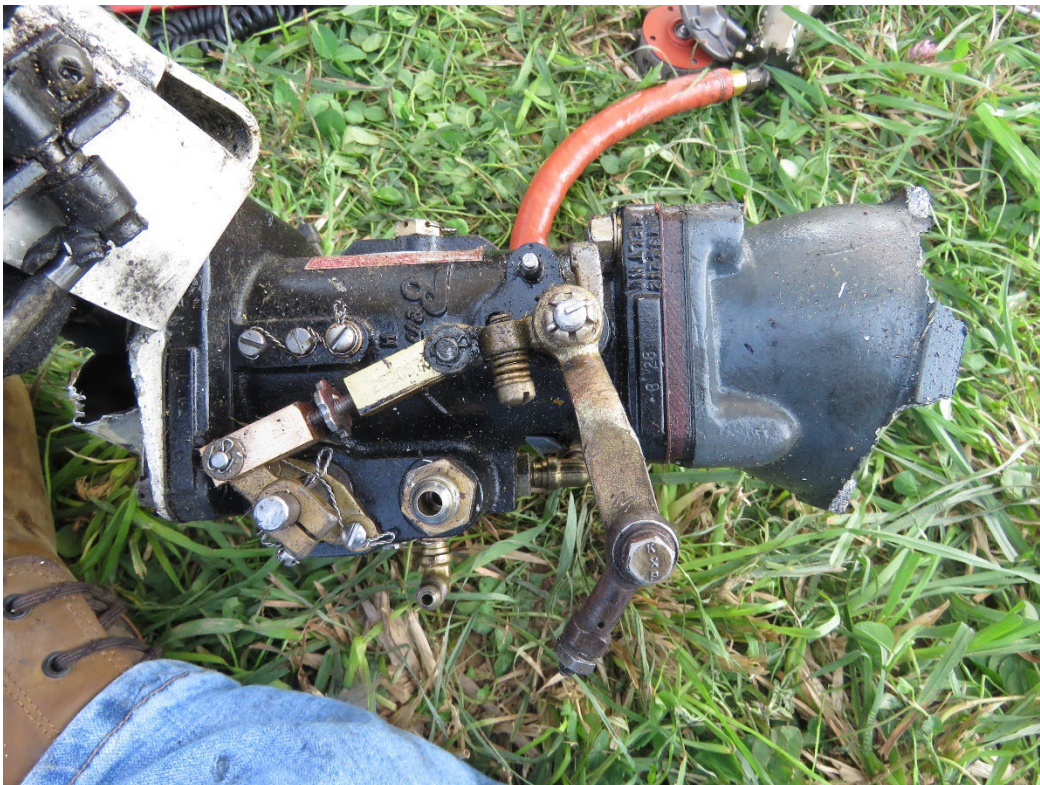
**Photo 34: View of the fuel injector. (Lycoming Photo)**

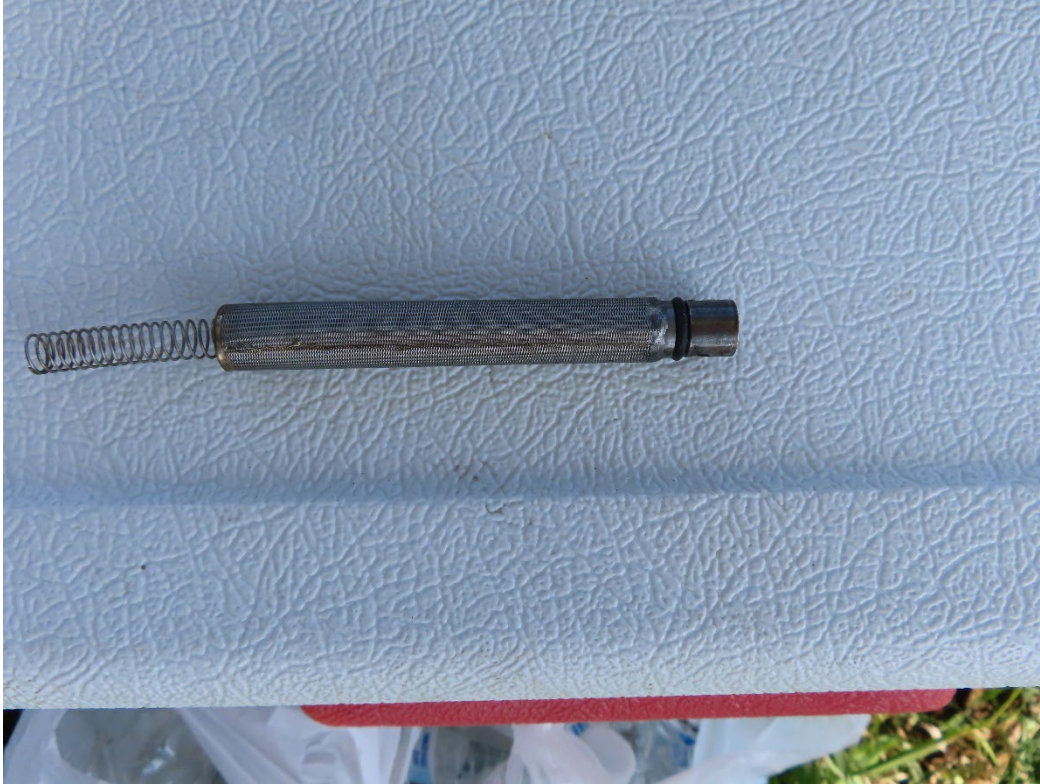
**Photo 35: Fuel injector inlet screen. (Lycoming Photo)**

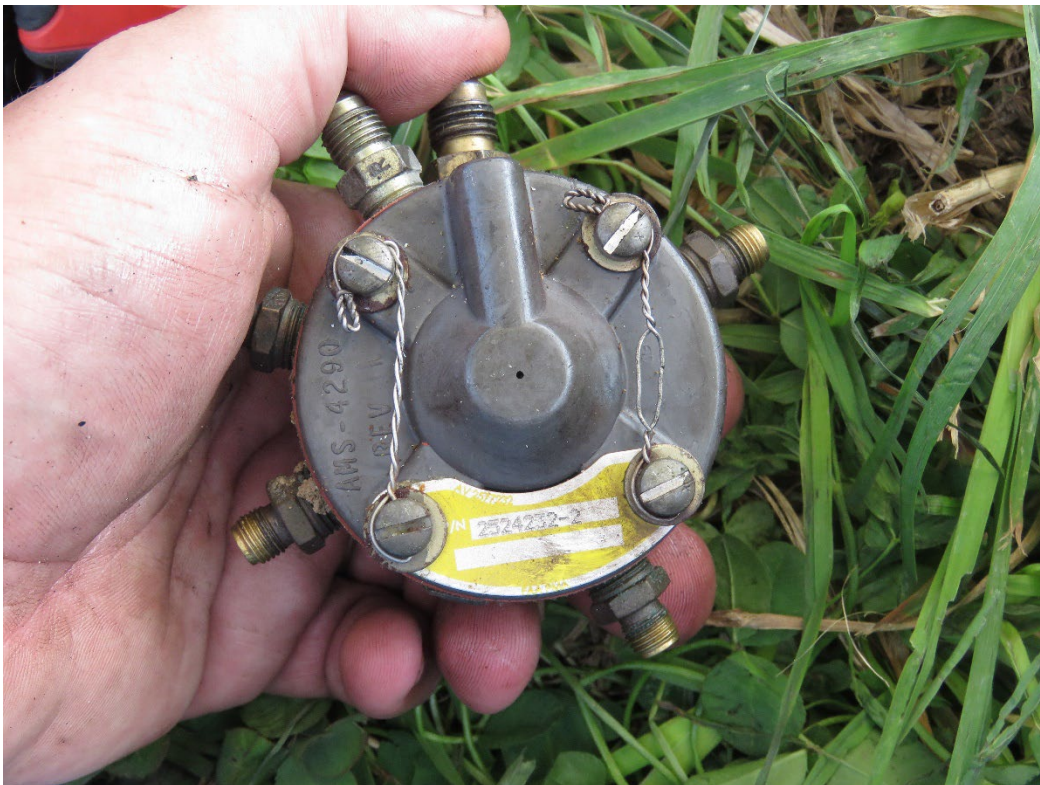
**Photo 36: View of the flow divider. (Lycoming Photo)**

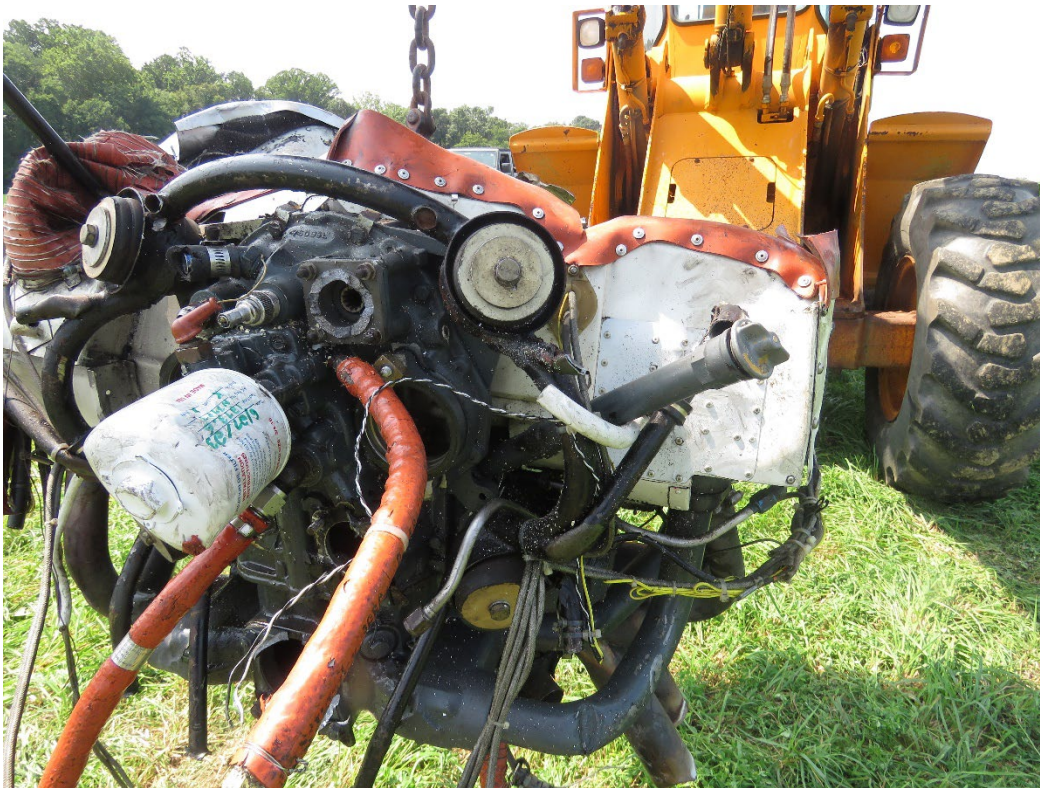
The oil filter remained installed on the accessory housing and was partially crushed into the oil filter adapter base assembly. The oil filter was not examined and was dated 6/27/2023. The oil suction screen was secured into the sump and was removed for further examination. The screen was clean with no obstructions noted. With the engine hoisted, the oil level gauge showed approximately 4qts of oil remained in the sump. The oil on the oil level gauge appeared visually clean.

**Photo 37: View of the oil filter attached to the accessory case. (Lycoming Photo)**

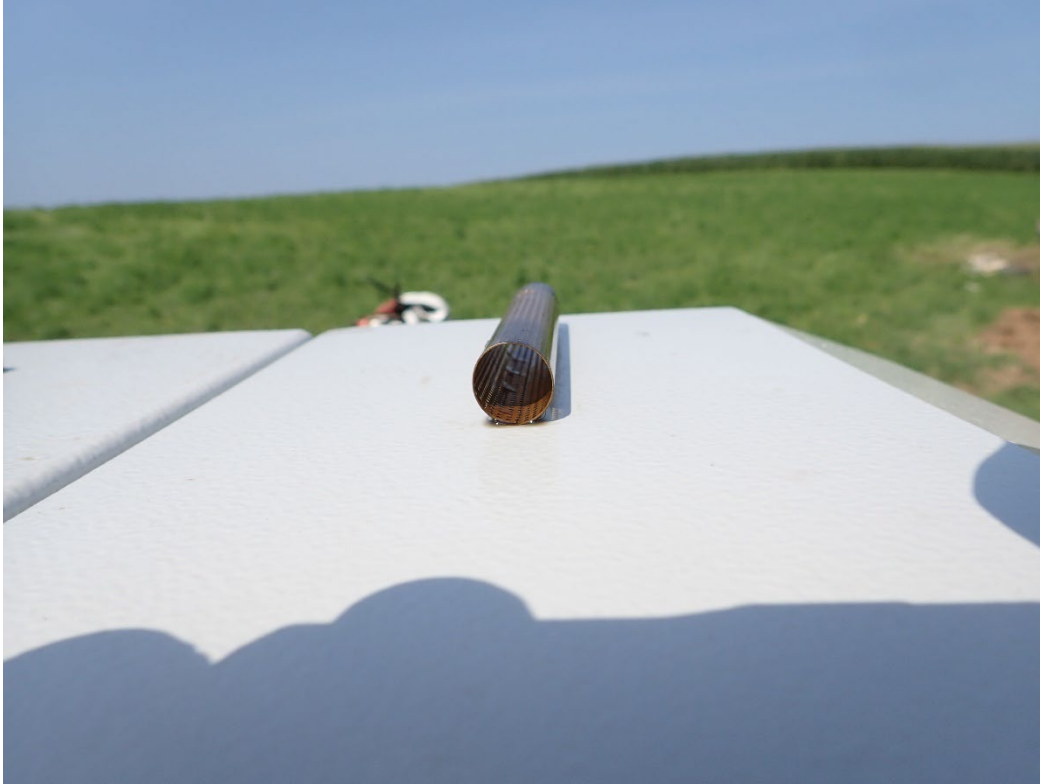
**Photo 38: Oil suction screen.**

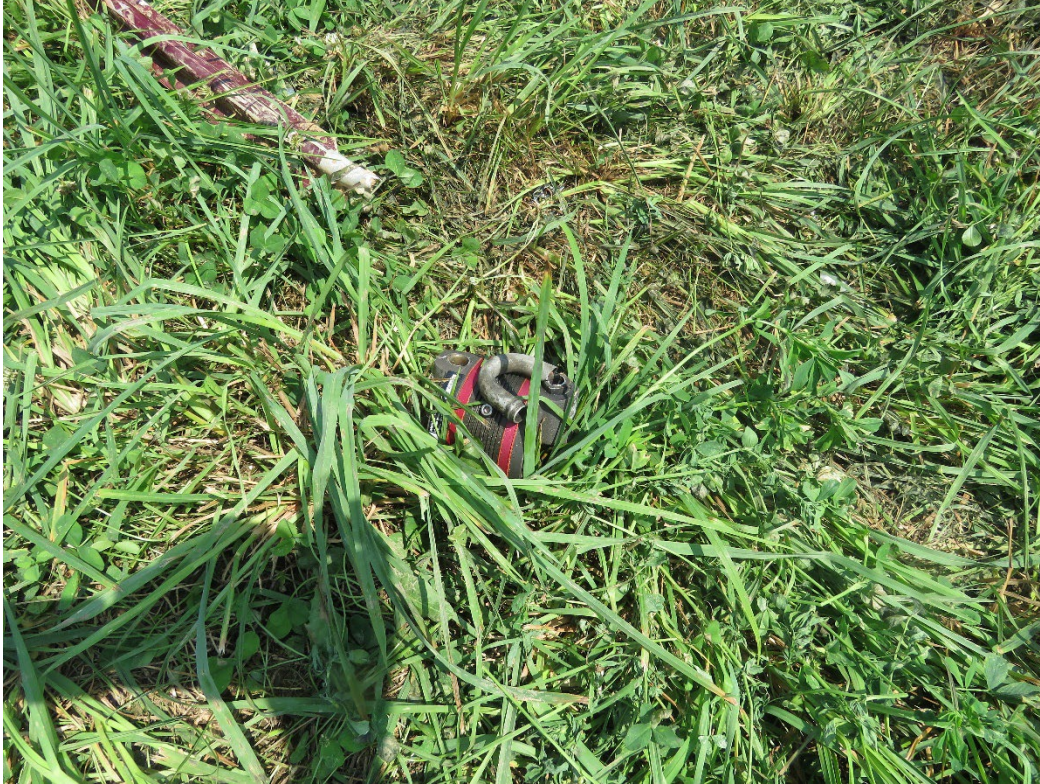
The vacuum pump was impact separated from the accessory housing of the engine and was found approximately 10 ft away from the engine. The pump was opened for further examination and one carbon vein was fractured.

**Photo 39: View of the vacuum pump impact separated from the engine. (Lycoming Photo)**

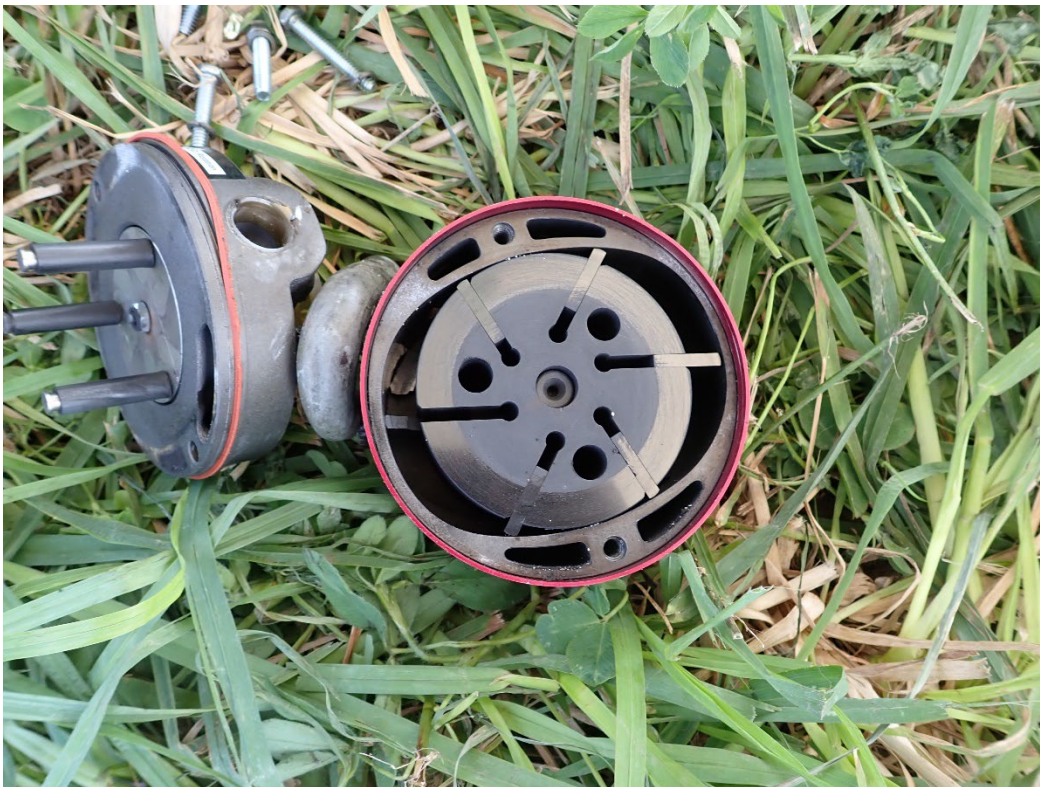
**Photo 40: View of the vacuum pump disassembled for examination.**

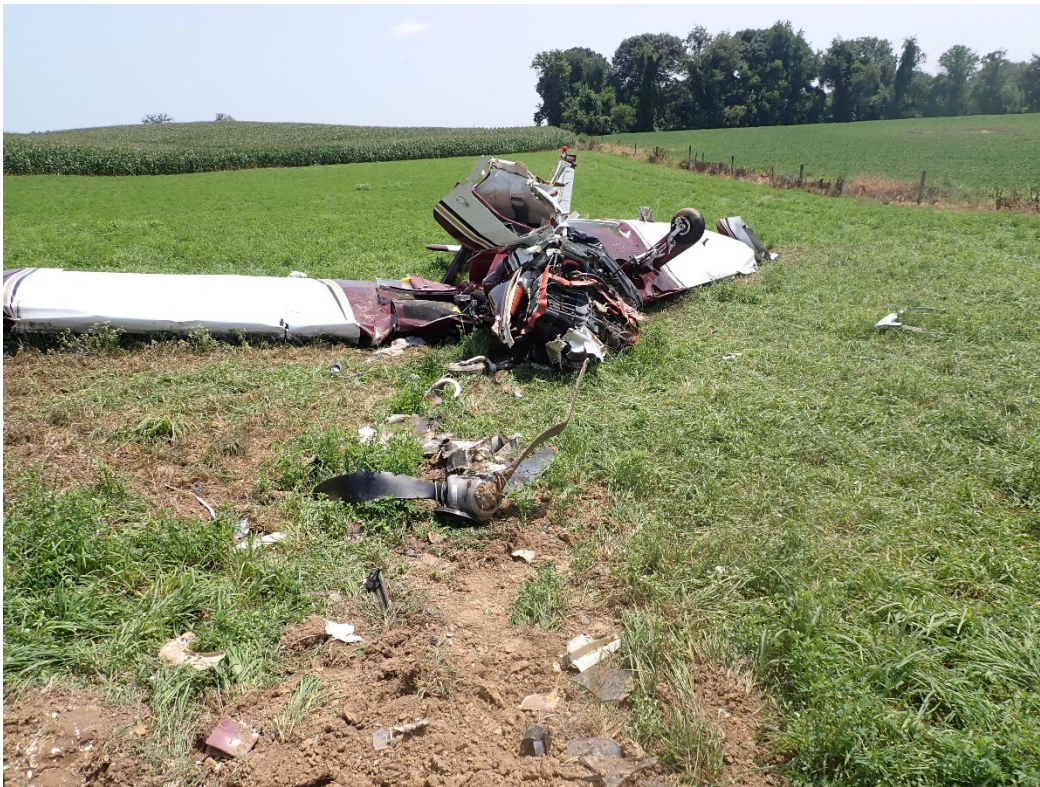
The three-bladed metal McCauley variable pitch propeller was impact separated from the engine crankshaft flange. The three blades were arbitrarily labeled A, B, and C and will be referred to as such going forward. Blade A exhibited leading edge gouging, polishing at the tip, chordwise scratches and was bent aft about 10° at the midspan. The propeller hub was fractured at the base of propeller blade B. Blade B was bent forward about 40° at the midspan, exhibited chordwise scratching, and leading edge gouging. The propeller hub was fractured at the base of blade C. Blade C was bent aft about 30° at the midspan, exhibited chordwise scratches, and leading edge gouging.

**Photo 41: Overview of the propeller.**

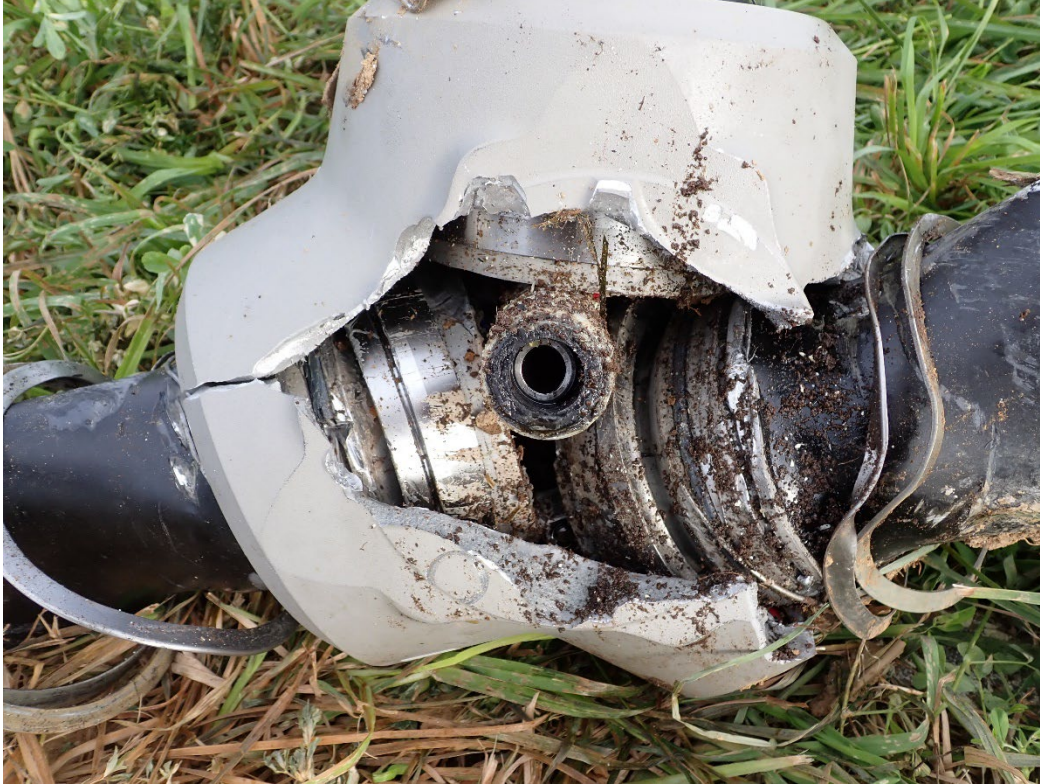
**Photo 42: View of damage to the propeller hub.**

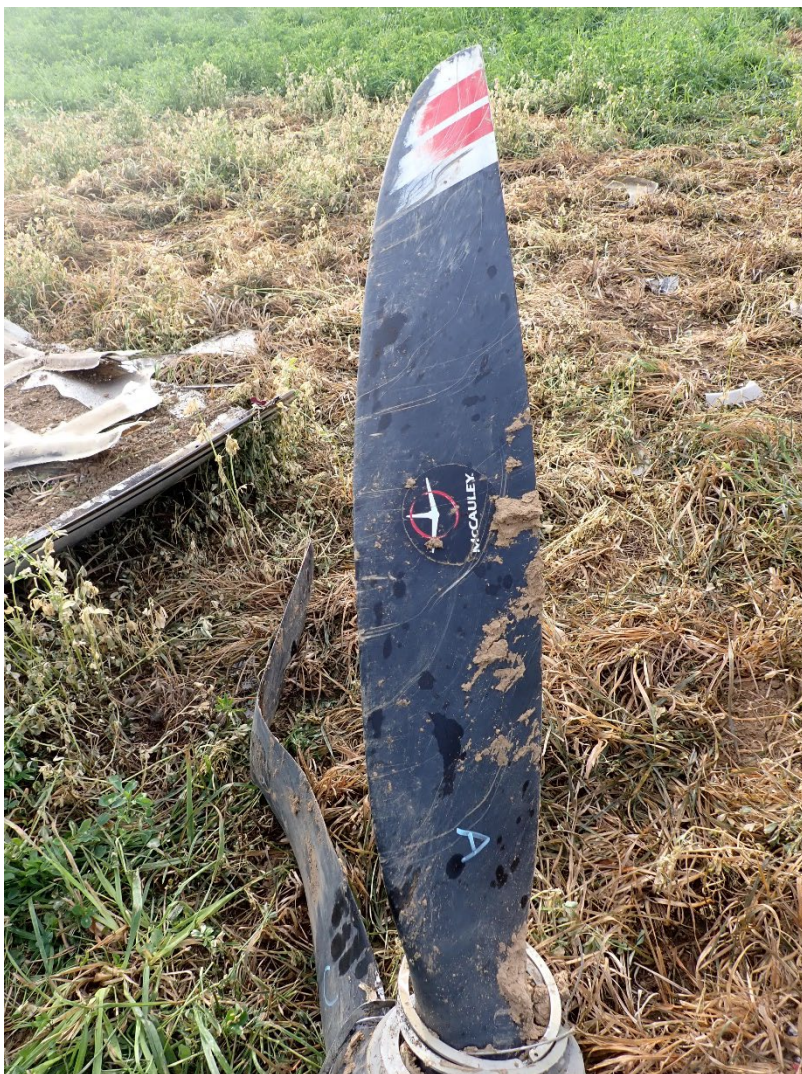
**Photo 43: View of propeller blade "A."**

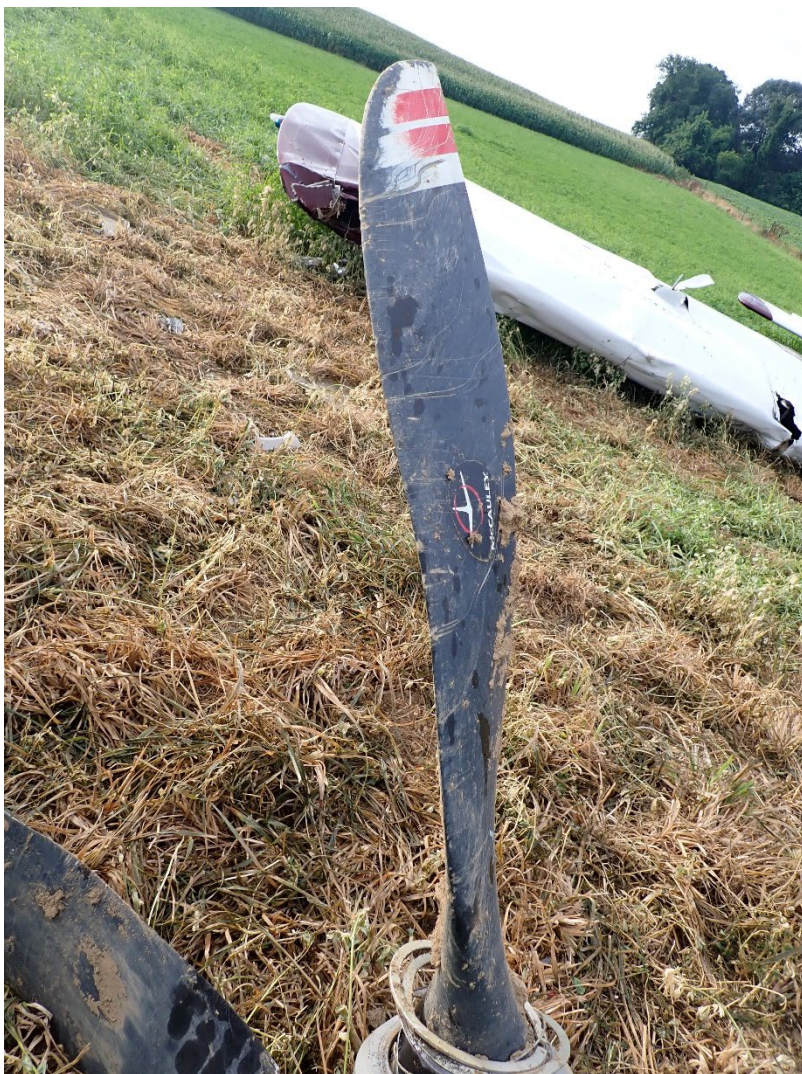
**Photo 44: View of the leading edge of propeller "A."**

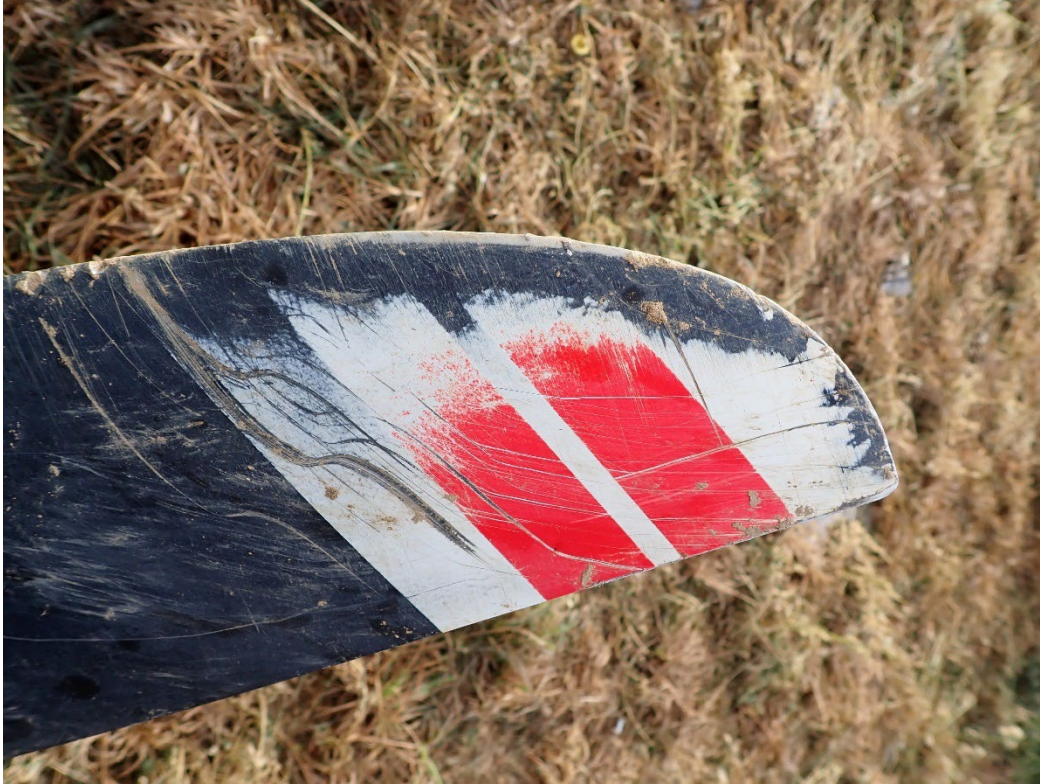
**Photo 45: Blade "A" leading edge gouging, chordwise scratching, and polishing. Blade A**

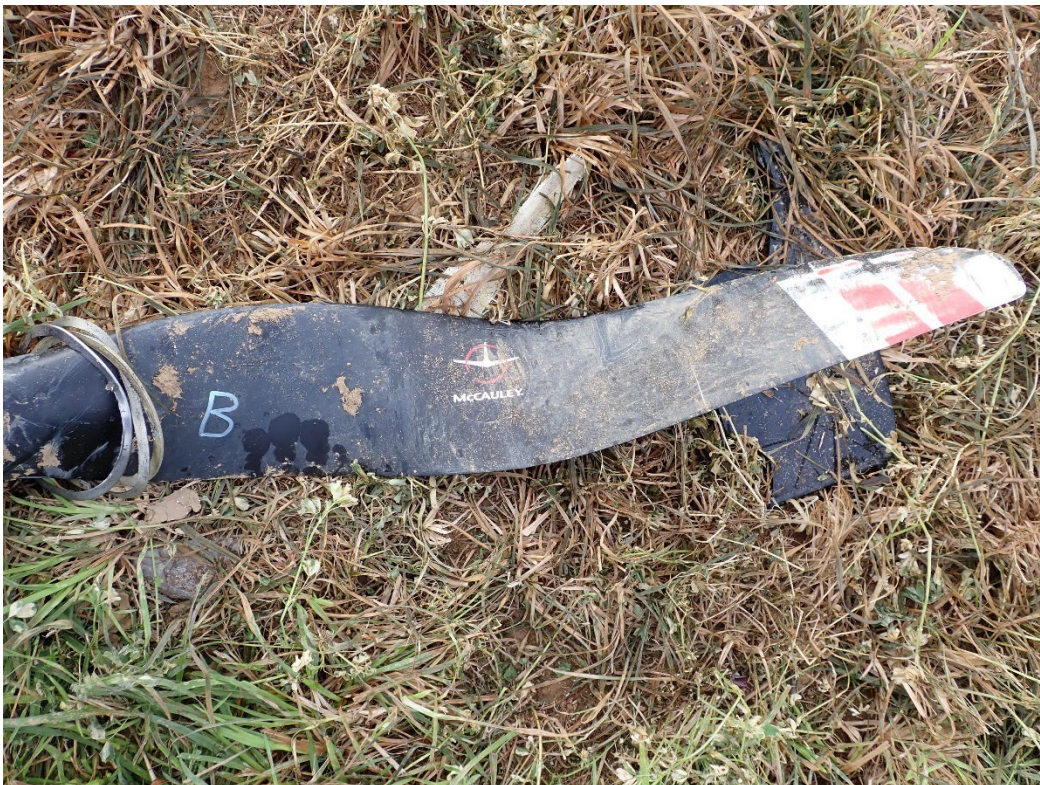
**Photo 46: Overview of propeller blade "B."**

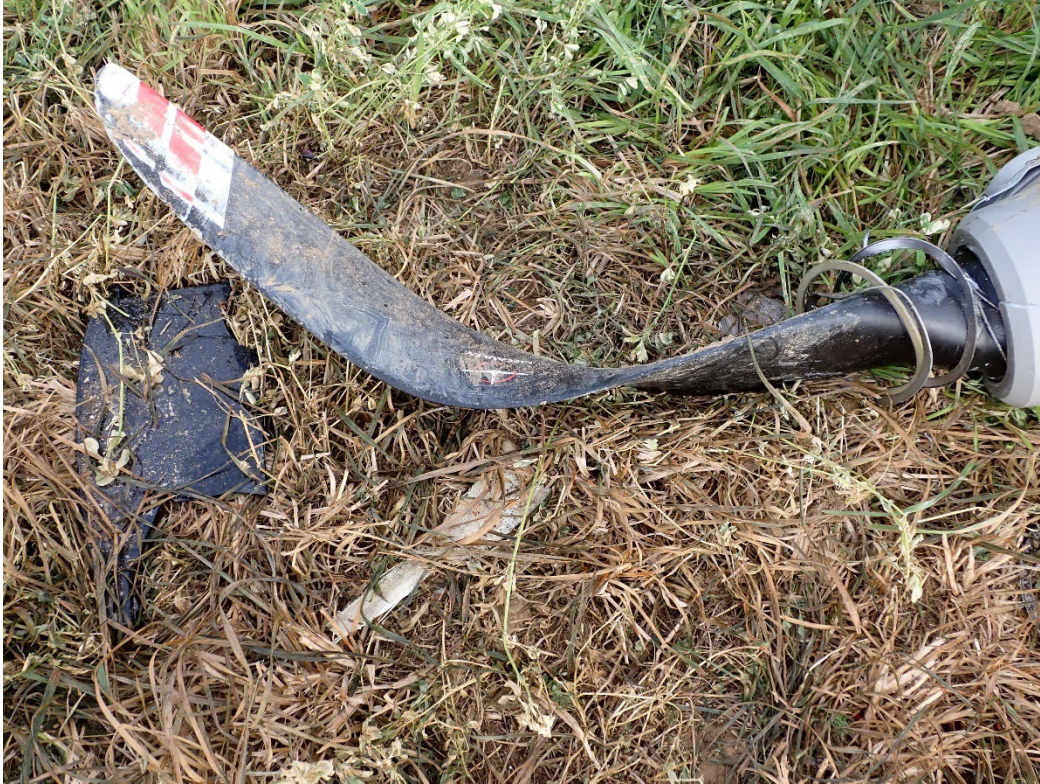
**Photo 47: View of the leading edge of blade "B."**

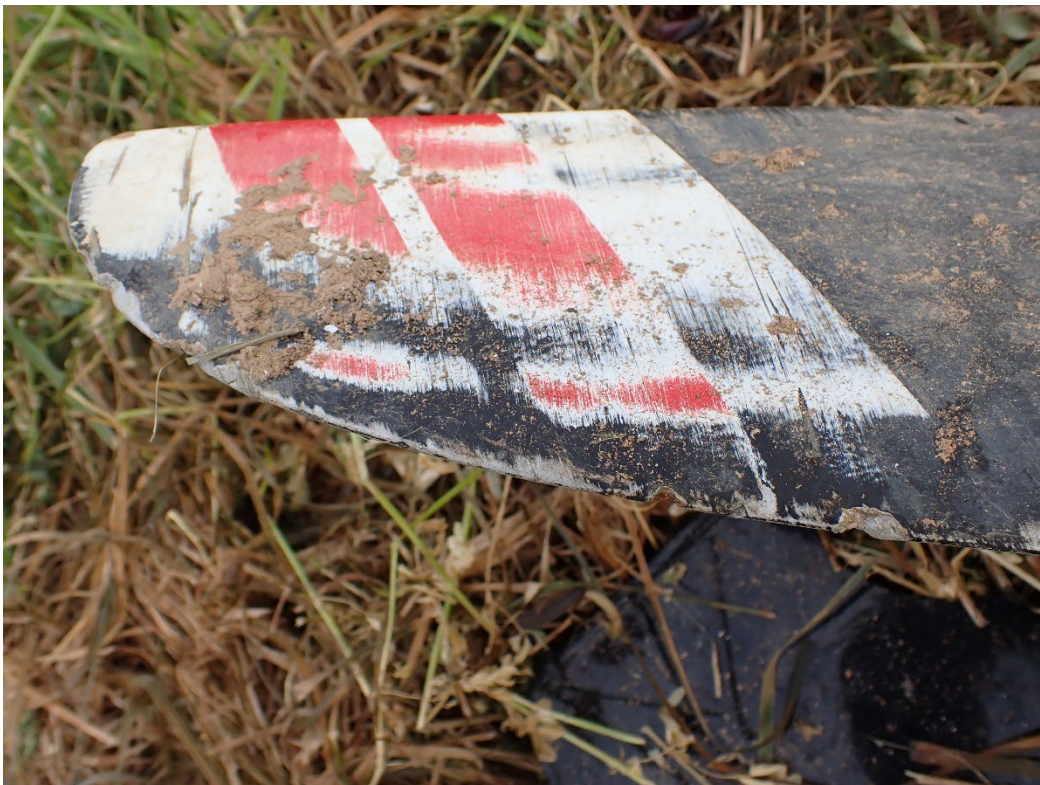
**Photo 48: View of leading edge gouging and chordwise scratching, blade "B."**

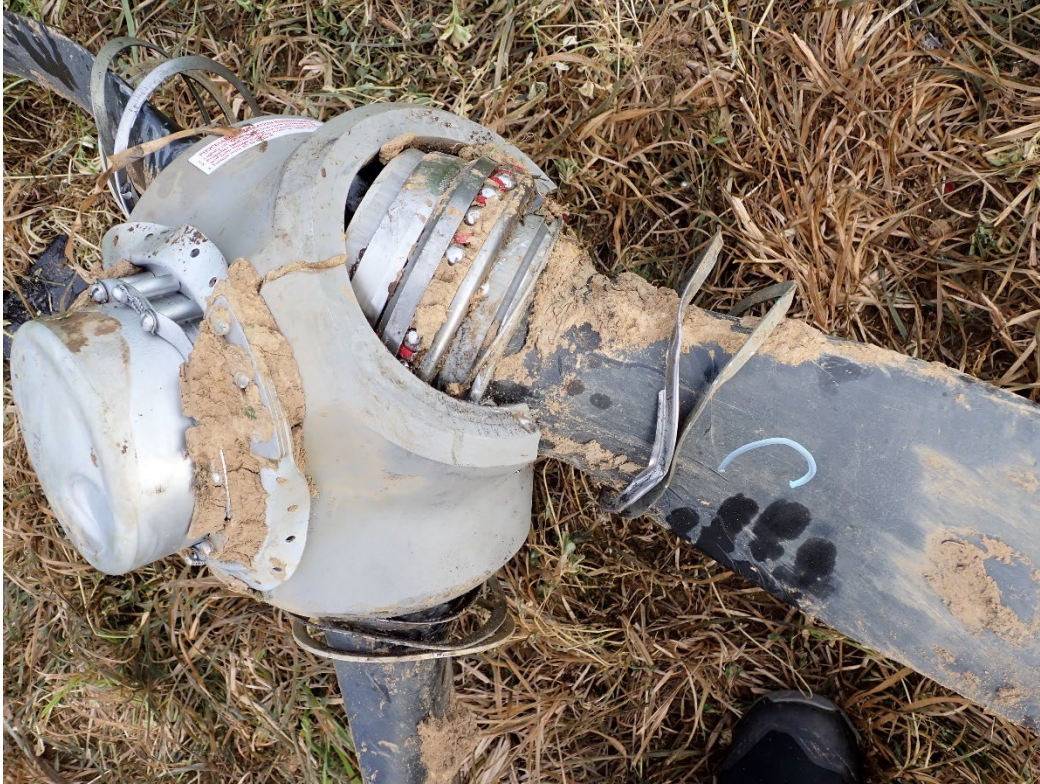
**Photo 49: Damage to the propeller hub, blade "C."**

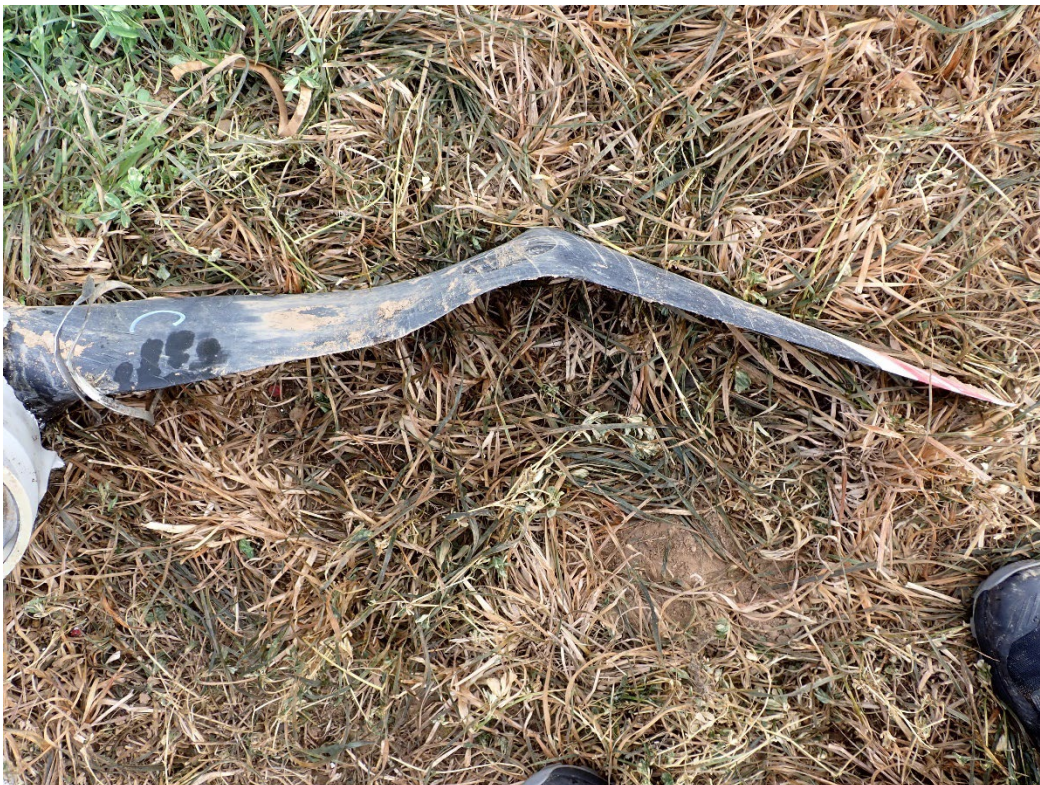
**Photo 50: Overview of blade "C."**

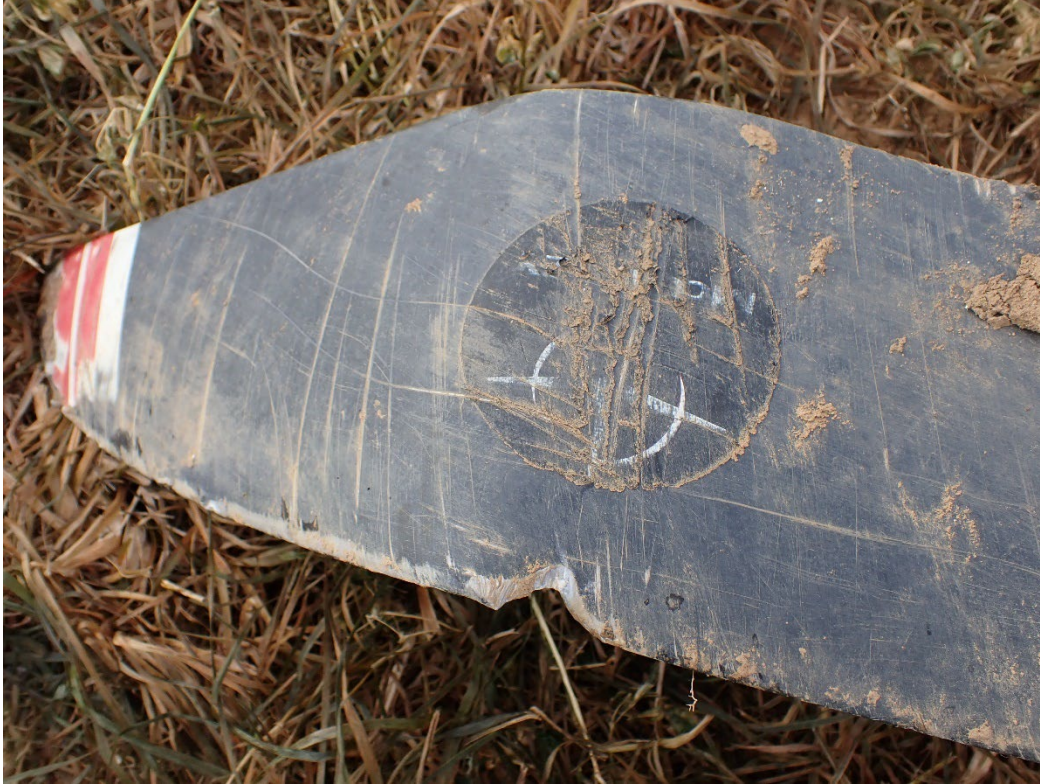
**Photo 51: Blade "C" leading edge gouging and chordwise scratching.**

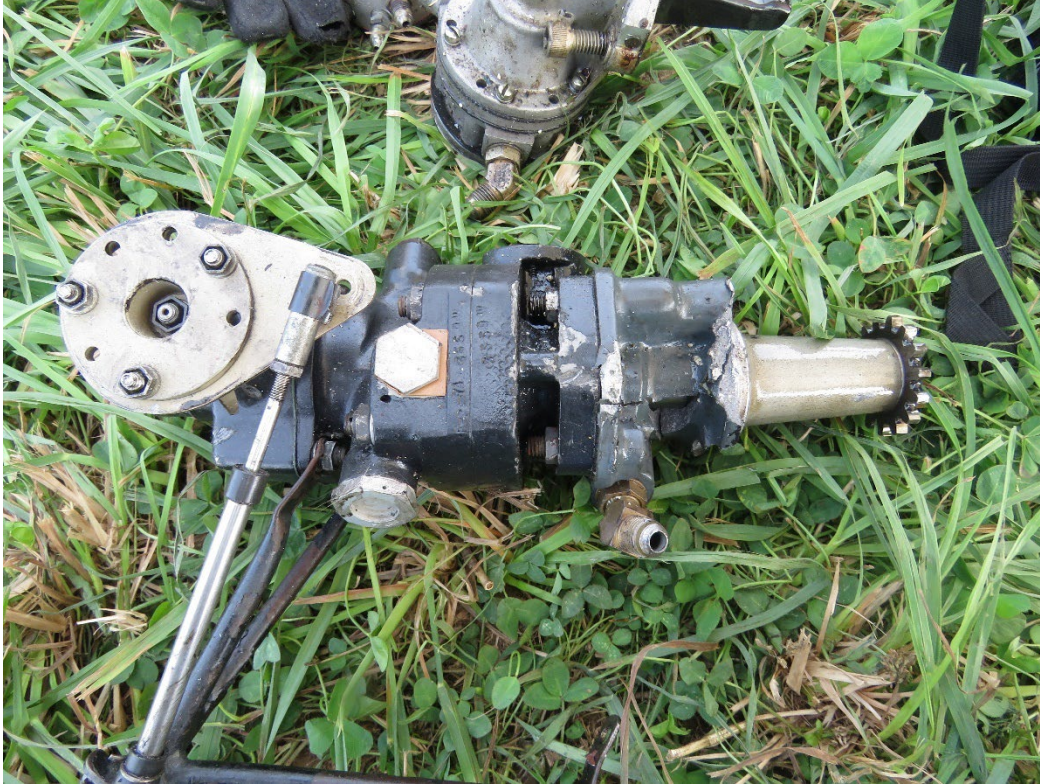
The rear-mounted propeller governor remained installed on the accessory housing but was damaged by impact forces at the mounting flange. The propeller governor control cable remained attached to the unit and was cut to facilitate the engine examination. The governor was removed and photographed. The unit rotated when the drive was rotated.

**Photo 52: View of propeller governor.**
