# National Transportation Safety Board

ERA23FA313

## **PROPELLER EXAMINATION**

Location: Churchville, MD  
Date: July 25, 2023  
Time: 1906 EDT  
2306 UTC  
Airplane: Piper PA-28R-200; N34PT

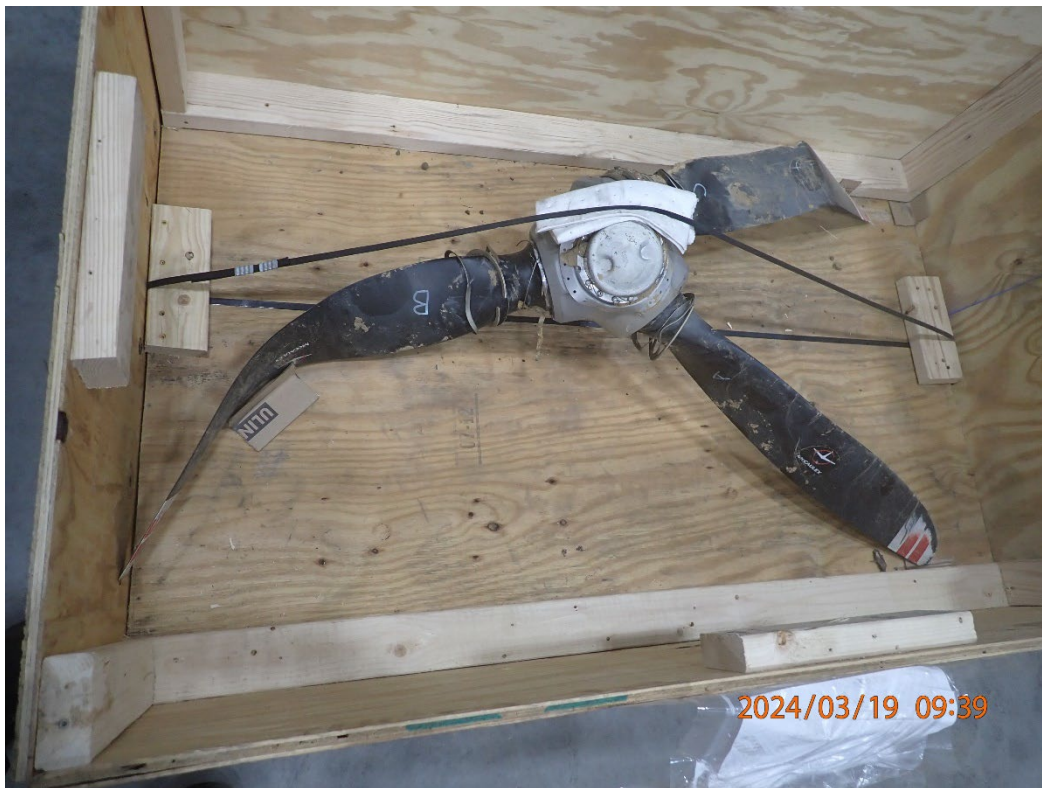
**Photo 1: The propeller as first viewed still seated in the crate.**

The propeller had sudden-failure type damage and gross part deflections typically associated with impact forces. The investigation found no evidence of any type of fatigue failure. There were no indications of any type of propeller failure or malfunction prior to the impact sequence.

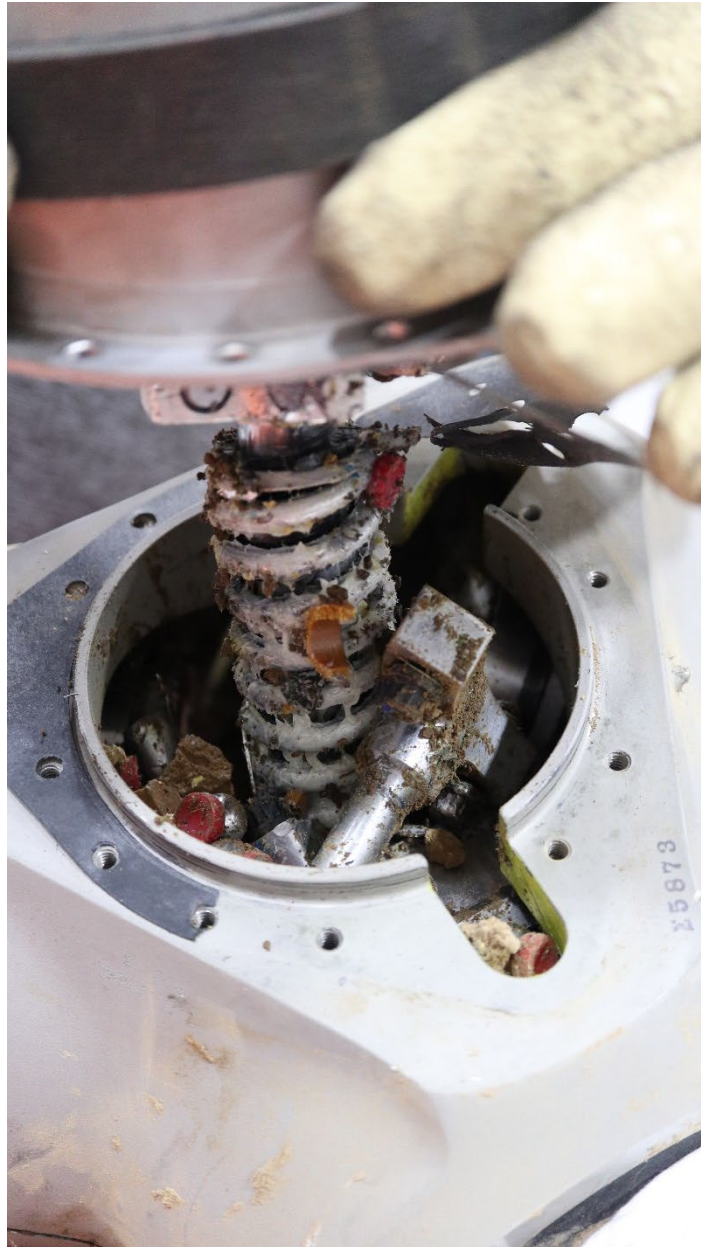
The blade angle actuation components exhibited gross part deflection and structural overload failure associated with the impact sequence. All three links were broken, the piston rod was bent, and the piston return spring was

deformed. Specific blade angles at the time of impact could not be determined. Internal witness marks did not give an indication of the blades being outside of the normal operating range of the propeller.

**Photo 2: Removal of the blade actuation piston and spring assembly. (McCauley Photo)**

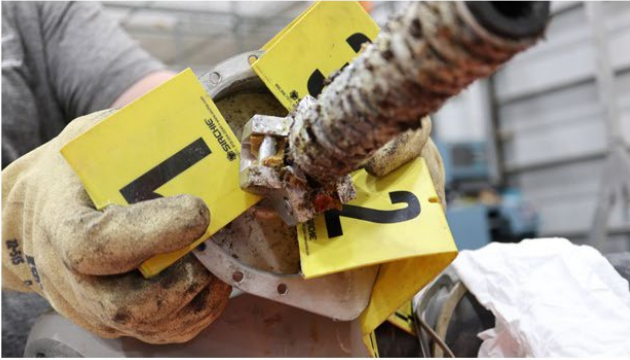
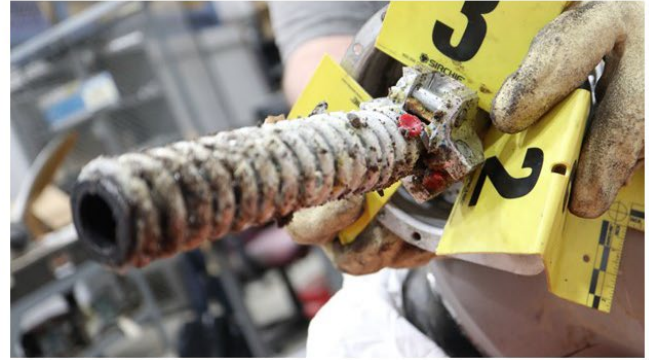
**Photo 3: View of broken actuator links. (McCauley Photos)**

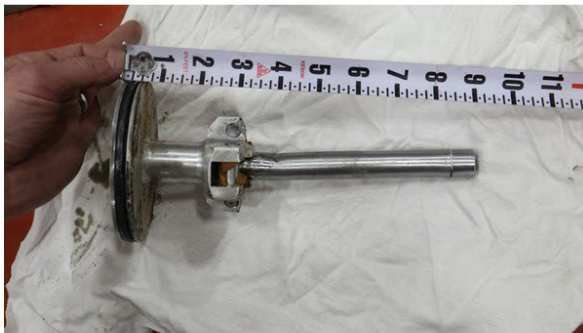
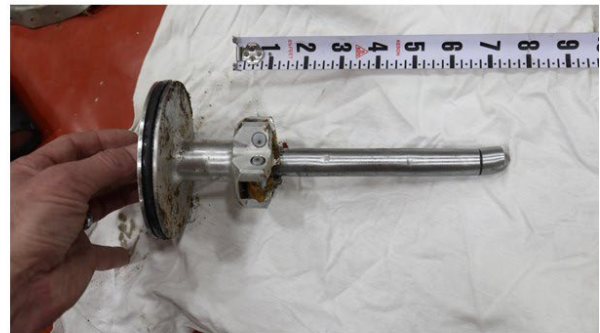
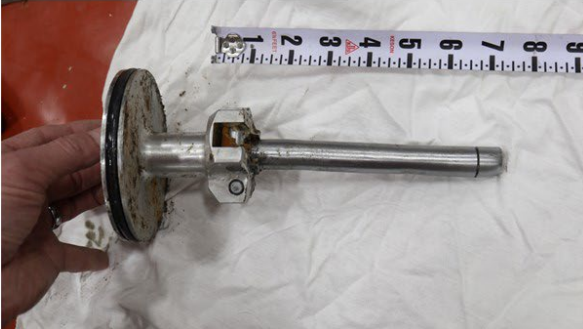
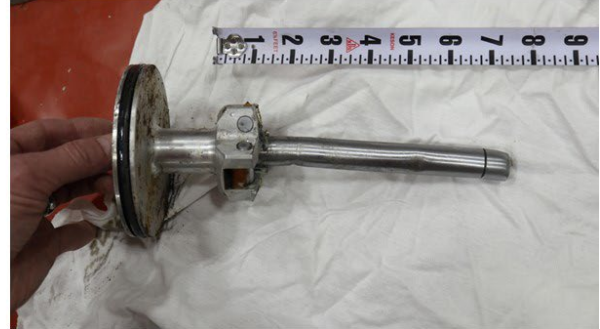
**Photo 4: View of deformations to the actuator piston rod. (McCauley Photos)**

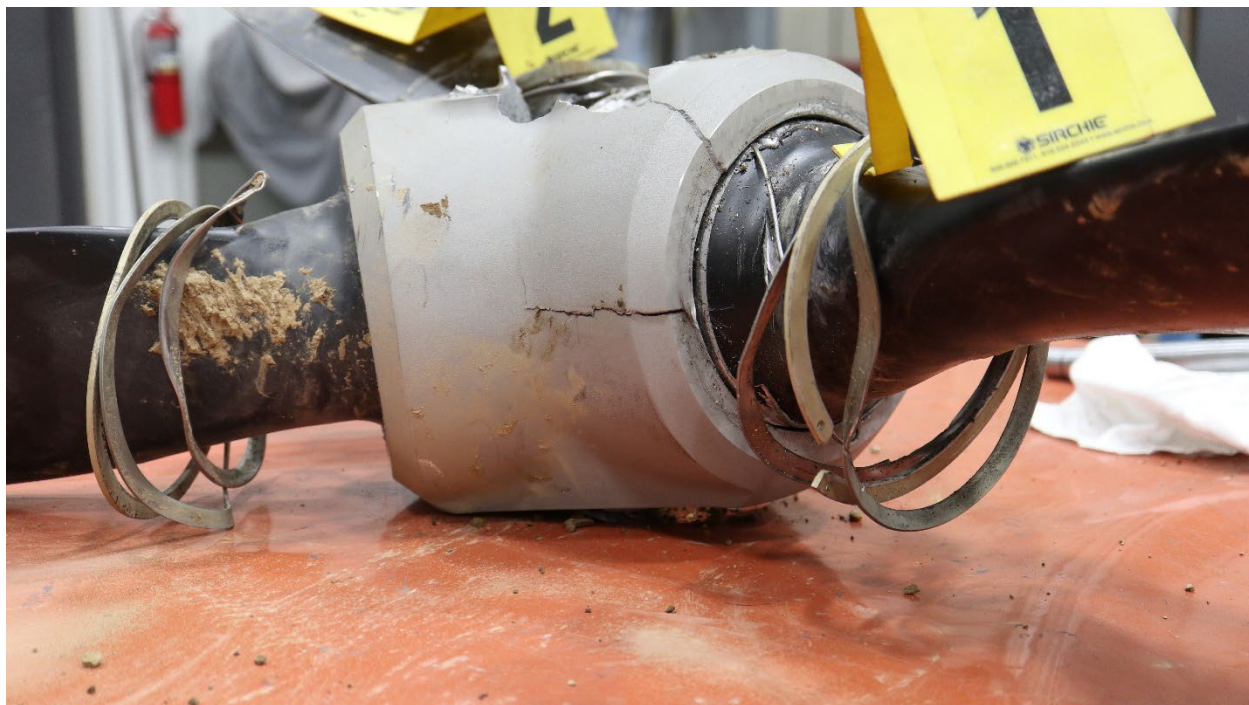
One of the three blade actuating pin assemblies was not found during the teardown investigation. The other two pin assemblies were found separated from their respective blade mounting locations. All three blade roots had witness marks associated with their respective pin assemblies being removed by overload forces. Additionally, the rear of the hub containing the mounting studs and the rear quarter of blade socket number 2 were missing, allowing open access to the loose and broken components on the inside of the hub.

**Photo 5: View of fractures to the No. 1 blade socket. (McCauley Photo)**

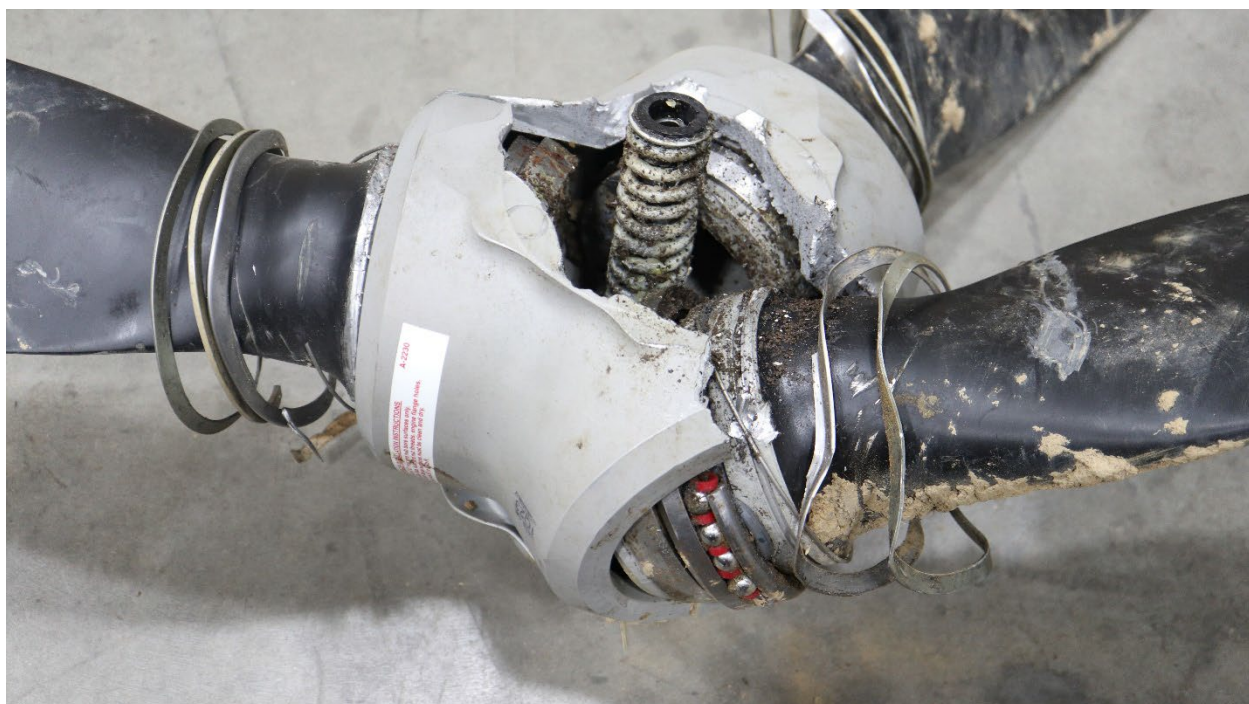
**Photo 6: View of the rear hub and missing rear quarter of blade socket No. 2. (McCauley Photo)**

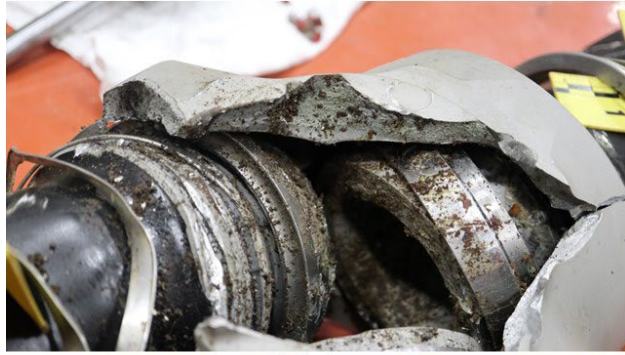
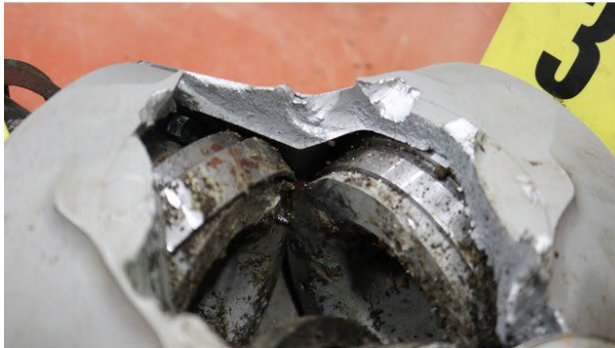
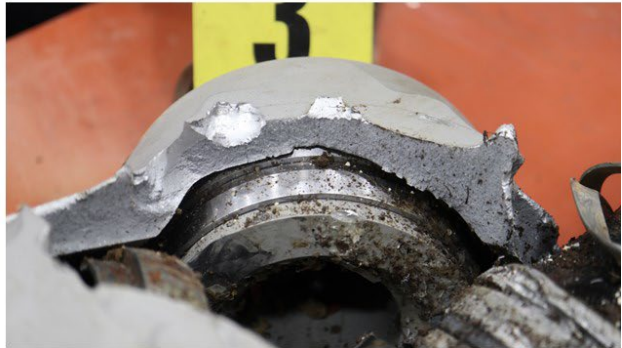
**Photo 7: View of rear hub fracture surfaces. (McCauley Photos)**

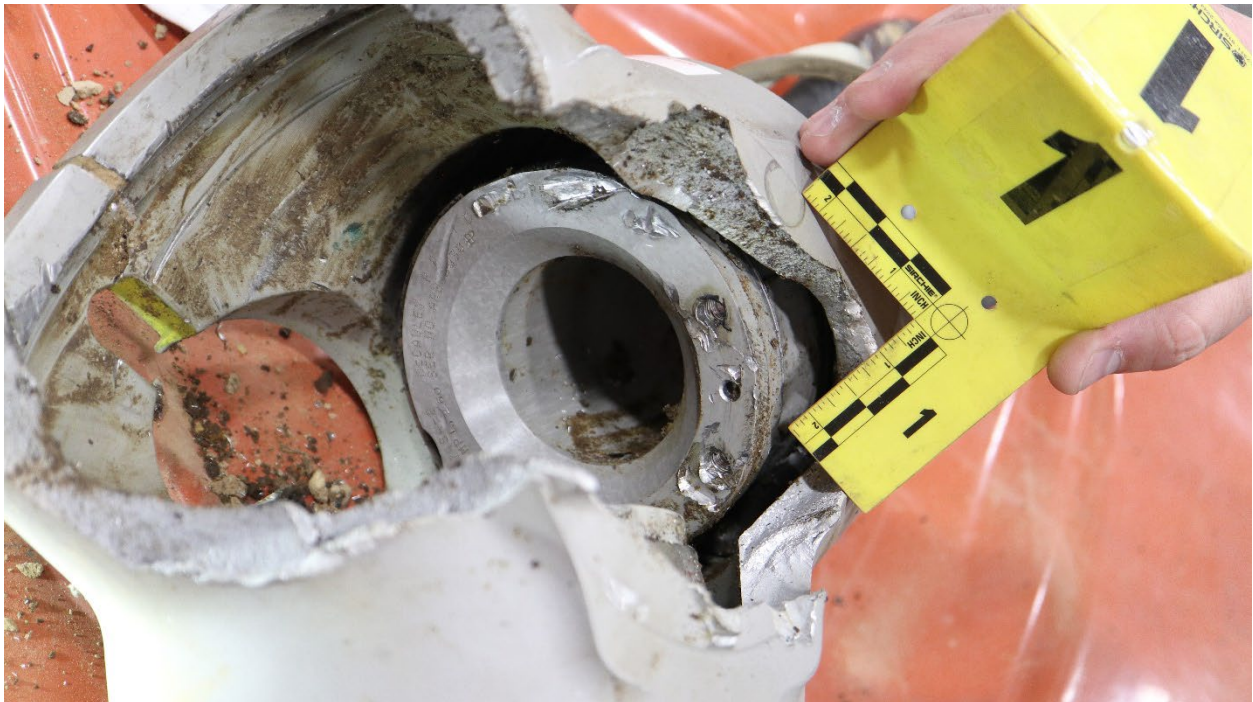
**Photo 8: View of the root of blade 1. (McCauley Photo)**

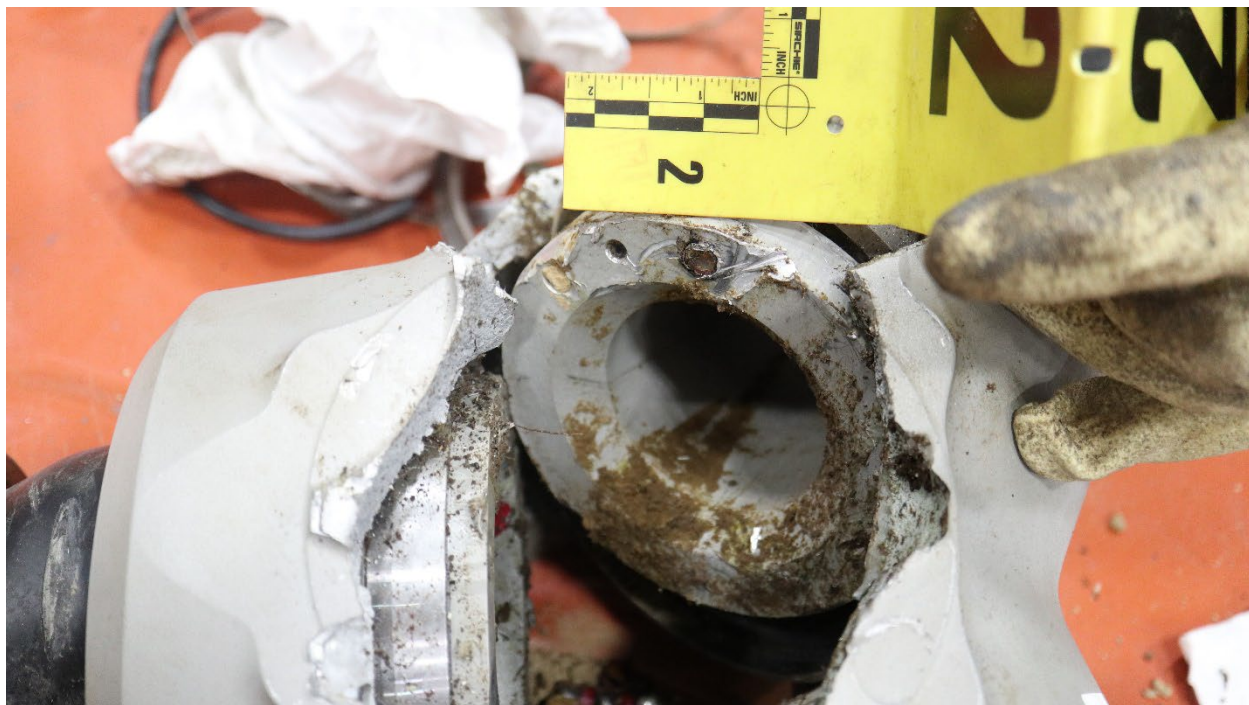
**Photo 9: View of the root of blade 2. (McCauley Photo)**

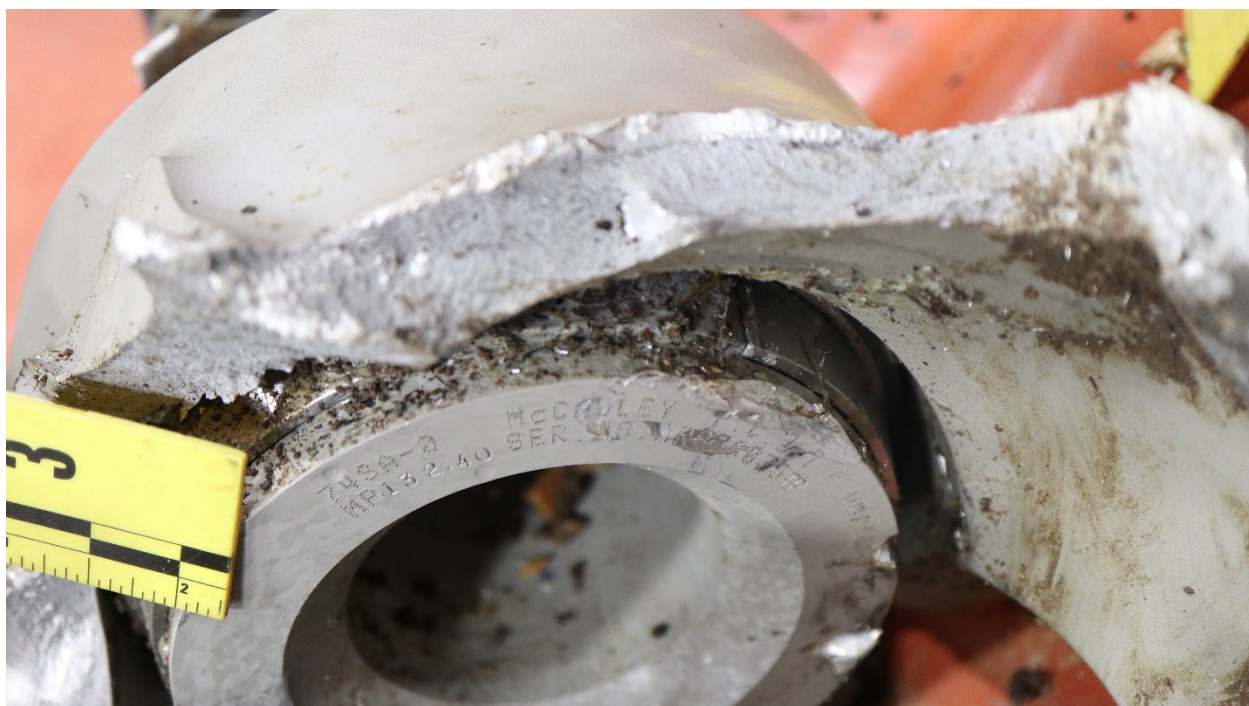
**Photo 10: View of the root of blade 3. (McCauley Photo)**

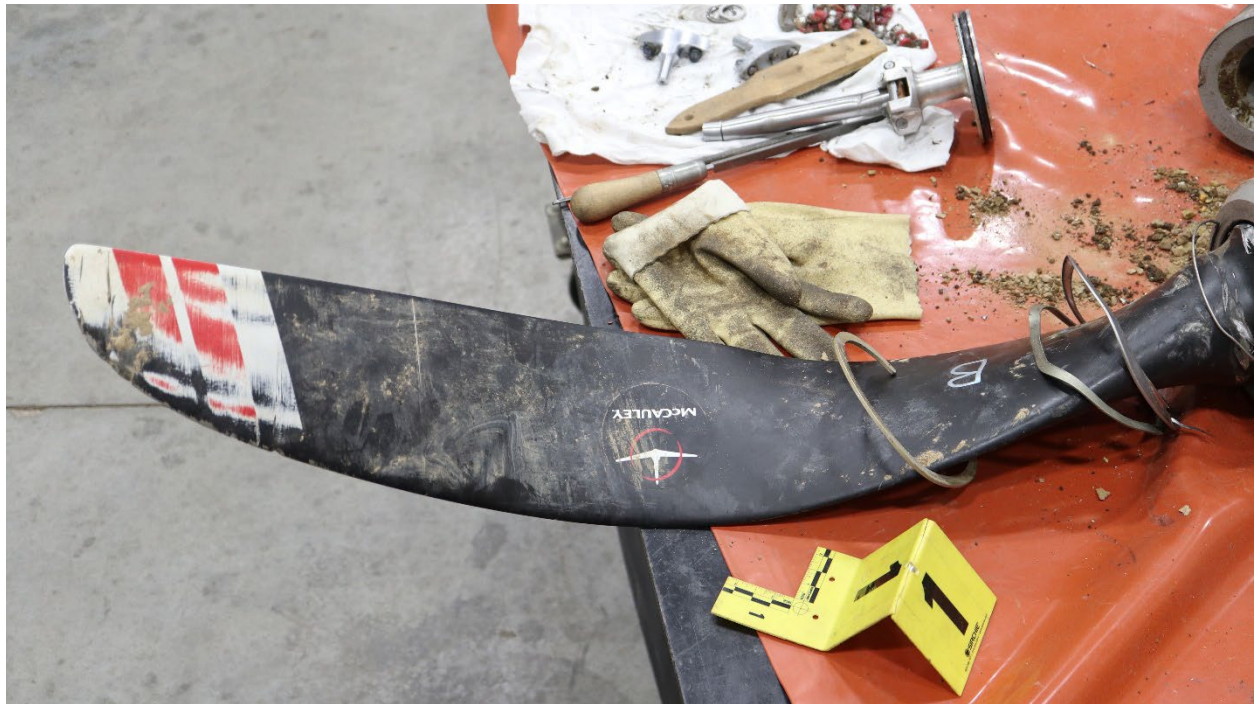
The propeller blades had chord wise scratches, leading edge paint removal, and leading edge gouges and nicks. These observations are consistent with a

high amount of rotational energy during the impact sequence. Engine power levels were not determined.

**Photo 11: Overview of blade 1. (McCauley Photo)**

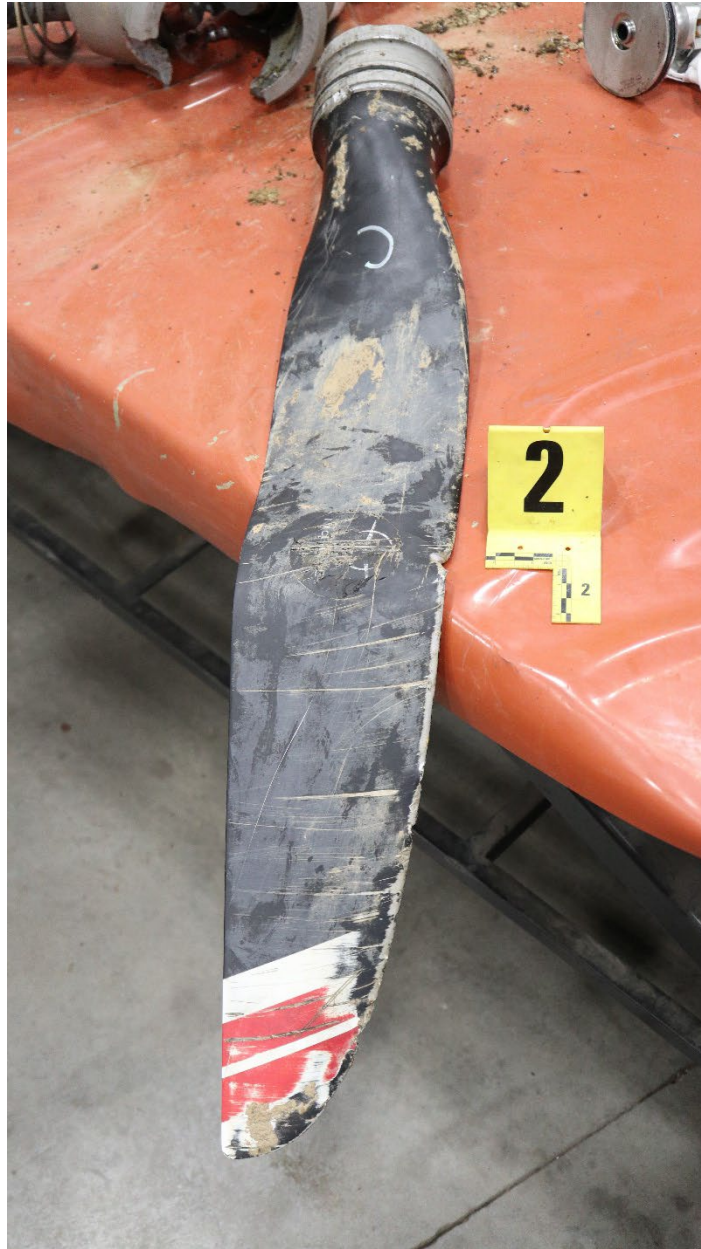
**Photo 12: Overview of blade 2. (McCauley Photo)**

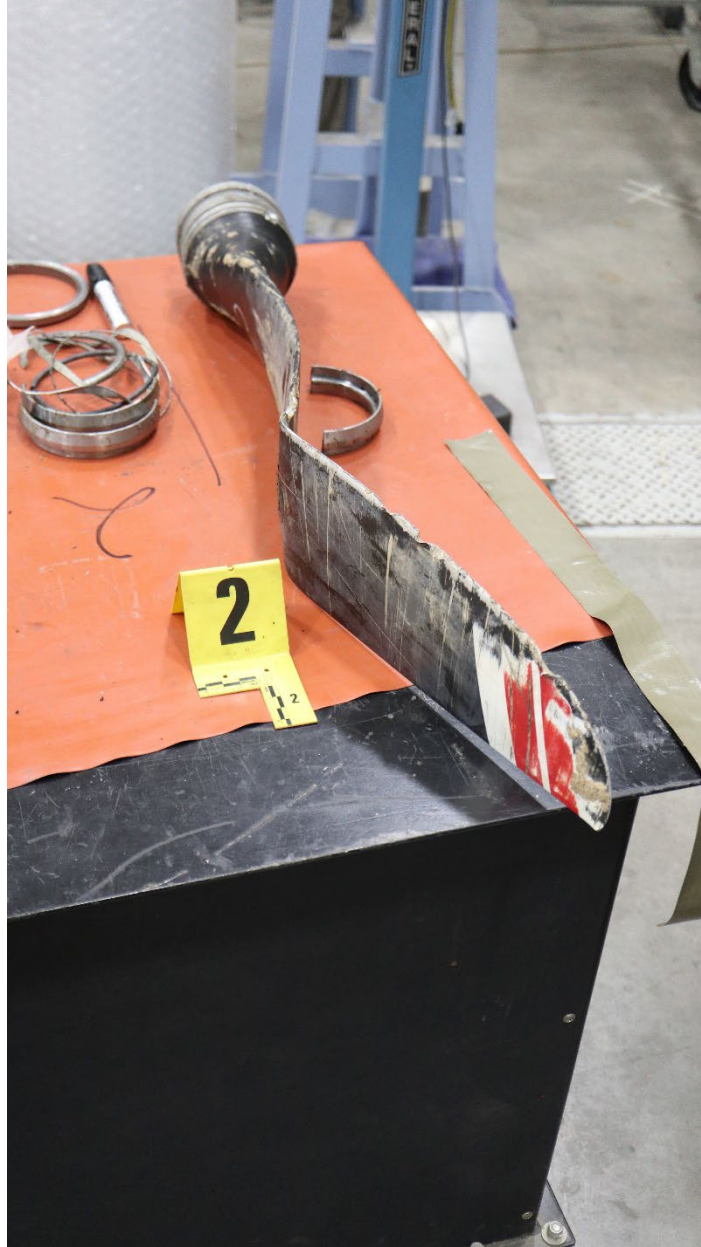
**Photo 13: View of the leading edge of blade 2. (McCauley Photo)**

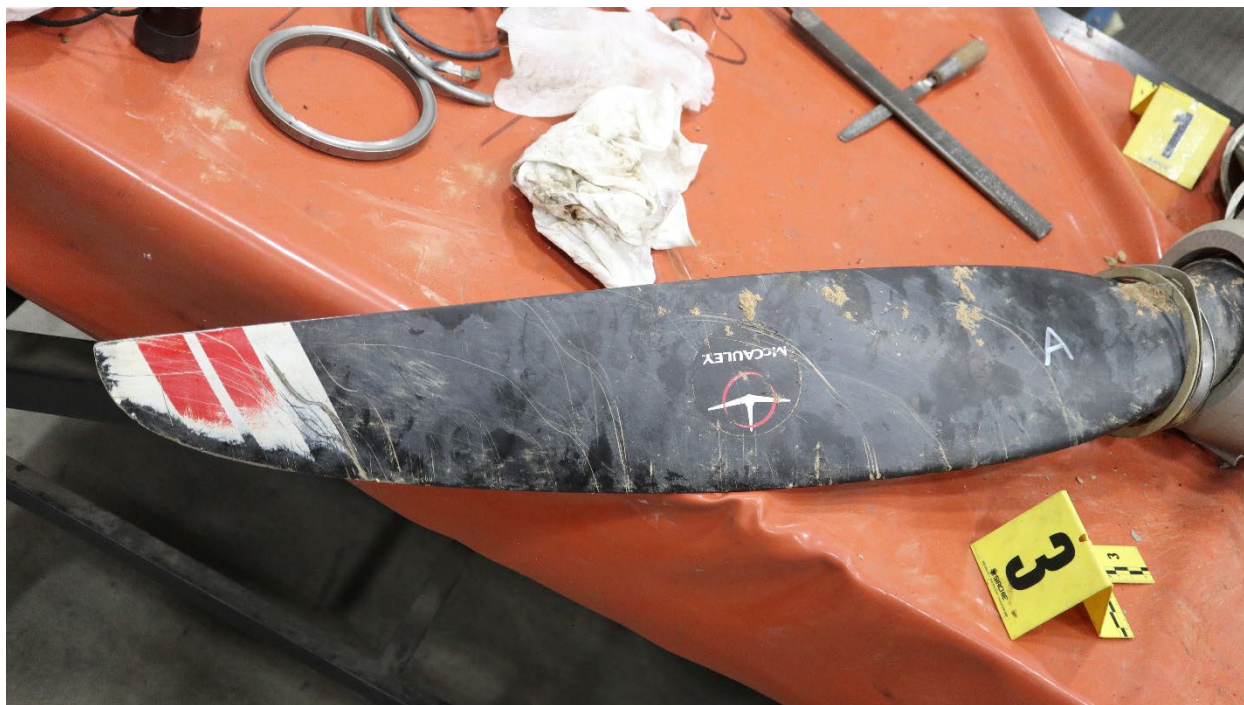
**Photo 14: Overview of blade 3. (McCauley Photo)**
