# National Transportation Safety Board

ERA23FA317

## **WRECKAGE EXAMINATION FACTUAL REPORT**

Location: Springfield, Ohio  
Date: July 29, 2023  
Time: 1206 EDT  
Airplane: Bell 206-L4, N652HA

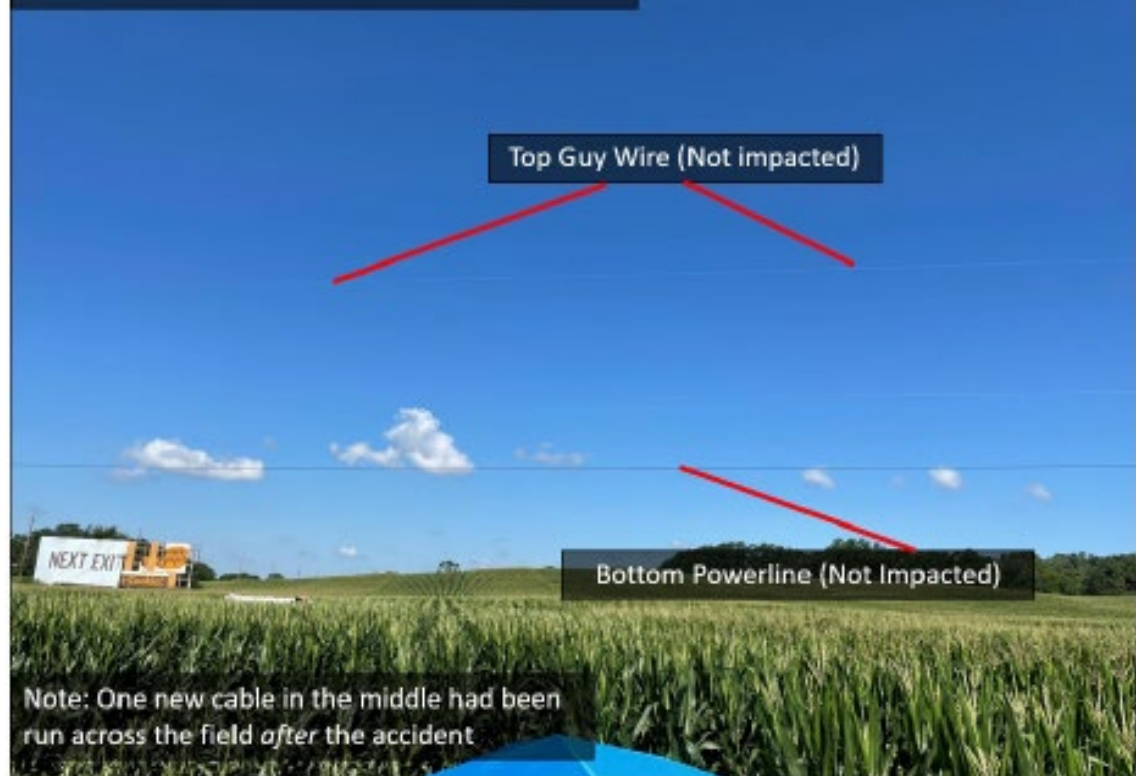
Note: One new cable in the middle had been run across the field after the accident
