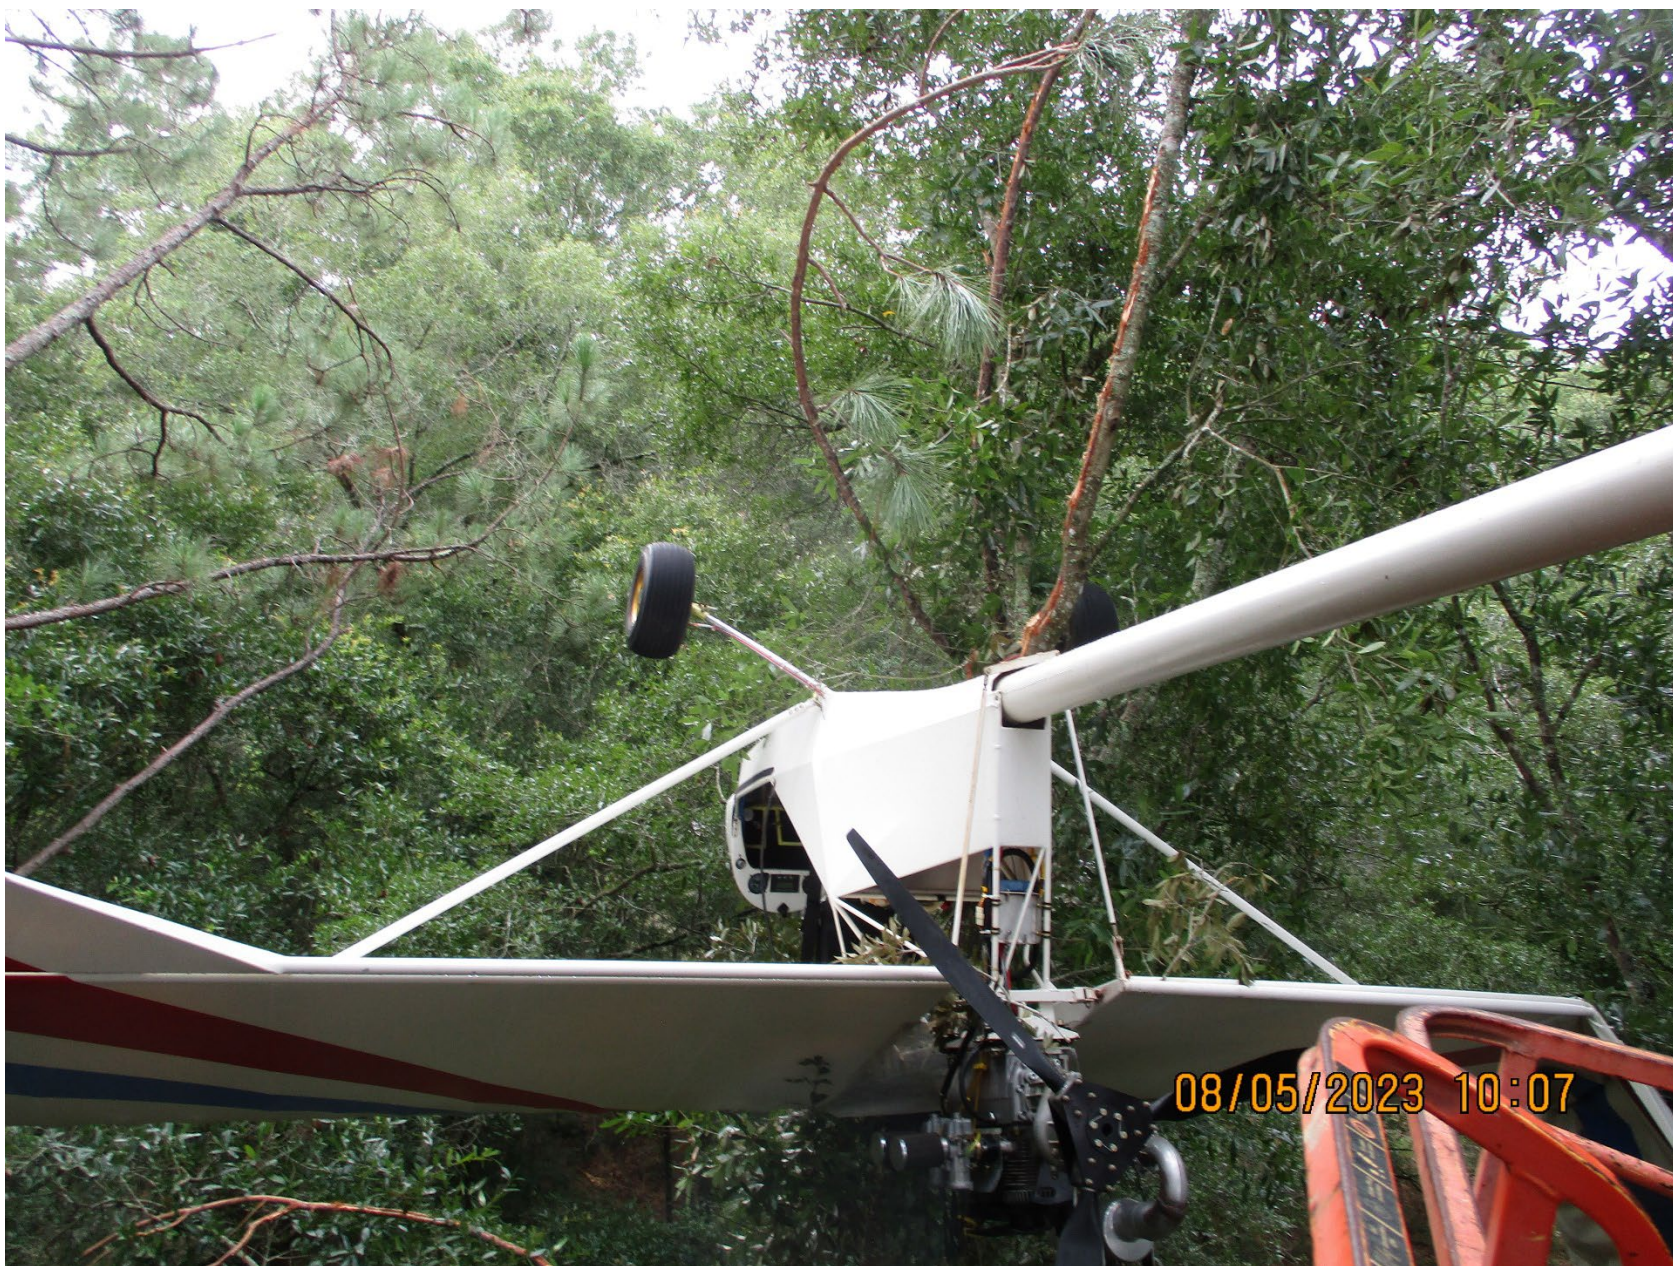
**Photo 1 – Main wreckage, inverted 50 ft up a tree**

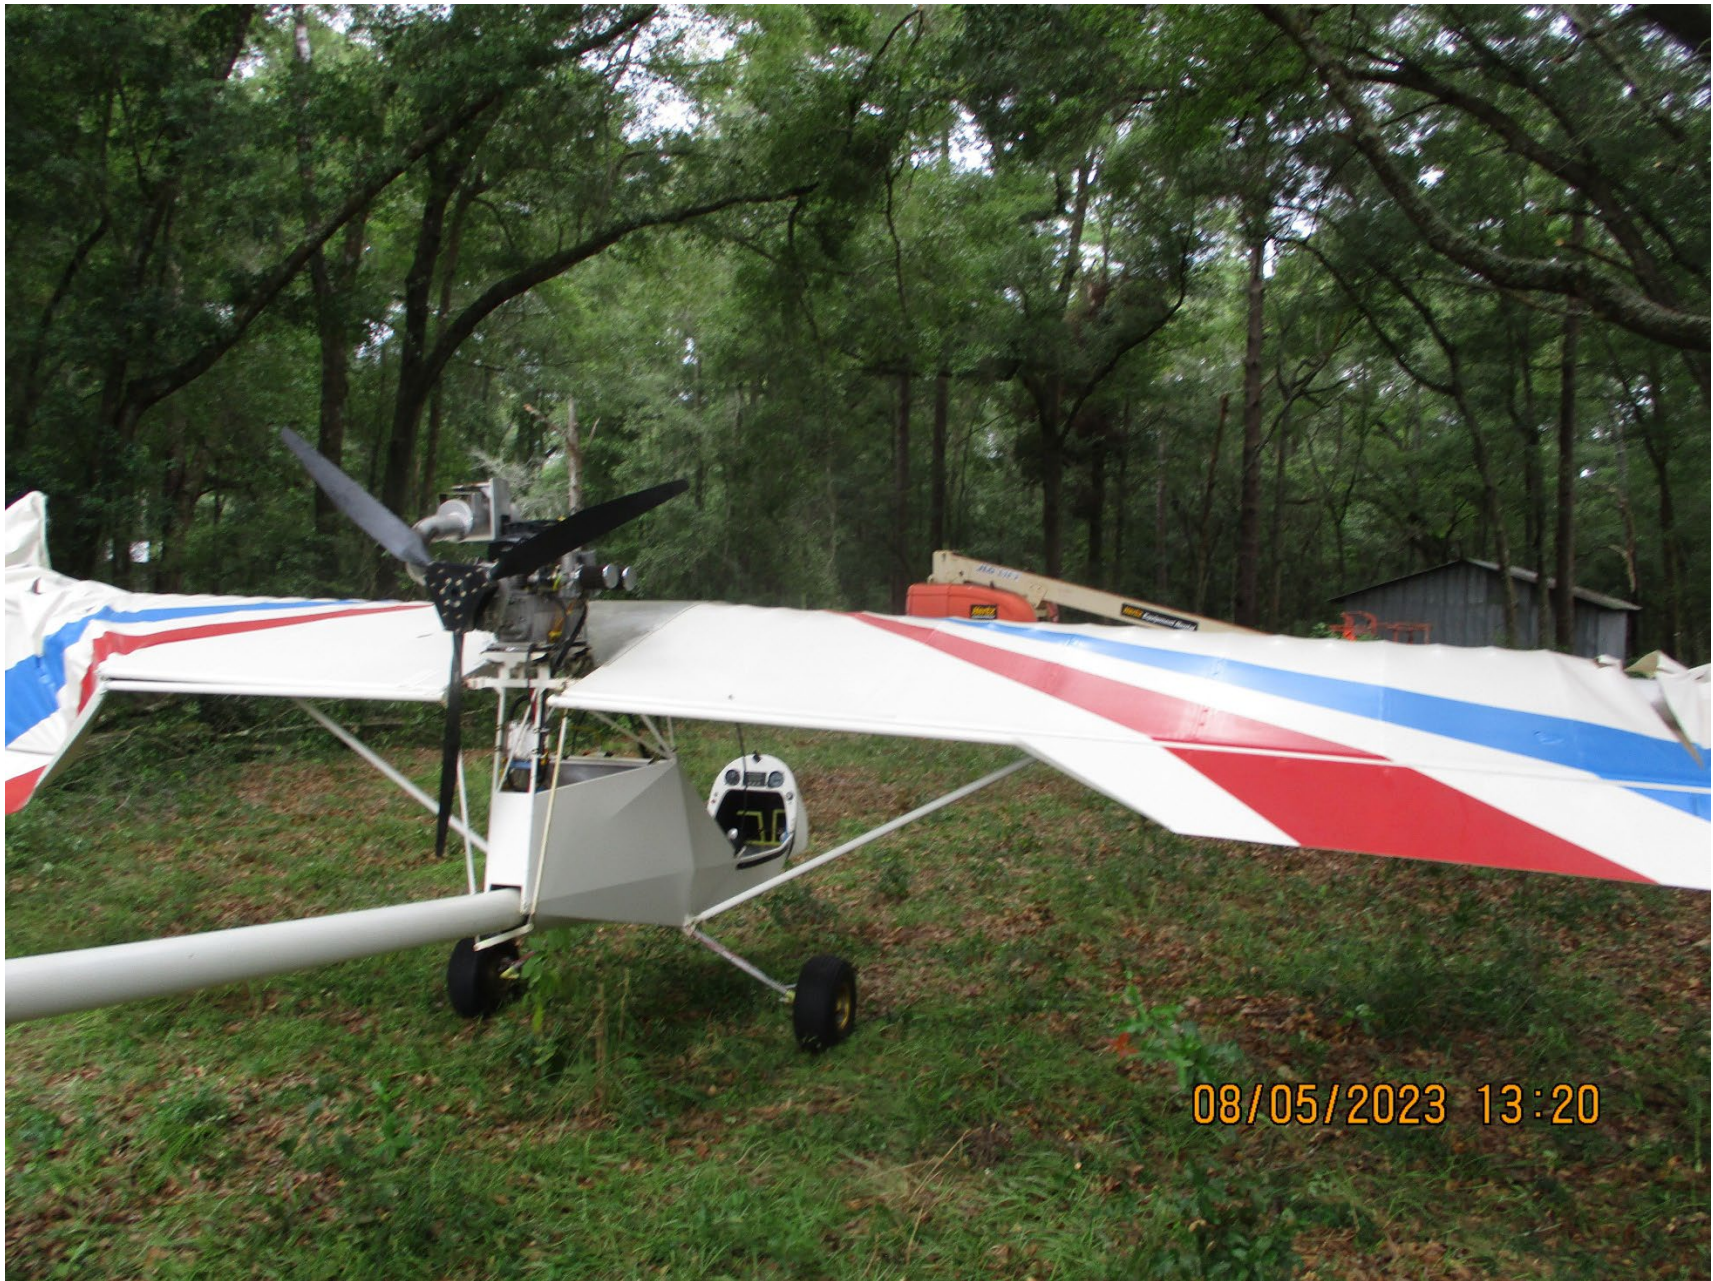
**Photo 2 – Main wreckage, on ground**

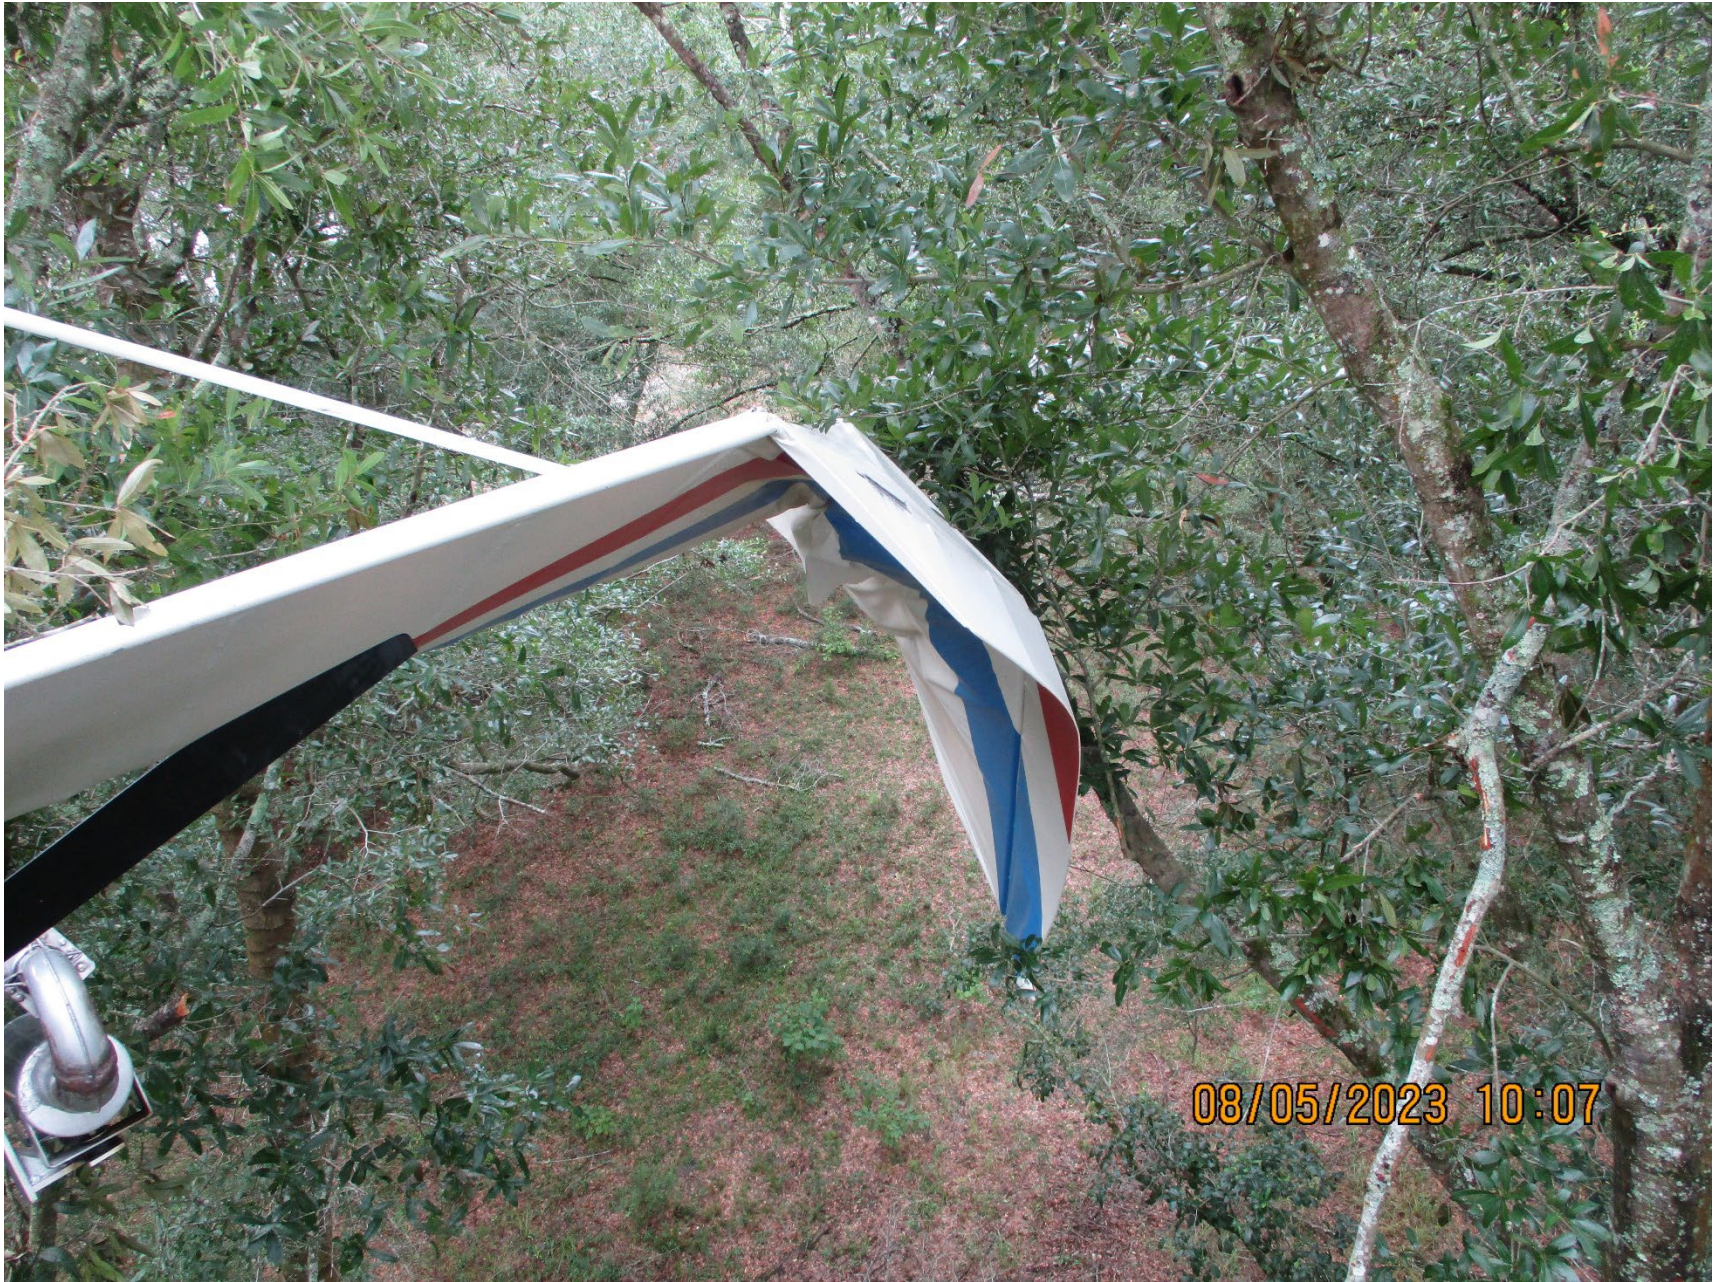
**Photo 3 – left wing tip damaged**

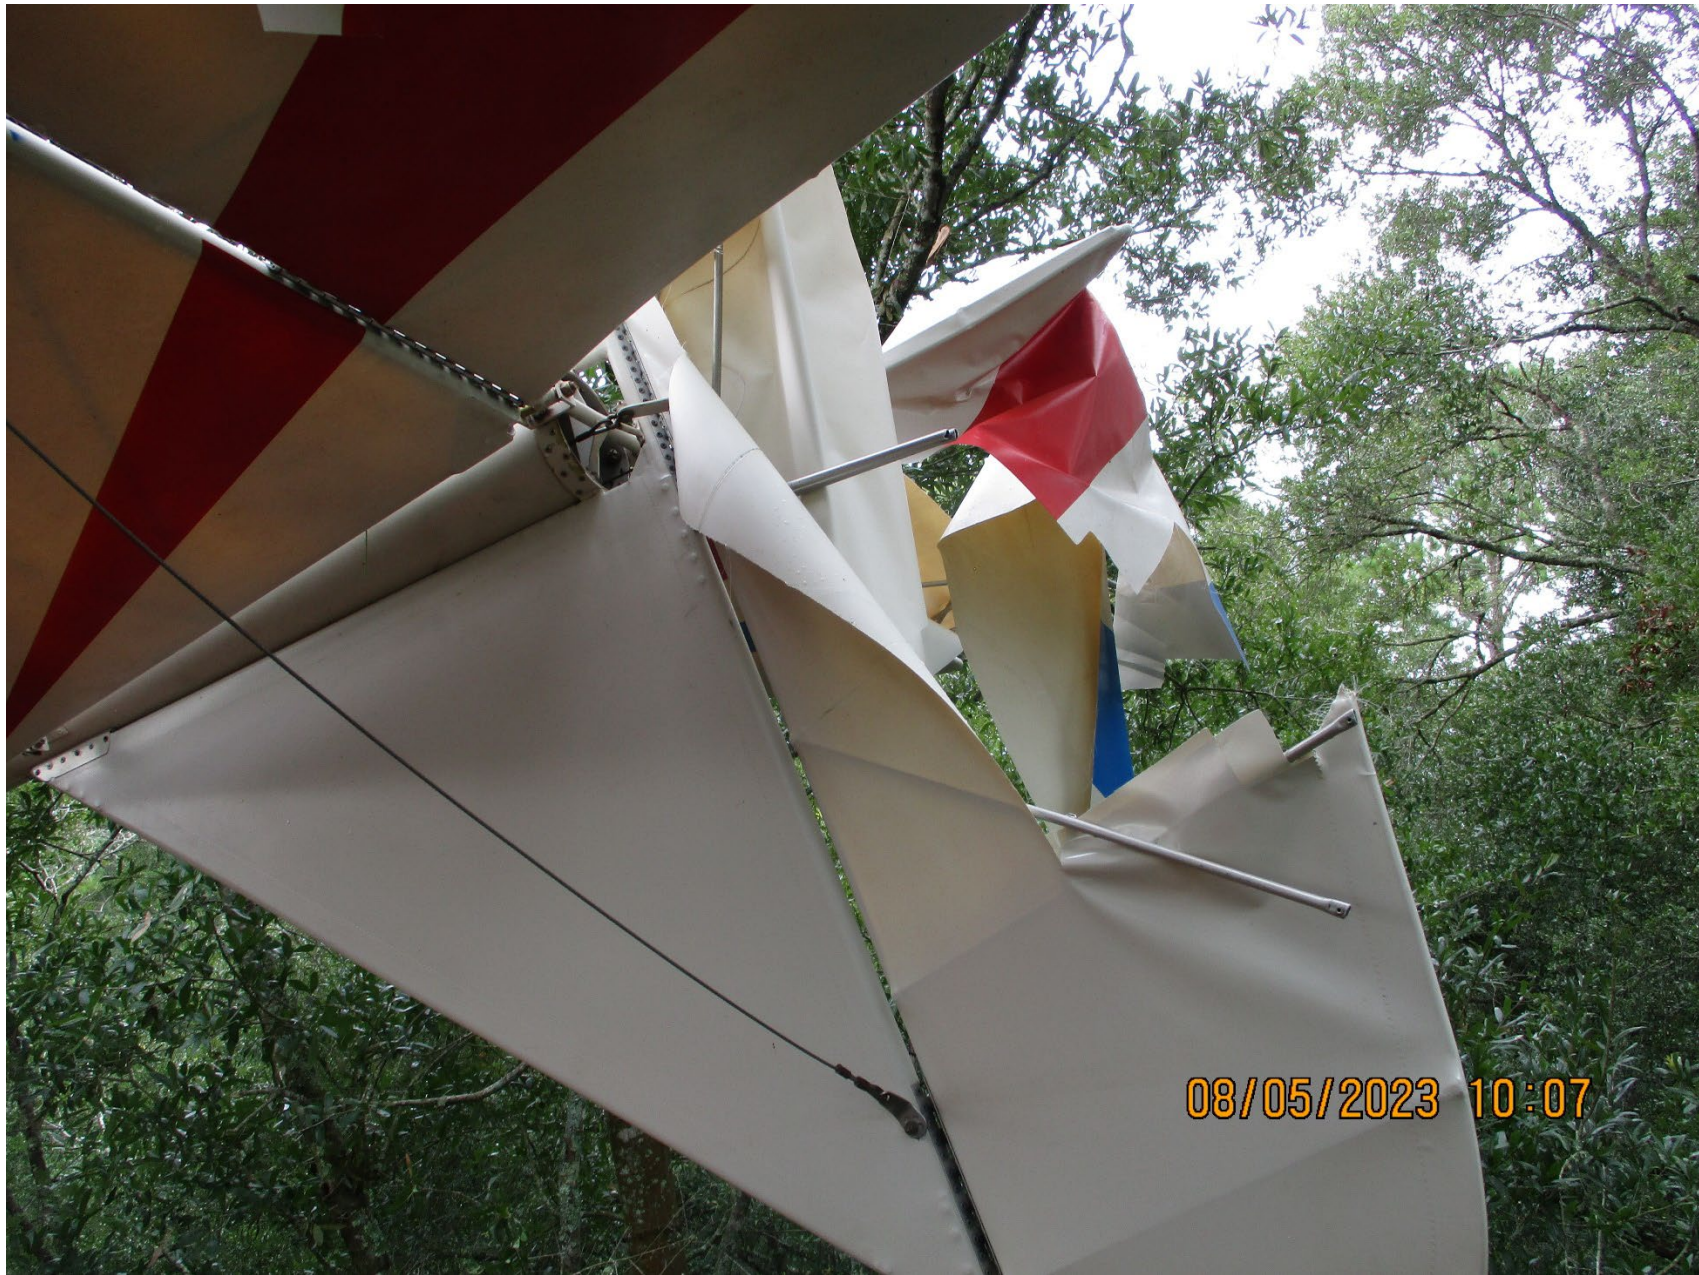
**Photo 4 – Rudder damaged**
