# National Transportation Safety Board

ERA23FA323

## VIDEO STUDY

Location: Pembroke Pines, Florida  
Date: August 4, 2023  
Time: 1201 eastern daylight time  
Aircraft: Cessna 172P

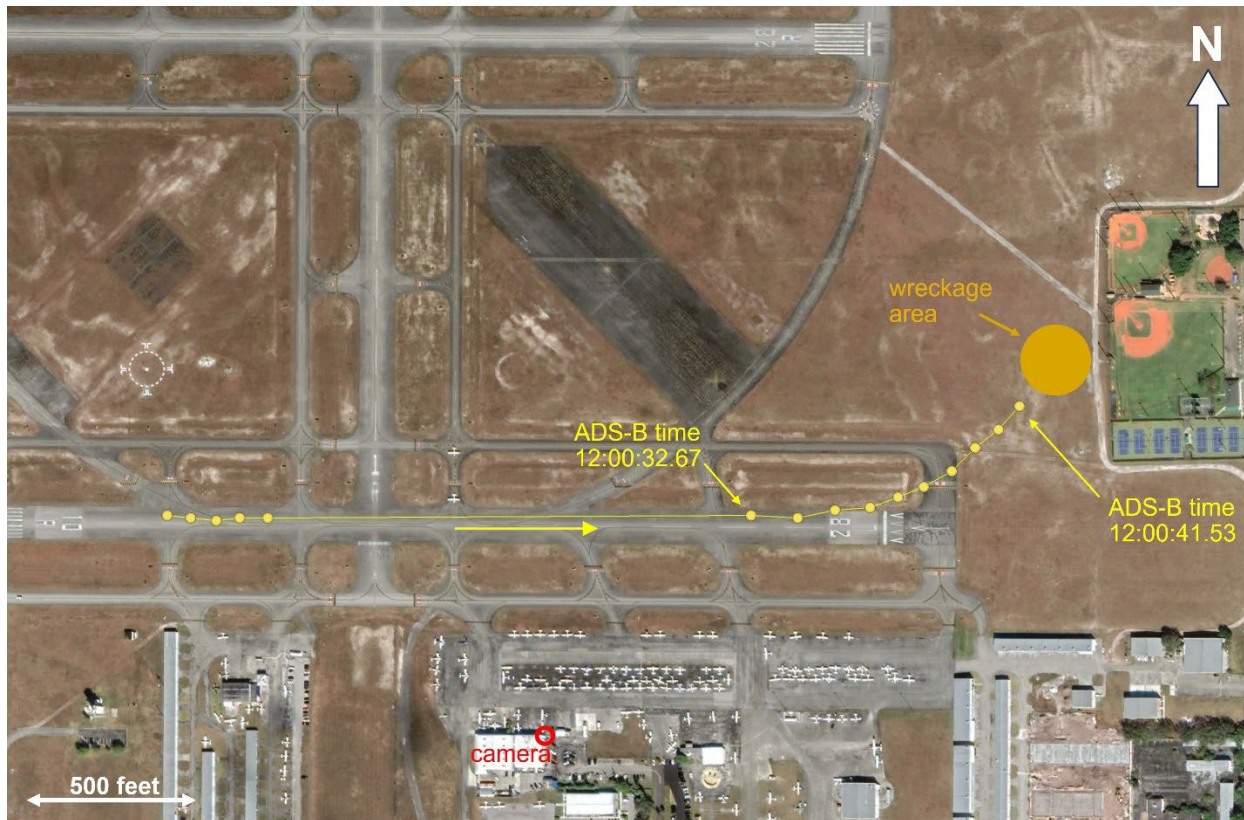
**Figure 1.** Aerial view of the accident area

Figure 1 is an aerial view of the accident area. Fifteen ADS-B locations are marked in the figure by filled yellow circular markers. Also marked are the locations of

the camera and the wreckage. Figure 2 is a frame from the video recorded at video time 37.27 seconds. The video time stamp on that frame was 12:00:34. The ADS-B time corresponding to video time 37.27 seconds was 12:00:35.58. Since the ADS-B time was considered to be the correct time, the analysis below and the corresponding figures will only use the ADS-B time.

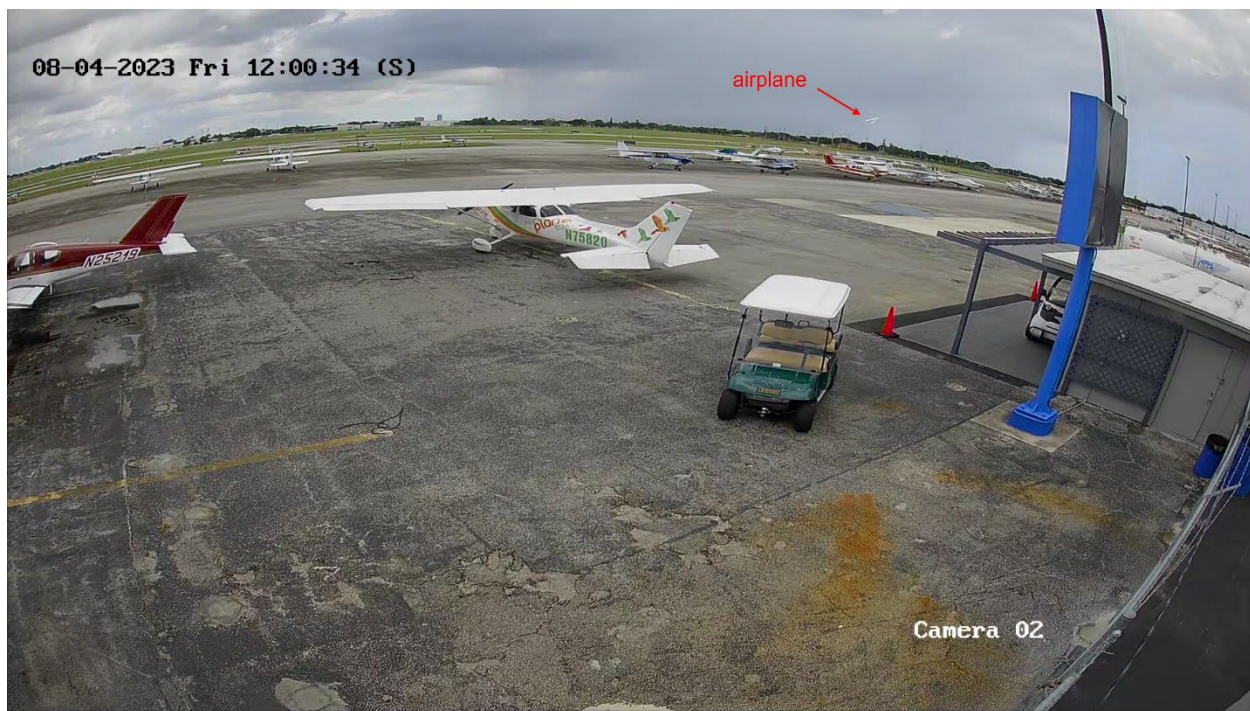
**Figure 2.** Video frame recorded at video time 37.27 seconds  
(ADS-B time 12:00:35.58)

The video frame in Figure 2 is significantly barrel-distorted because of the wide-angle lens of the camera. The distortion was corrected mathematically before analyzing the video.

The estimation of camera model parameters is based on references that are visible both in aerial images such as the one in Figure 1 and in video frames such as the one in Figure 2. The references used for camera model calibration included markings on the ground, the taxiway, the runway and the building seen on the right in Figure 2.

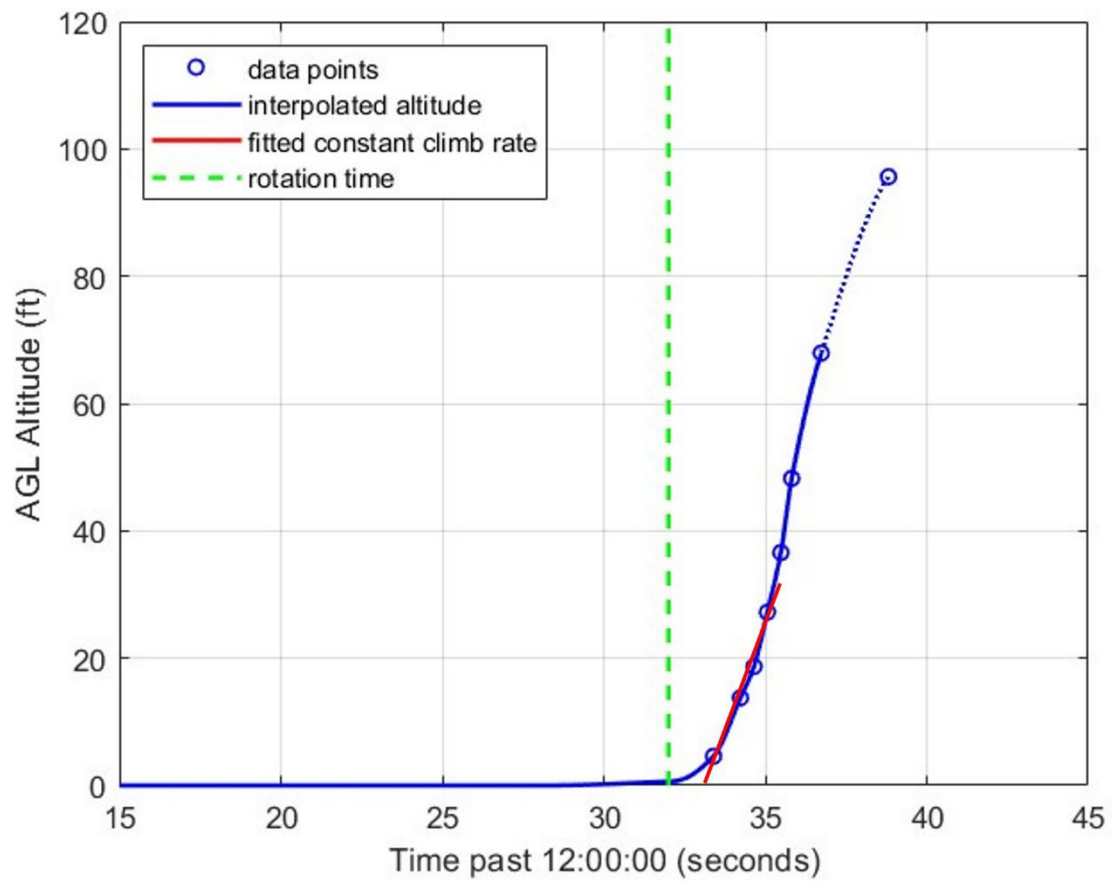
**Figure 3.** Estimated video-based altitude of the airplane vs. ADS-B time

Figure 3 shows the estimated AGL altitude of the airplane vs. ADS-B time. The altitude was that of the nose of the airplane. The altitude was set to zero when the three tires of the airplane were on the runway. The dotted segment of the altitude curve indicates that it had relatively low accuracy because the last shown altitude point was at a time when the airplane visibility was low due to clouds. The airplane is seen in the video initiating an increasing left-wing-down bank angle past video time 36.52 seconds that corresponds to ADS-B time 12:00:34.83. Therefore, it was desirable to estimate the wing angle of attack at that time.

The wing angle of attack is the difference between the wing pitch angle and the flight path angle. The flight path angle is given by  $\tan^{-1}(\text{vertical\_speed}/\text{ground\_speed})$ . The vertical speed is the slope of the altitude vs. time curve in Figure 3. The red straight line in Figure 3 is a constant climb-rate fit to the data at the time when the airplane started banking to the left. The slope of the red line indicated a vertical speed of 13.5 feet/second or 810 feet/minute.

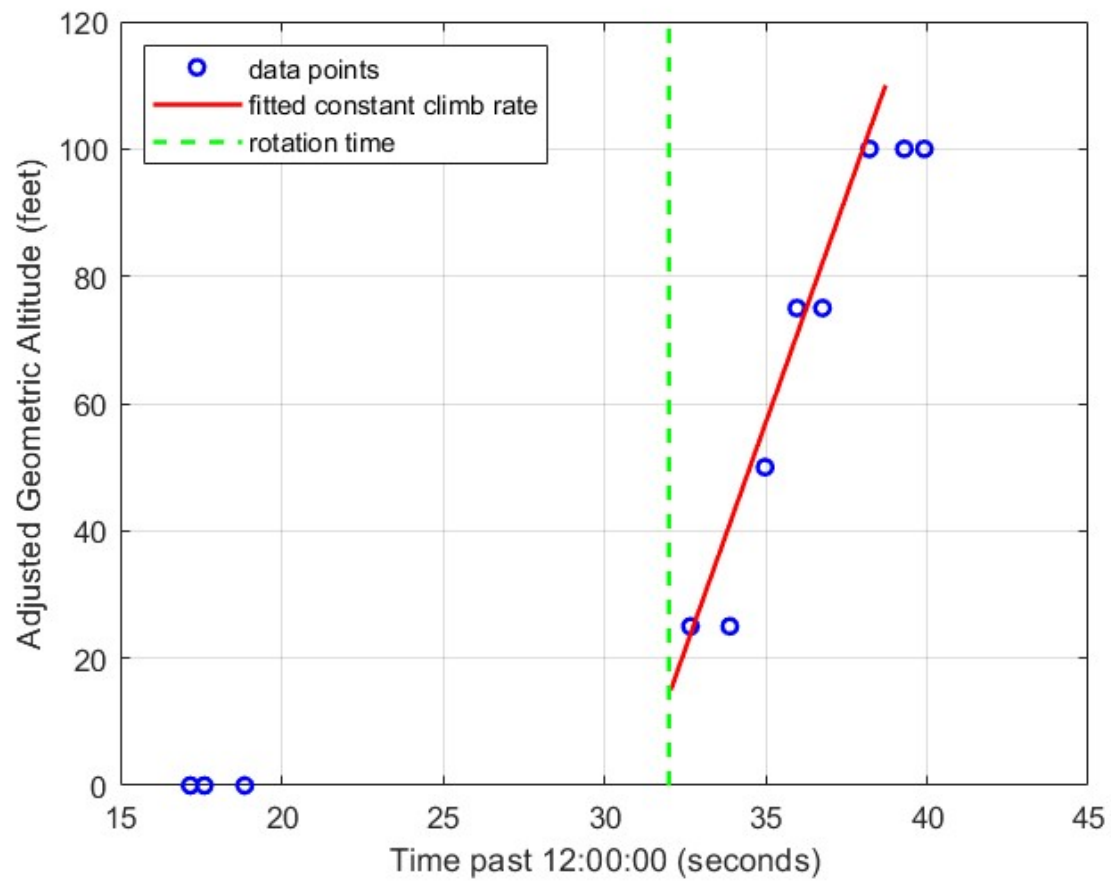
**Figure 4.** Estimated ADS-B based altitude of the airplane vs. ADS-B time

The ADS-B record listed geometric altitude with the resolution of 25 feet. Figure 4 is a plot of the geometric altitude after it was adjusted to be zero when the airplane was on the runway. The red line in the figure is an estimated constant climb-rate fit to the data. The slope of the red line is 13.5 feet/second, in agreement with the vertical speed estimated above through video analysis.

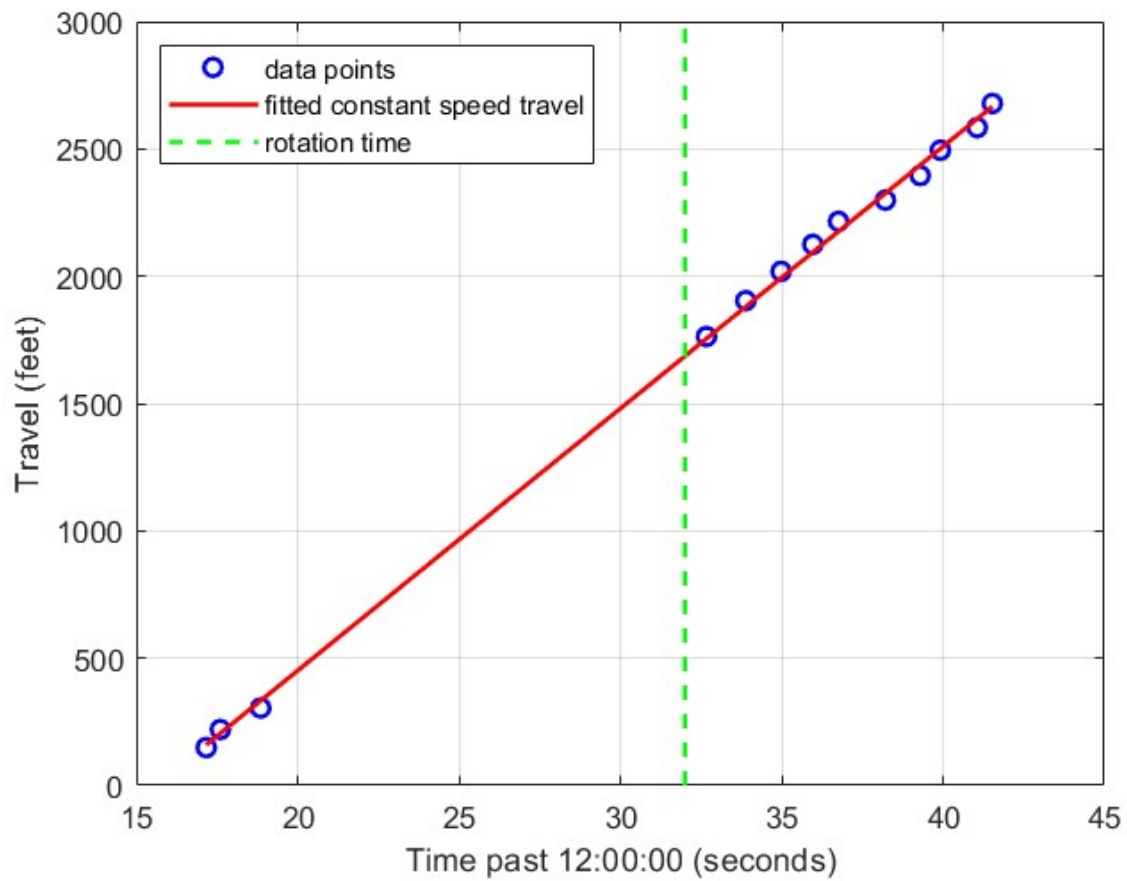
**Figure 5.** Ground travel of the airplane vs. ADS-B time

The ADS-B record included accurate ground track locations marked in yellow in Figure 1. To estimate the ground speed, ground track data was used to plot the total ground distance traveled between the last thirteen locations seen in the figure. Figure 5 is the plot of the total traveled distance vs. ADS-B time. The red line is a constant-speed fit to the data. The slope of that line is 103 feet/second or 61 knots.
