# National Transportation Safety Board

ERA23FA323

## EXAMINATION

Location: North Perry Airport, Hollywood, Florida (HWO)  
Date: August 4, 2023  
Time: 1201 pm local  
1601 (UTC)  
Airplane: Cessna 172  
Reg Num: N697FL  
Operator: ICARO AVIATION ACADEMY,

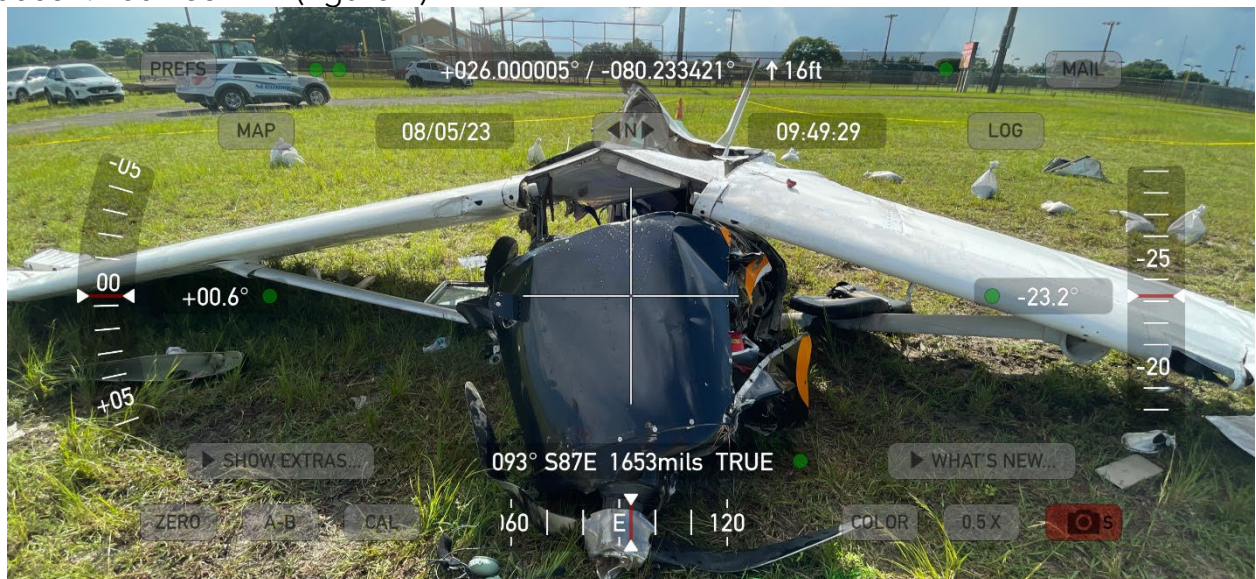
Pembroke Pines (North Perry Airport) Florida, (HWO), USA 650 ft NW of the runway 10 right departure end. Level terrain and sandy turf. Accident site was compact with a ground impact gouge about 30 feet from the main wreckage along with a leading edge left wing impact mark on the ground. The left wing struck the ground first, followed by the airplane fuselage impacting on the engine compartment and belly before coming to rest. coming to rest on its belly. Both wings collapsed downwards, and the cockpit was crumpled and compressed leaving only about 50% occupiable space. Both front seats had broken and were partially separated from their respective seat rail/track. The right seat collapsed forward pushing the occupant into the instrument panel. The pilot seat passenger was found in the aft section of the cockpit near the back seat. The accident site elevation was 16 feet. Lat/log 26.000005° / -80.233421° (figure 1)

Figure 1 Accident site with location/ direction details.

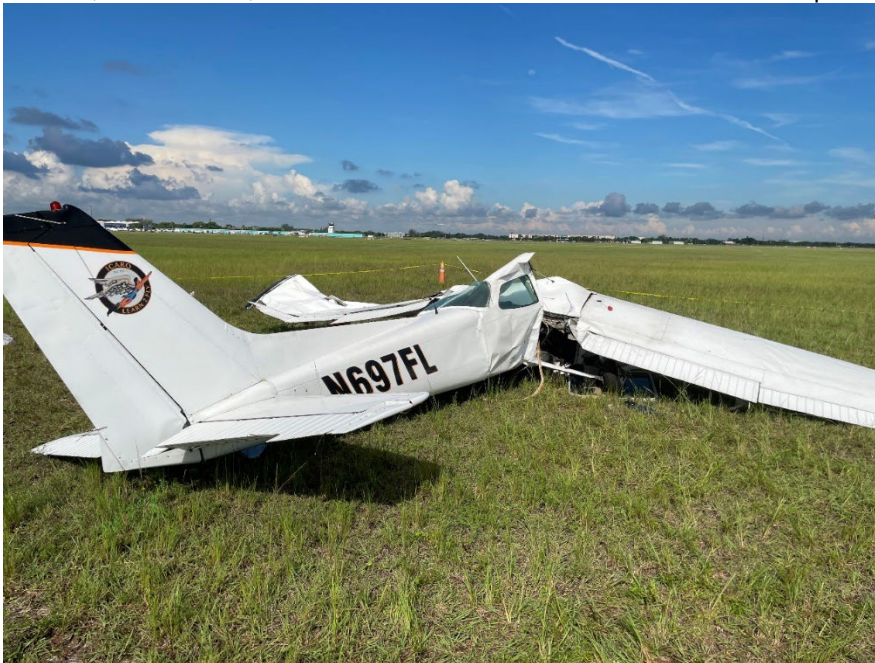
All tail control surfaces were intact and installed in their respective locations and moved manually with corresponding cable movement. Movement was limited due to binding of the control cables in the cockpit floorboard area that was severely crushed, however the lines were traced to their respective control locations and were not compromised/fractured. A hole was cut into the fuselage to observe all cables. No anomalies or other irregularities were discovered. Rudder continuity was established from the rudder-to-rudder pedals. Elevator continuity was established from both elevators to the cockpit controls. The elevator trim was found in a 20° tab up position. (Max is 25°). The elevator trim wheel in the was impact damaged.

**Figure 2 View of empennage looking forward.**

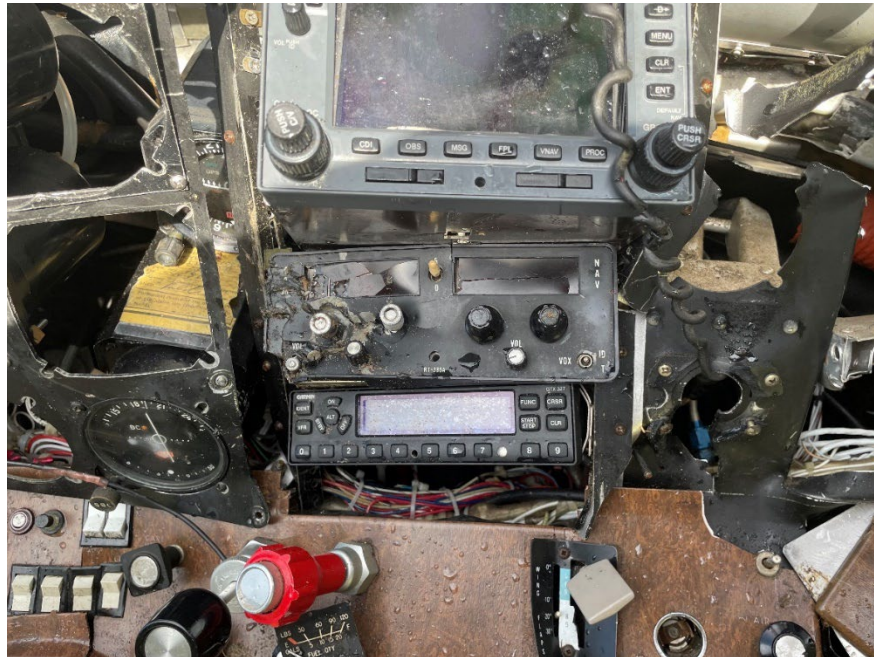
The left and right flaps were in their stowed positions and the flap actuator confirmed they were stowed at the time of impact. The cockpit flap control level was in the full up (stowed) position.

**Figure 3: Instrument panel showing the flap control handle and indicator position.**

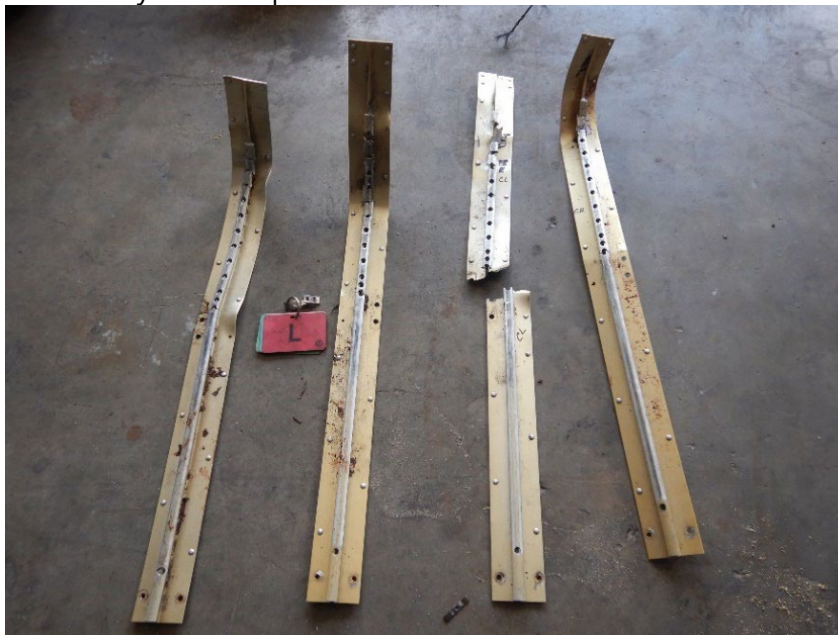
The pilot's (lef ) and co-pilot's (right) seat tracks exhibited impact damage. Both pilot seat tracks/rails were bent up and aft. Examination of the seat tracks/rails seat latch pin holes, the pilot's outboard seat track/rail exhibited a gouge mark on the aft side of pin hole No. 4 and a circular pin gouge mark just aft and outboard of pin hole No. 5. The pilot's inboard seat track/rail exhibited a pin gouge mark just forward of pin hole No. 5 and a gouge mark just forward and inboard of pin hole No. 4 and exiting to the side.

The co-pilot's inboard track/rail exhibited a gouge mark on the aft side and outboard of pin hole No. 5. There were no signatures of aft seat slippage on either seat. Note that a secondary seat stop was not installed on either seat.

**Figure 4 Pilot (l) and copilot's seat tracks**

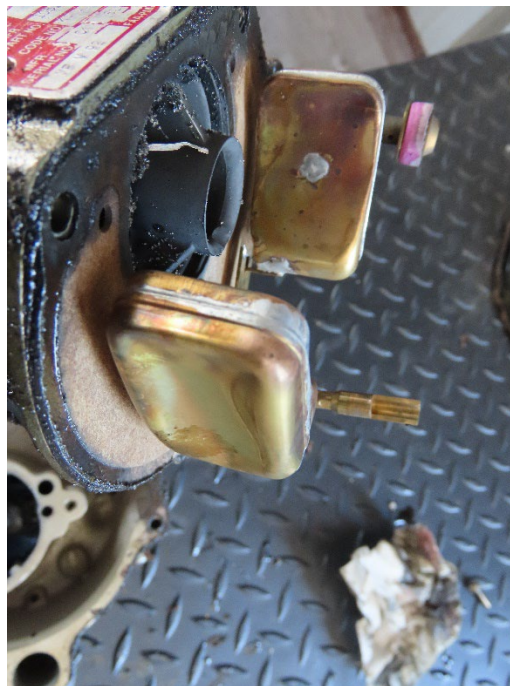
Both left and right fuel tanks remained largely intact and any drips that were observed by the FAA the day of the impact was likely due to broken/severed fuel lines. About 12 gallons of fuel was drained out of the right wing with about another 2 gallons being lost to spillage during the defuel. The left wing's fuel tank was drained of fuel and contained about 10 gallons. Total fuel retrieved was about 24 gallons of blue aviation fuel as tested on site. Each wing fuel screens (2 per tank) were removed and were free of any debris. The fuel from the engine fuel sump/gascolator was drained and tested for foreign debris and water with negative results. The carburetor was removed, and the floats contained hydraulic deformation, which dented each brass float uniformly indicating fuel in the carburetor.

**Figure 5 Fuel floats showing evidence of fluid deformation; The opposing side showed the same type of deformation.**

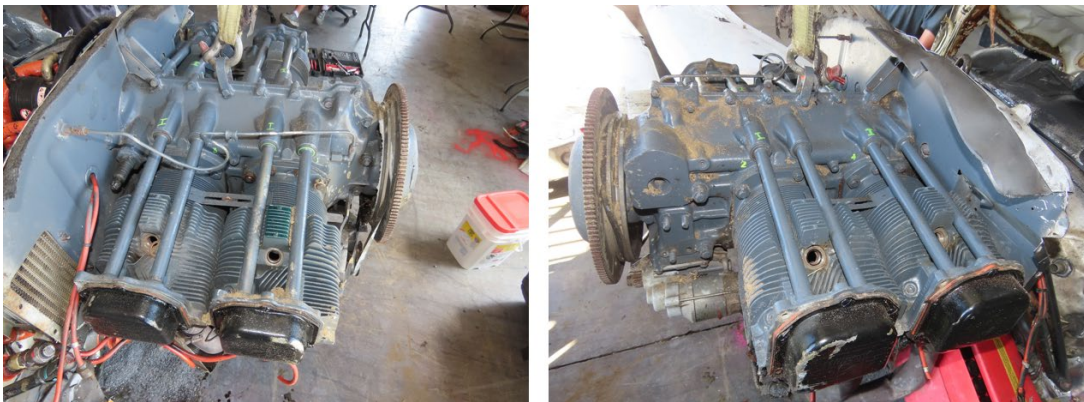
The engine crankcase was manually rotated 720° degrees of rotation several time to check for crankshaft continuity, compression and suction via the accessory drive and vacuum port. Continuity was confirmed and all pistons, valves springs and pushrods operated as designed. There was adequate compression on each of the 4 cylinders. Continuity of the crankshaft was confirmed throughout the engine. Maintenance records indicated that the No. 1 cylinder was recently overhauled.

**Figure 6 View of left and right side of engine prior to examination.**

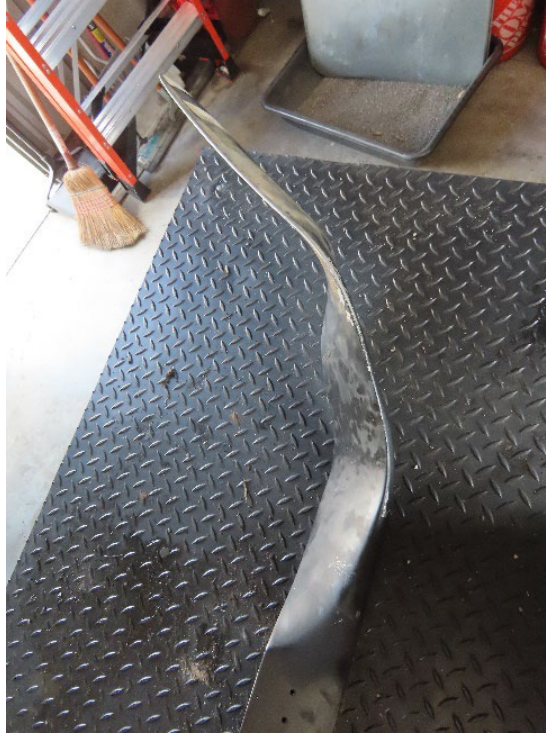
The propeller (McCauley Model # DTM7457; Serial # 735283) hub remained attached to the engine crankshaft flange and both blades were damaged. Both propeller blades showed evidence of abrasive polishing on the outer 12-inches of blade tip. Blade 1 contained a compound S-bend and twist and bending in the opposite direction of rotation. There was also a buckling wave bend on the trailing edge. The opposing blade 2 was bent aft mid span and did not have any twisting or S-bend but did have chordwise scraping.

**Figure 7 McCauley propeller exhibiting signs of s bending and polishing.**
