# National Transportation Safety Board

ERA23FA330

## **ENGINE EXAMINATION**

Location: Junction City, Georgia  
Date: August 10, 2023  
Time: 1005 EDT  
1405 UTC  
Airplane: Cessna P210N; N210JT

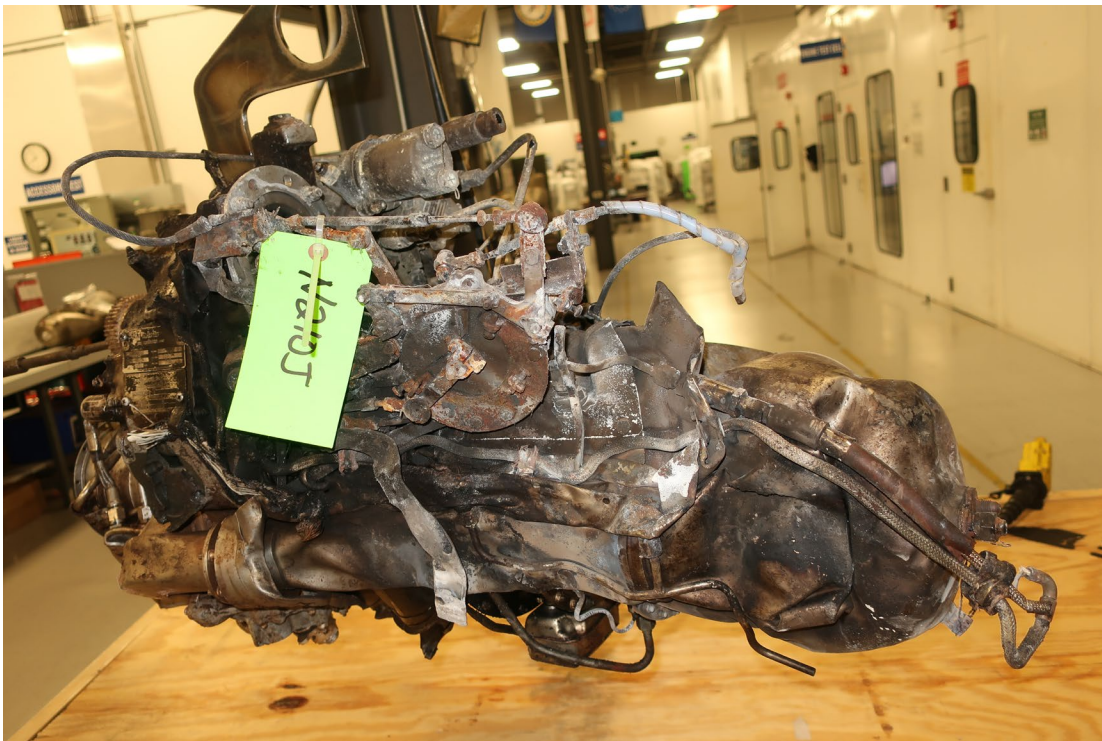
The propeller gearbox was separated from the engine and remained attached to the propeller. The accessories section displayed thermal signatures consistent with a post-crash fire. The left side of the engine was impact crushed inward with the left discharge tube embedded in the horizontal fireshield. The N1 and N2 systems were locked when rotation was attempted by hand via the compressor and fourth stage turbine wheel respectively. All the external lines and connections displayed varying amounts of bending and several were fractured.

**Photo 1: View of the left side of the engine as received. (Photo Courtesy of Rolls Royce)**

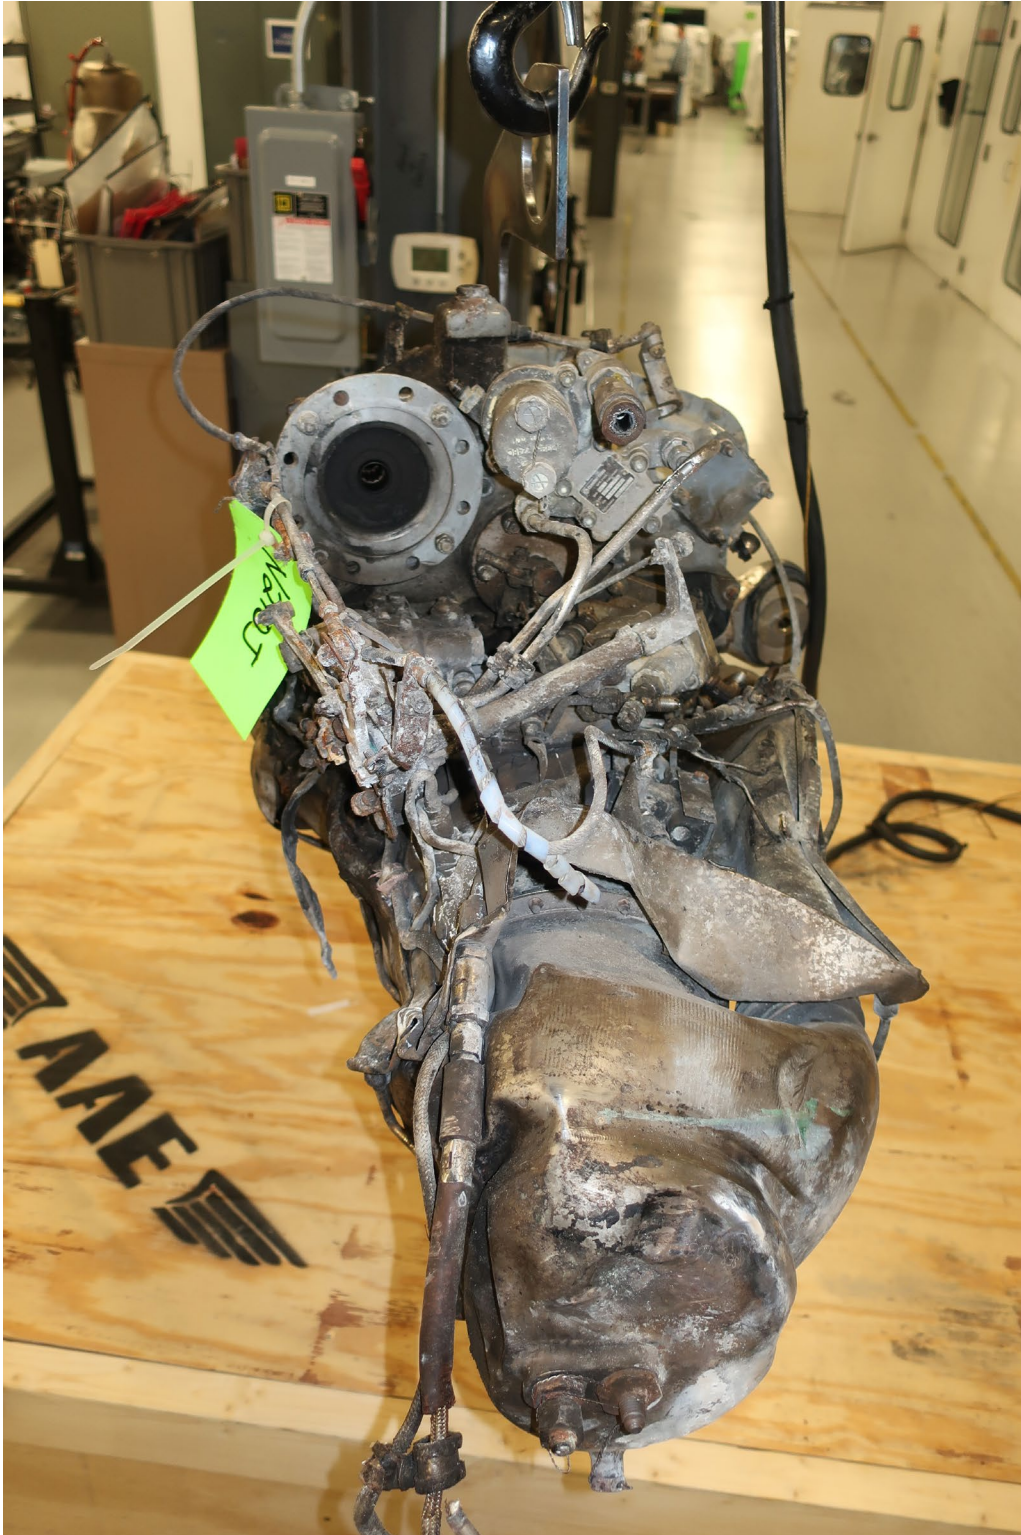
**Photo 2: View of the back of the engine as received. (Photo Courtesy of Rolls Royce)**

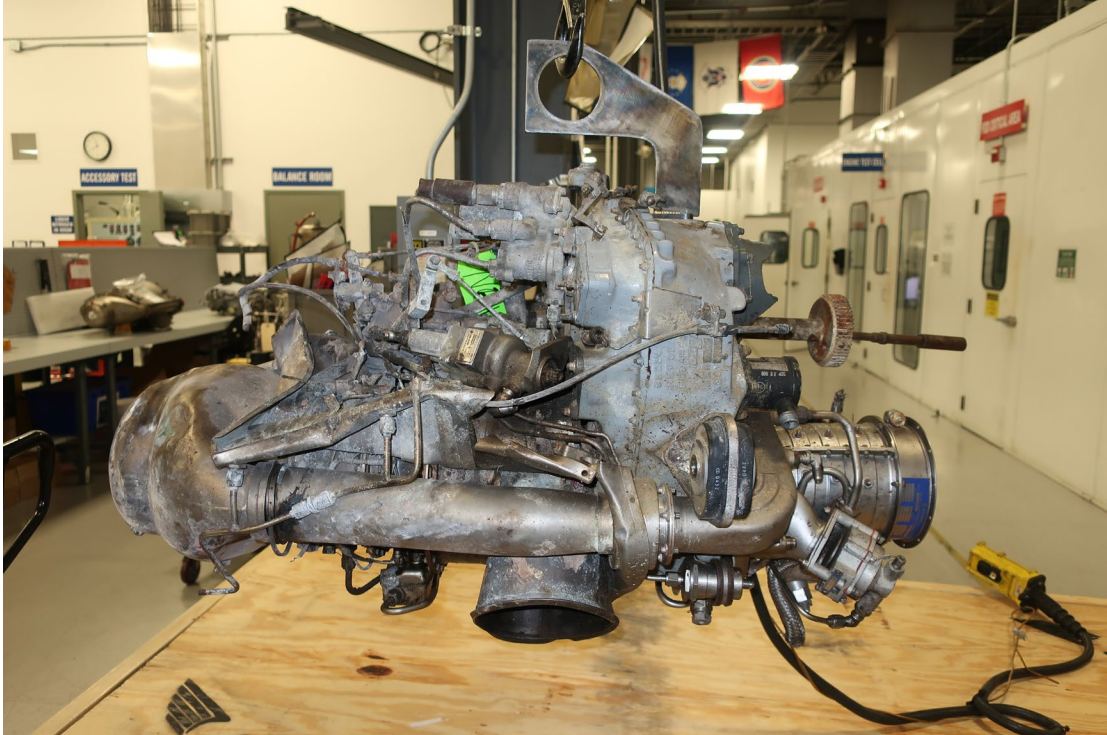
**Photo 3: View of the right side of the engine as received. (Photo Courtesy of Rolls Royce)**

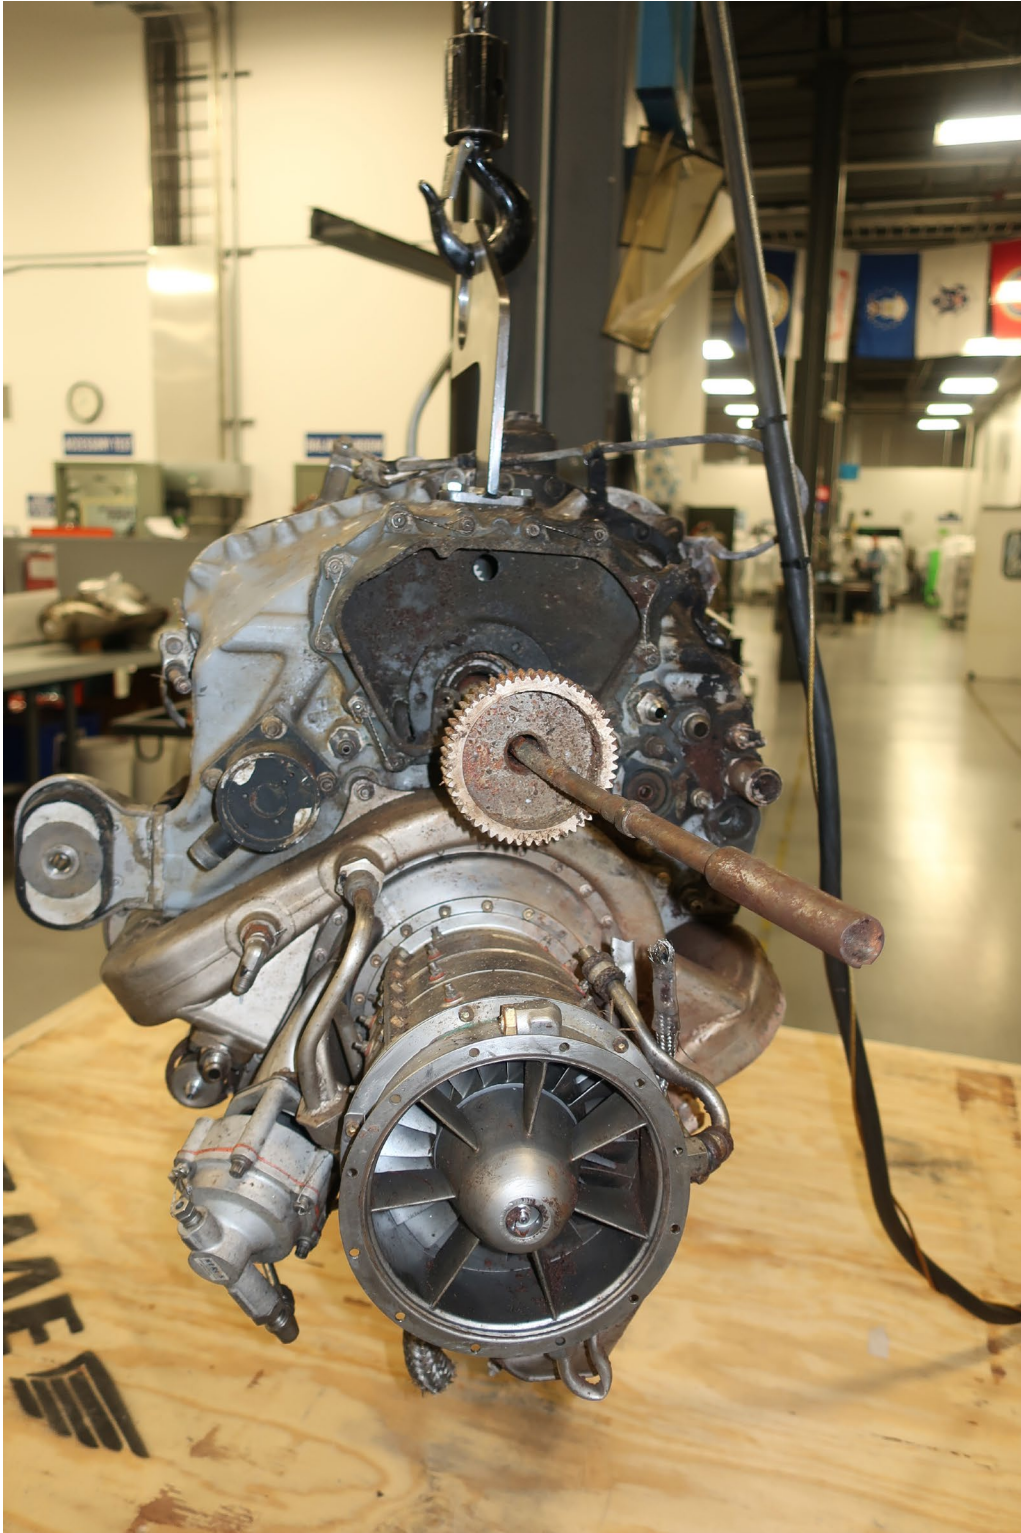
**Photo 4: View of the front of the engine as received. (Photo Courtesy of Rolls Royce)**

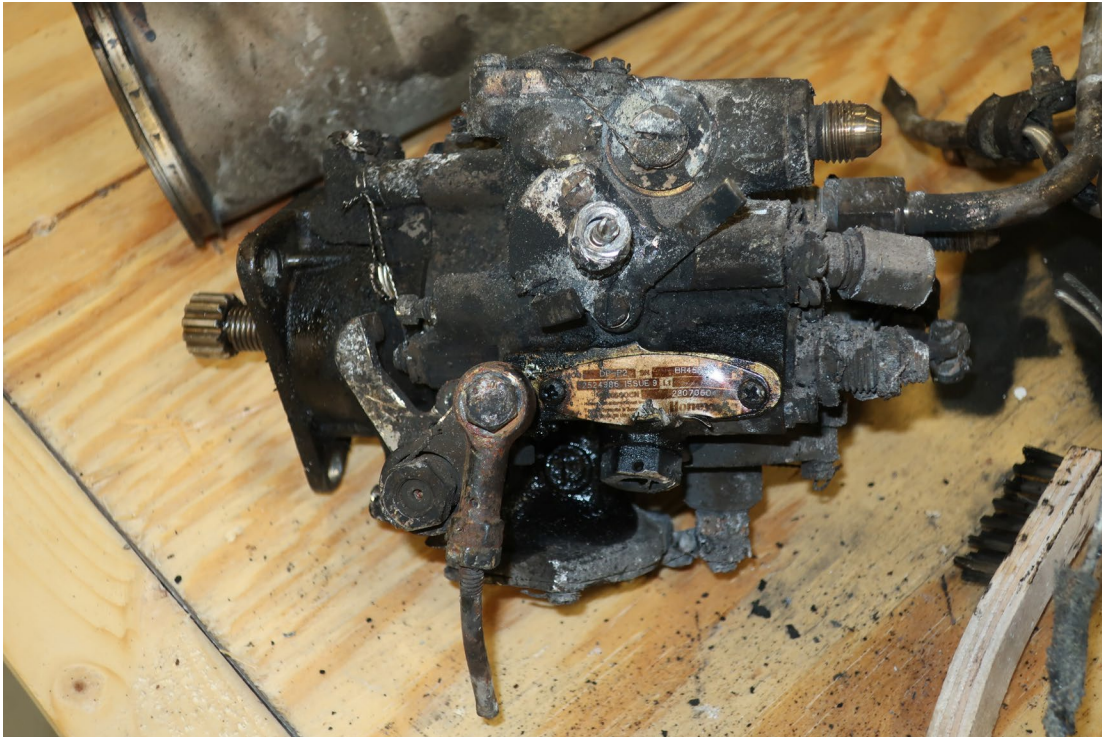
The fuel control unit driveshaft was intact and turned with some binding. The drive body was cracked longitudinally. The air and fuel line connections were fractured and bent. The unit was not disassembled.

**Photo 5: View of the fuel control unit. (Photo Courtesy of Rolls Royce)**

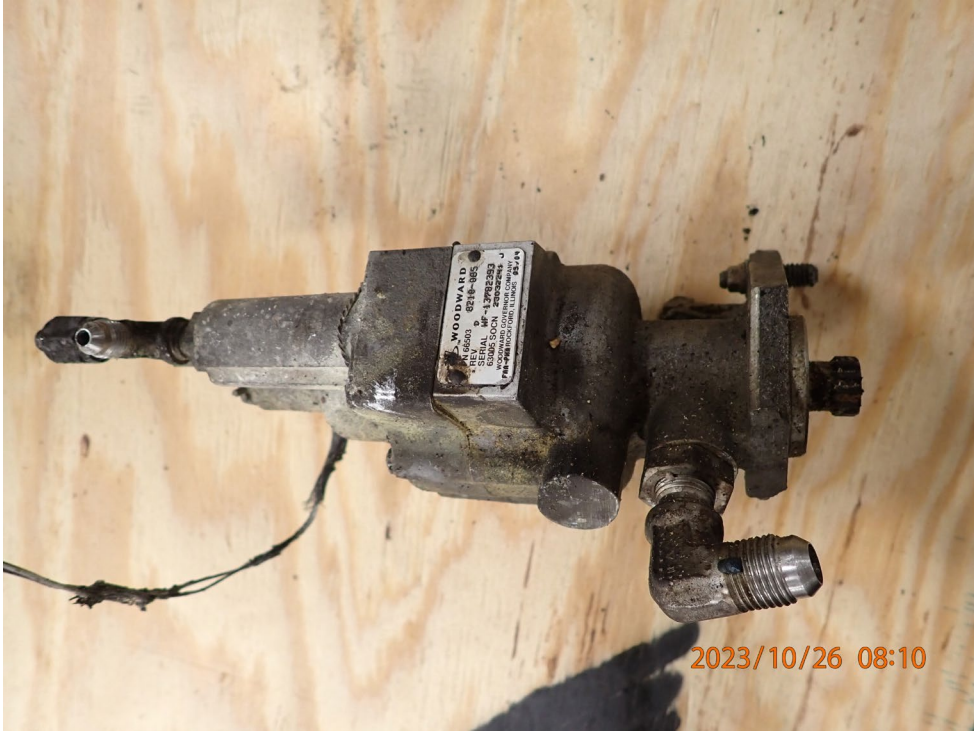
The propeller overspeed governor and driveshaft splines were generally intact and the driveshaft did not turn. The unit was not disassembled.

**Photo 6: View of the propeller overspeed governor.**

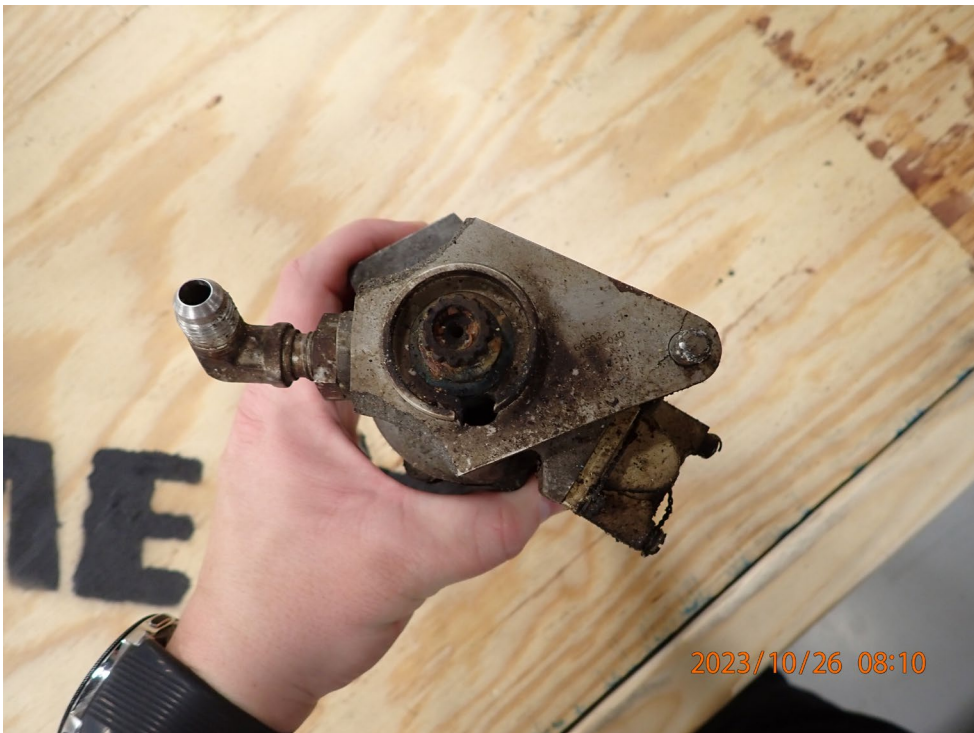
**Photo 7: View of the propeller overspeed governor driveshaft.**

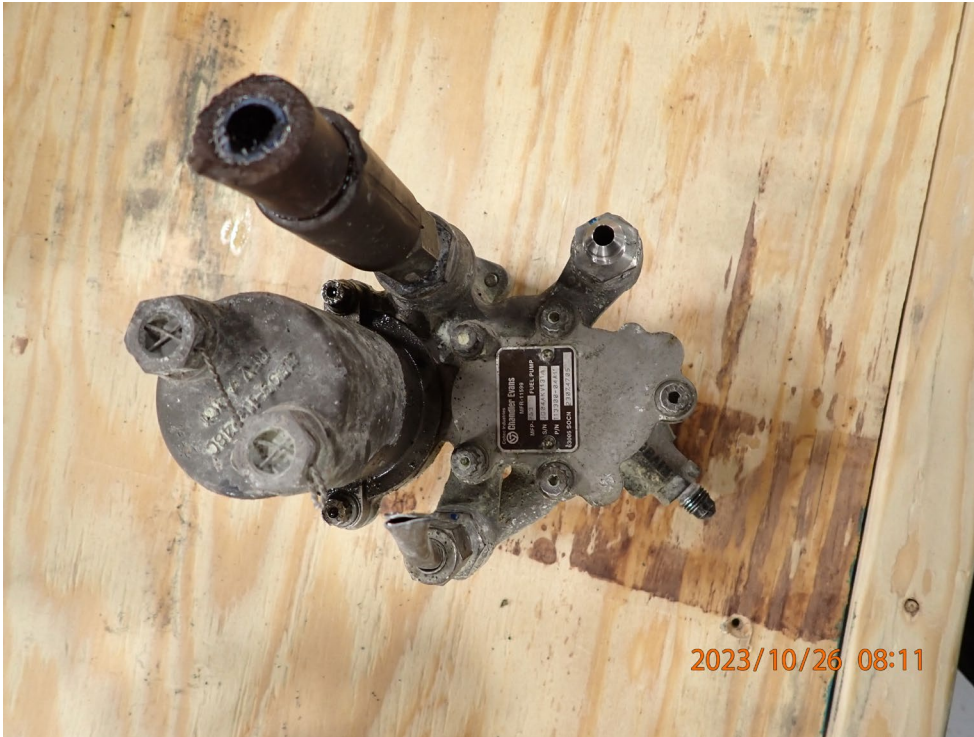
The fuel pump was removed, and the driveshaft remained lodged in the gearbox. The fuel filter element was inspected and was clean with some residual fuel in the bowl.

**Photo 8: View of the fuel pump.**

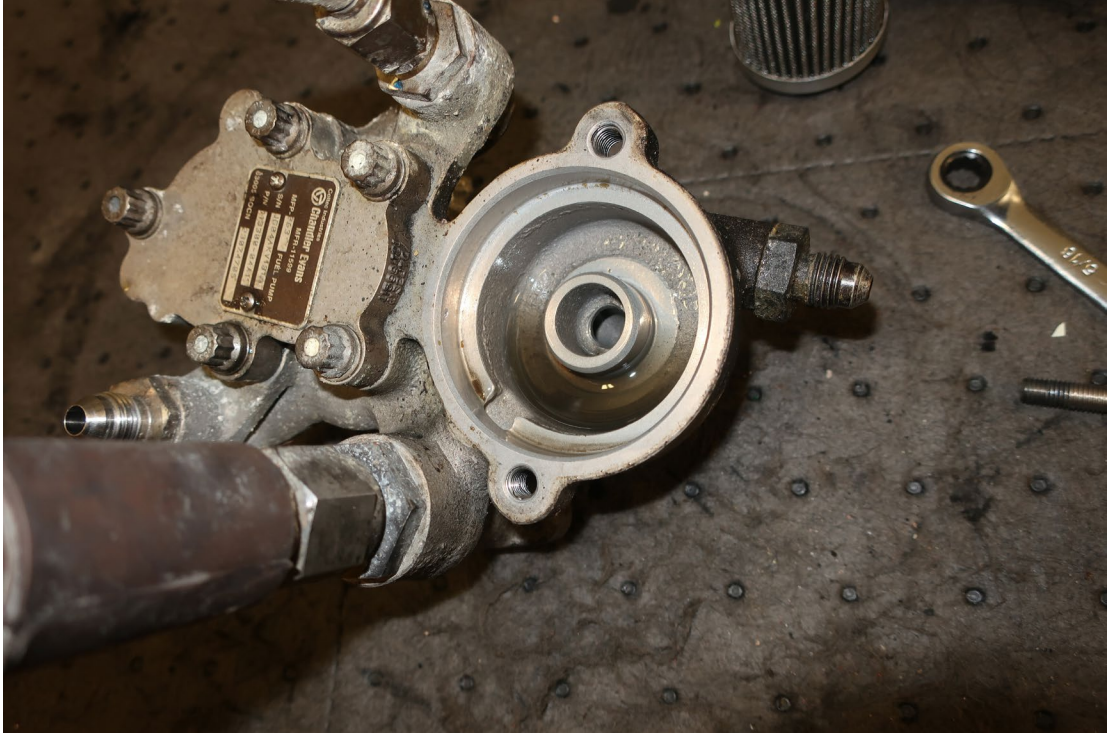
**Photo 9: View of the fuel pump bowl with residual fuel. (Photo Courtesy of Rolls Royce)**

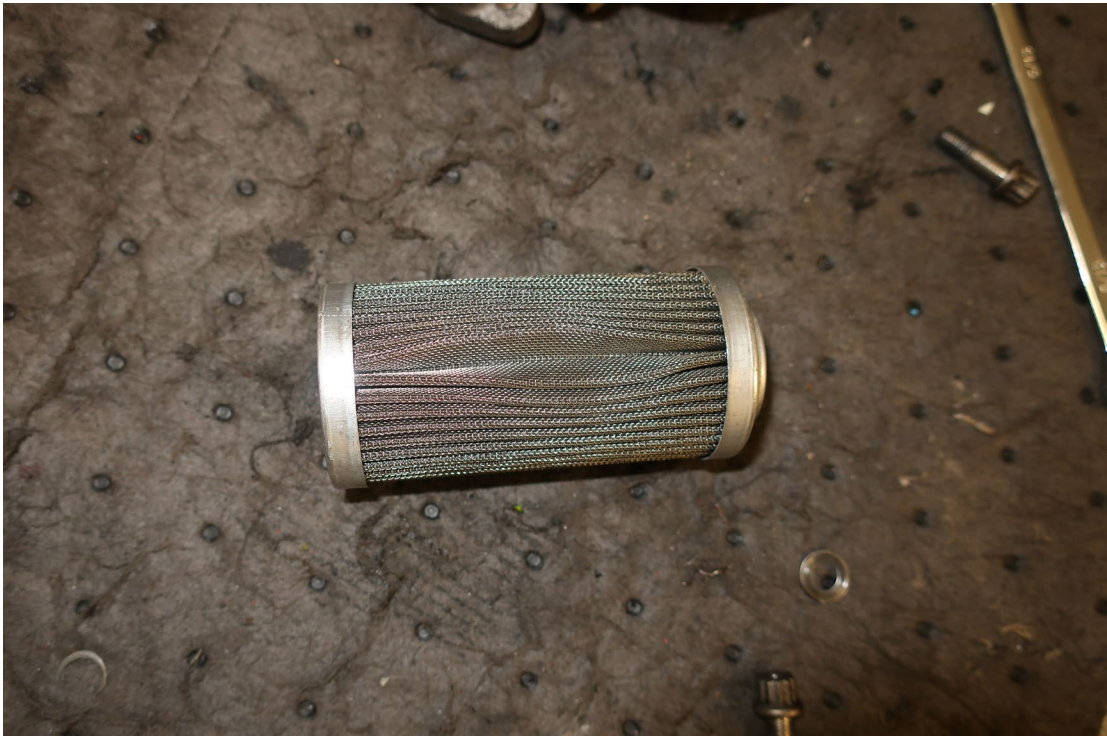
**Photo 10: View of the fuel pump filter. (Photo Courtesy of Rolls Royce)**

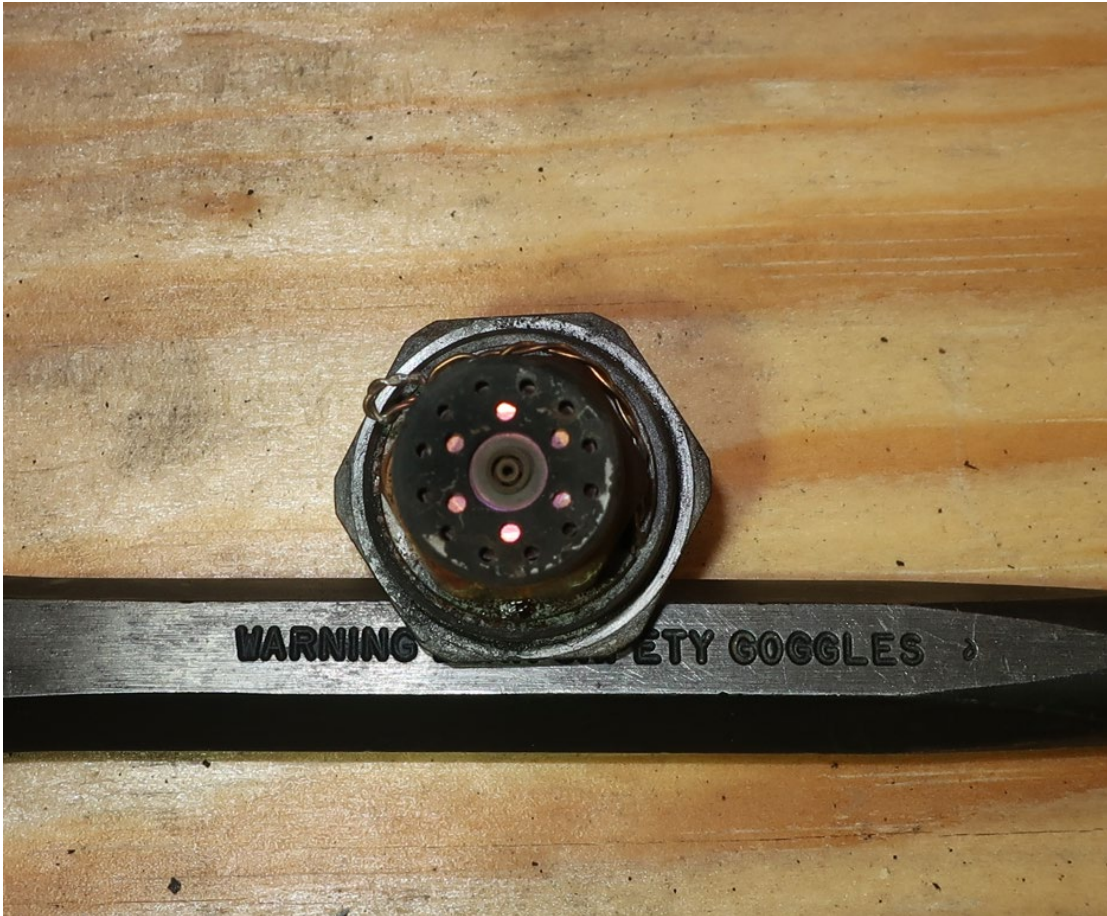
The fuel nozzle was visually clear and displayed no obvious blockages on the primary and secondary orifices. The nozzle was dark brown in appearance and was not disassembled.

**Photo 11: View of the fuel nozzle. (Photo Courtesy of Rolls Royce)**

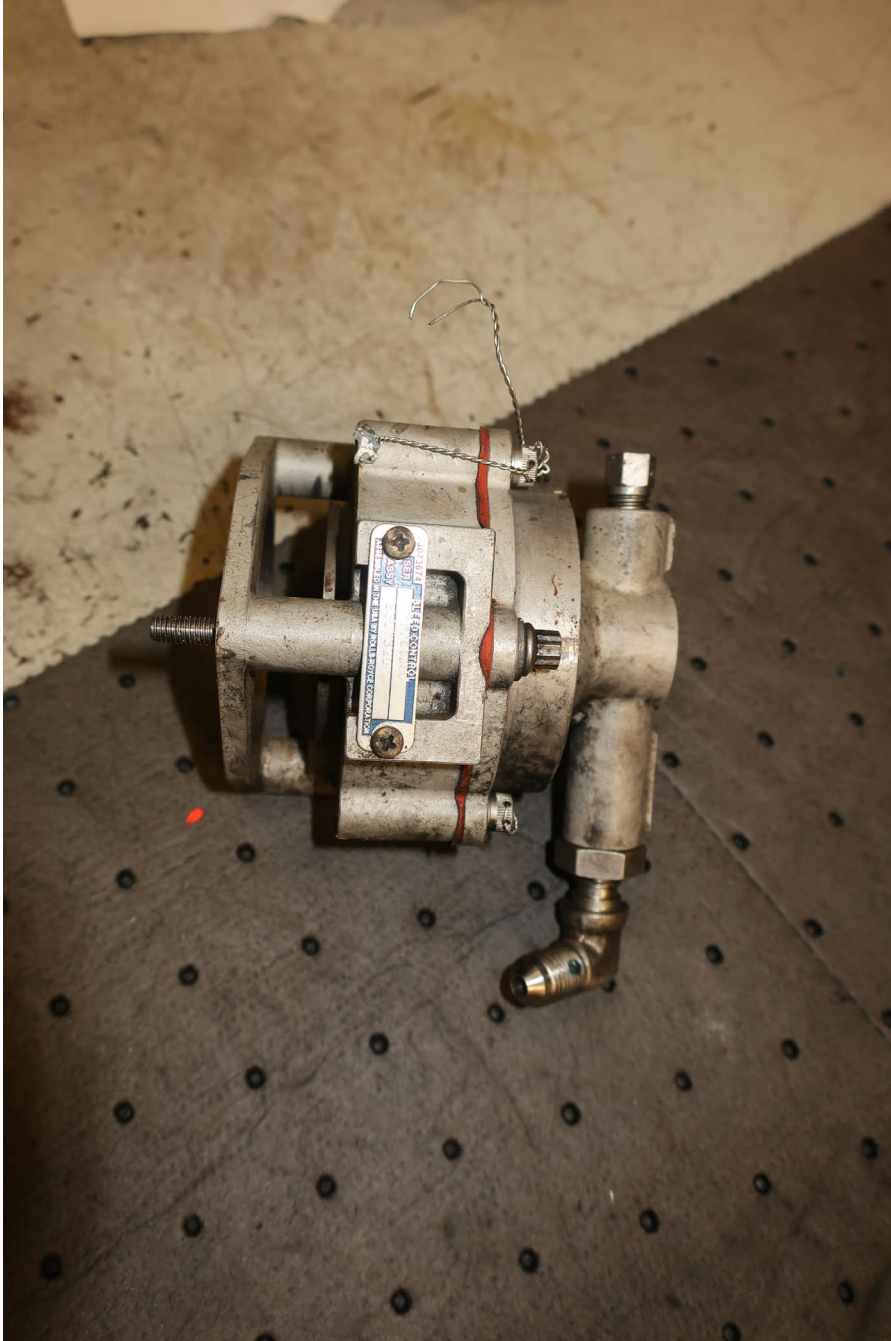
The compressor bleed valve was normal in appearance and the valve was fully open. The valve closed with normal resistance and no binding. The bleed valve was not disassembled.

**Photo 12: View of the compressor bleed valve. (Photo Courtesy of Rolls Royce)**

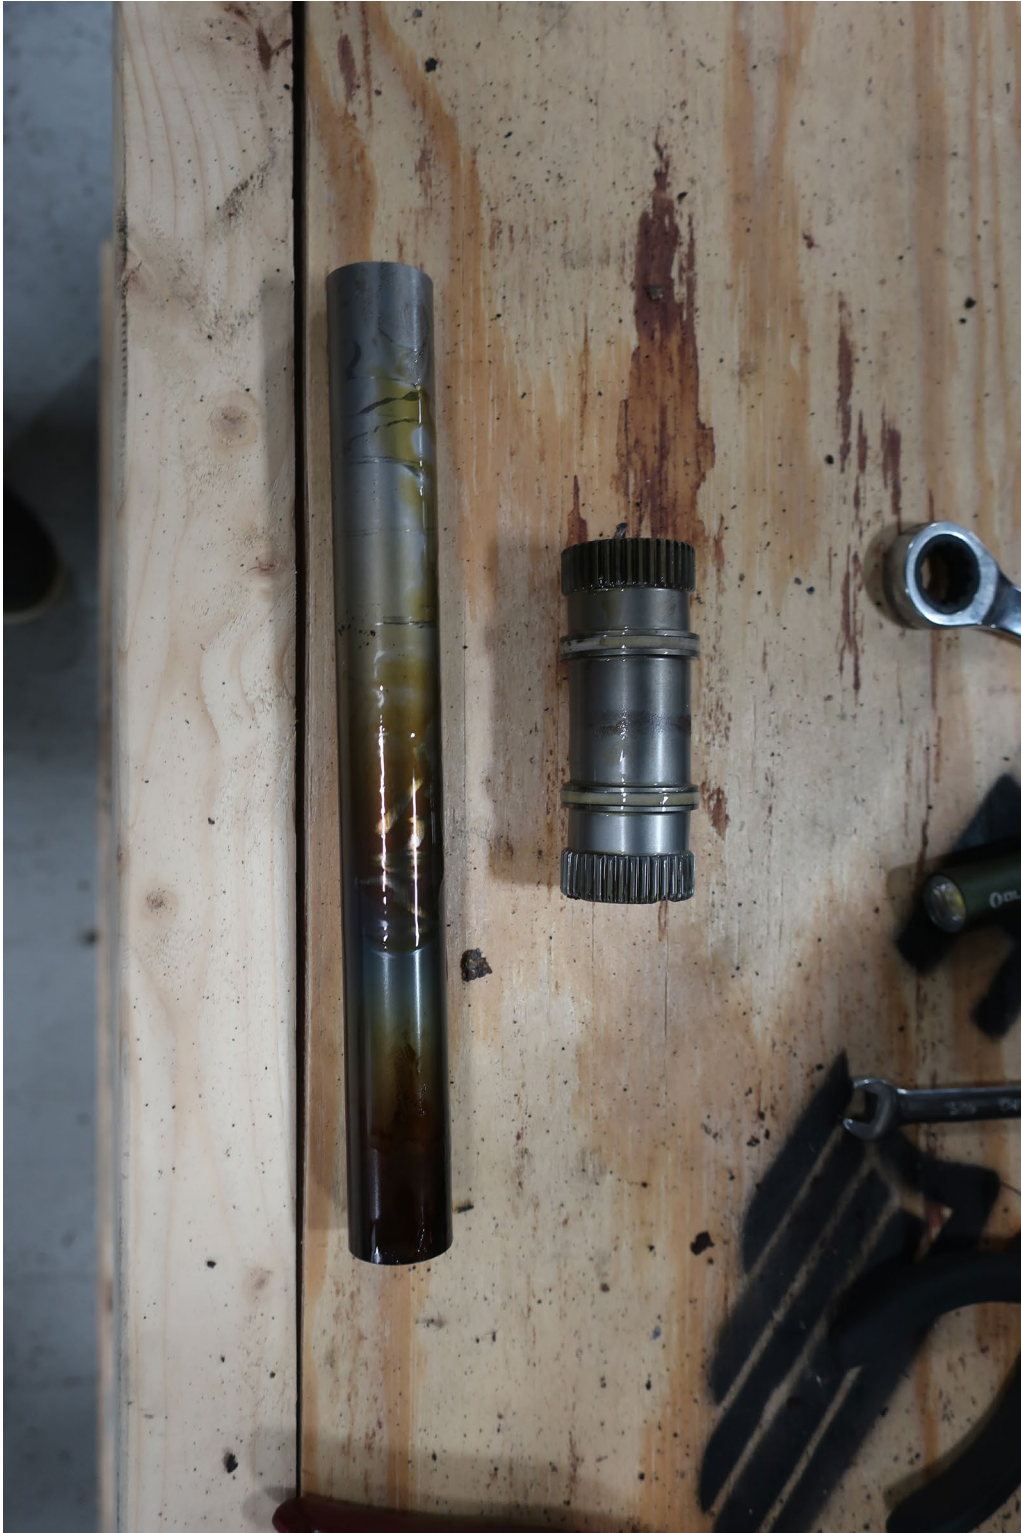
Once the turbine module was removed from the gearbox, the N1 and N2 rotors remained frozen. The N1 and N2 shafts were intact. The N2 shaft was bulged and bent slightly and the N1 shaft displayed slight flaring at the forward end. The power turbine support was removed from the exhaust collector to view the second and third stage turbine wheels and third stage turbine nozzle, which were intact and normal in appearance. The No. 6/7 bearing sump displayed coked oil which was dark in appearance. The fourth stage wheel was observed through the exhaust collector and no missing or fractured blades were noted. The first stage nozzle shield, first stage nozzle, and several first stage blades were viewed via borescope through the combustor with no significant damage noted. The interior of the combustion liner and exterior of the outer combustion case were crushed inward. The Nos. 5 and 6 bearings were intact. The Nos. 7 and 8 bearings were not observed.

**Photo 13: N1 and N2 shafts (Photo Courtesy of Rolls Royce)**

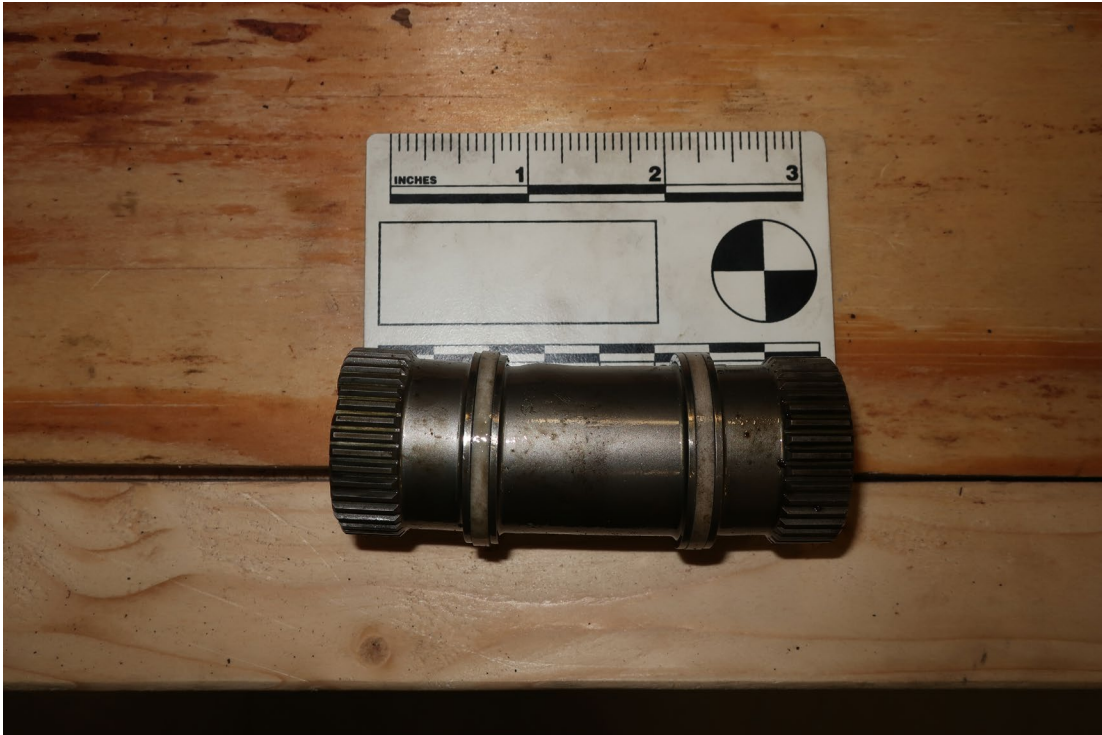
**Photo 14: View of the N2 shaft. (Photo Courtesy of Rolls Royce)**

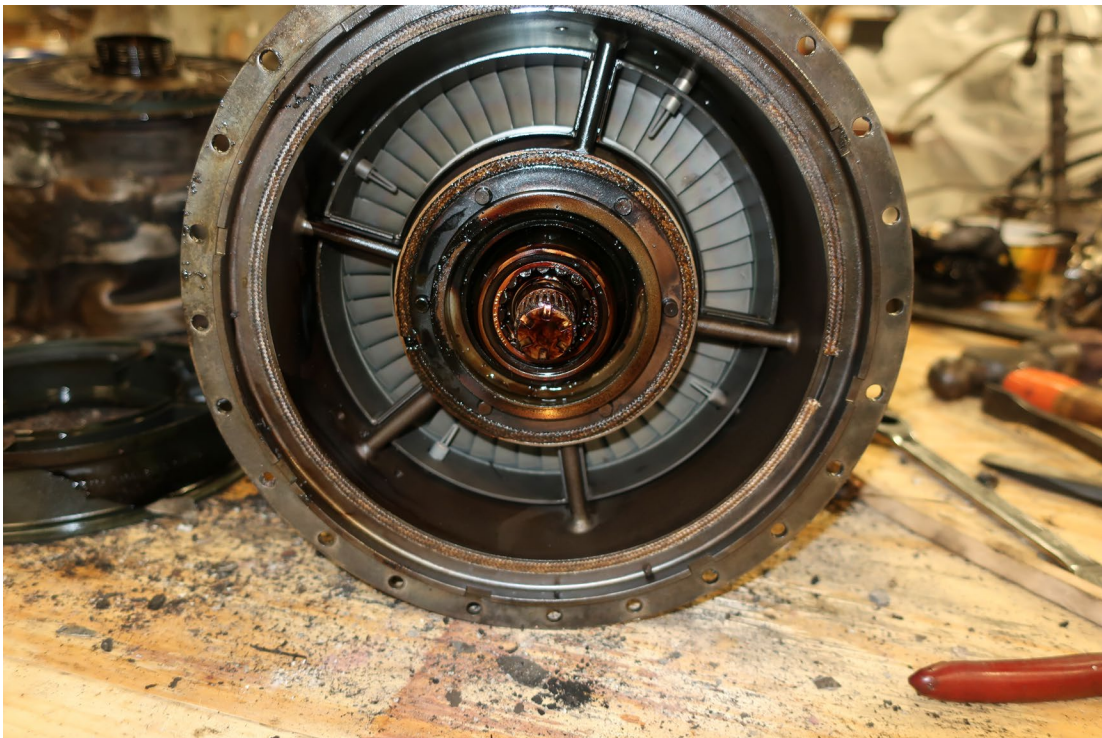
**Photo 15: View of the turbine section. (Photo Courtesy of Rolls Royce)**

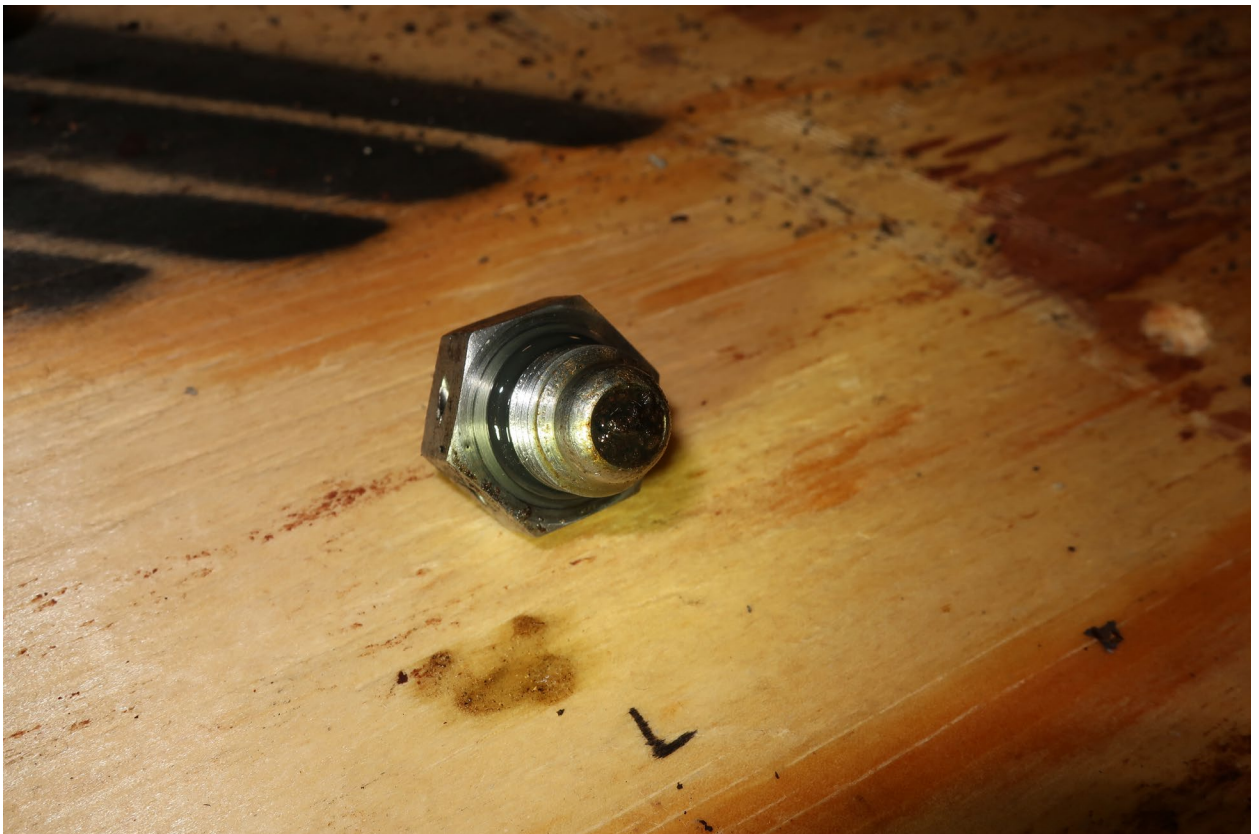
The left trunnion mount was fractured from the housing, leaving a hole in the case. Once the turbine was removed, the N2 geartrain was continuous and turned slightly. The gearbox N1 train was locked. The upper and propeller Magnetic Chip Detectors (MCD) were clean while the lower MCD tip displayed minimal non-ferrous brown debris. Visual observation of the geartrains through the turbine bore revealed no anomalies. The gearbox was not disassembled.

**Photo 16: View of the lower MCD. (Photo Courtesy of Rolls Royce)**

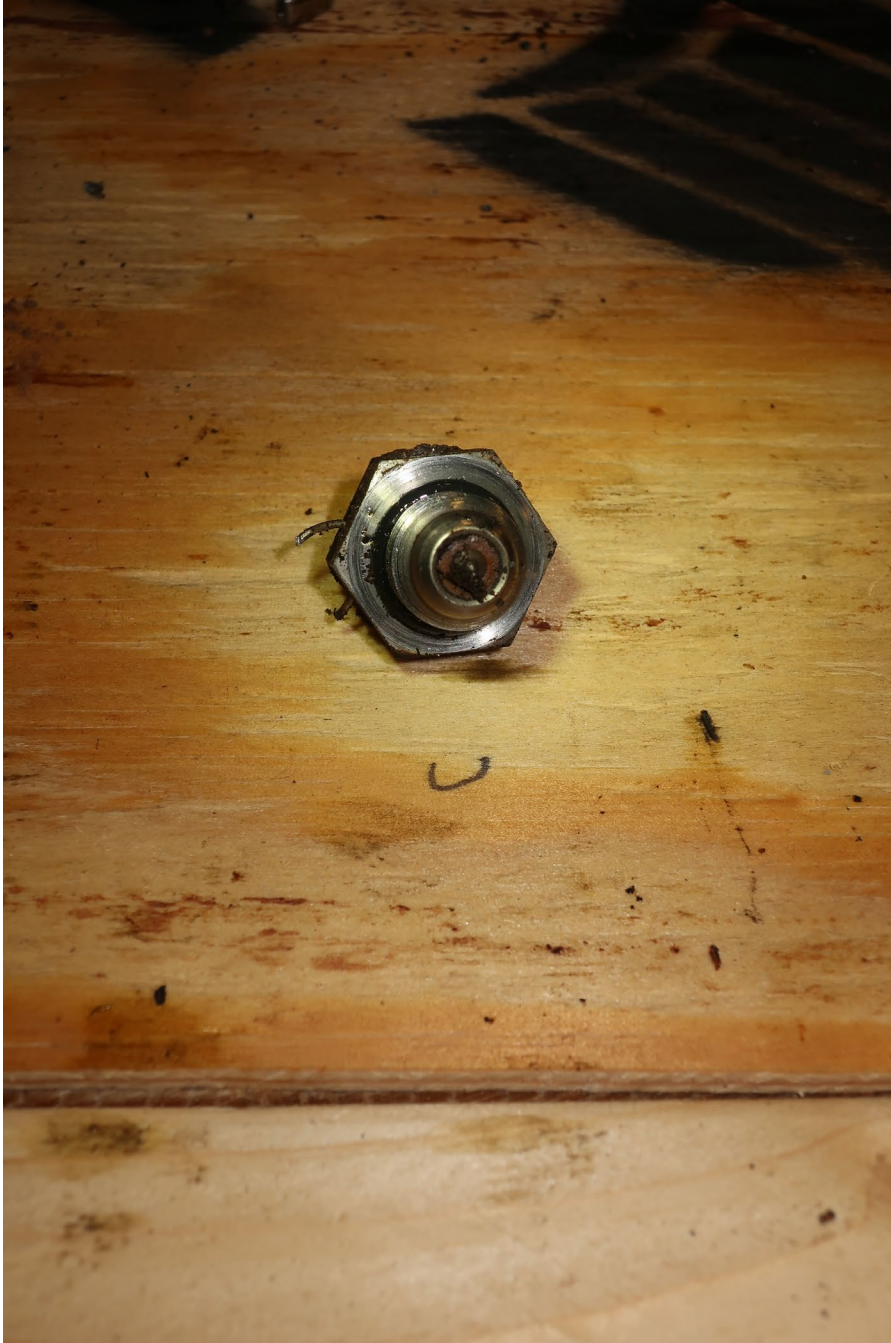
**Photo 17: View of the upper MCD. (Photo Courtesy of Rolls Royce)**

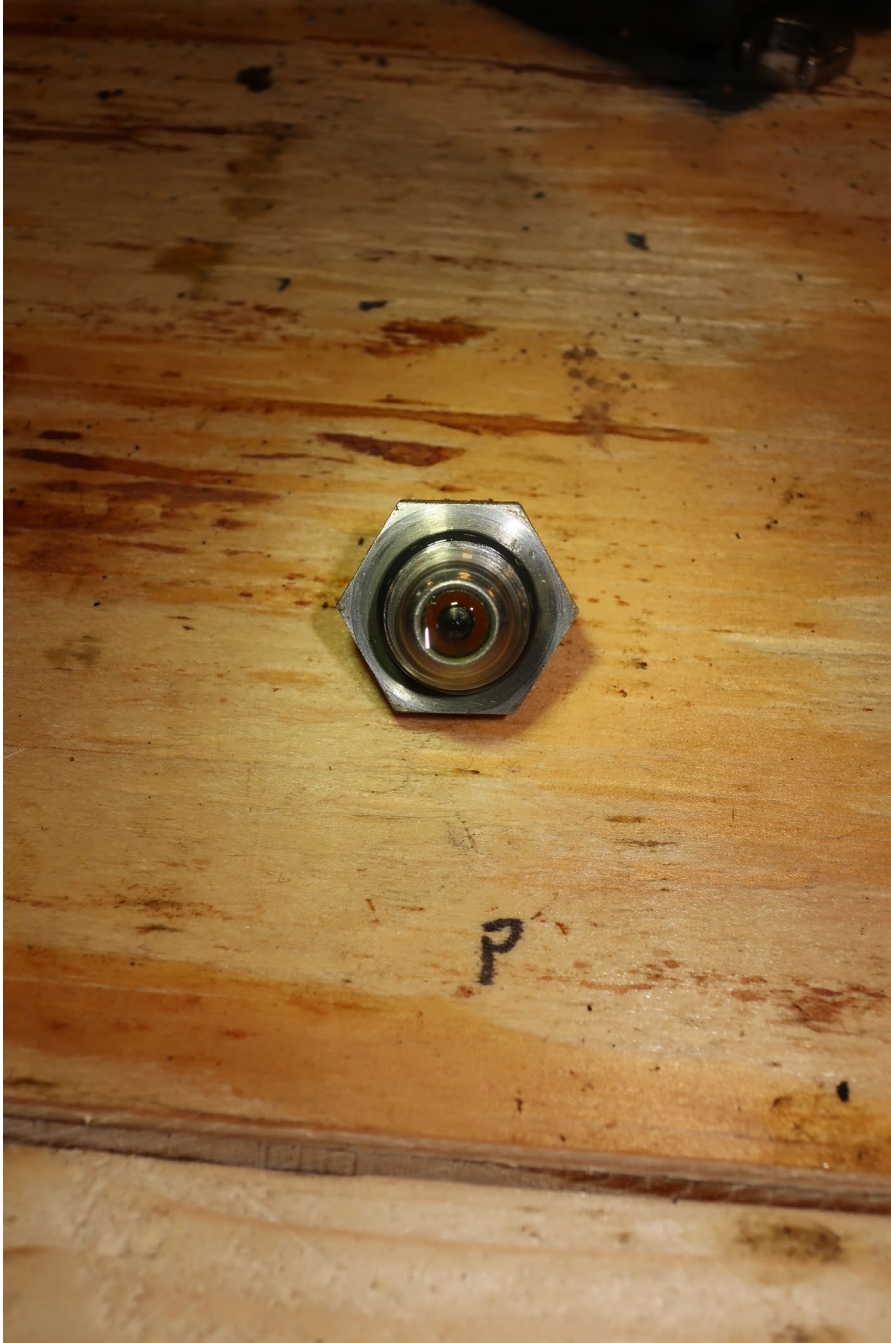
**Photo 18: View of the propeller MCD. (Photo Courtesy of Rolls Royce)**

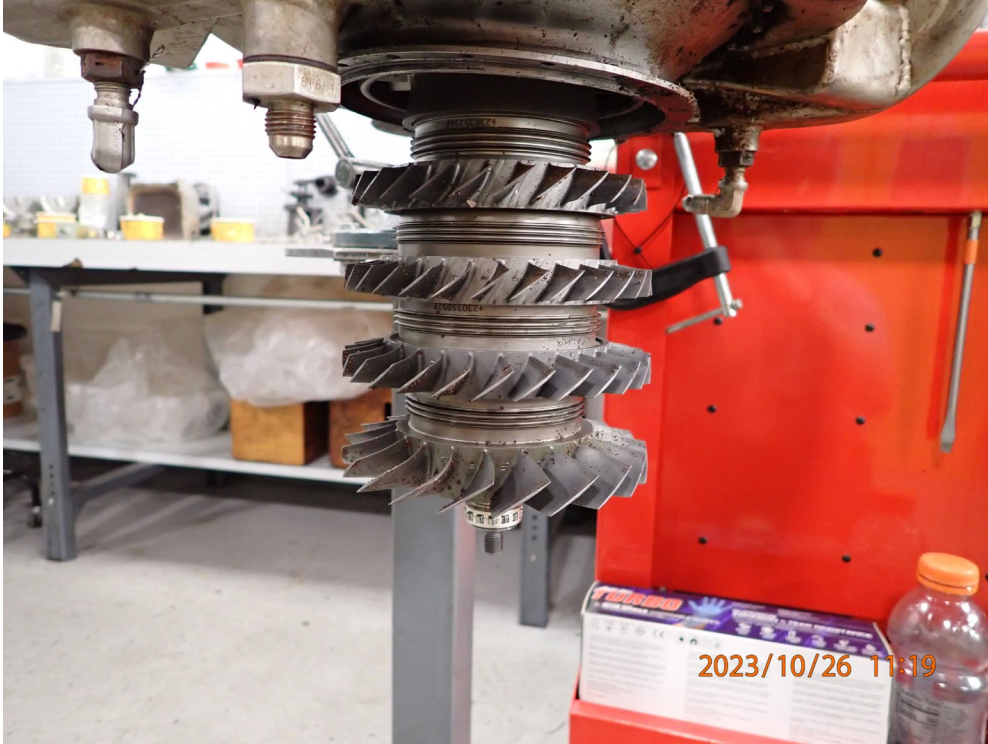
The compressor was completely disassembled. There was no obvious Foreign Object Damage (FOD) noted on the compressor inlet or first stage blades. The compressor rotor did not rotate. The No. 1 bearing was normal in appearance, oil wetted, and rotated smoothly. The No. 2 bearing spun freely and was normal in appearance. All the compressor vanes and blades were intact with no significant circumferential rub damage noted on the impeller

**Photo 19: View of the compressor blades.**

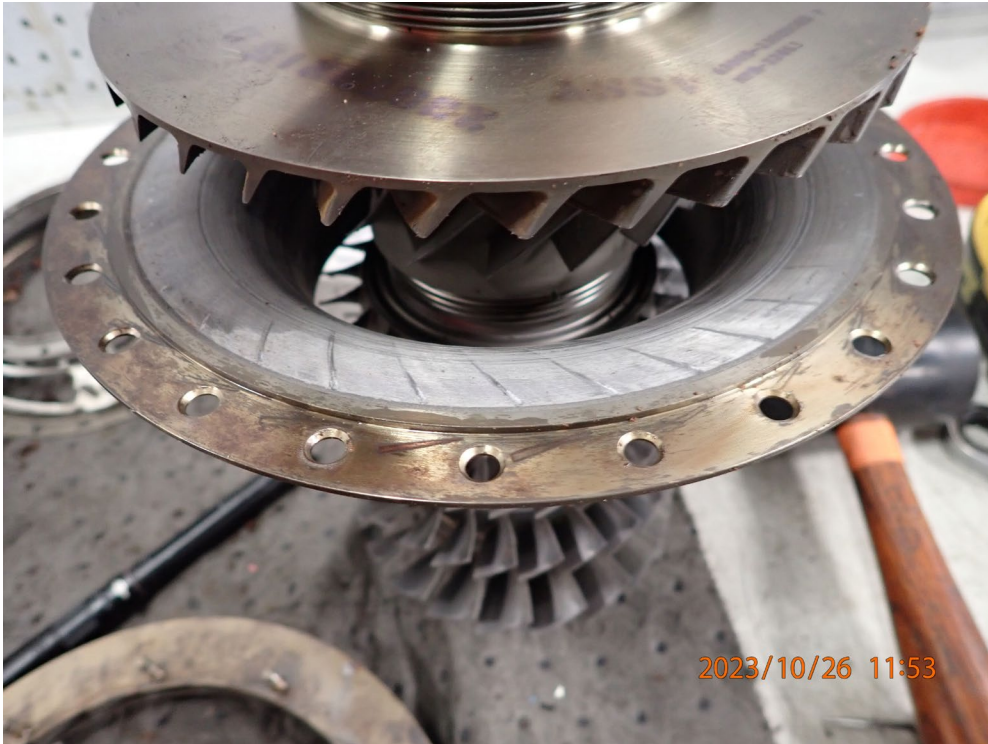
shroud or blade tracks. However, individual gouges were noted on all four stages of compressor blade tracks on the upper case half. Corresponding gouges were noted on a portion of the impeller shroud as well. The spur adapter gearshaft was fractured and bent near the aft splines.

**Photo 20: View of the impeller and impact gouges on the impeller shroud.**

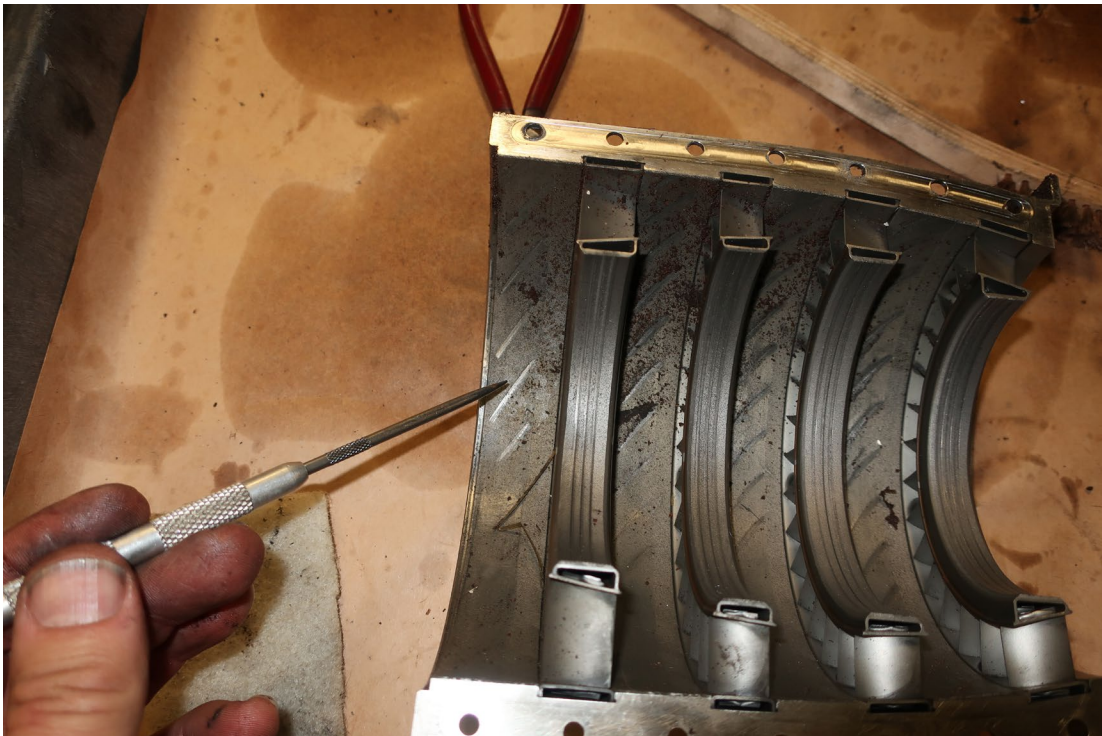
**Photo 21: Individual gouges on the upper case half. (Photo Courtesy of Rolls Royce)**

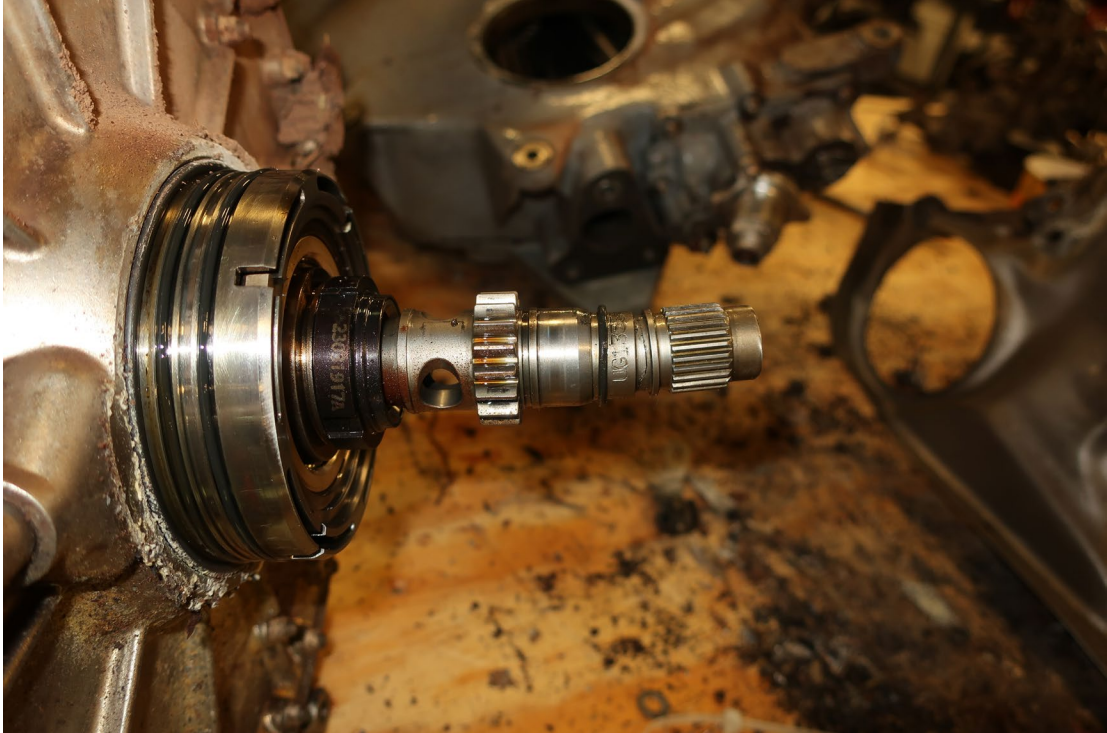
**Photo 22: View of the spur adapter gearshaft (Photo Courtesy of Rolls Royce)**
