# National Transportation Safety Board

ERA23FA330

## **WRECKAGE EXAMINATION**

Location: Junction City, Georgia  
Date: August 10, 2023  
Time: 1005 EDT  
1405 UTC  
Airplane: Cessna P210N; N210JT

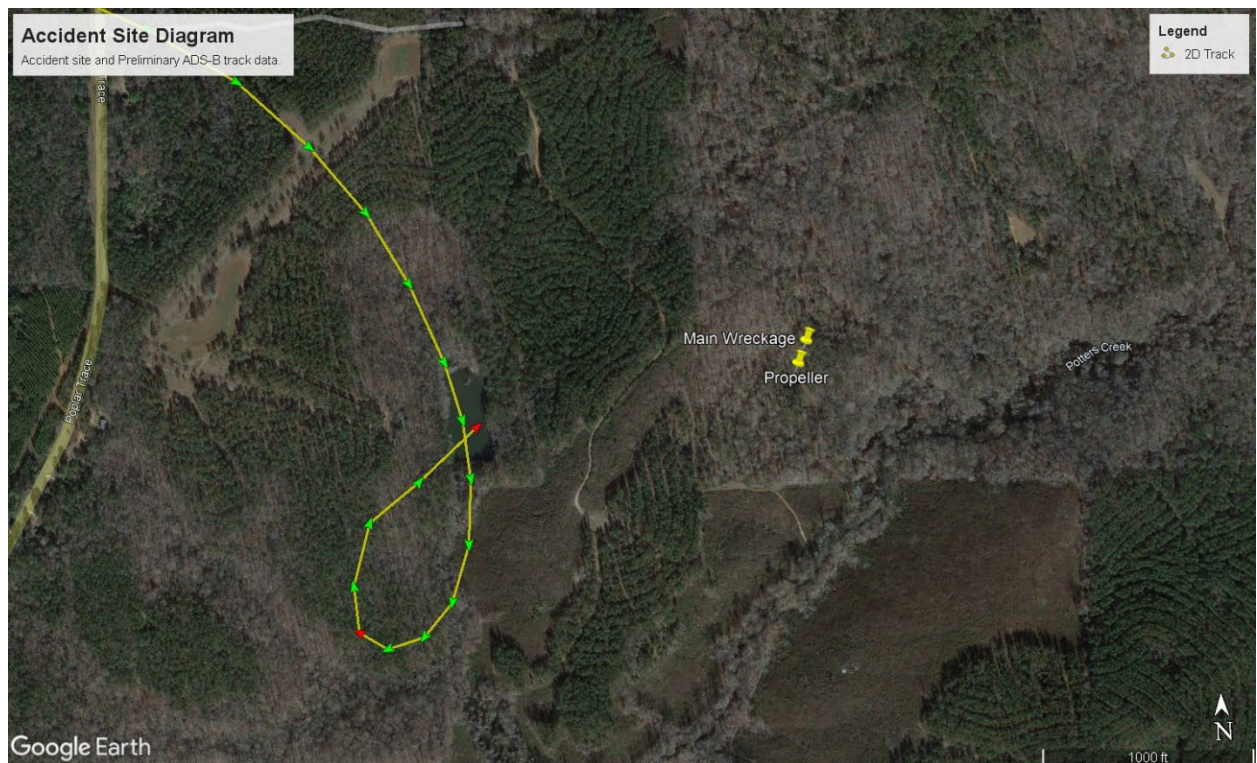
**Photo 1: Accident site diagram with ADS-b track data.**

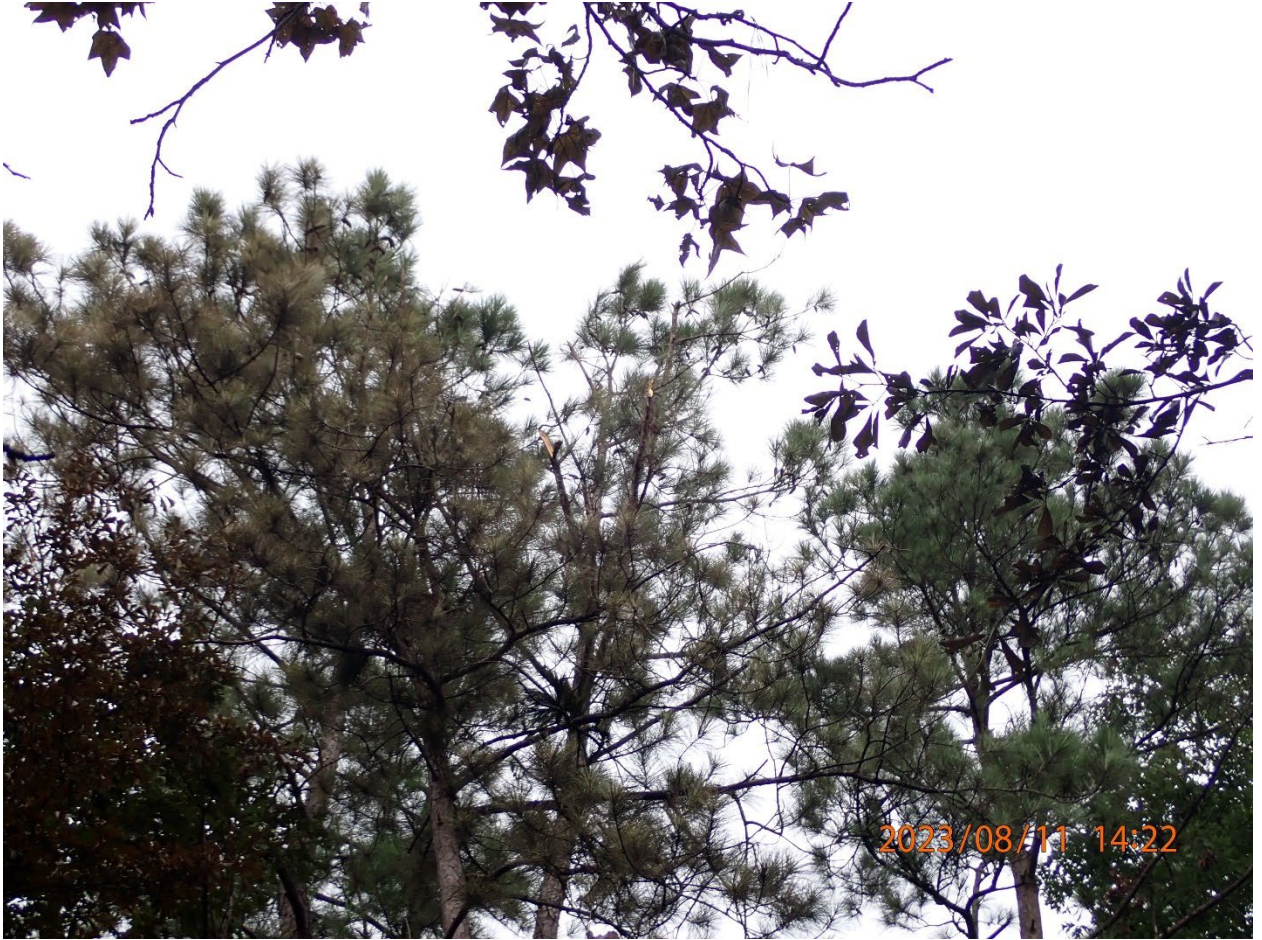
The main wreckage of the airplane came to rest on a heading of about 179° and an elevation of about 575 ft mean sea level in a heavily wooded area. There were multiple trees that exhibited impact damage from the airplane concurrent with a near vertical impact. The final tree impact was collocated with the remaining tail section of the wreckage and the top of the tree was fractured about 40 ft up from the base.

**Photo 2: View of tree impacts.**

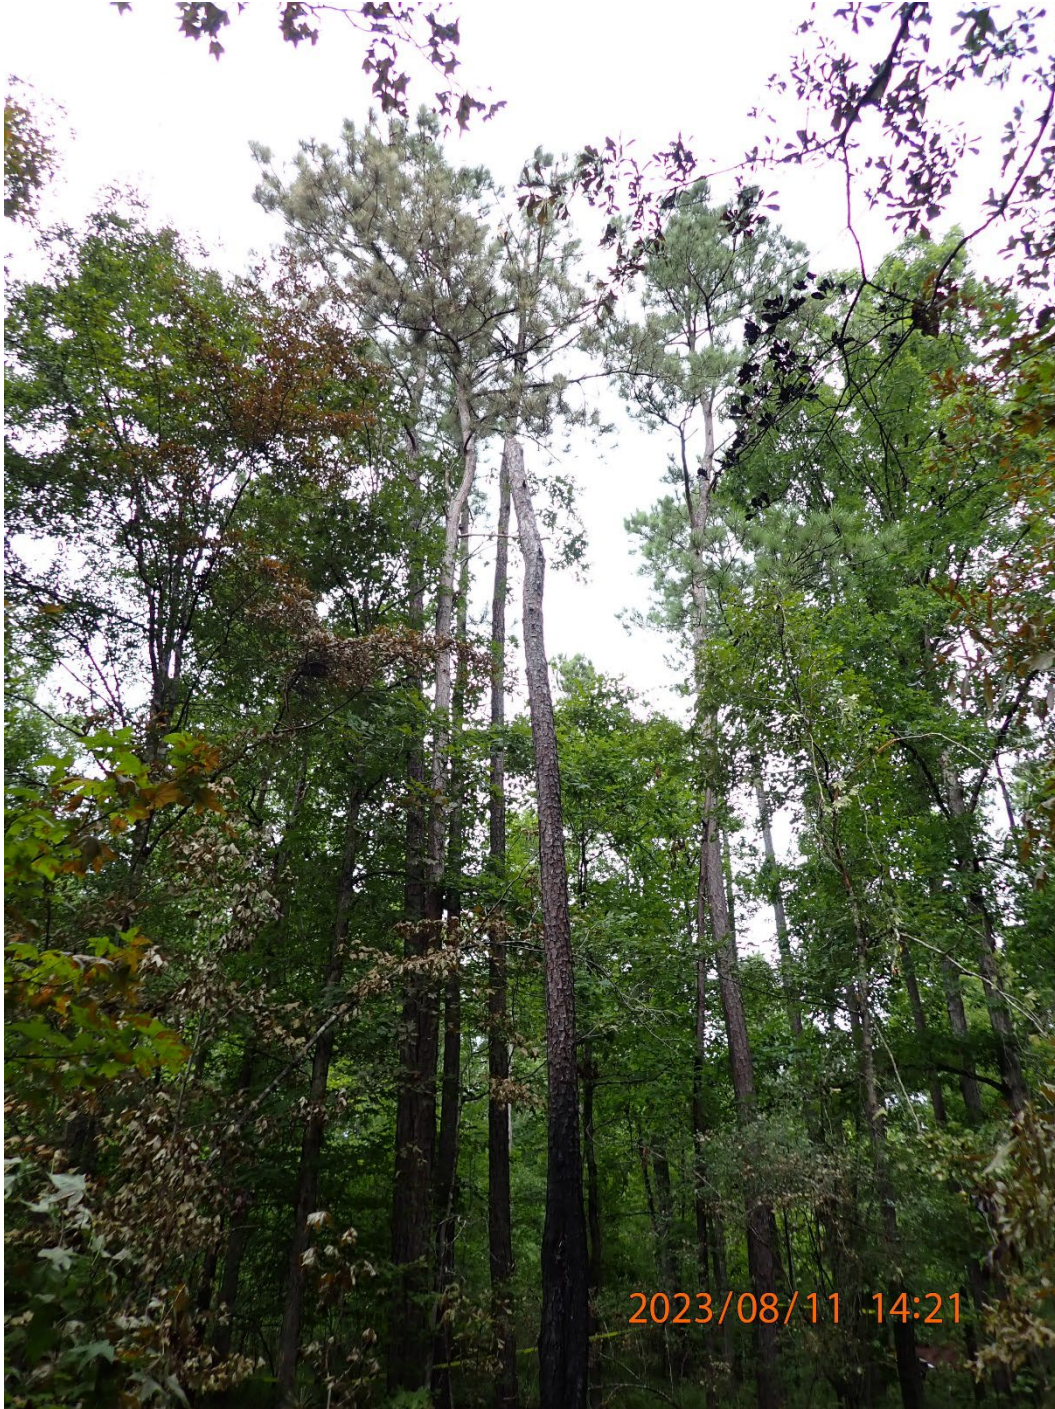
**Photo 3: Final impact tree.**

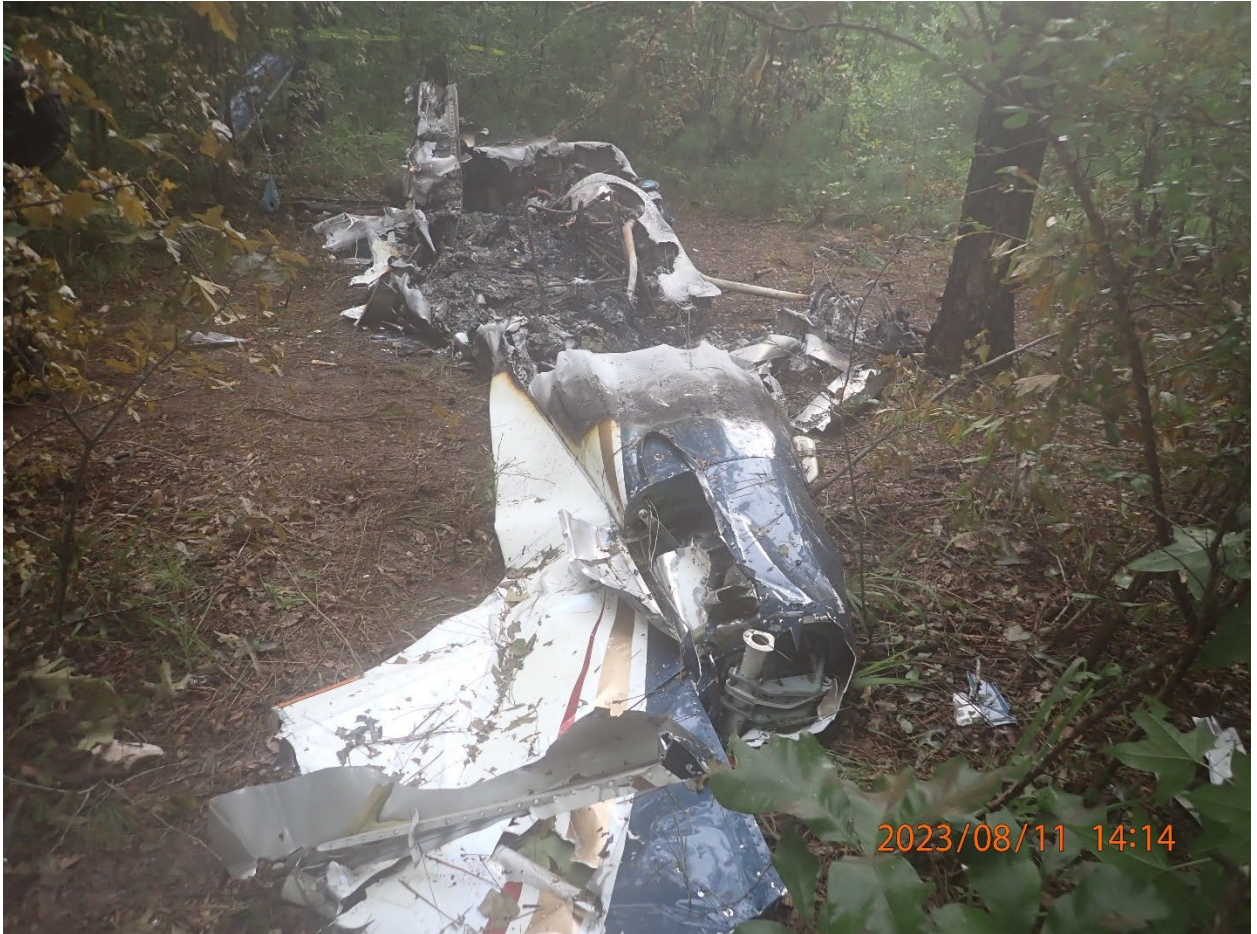
A majority of the fuselage was consumed by postaccident fire. The airplane was found on scene laying on it's left side and the left side of the fuselage was impact crushed inwards. The right side of the fuselage was destroyed by postaccident fire.

**Photo 4: Main wreckage at the accident site.**

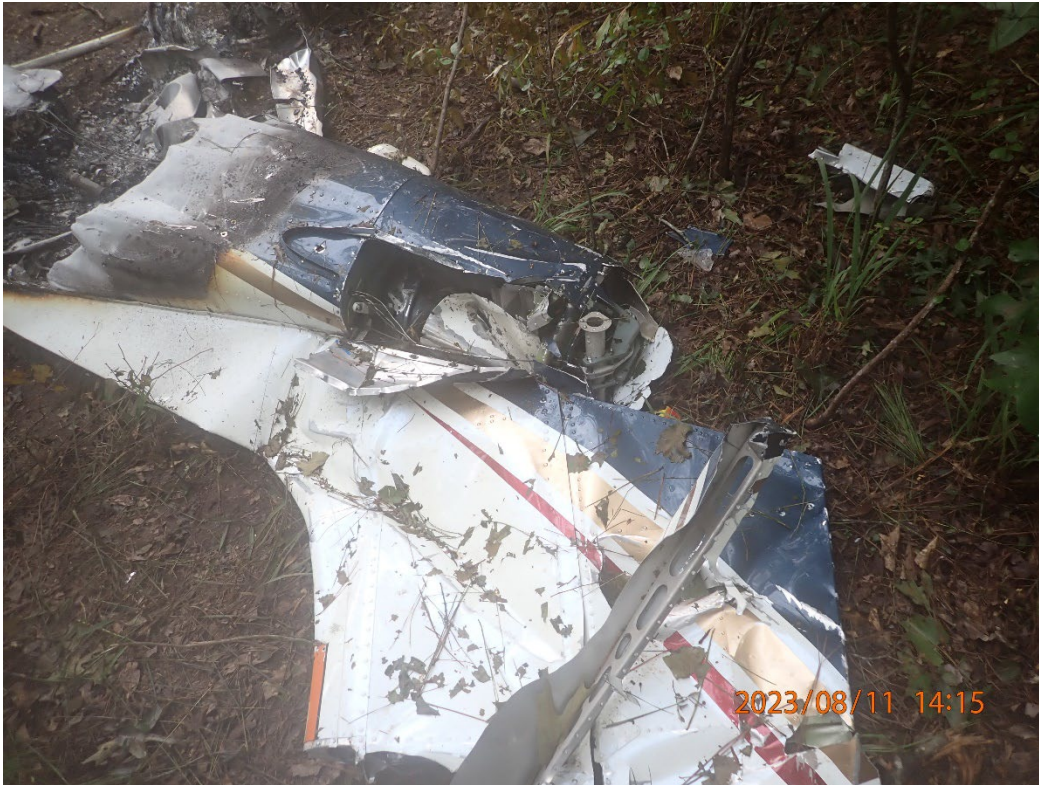
The horizontal stabilizer, elevator, and elevator trim separated from the airplane in flight and was not recovered. The elevator bellcrank remained in place with the cables attached. Elevator control continuity was established from the elevator bellcrank in the tail to the control in the cockpit through cuts made to facilitate recovery. The vertical stabilizer and rudder were separated just above the middle rudder hinge and were not recovered. The aft spar of the vertical stabilizer remained attached to the tail. The remaining vertical

**Photo 5: The empennage at the accident site.**

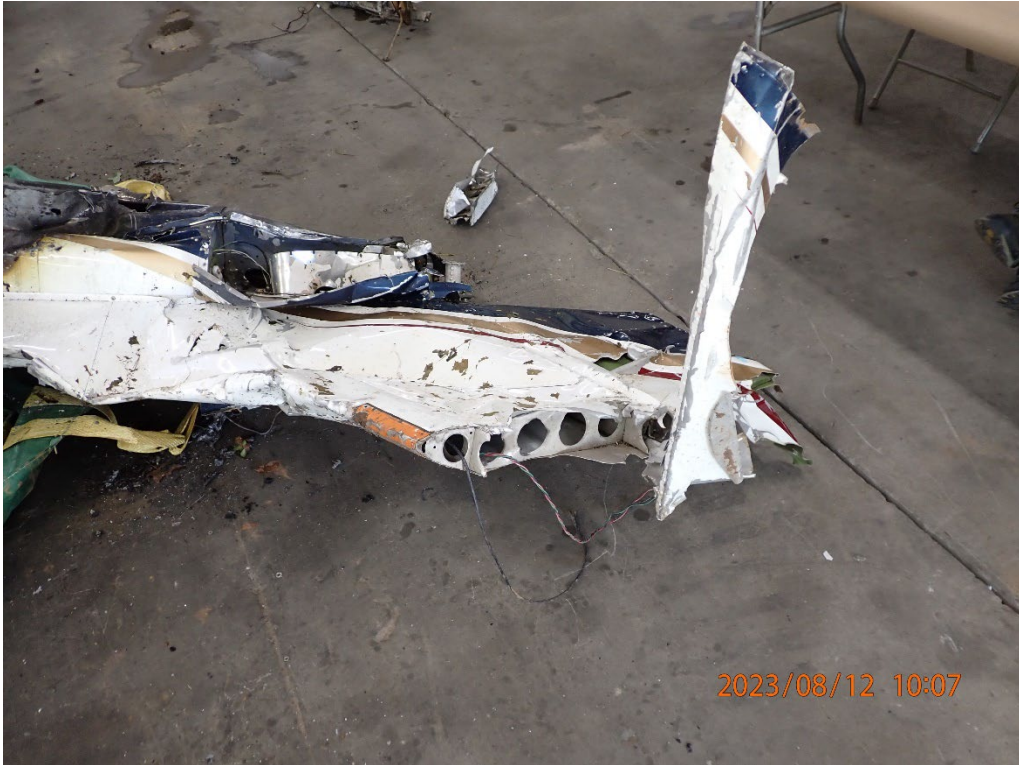
stabilizer and rudder remained attached to the tail. Rudder control continuity was confirmed from the rudder bellcrank to the rudder pedals in the cockpit through cuts made to facilitate recovery.

**Photo 6: View of the vertical stabilizer and rudder at the recovery facility.**

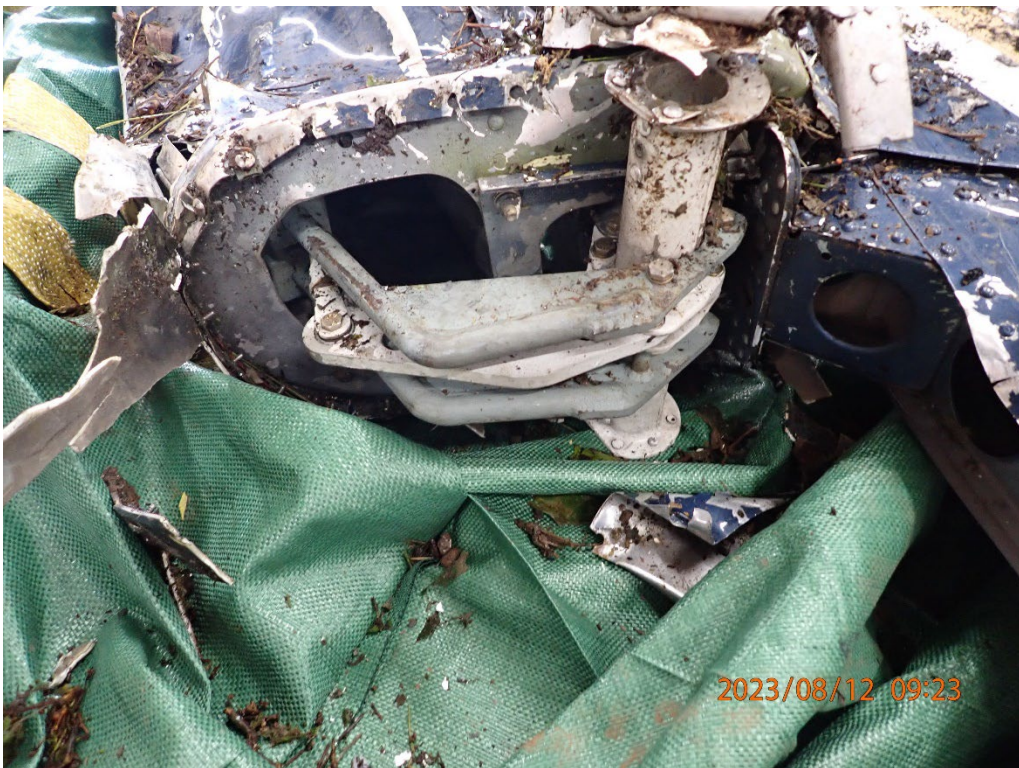
**Photo 7: Elevator bellcrank.**

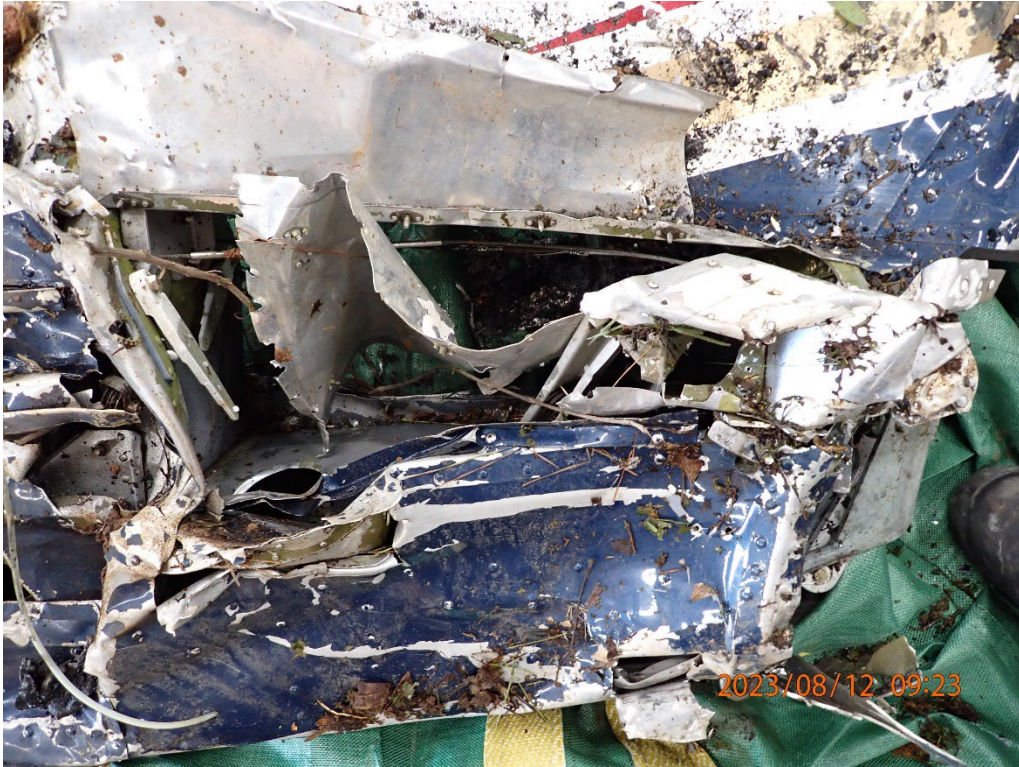
**Photo 8: Left side of the horizontal stabilizer box.**

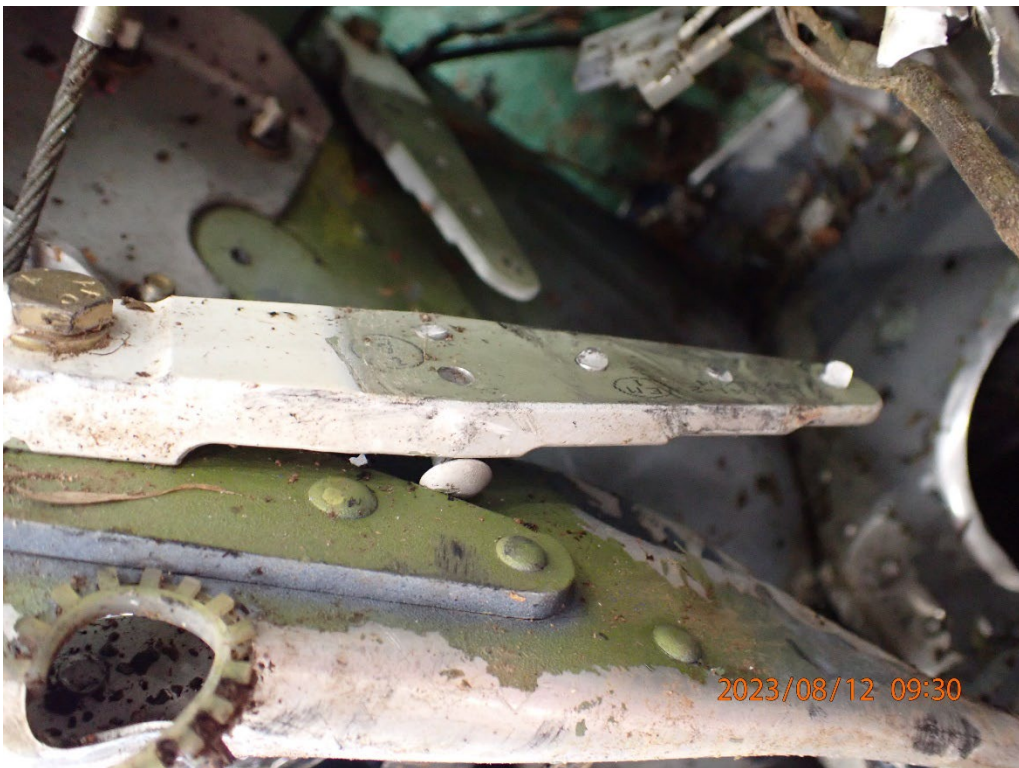
**Photo 9: Horizontal stabilizer forward spar attachment points.**

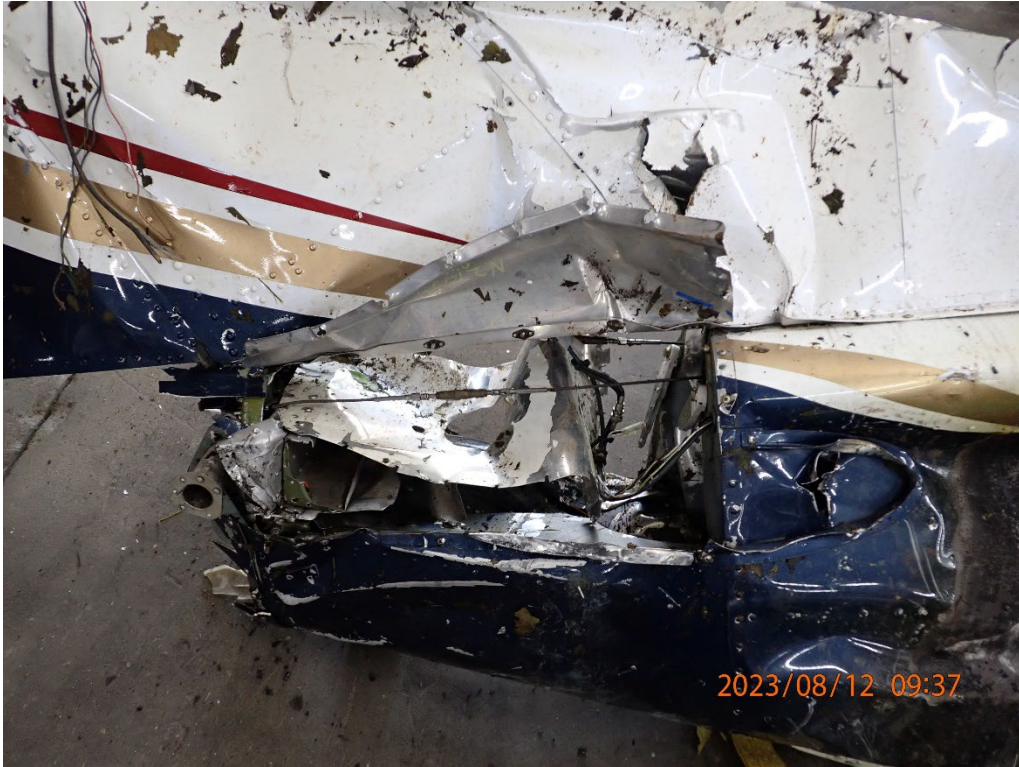
**Photo 10: Right side of the horizontal stabilizer box.**

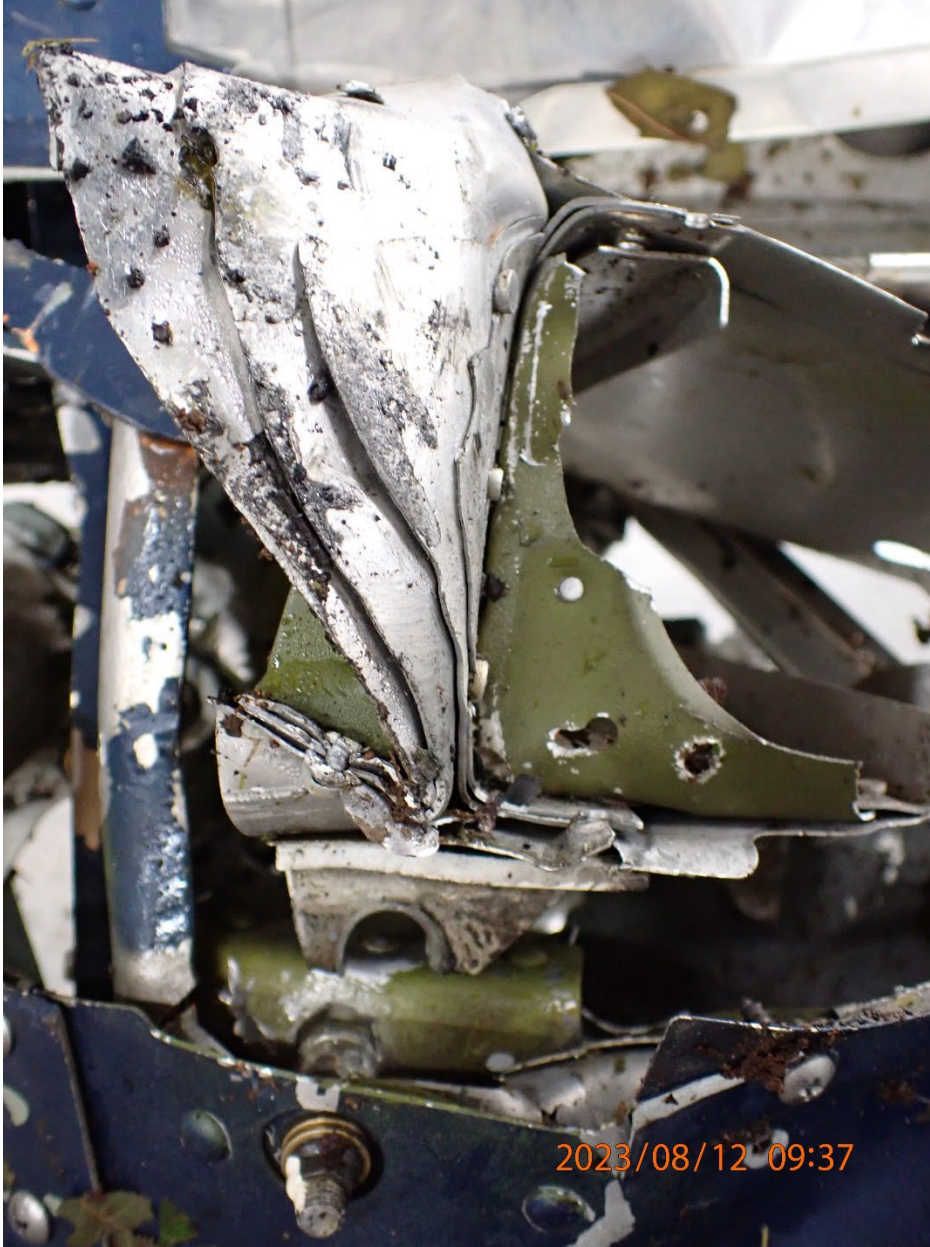
**Photo 11: Aft horizontal stabilizer spar right fracture surface.**

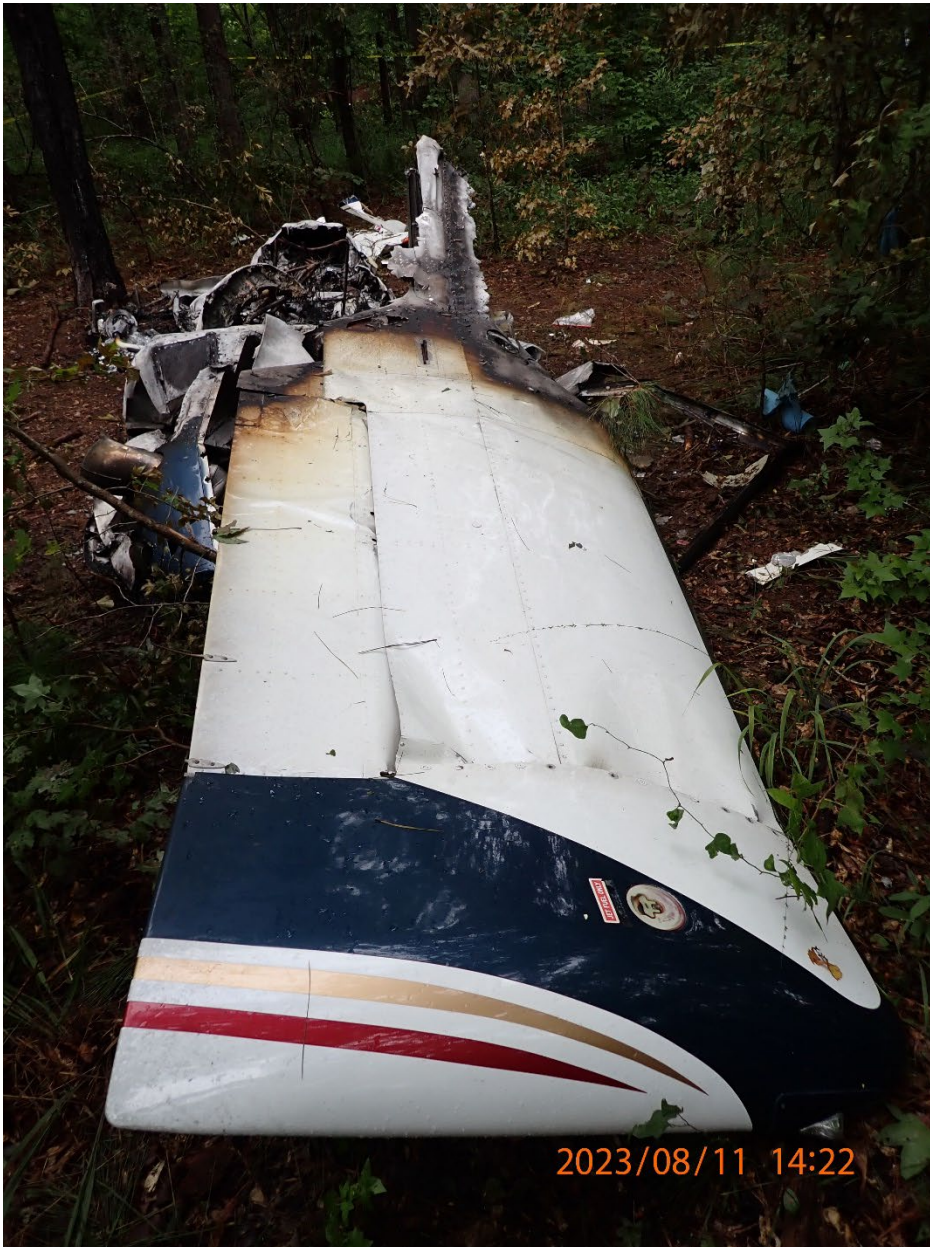
The right wing remained attached to the fuselage and exhibited thermal damage from a postaccident fire. The right aileron remained attached at all attachment points and exhibited thermal damage. Right aileron continuity was confirmed from the control surface to an overload fracture in the forward cabin door post the cable exhibited broom straw and unraveling. The left wing separated in flight and was not recovered. Left aileron direct control cable

**Photo 12: View of the top of the right wing at the accident site.**

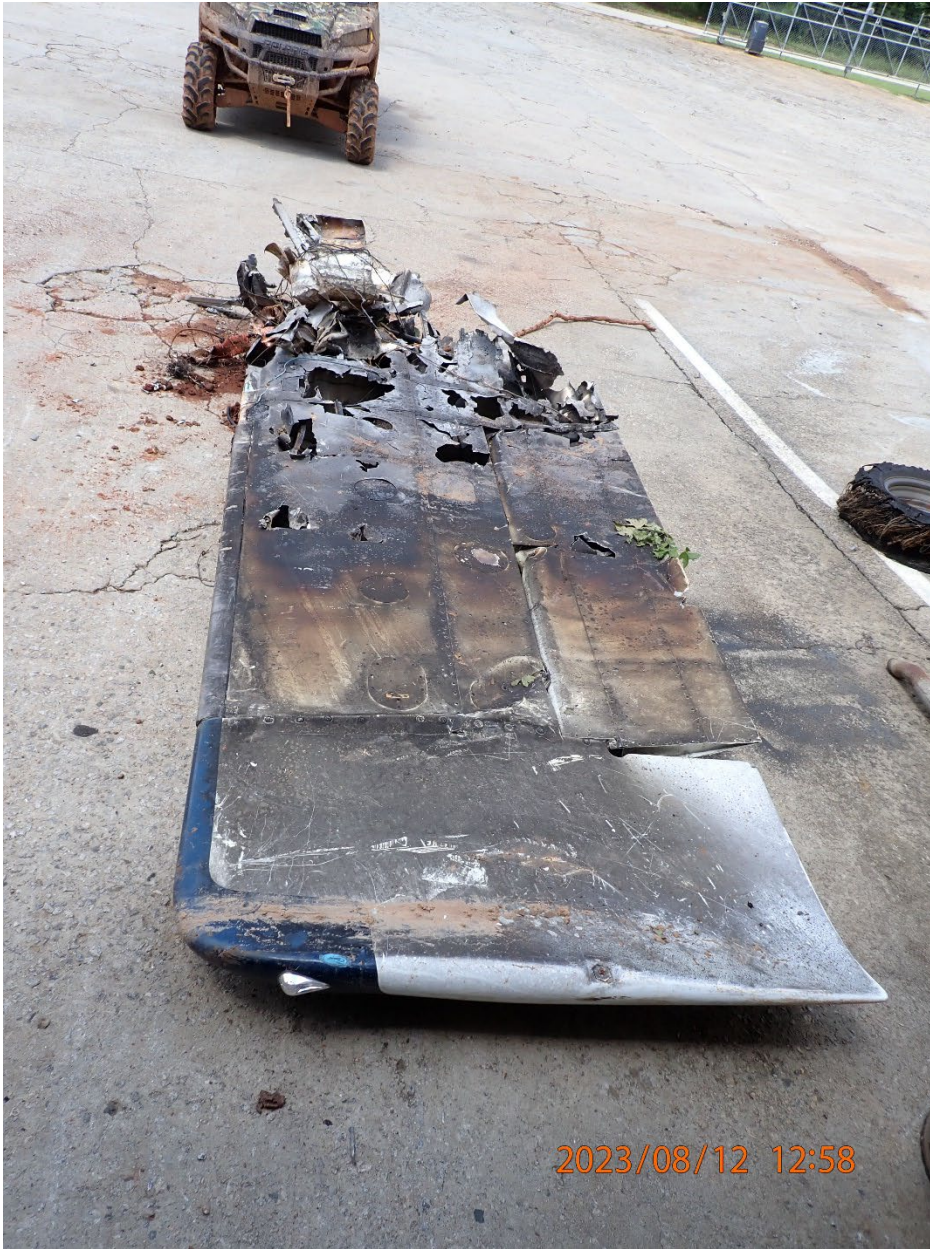
**Photo 13: View of the bottom of the right wing at the recovery facility.**

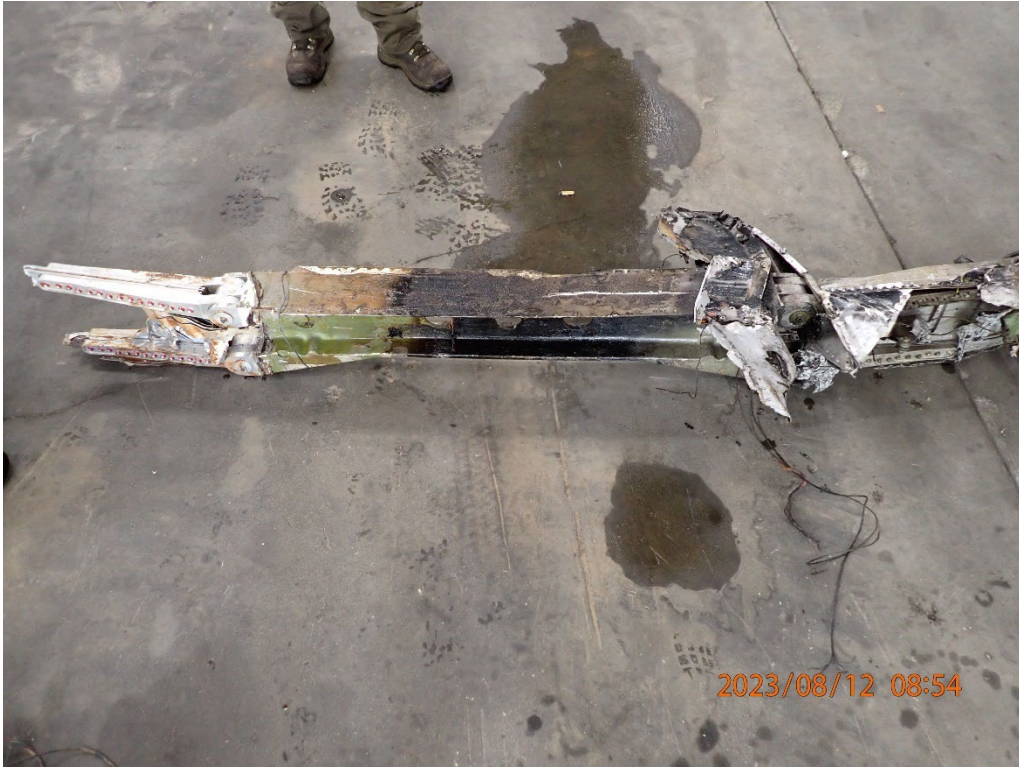
**Photo 14: View of main wing spar.**

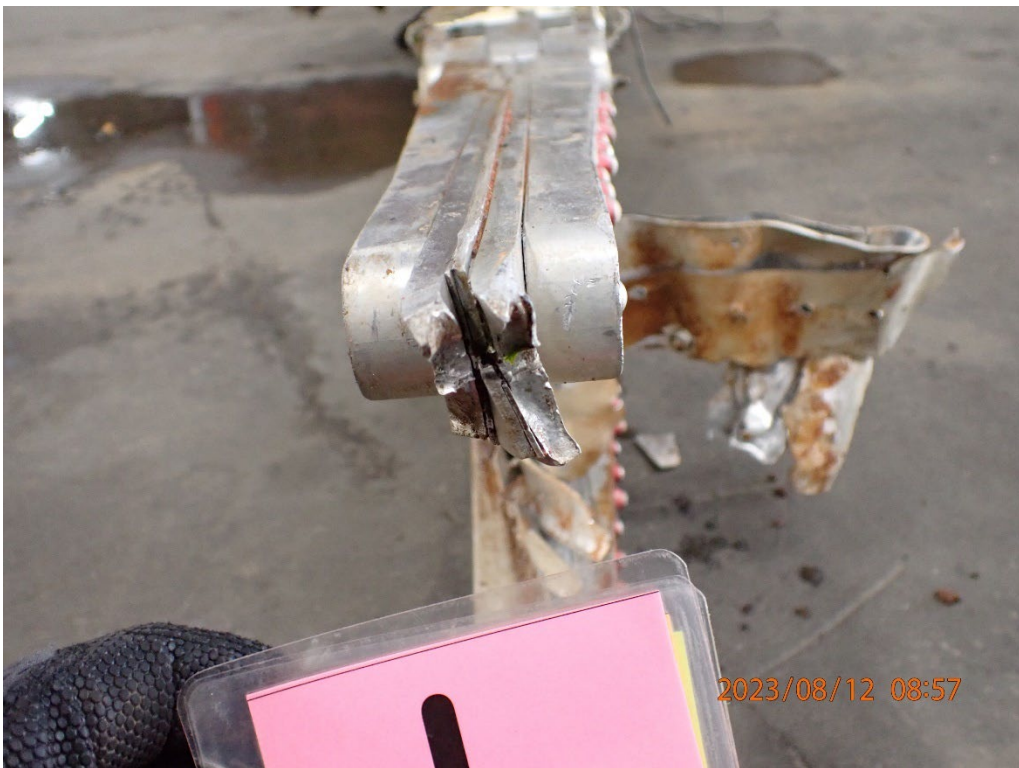
**Photo 15: Top left wing spar cap fracture surface.**

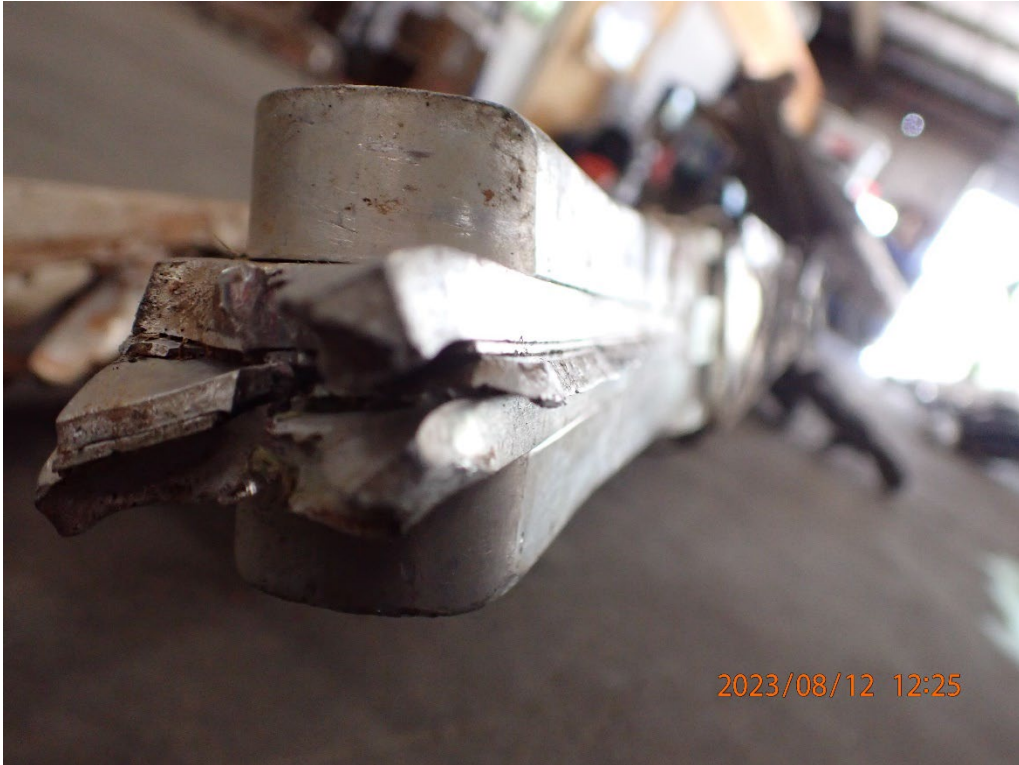
**Photo 16: View of the fracture surface of the top of the left wing spar.**

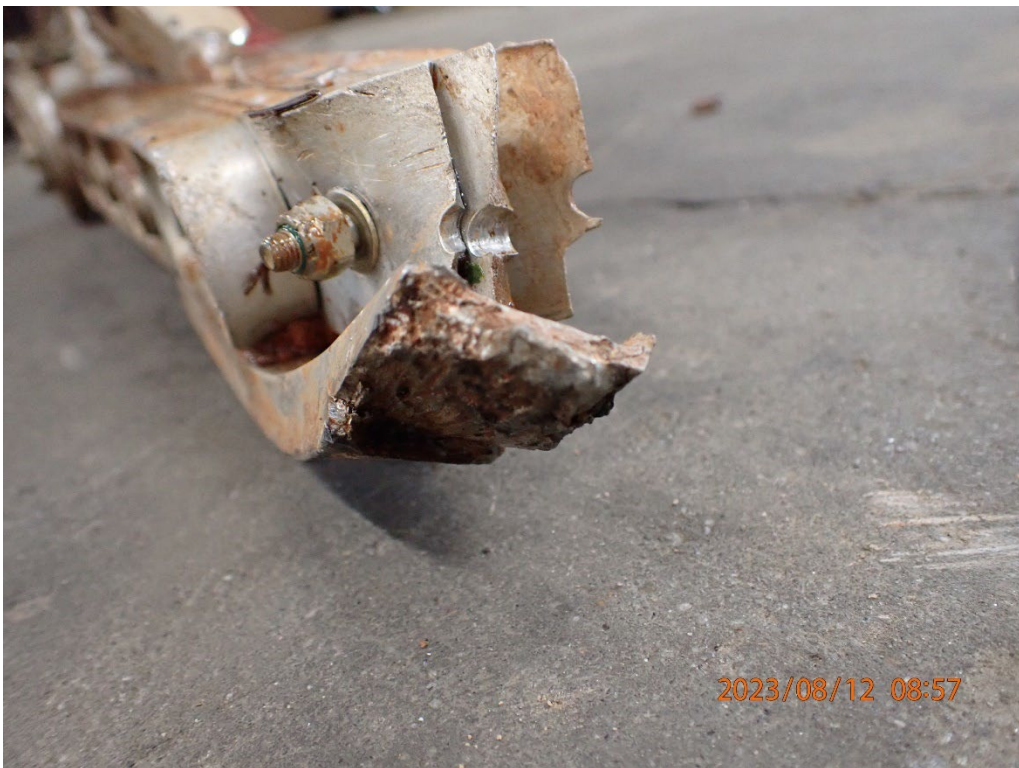
**Photo 17: Bottom left wing spar cap fracture surface.**

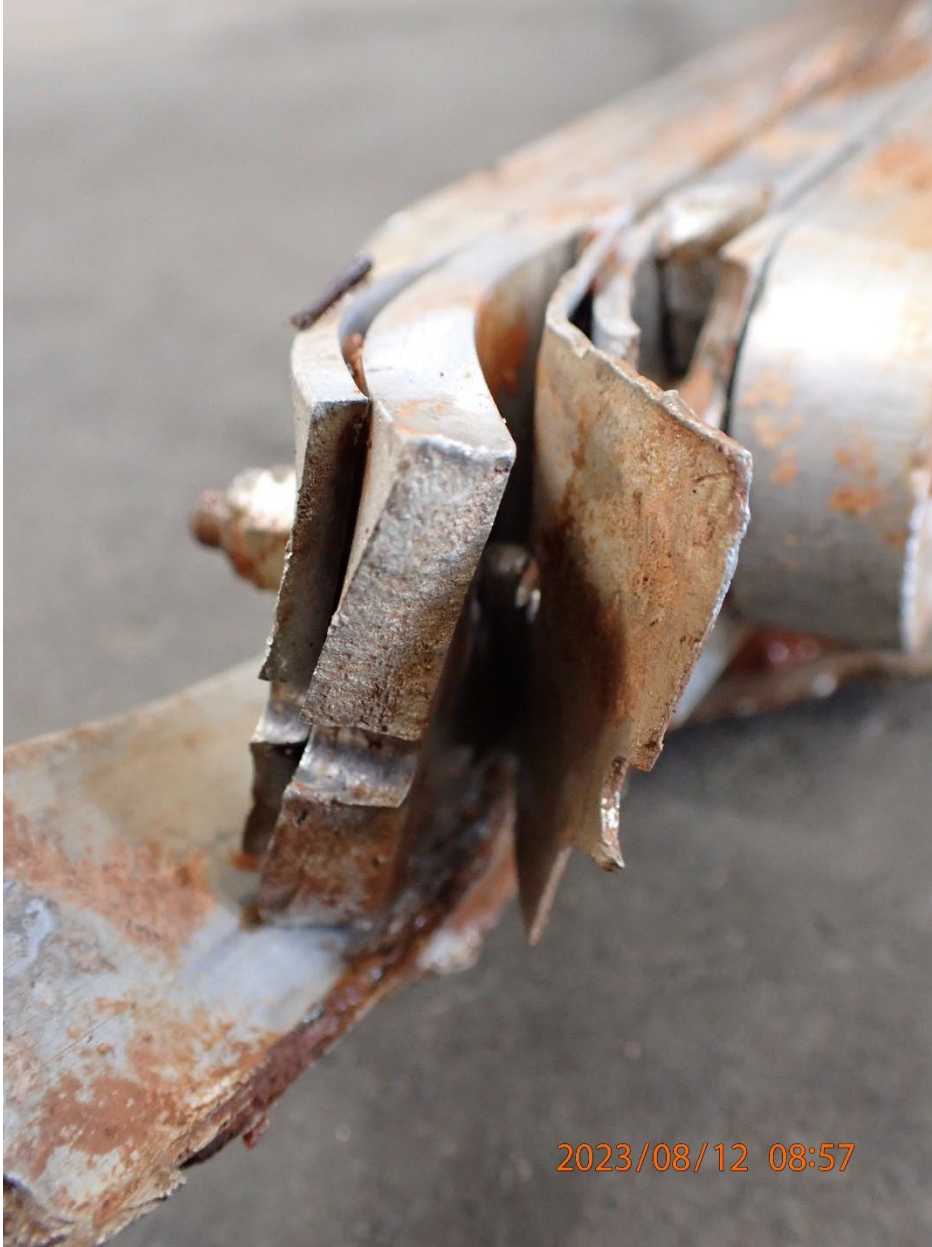
**Photo 18: Bottom left wing spar cap fracture surface.**

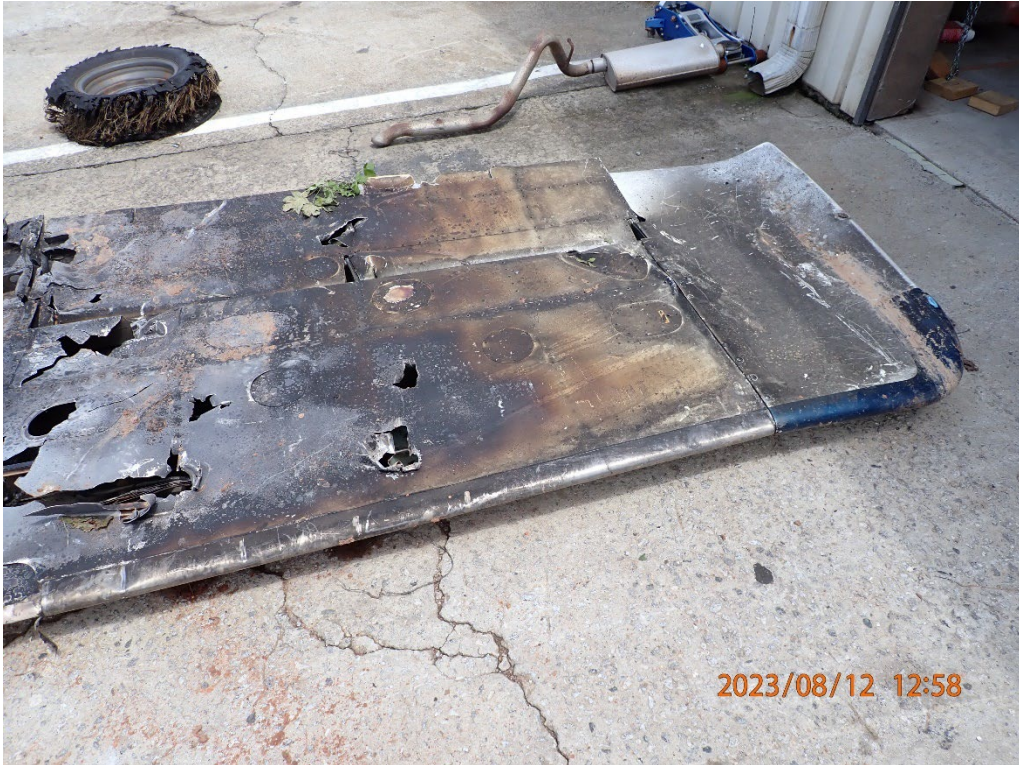
**Photo 19: View of the right aileron.**

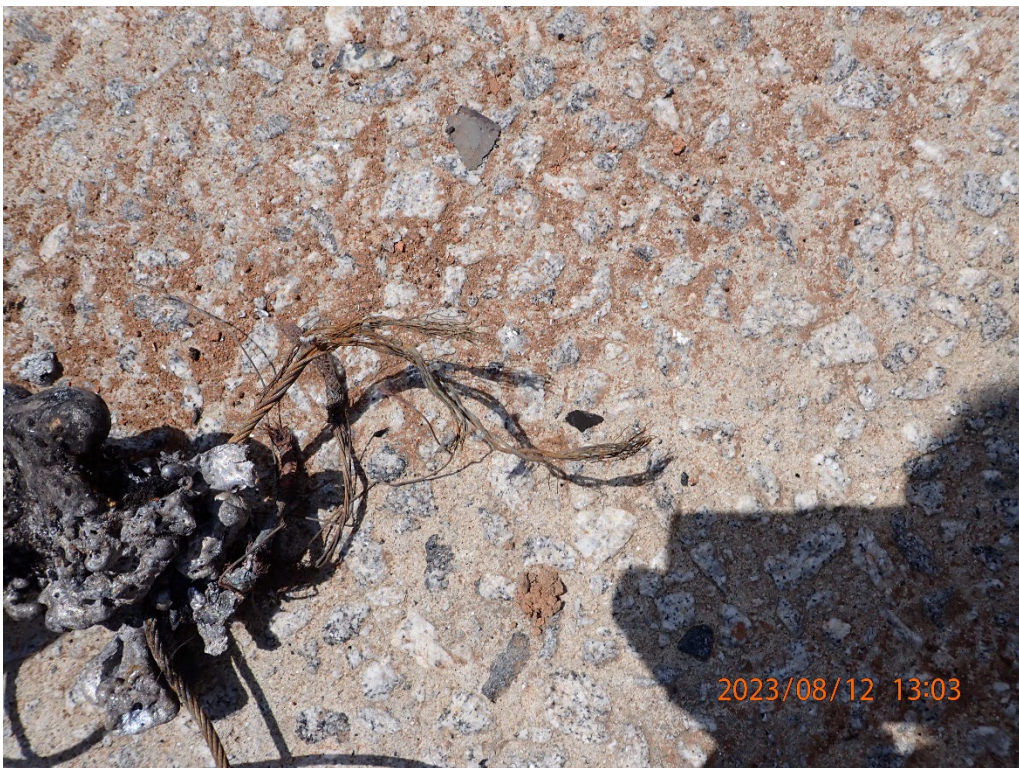
**Photo 20: View of the right aileron direct control cable.**

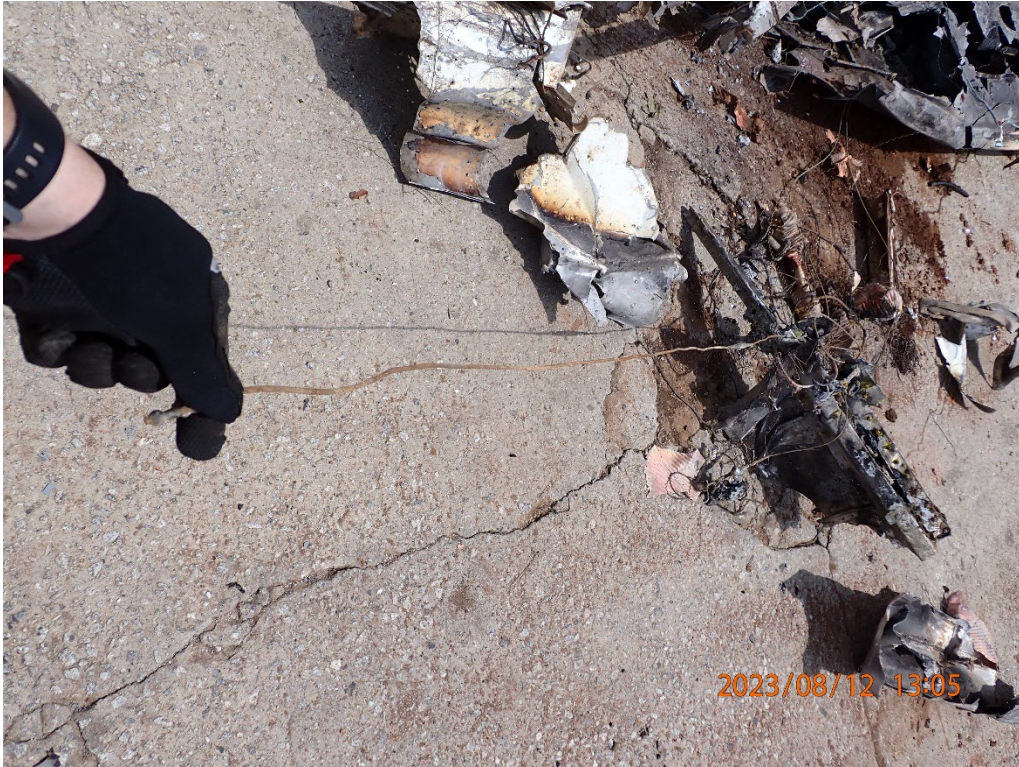
**Photo 21: View of the aileron balance cable.**

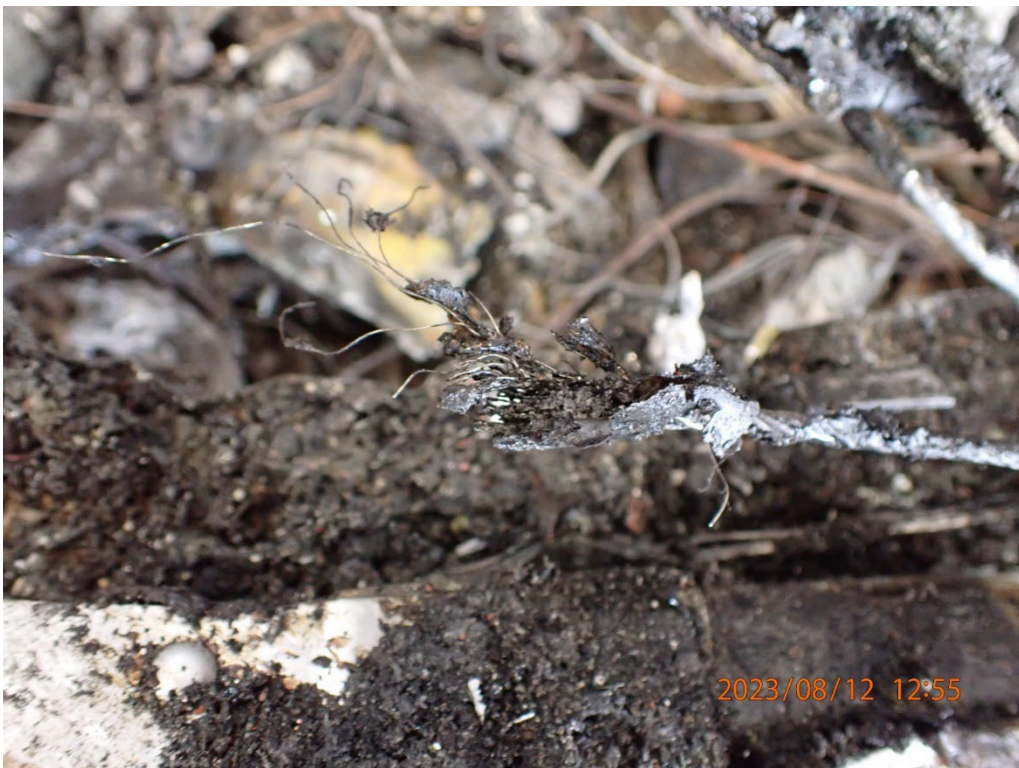
exhibited an overload fracture and broom straw at the forward door post and was continuous into the cabin. The aileron balance cable was continuous from the right aileron bellcrank to the stop which would normally attach to the left aileron bellcrank. The flap actuator was found in the main wreckage and examination of the flap actuator jackscrew showed the flaps were in the up position with a measurement of about 4 ¼ inches. The right flap remained attached to the right wing and exhibited thermal damage.

**Photo 22: View of the left aileron direct control cable.**

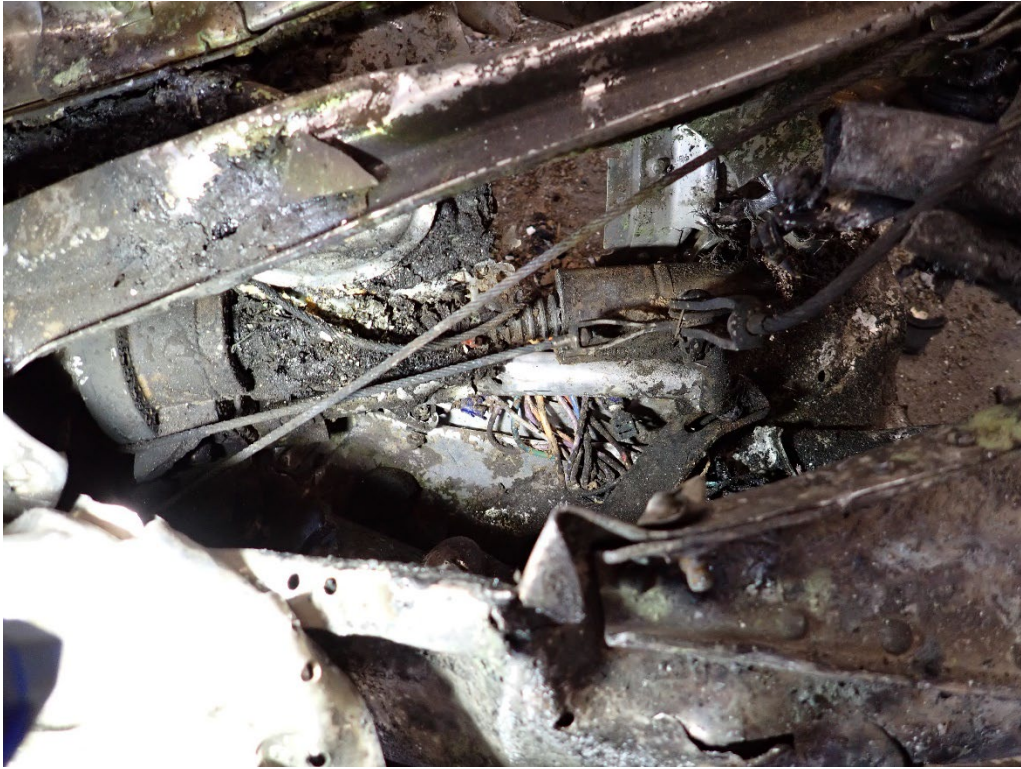
**Photo 23: Flap actuator jackscrew. (Textron Photo)**

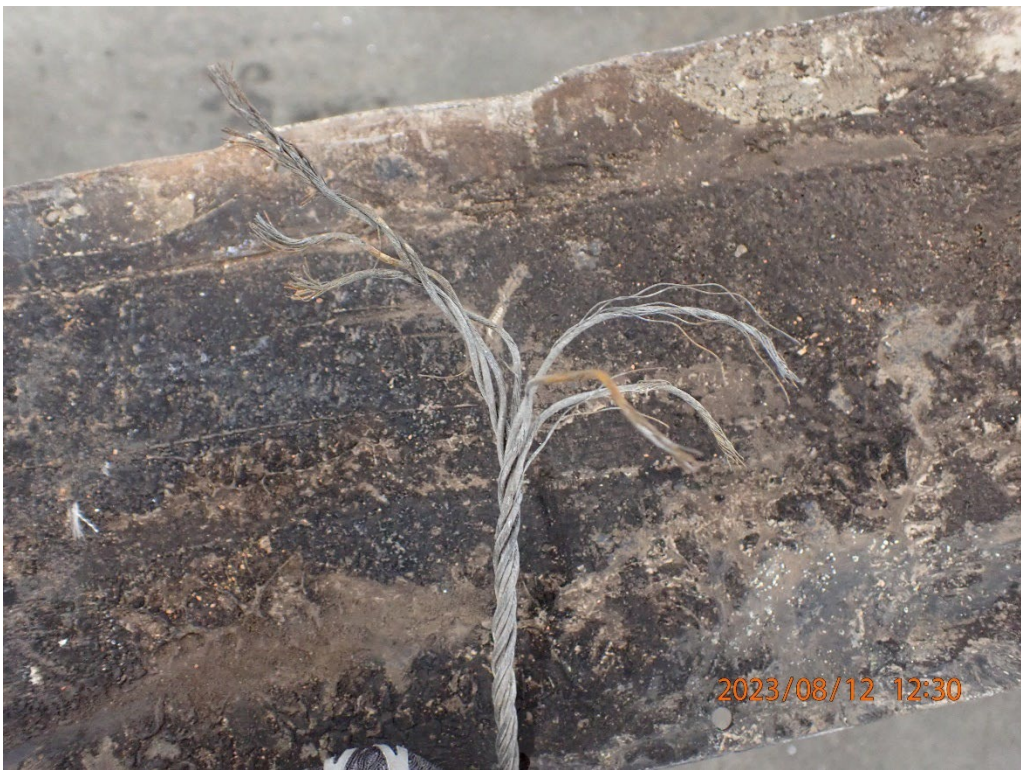
**Photo 24: View of flap control cable to left wing.**
