# National Transportation Safety Board

ERA23FA330

## **WRECKAGE EXAMINATION**

Location: Junction City, Georgia  
Date: August 10, 2023  
Time: 1005 EDT  
1405 UTC  
Airplane: Cessna P210N; N210JT

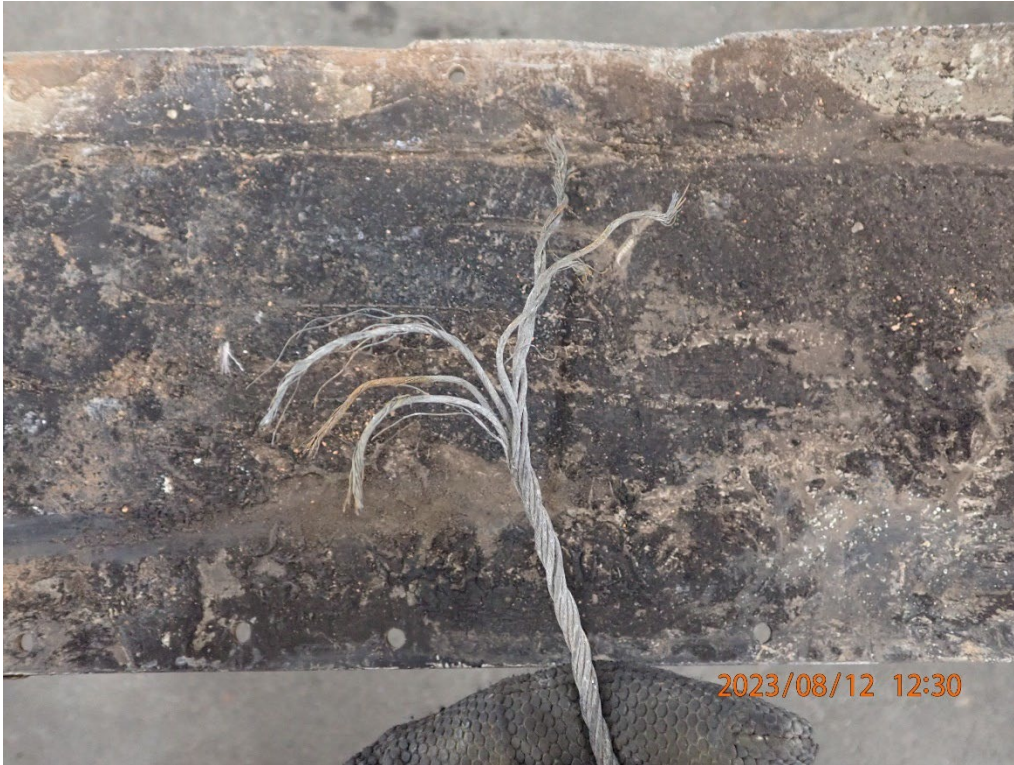
**Photo 25: View of flap control cable to left wing.**

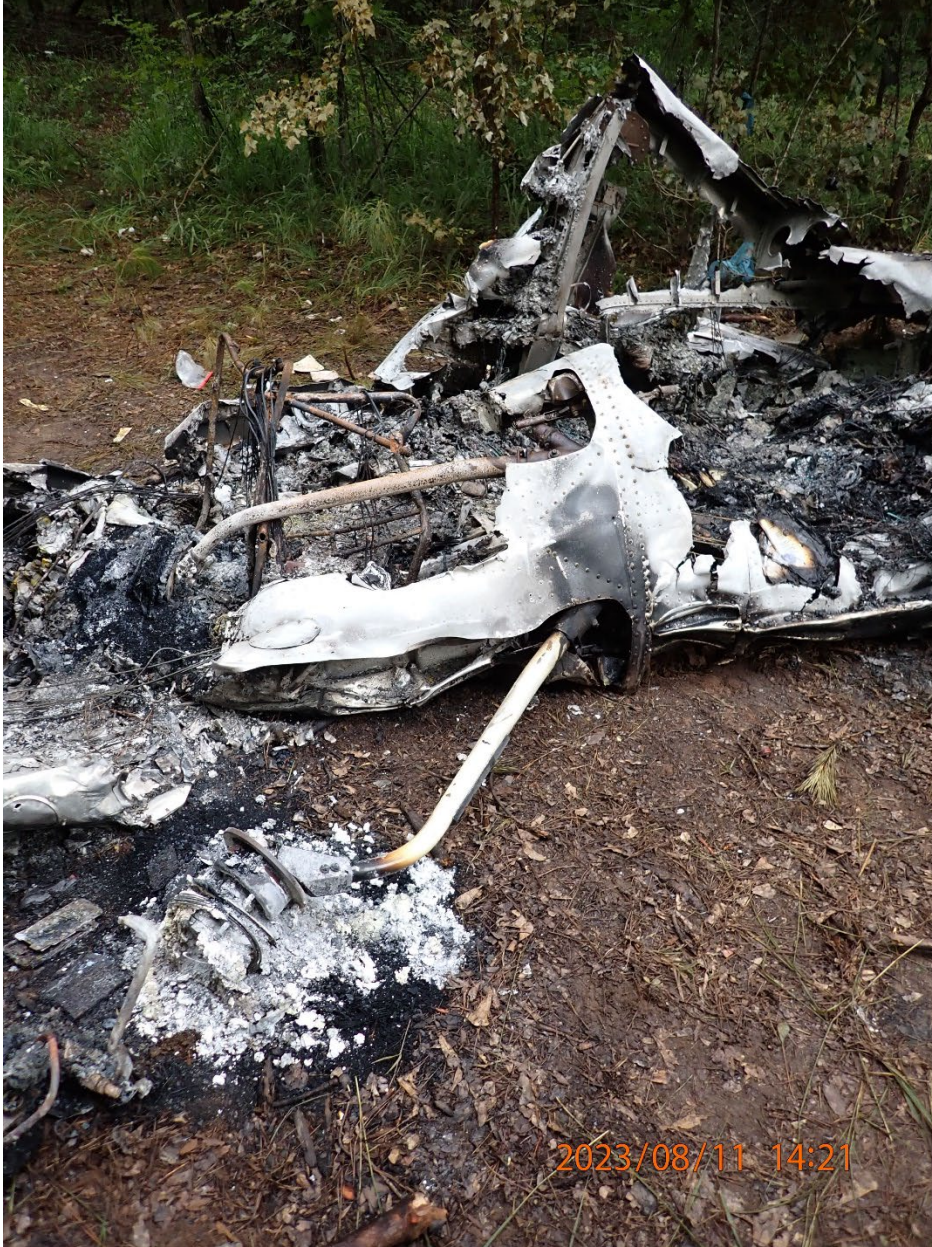
The landing gear was found in the up position and remained attached at all attachment points. All landing gear components were damaged by postaccident fire.

**Photo 26: View of the main landing gear as found at the accident site.**

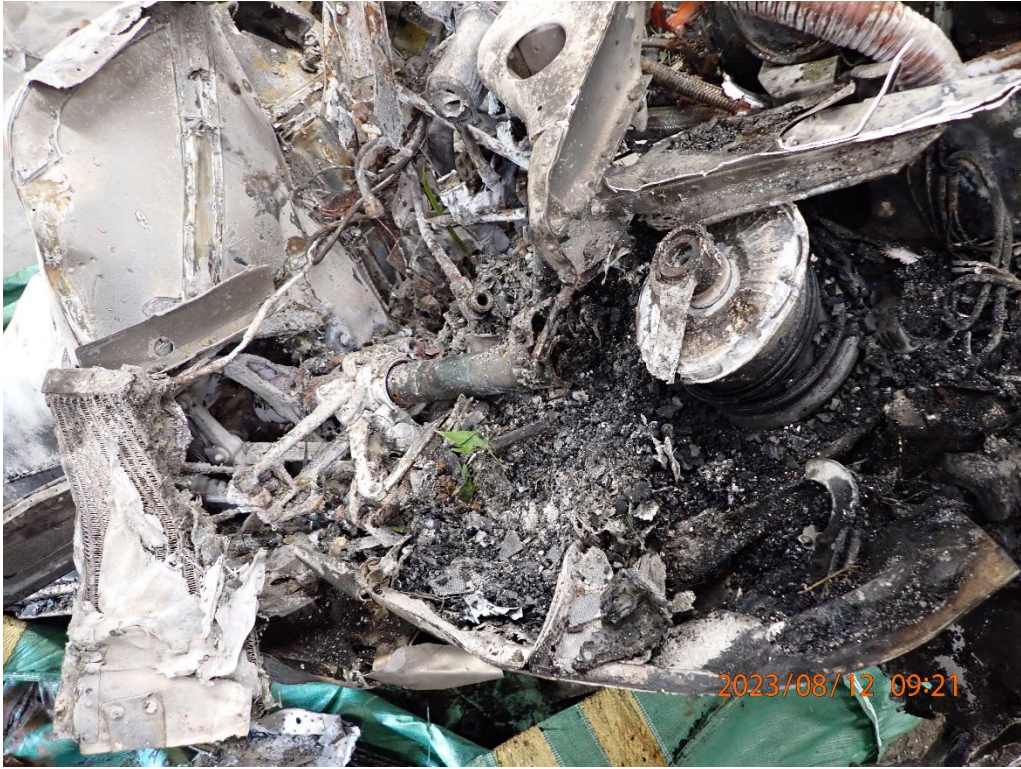
**Photo 27: View of the nose landing gear.**

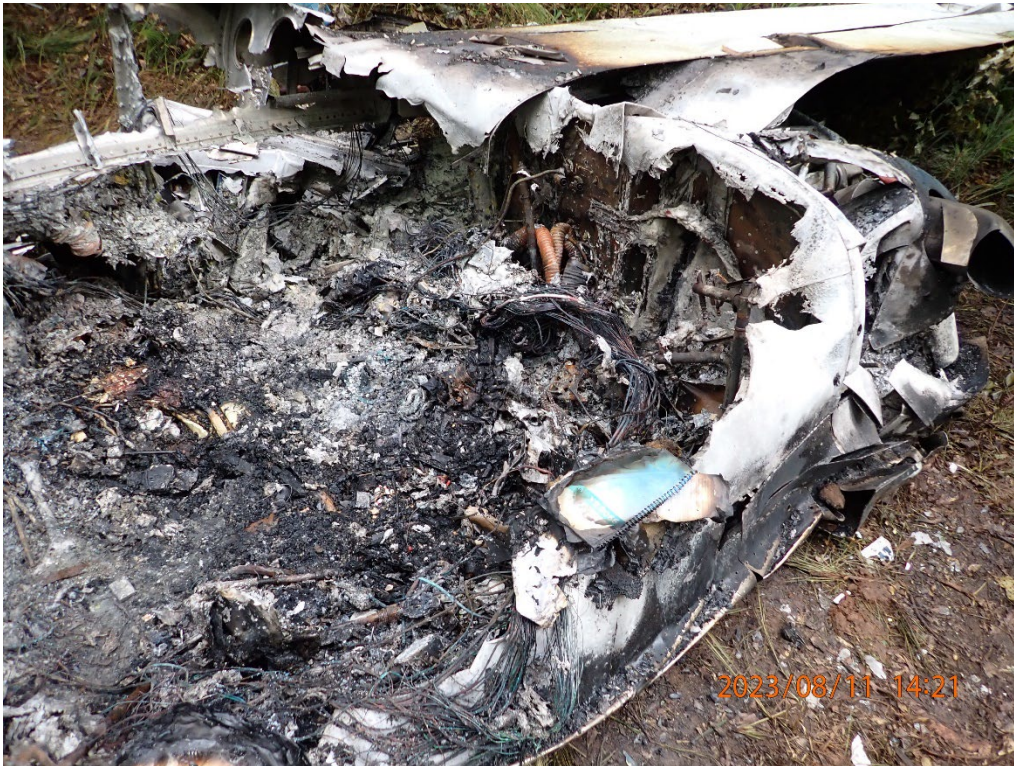
A majority of the cockpit was consumed by postaccident fire.

**Photo 28: View of the cockpit at the accident site.**

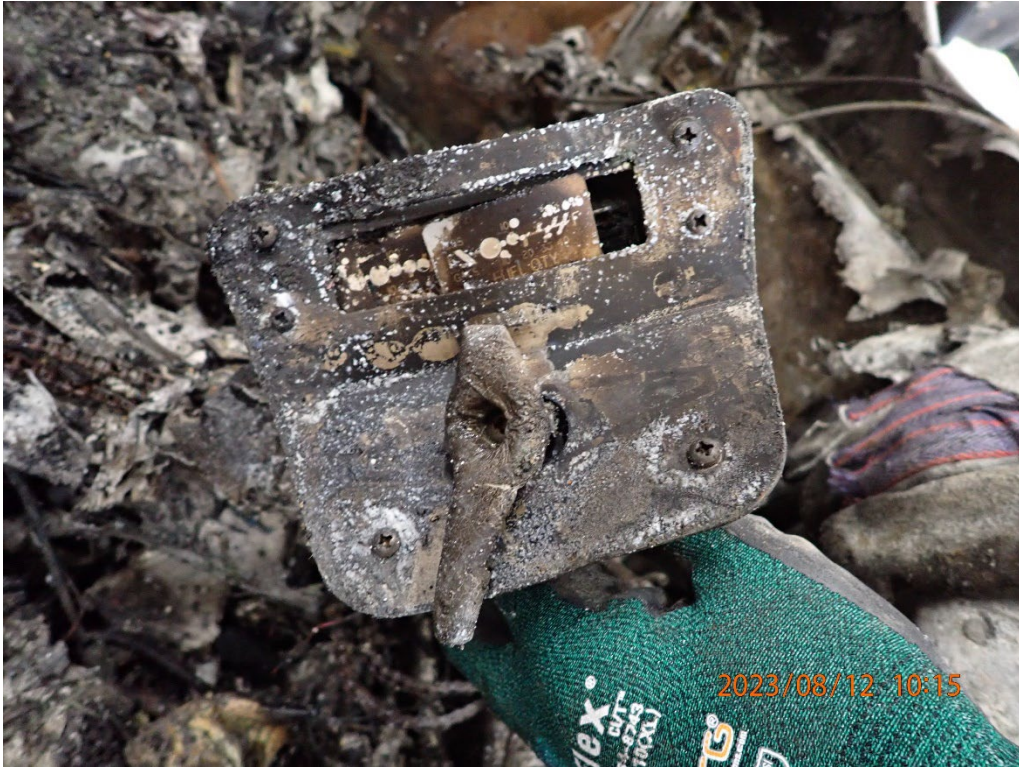
**Photo 29: View of the fuel selector cockpit control.**

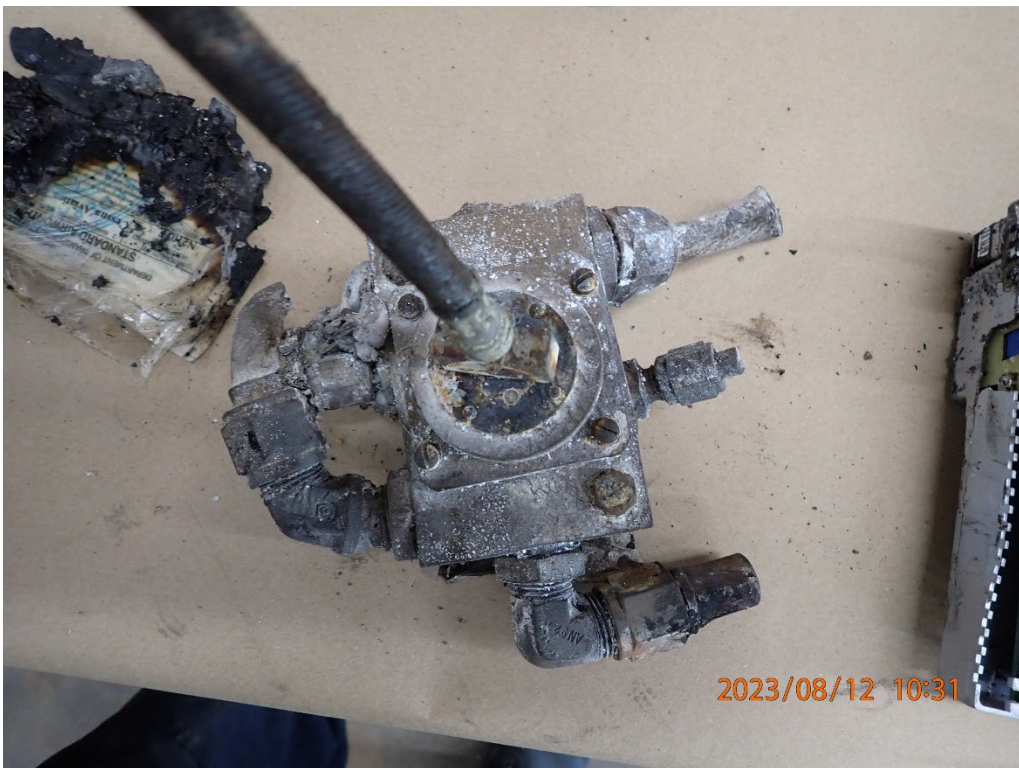
The fuel selector was damaged by postaccident fire. It was modified during the installation of the STC when the airplane was converted from the original reciprocating to the current turbine engine and the position could not be determined. The right wing fuel tank fuel cap remained seated in place.

**Photo 30: View of the fuel selector.**

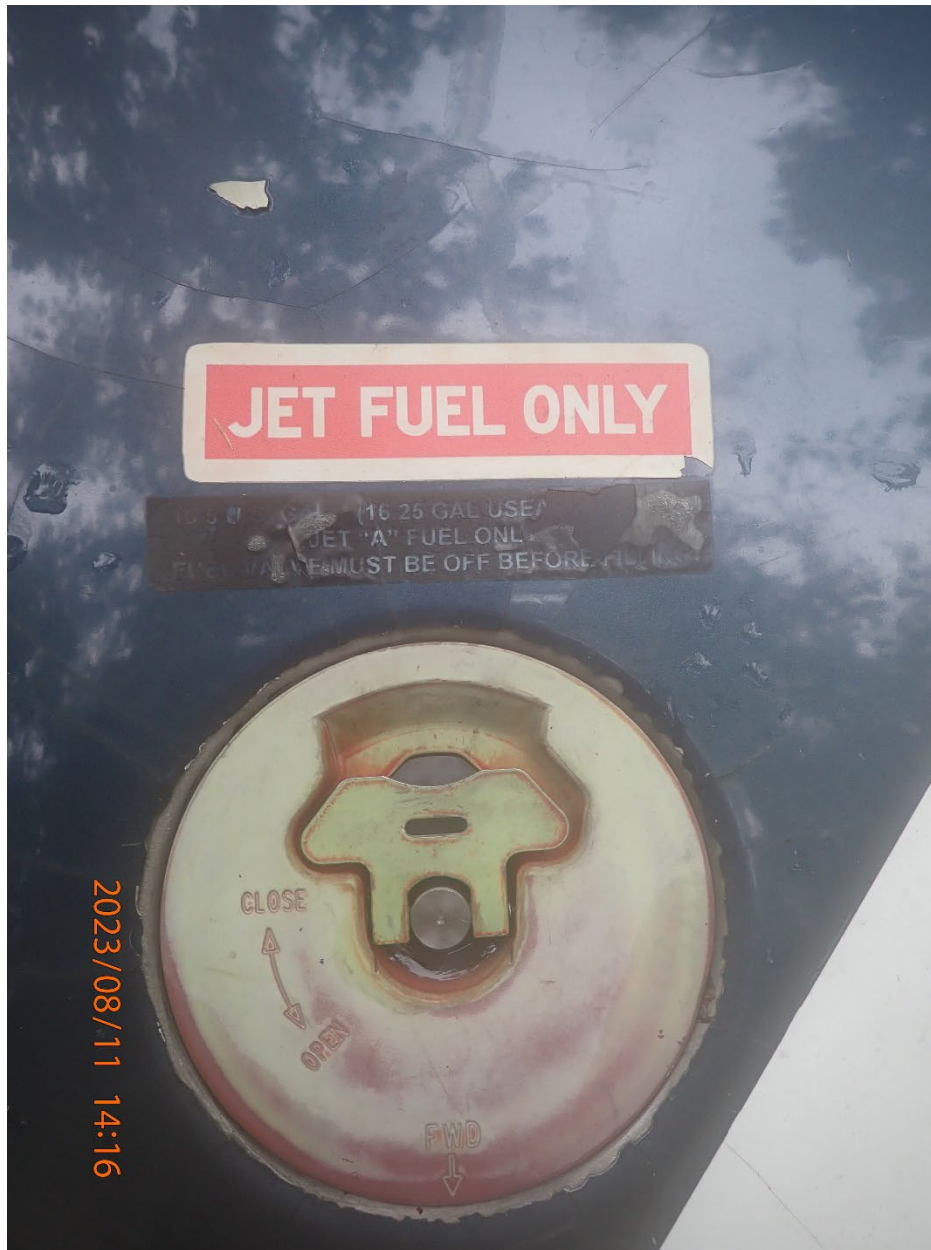
**Photo 31: View of the right wing fuel tank cap.**

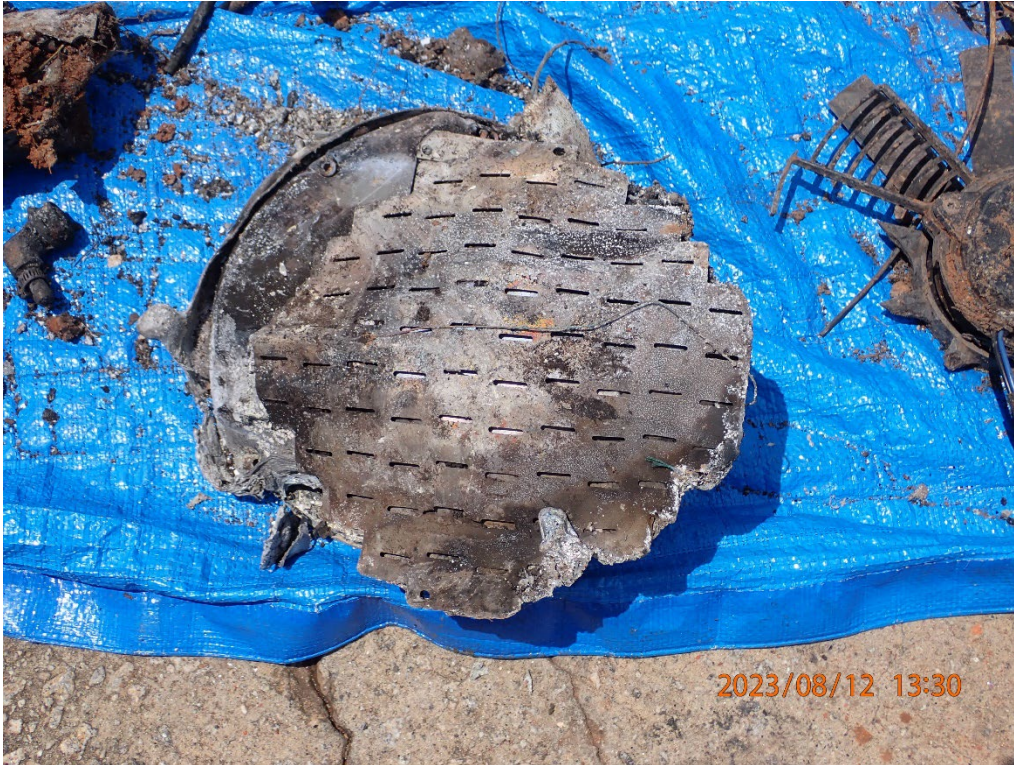
The airplane was equipped with onboard weather radar. The radar transmitter/receiver was among the main wreckage and was damaged by postaccident fire. The examination was unable to determine if the onboard weather radar was operating during the accident flight. The airplane was equipped with a TKS anti-ice system and heated propeller leading edge. This system was damaged by postaccident fire, and the examination was unable to determine if the system was on or off.

**Photo 32: View of the onboard weather radar sensor.**

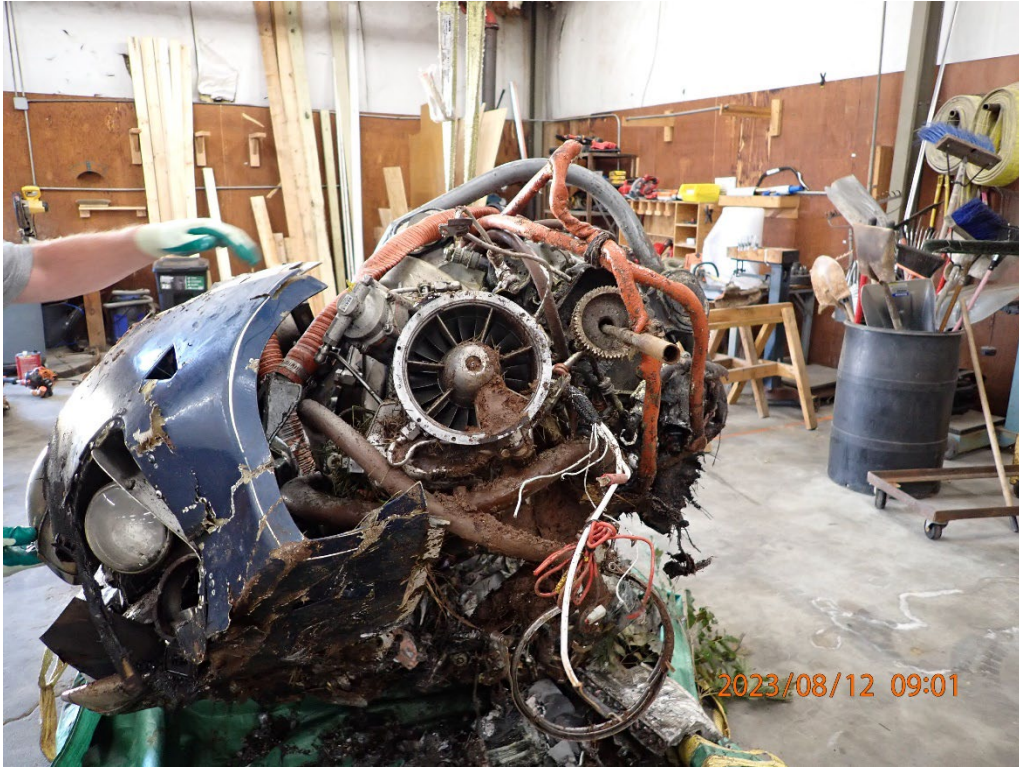
□ The engine was found in its normal relative position to the airframe and remained securely mounted to the engine mounts. The bottom left side of the engine displayed heavy impact damage from ground impact and displayed areas of a blackened coating from post-crash fire exposure.

**Photo 33: View of the engine at the recovery facility as first viewed.**

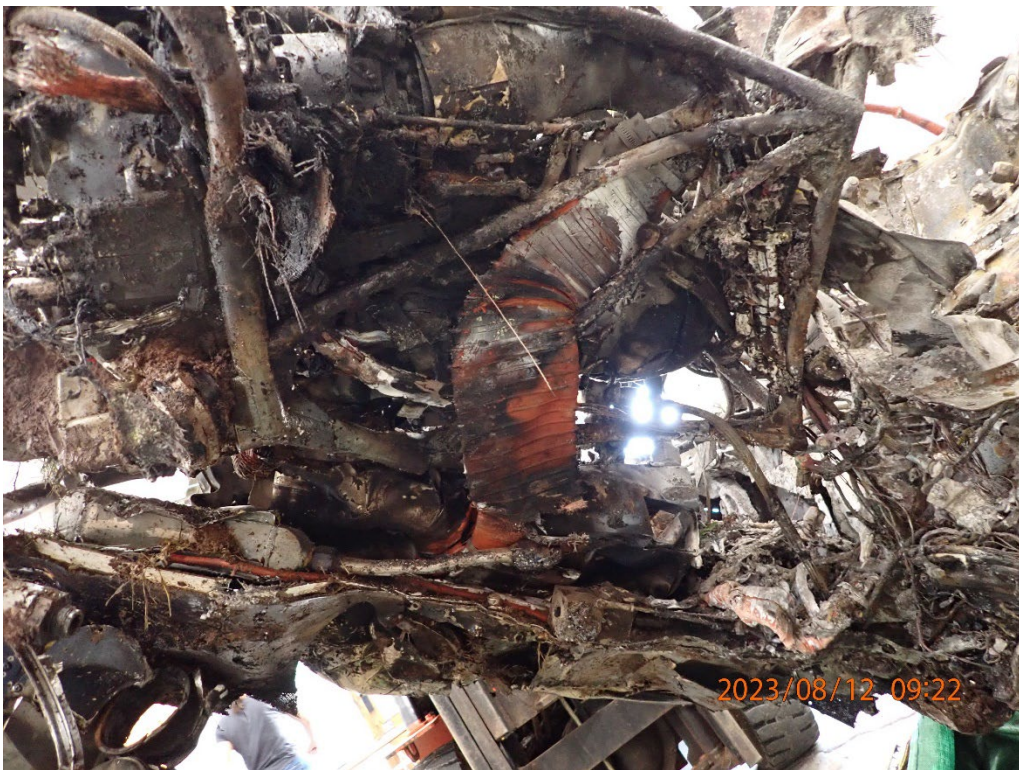
**Photo 34: View of the bottom of the engine mount.**

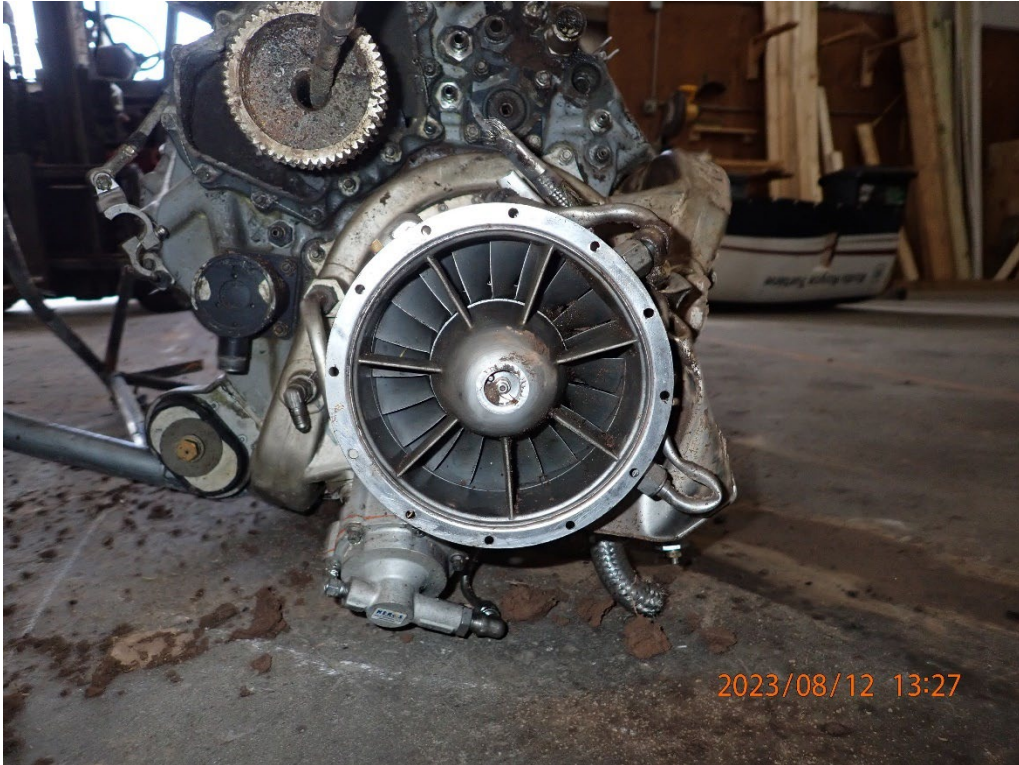
□ The compressor remained in its normal position with no external damage noted. The inlet guide vanes and visible portion of the first and second stage compressor blades and vanes were visually normal and displayed no visible damage. The bleed valve was in its normal position, open and the poppit valve could be manually actuated.

**Photo 35: View of engine compressor inlet.**

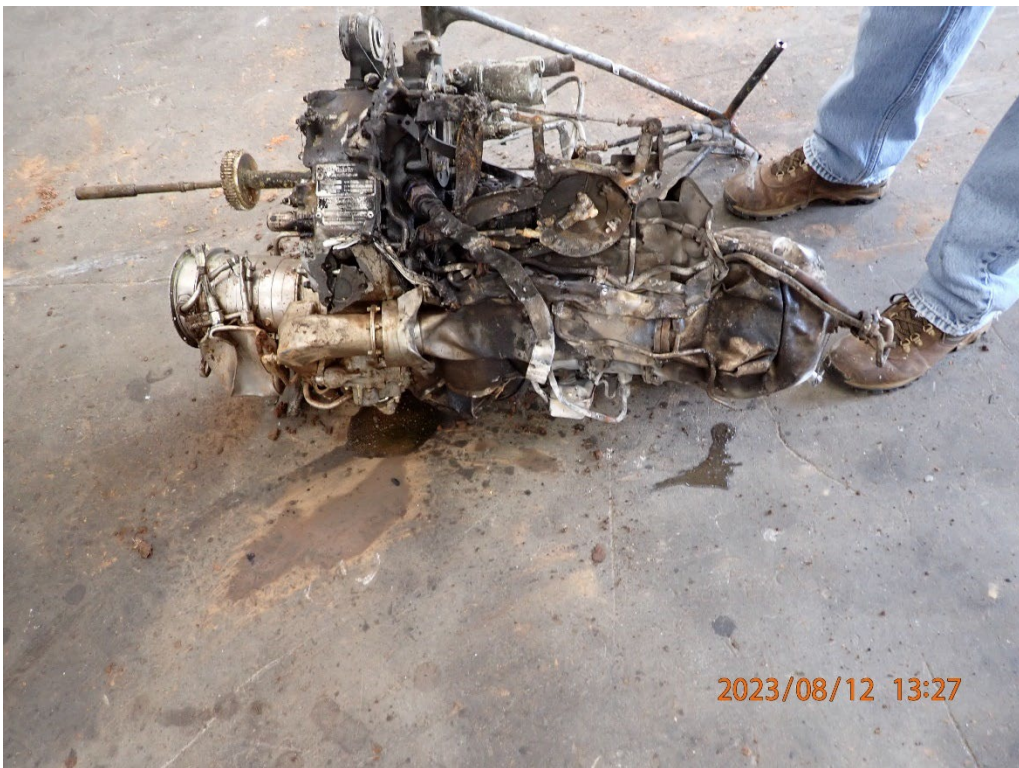
**Photo 36: View of the engine.**

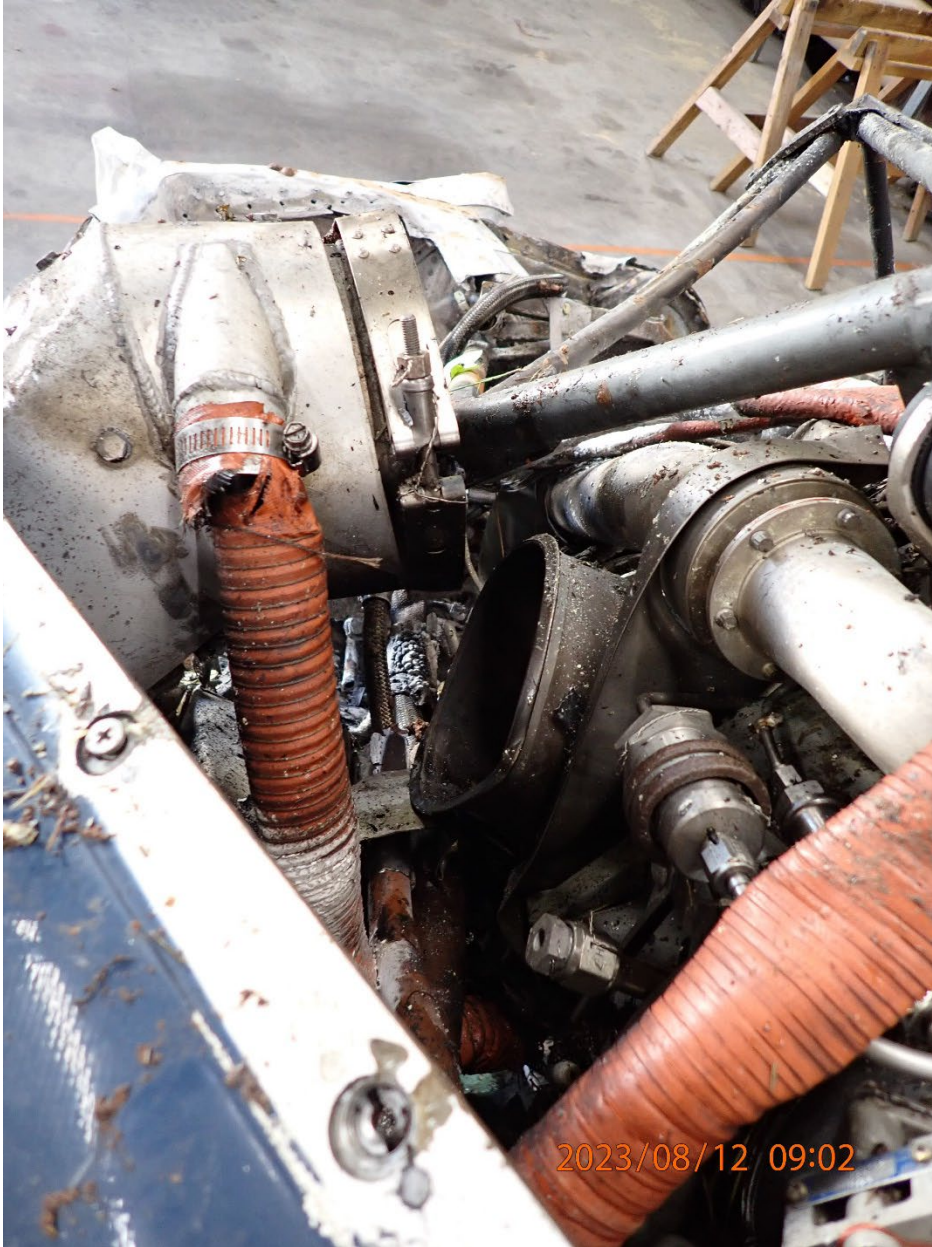
□ The turbine module and exhaust collector support remained in position. The left exhaust stack displayed crush damage with the right side exhibiting minor impact damage. Other than slight discoloration from post-crash fire the turbine was generally normal in appearance. The stage four turbine wheel as viewed through the exhaust collector revealed it to be in position with no evidence of damage.

**Photo 37: View of the right exhaust pipe held in place by hoses.**

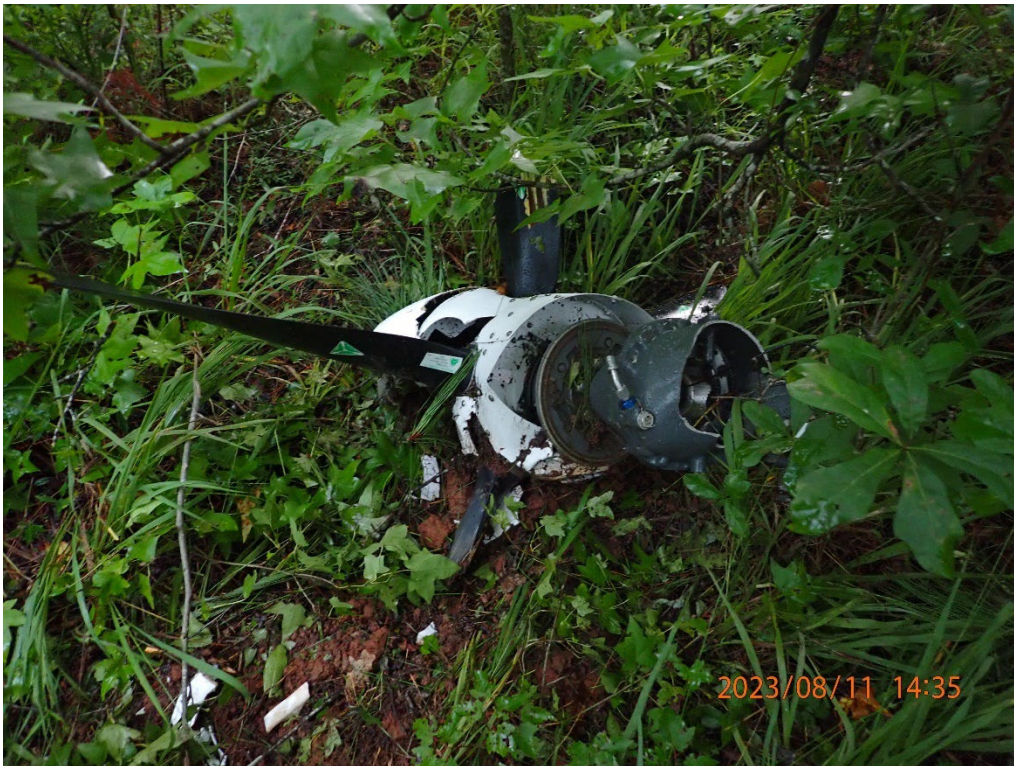
The wooden composite MT 5 bade propeller with the propeller gear box and governor was impact separated from the engine and found about 100 ft southwest of the main wreckage. The propeller was equipped with an electronically heated leading edge ice protection system. All 5 blades of the propeller exhibited impact damage. One blade was mostly intact with trailing edge damage, three blades were fractures about a third of the way up from the hub, and one blade was fractured at the hub. The propeller remained attached

**Photo 38: Propeller as found on scene.**

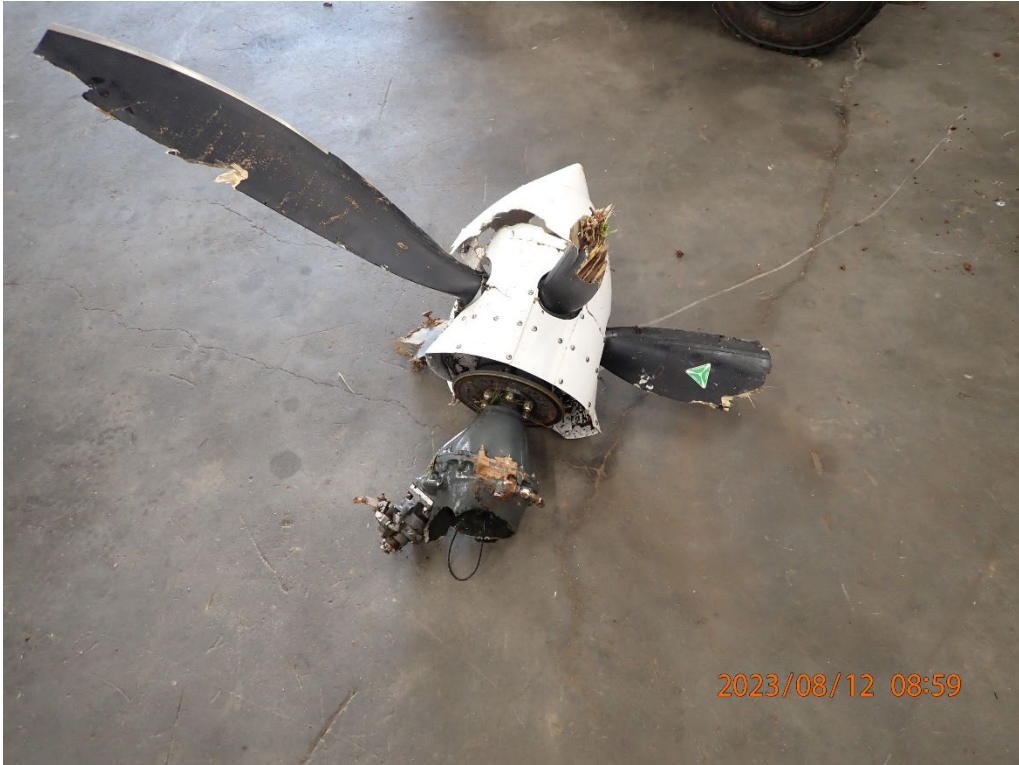
**Photo 39: Propeller, propeller gear box, and governor at the recovery facility.**

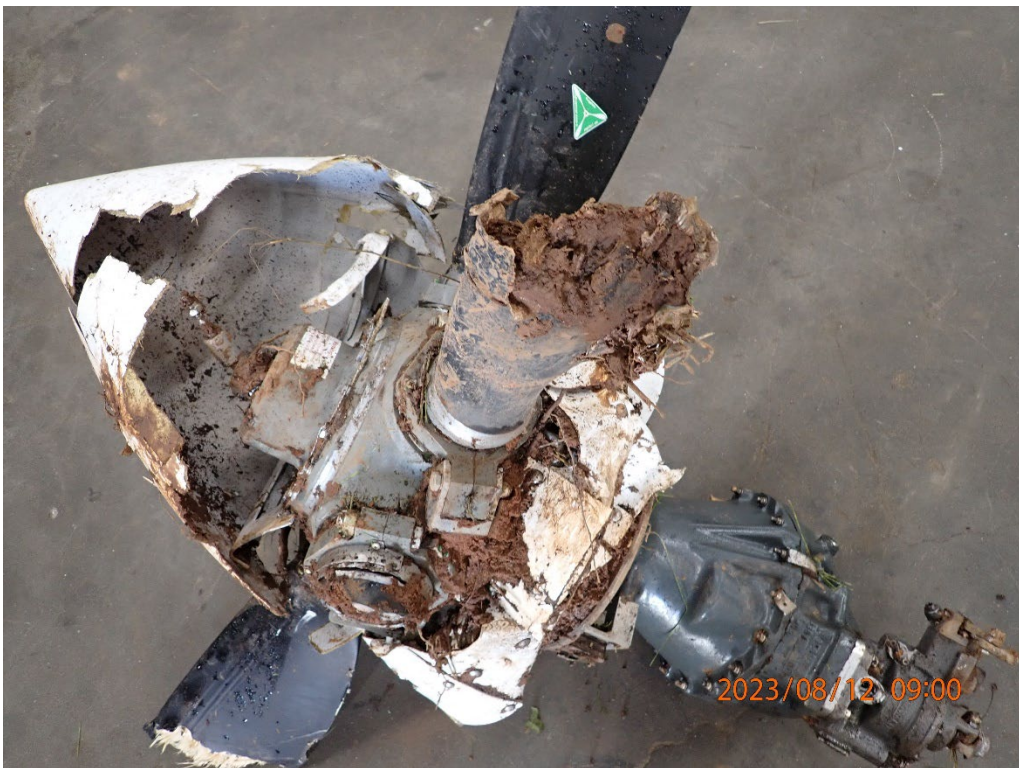
**Photo 40: View of the propeller.**

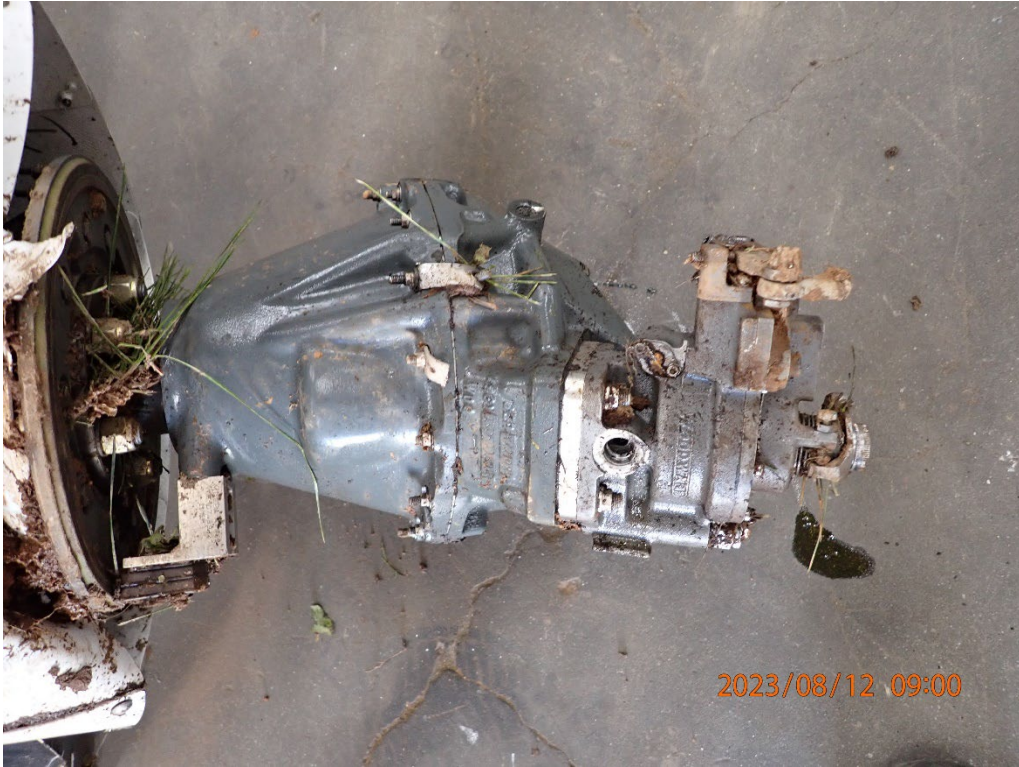
**Photo 41: View of the propeller gear box and governor.**

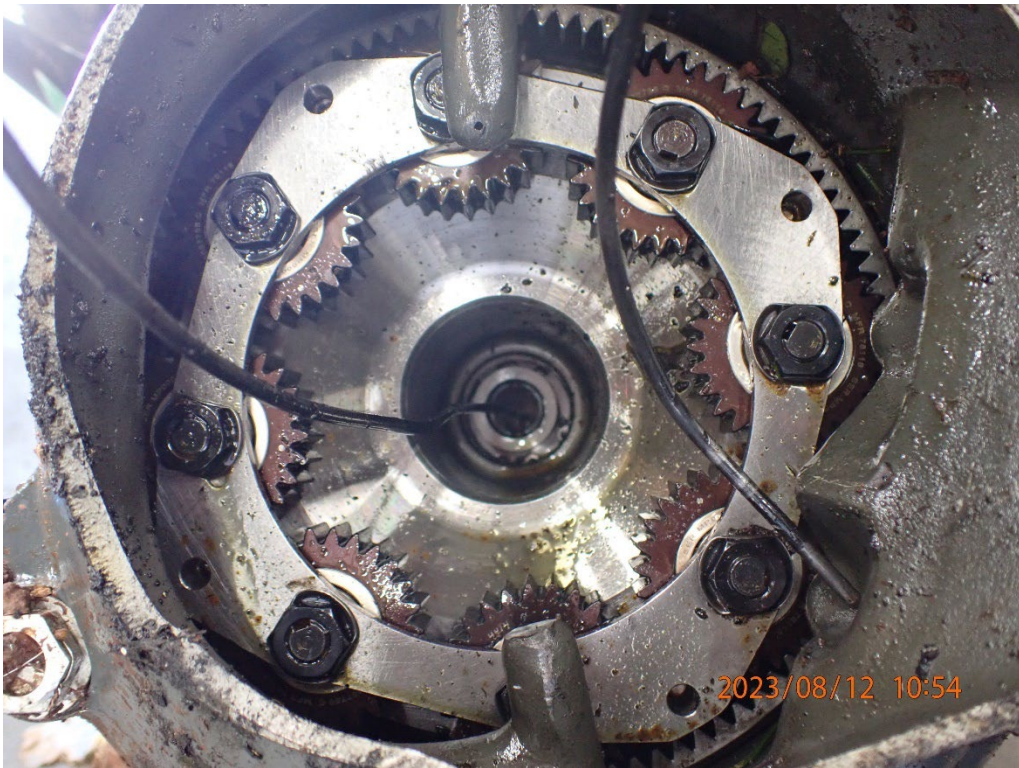
to the propeller gear box flange at all attachment points. The propeller gear box moved freely when rotated by hand and all gears inside rotated freely. The propeller governor remained attached to the propeller gear box at all attachment points. The propeller governor control arm head remained attached to the propeller governor. The control arm and cable were impact separated from the governor.

**Photo 42: View of the gears inside the propeller gearbox.**

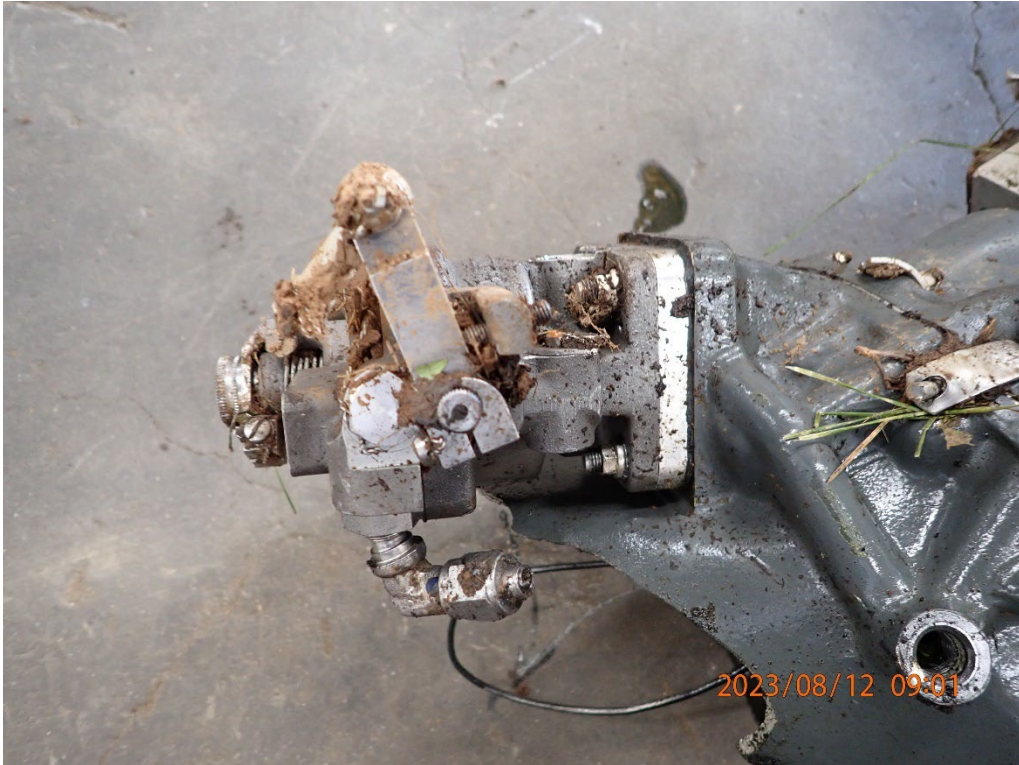
**Photo 43: View of the propeller governor.**

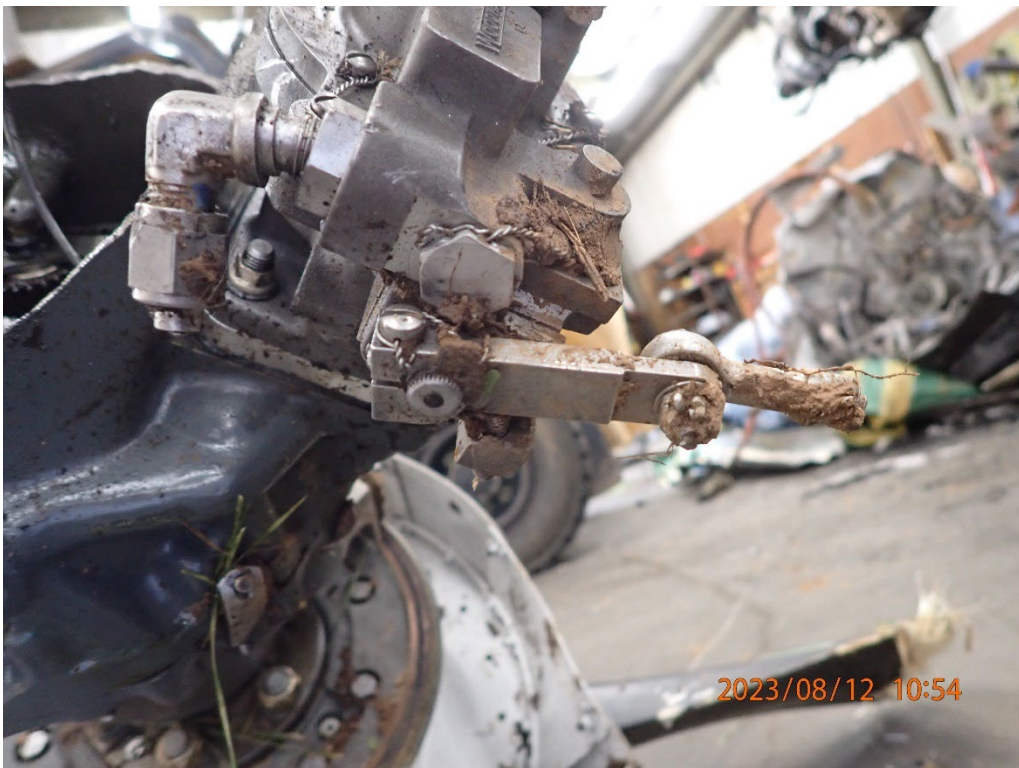
**Photo 44: View of the propeller governor control with control arm head attached.**

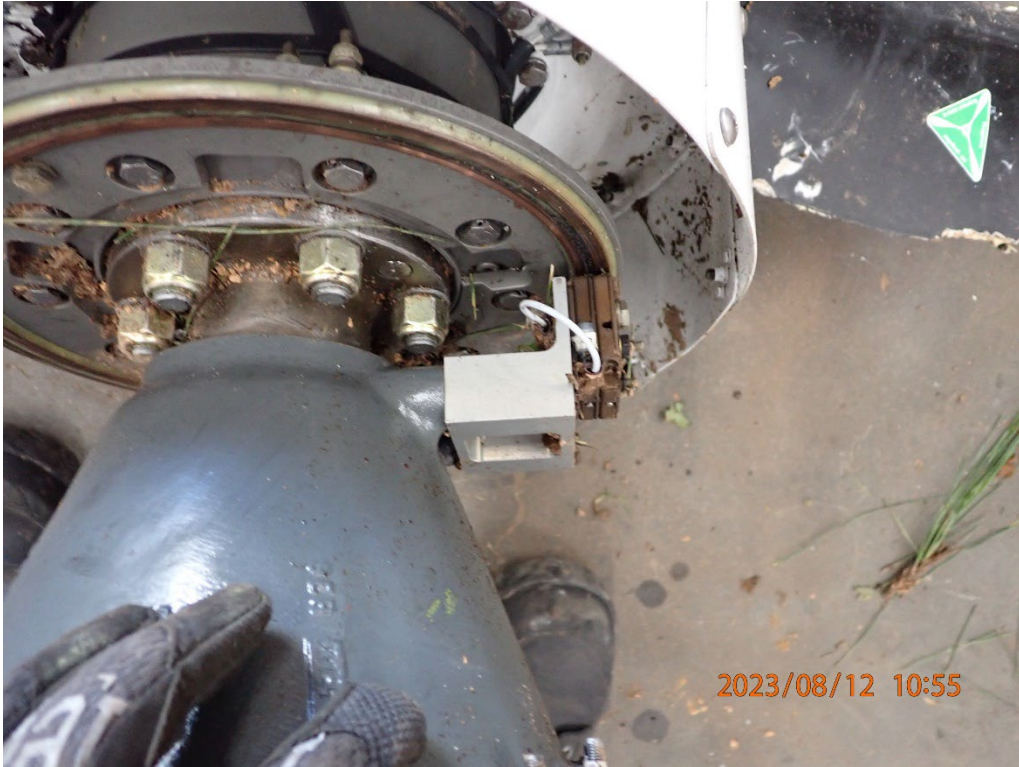
**Photo 45: Propeller slip ring and brush block for electrically heated leading edge.**
