# National Transportation Safety Board

ERA23FA340

## **MATERIALS LABORATORY**

Location: Fort Pierce, Florida  
Date: August 17, 2023  
Vehicle: Piper PA-28-161, N9855S  
Investigator: Adam Gerhardt, AS-ERA

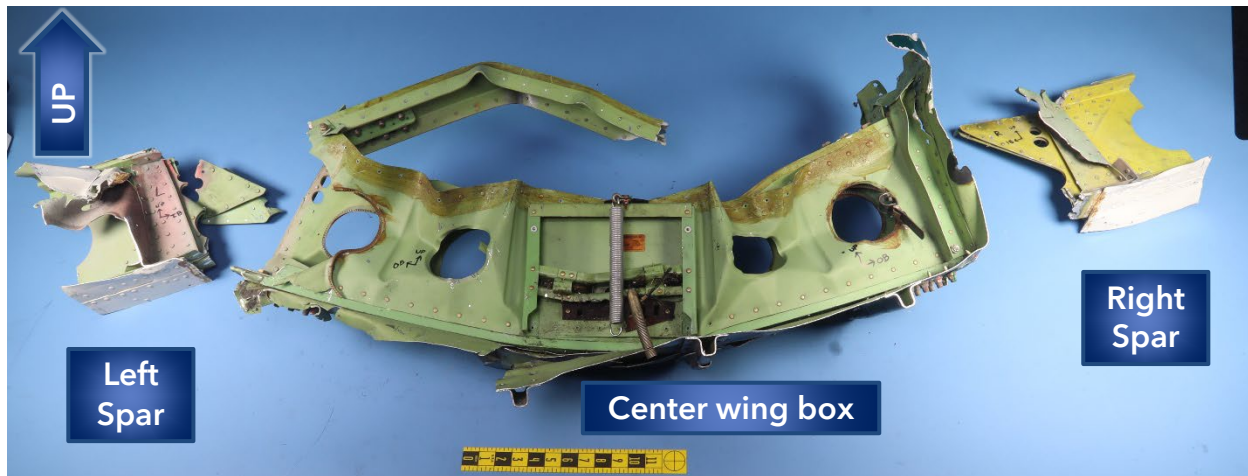
The submitted center wing box and the left and right wing main spar pieces are shown in figure 1 as received. The main spars for the left and right wings were fractured at or near the inboard wing attachment locations. The outboard ends of the center wing box were deformed upward relative to center, and the upper spar was crippled consistent with high upward wing loads on both the left and right wings before fracture.

**Figure 1.** Overall image of the submitted components.

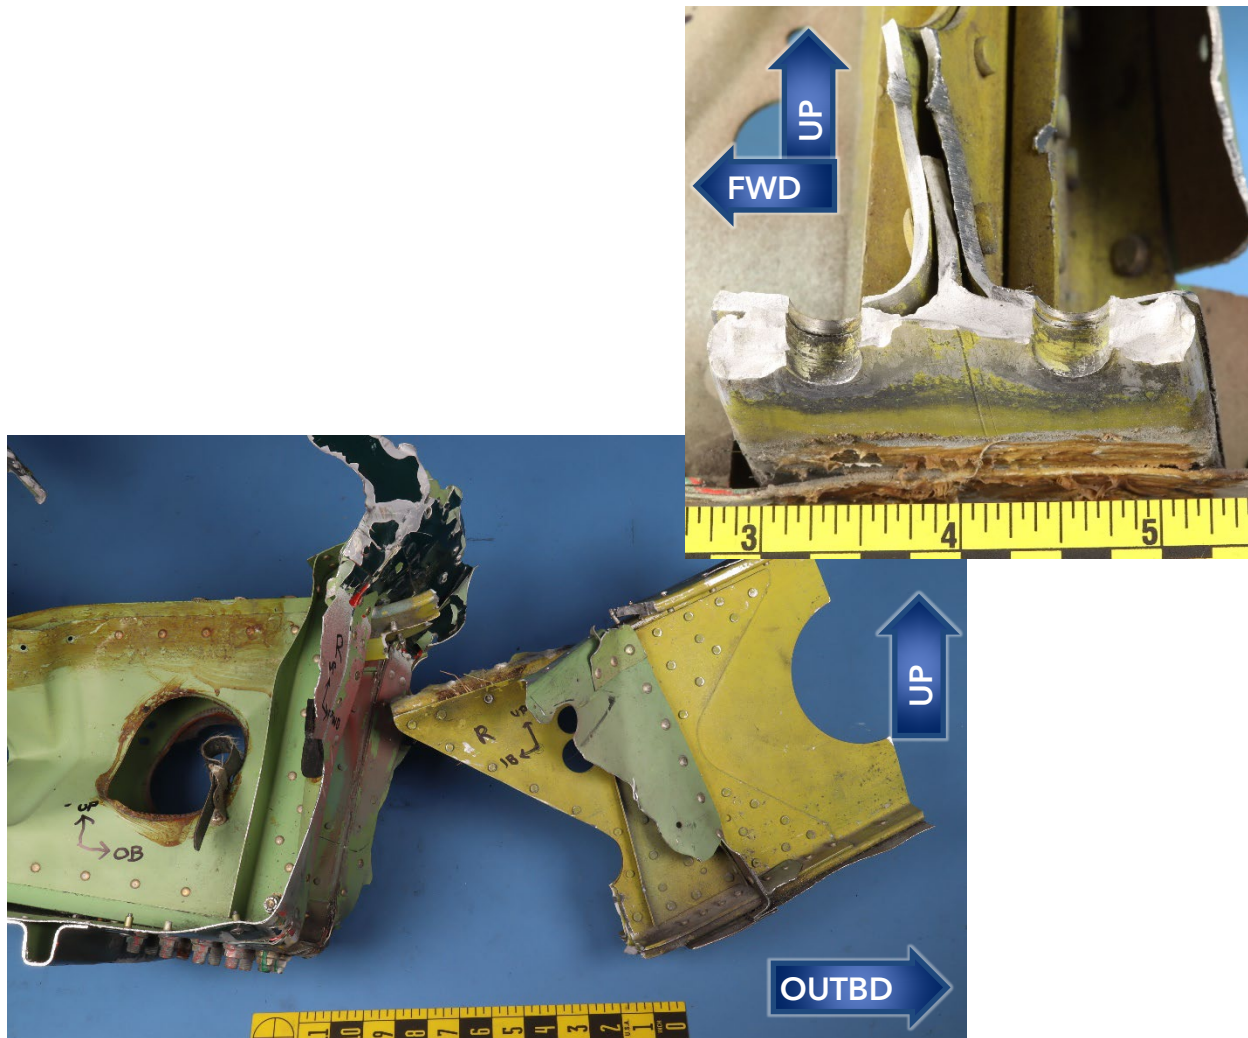
Closer views of the right wing spar fracture location are shown in figure 2. The right main spar lower cap was fractured at the outboard attachment holes for attaching the wing spar to the center wing box as shown in the image of the lower cap fracture surface in figure 2. The upper and lower caps showed upward deformation adjacent to the fracture and rough, matte-gray fracture features consistent with ductile overstress fracture. No evidence of any preexisting cracks or defects were observed associated with the fracture surfaces as determined by optical microscopy and subsequent scanning electron microscopy (SEM) examinations of the fracture surfaces on the lower cap.

**Figure 2.** Right wing fracture location as viewed from the aft (lower image) and looking outboard at the outboard side of the right wing spar lower cap fracture (upper right image).

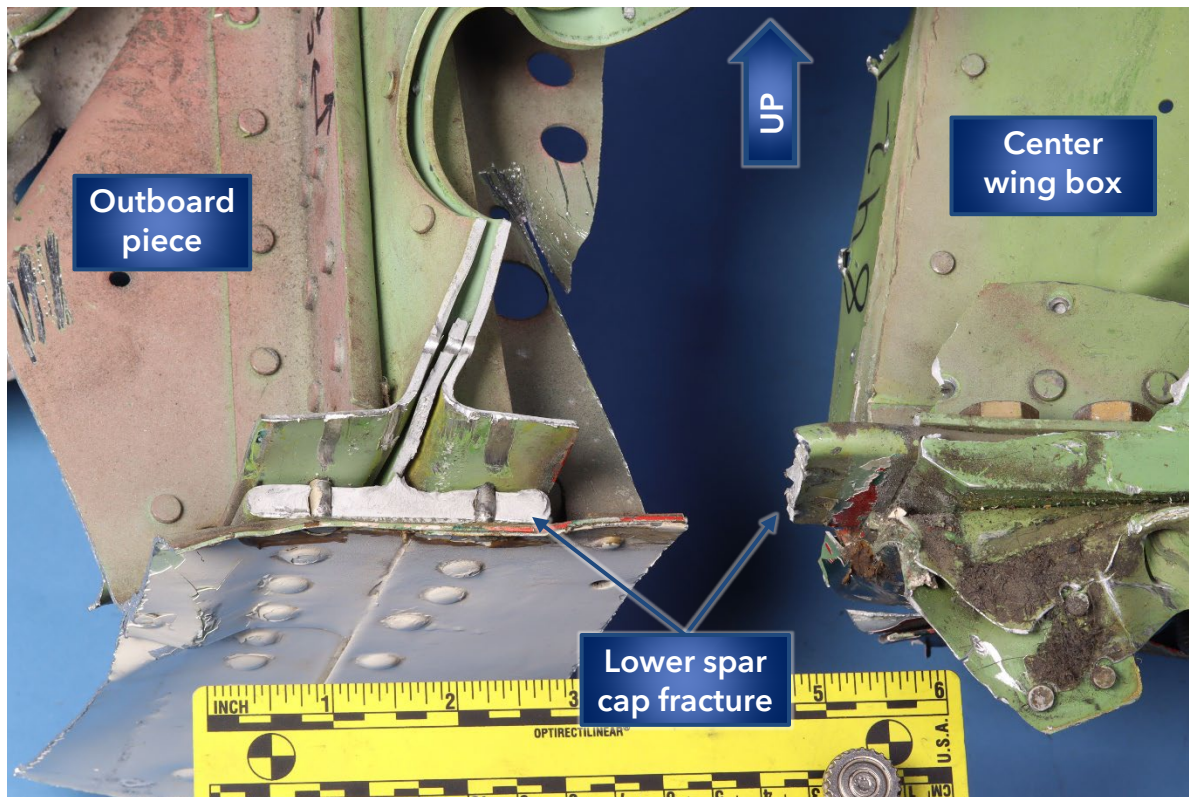
A closer view of the left wing main spar lower cap fracture location is shown in figure 3. The lower cap was fractured outboard of the main spar attachment bolt holes for attaching the wing to the fuselage, and the fracture intersected the inboard two rivet holes attaching the wing lower skin and spar doublers to the lower cap. The upper cap was also fractured at a similar location spanwise just outboard of the attachment location. The lower cap was bent downward adjacent to the fracture, and the inboard end of the wing's lower skin and spar web doublers were also deformed downward. The upper cap had rough matte gray features consistent with ductile overstress fracture. The fracture surface of the lower cap had mostly rough matte gray features, but the lower edge of the fracture had a smoother shiny appearance, features consistent with ductile overstress fracture with smearing at the compression side of a fracture with local bending. The overall deformation pattern on the left wing was consistent with a downward bending load associated with the left wing fracture following the upward load associated with the center wing box deformation.

**Figure 3.** Overall view of the lower cap fracture features at the left wing fracture location. The outboard piece is rotated forward relative to the center wing box to show the fracture surface on the outboard side of the fracture.

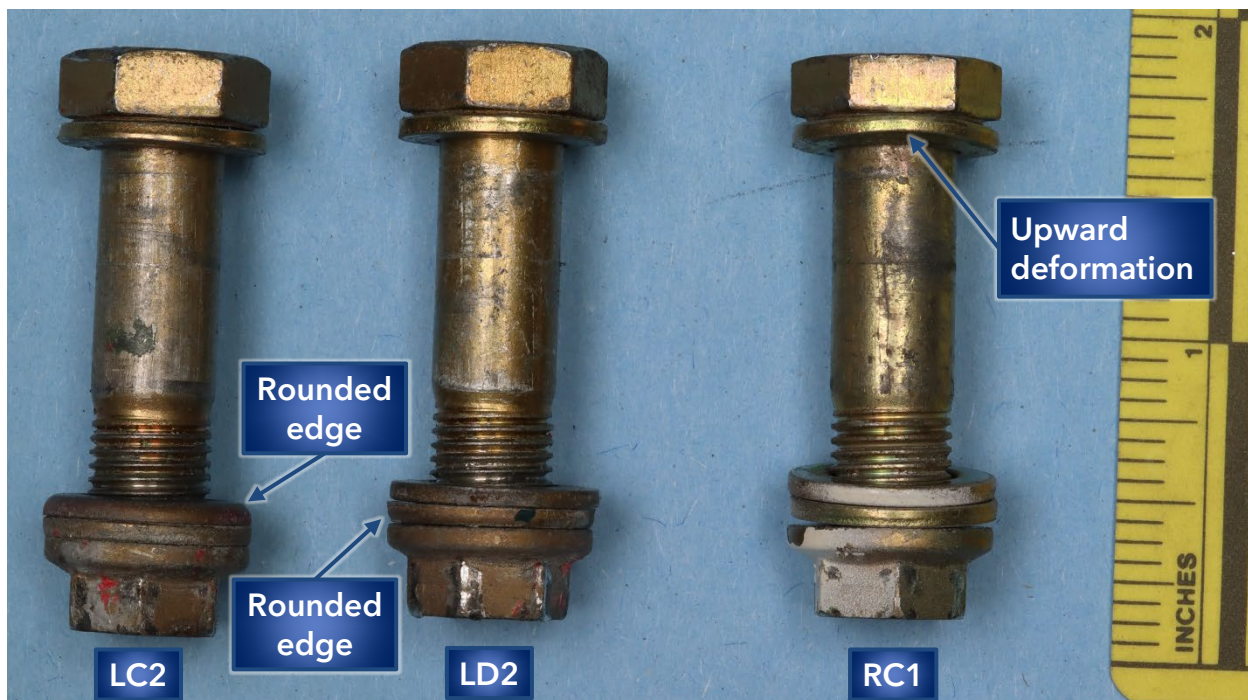
Most of the lower cap attachment hardware had washers with square edges on both sides of all three washers such as the RC1 assembly shown in figure 4. Assemblies LC2, LC3, LD2, and LD4 were the only assemblies that had a round-edged washer installed within the assembly, and each had the round-edged washer installed between the nut and lower skin. In assembly LC2, the face with the rounded edge was against the lower skin, and in the other three assemblies, the face with the rounded edge was against the nut. Close views of assemblies LC2 and LD2 after disassembly are shown in figure 4 where rounded edges on the washers are indicated.

**Figure 4.** Selected hardware showing washer configurations and deformation.

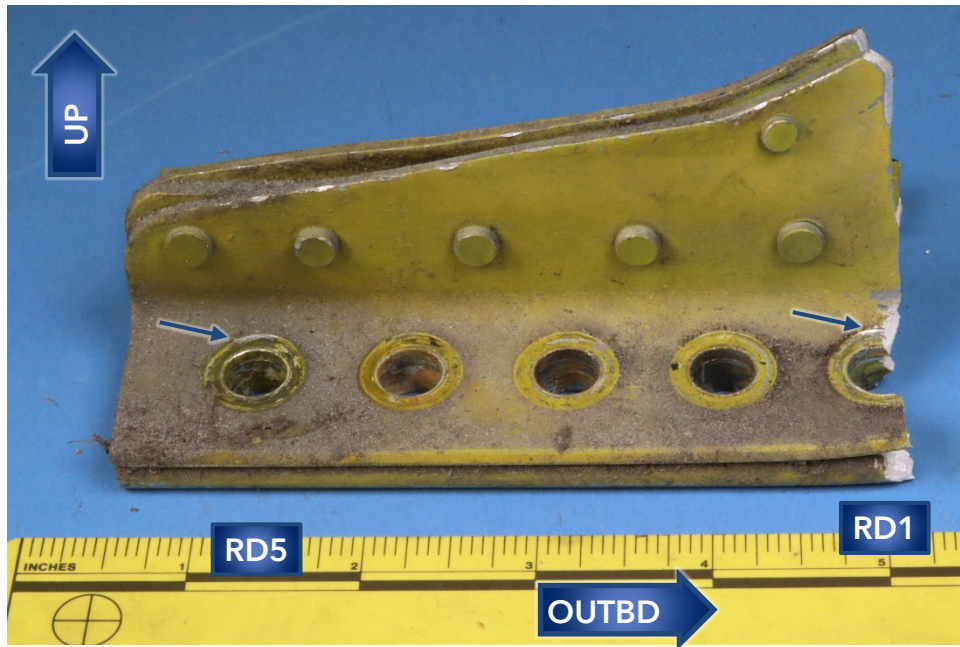
Contact damage was observed on the spar doubler at locations corresponding to the square edges of washers that were installed under the bolt heads such as areas

near holes RD1 and RD5 as shown in figure 5. Many of the washers installed under the bolt head had a deformed or worn edge in one portion of the circumference on the side of the washer facing the doubler consistent with contact with the fillet radius. A similar wear pattern was also observed on washers installed under the nut with square edges facing the lower skin corresponding to contact with the fillet radius on the stringer. The washers installed under the bolt heads at the LC1, LD1, RC1, and RD1 positions were deformed upward at the edge on one side of the washer consistent with contact with the fillet radius to the web. The deformed edge for the washer installed under the bolt head at position LC1 is indicated in figure 4. The deformation to the washers under the bolt head at the four number 1 positions was substantially greater than the wear and deformation observed at the remaining positions.

**Figure 5.** Inboard end of the right wing spar lower cap after disassembly from the center wing box. Unlabeled arrows indicate washer contact damage forward of attachment holes RD1 and RD5.

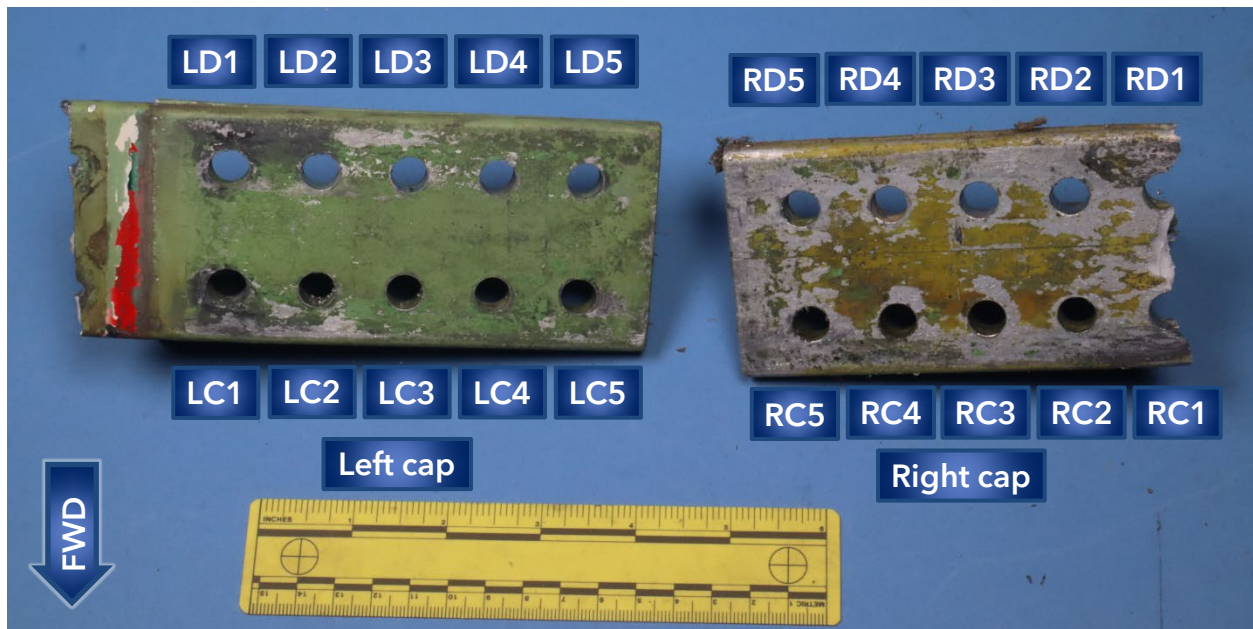
An overall view of the lower surface of the inboard end of the right wing main spar lower cap is shown in figure 6 after disassembly from the center wing box. The labels associated with each attachment hole are also shown for reference. The right spar cap was covered with a greenish yellow primer, and the attachment holes were also covered with primer on both spar caps. No primer was observed on the shanks of the attachment bolts that had been removed from the holes. According to Piper representatives, during the manufacturing process, the spars are coated with primer before the attachment holes are drilled, and the holes remain uncoated in the original assembly.

An overall view of the lower surface of the inboard end of the left wing main spar lower cap is shown in figure 6 after disassembly from the center wing box. The

labels associated with each attachment hole are also shown for reference. The left spar cap was covered with a green primer. Similar to observations on the right wing main spar lower cap, the attachment holes were also covered with primer on both spar caps, and no primer was observed on the shanks of the attachment bolts that had been removed from the holes.

**Figure 6.** Lower surfaces of the inboard ends of the main spar lower caps from the left and right wings after disassembly from the center wing box. Hole numbers were labeled as shown.

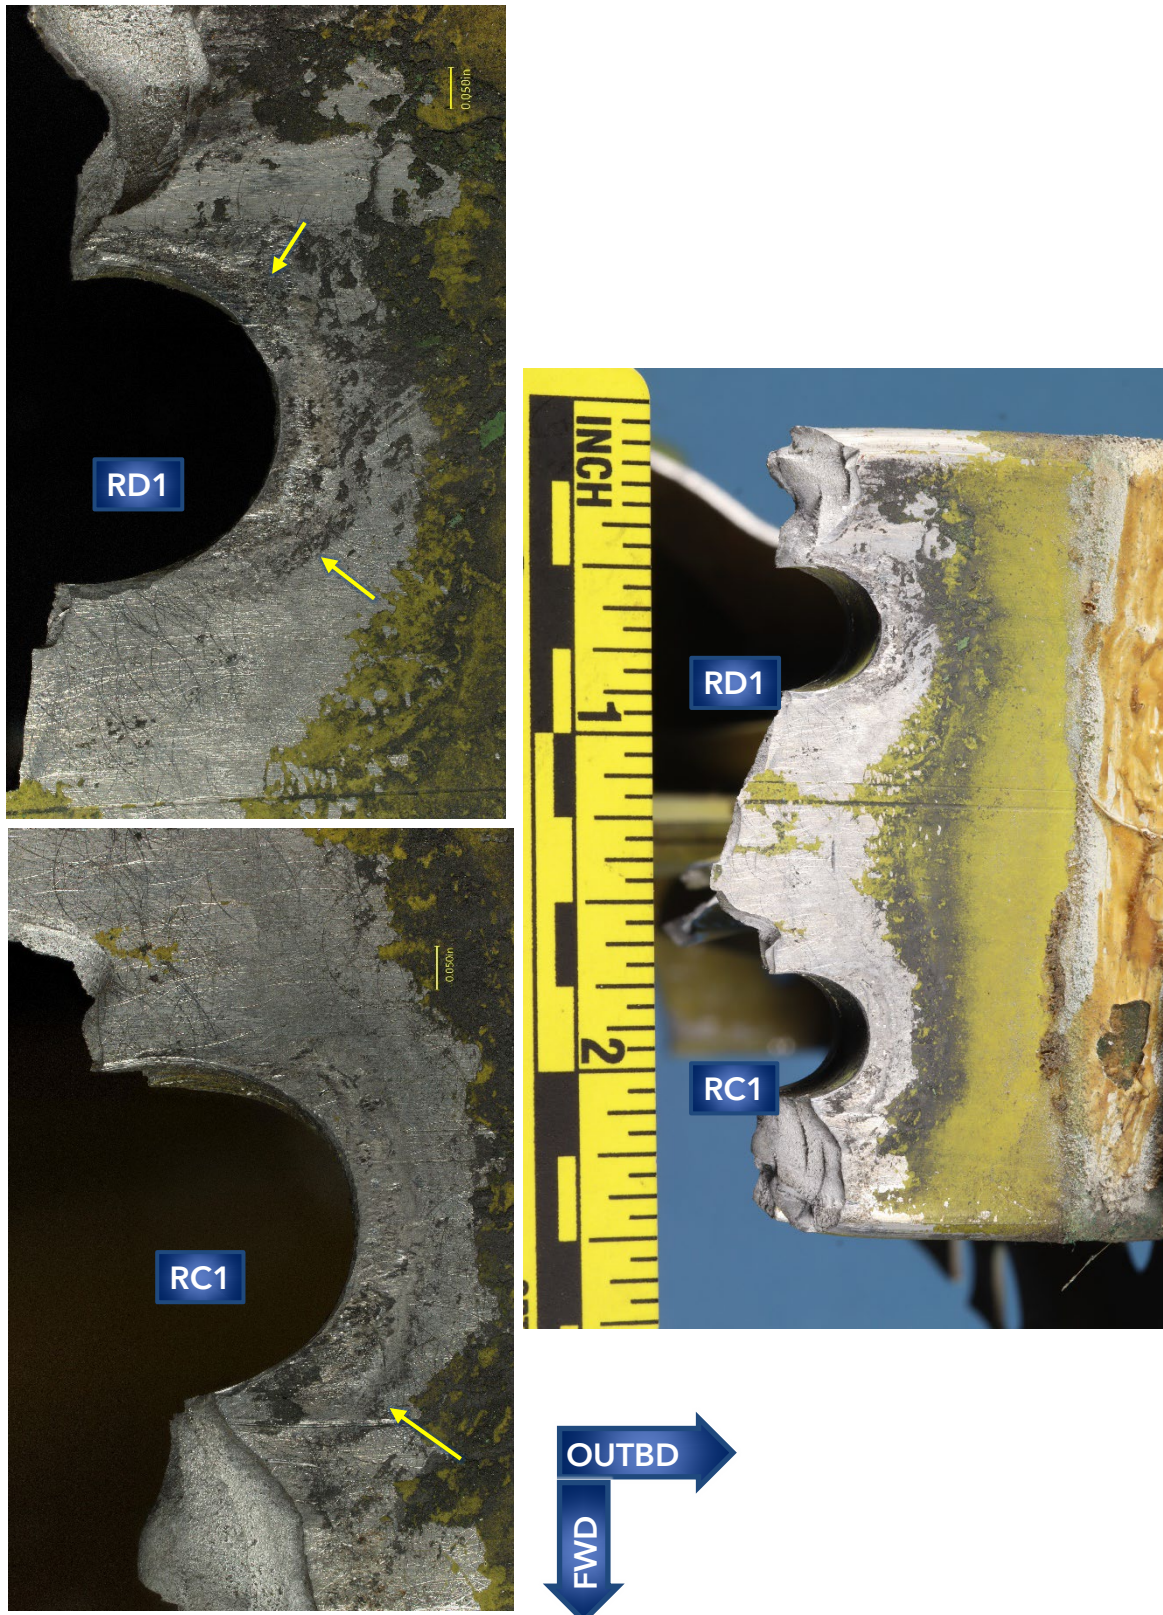
Close views of the lower surface on the outboard piece of the right wing main spar lower cap adjacent to the fracture at holes RC1 and RD1 are shown in figure 7. Primer in the area around the attachment holes was missing, and the underlying exposed surfaces mostly had a circular scratch pattern consistent with orbital sanding methods used during manufacture. The area on the outboard side of holes RC1 and RD1 was disturbed, and the circular scratch pattern was eliminated by rubbed and smeared surfaces consistent with fretting contact damage as indicated with unlabeled arrows in figure 7.

**Figure 7.** Right wing main spar lower cap showing the lower surface outboard of the fracture through attachment holes RC1 and RD1. Arrows in the left images indicate areas of fretting damage adjacent to the holes.

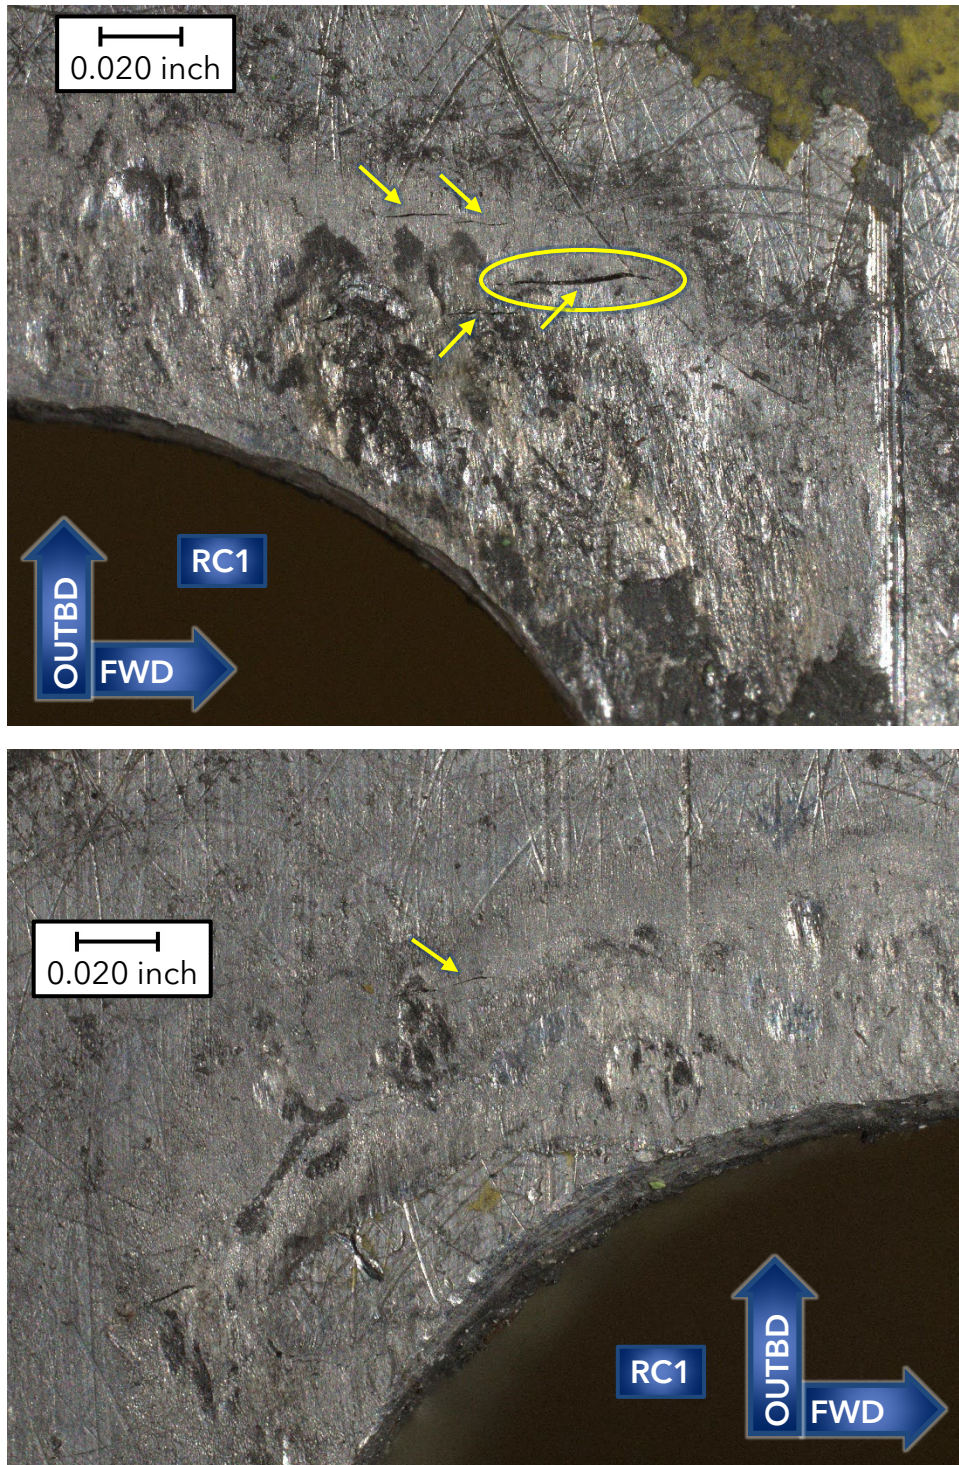
Closer views of the fretted areas outboard of attachment holes RC1 and RD1 are shown in figures 8 and 9. Small crack indications as indicated with unlabeled arrows in figures 8 and 9 were observed on the lower surface outboard of the holes near the edges of the fretted regions. The crack indications were oriented in the transverse direction outboard of the holes both forward and aft of the centerline for each hole.

**Figure 8.** Closer views of the lower cap lower surface outboard of hole RC1. Unlabeled arrows indicate locations of small visual crack indications, and the circle indicates a crack that was opened by laboratory fracture.

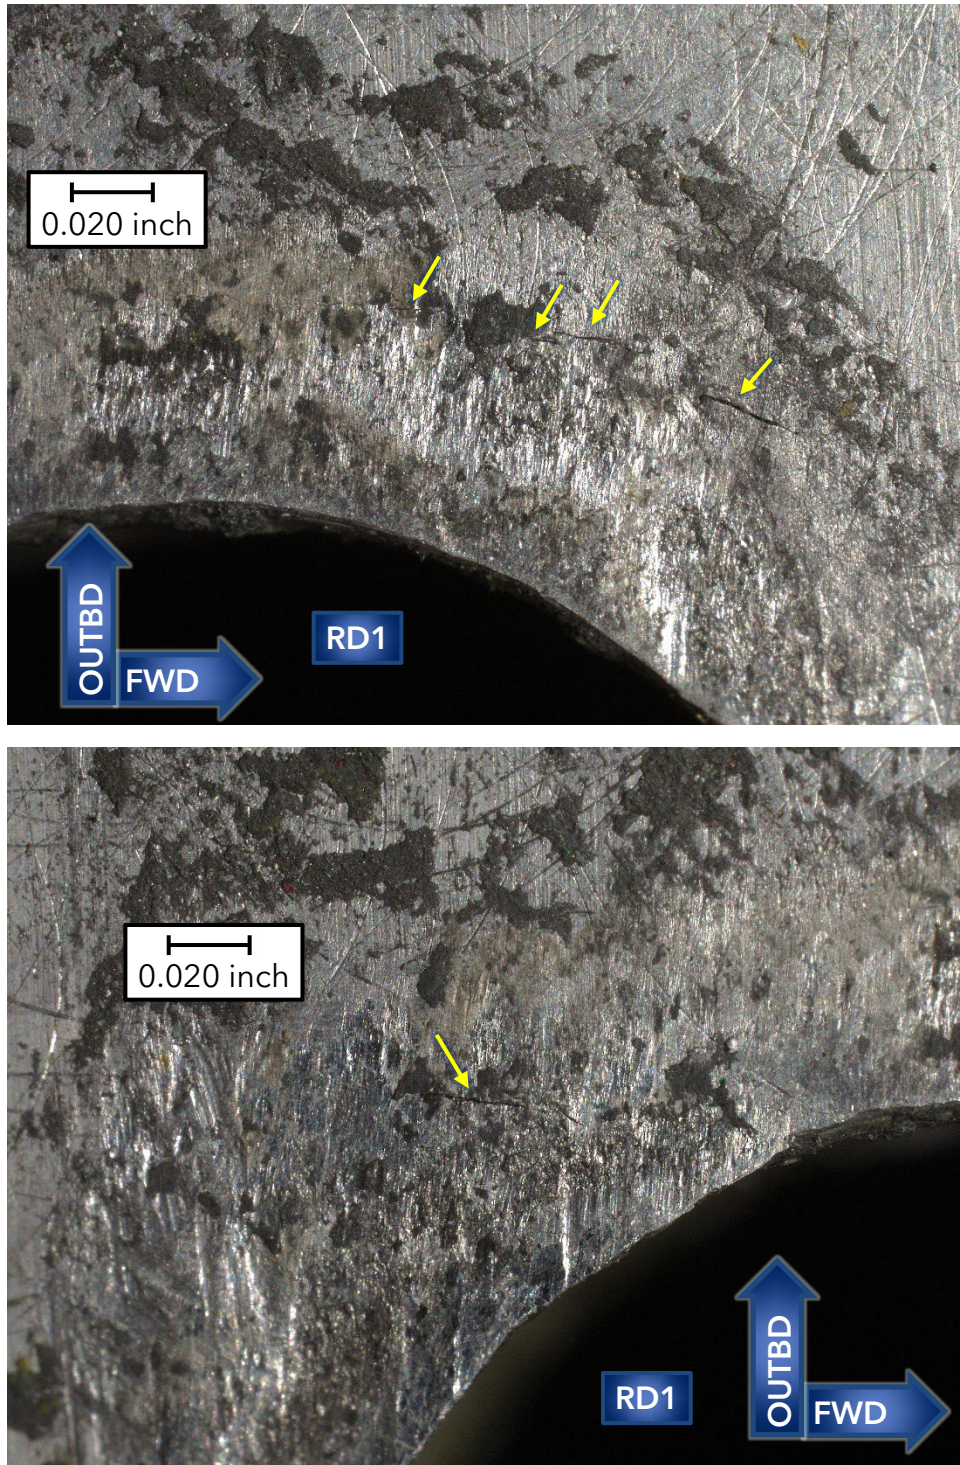
**Figure 9.** Closer views of the lower cap lower surface outboard of hole RD1. Unlabeled arrows indicate locations of small visual crack indications.

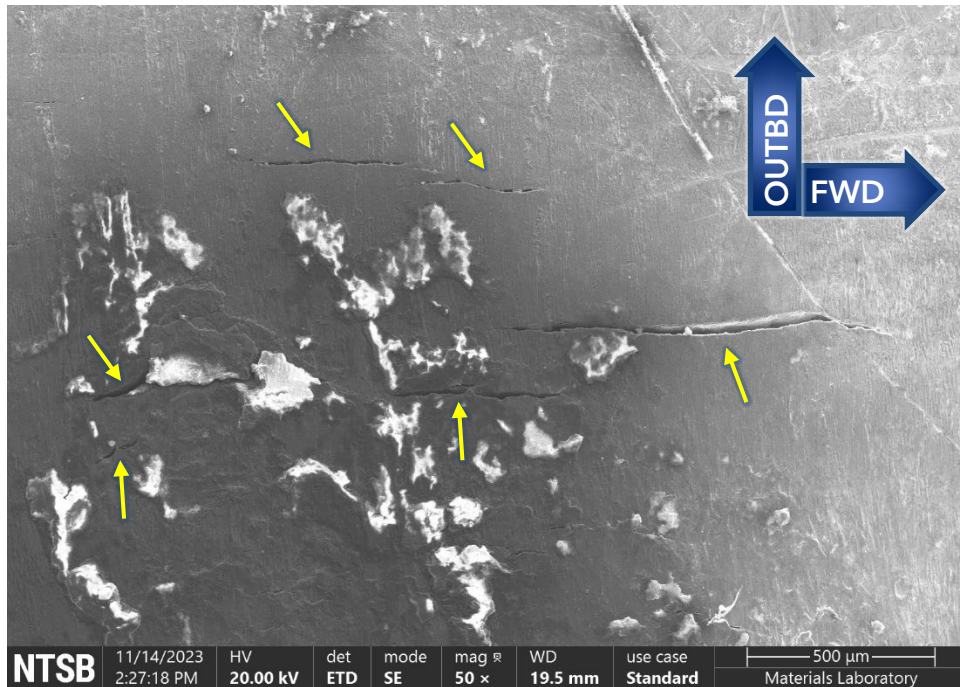
SEM. An SEM image of surface cracks near hole RC1 forward of the hole centerline is shown in figure 10. The four largest crack features in figure 10 corresponded to the visual crack indications shown in the upper image in figure 8.

**Figure 10.** SEM image of crack features shown in the upper image in figure 8. Arrows indicate crack indications observed using an SEM.

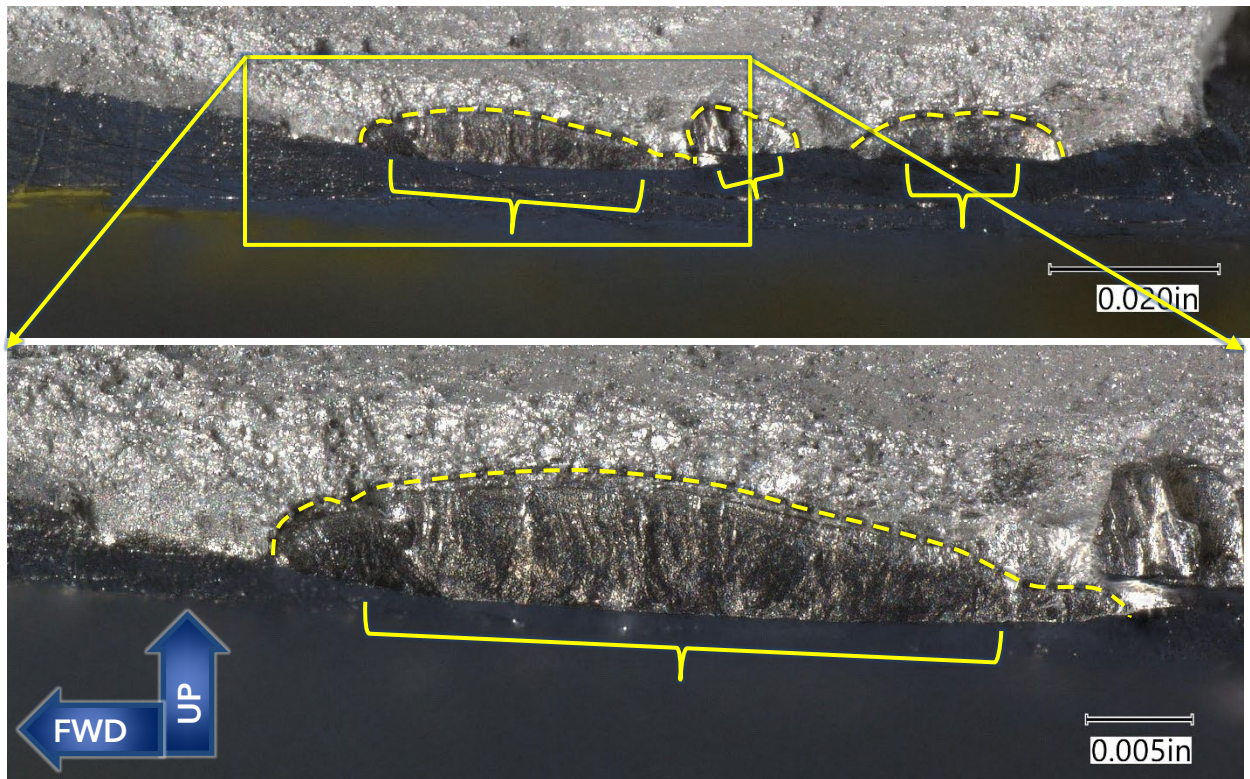
The outboard side of the lab fracture that exposed cracks outboard of hole RC1 was cleaned using an ultrasonic cleaner while submerged in acetone. A portion of the fracture appeared relatively dark consistent with preexisting cracks. The preexisting cracks had relatively flat fracture features with curving crack arrest lines, features consistent with fatigue. Close views of fatigue cracks exposed by the lab fracture are shown in figure 11, where dashed lines indicate the extent of the fatigue region, and brackets indicate fatigue origin areas. The cracks had multiple fatigue origins with broad origin areas relative to the crack depth. The largest of the fatigue regions shown in the detail image in figure 11 was 0.040 inch long where it intersected the lower surface and extended up to 0.006 inch deep.

**Figure 11.** Outboard side of laboratory fracture outboard of hole RC1 after opening the crack shown circled in figure 8. Dashed lines indicate the fatigue boundaries, and brackets indicate the fatigue origin areas.

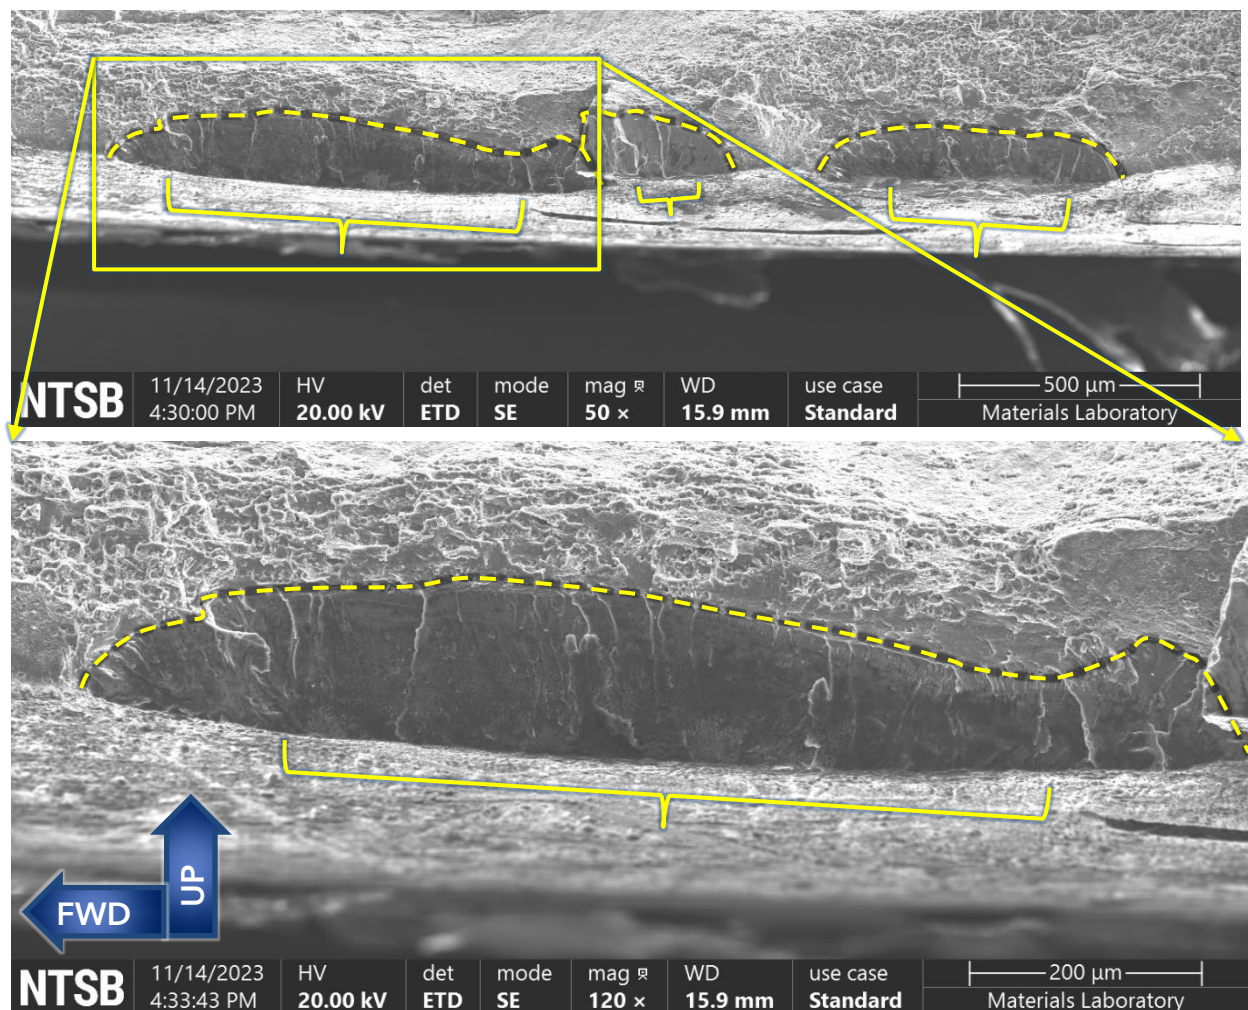
The lab fracture near hole RC1 was further examined using an SEM, and SEM images of the fatigue regions are shown in figure 12. The SEM images showed flat features with curving crack arrest lines consistent with fatigue extending to the boundaries shown. The cap lower surface adjacent to the crack was disturbed from fretting damage, but no other anomalies were observed associated with the fatigue origins.

**Figure 12.** SEM image of the laboratory fracture outboard of hole RC1. Dashed lines indicate the fatigue boundaries, and brackets indicate the fatigue origin areas.

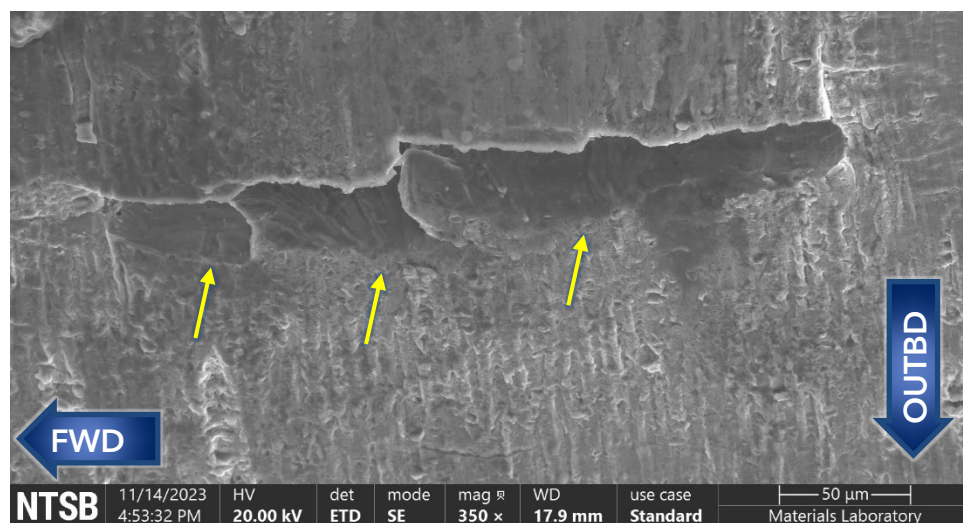
A secondary crack was observed on the lower surface outboard of the lab fracture that had opened slightly during the lab fracture. The secondary crack had flat features with radial marks, ratchet marks, and curving crack arrest lines consistent with fatigue emanating from multiple origins indicated with unlabeled arrows in figure 13. The lower surface of the cap around the secondary crack was also disturbed consistent with fretting damage.

**Figure 13.** SEM image of a secondary fatigue crack located outboard of the laboratory fracture near hole RC1. Arrows indicate origin areas.

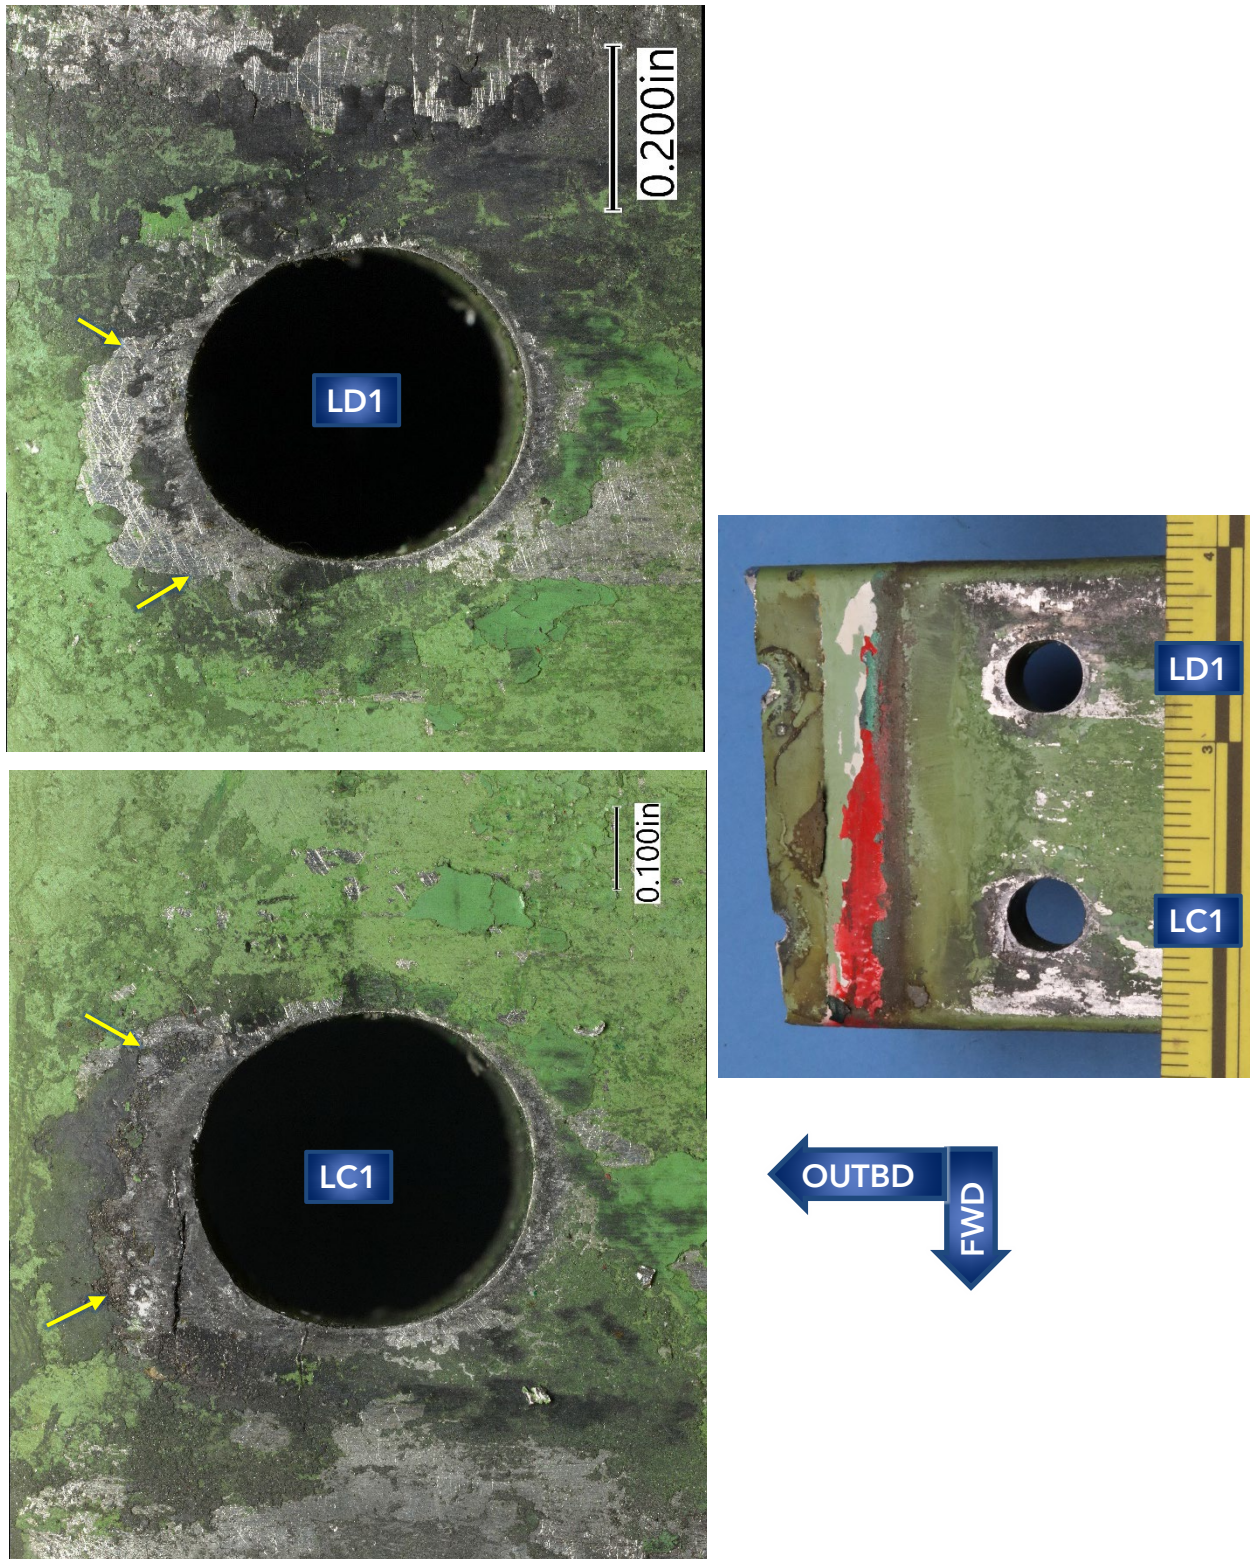
Close views of the lower surface at holes LC1 and LD1 in the left wing main spar lower cap are shown in figure 14. Compared to the right wing lower cap surface, more primer was present in the area around the attachment holes, but areas on the outboard side of holes LC1 and LD1 were disturbed, and the circular scratch pattern was replaced with rubbed and smeared surfaces consistent with fretting contact damage as indicated with unlabeled arrows in figure 14. The diameter of holes LC1 and LD1 were measured in the spanwise and transverse directions, and results showed elongation in the spanwise direction as shown in table 2.

**Figure 14.** Left wing main spar lower cap showing the lower surface inboard of the fracture with closer views of the areas around attachment holes LC1 and LD1. Arrows in the left images indicate areas of fretting damage adjacent to the holes.

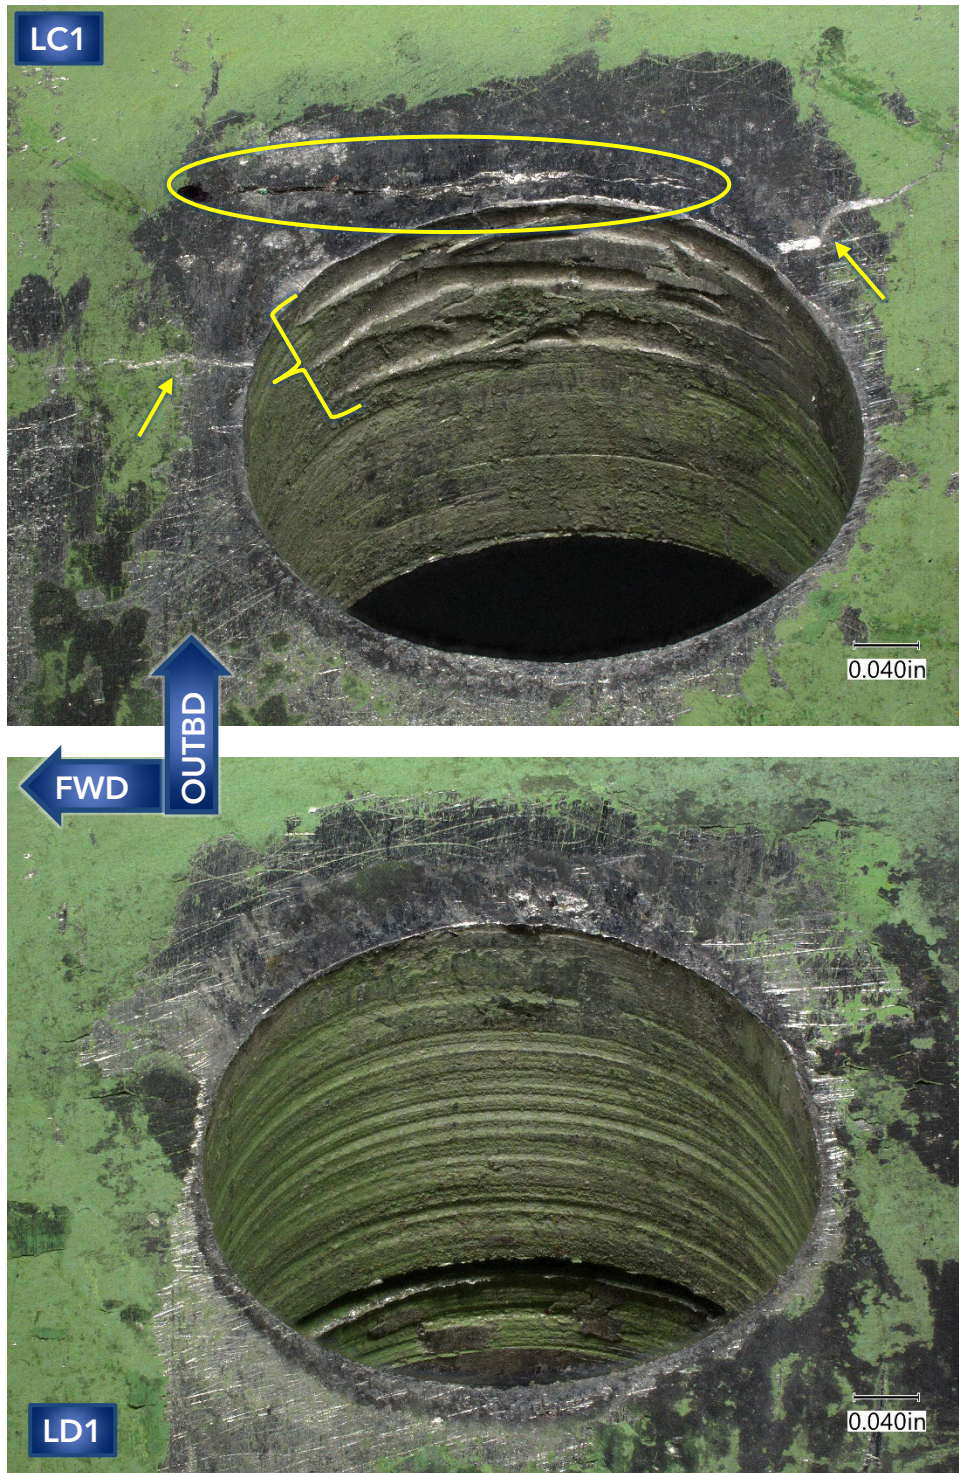
Closer views of the fretted areas outboard of attachment holes LC1 and LD1 are shown in figure 15. In the upper image in figure 15, a crack indication in the fretted area outboard of hole LC1 is circled, and arrows point to additional cracks emanating from the forward and aft sides of the hole. The circled crack indication and the crack at the forward side of hole LC1 were oriented in the transverse direction while the crack at the aft side of the hole angled aft and outboard.

Several relatively prominent grooves were observed on the outboard side of the hole near the lower surface as indicated with a bracket in the upper image in figure 15. A series of circumferential machining grooves were observed in the interior surface of hole LD1 as shown in the lower image in figure 15.

**Figure 15.** Oblique views of holes LC1 (upper image) and LD1 (lower image). Unlabeled arrows indicate visual crack indications emanating from the lower corner of hole LC1, and the circled crack was opened by lab fracture. A bracket indicates a series of relatively prominent circumferential imprints on the outboard side of the hole bore.

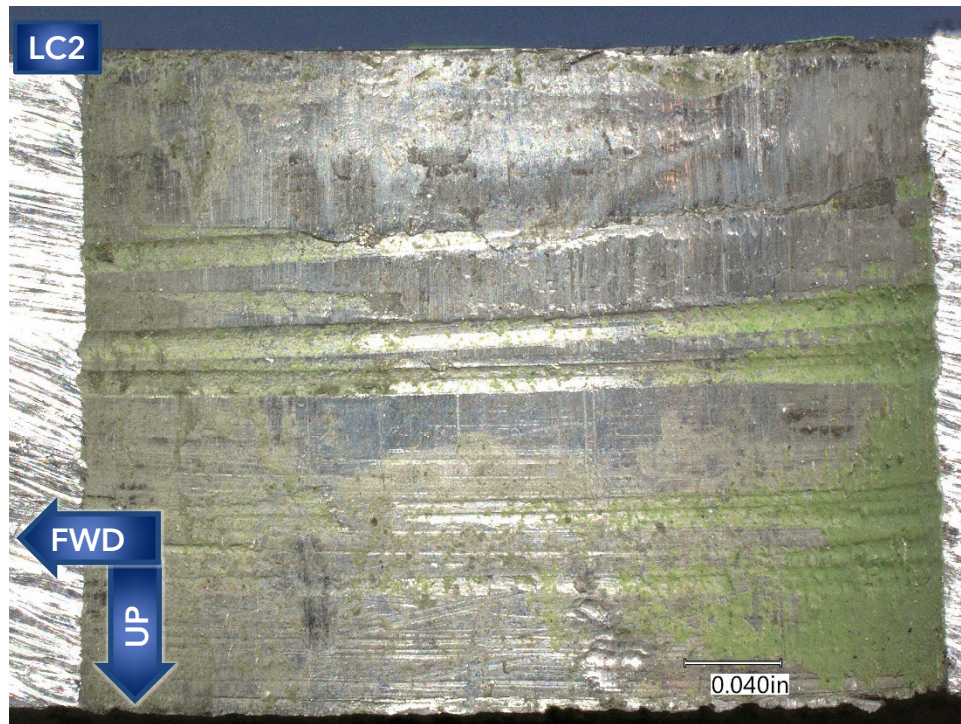
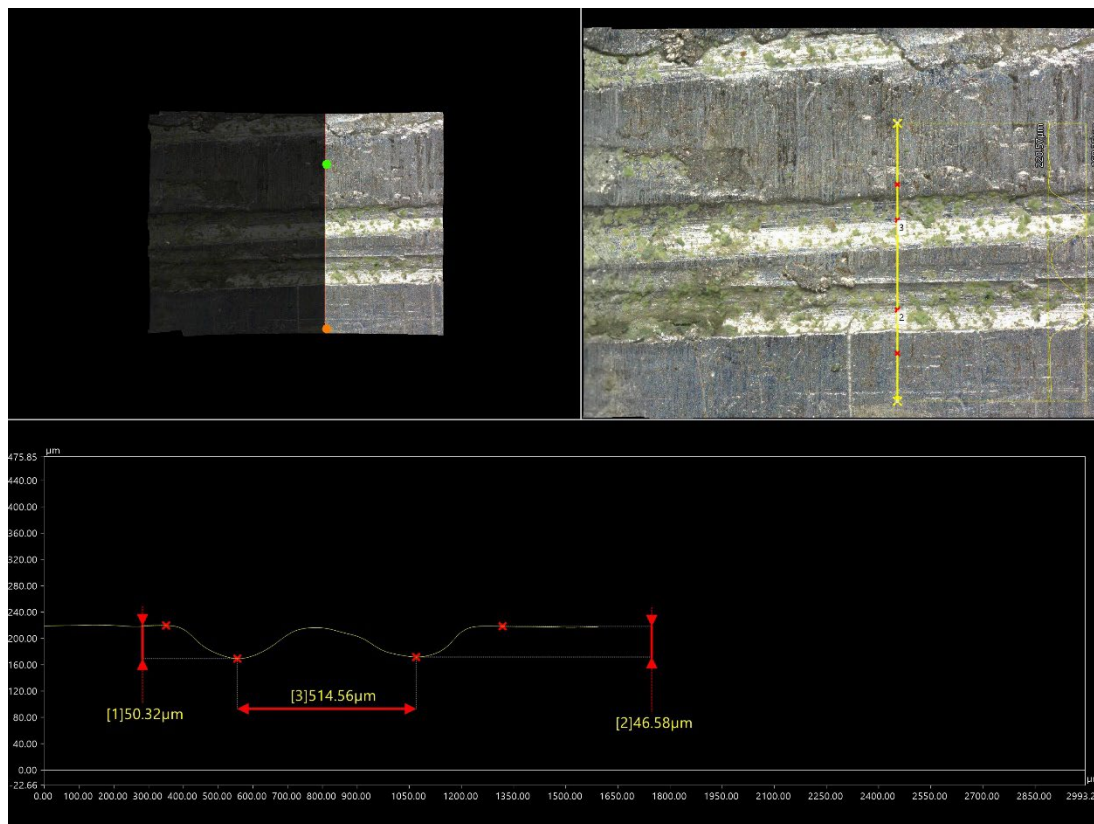
A transverse cut was made through the center of holes LC2 and LD2 to facilitate further examination of the lower cap piece, and the sectioned piece was submerged in acetone and cleaned using an ultrasonic cleaner. The bores for holes LC2 and LD2 were then examined directly. Nearly circumferential grooves were observed in hole LC2 as shown in figure 16. A relative depth profile was obtained for the hole surface along a line parallel to the hole axis using a Keyence VHX-7000 microscope with a 100x objective, and the resulting profile is shown in figure 16. The

scanned grooves had relative depths of 0.0018 to 0.0020 inch (46.6 to 50.3 microns) deep, and the spacing between the two grooves was 0.0203 inch (514.5 microns).

**Figure 16.** Outboard side of hole LC2 showing circumferential grooves in the surface (upper image). The lower image shows a relative depth profile scan obtained across two of the grooves using a Keyence VHX-7000 optical microscope with a 100x objective lens.

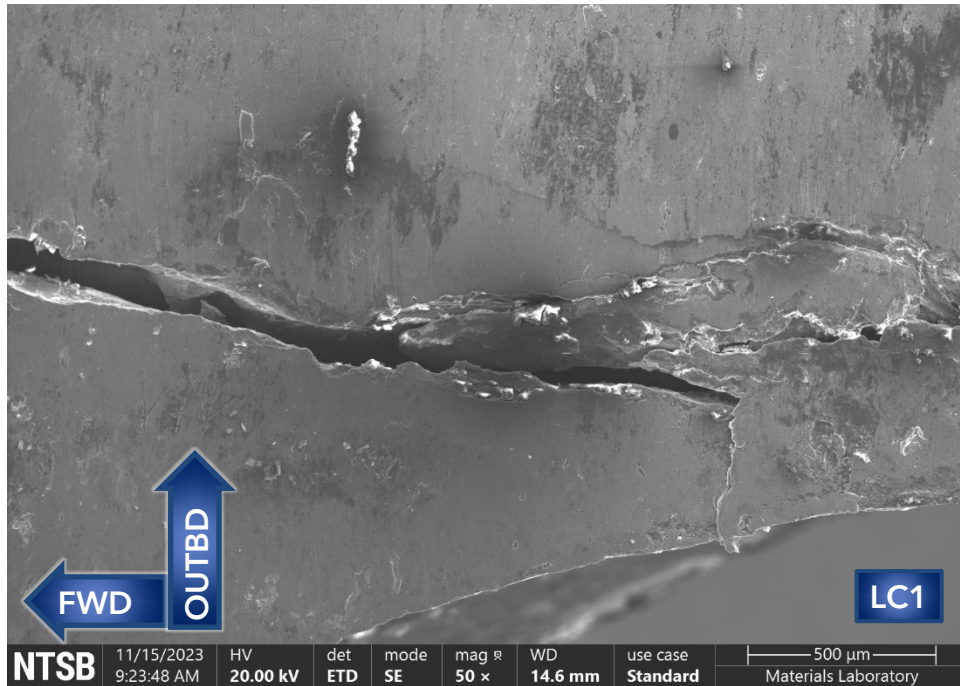
The lower surface of the left cap piece was examined using an SEM around holes LC1 and LD1. An SEM image of the crack feature at the outboard side of hole LC 1 is shown in figure 17. The lower surface had a smooth rubbed appearance adjacent to the crack in this area. Further scanning of the lower surface revealed isolated areas with angular impressions and embedded faceted nonconductive particles such as the area shown circled in figure 18. Energy dispersive x-ray spectroscopy (EDS) was used to analyze the composition of the embedded particles, and two examples of typical EDS spectra obtained with a 20 kV accelerating voltage are presented in figure 19. The spectra generally consisted of a high peak of silicon and smaller peaks of oxygen and carbon as shown in both spectra in figure 19. Some spectra also contained a peak of aluminum as shown in the lower spectrum in figure 19.

**Figure 17.** SEM image of the lower surface of the cap from the left wing showing the crack just outboard of hole LC1.
