# National Transportation Safety Board

ERA23FA340

## **MATERIALS LABORATORY**

Location: Fort Pierce, Florida  
Date: August 17, 2023  
Vehicle: Piper PA-28-161, N9855S  
Investigator: Adam Gerhardt, AS-ERA

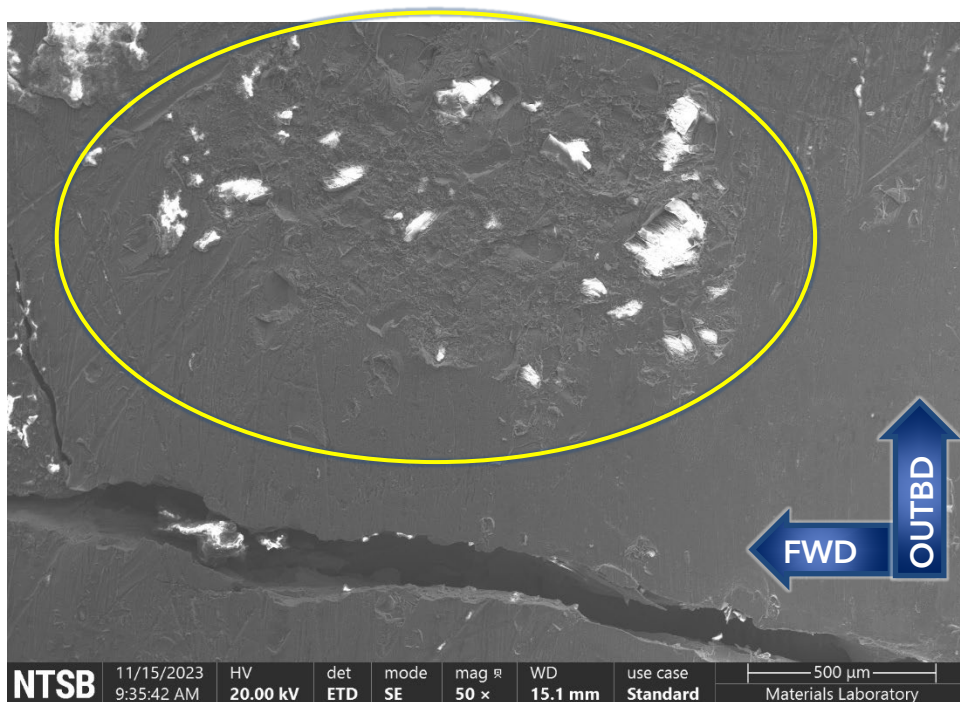
**Figure 18.** SEM image of a cluster of angular imprints and embedded nonconductive faceted particles (circled area) on the lower surface of the cap from the left wing outboard of the crack near hole LC1.

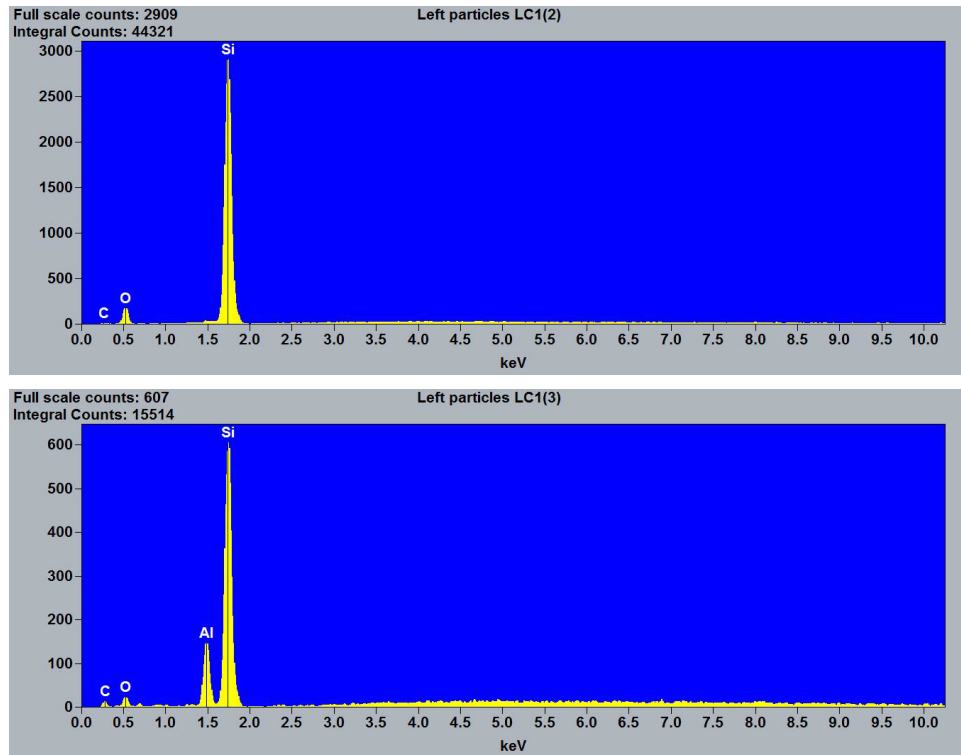
**Figure 19.** Typical EDS spectra of faceted particles shown in figure 18.

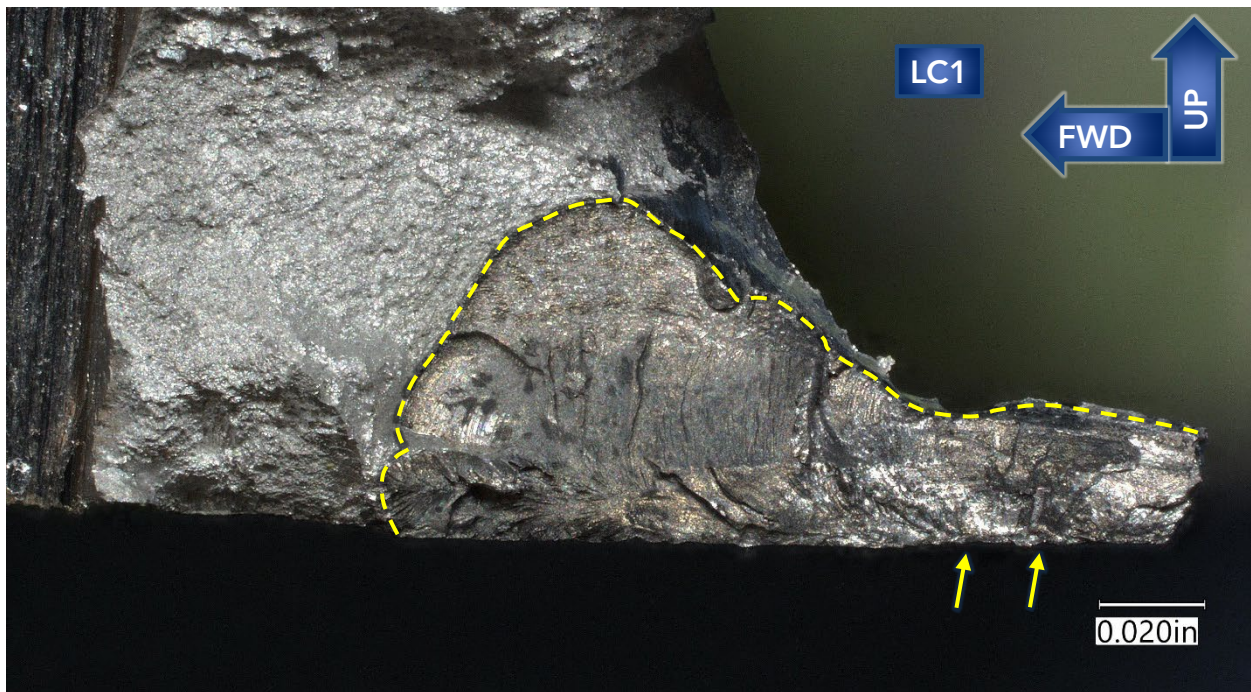
The inboard side of the lab fracture that exposed the crack outboard of hole LC1 was cleaned using an ultrasonic cleaner while submerged in acetone. A portion of the fracture appeared relatively dark consistent with a preexisting crack. The preexisting crack had relatively flat fracture features with curving crack arrest lines, features consistent with fatigue. A close view of the fatigue crack exposed by the lab fracture is shown in figure 20, where dashed lines indicate the extent of the fatigue region, and arrows point to two fatigue origin areas. The exposed fatigue region was 0.146 inch long where it intersected the lower surface and extended up to 0.064 inch deep.

**Figure 20.** Inboard side of the laboratory fracture outboard of hole LC1 after opening the crack shown circled in figure 15. A dashed line indicates the fatigue boundary, and arrows indicate fatigue origin areas.

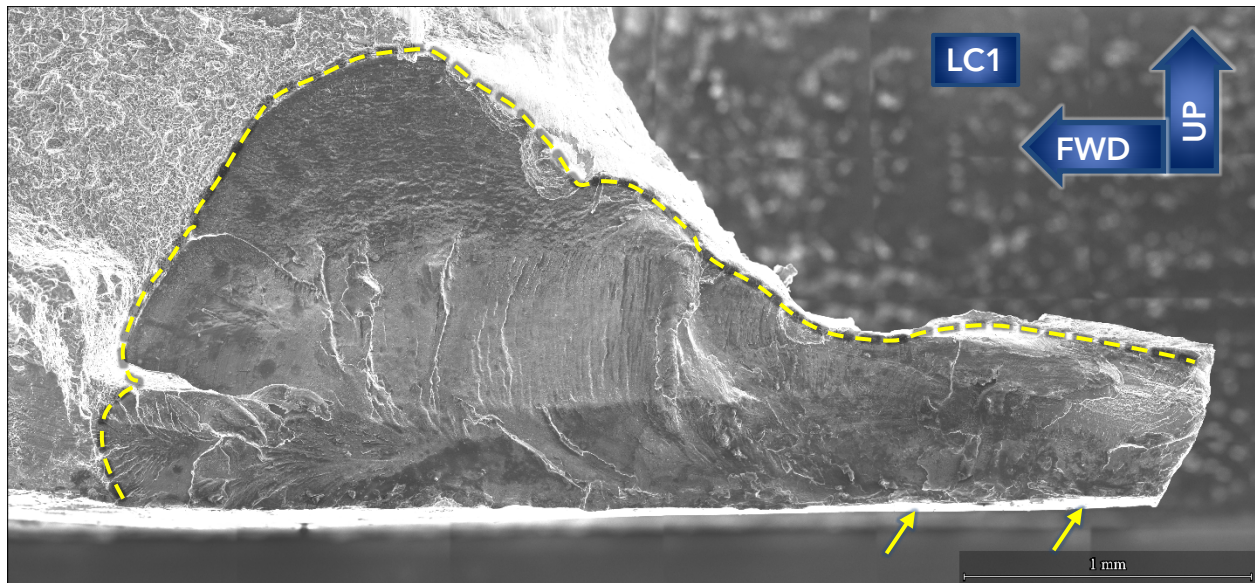
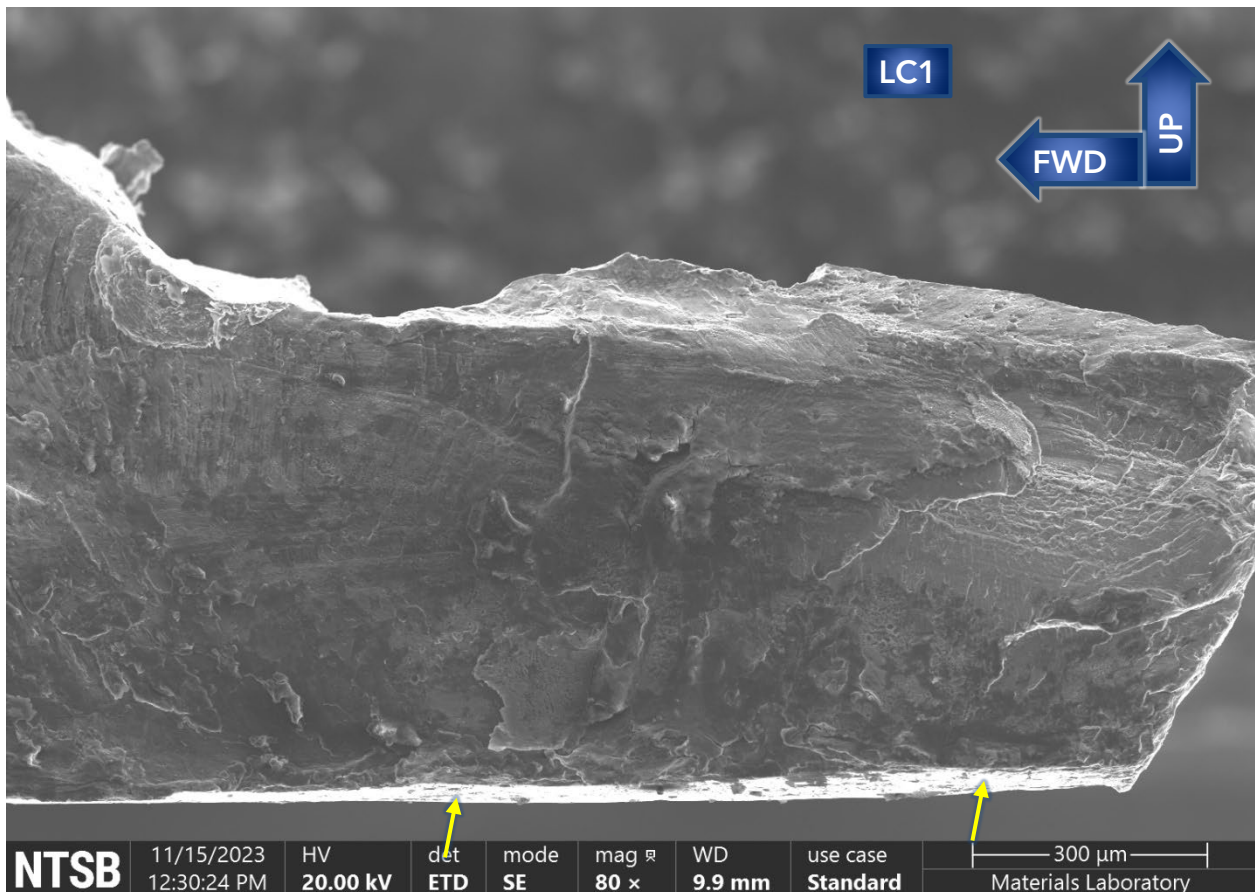
The lab fracture near hole LC1 was further examined using an SEM, and SEM images of the fatigue region are shown in figures 21 and 22. The upper image in figure 21 is a montage of SEM images stitched together to provide an overall view of the fatigue region, and the lower image in figure 21 shows a closer view of the fatigue origins. In figure 22, unlabeled arrows indicate local fatigue crack propagation directions consistent with cracks emanating from the origin areas indicated in figure 21. The SEM images showed flat features with curving crack arrest lines consistent with fatigue. The cap lower surface adjacent to the crack as shown in figure 23 was smeared from rubbing damage that deformed the edge of the crack and obscured any potential features associated with the fatigue origins.

**Figure 21.** SEM image of the inboard side of the laboratory fracture outboard of hole LC1 after opening the crack shown circled in figure 15 (upper image) with a closer view of the origin areas (lower image). A dashed line indicates the fatigue boundary, and arrows indicate fatigue origin areas.

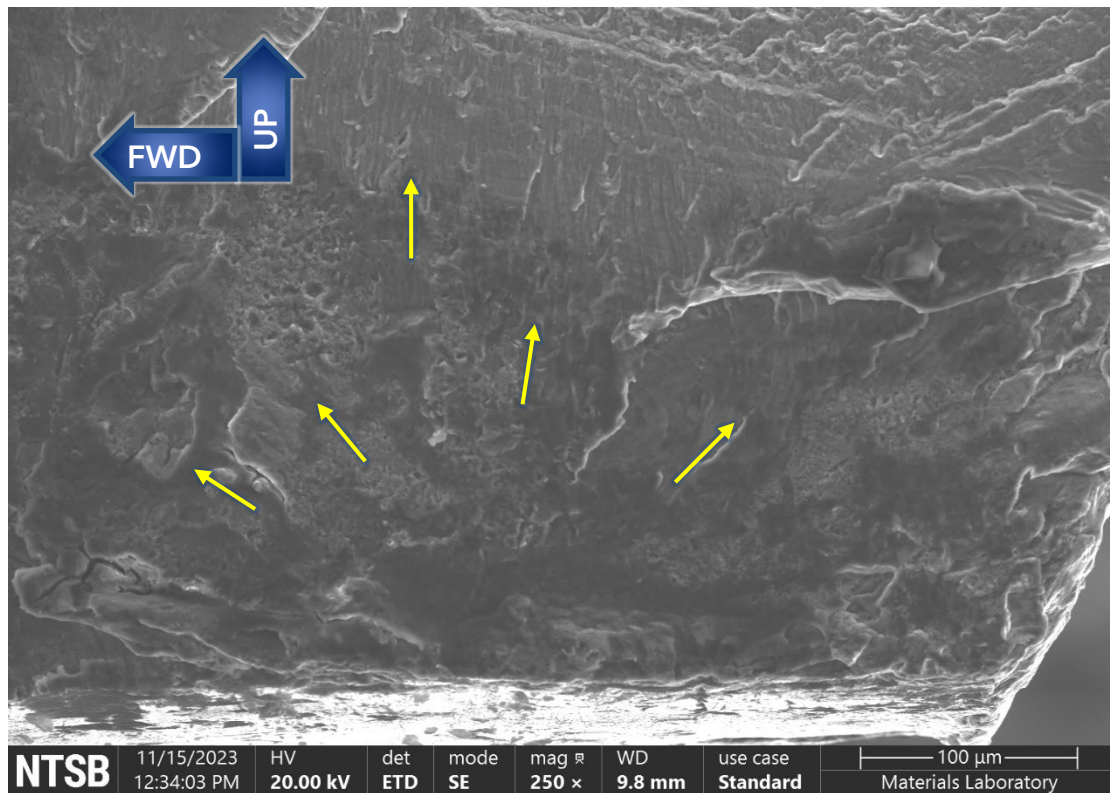
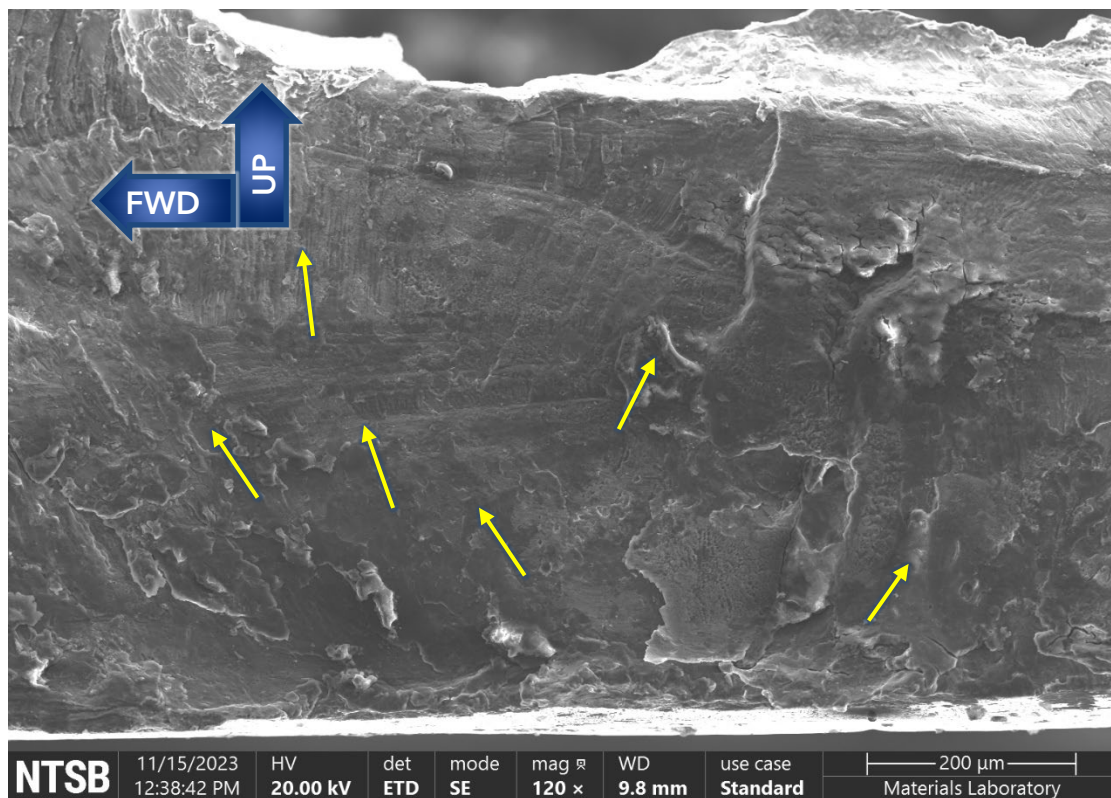
**Figure 22.** SEM images of the origin areas shown in figure 21. Unlabeled arrows indicate the local direction of fatigue propagation emanating from the origin areas.

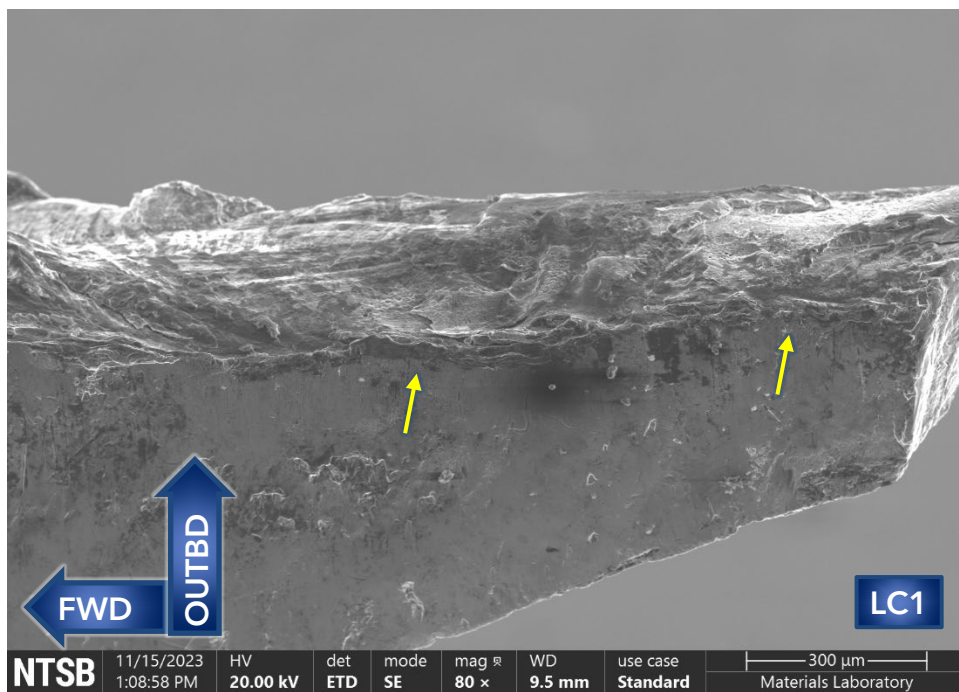
**Figure 23.** SEM image of the lower surface of the cap from the left wing after lab fracture to open the crack where unlabeled arrows point to the lower surface adjacent to the fatigue origins.
