# National Transportation Safety Board

ERA23FA340

## **AIRWORTHINESS FACTUAL REPORT**

Location: Ft. Pierce, Florida  
Date: August 17, 2023  
Time: 1202 local  
1602 UTC  
Airplane: Piper PA28-161, N9855S

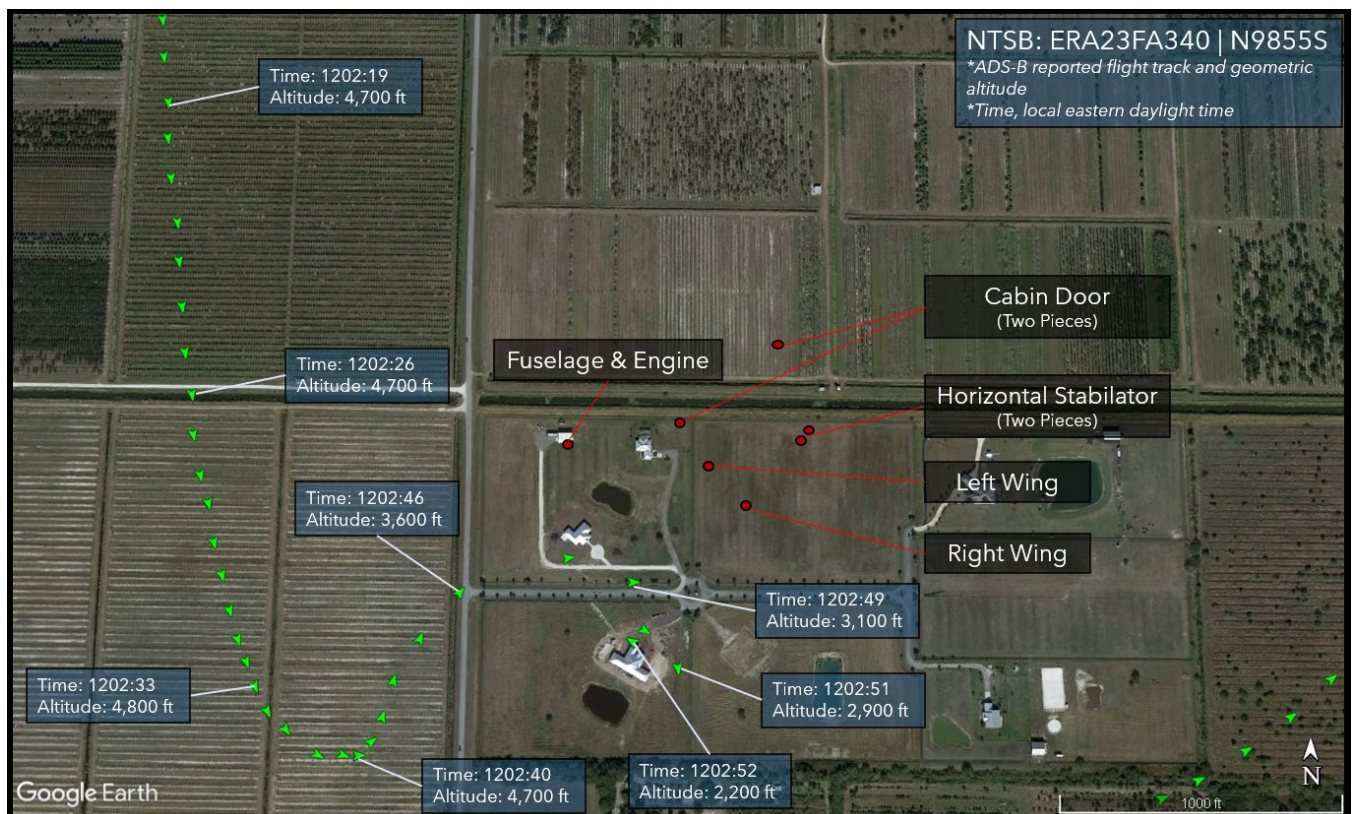
The wreckage impacted a small aluminum frame building that housed a recreational vehicle (RV). The airplane came to rest partially through the building and partially into the RV. The engine remained attached to the fuselage. Both wings and horizontal stabilator separated from the aircraft in-flight and were located about 600-700 ft east of the fuselage in the debris area noted in the figure below. The horizontal stabilator had separated into two pieces and were found near each other in the debris field. Fragments of cockpit door were also located in this debris area along with miscellaneous items from the cockpit such as the tow bar and a pilot headset.

**Figure 1: Overview of ADS-B flight track and wreckage distribution.**

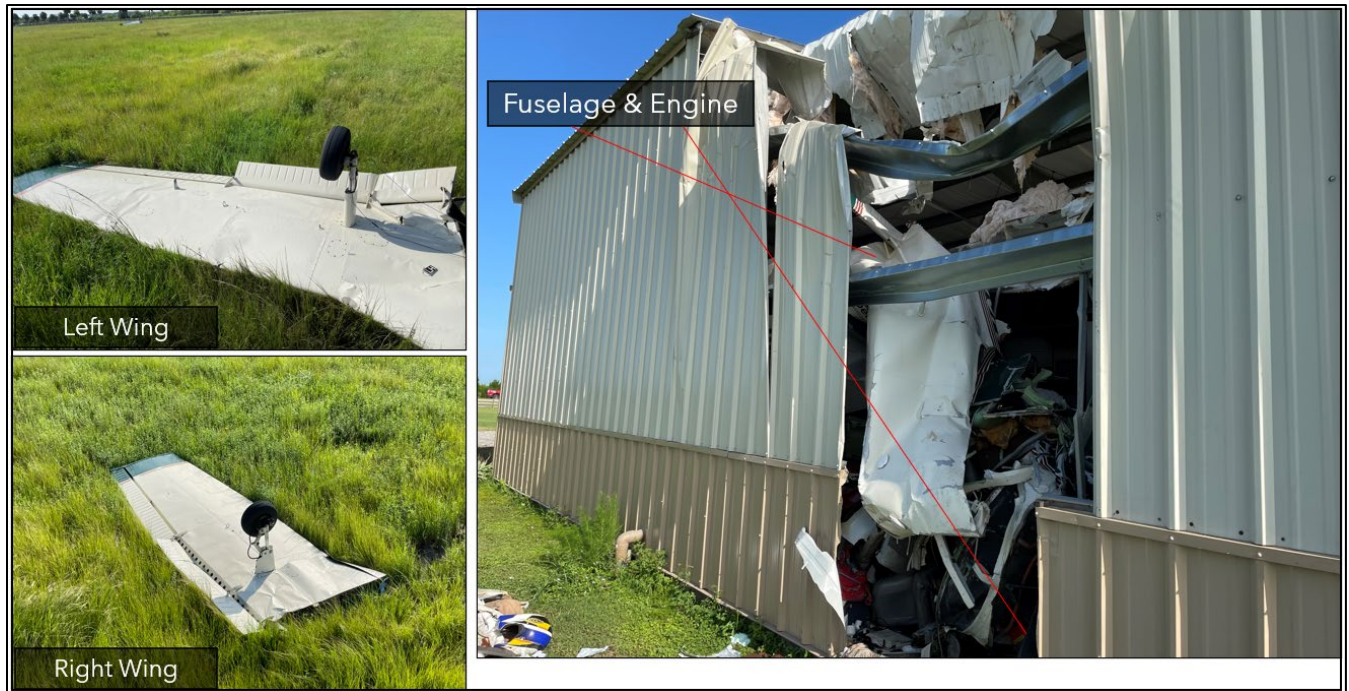
The left and right wing both separated at the wing attachment area at the fuselage. Both ailerons were located with their respective wings.

**Figure 2: View of both wings, fuselage and engine at the accident site.**

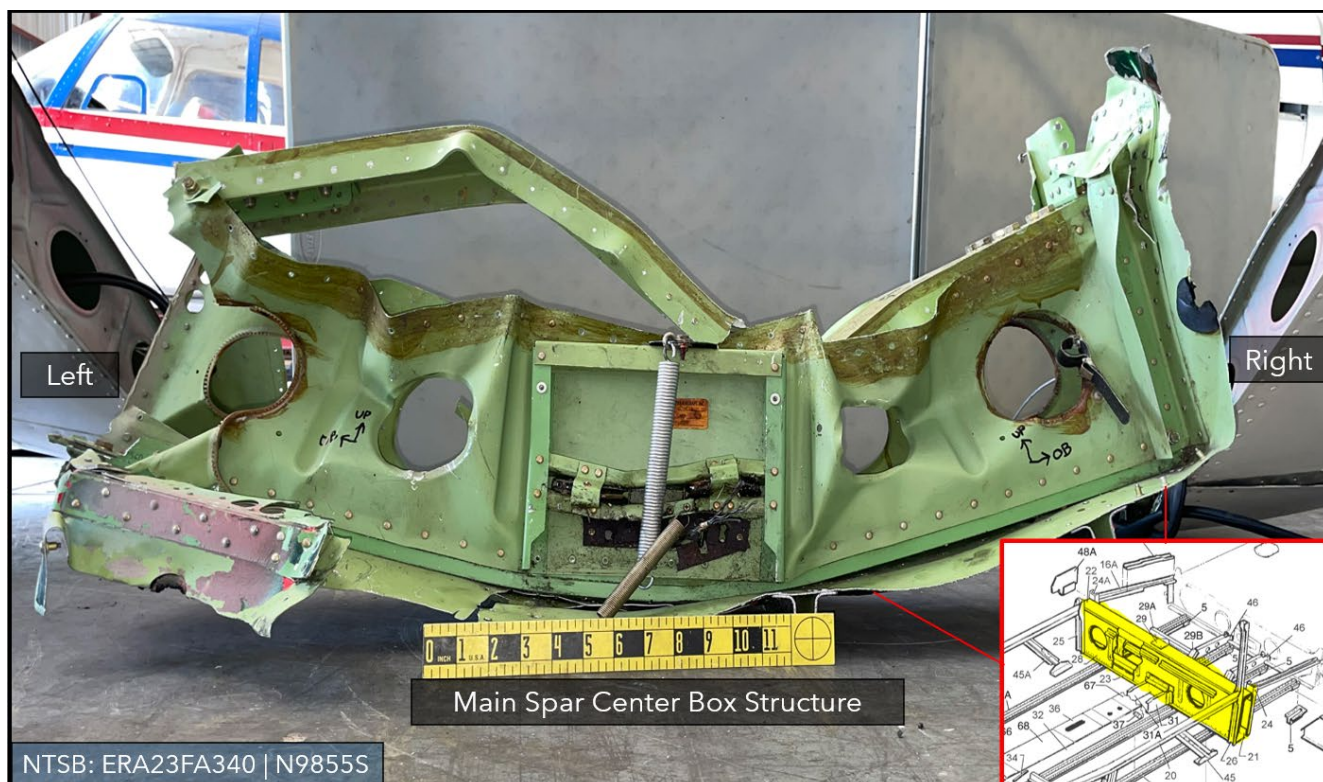
There was a pronounced symmetrical upward curve of the upper and lower spar caps. The lower spar cap was intact and with the center wing box on the ground the right and left sides rested about 5 inches above the floor. The upper spar cap was buckled (s-bend) with an upward buckle about 12 inches from the left side and a downward buckle and fracture of the cap about 21 inches from the right side.

**Figure 3: View of the main spar center box structure (with image from Piper Maintenance Manual).**

The forward and aft spar webs were separated from the upper spar cap along most of the length and remained attached to the lower spar cap. The upper and lower left and right wing fittings were fractured with portions retained in the center section. The 8 wing attach bolts per side on the left and right sides of the upper spar cap were intact and installed. The 10 wing attach bolts per side on the left and right sides of the lower spar cap were intact and installed. The outboard two wing attach bolts on both the left and right sides had green torque stripe while all the other lower wing attach bolts had red torque stripe. There was no noticeable deformation of the right lower wing fitting horizontal leg that was retained in the center section, but the web was bent aft. The right upper wing fitting that was retained in the center section was deformed upward. There was no noticeable deformation of the left lower wing fitting horizontal leg that was retained in the center section, but the web was bent aft. The left upper wing fitting that was retained in the center section was deformed slightly upward. The fracture faces on the retained fittings all had an angled, dull, grainy appearance consistent with overstress separation when examined visually and with a 10x loupe.

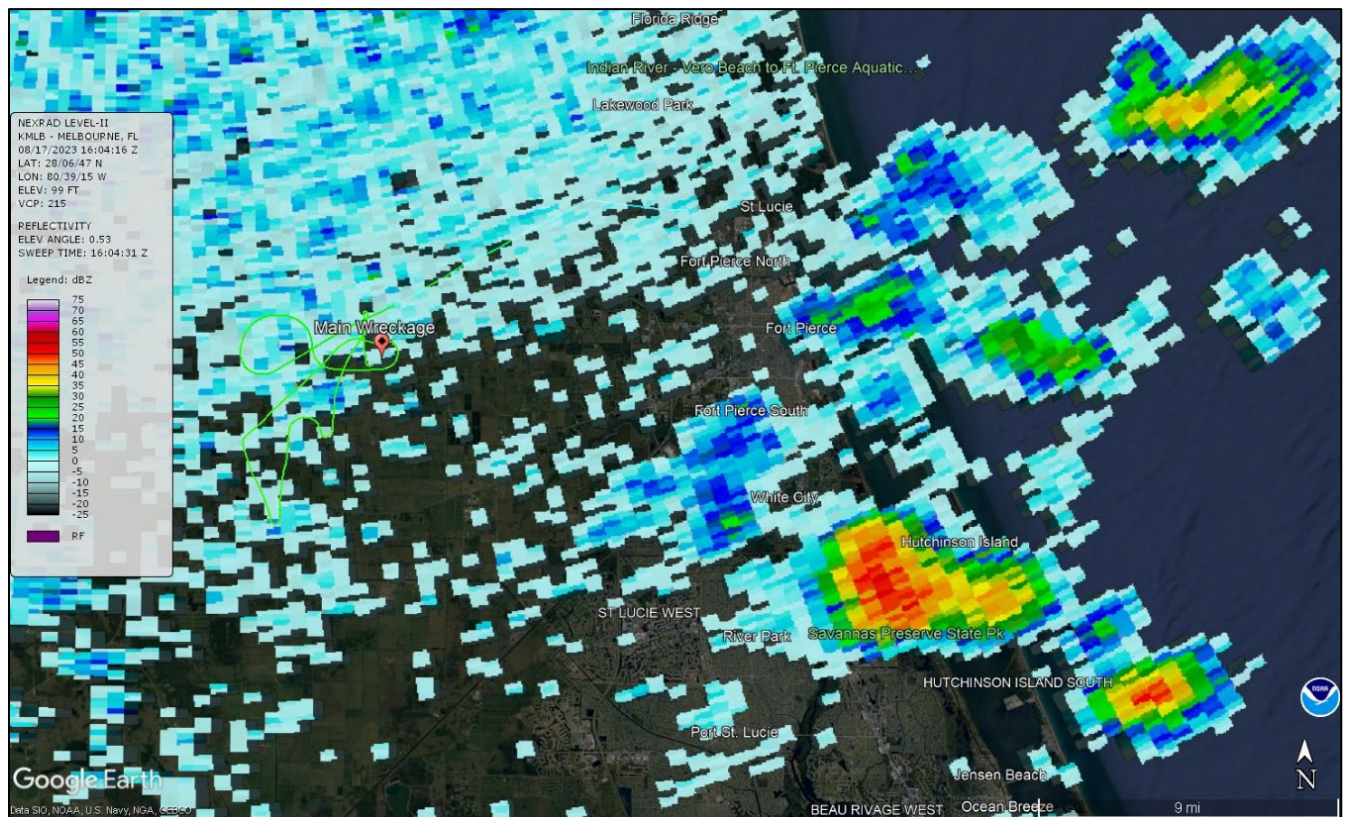
Review of routine hourly weather observation data from the nearby weather reporting station Fort Pierce (FPR), St. Lucie County International Airport, and archived weather radar, found unremarkable conditions along the route of flight.

**Figure 4: Nexrad Level II Melbourne, Florida Radar Reflectivity 1204 local. The flight track is depicted in light green, and the main wreckage location is marked with the orange and black arrow.**

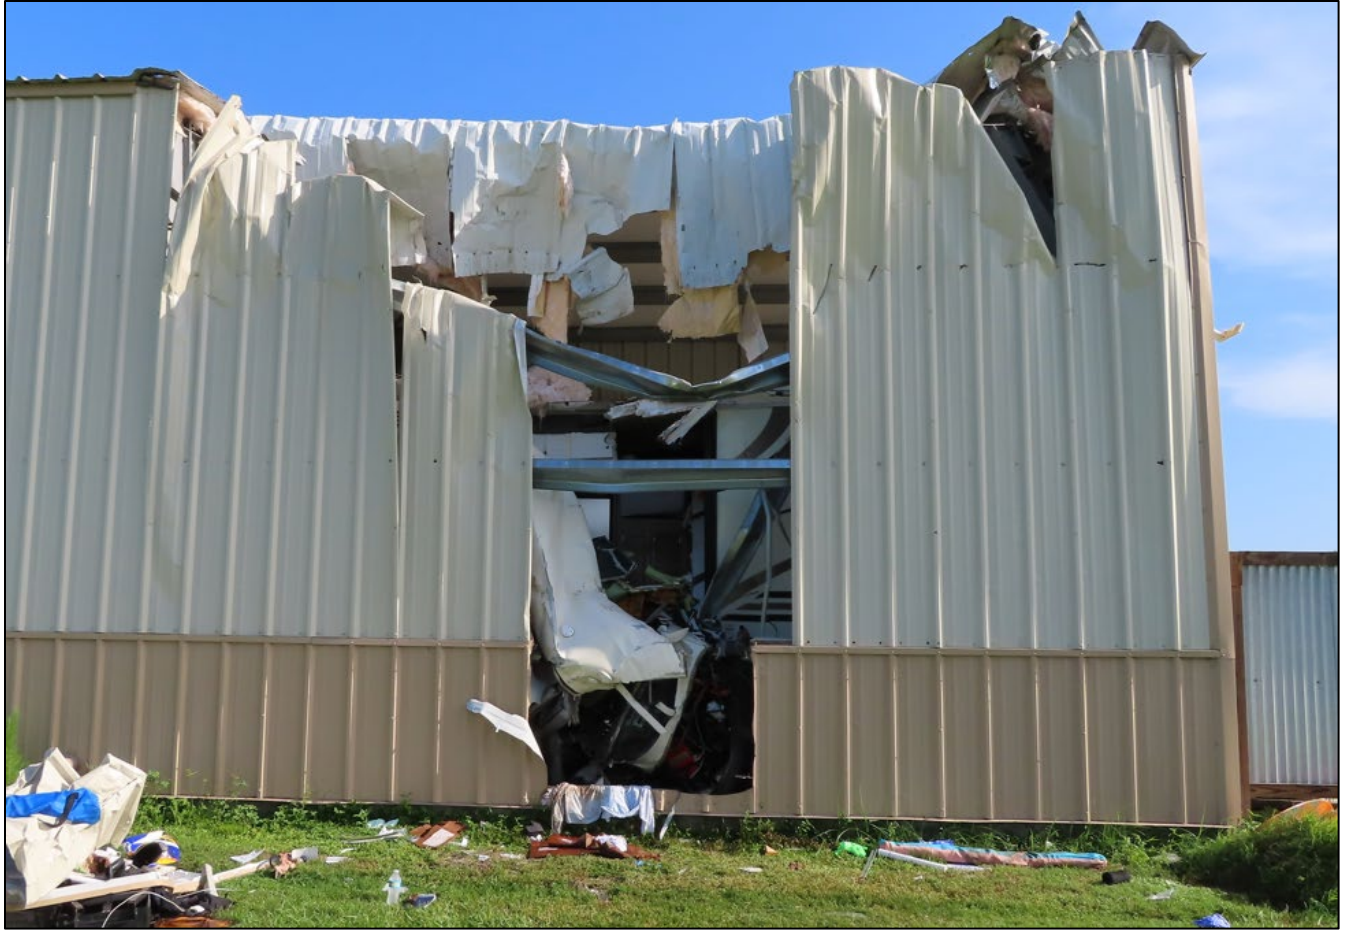
**Figure 6: View of fuselage, building, and Recreational Vehicle Impacted.**

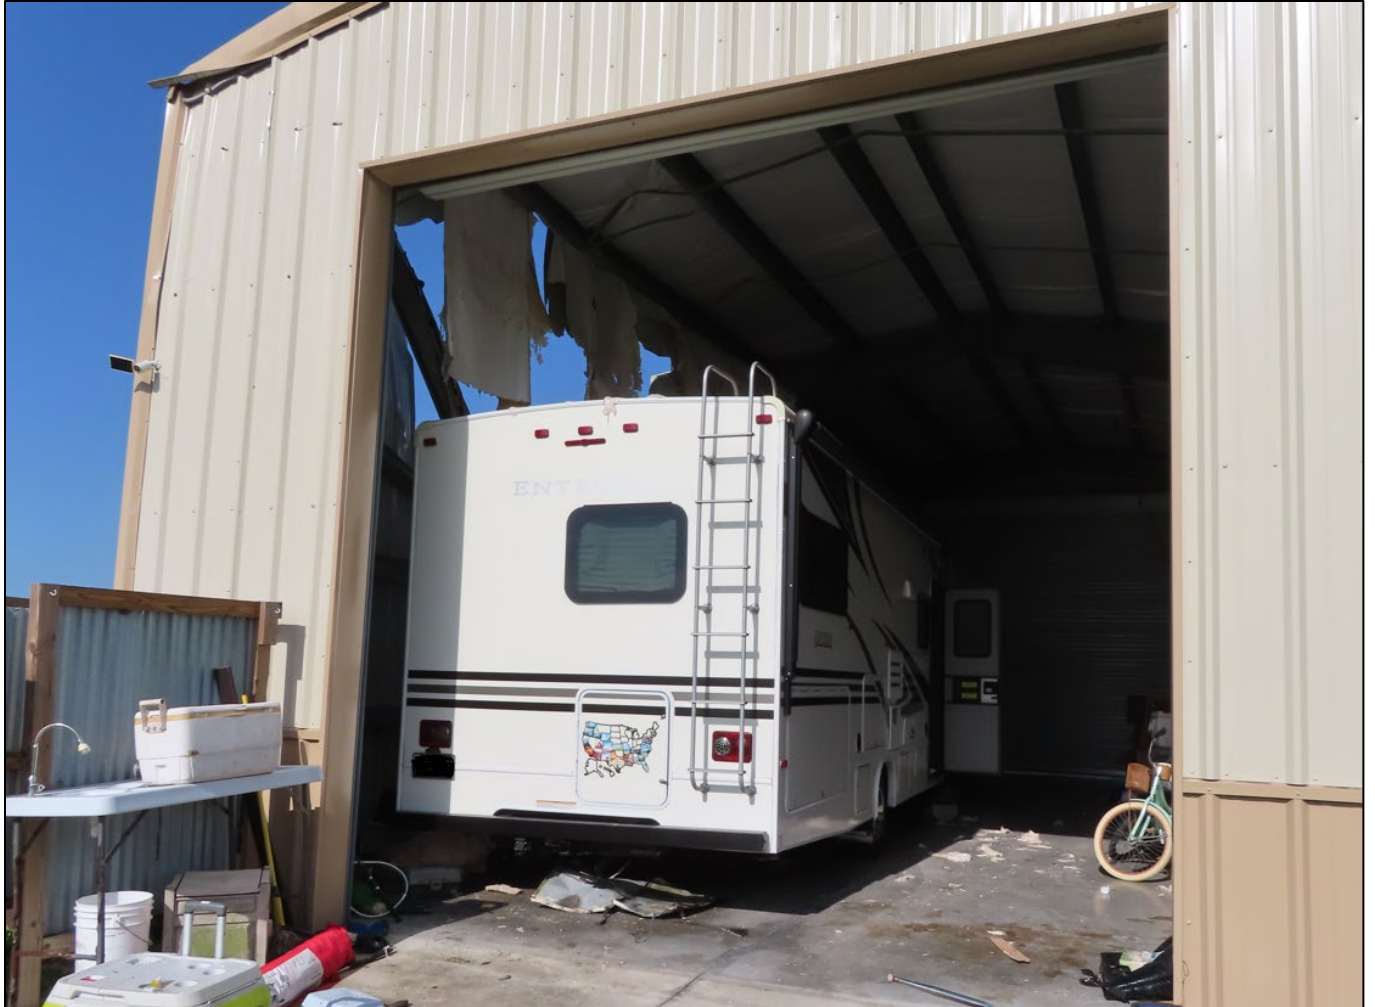
**Figure 7: View of building and Recreational Vehicle Impacted.**

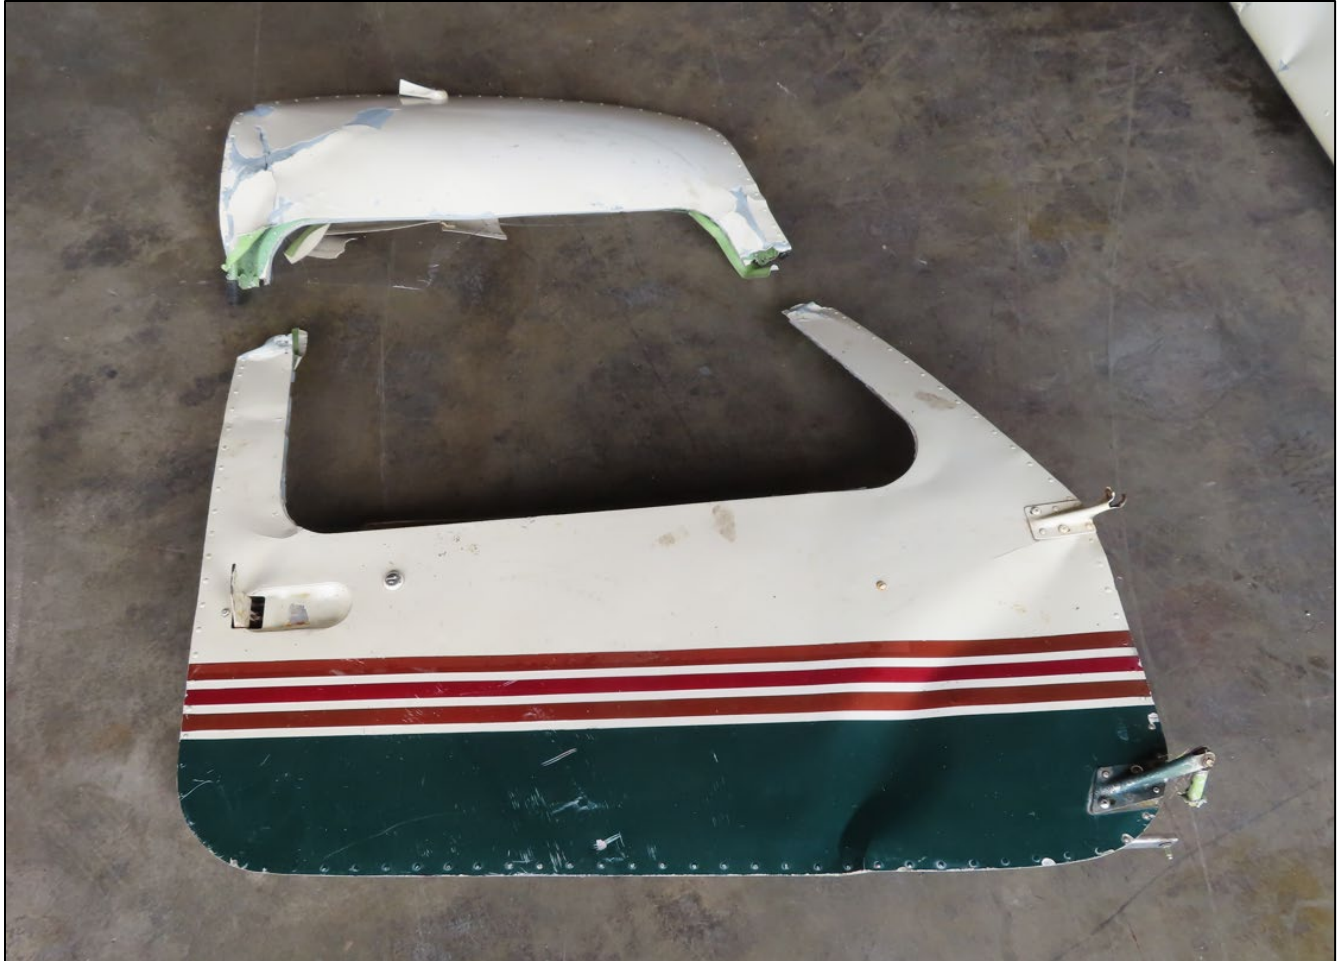
**Figure 8: View of the cockpit door which had fragmented into two pieces.**

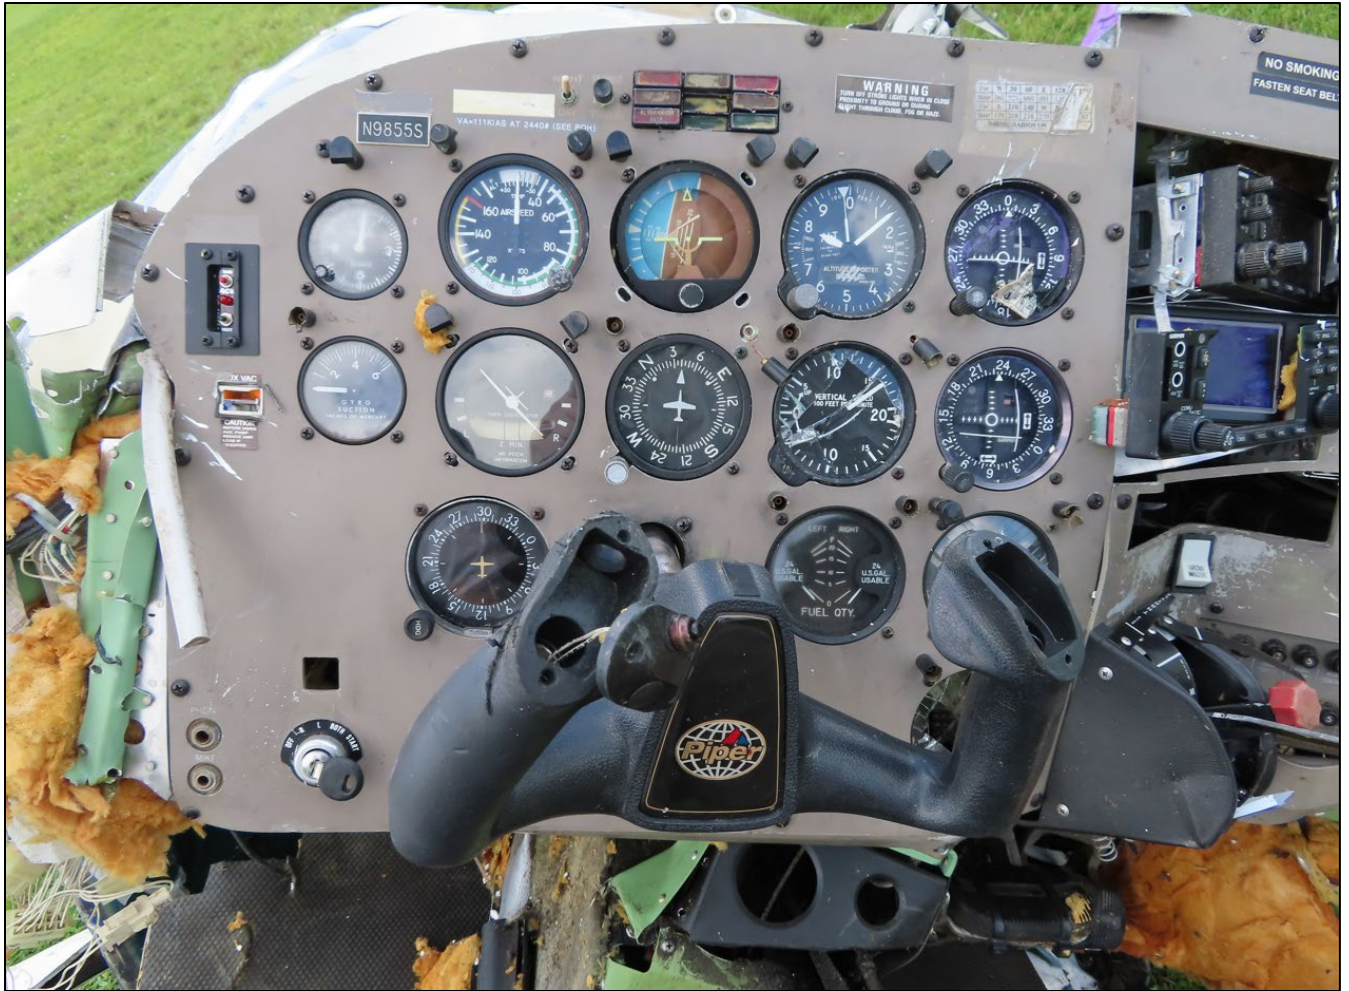
**Figure 9: View of the left side of the cockpit and flight controls.**

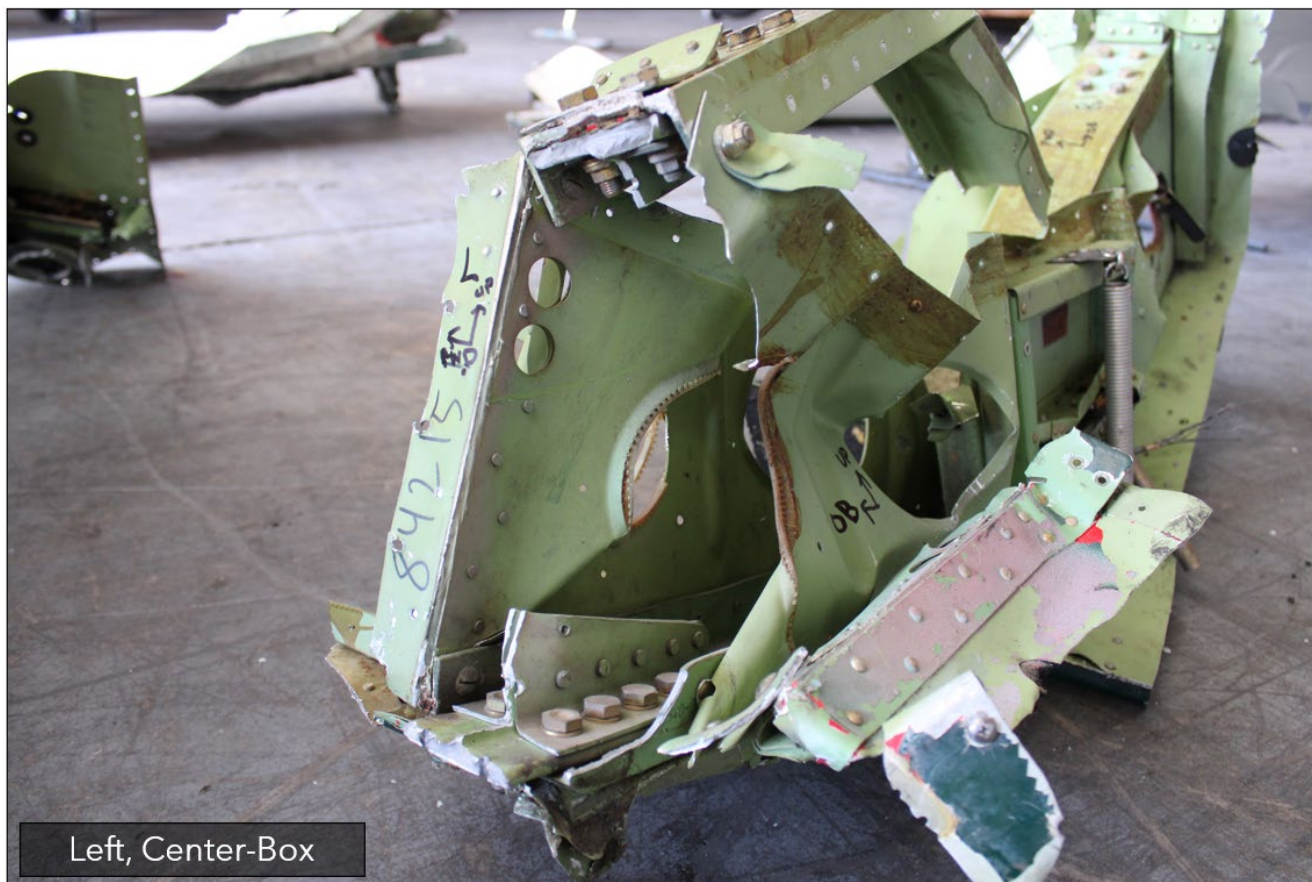
Left, Center-Box

**Figure 10: View of the left side of the center spar box.**

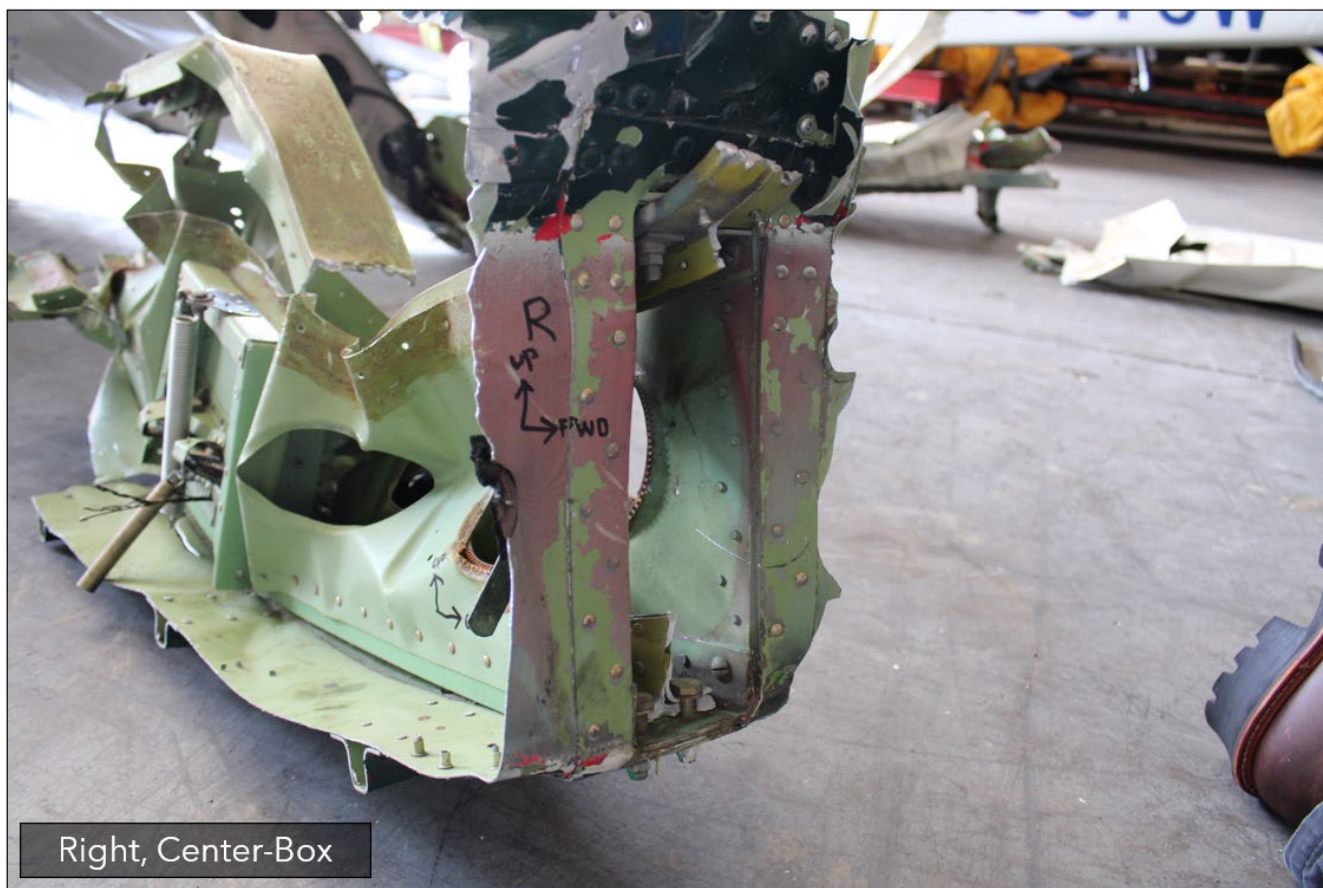
**Figure 11: View of the right side of the center spar box.**

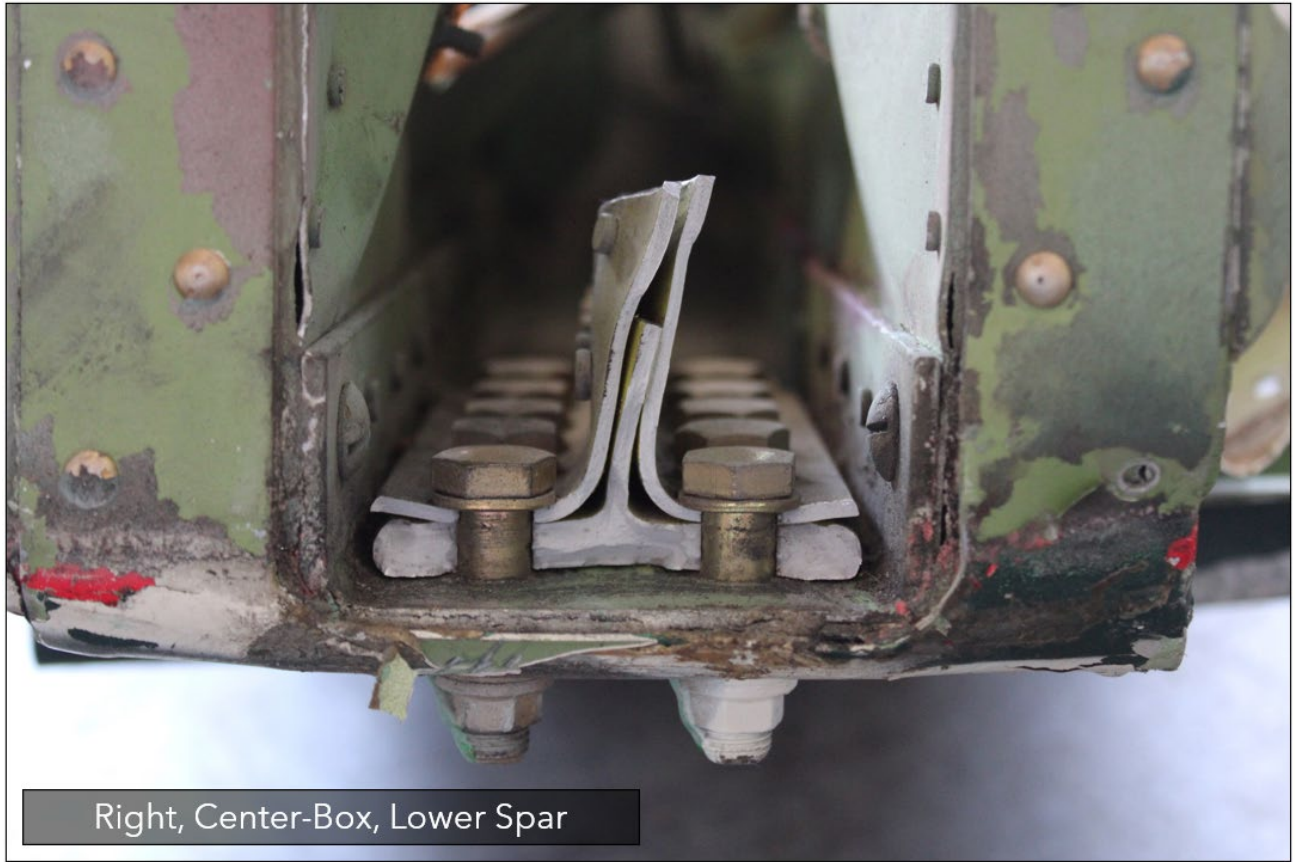
**Figure 12: View of the right side of the center spar box, lower spar.**

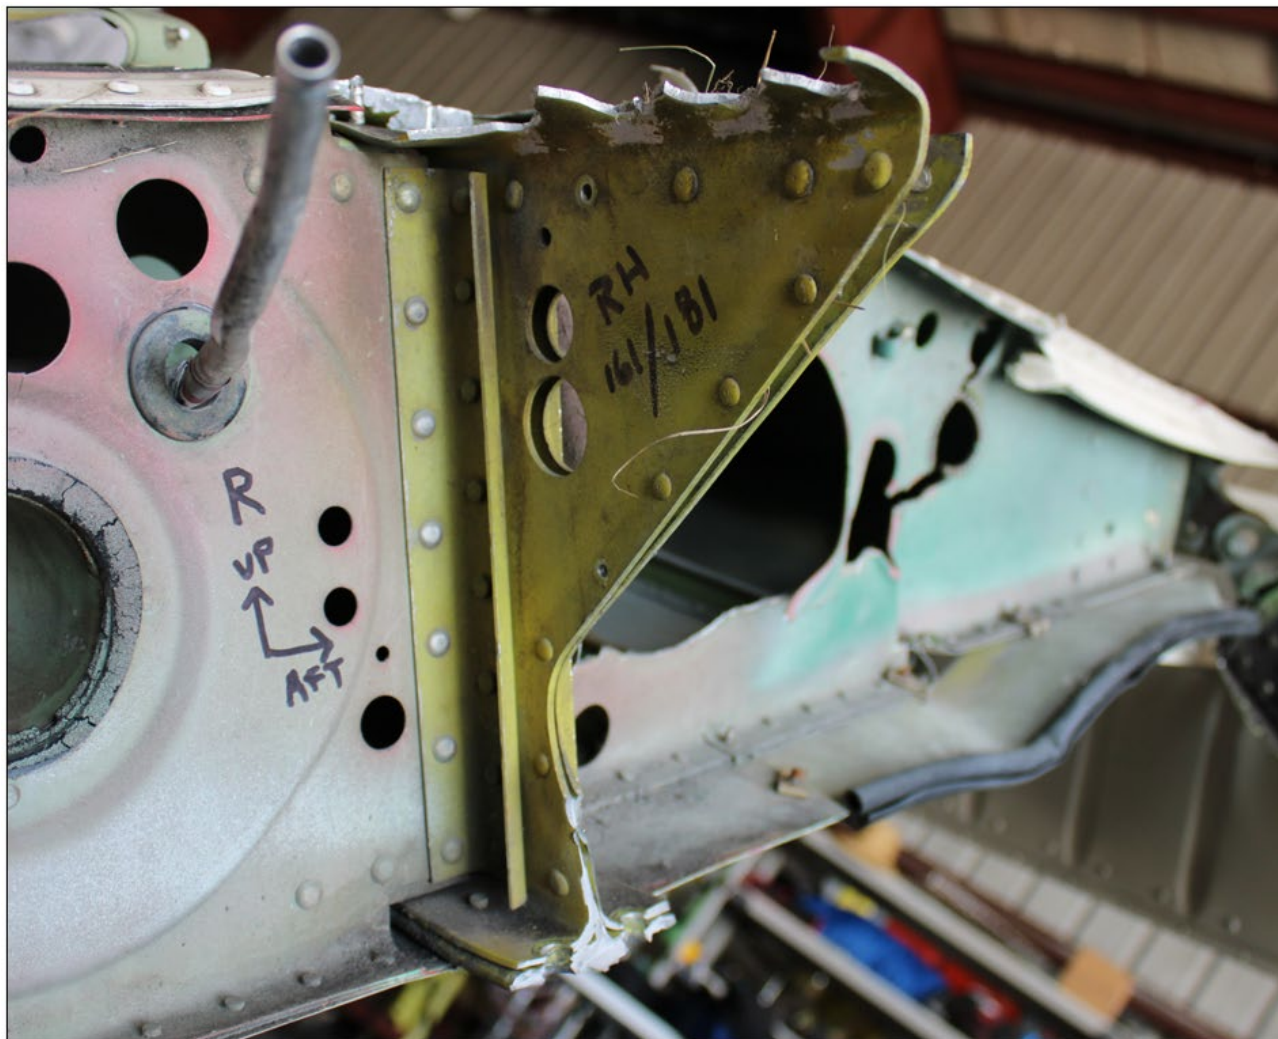
**Figure 13: View of the right side of the center spar box, upper spar.**

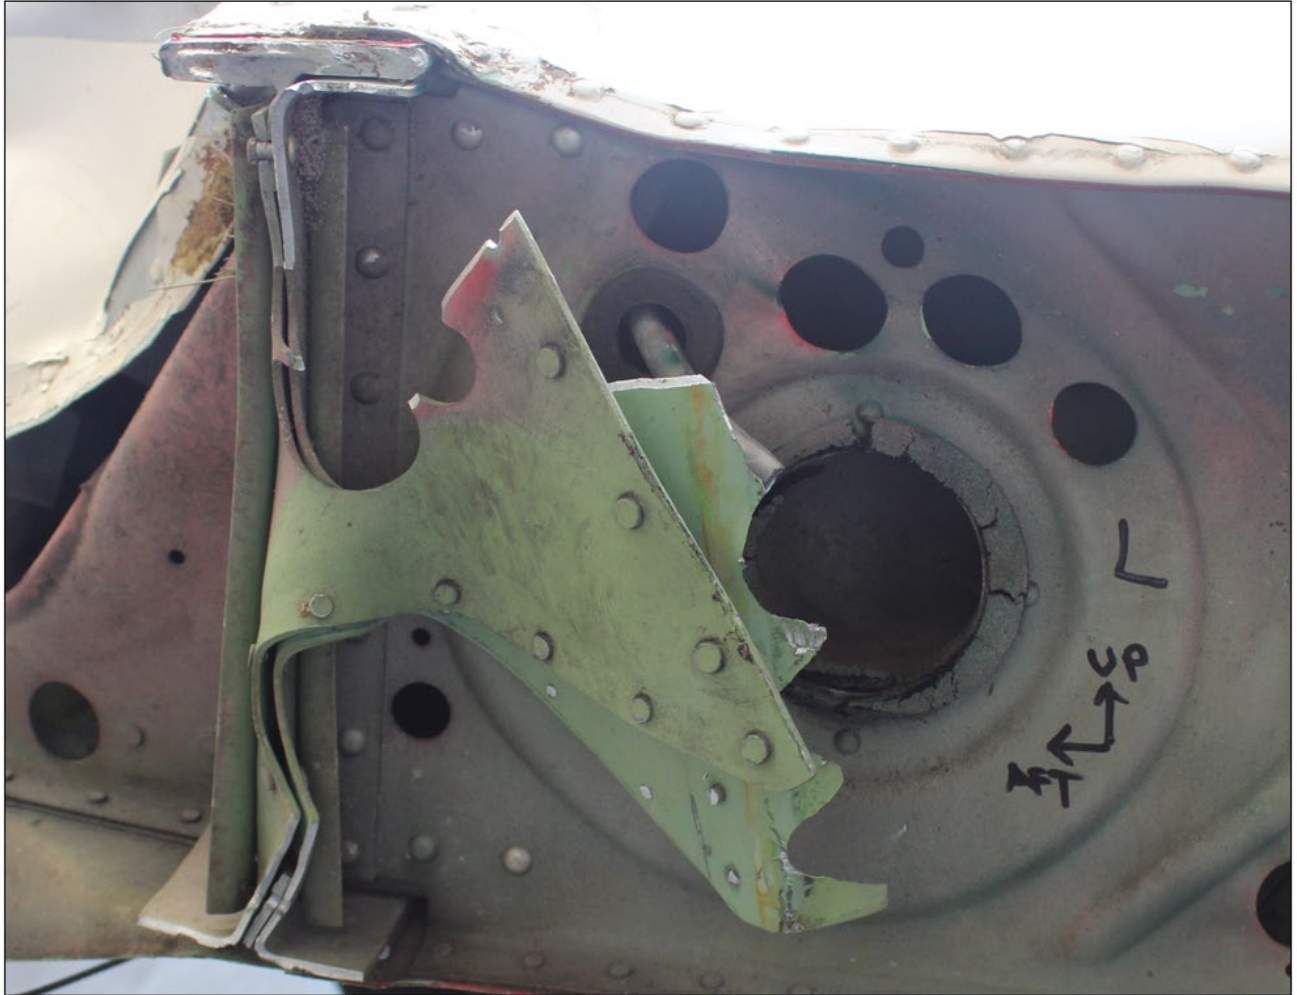
**Figure 14: View of the left side of the center spar box.**
