# National Transportation Safety Board

ERA23FA340

## **OPERATIONS AND ORGANIZATION**

Location: Ft. Pierce, Florida  
Date: August 17, 2023  
Time: 1202 local  
1602 UTC  
Airplane: Piper PA28-161, N9855S

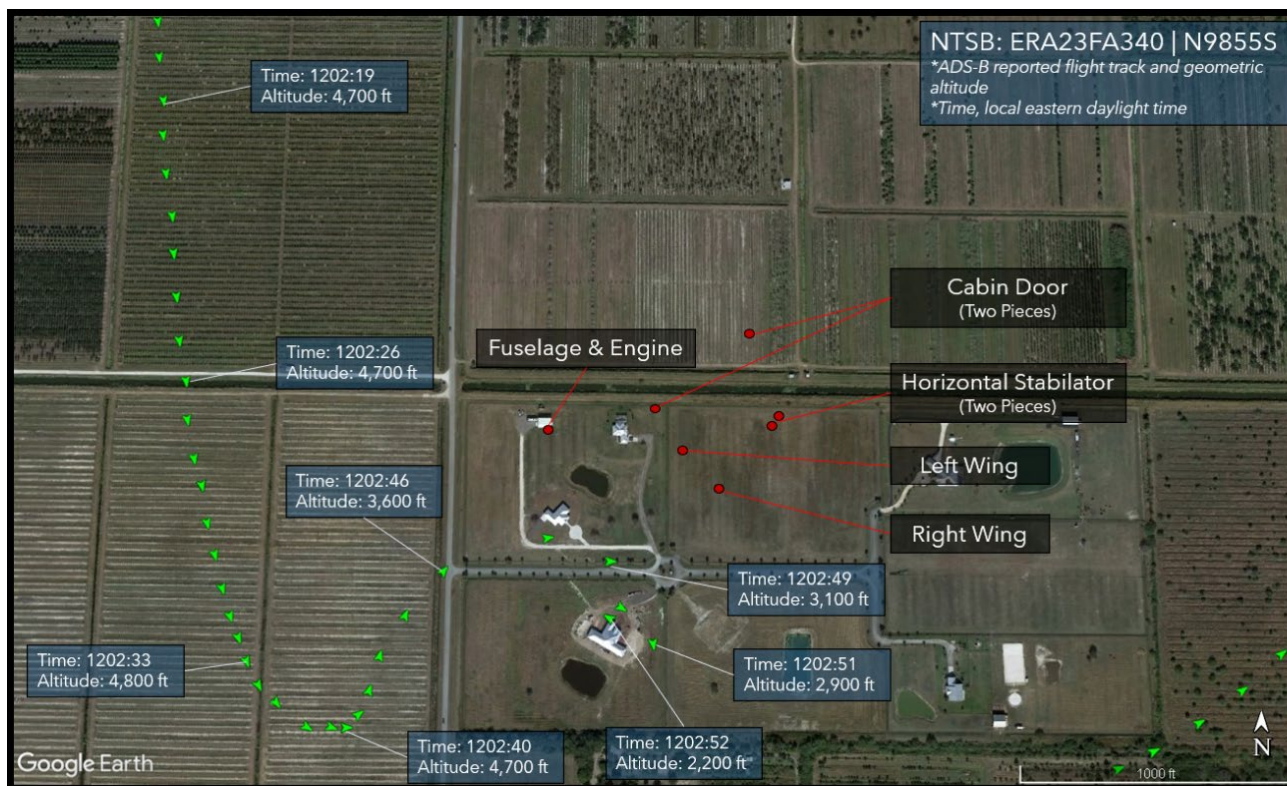
The fuselage, with the engine remaining attached to the airframe, impacted an aluminum frame building that housed a recreational vehicle (RV). The airplane came to rest after descending through the building and partially into the RV. Both wings and two horizontal stabilator sections separated from the airplane in-flight and were located about 700-800 ft east of the fuselage. Fragments of the cabin door were also located several hundred feet from the fuselage, along with miscellaneous items from the cockpit such as the tow bar. Figure 1 provides an overview of the ADS-B flight track and wreckage distribution.

**Figure 1: Overview of the final 30 seconds of ADS-B flight track data and wreckage distribution.**
