# National Transportation Safety Board

ERA23FA340

## **AUTOMATIC DEPENDENT SURVEILLANCE- BROADCAST (ADS-B) STUDY**

Aircraft Performance Study

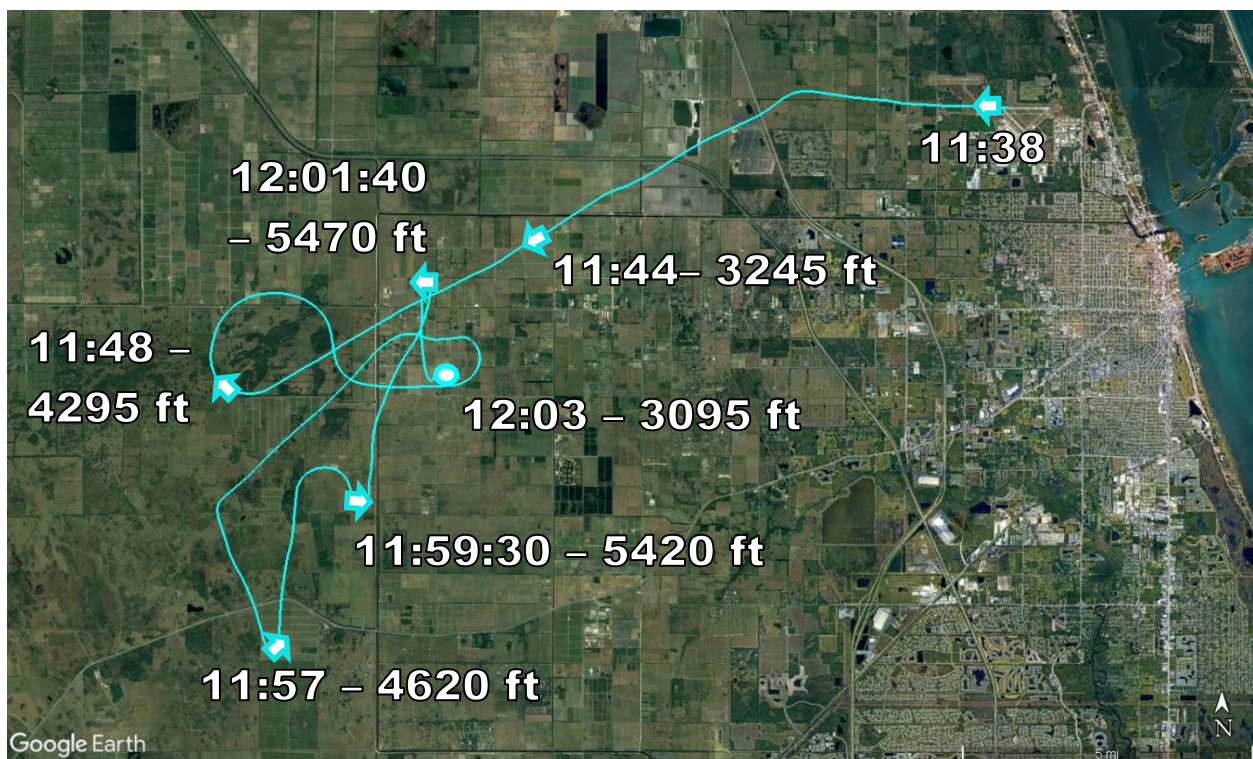
The airplane took off from FPR about 11:38 (Figure 2 and Figure 3). The airplane climbed and headed to an area southwest of the airport where it performed a series of maneuvers. Altitude varied between 4,200 ft and 5,500 ft mean sea level (MSL) and calibrated airspeed between 50 kts and 125 kts until the end of flight.

**Figure 2.** Flight path with selected times and altitudes MSL marked.

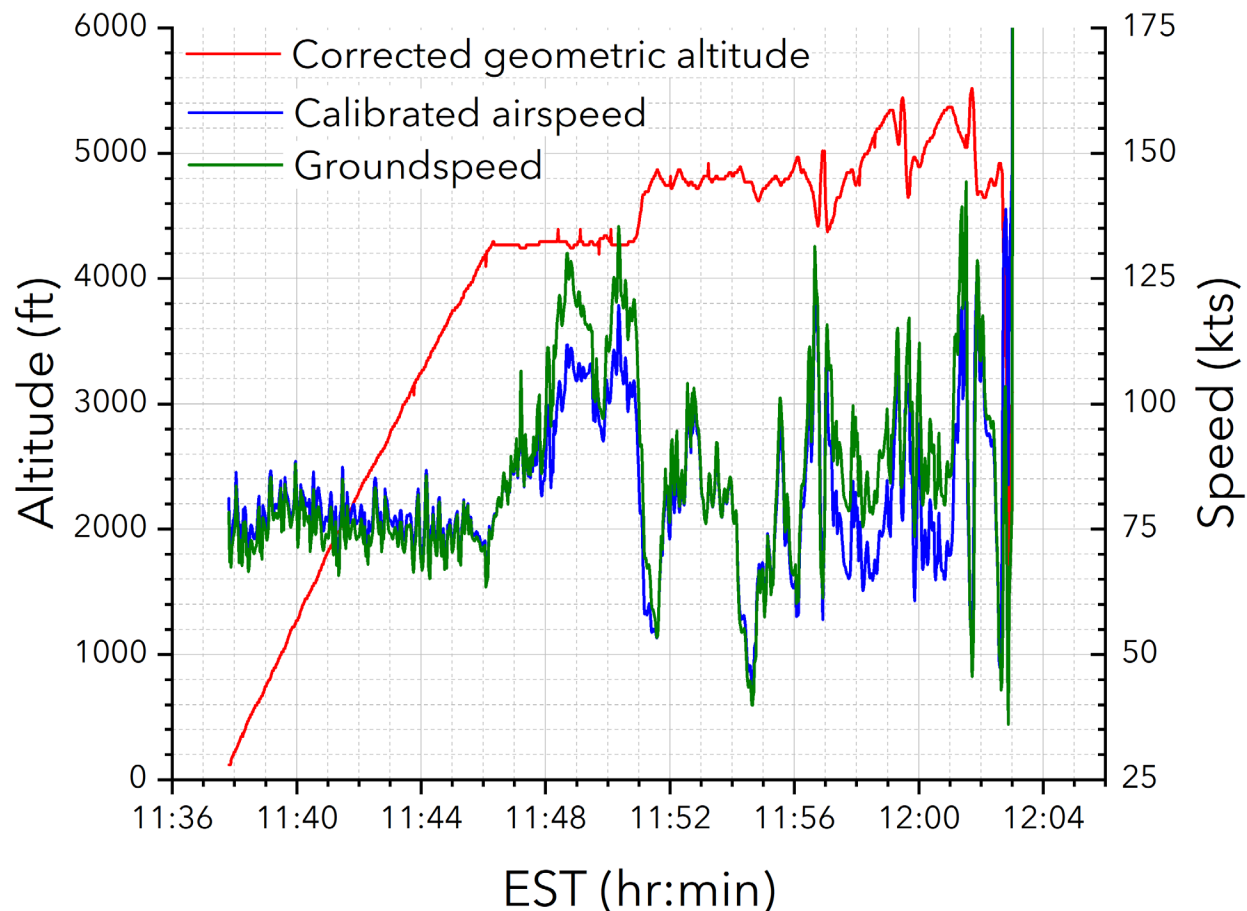
**Figure 3.** Altitude and calculated ground and airspeed for the flight.

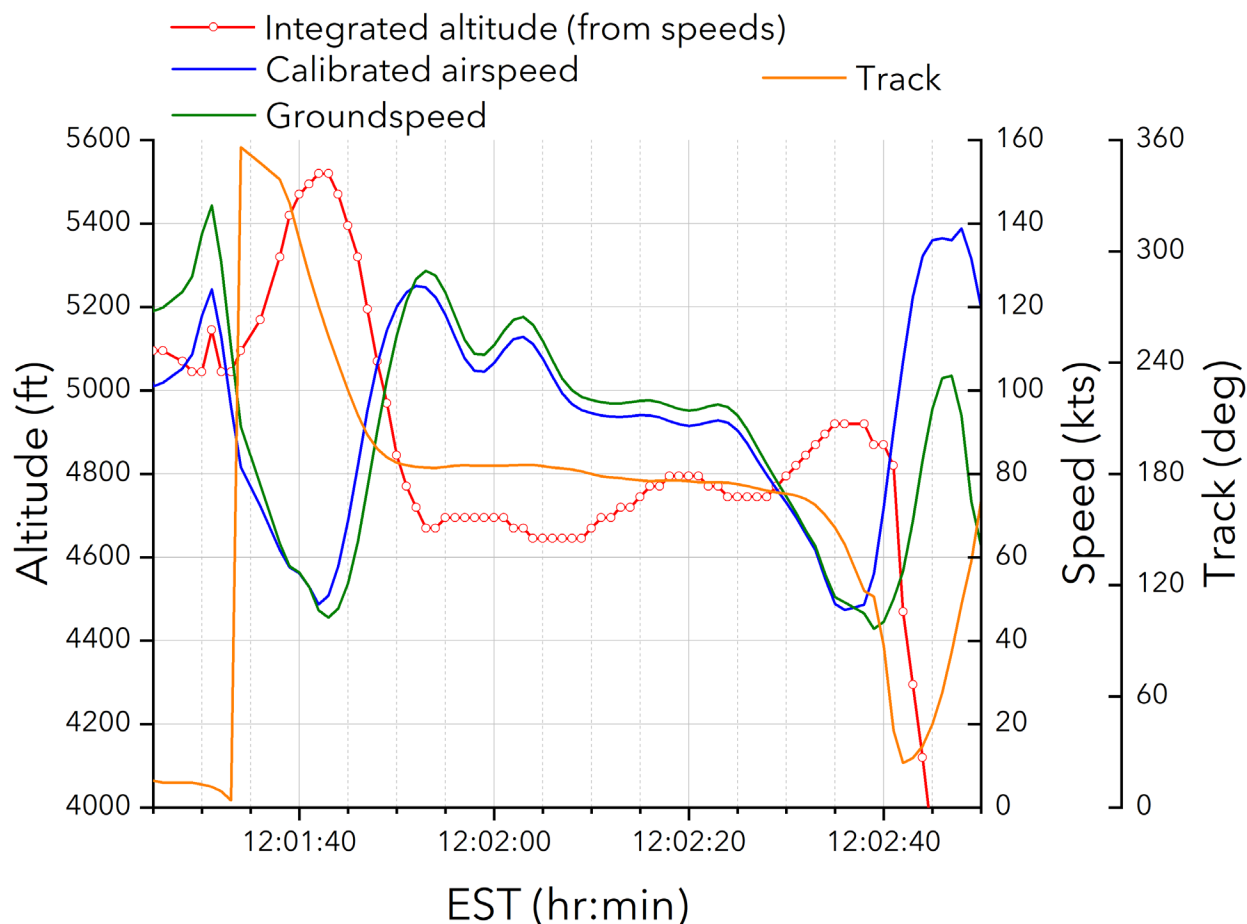
Just after 12:02:41, the descent rate suddenly increased to over 10,000 ft/min and a second later the track turned to the right.

**Figure 4.** Altitude, calculated ground and airspeed, and track for the final maneuvers.

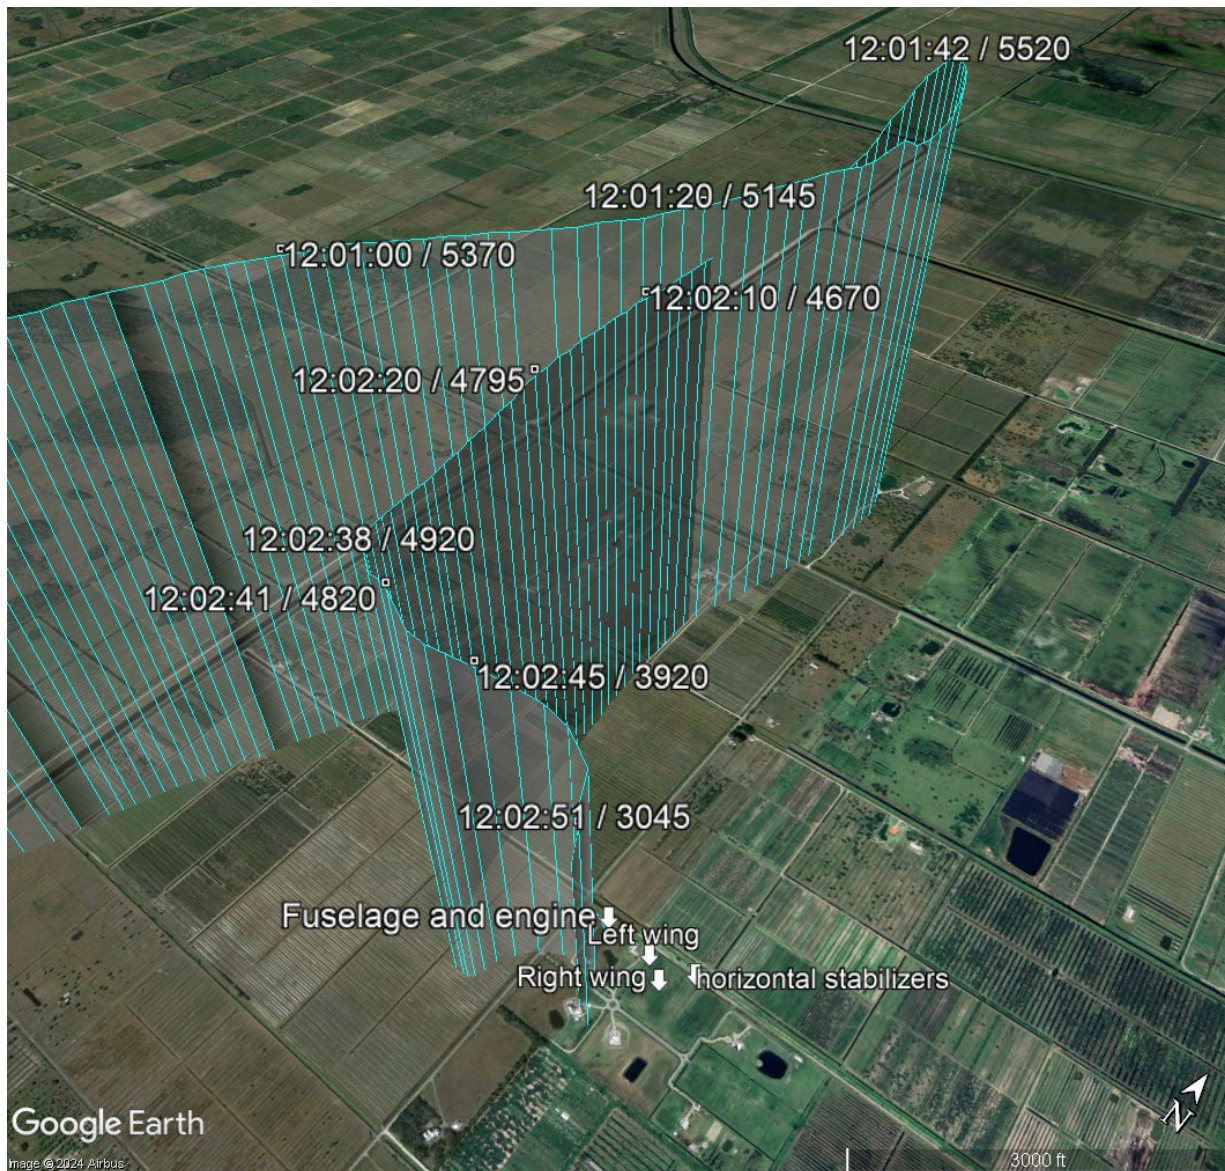
Figure 5. Starting at 12:01:30, the airplane executed a climbing left turn while slowing below 50 kts calibrated airspeed. The airplane descended 800 ft while accelerating to over 120 kts of airspeed while completing a 180° left turn. This maneuver looked similar to earlier 180° turns, however the minimum speed was lower than the prior maneuvers and below the reported stall speed. The airplane then flew level and straight for about 30 seconds before again beginning a climbing left turn while losing airspeed. The airplane reached a minimum airspeed of 47 kts at 12:02:36 and began descending at 12:02:39. The airplane accelerated as it descended. By 12:02:41, the airspeed was calculated to be 90 kts and the corrected altitude was 4,820 ft.

**Figure 5.** Flight path and altitude for the end of flight. The fuselage and wing final locations are also shown.

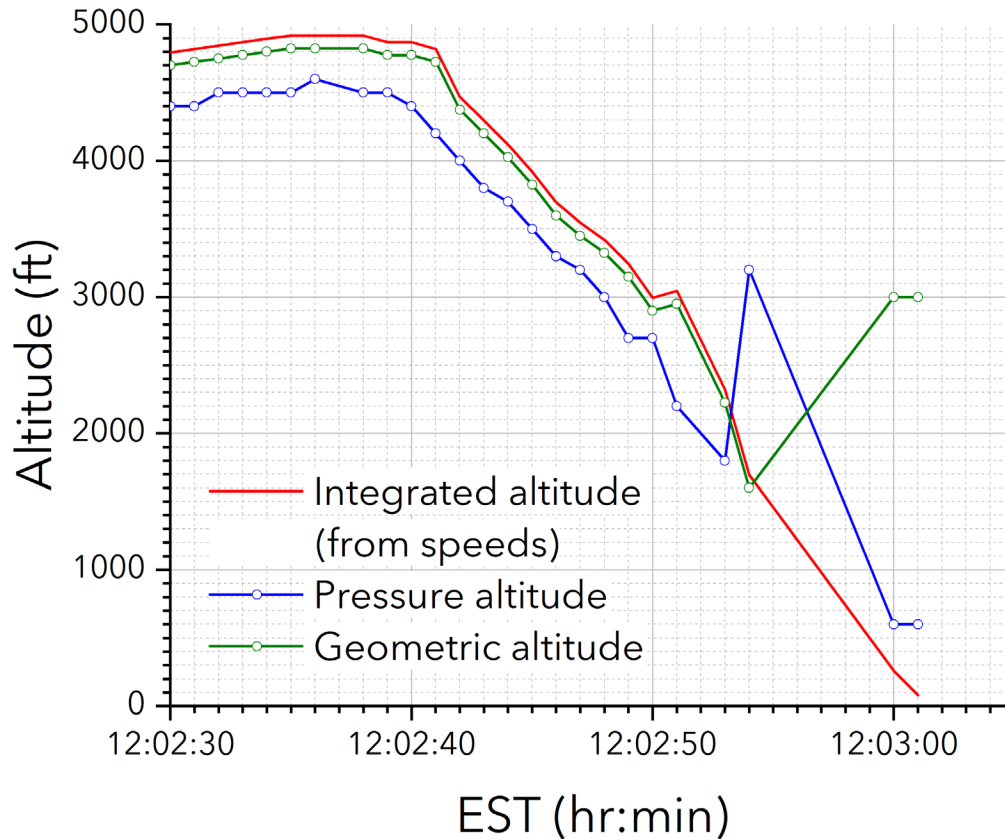
During the descent, the ADS-B record of pressure and geometric altitude diverged after 12:02:53 (Figure 6). Pressure altitude increased from 1,800 ft to 3,200 ft in one second before falling to 600 ft by 12:03:00. Geometric altitude continued to decrease from 2,250 ft at 12:02:53 to 1,600 ft before suddenly increasing at 12:03:00 to 3,000 ft. ADS-B also records the airplane's speed in three dimensions and a flight path was integrated from these speeds. The integrated velocity is shown in Figure 6, which did not show an increase in altitude after 12:02:53. The altitude discrepancies are likely due to the inflight breakup of the airplane that occurred.

**Figure 6.** Pressure and geometric altitude from ADS-B and altitude integrated from ADS-B recorded speeds.

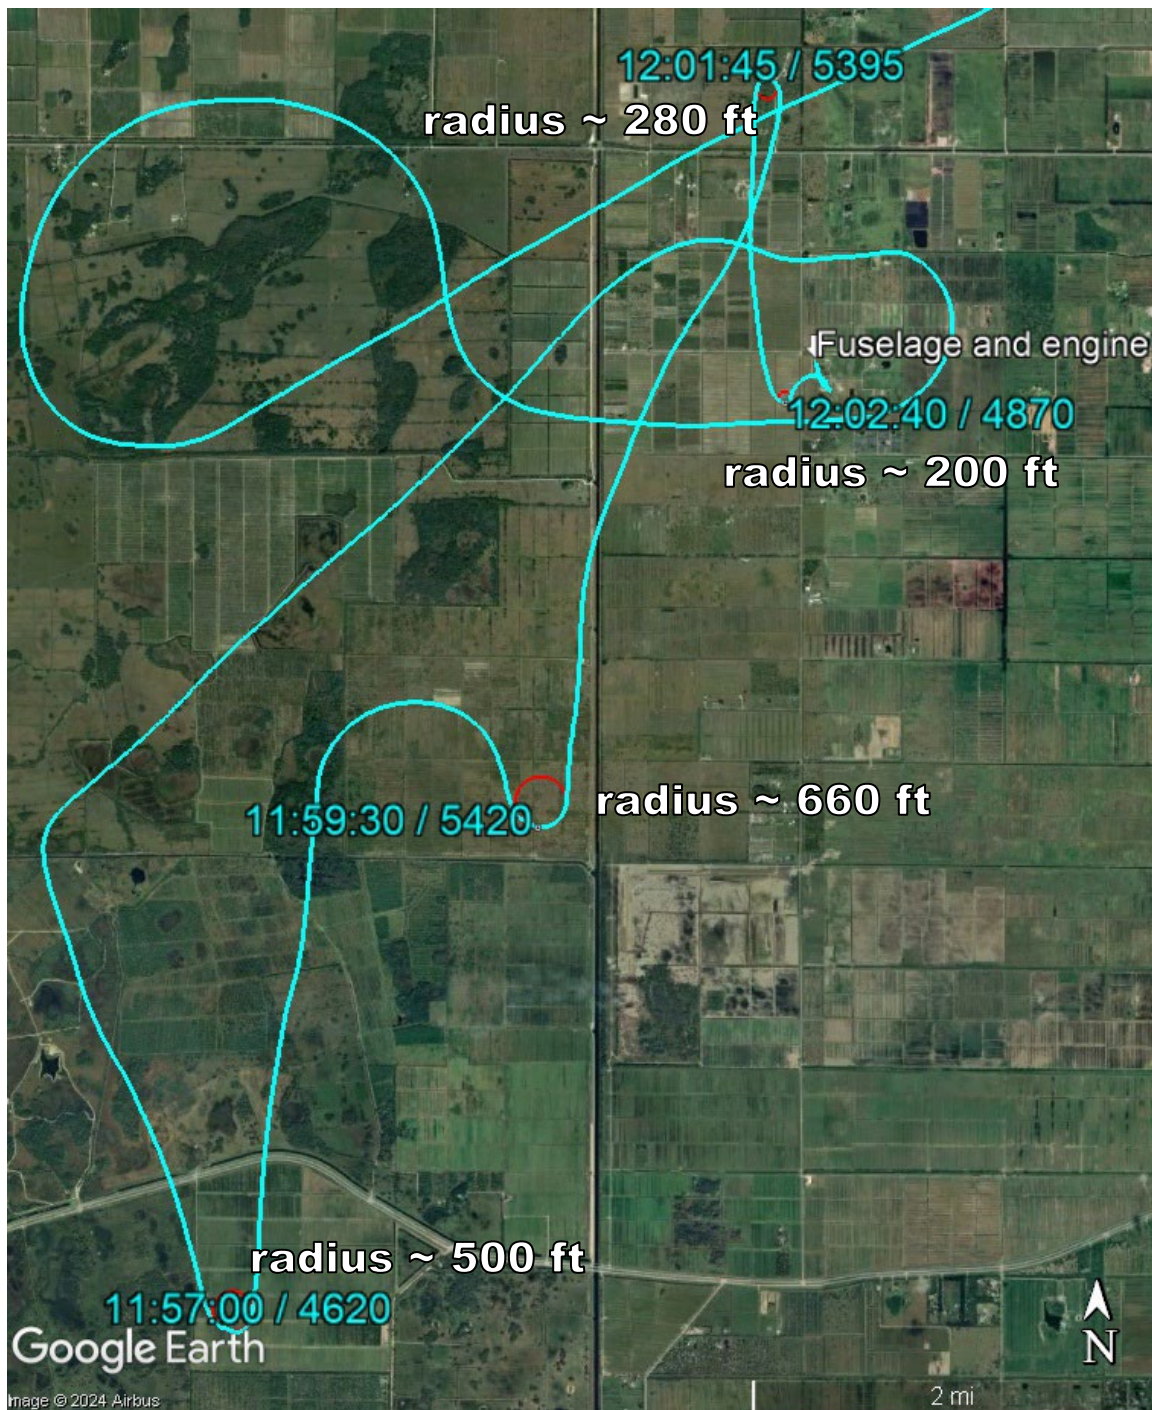
The wreckage examination found that the wings came off under large positive g-loading, the right wing being lost first. As discussed earlier, the airplane made several 180° left turns, four of which are shown in Figure 7. The turn at 11:57 had a radius of 500 ft and a low speed of 57 kts. The turn at 11:59:30 had a radius of 660 ft with a low speed of 77 kts. For both turns the airplane began accelerating while still in the turn, increasing bank angle and load factor,  $n$ , on the airplane to about 1.4 g according to

**Figure 7.** ADS-B flight path with four turns of interest notated.

The final two 180° turns were significantly tighter. The turn at 12:01:45 had a radius of 280 ft and the airplane accelerated to over 100 kts true airspeed while still in the turn, resulting in a calculated bank angle over 70° left wing down and a load factor of 3.6 g, near the 3.8 g limitation of the airplane [1].

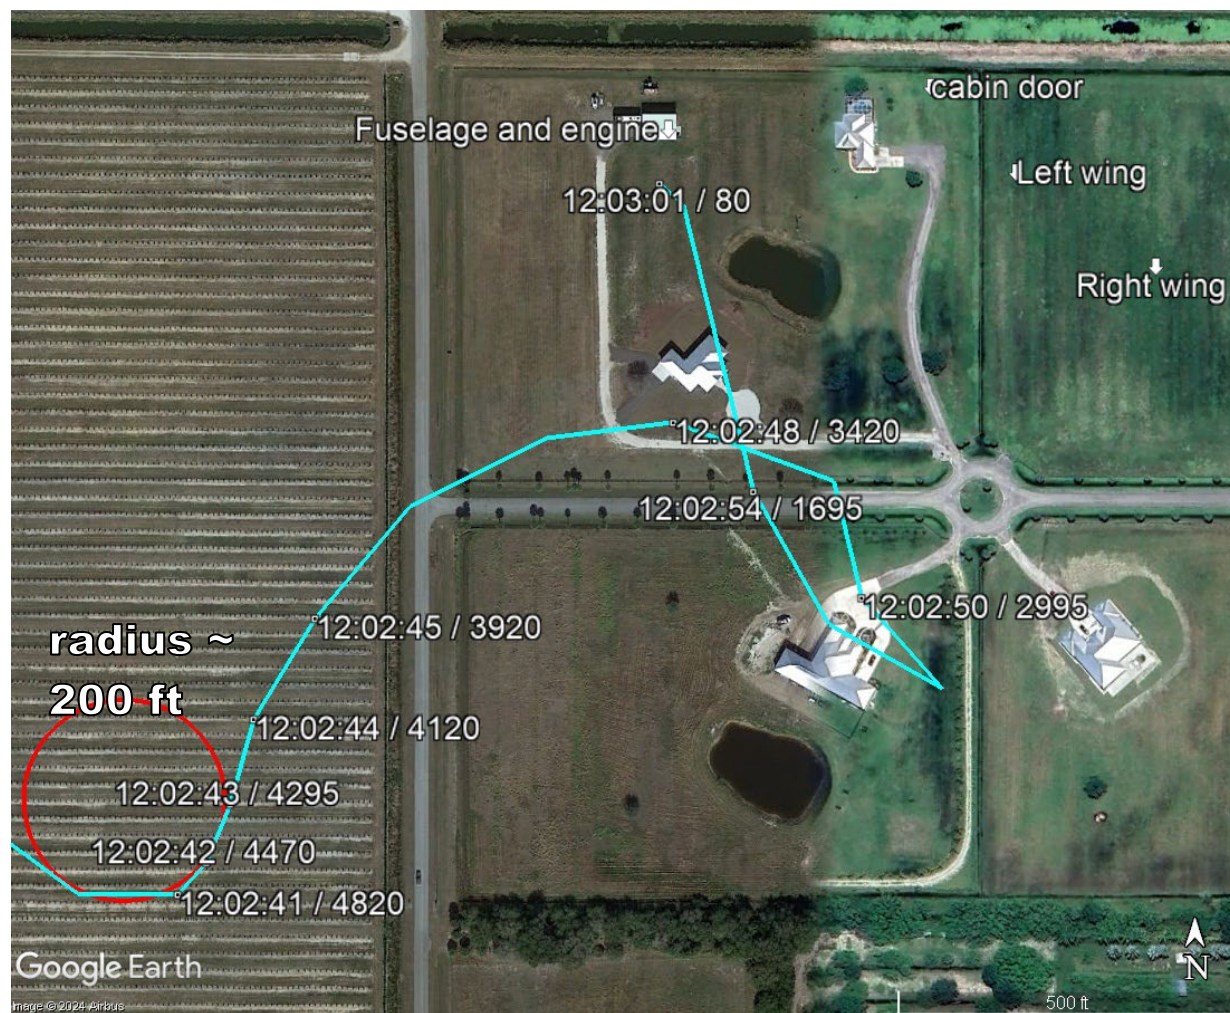
The final turn started with a radius of 200 ft which tightened as the airplane accelerated. At 12:02:41, the airplane's true airspeed was 99 kts, which for a 200 ft turn would result in a bank angle over 75° left wing down corresponding to a load factor of 4.5 g, which is above the airplane's limitations. Uncertainties in the ADS-B data mean that this calculation is not an absolute value, but it is consistent with an increasingly tight and fast turn. The pilot reported that the right wing departed the airplane, which would result in a right rolling moment as the left wing continued to provide lift. As discussed earlier, after 12:02:41 the airplane's descent markedly increased and the flight path turned to the right, likely coinciding with the loss of the right wing.

**Figure 8.** ADS-B flight path for final turn and break up.
