# National Transportation Safety Board

ERA23FA352

## **MATERIALS LABORATORY**

Factual Report 24-032

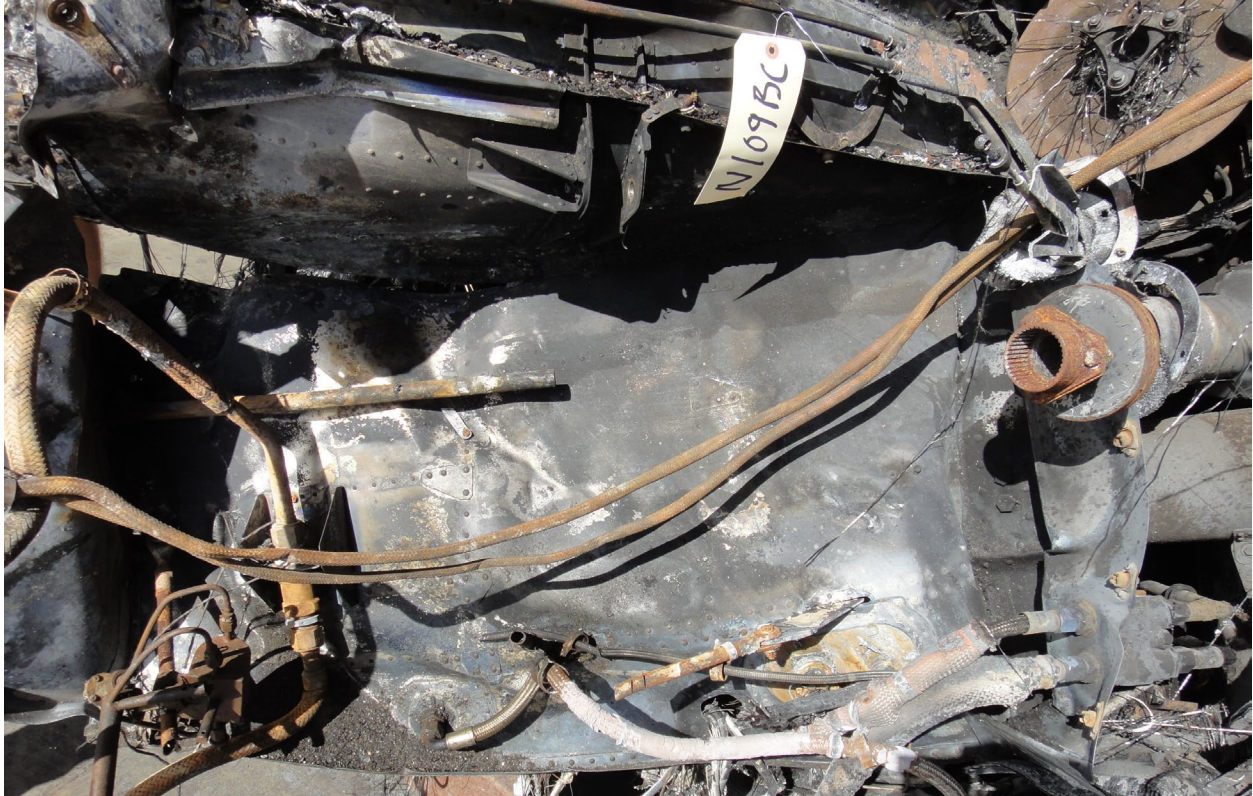
All firewall sections were present, and no material was missing<sup>1</sup>. The fire wall components are shown in Figure 1. All sections sustained impact damage. Heavy soot and a powdery greyish-white material coated the interior surfaces of the firewall sections. An area of oily residue was found on the lower firewall along the inboard edge as shown in Figure 2. Blue thermal discoloration was present along the inboard and aft edges of the lower firewall as shown in Figure 3. Several areas of bright blue and brass colored, splatter-shaped patterns of thermal discoloration found on both interior and exterior surfaces of the lower and aft firewalls as shown in Figure 4.

**Figure 1.** Photograph of inboard and lower firewall for #2 engine.

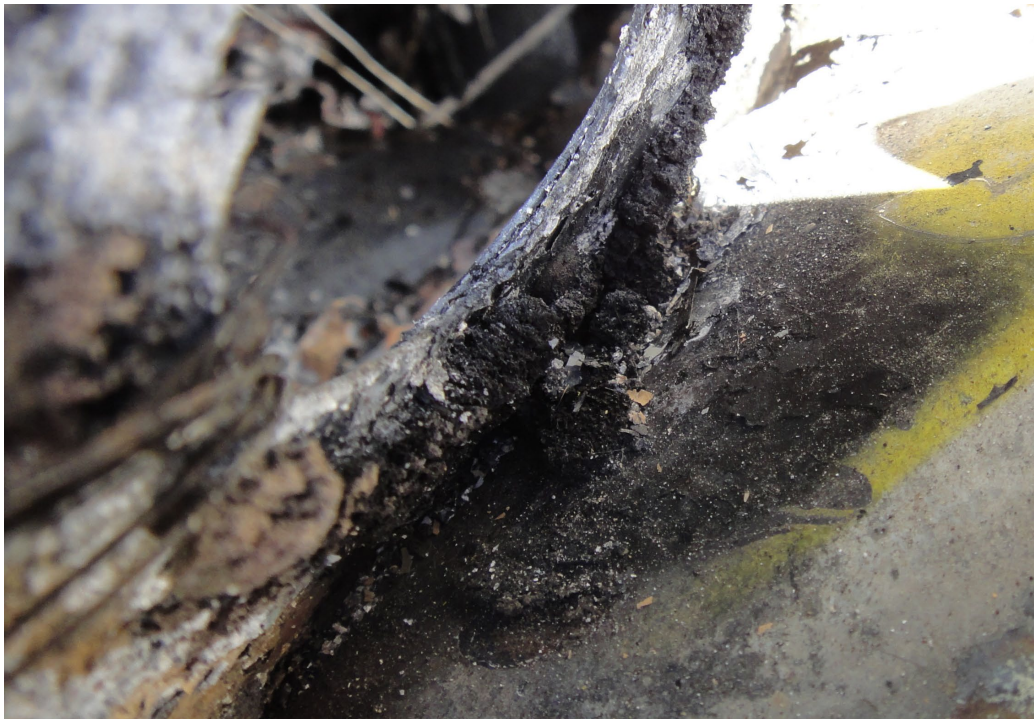
**Figure 2.** Photograph of area of oily residue was found on the lower firewall, inboard edge #2 engine.

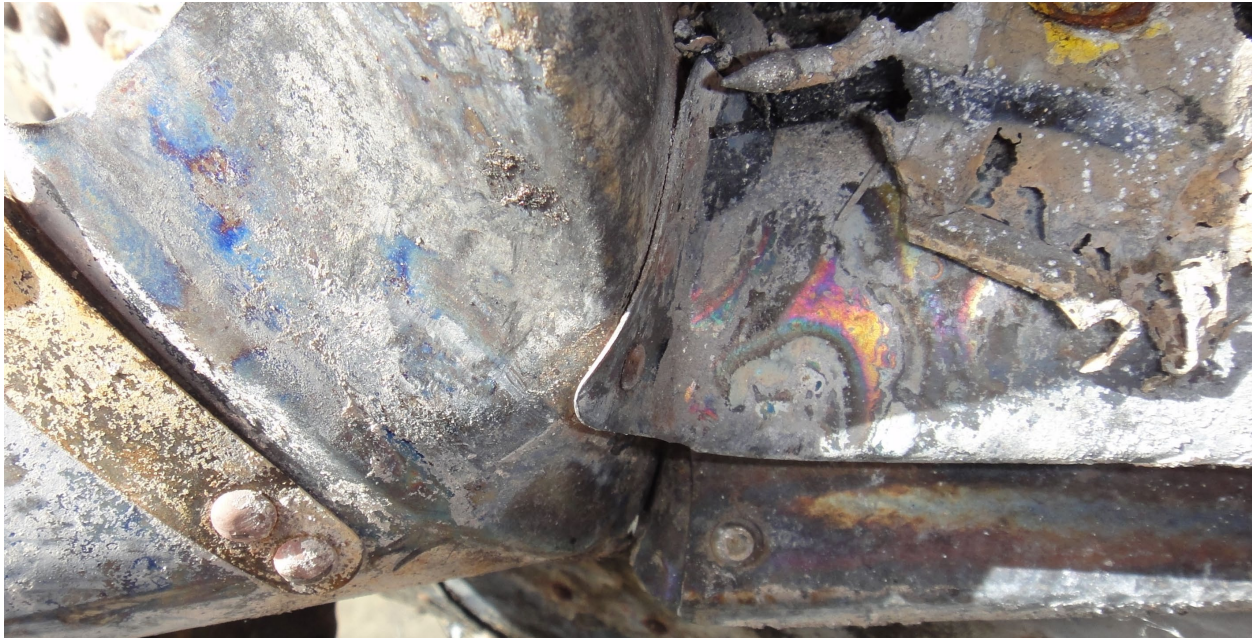
**Figure 3.** Photograph of discoloration on aft inboard corner of #2 engine compartment.

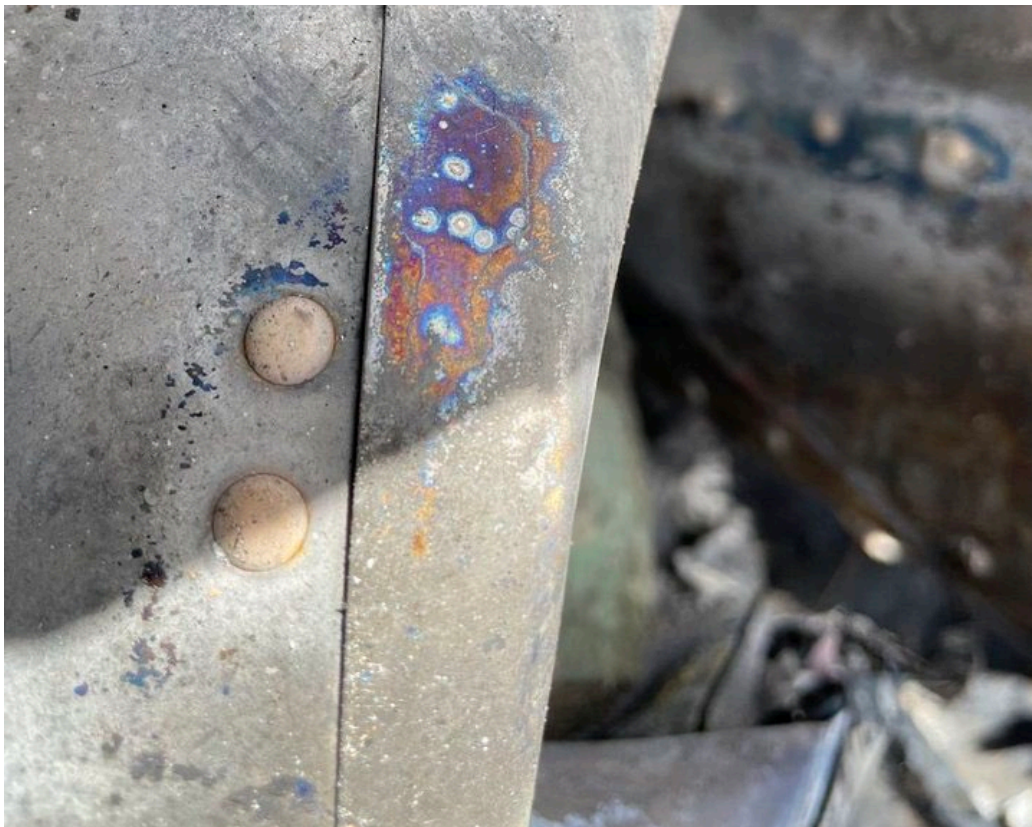
**Figure 4.** Photograph of blue and brass colored, splatter-shaped thermal patterns on #2 engine firewall.

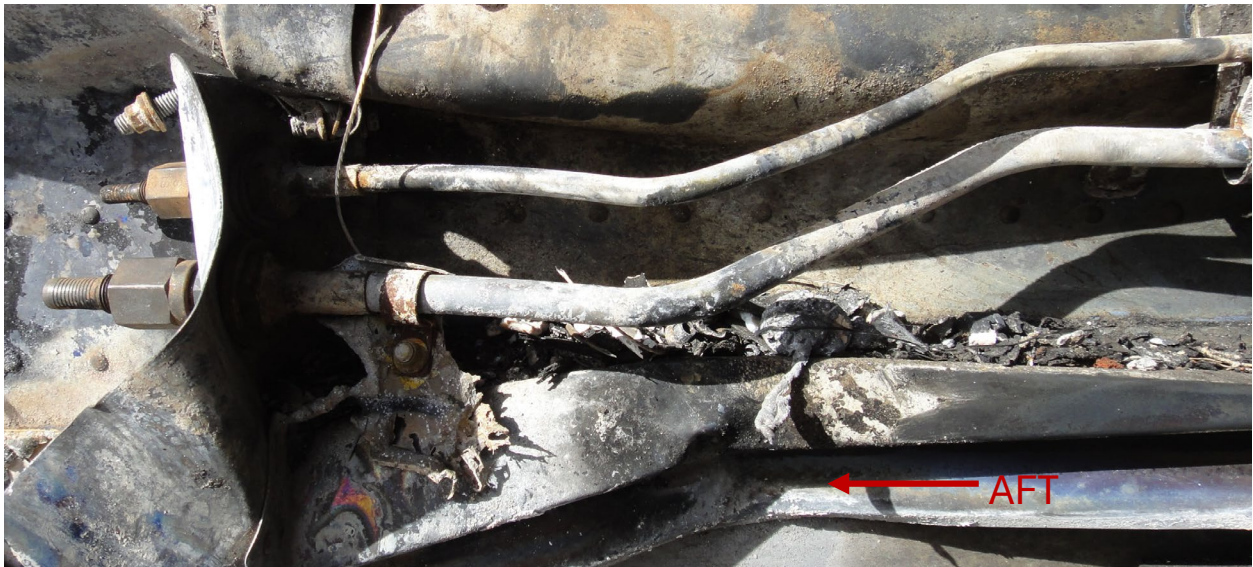
Heavy soot covered most lower surface. Hydraulic lines located in the compartment were intact. The hydraulic lines were heavily sooted with the exception of the aft section. This aft portion was covered with a white, powdery material as shown in Figure 5. Blue thermal discoloration was present along the edge that bordered the

**Figure 5.** Photograph of white powdery residue on drive shaft.

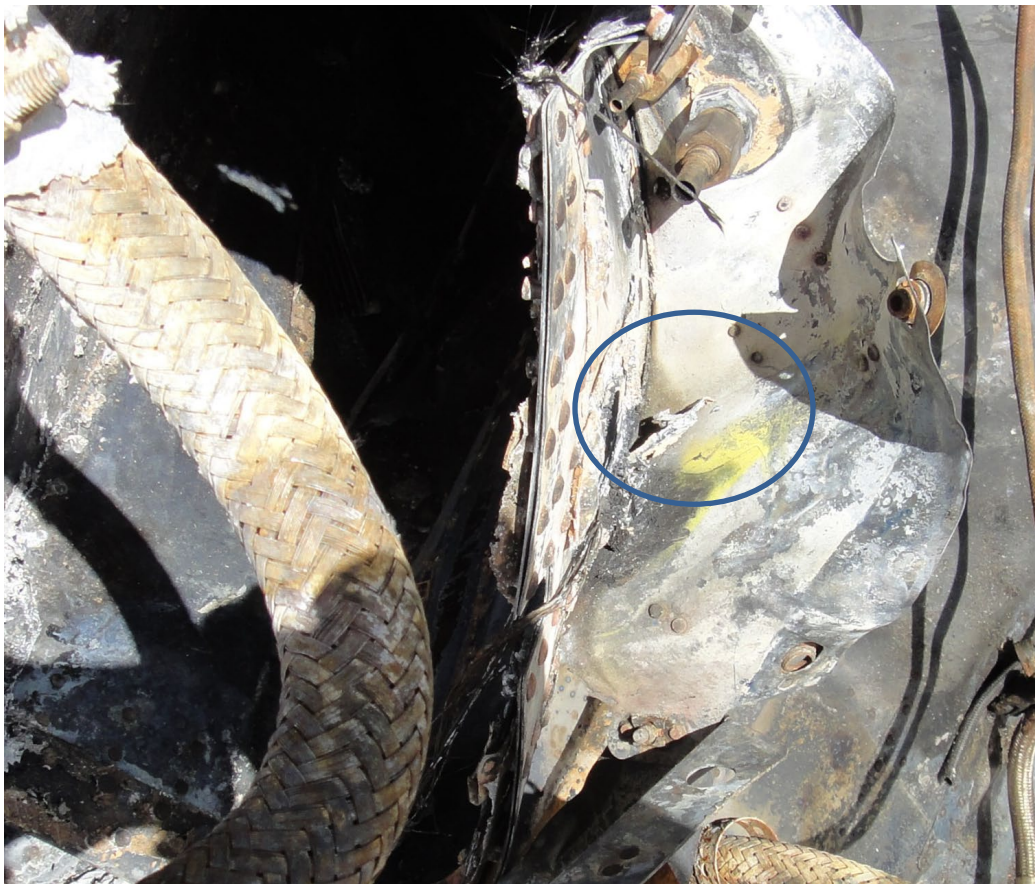
#2 engine compartment and the aft edge of the driveshaft compartment. The thermal damage extended through the lower firewall to the exterior surface in a few areas. A bright yellow substance/discoloration was located on the aft, right-side exterior of the compartment as shown in Figure 6.

The yellow residue spectrum was consistent with a straight-chained aliphatic hydrocarbon containing silicon. No strong matches were found in the spectral library search for a single material however the unknown material shared significant spectral peaks with several lubricants and lubricant additives. The sample was analyzed using an x-ray fluorescence (XRF) handheld alloy analyzer. The alloy analyzer found the presence of sulfur (S) and silicon (Si). These findings were consistent with the presence of a lubricating oil. Sulfur and silicon are present in oil additives. Exemplar samples of fluids from the aircraft were not evaluated.

**Figure 6.** Photograph of yellow residue (circled) on #2 engine firewall.

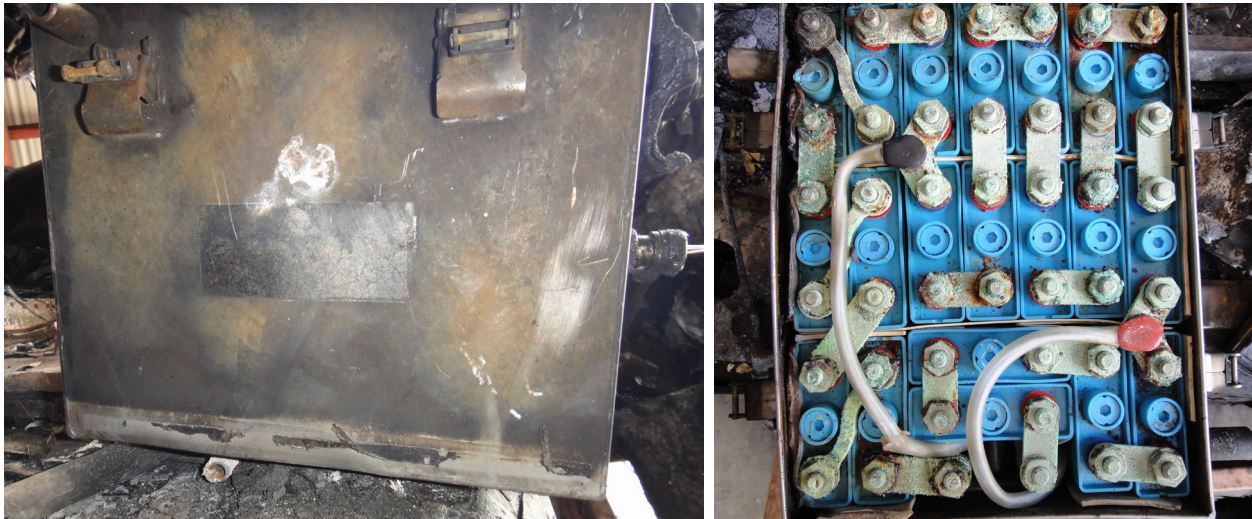
The battery case was intact as shown in Figure 7. Soot covered the exterior of the case. The polymeric connector was melted with areas of missing material. The battery interior was intact and exhibited a small amount of thermal damage to aft, inboard corner (as installed in aircraft) to the polymeric cell separators located on the top of the battery. The interior of the case lid exhibited some thermal-related building of the polymeric liner. There was light thermal degradation to the lid seal on the edge (facing aft as installed in aircraft). There were no visible signs of thermal runaway of the battery cells.

**Figure 7.** Photograph of aircraft battery case (left) and interior (right).

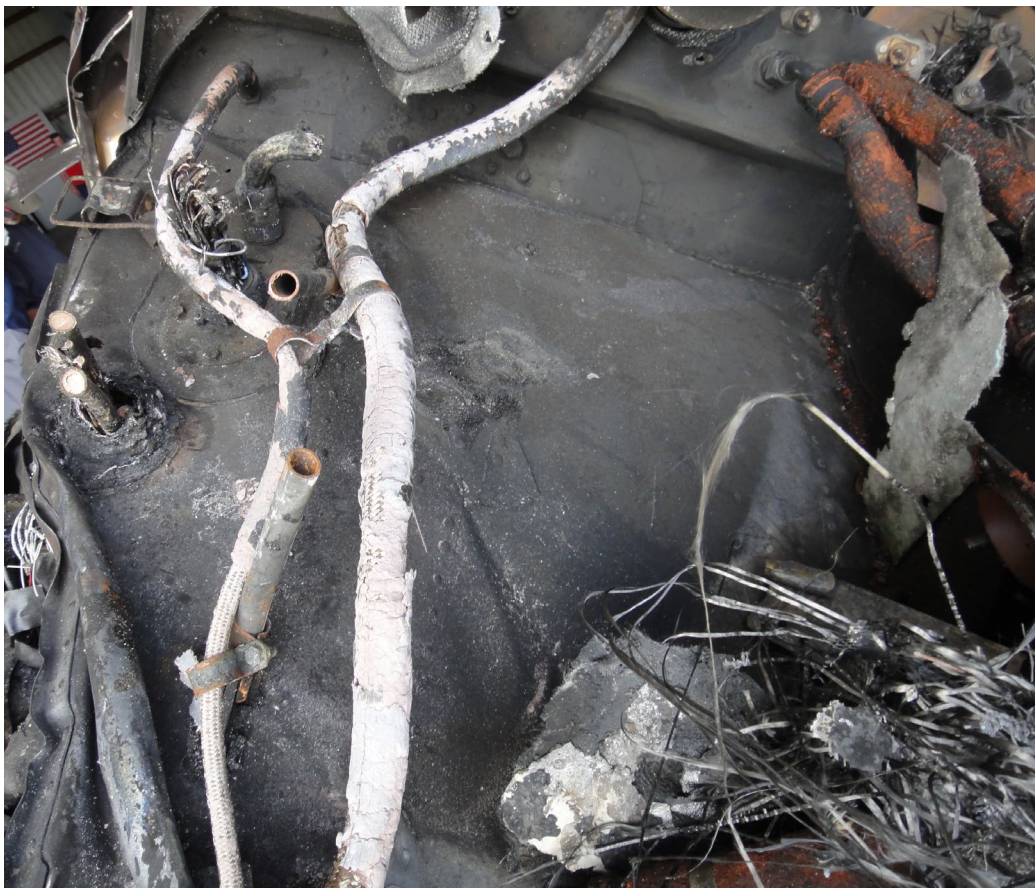
All firewall sections were present, and no material was missing. Heavy soot covered all interior surfaces of the firewall panels as shown in Figure 8. A large area of blue-colored thermal damage was present on the upper outboard corner of the aft firewall as shown in Figure 9. There were several smaller areas of bright blue and brass colored, splatter-shaped patterns of thermal discoloration over the aft and lower firewalls. Thermal discoloration was also present along the seam adjacent to the driveshaft compartment as shown in Figure 10. A bright yellow, slightly oily substance was found just aft of the #1 aft firewall and below the hydraulic lines located adjacent to the driveshaft compartment.

**Figure 8.** Photograph of engine #1 inboard firewall.

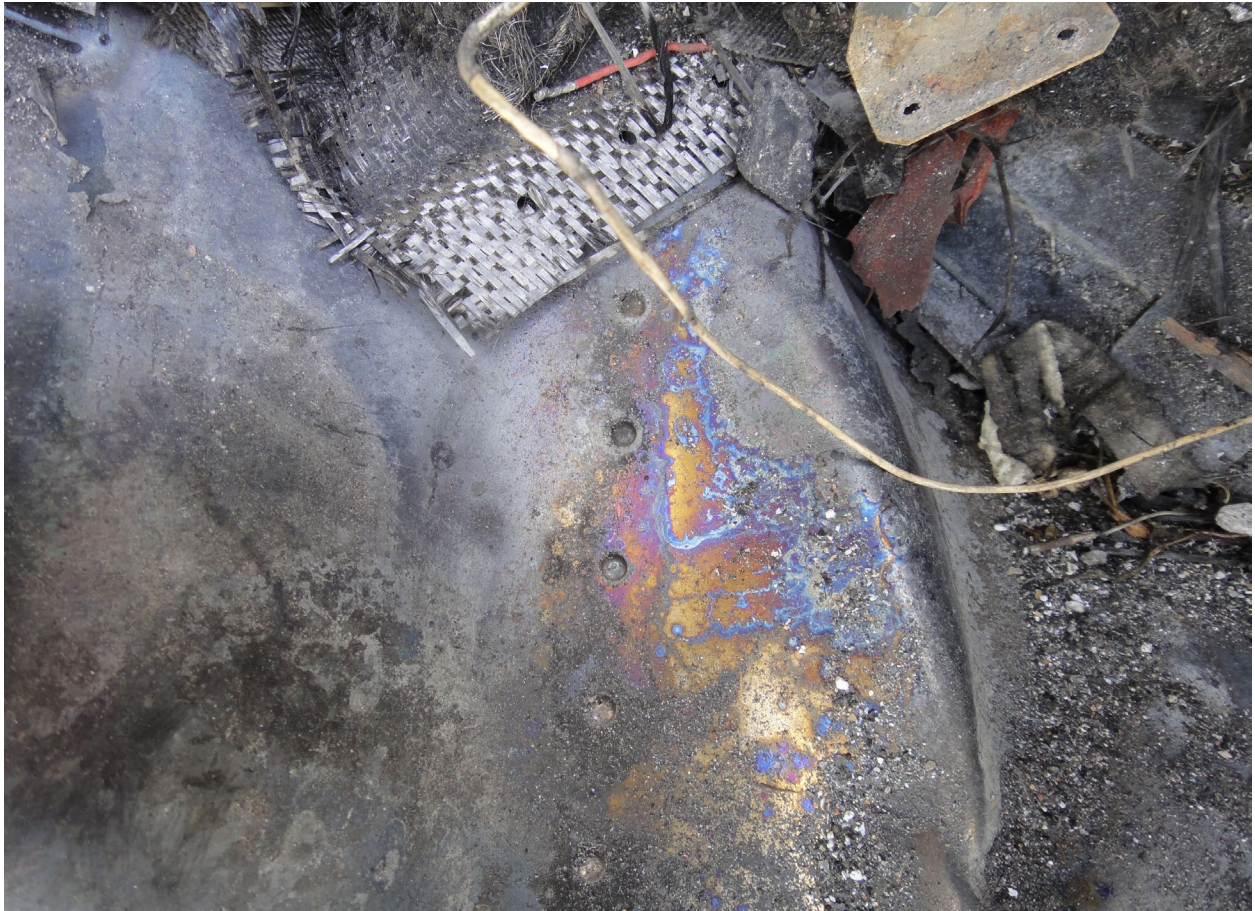
**Figure 9.** Photograph of thermal discoloration on #1 engine firewall.

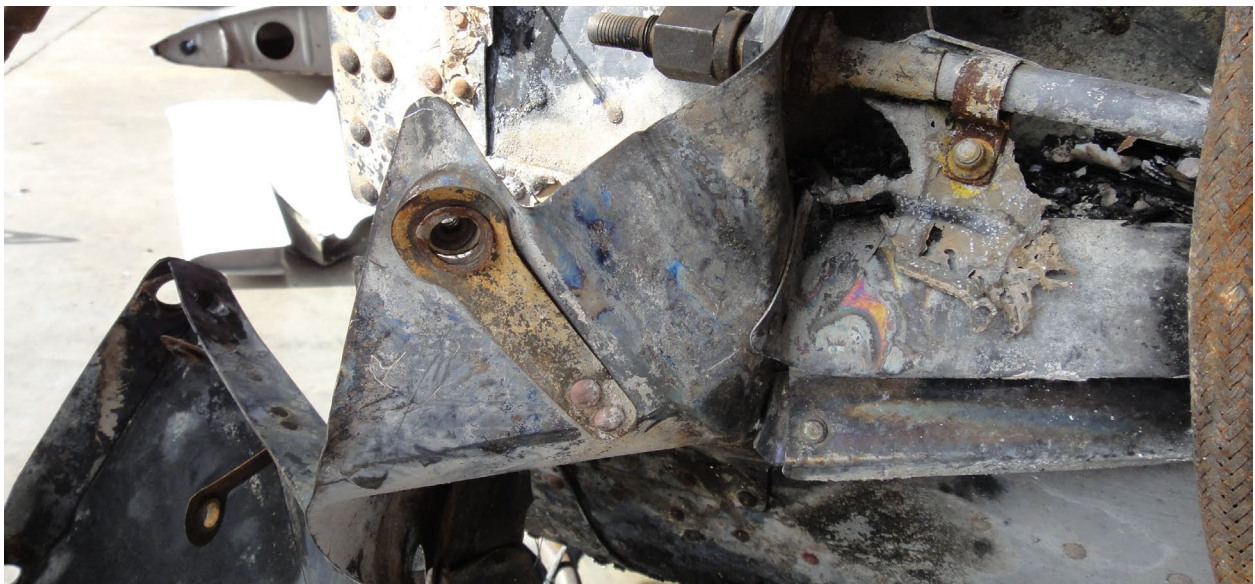
**Figure 10.** Photograph of thermal discoloration on driveshaft compartment seam.

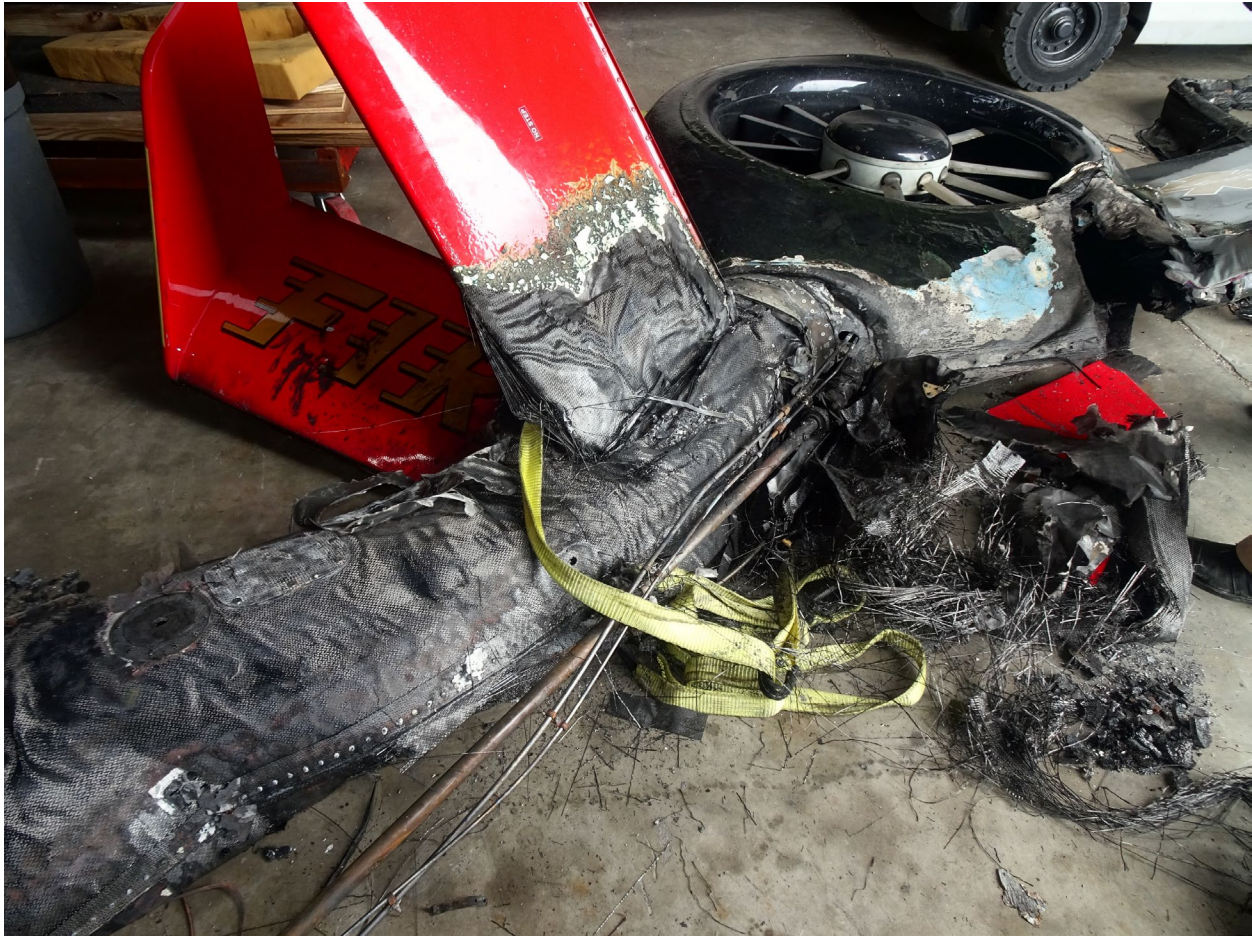
The tail boom and rotor housing sustained heavy thermal damage as shown in Figure 11. The paint was missing along the entire length of the boom and composite material sustained significant thermal damage-the resin had burned out with only carbon fiber material and associated honeycomb material remaining. The paint was mostly missing on the lower surfaces of the winglets and the paint on the upper surfaces was blistered and sooted. The tail rotor housing was missing several areas of paint on the lower surface. The paint on the upper portion was intact but sooted and blistered in areas.

**Figure 11.** Photograph of tail boom and rotor housing.

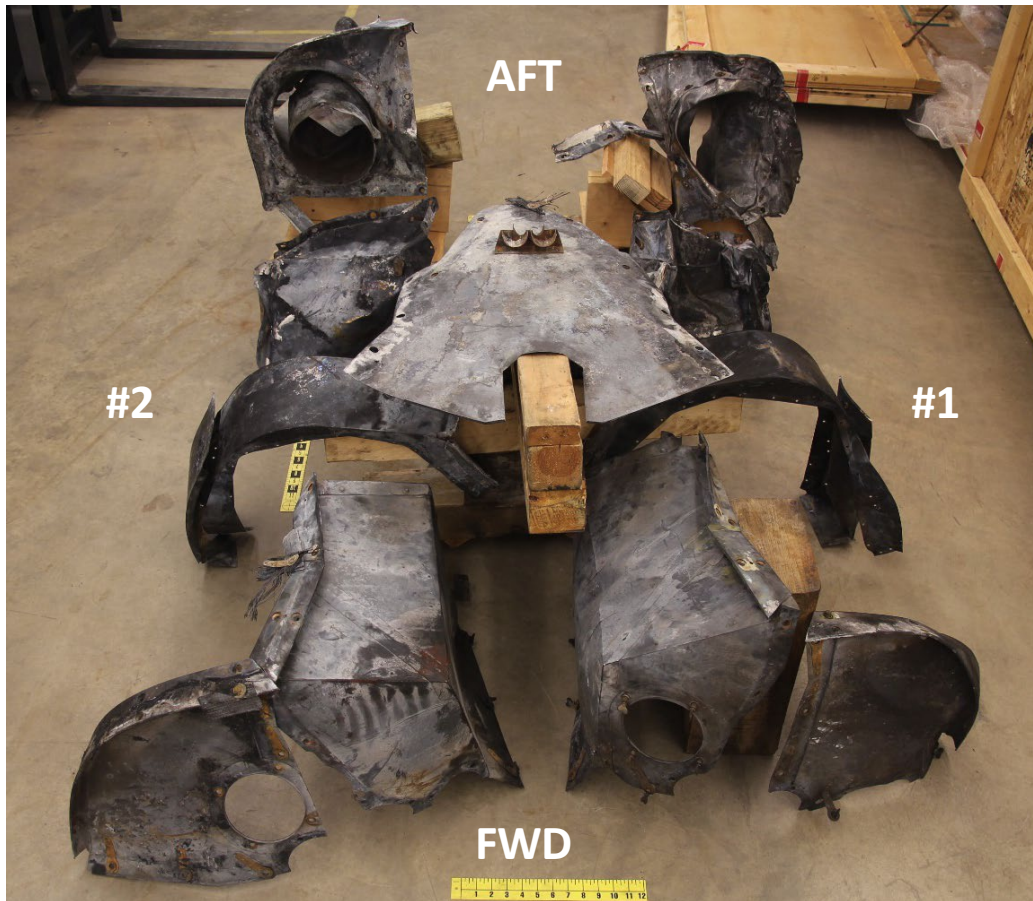
Discolored areas were observed on the firewall pieces during a wreckage exam completed by the investigative team. The firewall pieces for both engines were subsequently submitted to the NTSB Materials Laboratory for further examination<sup>2</sup>. The remaining pieces reconstructed into their onboard configuration are shown in Figures 12 and 13.

**Figure 12.** Photograph of laboratory firewalls reconstruction (forward).

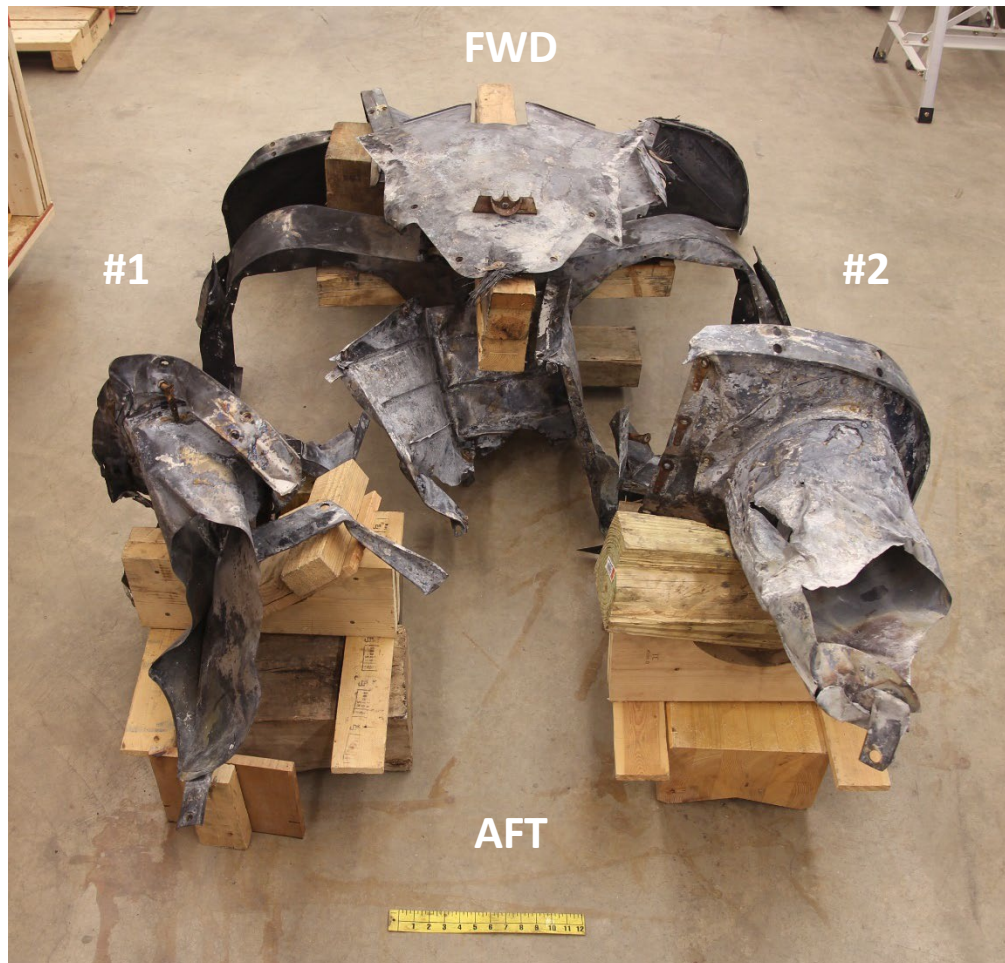
**Figure 13.** Photograph of laboratory firewalls reconstruction (aft).

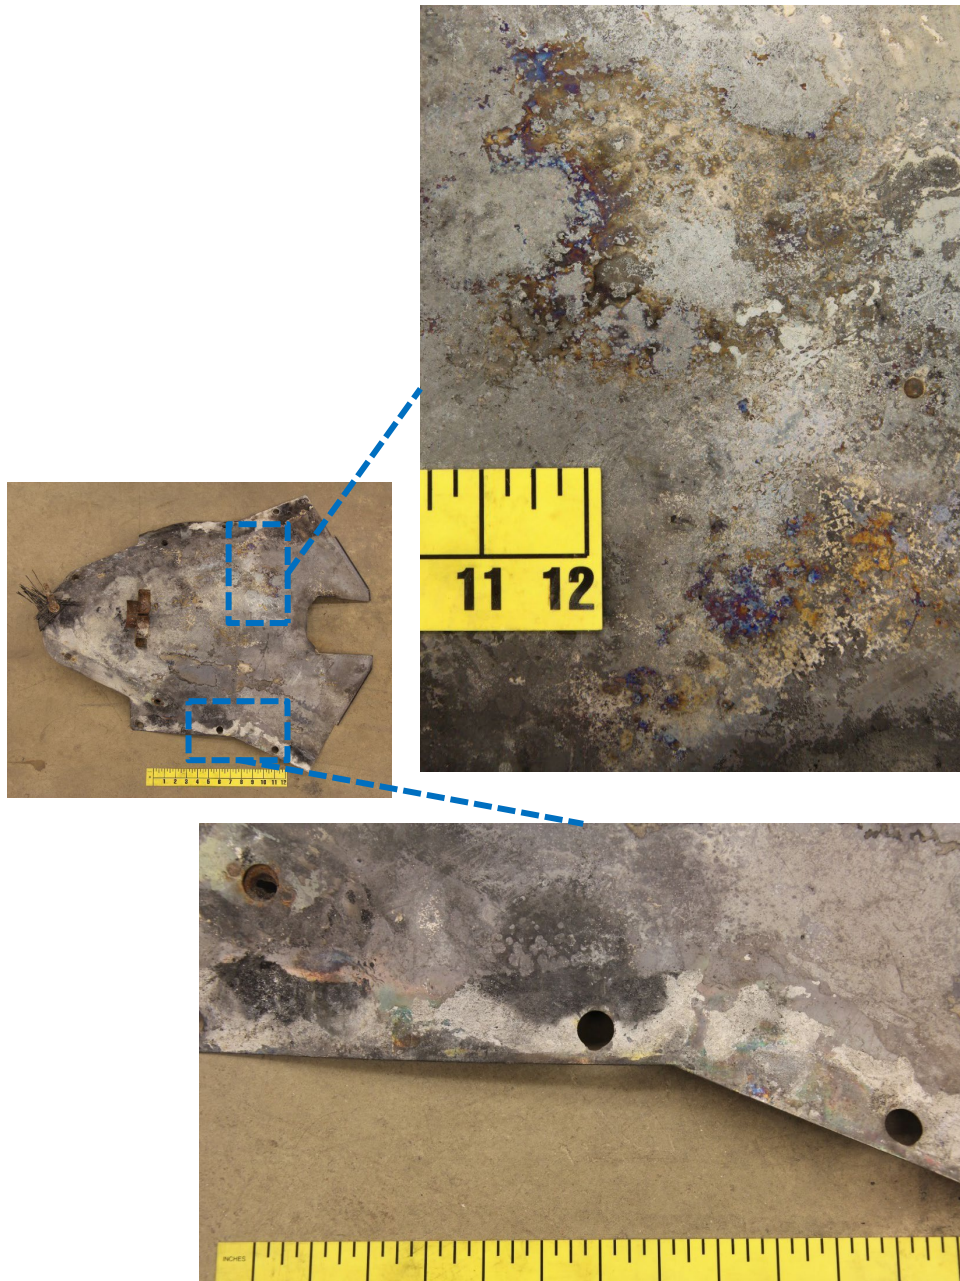
Along with overall dark-colored fire damage to the pieces, three types of discoloration were observed. Shown in Figure 14, the first type of discoloration was

dark blue, purple, and brass, and appeared to be spatter from burning metal, polymer, or other solids near or in contact with the pieces. The second type of discoloration was light green, yellow, and pink, and appeared to be staining from liquid that experienced high heat and possibly burned after spilling onto the pieces as shown in Figure 15. The third type of discoloration, as shown in Figure 16, was blue, purple, green, and red, and appeared to be the result of heat discoloration from contact with another component that experienced elevated temperatures.

**Figure 14.** Photograph of discoloration on the outboard side of the intake cover.

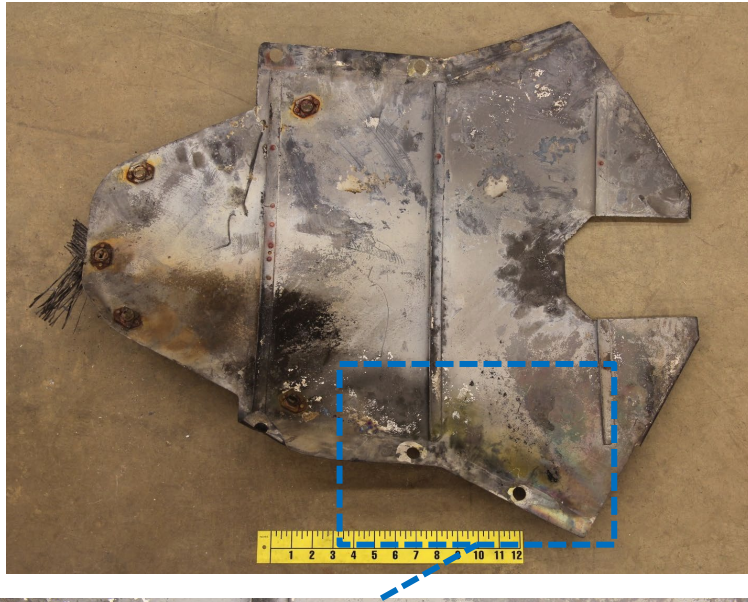
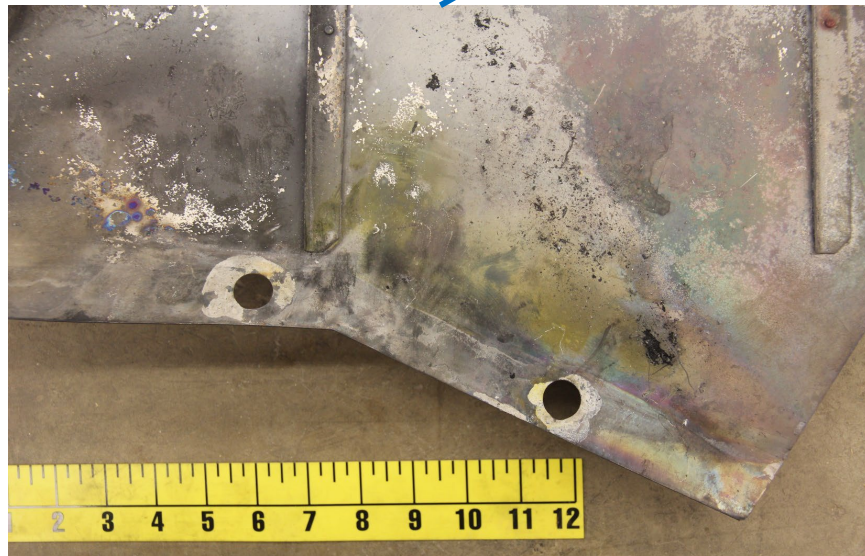
**Figure 15.** Photograph of discoloration on the inboard side of the intake cover.

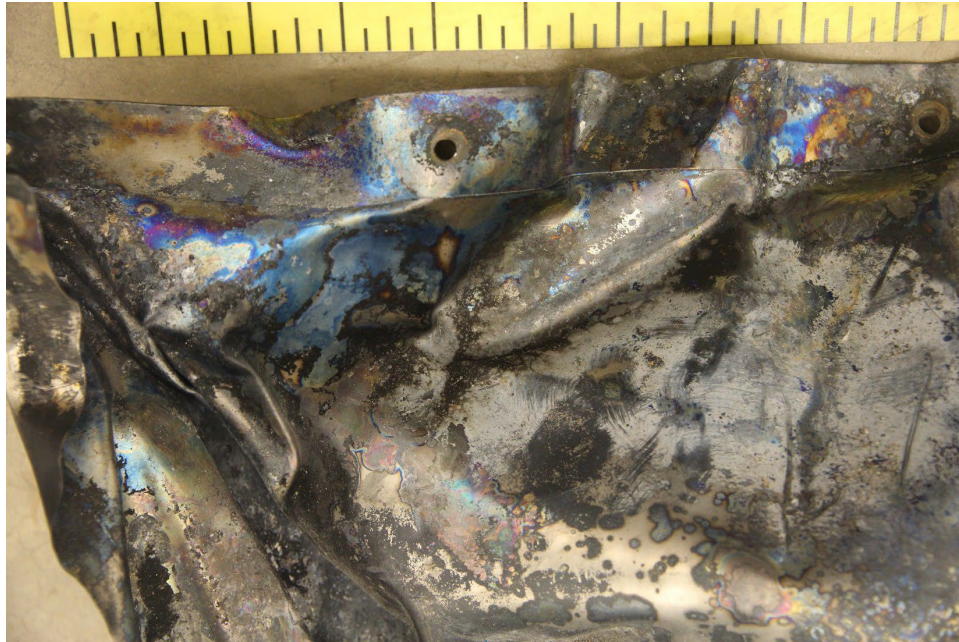
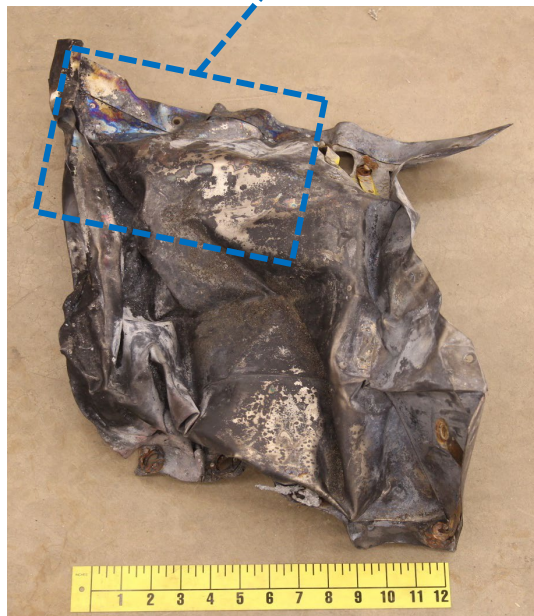
**Figure 16.** Photograph of thermal discoloration on #1 engine hot section firewall (lower), forward.

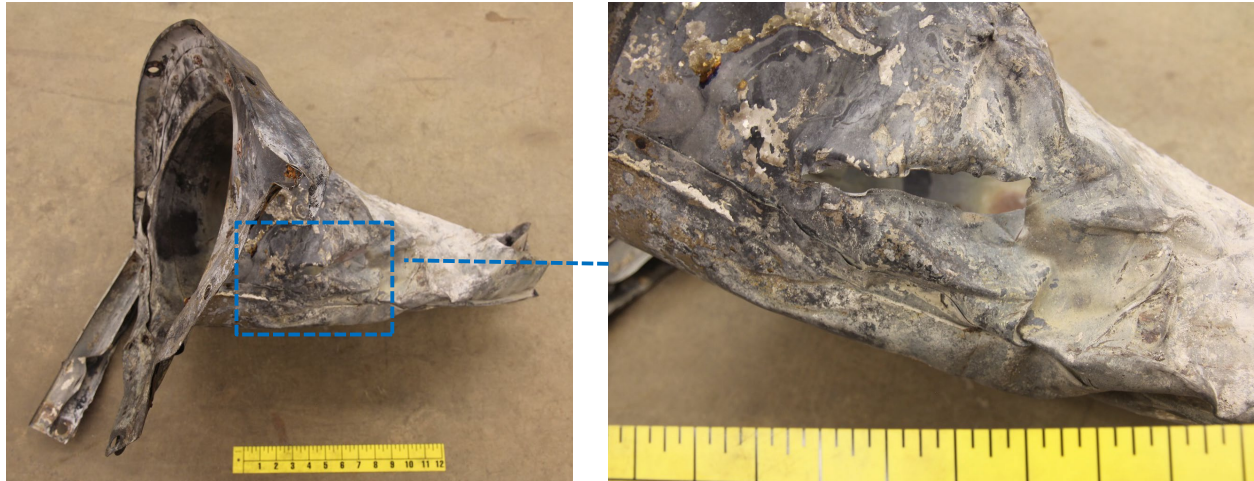
In addition, small tears were observed on several pieces of hot section firewall. The small tears appeared to be due to buckling, either during the accident or due to heat weakening the material of the pieces during the post-crash fire. One piece, the #2 engine exhaust ejector, had a large tear consistent with a puncture as shown in Figure 17.

**Figure 17.** Photograph of puncture (tear) in wall of the #2 engine exhaust ejector.
