# National Transportation Safety Board

ERA23FA352

Group Chair's Factual Report

Location: Pompano Beach, Florida  
Date: August 28, 2023  
Time: 0844 eastern daylight time  
Helicopter: Airbus Helicopters Deutschland EC135 T1, registration N109BC

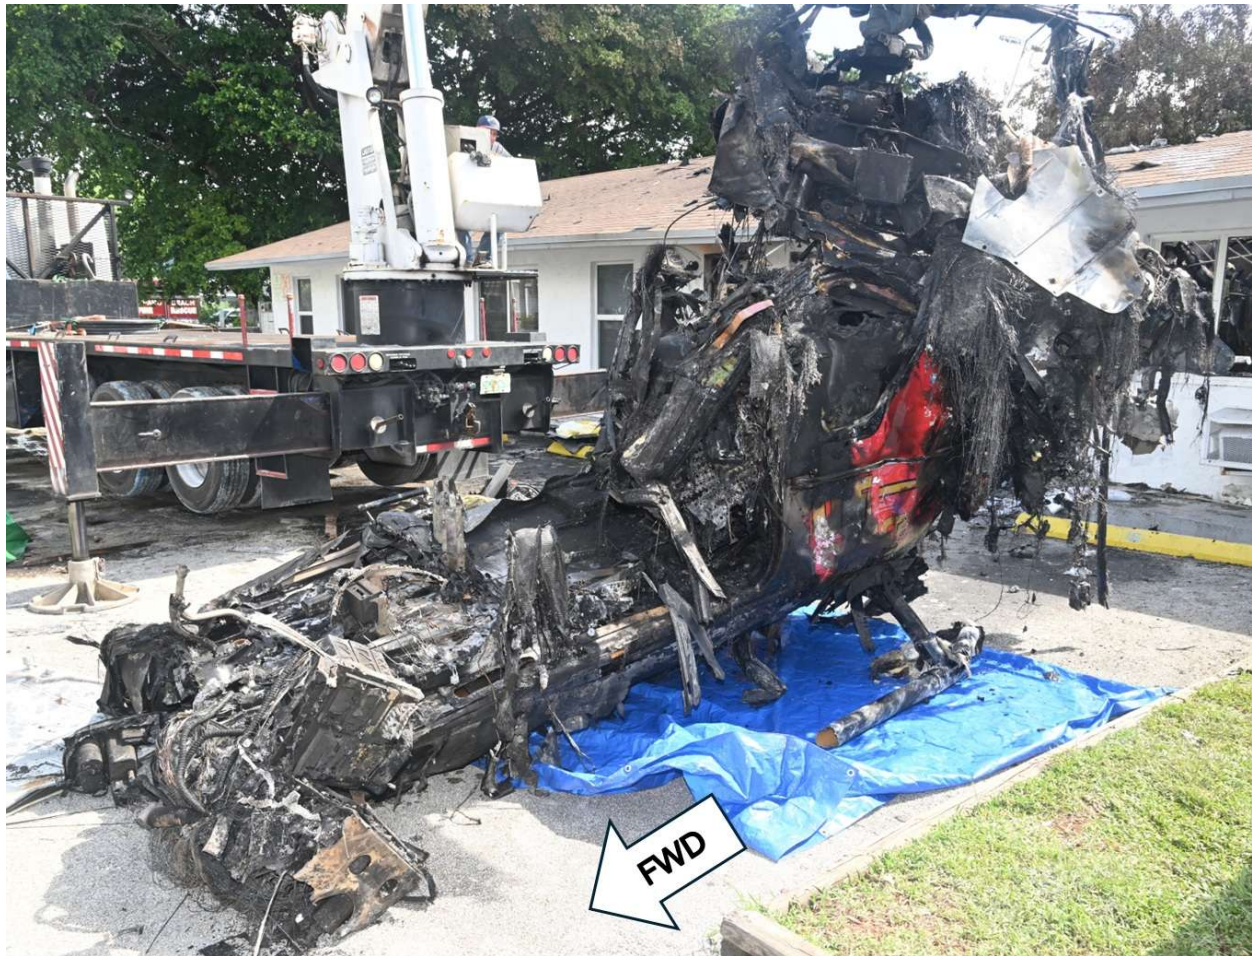
The engine deck, aft portion of the main fuselage, and fuselage floor remained partially attached to each other. The cabin roof, cockpit doors, cabin doors, and the rear clamshell doors were consumed by the postcrash fire (**Figure 8**). The equipment deck, above the clamshell doors, was not present and likely consumed by fire. The seats within the cabin were mostly consumed by the postcrash fire, but portions of their frames remained installed on their seat tracks in the fuselage.

**Figure 8.** The main fuselage wreckage after removal from the building. (Image courtesy of BSO)

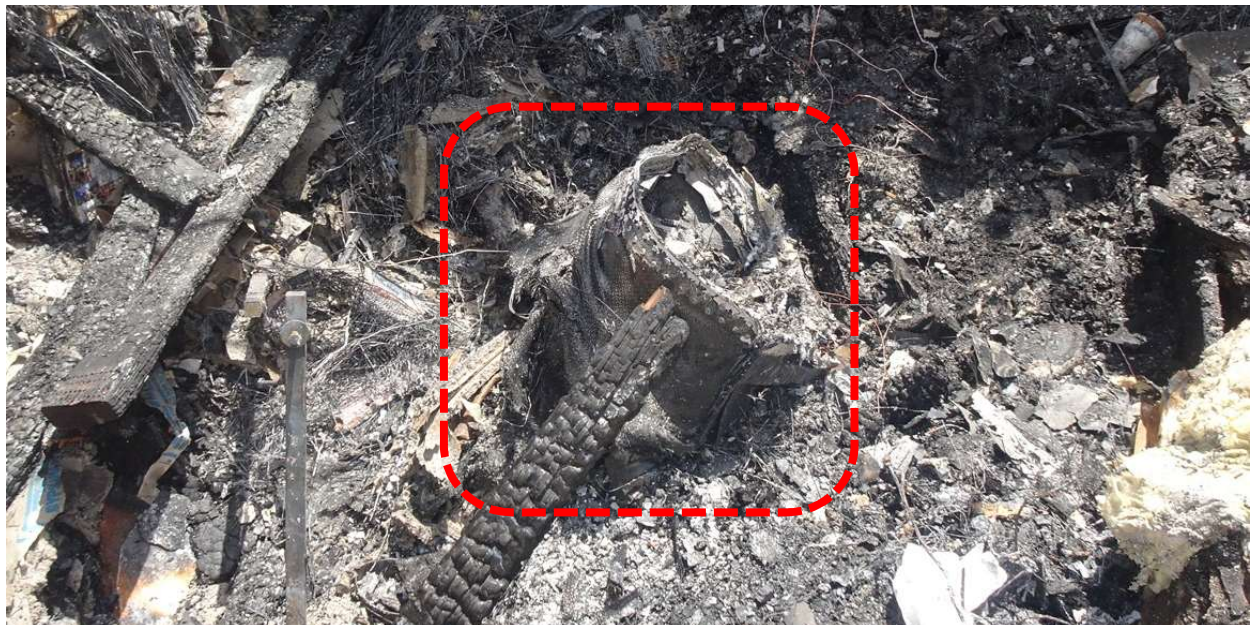
The tail boom connecting frame exhibited significant thermal damage and the attachment flanges had melted. The forward end of the tail boom connecting frame, containing a double-row of rivets for the attachment flange, was located with the main fuselage wreckage and exhibited thermal damage from the postcrash fire (**Figure 9**). The forward end of the tail boom connecting frame separated from the main fuselage wreckage during recovery of the main fuselage. The skid landing gear had fractured in multiple locations and was partially consumed by the postcrash fire. The aft portion of the left skid remained attached to the aft crosstube.

**Figure 9.** The tail boom connection to the main fuselage as seen in the building.

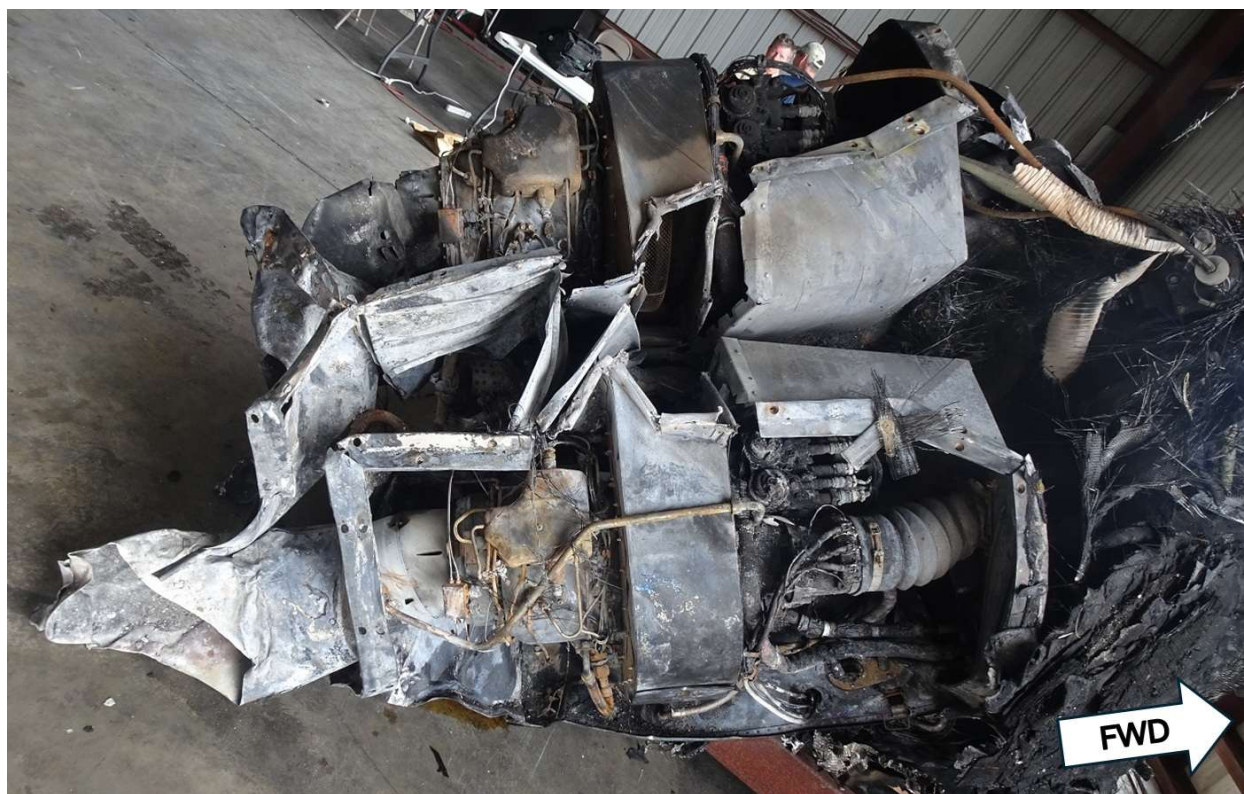
The engine compartment, including firewalls, was significantly deformed from impact forces (**Figure 10**). All No. 1 engine firewall sections were present and exhibited significant thermal damage throughout all surfaces. Due to the thin-wall nature of the firewalls, an inflight fire in the vicinity of the firewalls versus postcrash thermal damage to the firewalls could not be discerned. On the aft firewall, adjacent to where the exhaust ejector attaches to the aft firewall, there was a fracture near the outboard edge that was about 1-inch in length. This fracture showed signatures consistent with overload. The tail cone attachment and the central firewall (aft of the engine air inlets) had no punctures or perforations. The No. 1 engine firewalls were removed from the wreckage and subsequently sent to the NTSB Materials Lab in Washington, DC for further evaluation. **Attachment 1** contains additional photos of the engine firewall system. For additional details of this evaluation, see NTSB Materials Laboratory Factual Report Nos. 24-027 and 24-032 in the docket for this investigation.

**Figure 10.** The Nos. 1 and 2 engine firewalls (top looking down).

All No. 2 engine firewall sections were present, and no material appeared to be missing. All sections sustained impact damage. Heavy soot and a powdery greyish-white material coated the interior surfaces of the firewall sections. An area of

oily residue was found on the lower firewall along the inboard edge. Blue thermal discoloration was present along the inboard and aft edges of the lower firewall. Several areas of bright blue and brass colored, splatter-shaped patterns of thermal discoloration found on both interior and exterior surfaces of the lower and aft firewalls. A bright yellow slightly oily substance was found just aft of the No. 2 engine aft firewall and below the hydraulic lines located adjacent to the driveshaft compartment. On the aft firewall, adjacent to where the exhaust ejector attaches to the aft firewall, there was a fracture, about 1-inch in length, near the outboard edge, similar in location to the fracture found on the No. 1 engine aft firewall. The No. 2 engine firewalls were removed from the wreckage and subsequently sent to the NTSB Materials Lab in Washington, DC for further evaluation. **Attachment 1** contains additional photos of the engine firewall system. For additional details of this evaluation, see NTSB Materials Laboratory Factual Report Nos. 24-027 and 24-032 in the docket for this investigation.

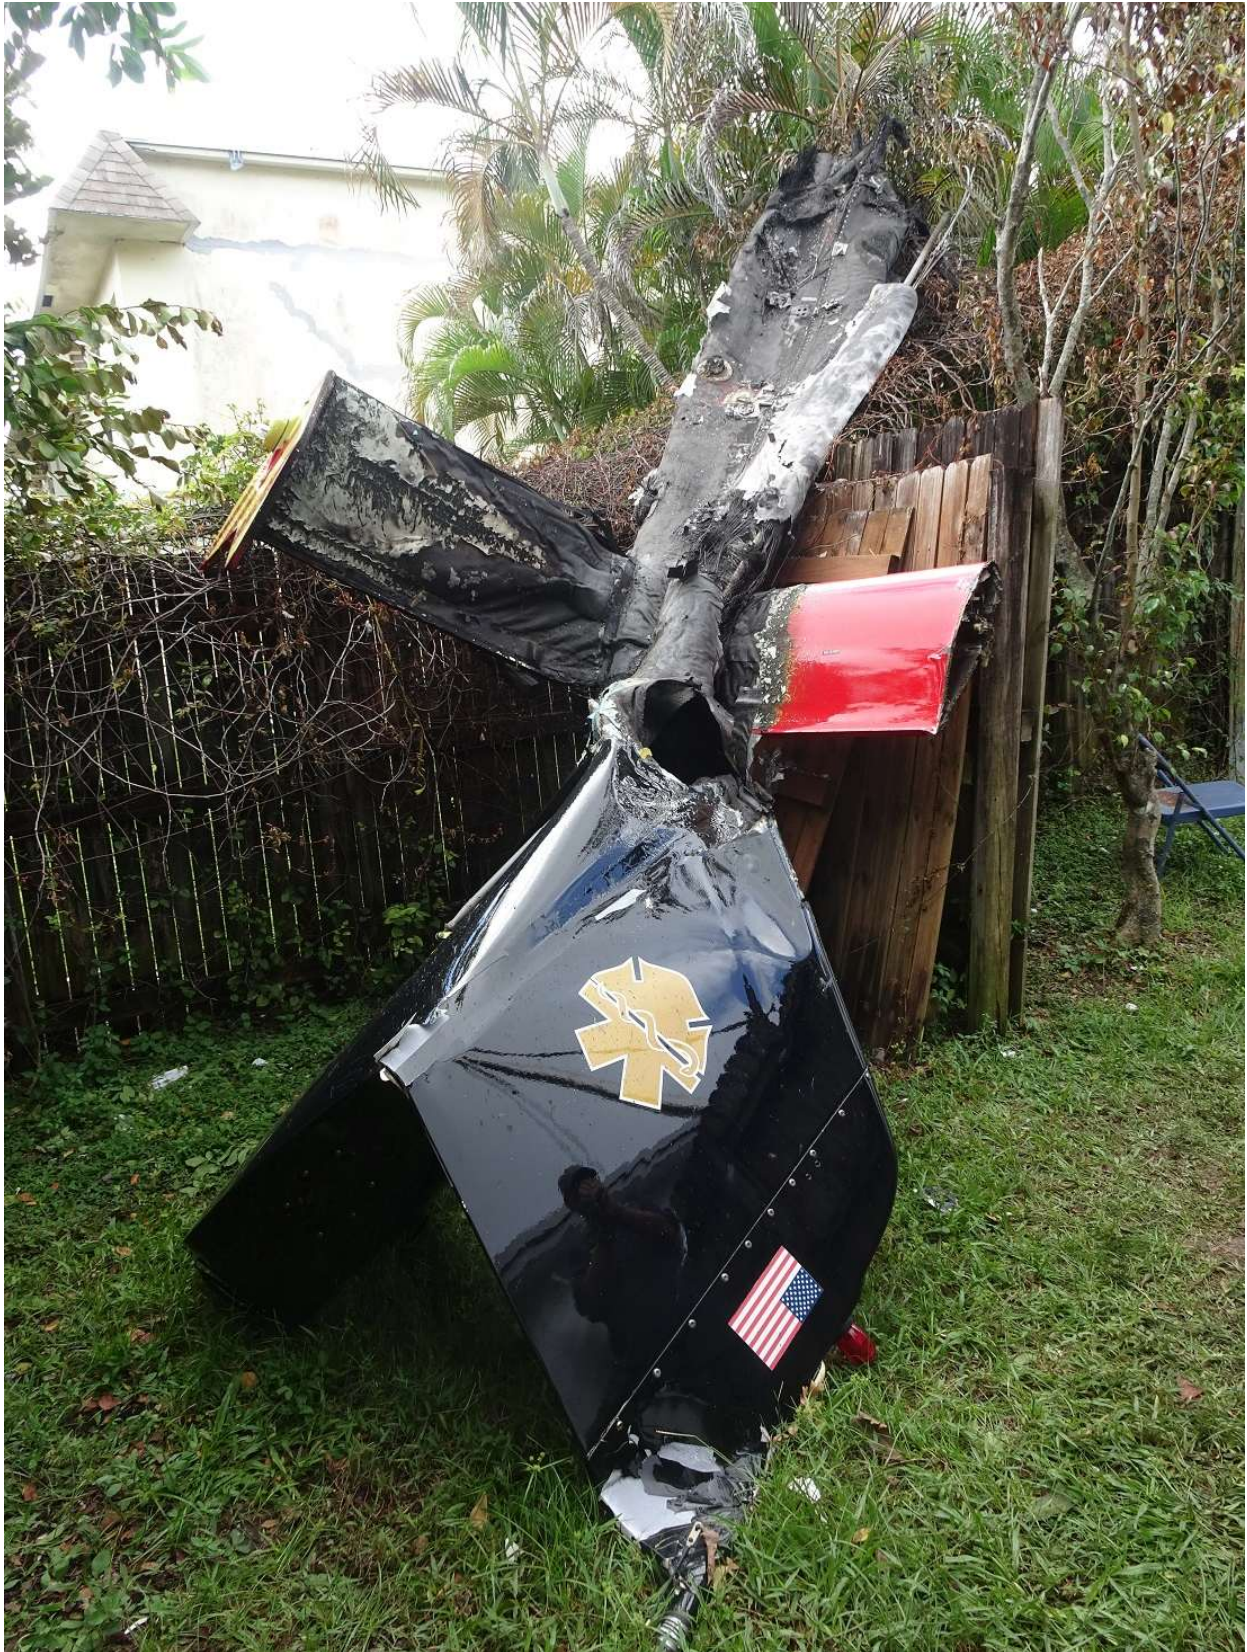
The left horizontal stabilizer exhibited thermal damage all over its horizontal surfaces. The left horizontal stabilizer end plate remained attached to the left horizontal stabilizer and its forward and inboard surfaces were thermally damaged but the paint on its outboard surface was mostly intact. The right horizontal stabilizer's horizontal surfaces exhibited thermal damage on a portion of its inboard end, but the paint on the remainder of the horizontal surfaces was mostly intact. The outboard end, including end plate, of the right horizontal stabilizer was fractured chordwise, possibly due to main rotor blade contact as a piece of the main rotor blade tip end skin was found near the tail boom. A fractured portion of the right end plate was found in the backyard of the building with the main fuselage wreckage.

**Figure 11.** The tail boom, horizontal stabilizer, vertical fin, and fenestron wreckage.

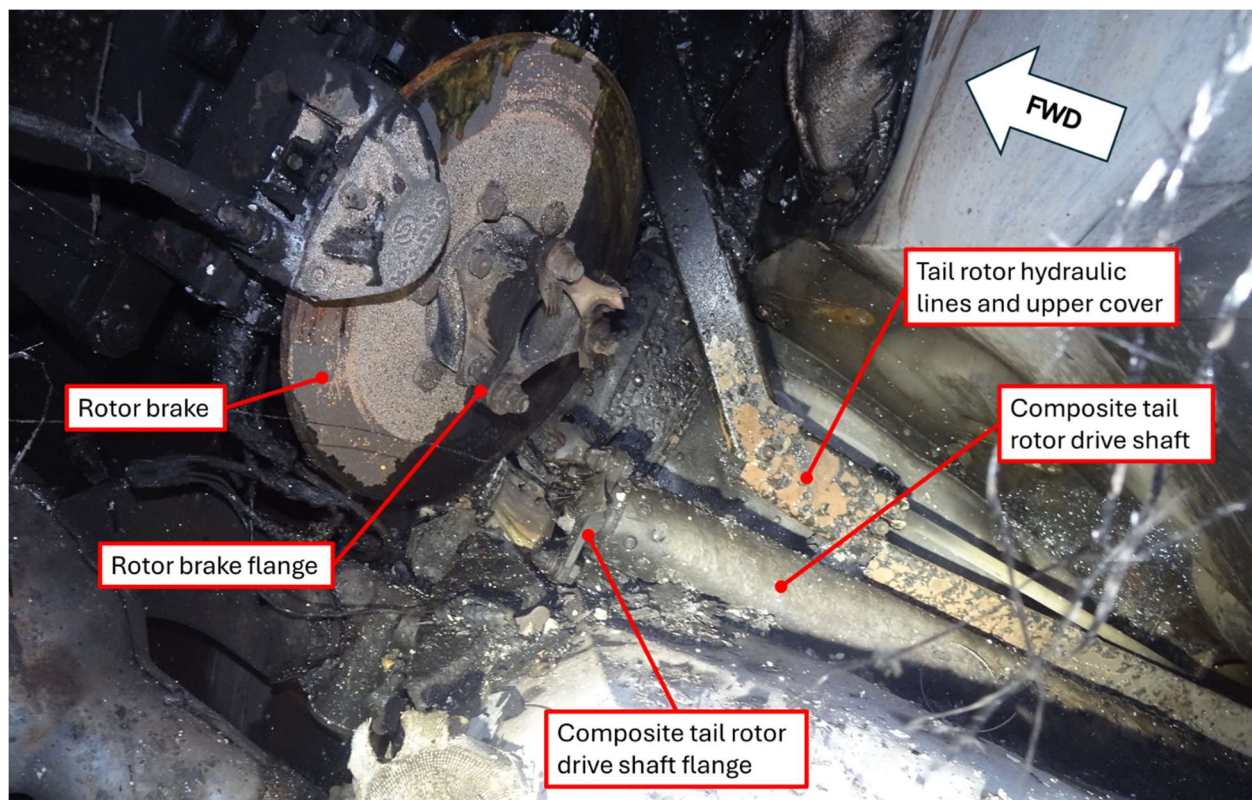
The forward [composite] tail rotor drive shaft was found with the main fuselage wreckage at its normally installed location and was thermally damaged. At the forward end of the forward composite tail rotor drive shaft, the flexible coupling between the composite drive shaft and rotor brake had fractured, but the fractured portions of the coupling remained attached on the respective flanges (**Figure 12**). The full length of the composite tail rotor drive shaft was present, but the composite tube was partially splayed and exhibited more thermal damage near its aft flange about 20 to 32 inches from the forward flange (**Figure 13**). The aft flange of the composite tail rotor drive shaft was attached to the forward end of the steel tail rotor drive shaft via flexible coupling. The flexible coupling between the composite and steel tail rotor drive shafts was intact but exhibited slight opening of its laminates.

**Figure 12.** The fractured flexible coupling connection between the rotor brake and the composite tail rotor drive shaft.

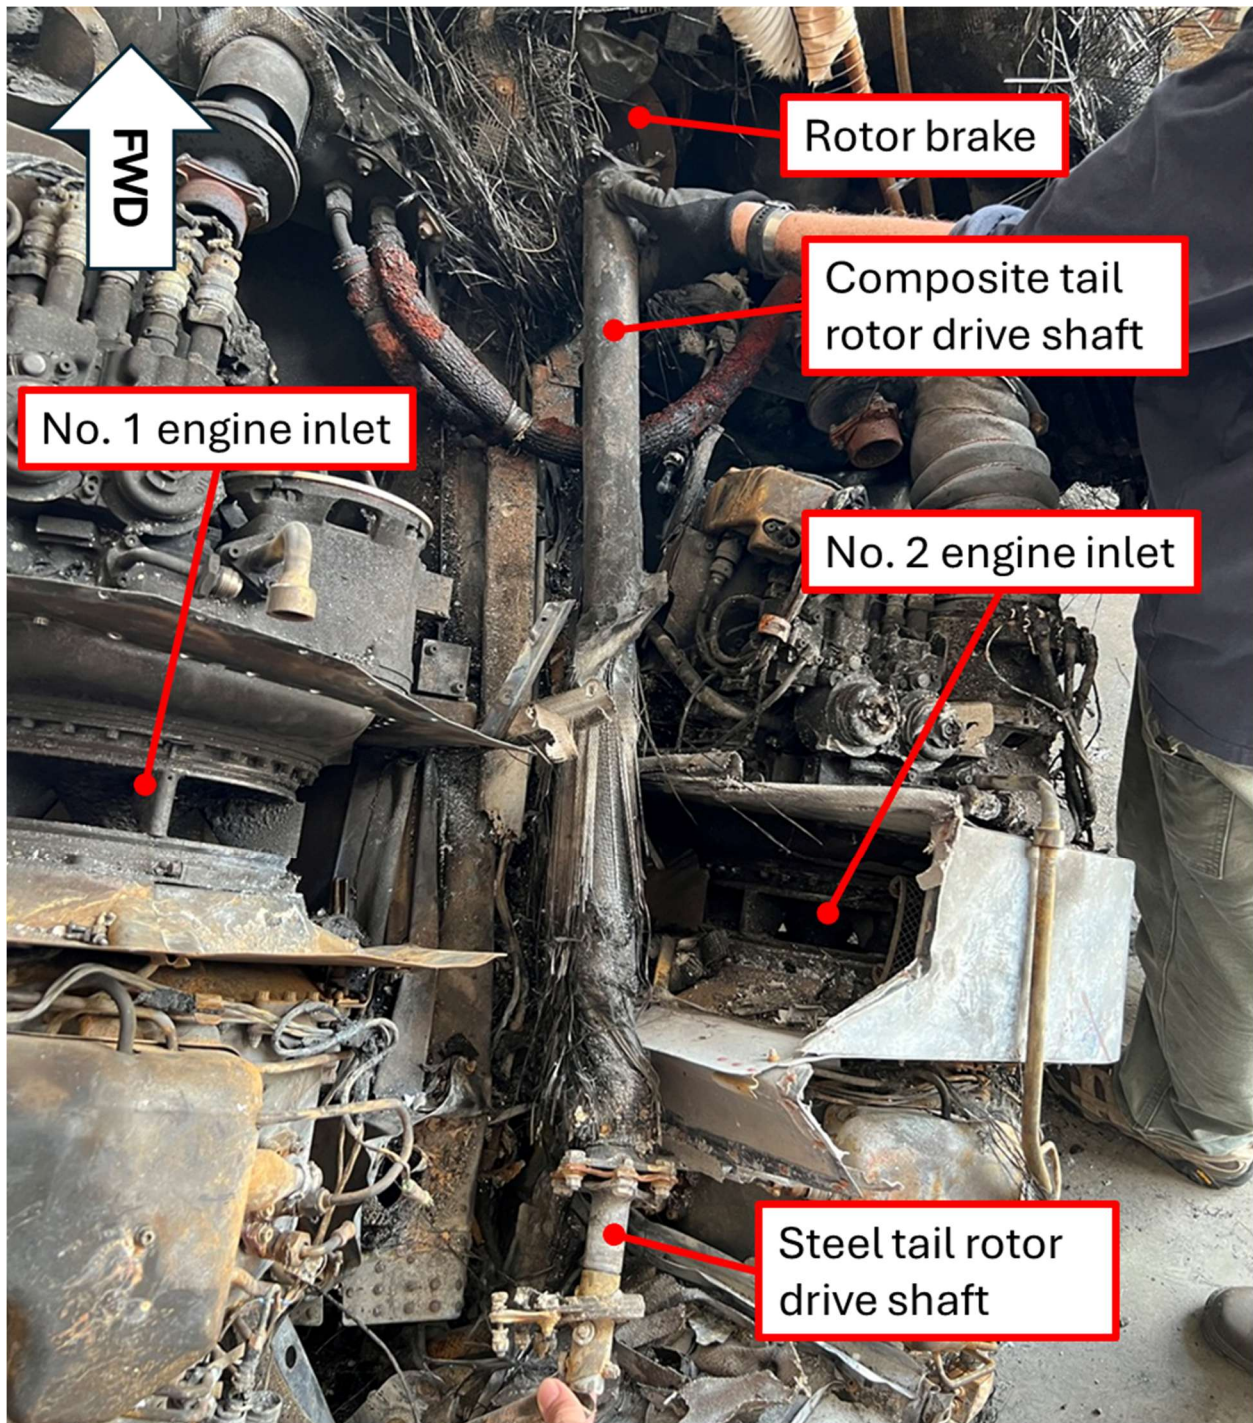
The full length of the aft composite tail rotor drive shaft was present. The forward half of the drive shaft was thermally damaged, but the aft end of the drive shaft did not exhibit significant thermal damage. Manual rotation of the fenestron resulted in a corresponding rotation of the aft composite and steel tail rotor drive shafts, but rotation was limited due to the thermally compromised aft composite tail rotor drive shaft.

**Figure 13.** Damage to the aft portion of the composite tail rotor drive shaft exhibited more thermal damage than its forward portion. The aft flange of the composite tail rotor drive shaft is connected to the forward flange of the steel tail rotor drive shaft via flexible coupling. (Image courtesy of Airbus and modified by the NTSB)

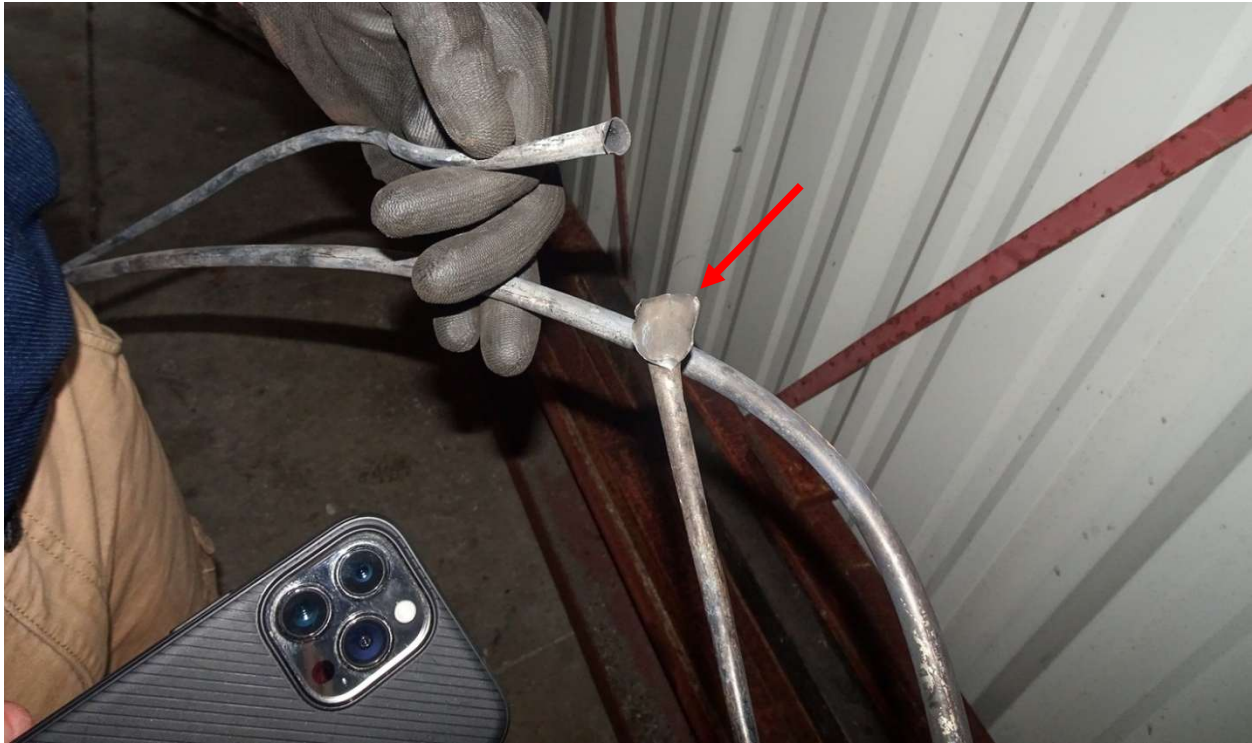
For the tail rotor hydraulic lines near the tail boom separation point, the ferrule connection for both pressure and return lines were loose and able to be turned about 2-3 complete rotations until the nut became tight. Additionally, the tail rotor hydraulic pressure line exhibited a burst-like fracture about 11 inches aft of the ferrule connection (**Figure 14**).

**Figure 14.** The tail rotor hydraulic actuator pressure line that exhibited a burst-like appearance.

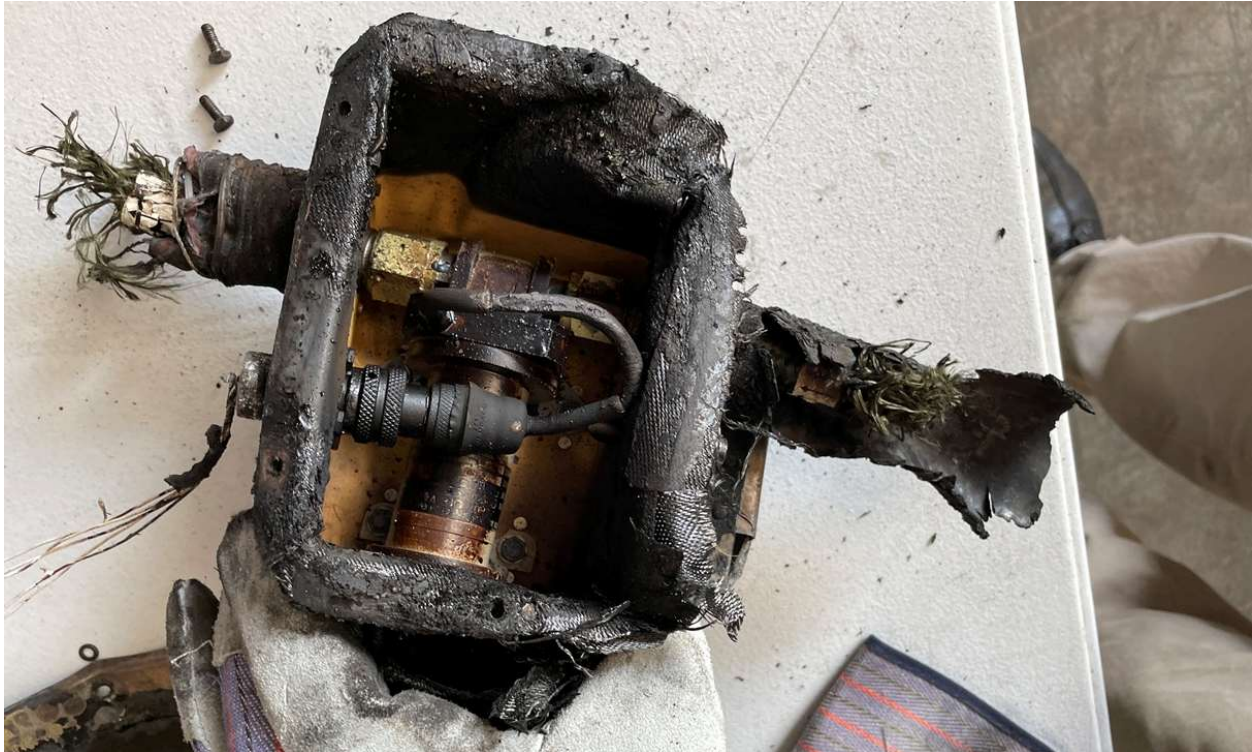
The No. 1 emergency fuel shutoff valve allows or restricts fuel flow from the left fuel supply tank to the No. 1 engine. The emergency fuel shutoff valve for the No. 1 engine remained installed below the engine deck and its fuel lines remained connected. The fuel shutoff valve assembly was removed from the wreckage (**Figure 15**). A flexible plastic rod was inserted through one of the fuel lines connected to the shutoff valve assembly and the plastic rod came out of the fuel line on the other end of the shutoff valve assembly.

**Figure 15.** The emergency fuel shutoff valve for the No. 1 engine after removal from the main fuselage wreckage.

The No. 1 fuel shutoff valve was subsequently examined using a computed tomography (CT) scan. The CT scan confirmed the valve was in the open position and found no separations of its internal wiring. Additional details of the findings from the CT scan of the No. 1 emergency fuel shutoff valve can be found in the Computed Tomography Specialist's Factual Report in the docket for this investigation.

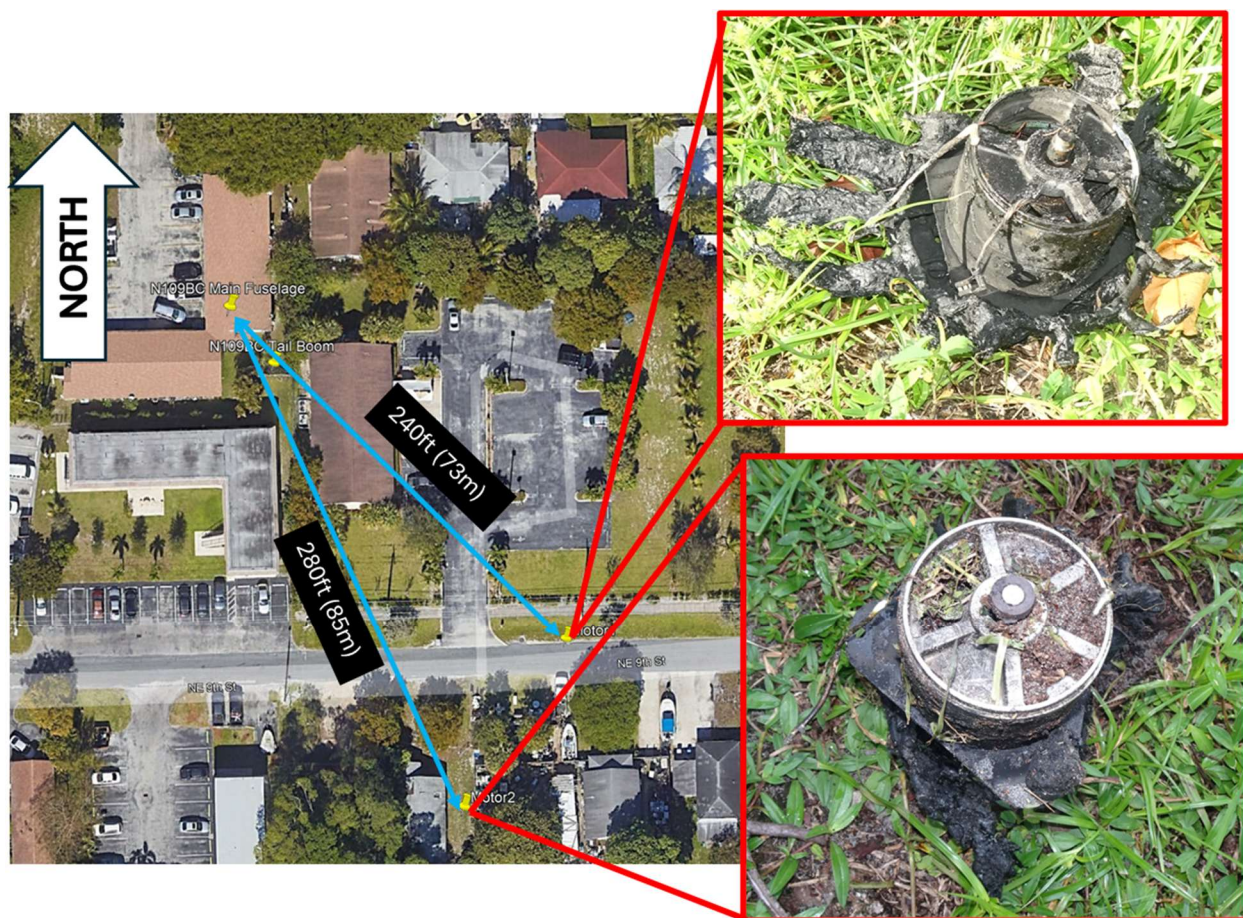
The support frame was present in the main wreckage, but the condenser assembly and its ducting were consumed by fire. Remnants of the two fan motors for the condenser assembly were found about 240 feet and 280 feet from the wreckage site (**Figure 19**).

**Figure 19.** The two separated condenser fans found away from the area of the main fuselage and tail boom wreckage.

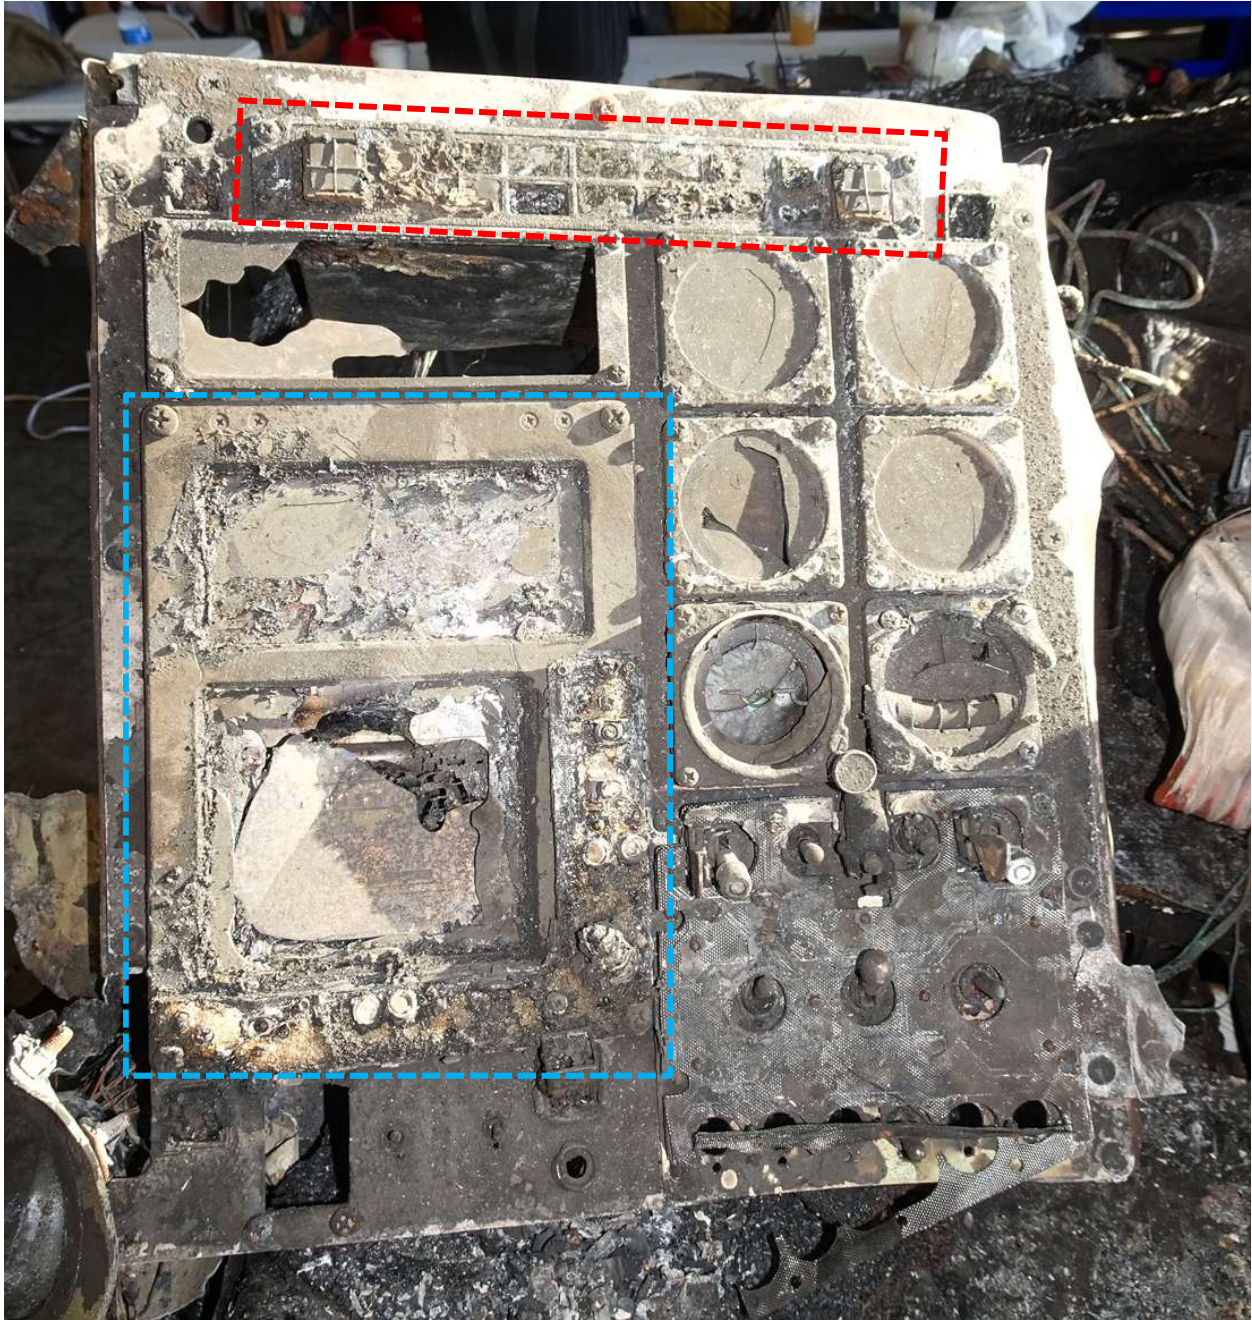
The instrument panel was present but exhibited thermal damage. Usable information could not be gleaned from the remainder of the cockpit instruments. The warning unit was present, but its housing was partially burned through (**Figure 23**). Thermal damage to the warning unit precluded recovery of its nonvolatile memory. The No. 1 and No. 2 engine fire button's breakable wire for the safety guards were found unbroken (**Figure 24**). The safety guards for both Nos. 1 and 2 engine fire buttons did not exhibit inward deformation, such as when the safety guard is forcefully pushed inward.

**Figure 23.** The instrument panel showing the CDS (blue outline) and warning unit (red outline).

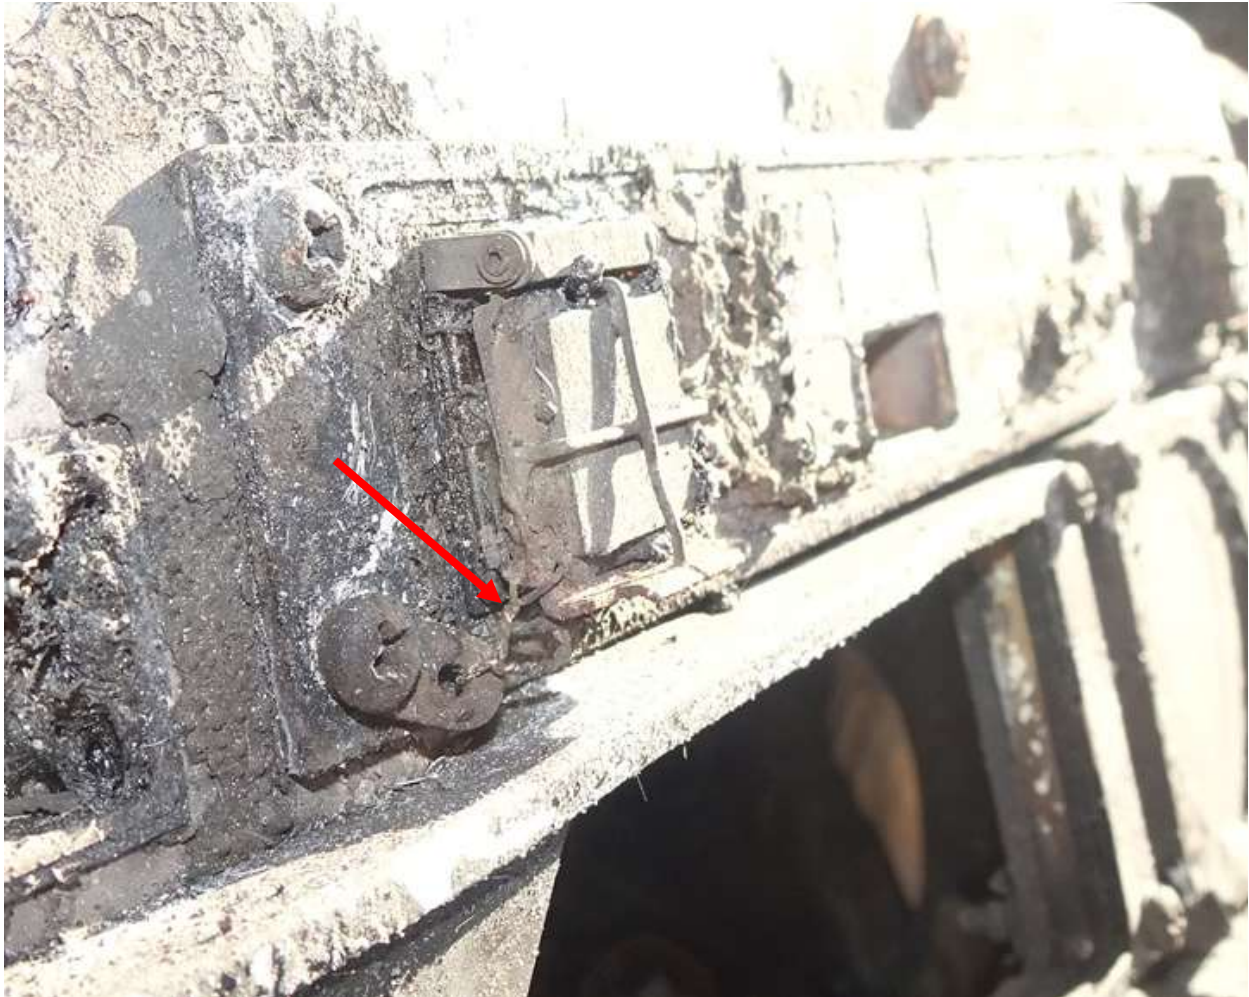
**Figure 24.** The No. 1 engine fire button showing the breakable wire (red arrow) and the safety guard over the button.

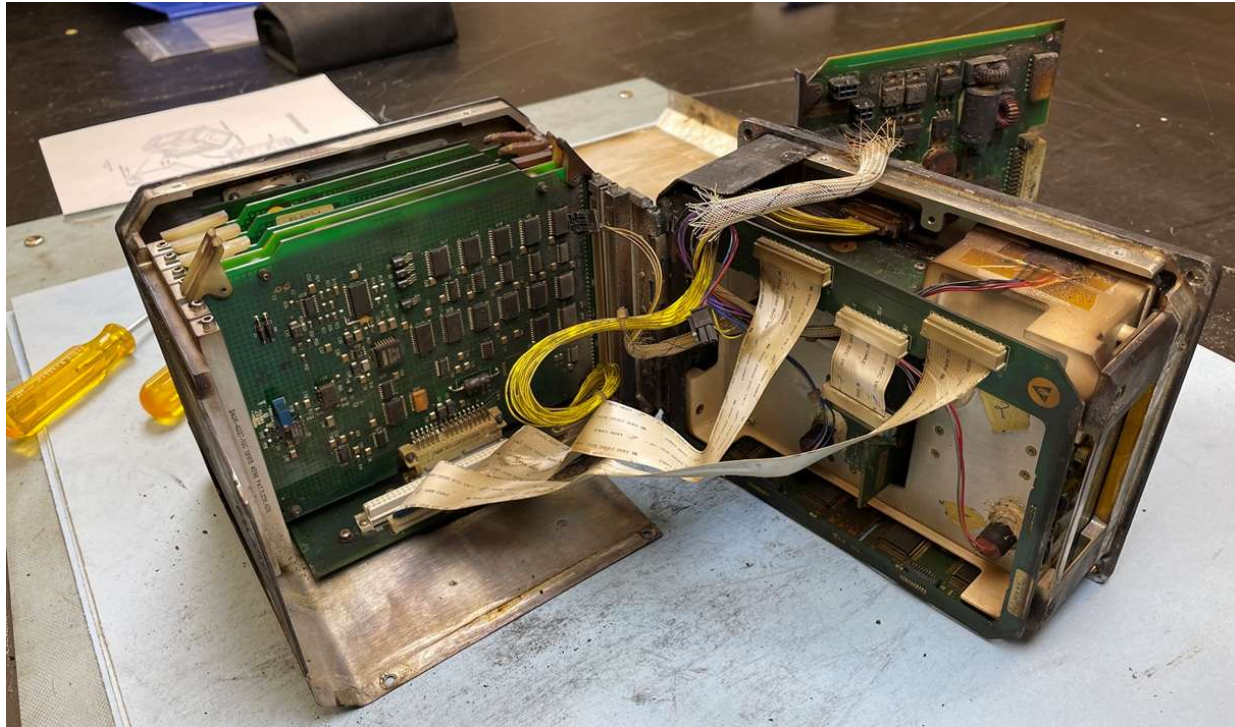
The accident helicopter's CDS housing was opened to reveal its internal circuit cards (**Figure 25**). The circuit cards exhibited tinting from thermal exposure but were otherwise whole without evidence of cracks or fractures. The central processing unit (CPU) A circuit card was removed from the CDS and the U16 erasable programmable read-only memory (EPROM) chip was removed from the CPU A circuit card. A blank U16 EPROM chip was provided to the NTSB by Ontic.<sup>3</sup> The NTSB Recorders Lab downloaded the binary data from the accident U16 EPROM chip and loaded the binary data onto the blank U16 EPROM chip. The U16 EPROM chip, with the loaded binary file, was subsequently shipped to Ontic to install on an exemplar CDS, which was an engineering unit. The exemplar CDS was installed on a test bench and powered, but the CDS did not power up. After troubleshooting, it was determined that the CDS would not power up with the accident binary data loaded onto the U16 EPROM chip, which possibly indicated that the accident binary data may be corrupted. Since a binary file decoding tool did not exist for the CDS, further work on the accident flight CDS data was not conducted.

**Figure 25.** The accident CDS circuit cards upon opening its housing.

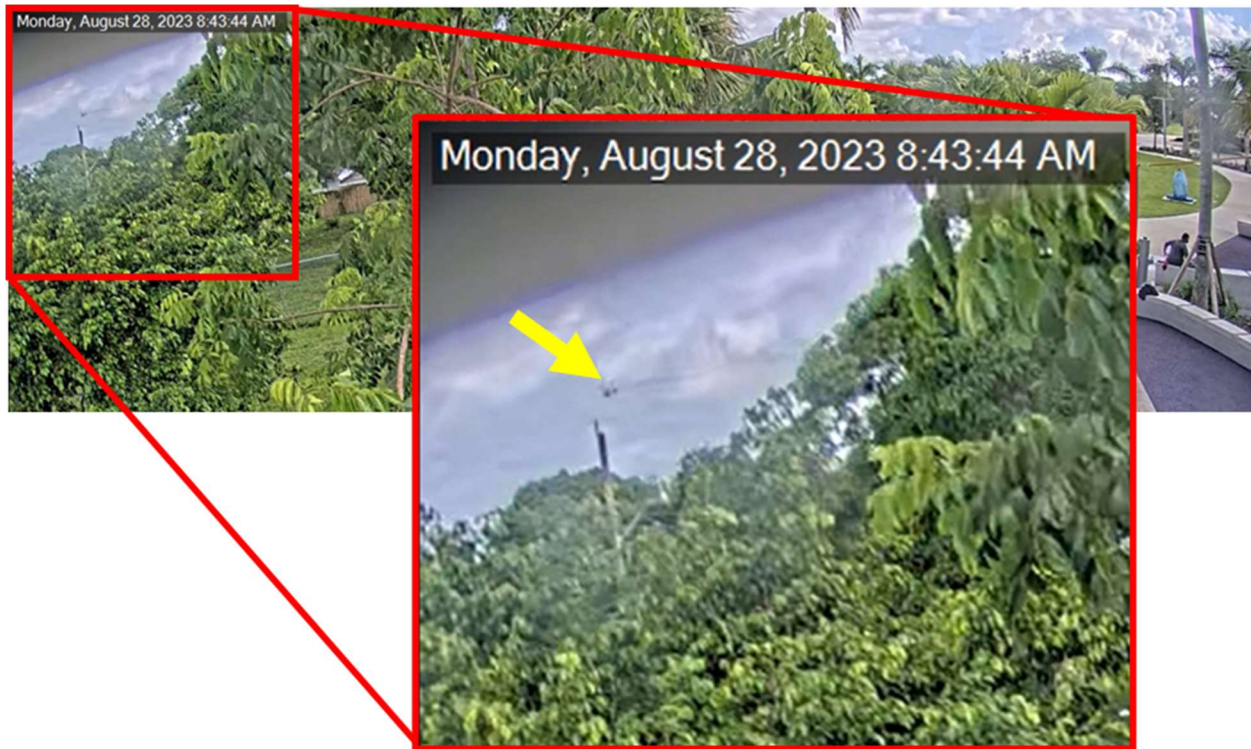
**Figure 29.** A second still image from the ground surveillance video from Annie Adderly Gillis Park that shows the helicopter with a possible smoke trail behind the helicopter (yellow arrow). (Video courtesy of BSO, still image captured and modified by the NTSB)

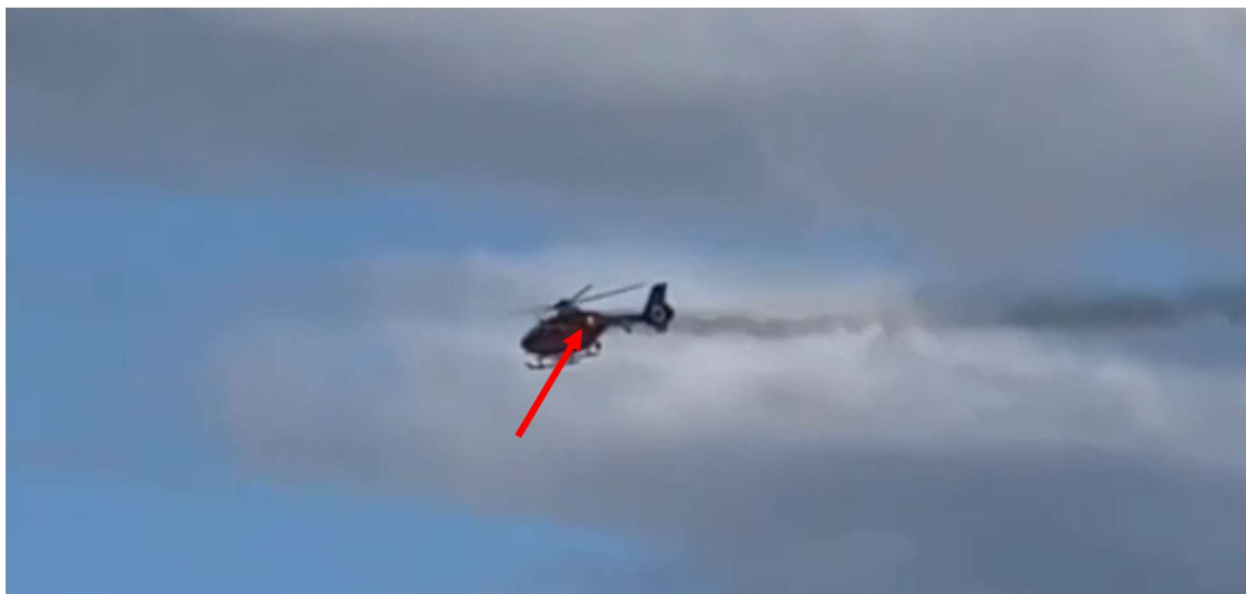
The Airworthiness Group reviewed several ground witness videos that showed the accident flight. The longest duration video showed visible flames and smoke emanating from the area of the No. 1 engine exhaust and the air conditioner condenser fans (**Figures 30 and 31**). About 1 minute after the start of the video, the helicopter abruptly yaws, the tail boom partially separates from the fuselage, and the helicopter descends toward the ground while spinning. The tail boom remains partially attached to the main fuselage during the spinning descent. Based on the 1-minute duration of the visible flames and smoke, the Airworthiness Group estimated the start time of the video was about 8:43:48 eastern daylight time (**Appendix A, Figure A-2**). Another ground witness video, about 36 seconds in duration, that showed the right side of the accident helicopter showed a smoke trail emanating from the helicopter for the duration of the video when the helicopter was visible (**Figure 32**). About 5 seconds before the helicopter's tail boom partially separated from the fuselage, and 16 seconds from the start of the ground witness video, visible flames were observed in the central area where the tail boom attaches to the main fuselage (**Figure 33**). In another ground witness video that shows the partial separation of the helicopter's tail boom and its uncontrolled descent, a small object separates from the helicopter about 5 seconds after the tail boom partially separates (**Figure 34**). This small object has a smoke trail as it descends with the helicopter (**Figure 35**). The small object was likely an air conditioner condenser fan motor found separated from the main wreckage (**Figure 19**).

**Figure 30.** A still image from the start of the ground witness video that showed the accident helicopter with a smoke trail and visible flames (red arrow) emanating from the area of the No. 1 engine exhaust and the air conditioner condenser fans. (Video courtesy of BSO, still image captured and modified by the NTSB)

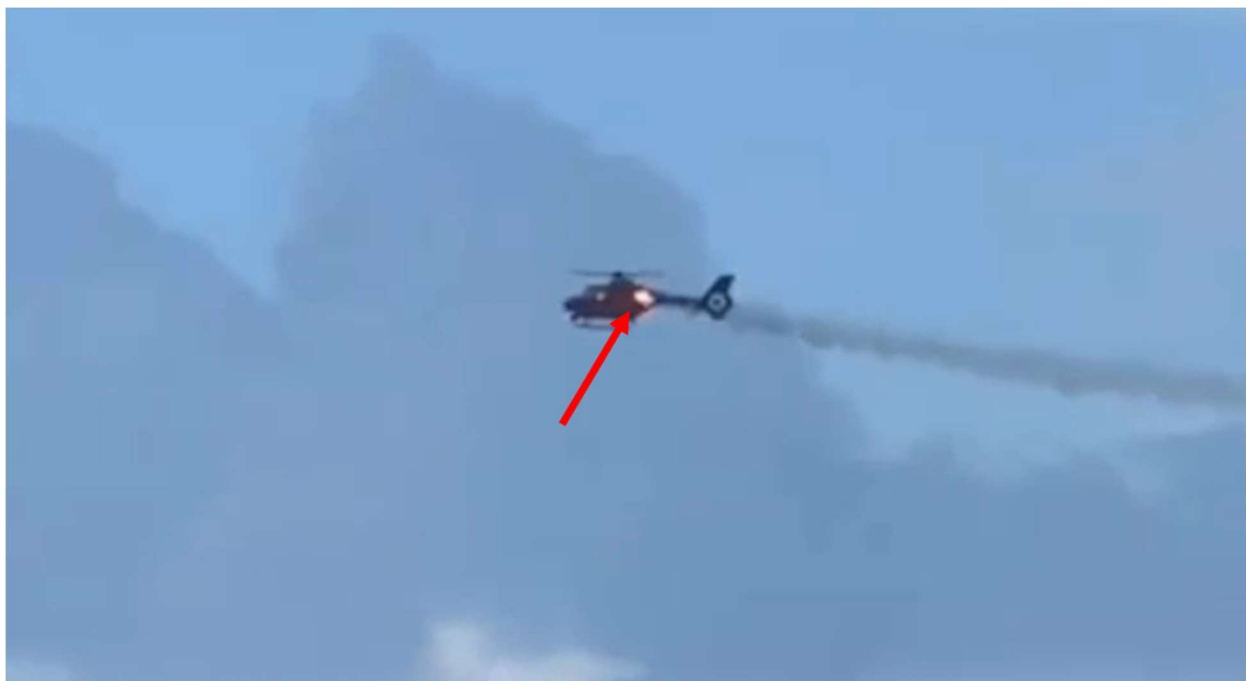
**Figure 31.** A still image taken about 35 seconds after the start of the 1-minute long ground witness video. The area of the visible flames (red arrow) appears larger than compared to the beginning of the video. (Video courtesy of BSO, still image captured and modified by the NTSB)

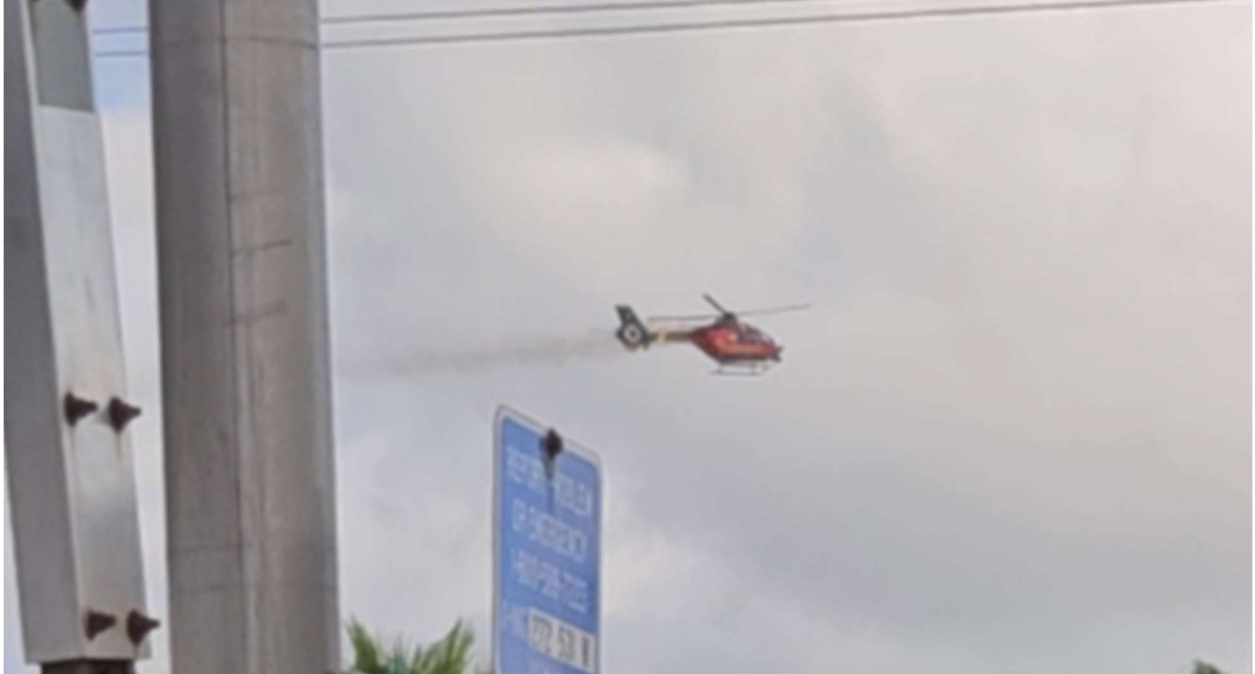
**Figure 32.** Visible smoke emanating from the accident helicopter. This still frame was captured about 10 seconds from the start of the ground witness video. (Video courtesy of BSO, still image captured by the NTSB)

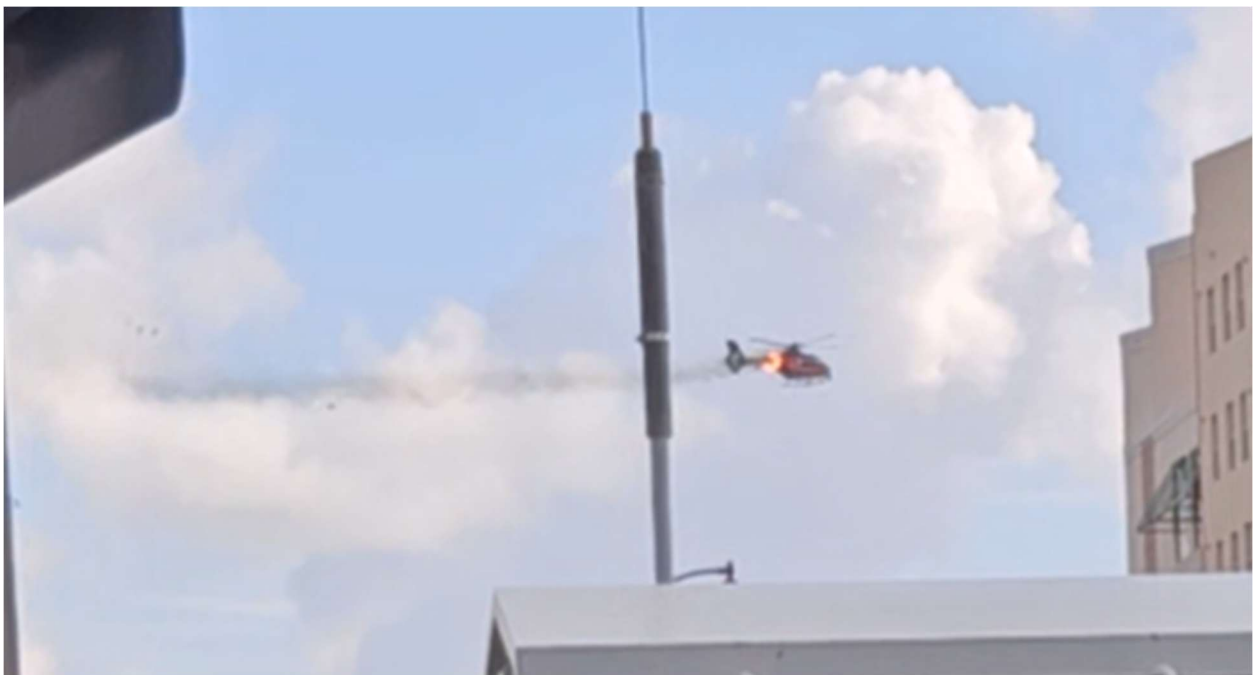
**Figure 33.** Visible flames emanating from the center tail boom area. This still frame was captured about 20 seconds from the start of the ground witness video, and about 5 seconds before partial separation of the tail boom. (Video courtesy of BSO, still image captured by the NTSB)
