# National Transportation Safety Board

ERA23FA352

Group Chair's Factual Report

Location: Pompano Beach, Florida  
Date: August 28, 2023  
Time: 0844 eastern daylight time  
Helicopter: Airbus Helicopters Deutschland EC135 T1, registration N109BC

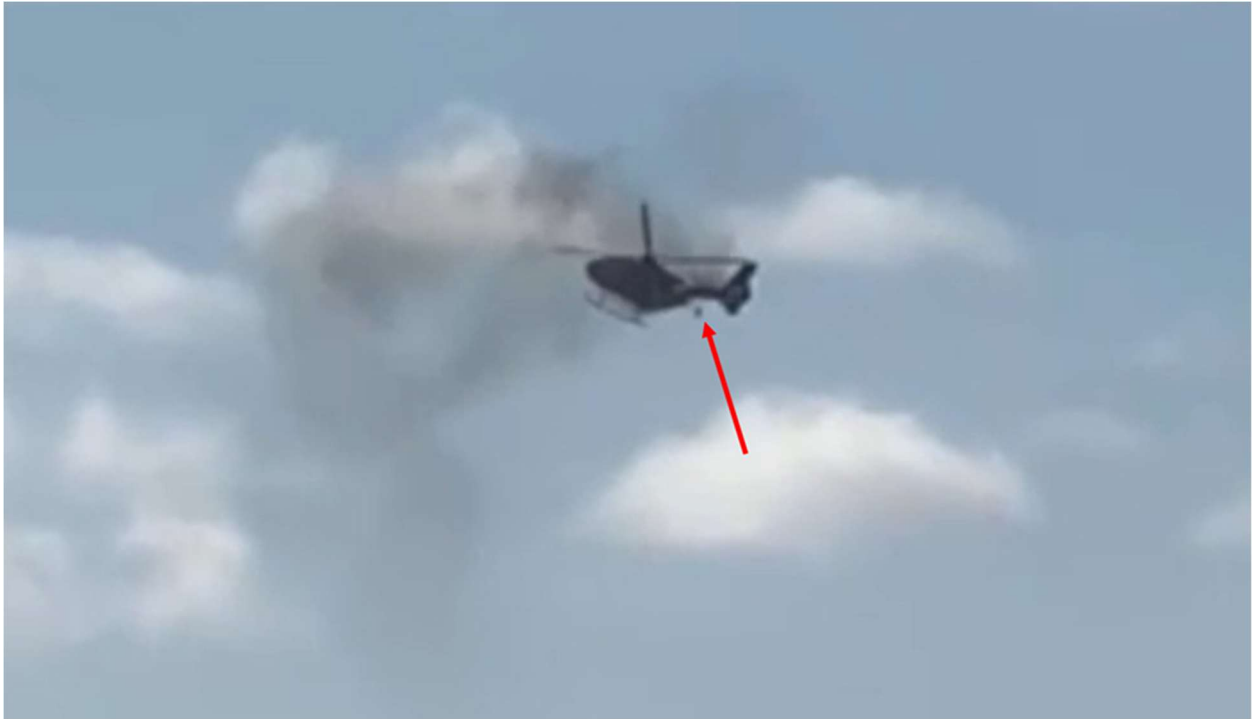
**Figure 34.** The small object that separated from the helicopter about 5 seconds after partial separation of the tail boom.

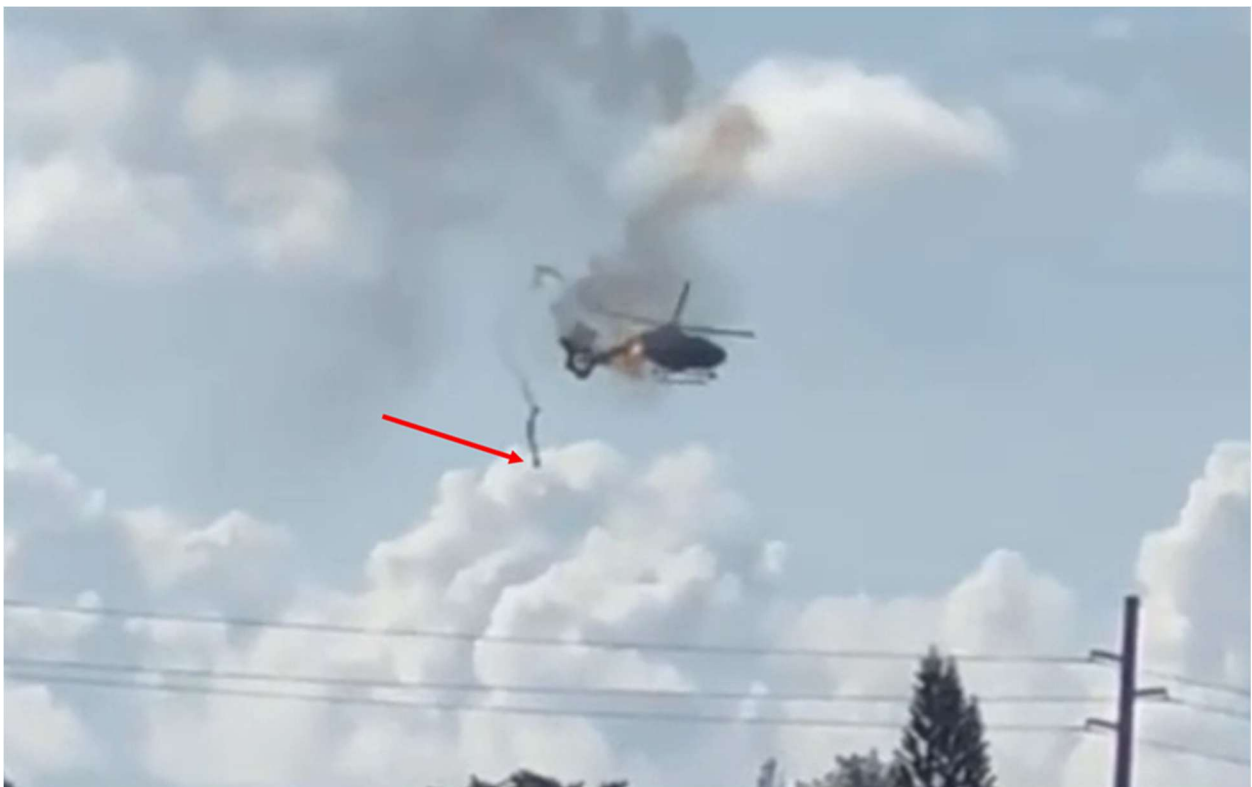
**Figure 35.** The visible smoke trail of the small object that separated from the helicopter.
