ERA23FA352

BEA Technical Document No. 2023-0379\_tech04

**ECU #1 examination**

Accident on **28th August 2023**  
near **Pompano Beach (United States)**  
to the **helicopter EUROCOPTER > EC135 > T1**  
registered **N109BC**

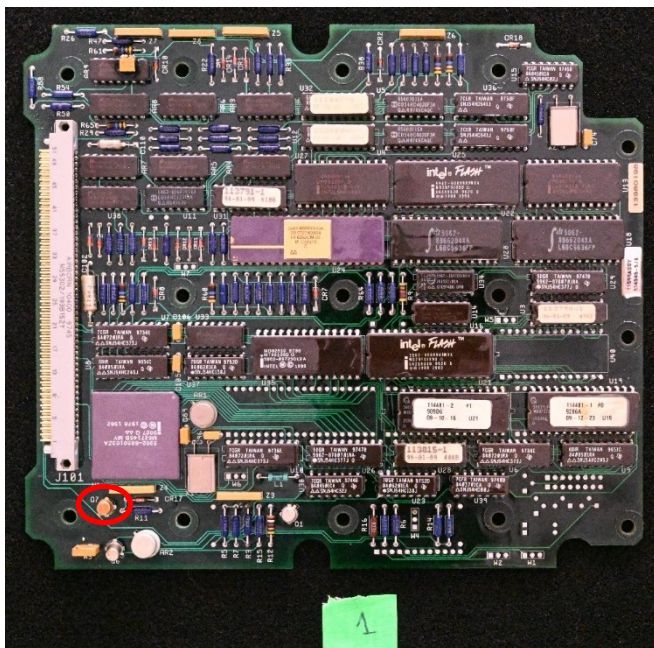
Figure 1 : Board 1 top side

The board was in good condition. One transistor (circled in red) was found coloured in orange. This coloration was also found on the inner side of the casing in front of the component.

Transistor Q7 was found coloured in orange on the top side of the board number 1. A similar coloration was found at the corresponding location on the casing. The reason of this colouring was not identified.

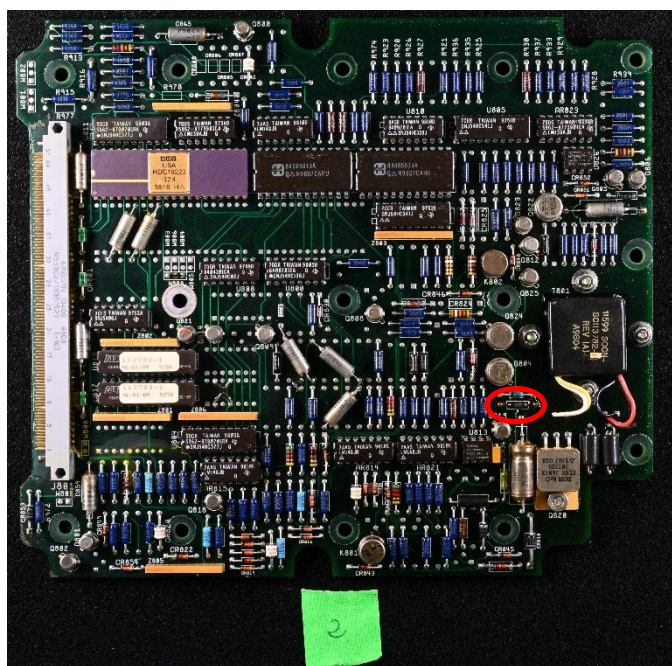
Figure 4 : Board 2 top side

The board was in good condition. One resistor (circled in red) presented thermal damages. No other damage was identified on this board.

One resistor was found thermally damaged on the top side of the board number 2. As the damages are only located on the component itself and its solder joint, it is not compatible with the exposure to an external heat source and may be due to an overcurrent. Taking in account the overall damages of the computer boards, a more detailed analysis of the electronics schematics should be performed to assess what could have led to the resistor overheat.

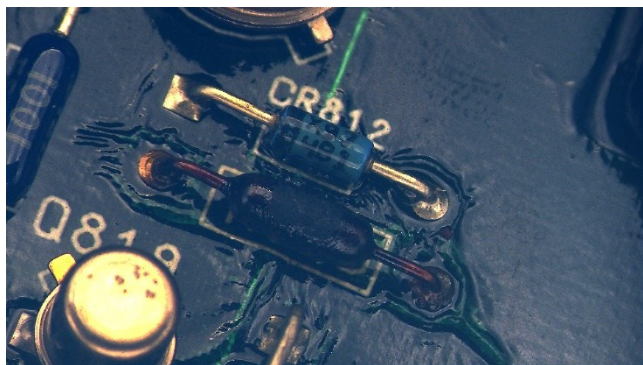
### 2.2.1. Damaged resistor

None of the observed damages were mentioned in Triumph EMC-35B ECU Potential Failure Modes document. As the two damages of the component from board 2 and 4 cannot be explained directly by the heat exposure, it should be assessed whether these damages could have led to a simultaneous double N1 and double N2 failure.

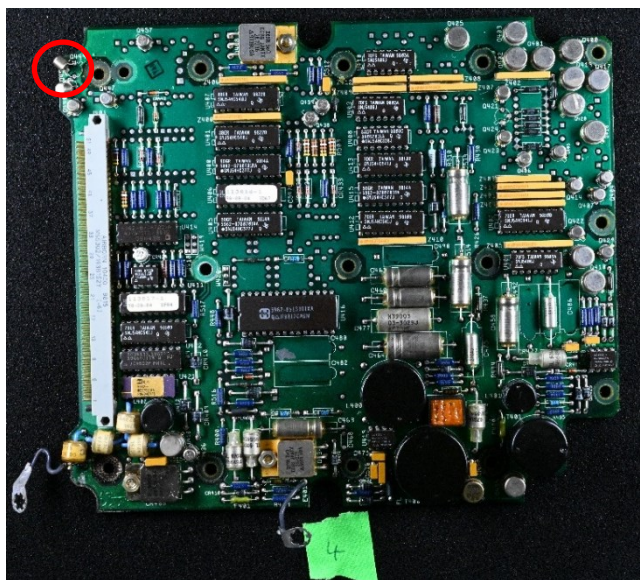
Figure 8 : Board 4 top side

The board was in good condition. One transistor (circled in red) was partially unsoldered from the board.

Transistor Q449 was found partially unsoldered on the top side of the board number 4. This damage is not compatible with the exposure to an external heat source and may be due to the impact with the ground.

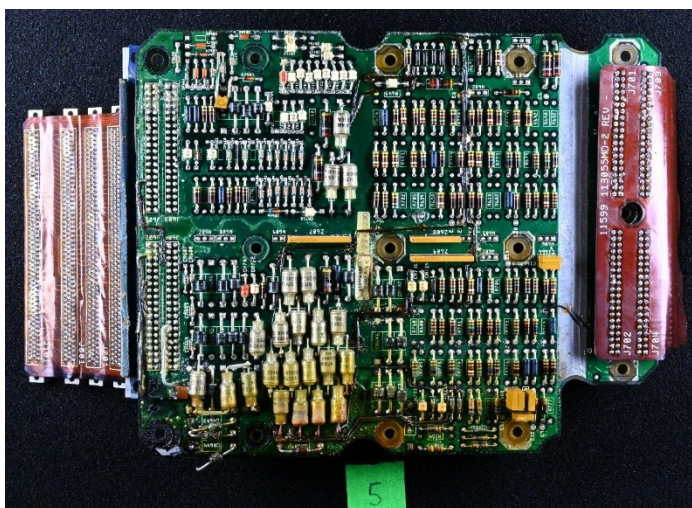
Figure 9 : Board 5 top side

To remove the board from the casing, the flex connecting the board to the ECU external connectors was cut. The board was thermally damaged. The damages were localized on the board and not homogeneous.

The board number 5 was found thermally damaged. It is consistent with a consequence of the in-flight fire or post-crash fire. The thermal damages were localised on the board which indicates a localised exposure to the fire.

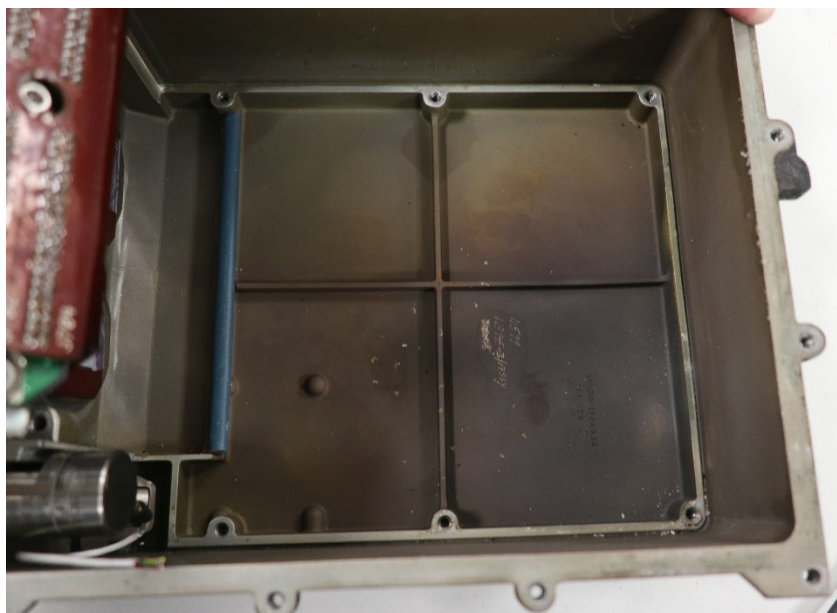
The location of the damages on the board was consistent with thermal damages observed on the inner part of the casing.

Figure 11 : Thermal damages on the inner side of the casing

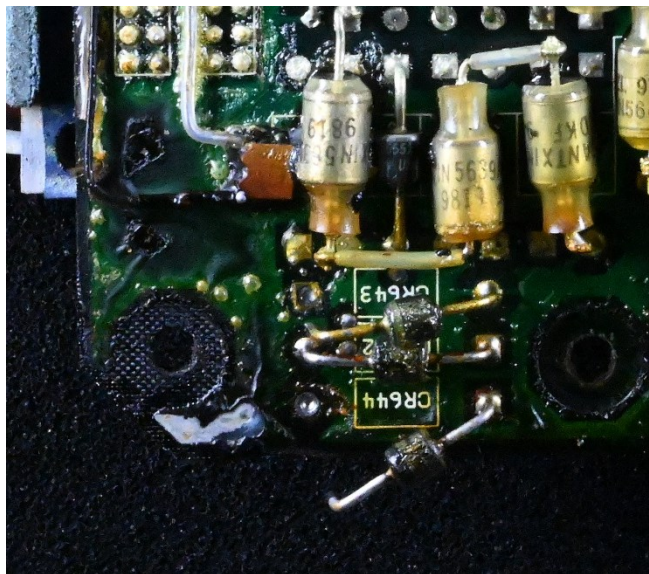
The two diodes (CR644 and CR643) found partially unsoldered on the X-ray view were identified.

**Figure 13 : Damaged diodes on board 5**

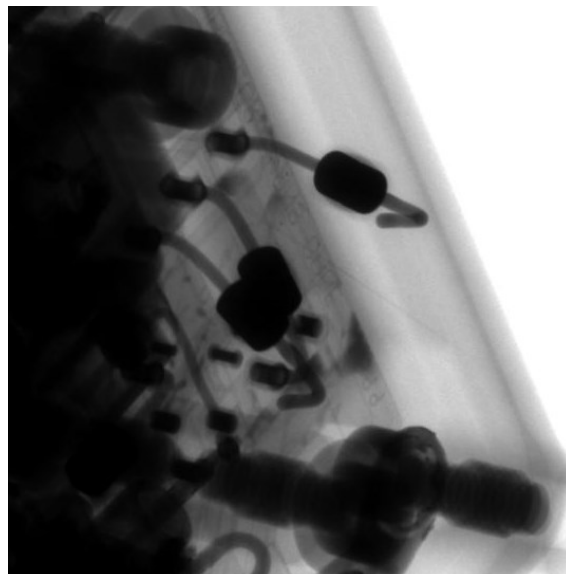
**Figure 12 : X-Ray view of the damaged diodes on board 5**

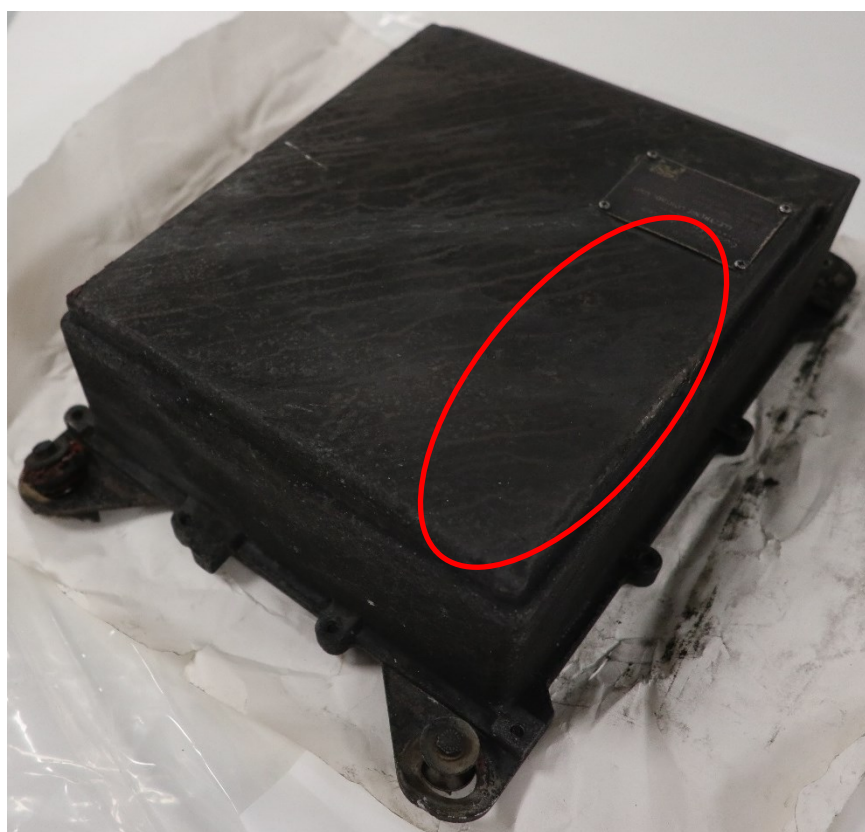
**Figure 14 : ECU Highest thermal exposure area deduced from board 5 damages**
