# National Transportation Safety Board

ERA23FA352

## **POWERPLANTS**

Group Chair's Factual Report

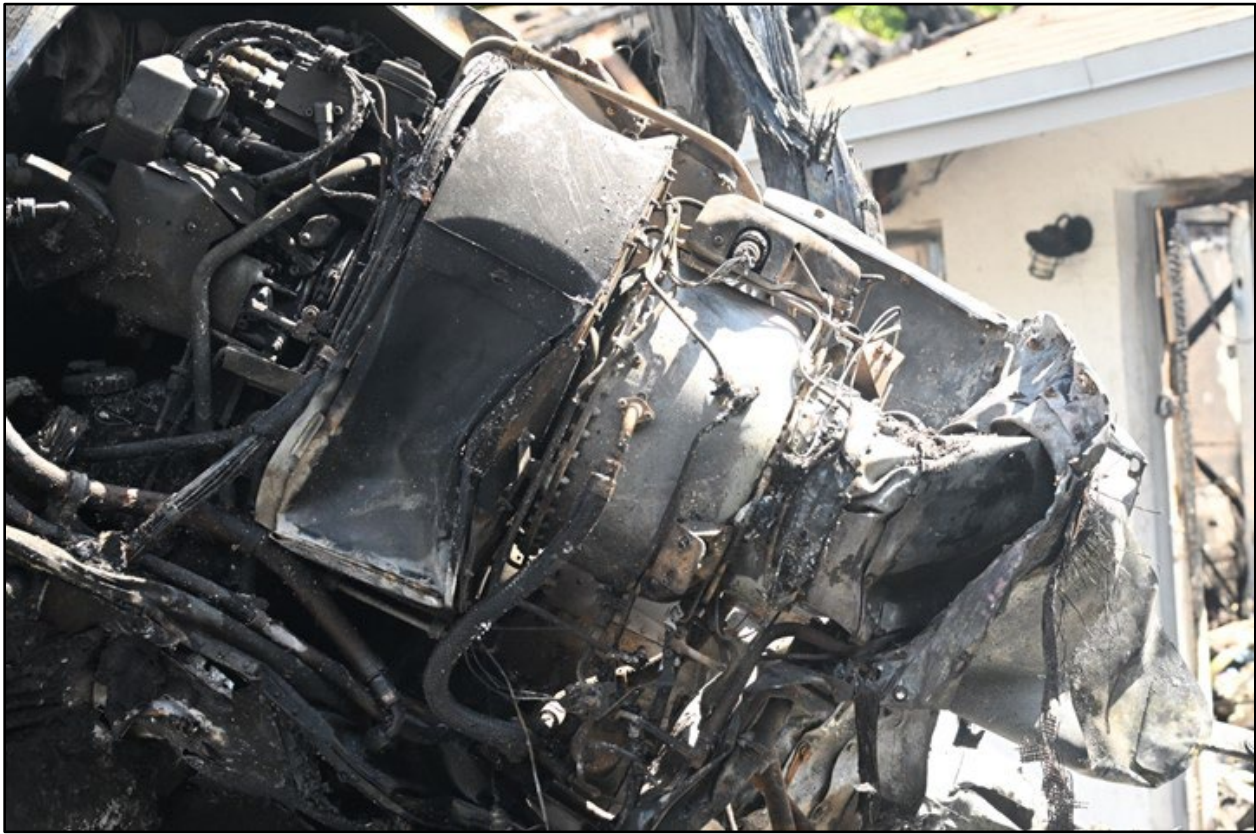
**Figure 2.** No. 1 Engine

The No. 1 engine was present in its normally installed, left hand position No. 1 location (Figure 2). The engine exterior exhibited thermal damage. The exhaust support (with struts) and exhaust pipe were deformed to the right and forward. The exhaust pipe had one puncture that was seen on the lower-outboard (6:00 to 9:00 o'clock) quadrant. The puncture measured about 1 inch long. The compressor inlet struts, and adjacent surfaces had a dark grey to black colored material adhered to it, primarily concentrated on the 12:00 o'clock strut. The compressor impeller was able to be manually rotated. Manual rotation of the compressor impeller resulted in

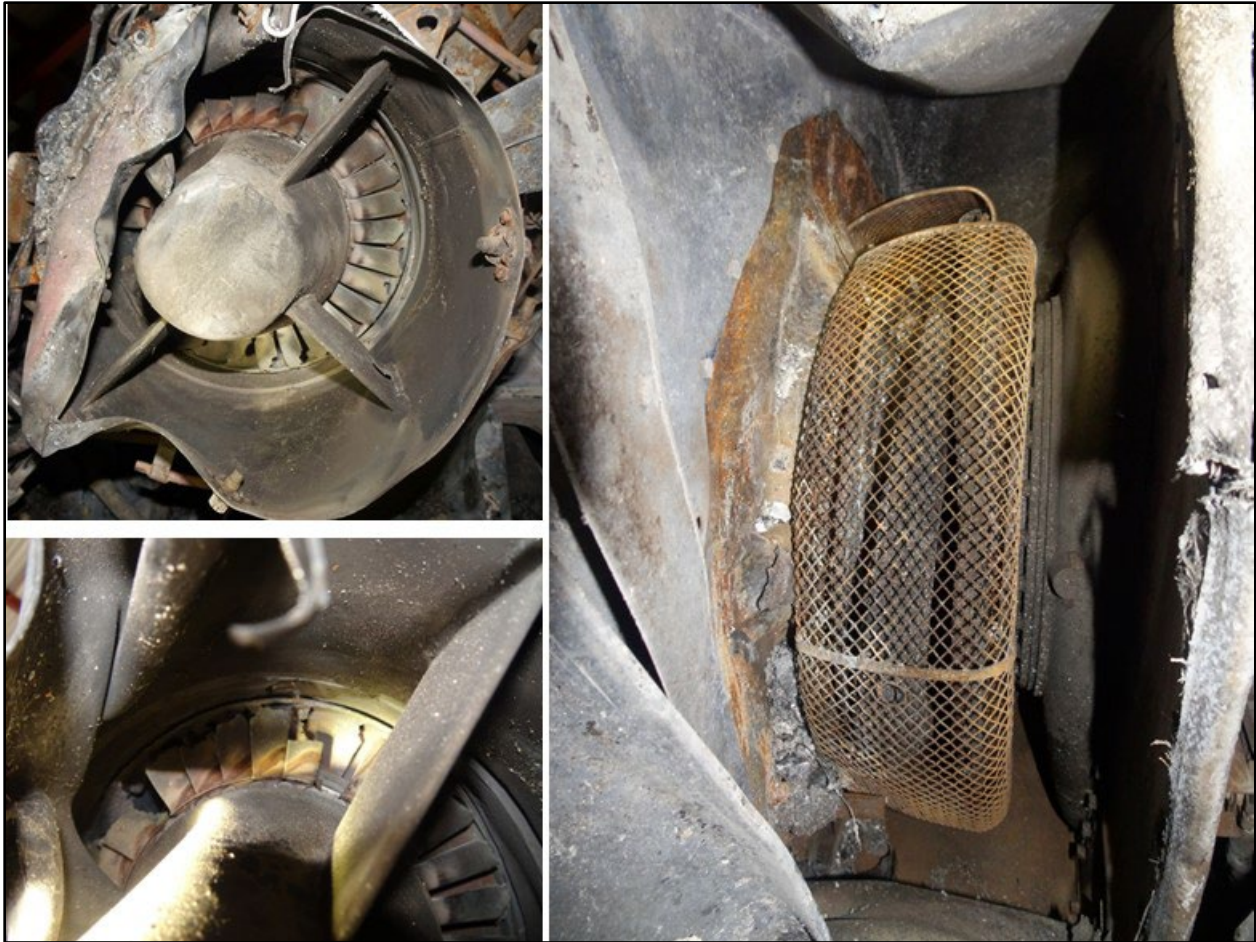
**Figure 3.** No. 1 Engine - View of Power Turbine Blades (L) and Inlet Screen (R)

Four PT blades were missing from their root end and a fifth PT blade had fractured chordwise and its outboard half was missing (Figure 3). The remaining visible PT blades exhibited varying degrees of damage on the outboard end of the blades. The visible PT blades exhibited a brown-colored staining near their root. Two of the visible stators (immediately upstream of the PT) exhibited missing material near the outboard end. The air intake screens (referred to as guards) were found installed but damaged, the carbon fiber air intake lips that support the air intake screens were present but damaged, and the braze material on the air intake screens appeared melted (Figure 3).

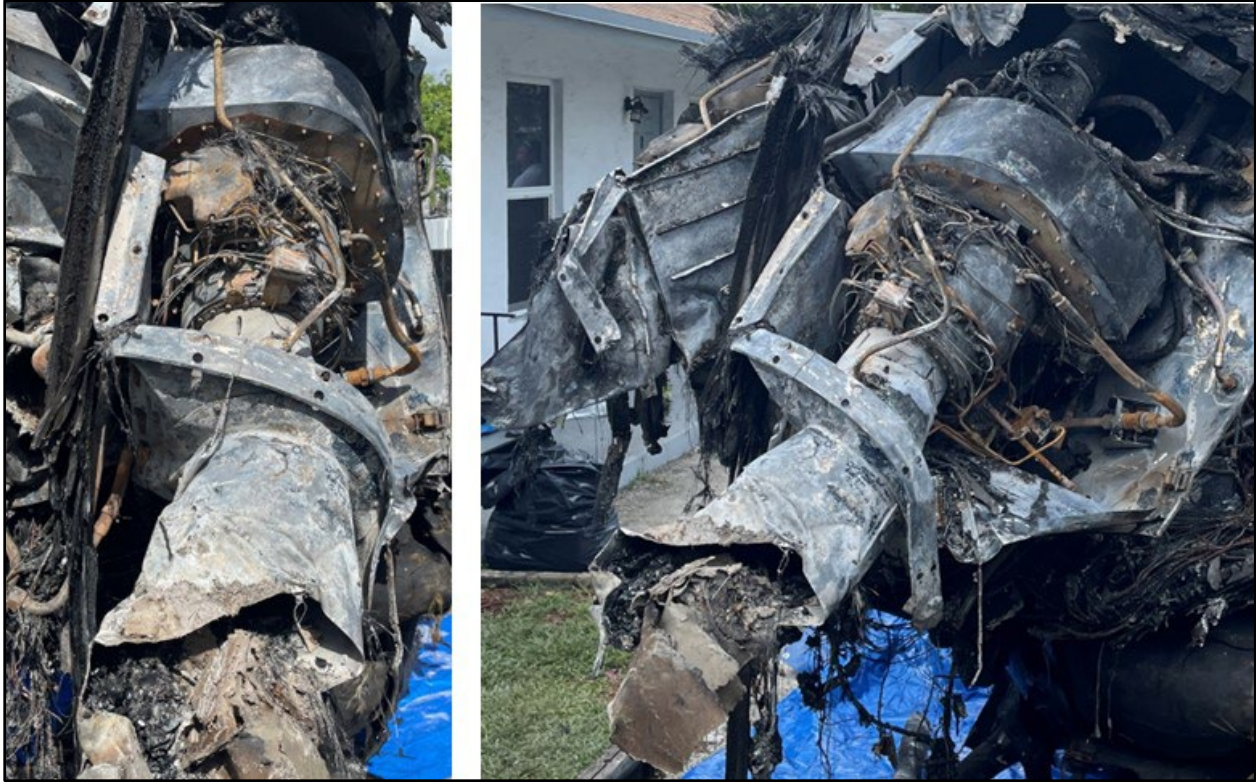
**Figure 4.** No. 2 Engine

The No. 2 engine was present in its normally installed, right hand No. 2 location (Figure 4). The engine exterior exhibited thermal damage. The engine was found disconnected from the main transmission gearbox at the connection point between the power output shaft and the main gearbox.

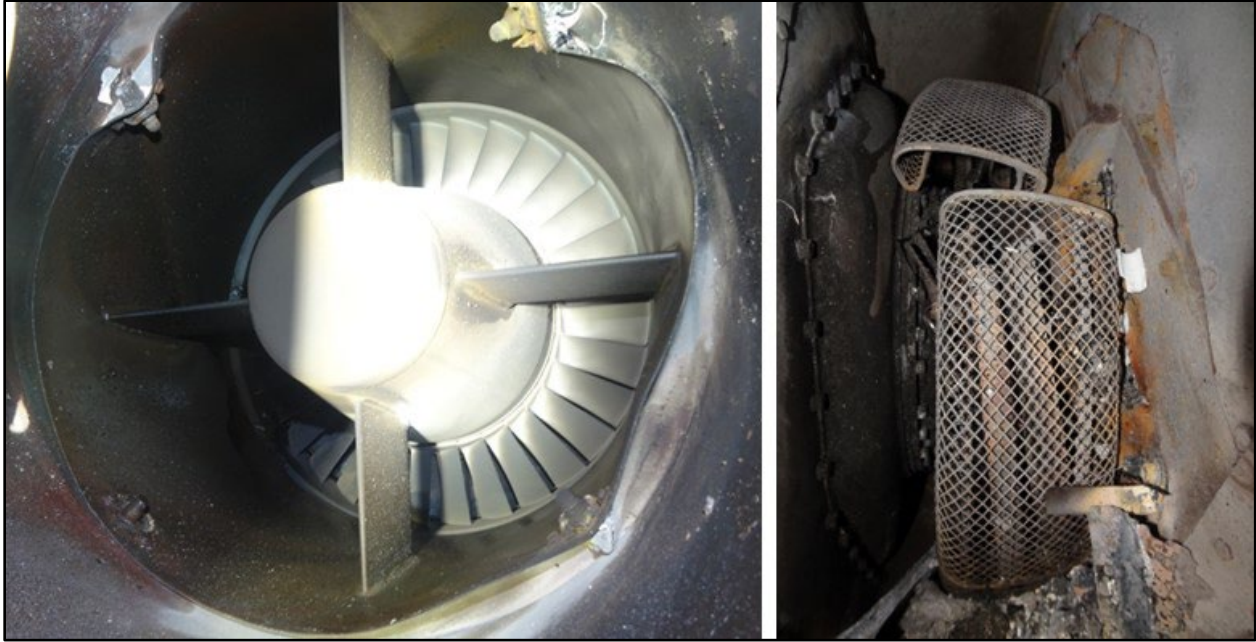
**Figure 5.** No. 2 Engine - View of Power Turbine Blades (L) and Inlet Screen (R)

The PT blades were visible through the tail pipe, all PT blades were present and appeared intact with no abnormal discoloration (Figure 5). The air intake screens were found installed but damaged, the carbon fiber air intake lips that support the air intake screens were present but damaged, and the braze material on the air intake screens appeared melted (Figure 5). The lower portion of the emergency fuel shutoff valve was not present in its normally installed location, but the fuel line remained connected to the upper fitting (on the engine deck) of the shutoff valve. The No. 2 engine manual mode throttle (at the engine) was also found at approximately the 12:00 o'clock position, consistent with the neutral position.

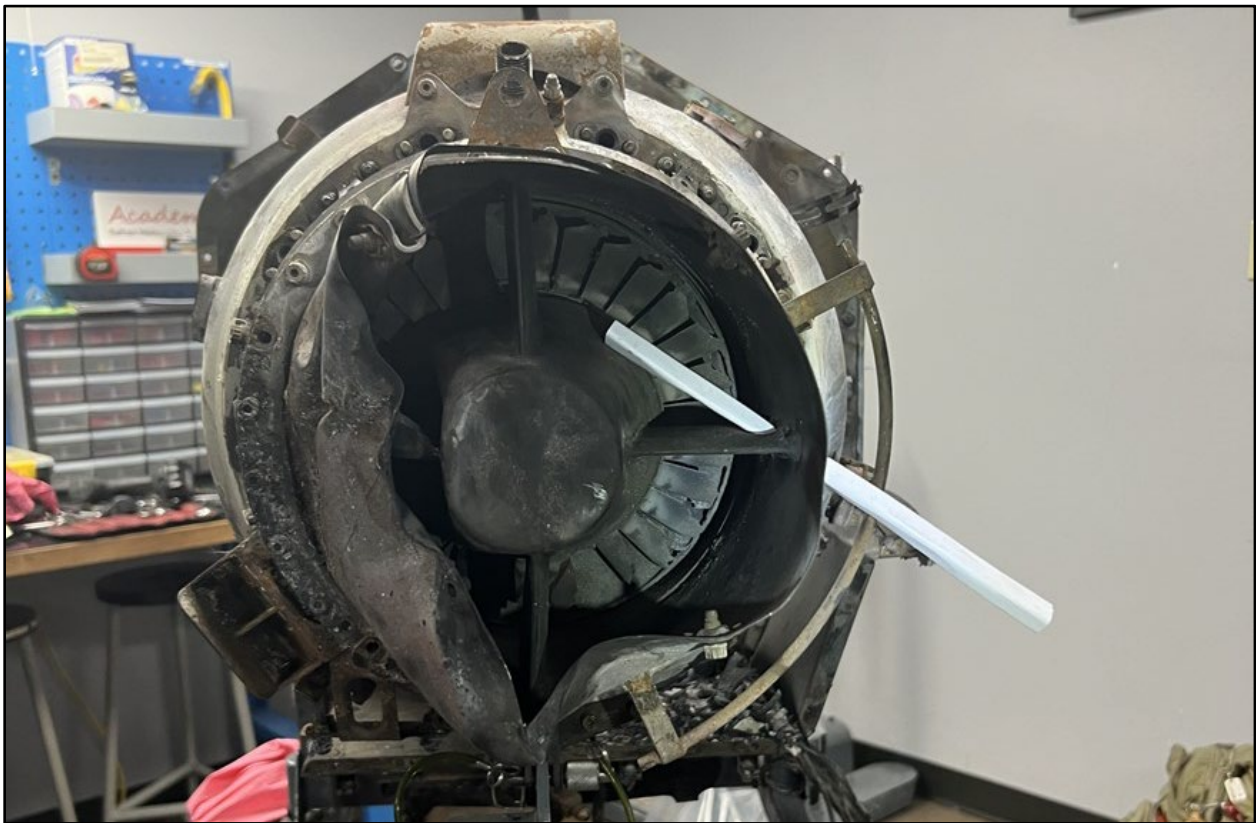
The turbine exhaust case had crushing damage from the 5:00 to 12:00 o'clock positions. There was a penetration in the turbine exhaust case at the 3:00 o'clock strut aft of the PT rotor blades (Figure 13). The material on the outside of the turbine exhaust case penetration was deformed radially inward toward the engine.

**Figure 13.** Turbine Exhaust Case Crushing Damage and Turbine Case Hole

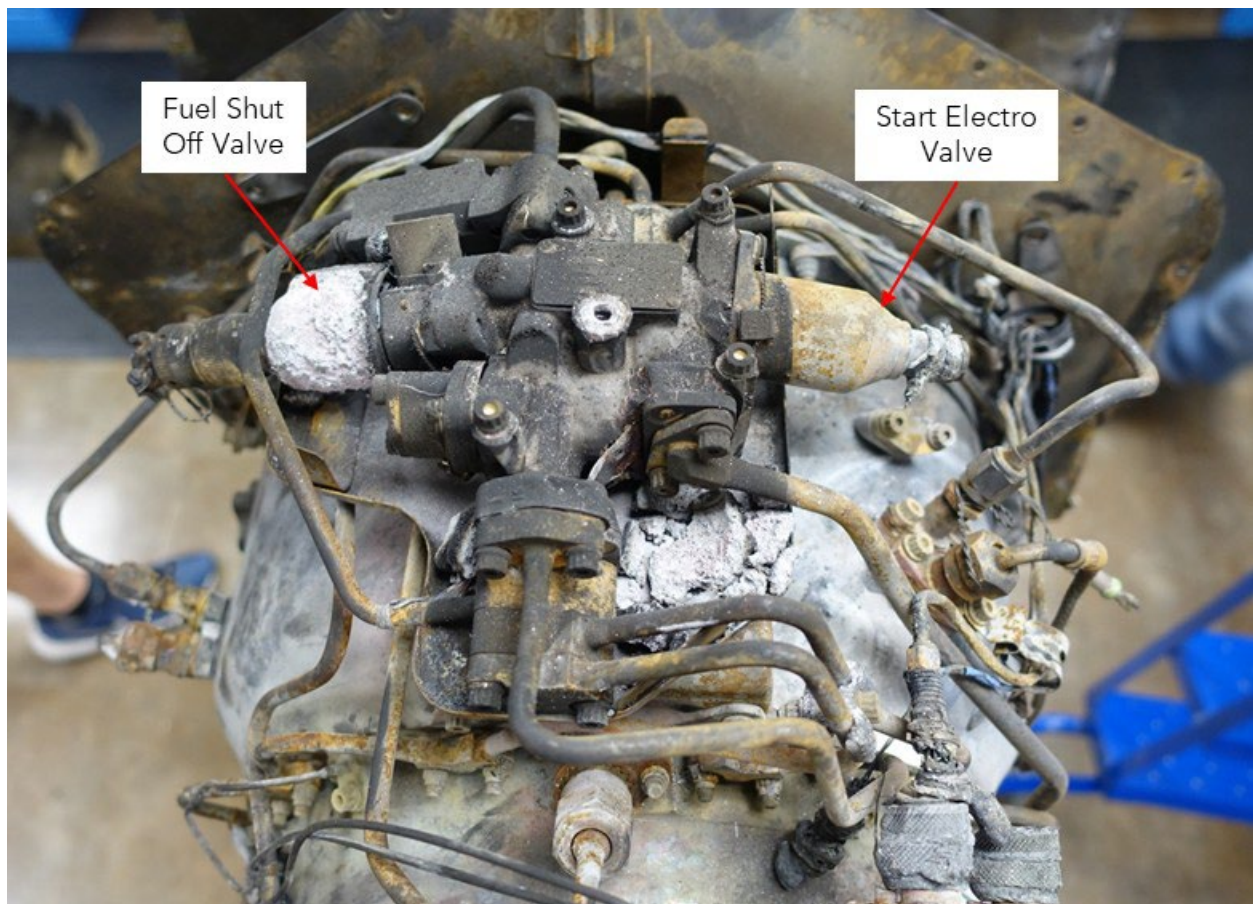
**Figure 14.** Fuel Adjusted Valve Assembly

The adjusted fuel valve assembly cover was secured on the turbine case (12:00 o'clock) and there was no evidence of fuel line chafing due to contact with the cover. The stirrup fitting that secures the preference injector pipe assembly and the right injector half manifold assembly was installed correctly as outlined in SafranHE Service Letter No. 3052/23/ARS2. After the adjusted fuel valve assembly cover was removed, dark discoloration was visible on all assembly external surfaces, the fire protection coating on the stop electro-valve was thermally damaged (Figure 14). All other fuel lines appeared intact and the joints appeared properly engaged.

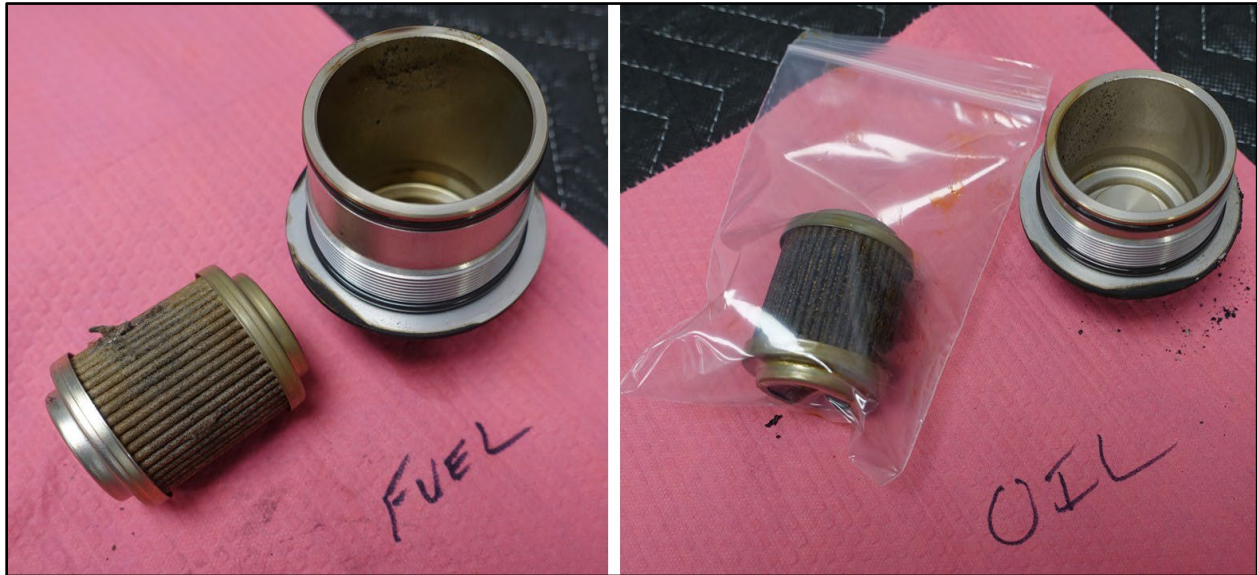
debris was collected for analysis at SafranHE. The oil reservoir<sup>6</sup> was intact with no evidence of tank breaches; the remaining oil was drained during disassembly and found to be approximately 1.5 to 2 liters of oil. The oil did not smell acid/abnormal and appeared normal for service run engines. Oil samples were collected for analysis at SafranHE.

**Figure 15.** Fuel and Oil Filters \*\*Fuel Filter Damage During Examination

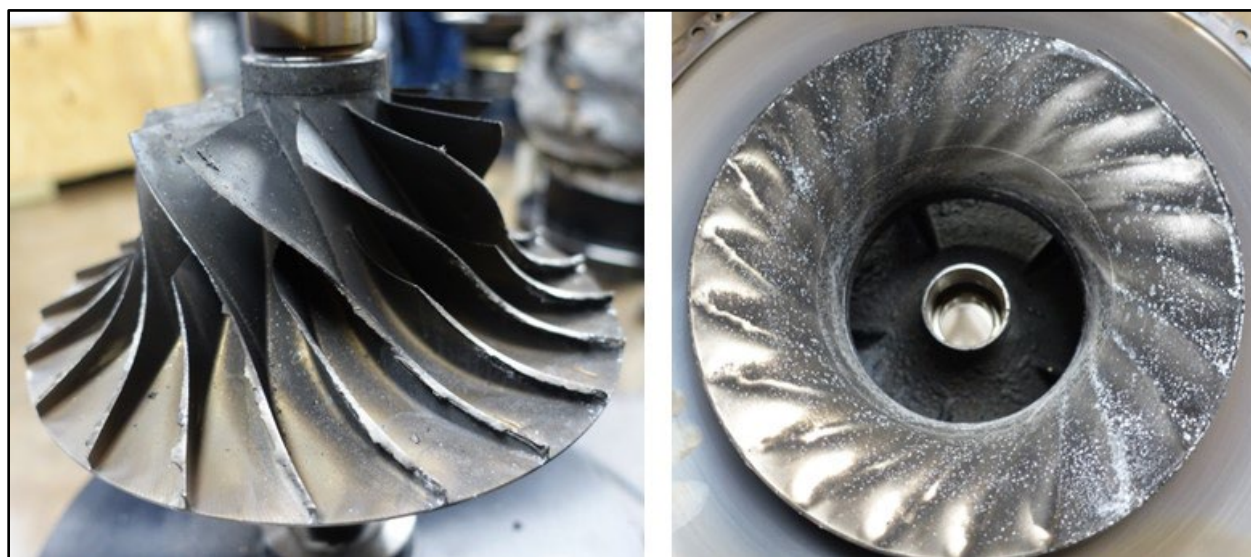
The centrifugal compressor impeller had dark discoloration on all blade surfaces. There were indications of contact rub and material accumulation adhered to the impeller blade leading edges that could be removed with a knife (Figure 17). There was corresponding, heavy, and uniform, 360-degree rotational scoring/rub and material loss on the impeller cover, consistent with axial impeller contact. The impeller cover also appeared discolored with visible dark areas where the impeller blades came to rest and white spots observed 360-degrees around the cover surface (Figure 17). The gas generator front thrust (ball) bearing was oil wetted and rotated smoothly.

**Figure 17.** Centrifugal Impeller (l), Impeller Cover Material Accumulation (R)

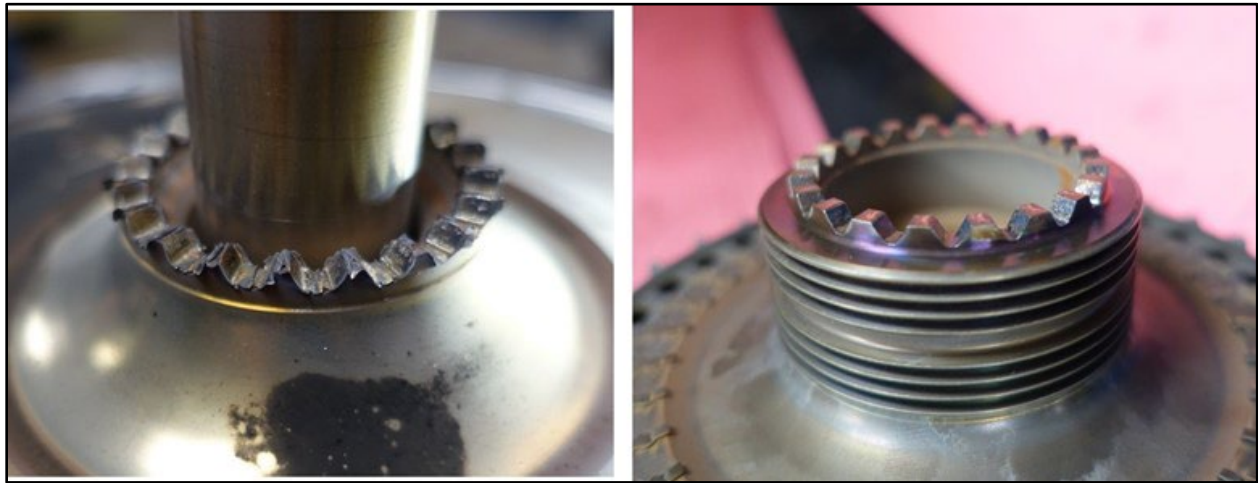
**Figure 18.** Impeller Curvic Coupling (L), Gas Generator Turbine Disk Forward Curvic Coupling(R)

The gas generator turbine spline nut was removed with hand tools and was well below normal torque<sup>7</sup> that would be needed to stretch the gas generator shaft. The aft impeller curvic coupling of the impeller (impeller is made of titanium based alloy) exhibited fretting wear and material displacement on the curvic teeth contact surfaces. The mating curvic coupling teeth on the front of the gas generator turbine disk (the gas producer turbine disk is made of a nickel-based alloy) were intact (Figure 18).

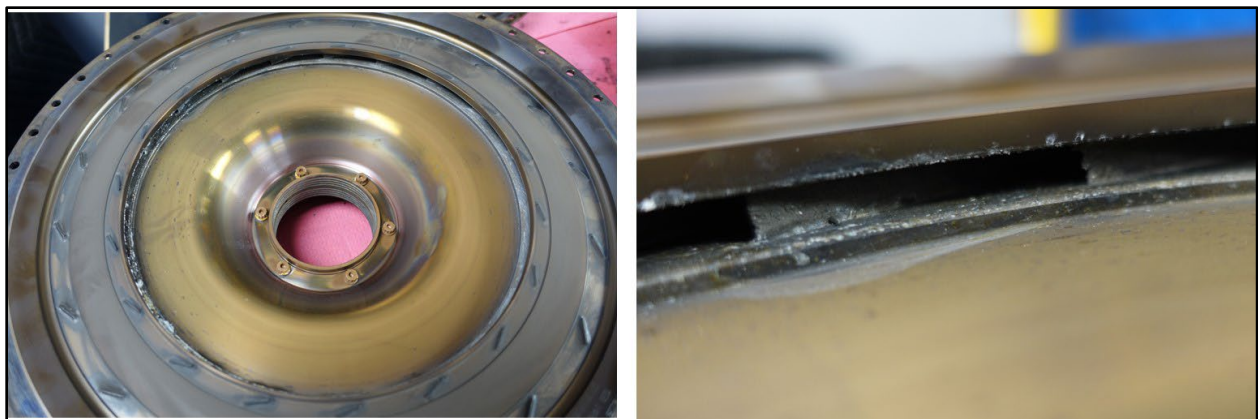
The compressor diffuser vane leading edges appeared rough with non-uniform wear. According to SafranHE, vane erosion is not typical of similar service run engines. Discoloration and white spots were also observed around the entire 360-degree circumference of the diffuser vane inlet (Figure 19).

**Figure 19.** Diffuser (L), Close Up of Diffuser Vane Leading Edge Erosion (R)

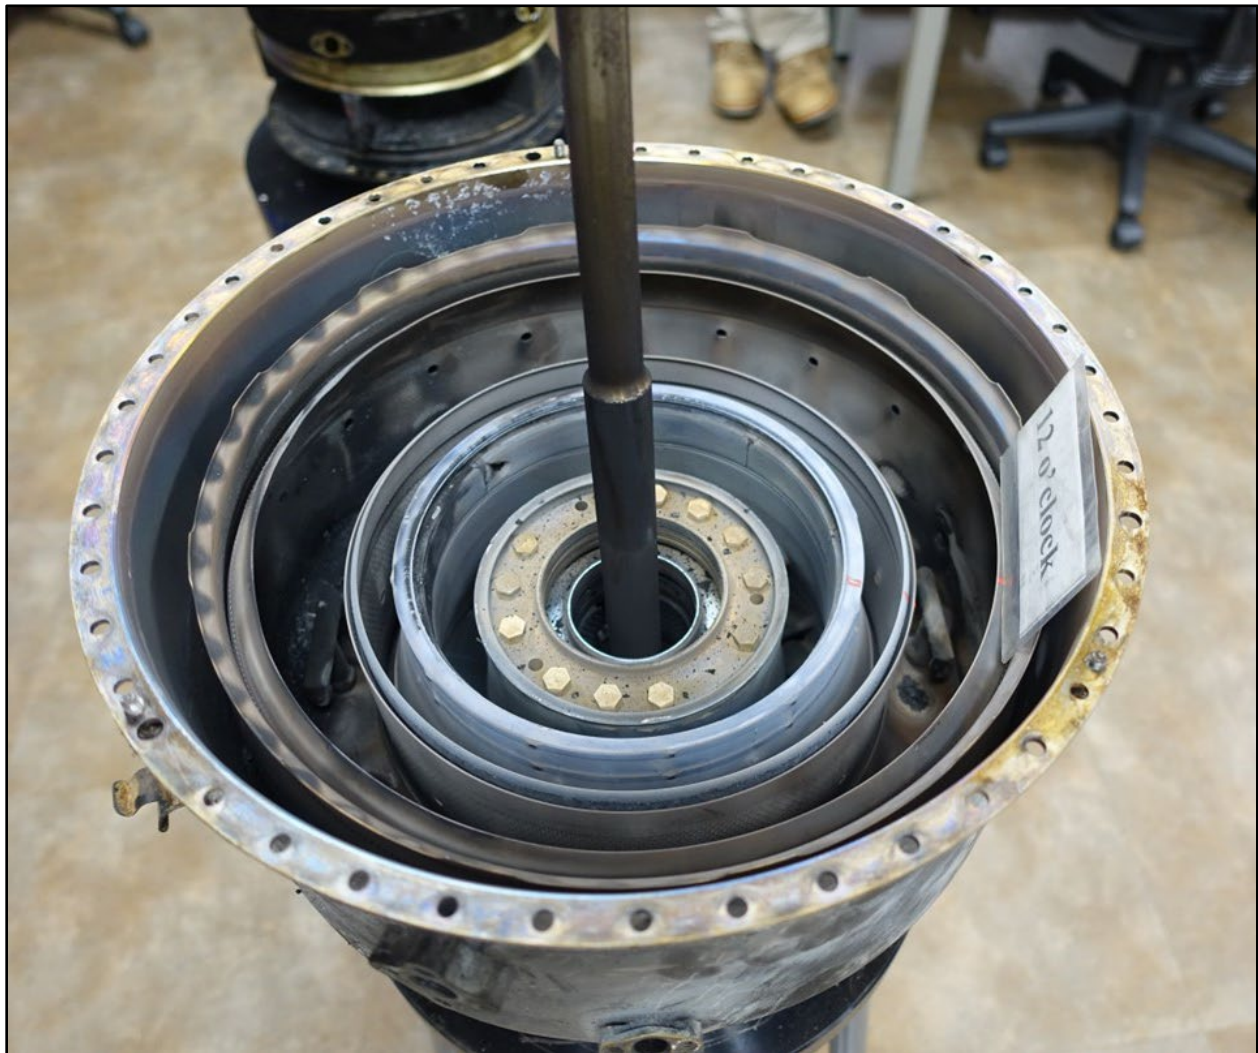
**Figure 20.** Combustion Chamber

The combustion chamber was intact with no evidence of burn through or uneven wear, and the flame tubes and pre-vaporization tubes appeared undamaged (Figure 20). Black spots were observed under the fuel pre-vaporization tubes in the combustor that were typical for service run engines according to SafranHE. A small amount of fine ash like debris was present in the chamber. The left and right main fuel manifold injectors and the preference injector were intact with dark black discoloration on multiple injector tips (Figure 21).

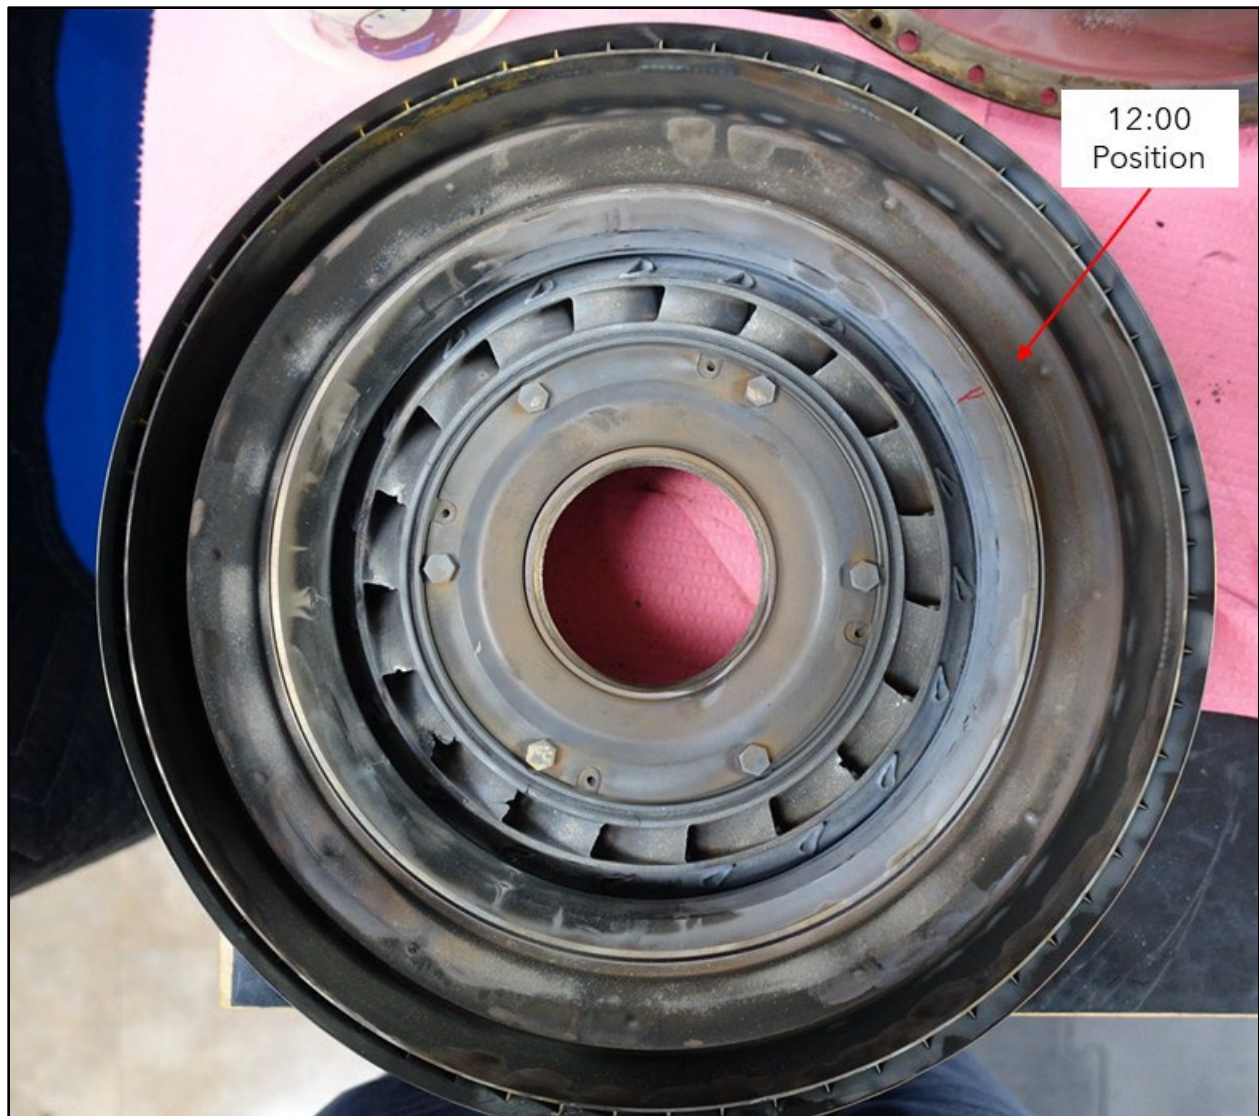
**Figure 22.** Gas Generator Turbine NVGs, Trailing Edge Side

The gas generator turbine nozzle guide vanes (NGV) had metal spray on the pressure and suction vane surfaces. The gas generator turbine NGVs exhibited trailing edge damage and material loss from the 2:00 to 7:00 o'clock positions (Figure 22). The labyrinth seal in the center bore of the gas generator turbine NGV assembly had deep cuts in the abradable material where the gas generator turbine forward shaft teeth made contact.

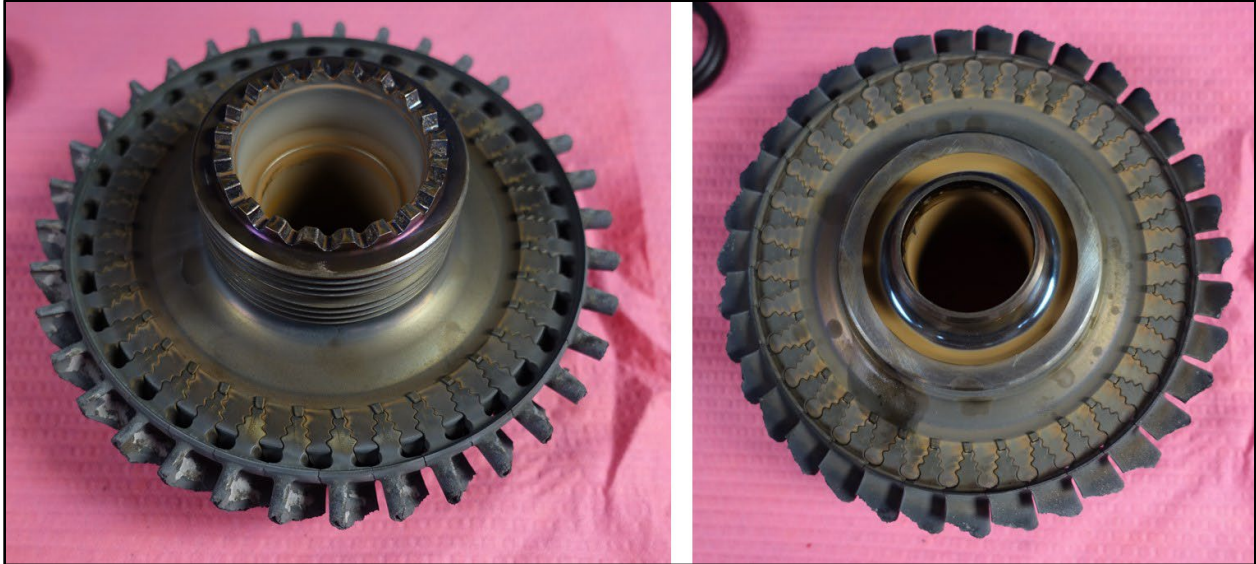
**Figure 23.** Gas Generator Turbine, Forward Side (L), Aft Side (R)

The gas generator turbine blades were all fractured transversely at about mid span. The remaining blade airfoil tip surfaces appeared rough/jagged and thermally distressed. The gas generator turbine blades had white discoloration on the leading-edge surfaces (Figure 23). All gas generator turbine disk posts and blade fir trees appeared undamaged and all blade locks were present.

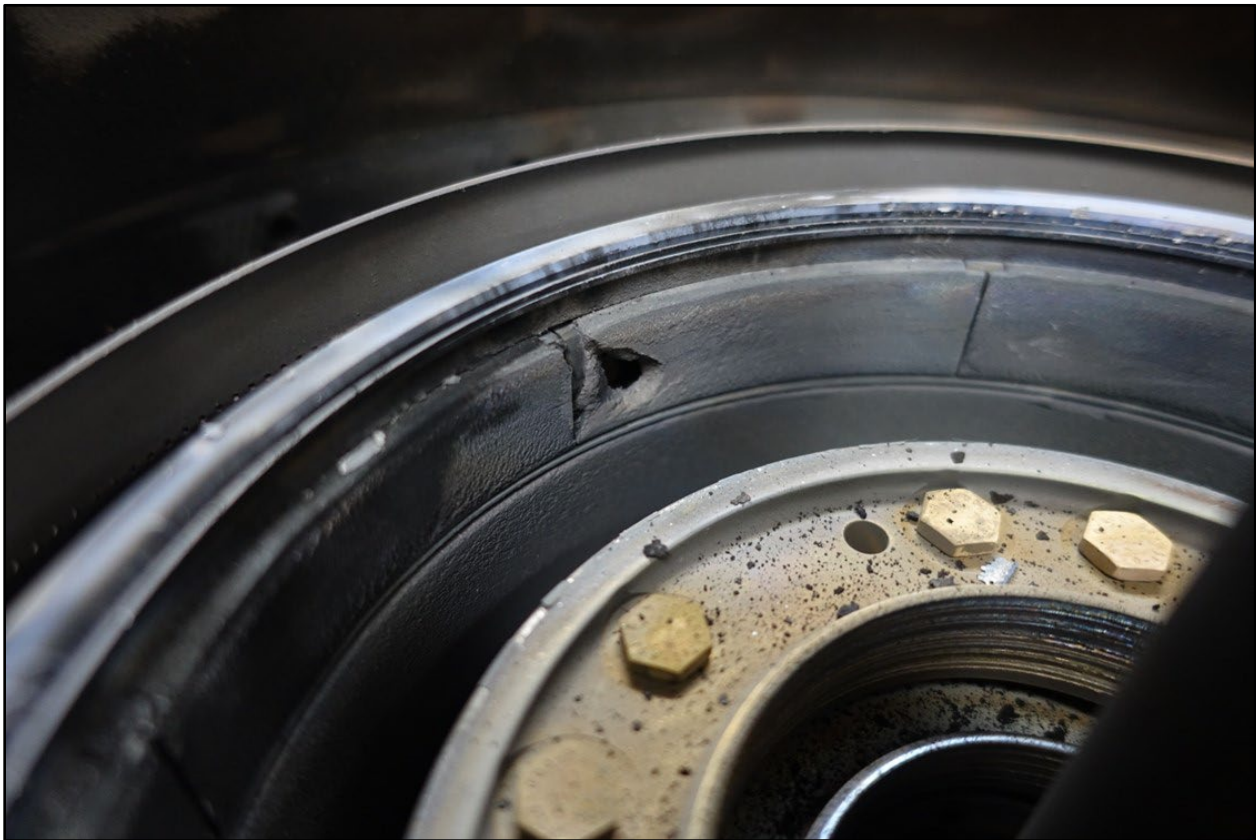
The gas generator turbine shroud segments were all present and had 360-degree rub. One gas generator turbine shroud segment, located at the 5:00 o'clock position, exhibited missing material (Figure 24).

**Figure 24.** Gas Generator Turbine Shroud - Missing Material

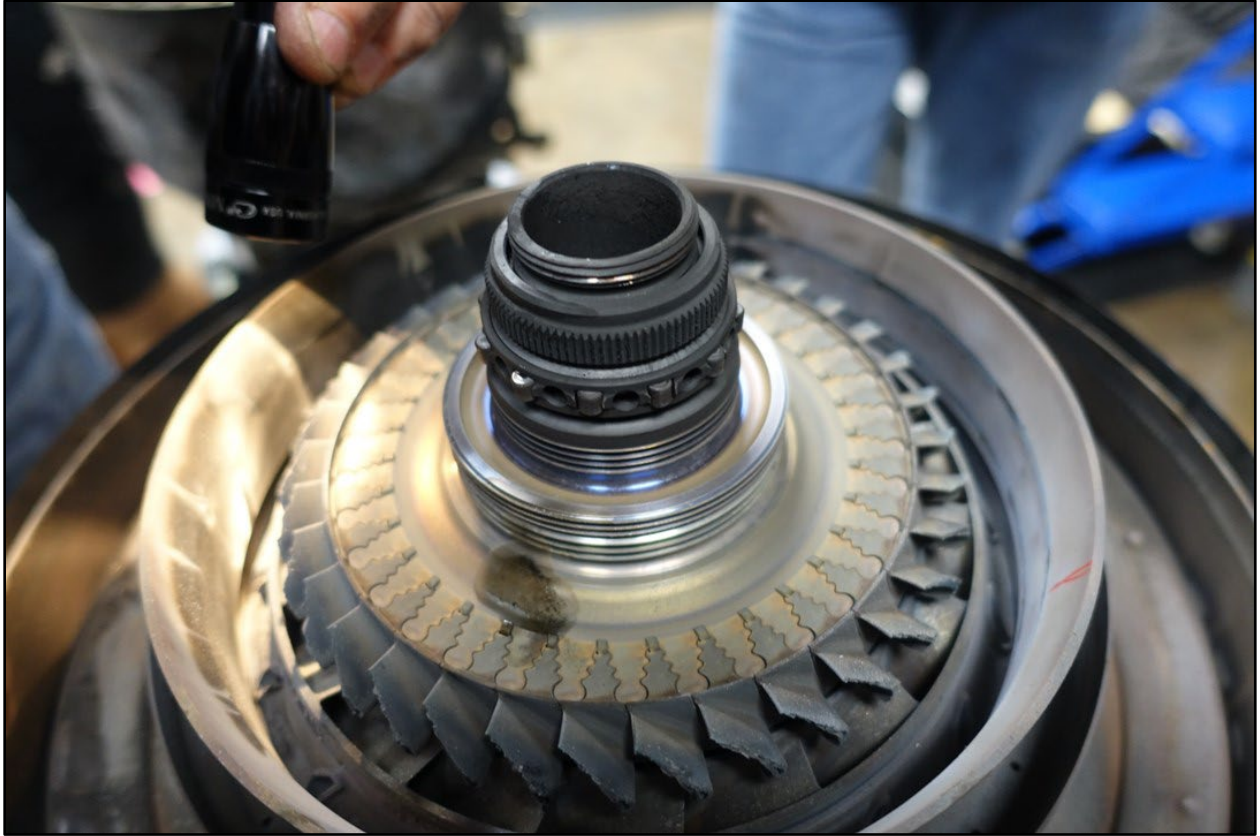
**Figure 25.** Gas Generator Turbine Rear Bearing

The gas generator turbine rear bearing appeared undamaged but had no residual oil and appeared dry. The roller bearing was intact and rotated with minimal resistance (Figure 25).

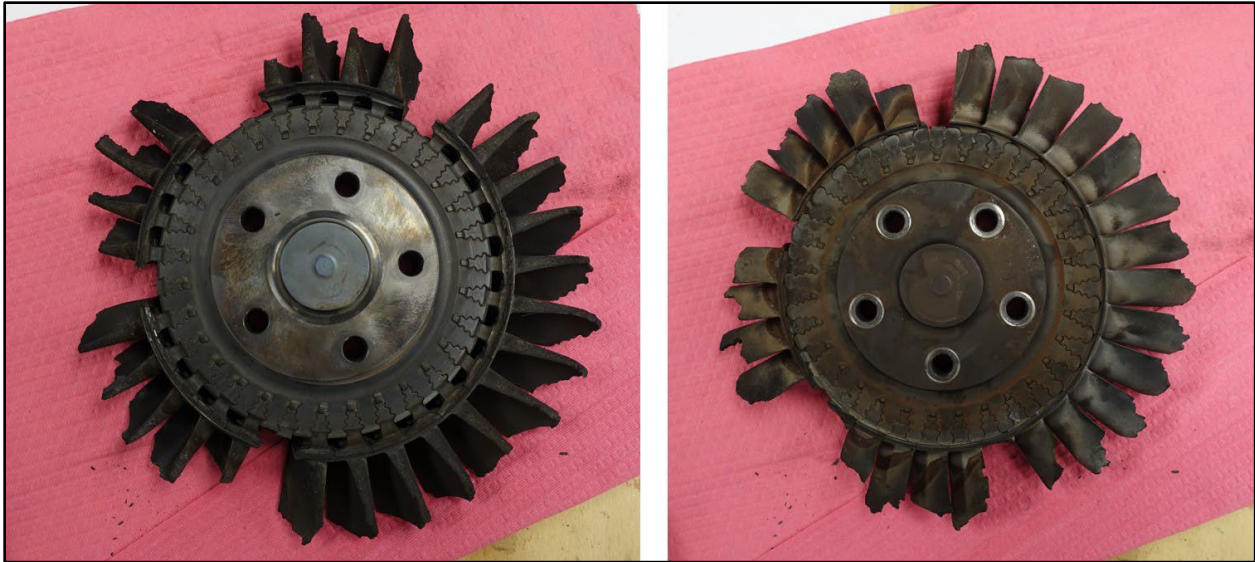
**Figure 26.** PT Disk – Forward Side (L), Aft Side (R)

All PT disk blades were fractured transversely across the airfoil and various lengths; the fracture surfaces appeared rough/jagged and thermally distressed (Figure 26) with light metal spray observed adhered to the leading and trailing edges airfoils. Five PT disk blades were separated below the blade platform; all five fracture surfaces exhibited a similar thumbnail shaped area, located at the corner of the leading edge and pressure side of the blade shank, that had flat fracture features in comparison to the rough features on the remaining fracture surface (Figure 27).

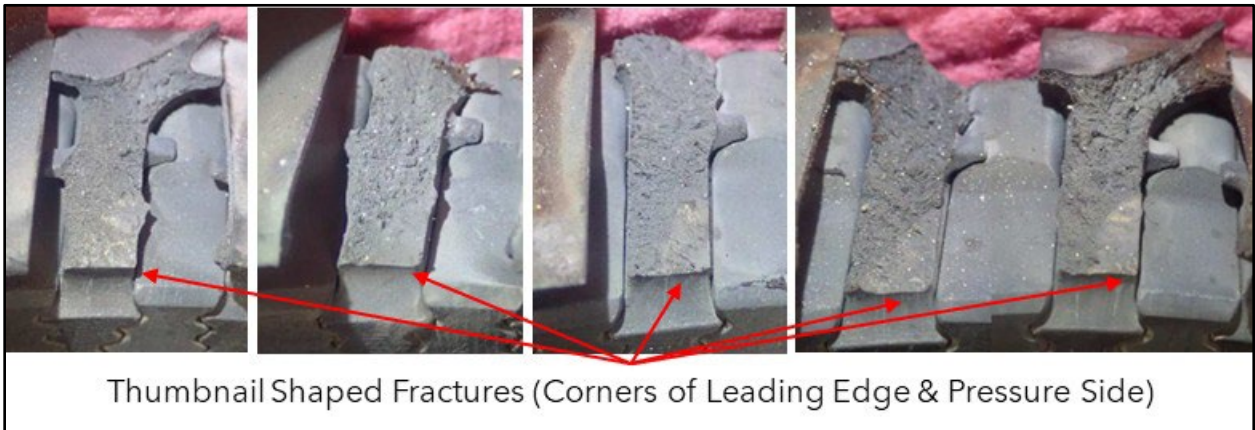
The Safran laboratory performed fractography and metallography on the five fractured power turbine blades. All presented a similarly shaped area of crack initiation/propagation with characteristics consistent with fatigue, initiation occurred below platform in the blade shank at the corner of the leading-edge side and the pressure side, no material anomalies were found at the initiation sites.

**Figure 27.** Fractured PT Disk Blades

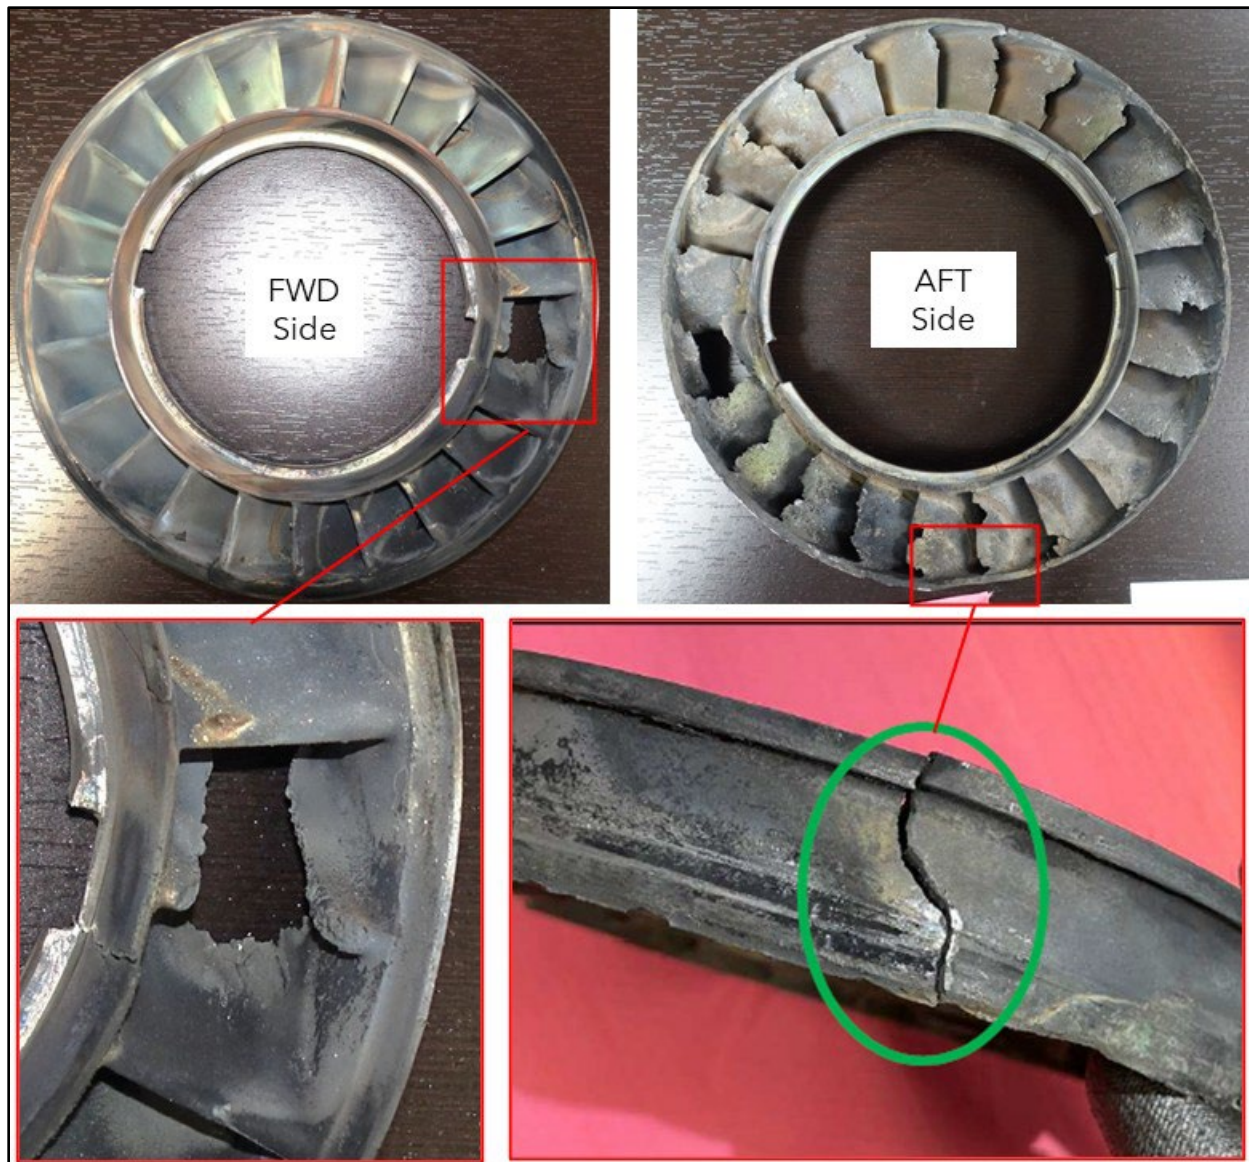
**Figure 28.** PT NGVs

All the PT NGVs had dark discoloration, with residue and metal spray adhered to all vane surfaces. A single vane was thermally consumed at the 6:00 o'clock position and there was a crack at the adjacent vane inner diameter platform. The trailing edges of all the NGVs exhibited impact and thermal damage 360-degrees around the nozzle assembly. The trailing edge damage and material loss was most severe between the 3:00 and 7:00 o'clock positions (Figure 28).

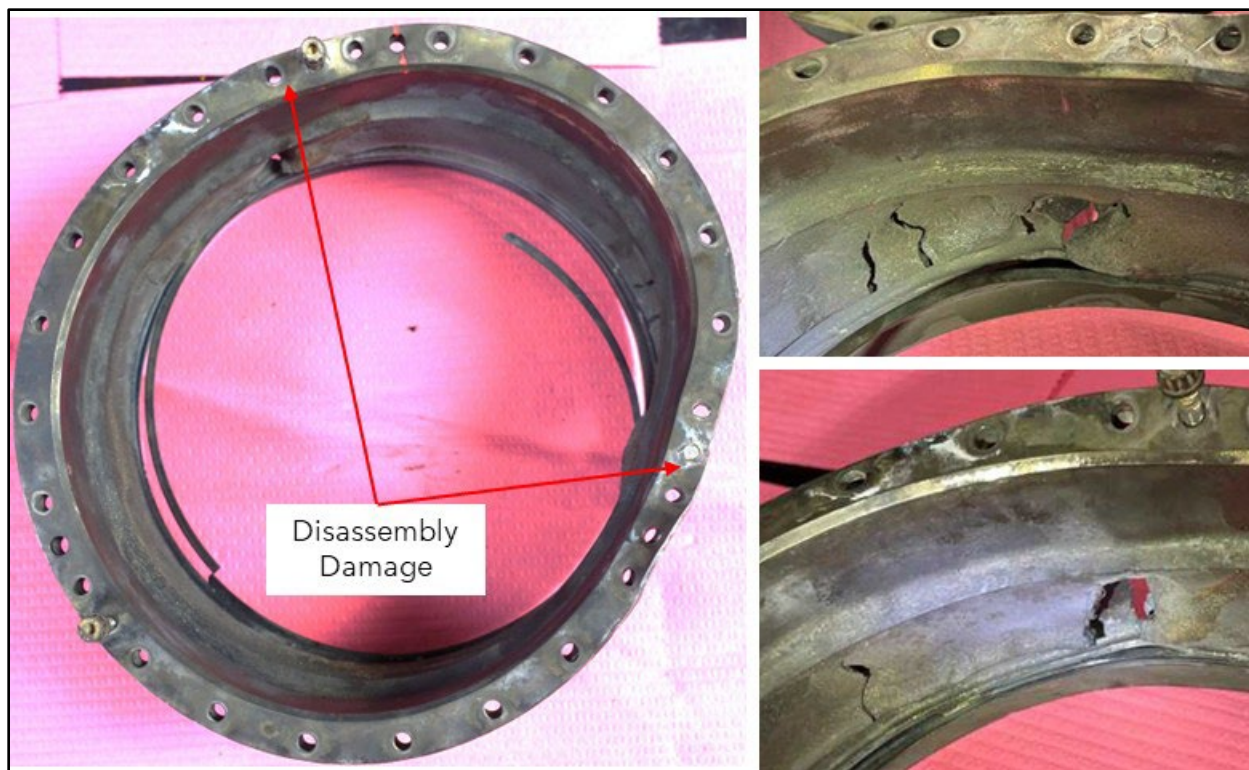
The PT outer shroud exhibited two areas of impact and thermal damage which made removal during disassembly difficult, and the subsequent removal process induced additional damage/deformation to the outer diameter of the part (Figure 29). The PT containment shield, located outboard of the PT outer shroud, showed evidence of impact damage (Figure 30).

**Figure 29.** PT Shroud -Damaged During Removal

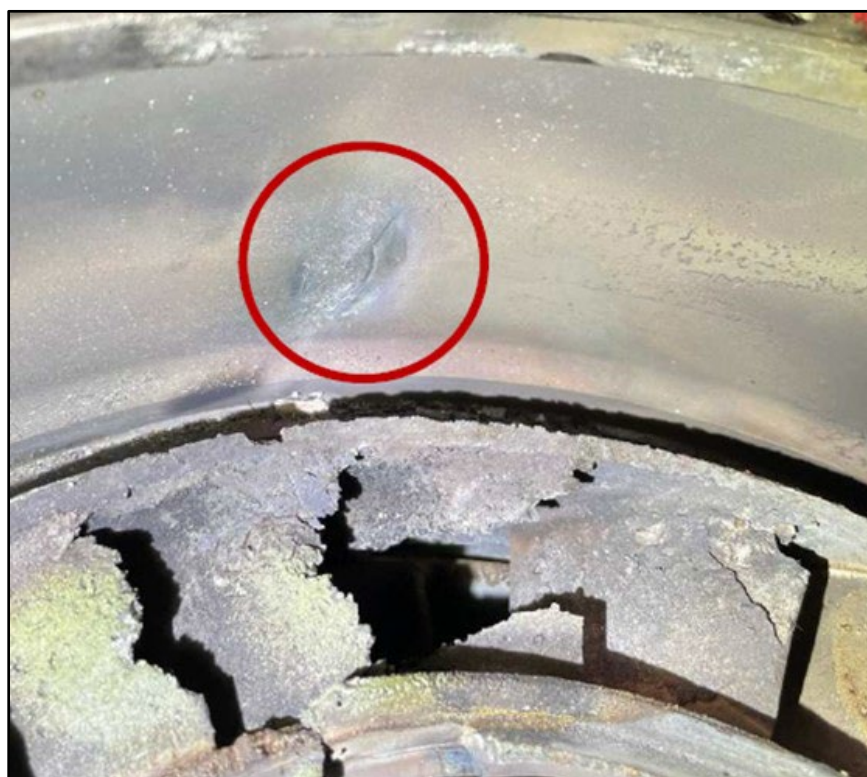
**Figure 30.** PT Containment Shield - Impact Mark

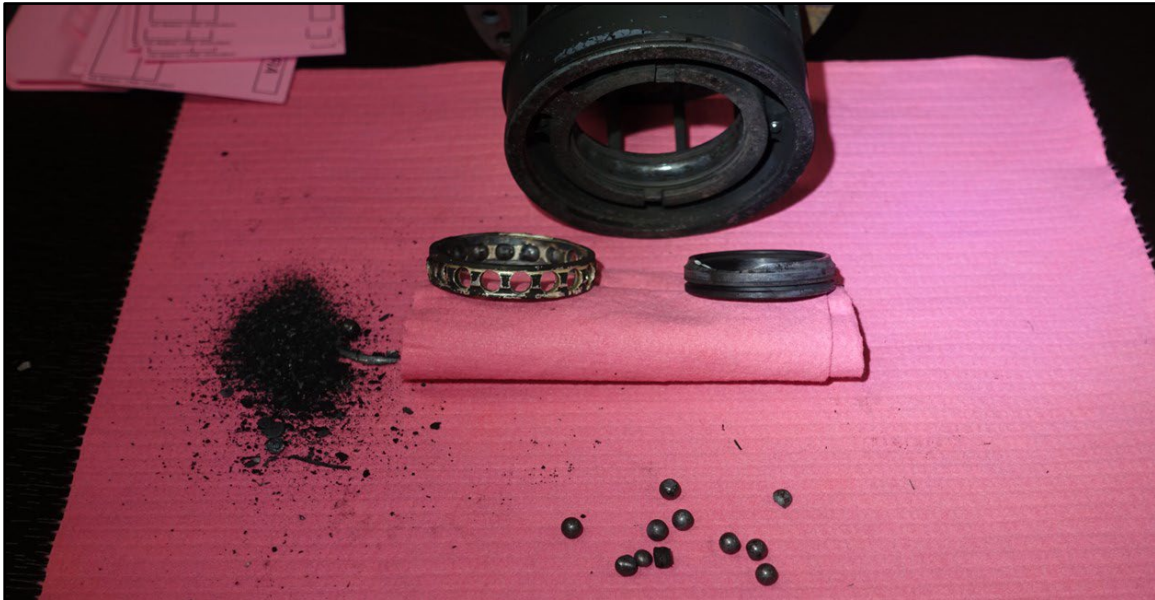
**Figure 31.** PT Thrust Bearing

The PT thrust (ball) bearing assembly was destroyed. Multiple ball bearing elements were smeared into the bearing cage and additional loose bearing elements were collected in the bottom of the bearing housing (Figure 31). The bearing races also exhibited deformation and smearing. Dark powdered material was recovered from the turbine bearing housing when the ball bearings were collected.
