# National Transportation Safety Board

ERA23FA352

## **POWERPLANTS**

Group Chair's Factual Report

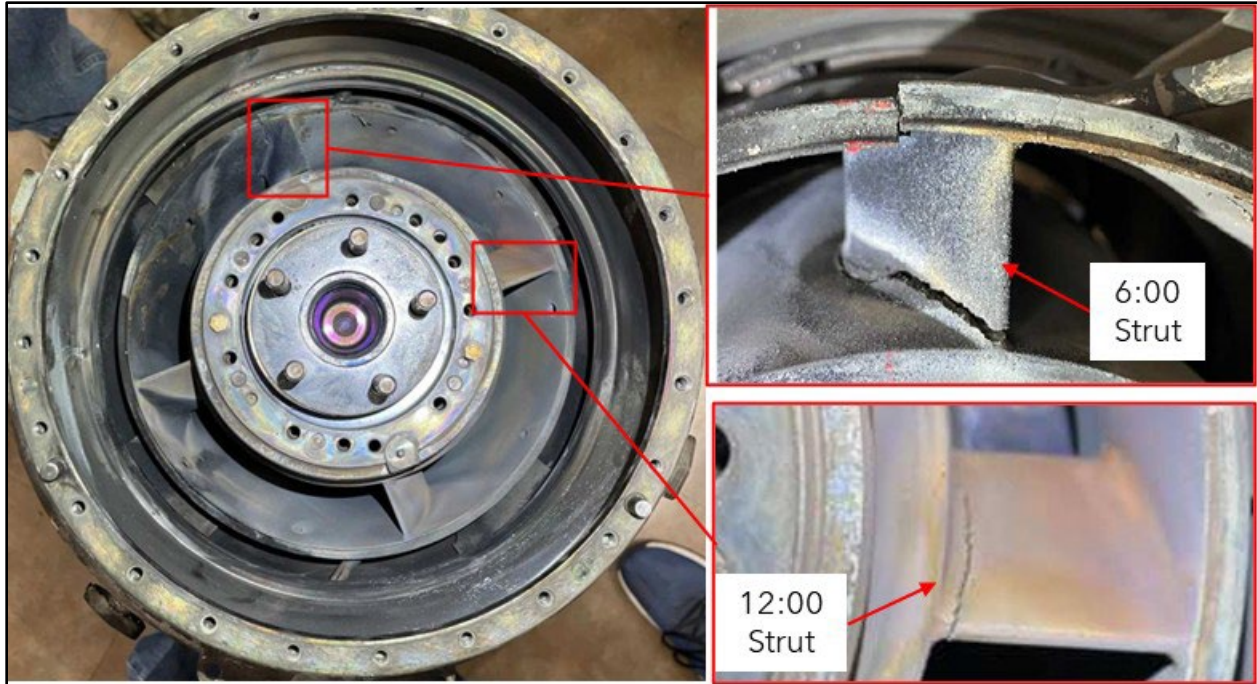
**Figure 32.** Rear Bearing Support - Forward Side

The inner support struts located at the 6:00 and 9:00 o'clock positions of the rear bearing support were fractured near the fillet between the strut and the inner ring (Figure 32). The oil supply tube and the oil scavenge tube, located within the 12:00 and 6:00 o'clock struts respectively, were visually undamaged. All four of the outer flange struts of the rear bearing support struts were found fractured (Figure 33) from the outlet diffuser case.

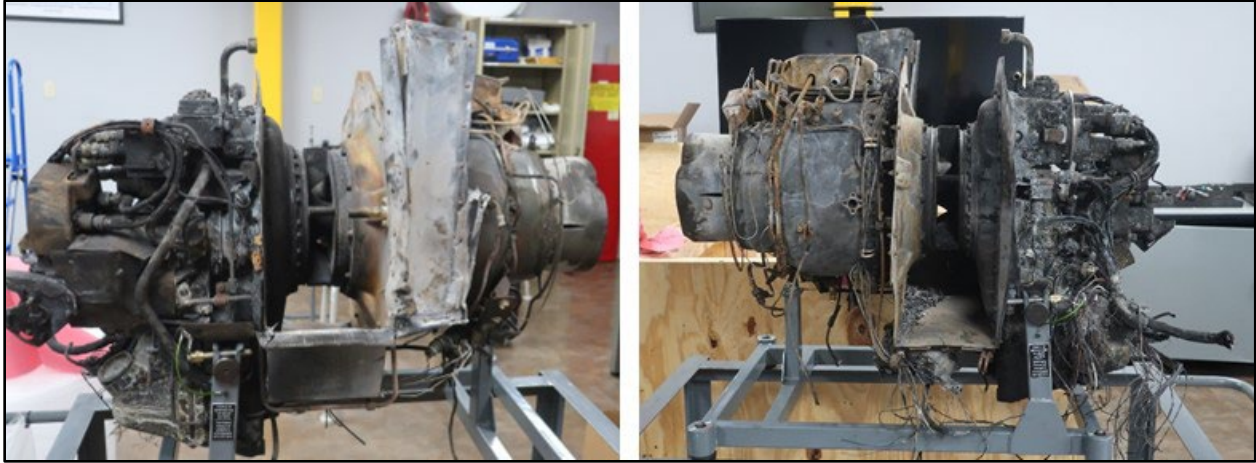
**Figure 35.** ESN 30182 As Received - Left Side (L), Right Side (R)

All external engine surfaces were sooted/discolored (Figure 35). Multiple engine wire harnesses exhibited thermal damage and were charred and brittle (Figure 36). The ESN on the engine data plate was verified as 30182 (Figure 37).

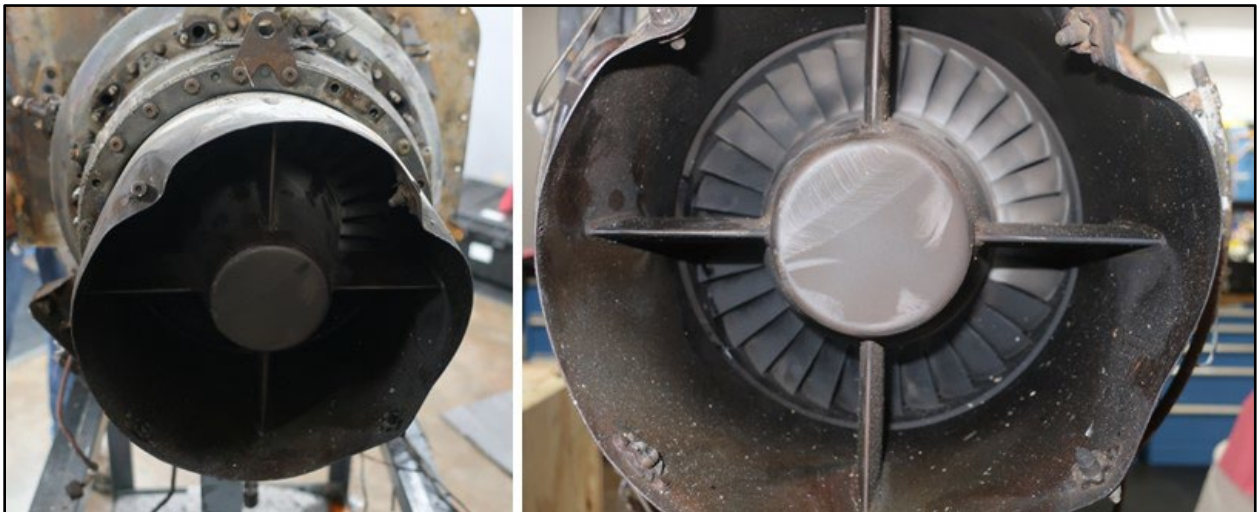
The turbine exhaust case exhibited localized deformations at three of the four bolt locations connecting the exhaust case to the exhaust pipe, and the power turbine blades appeared unremarkable when looking through the exhaust pipe (Figure 39).

**Figure 39.** Exhaust Pipe Deformations (L), PT Blades (R)

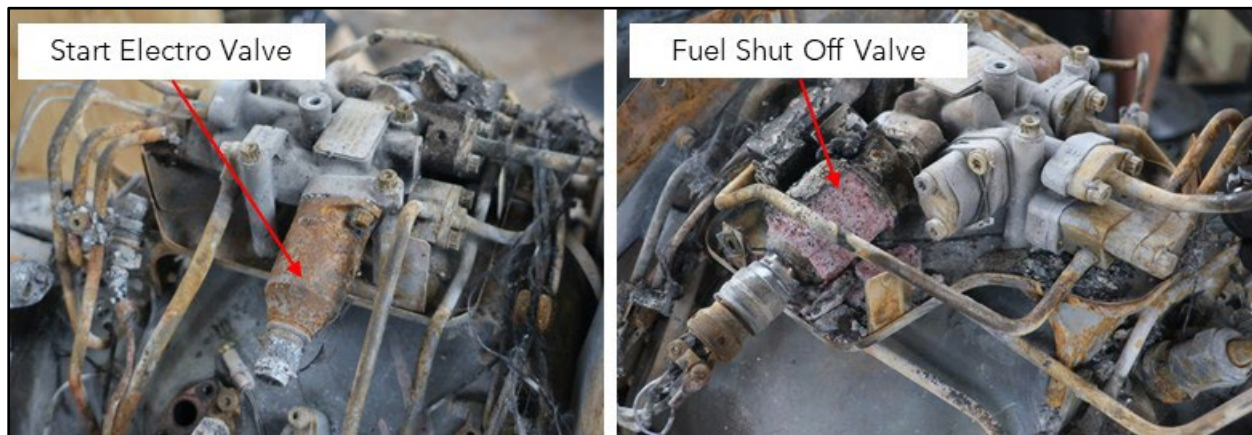
**Figure 40.** Fuel Adjusted Valve - Right Side (L), Left Side (R)

The adjusted fuel valve assembly cover was secured on the turbine case and there was no evidence of fuel line chafing due to contact with the cover (Figure 40). The stirrup fitting that secures the preference injector pipe assembly and the right injector half manifold assembly was installed correctly as outlined in SafranHE Service Letter No. 3052/23/ARS2. After the adjusted fuel valve assembly cover was removed, the fire protection coating on the stop electro-valve was thermally damaged. All fuel lines appeared intact and flange connections/interfaces appeared properly engaged.

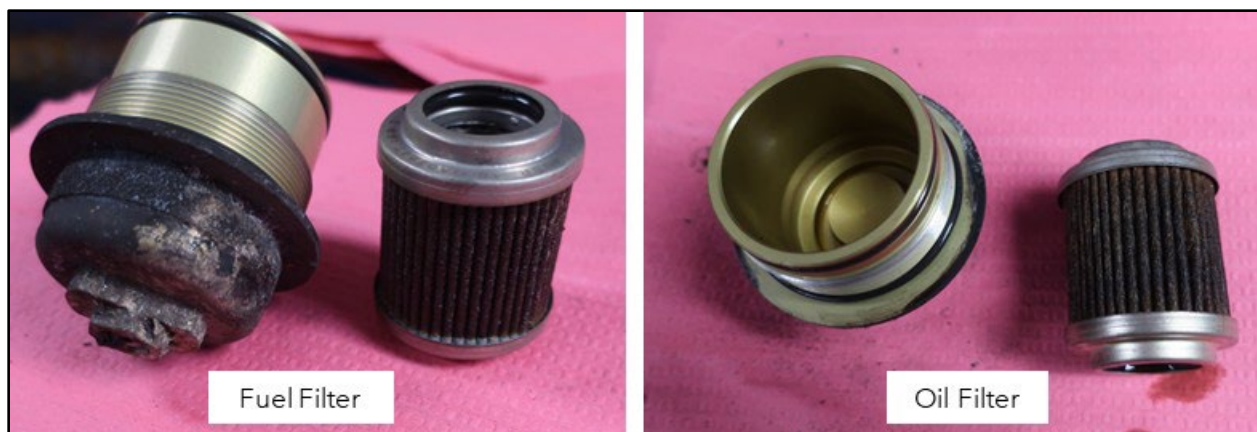
**Figure 41.** Fuel Filter (L), Oil Filter (R)

Burned residue was adhered to the exterior of the fuel and oil filter housings on the AGB. The fuel filter was fuel wetted when removed from the housing with no visible debris/obstructions between the filter pleats. The oil filter was oil wetted when removed from the housing with no visible debris/obstructions between the filter pleats. (Figure 41).

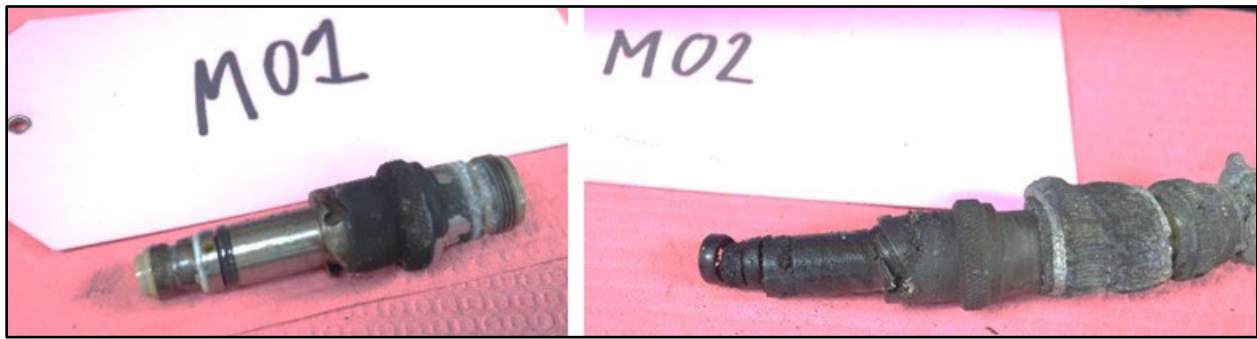
**Figure 42.** MCDs - (M01) Reduction Gearbox (L), (M02) Rear Bearing (R)

The electrical MCD for the M01 module did not have any ferrous debris attached to the magnet. The rear bearing electrical MCD (labeled M02) as well as the MCD housing sustained thermal damage with no evidence of ferrous debris on the magnet but a sample was collected for analysis at SafranHE (Figure 42).

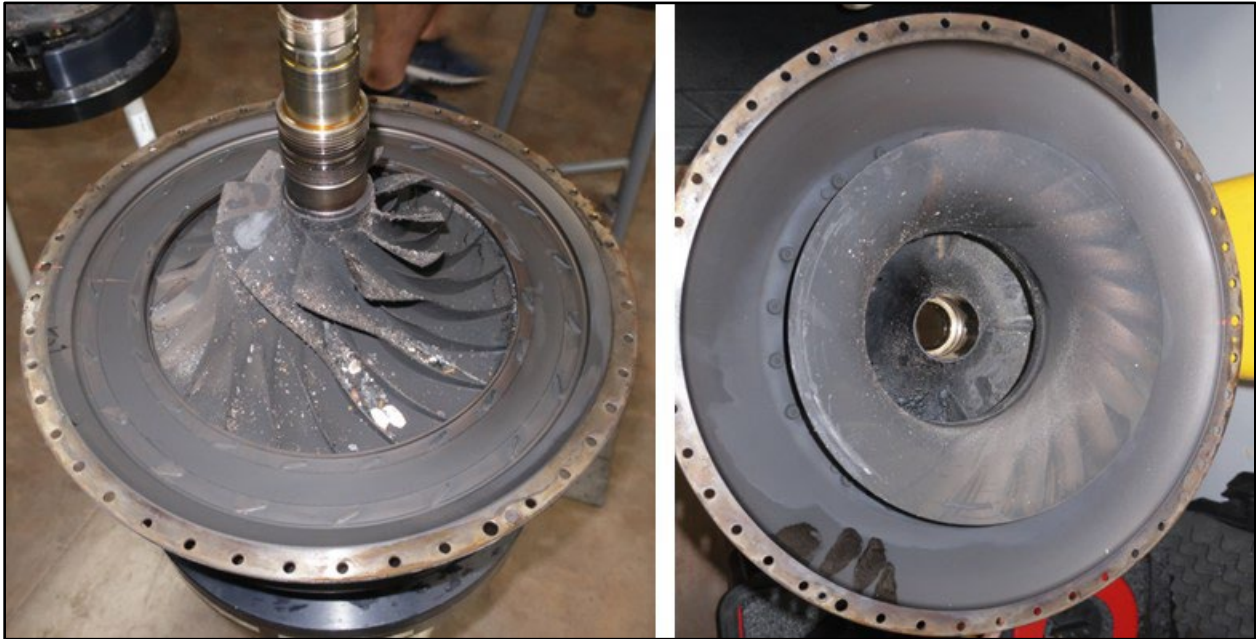
**Figure 43.** Centrifugal Compressor Impeller (L), Impeller Cover (R)

impeller trailing edges, and the impeller cover interior surface had a dimpled appearance (Figure 43). The gas generator thrust bearing was oil wetted and rotated smoothly.

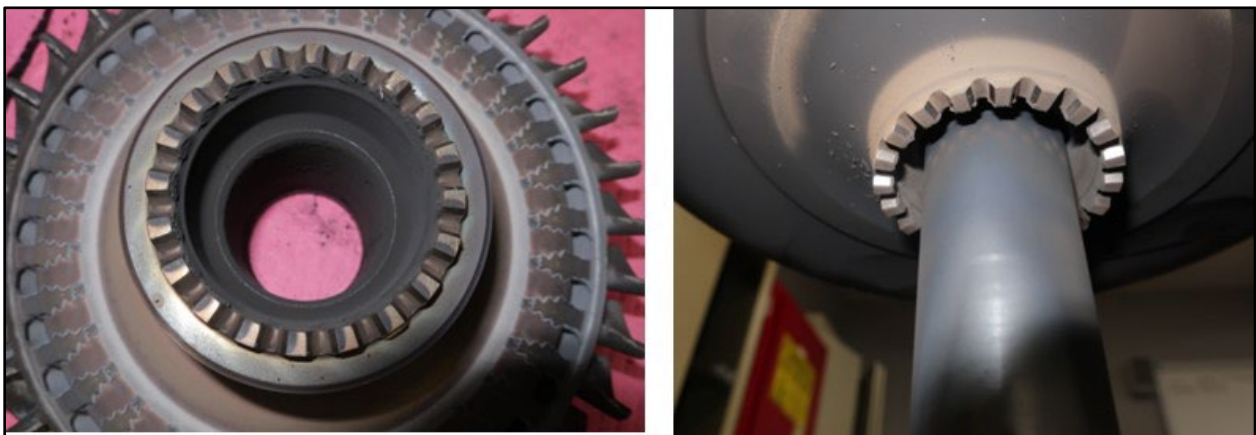
**Figure 44.** Gas Generator Turbine Disk Curvic Coupling (L), Impeller Curvic Coupling (R)

The aft impeller curvic coupling on the impeller and the mating curvic coupling on the front of the gas generator turbine disk showed no evidence of damage and appeared typical of service run engines (Figure 44).

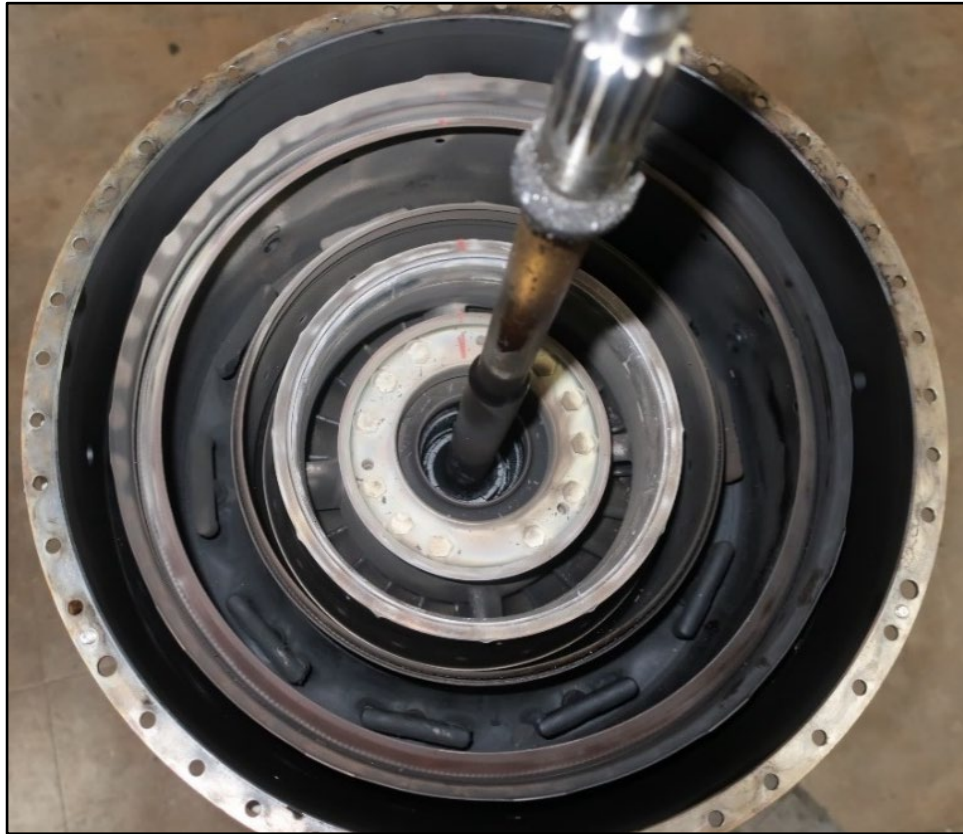
**Figure 45.** Combustion Chamber

The combustion chamber was intact with no evidence of burn through or uneven wear, and the flame tubes and pre-vaporization tubes were undamaged (Figure 45). The chamber had dark discoloration on all surface and black spots were observed under the fuel pre-vaporization tubes in the combustor, typical for service run engines according to SafranHE.

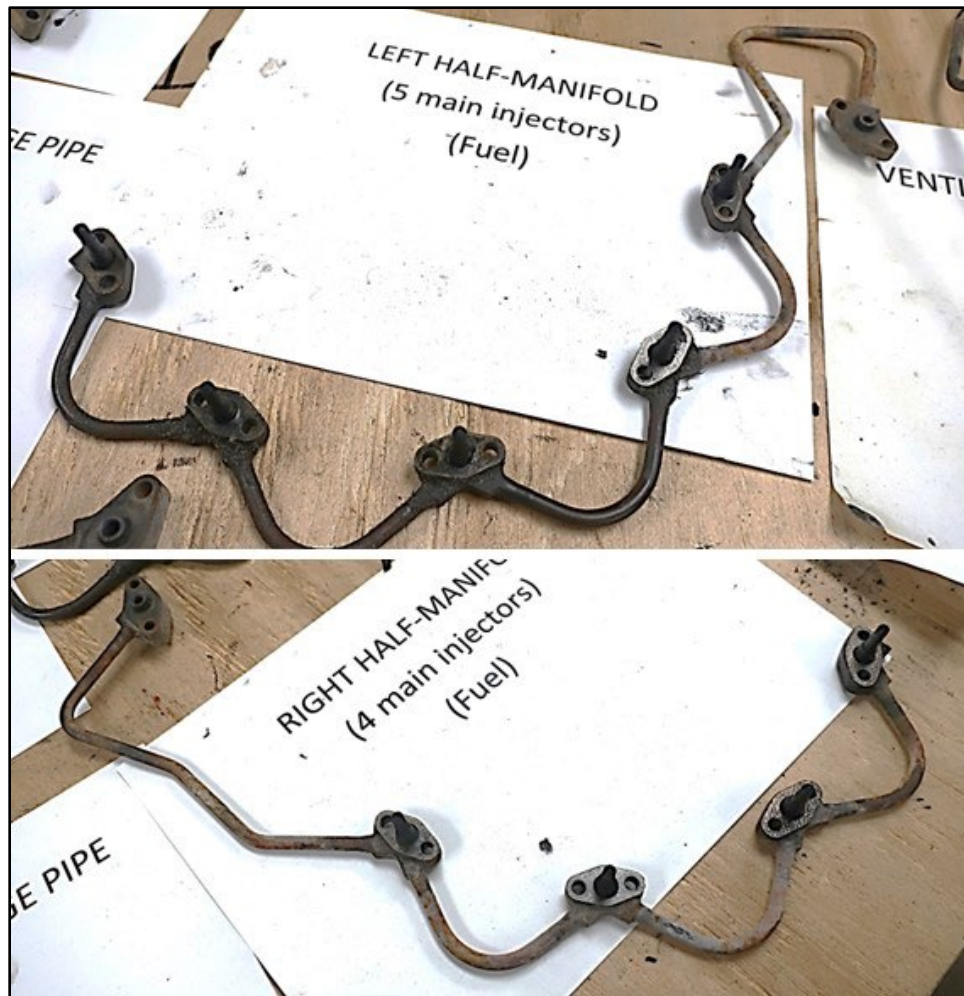
**Figure 46.** Fuel Injector Manifolds

The left and right main fuel manifold injectors and the preference injector were intact with dark black discoloration on multiple injector tips (Figure 46).

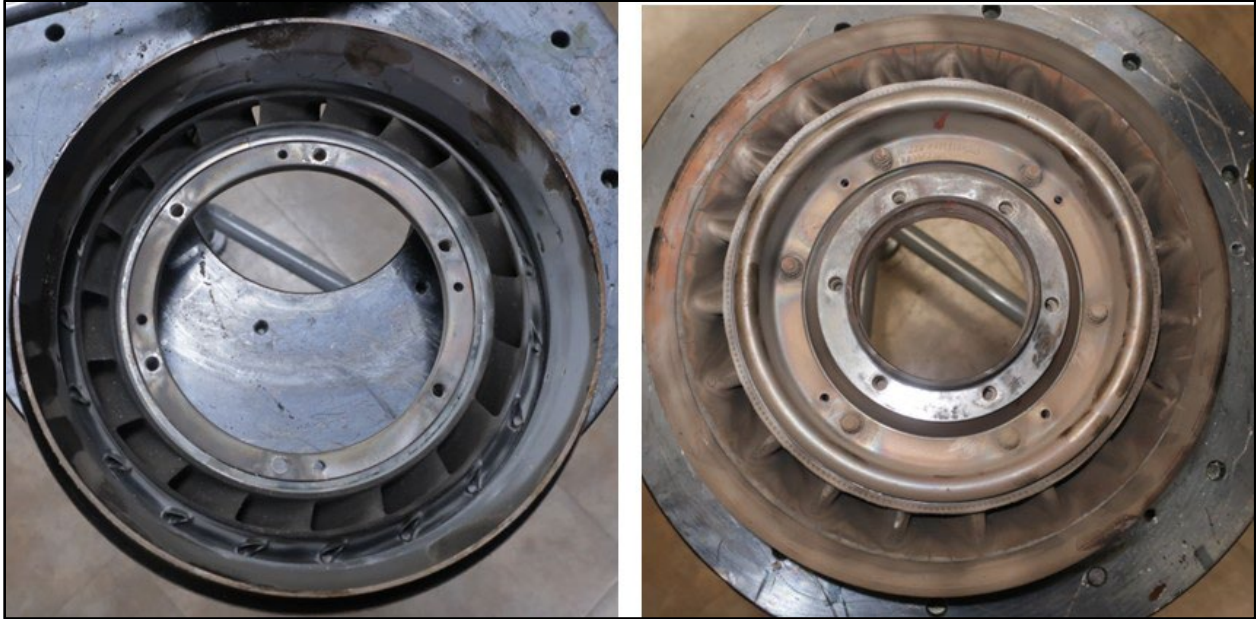
**Figure 47.** Gas Generator Turbine NGVs - Trailing Edge (L), Leading Edge (R)

The gas generator turbine NGVs were all present and had a dark discoloration or sooted appearance but were otherwise unremarkable. The gas generator turbine disk blades appeared intact with no evidence of damage (Figure 47). Some gas generator turbine NGVs exhibited localized white discoloration and a flaking appearance, similar to the gas generator turbine disk blades.

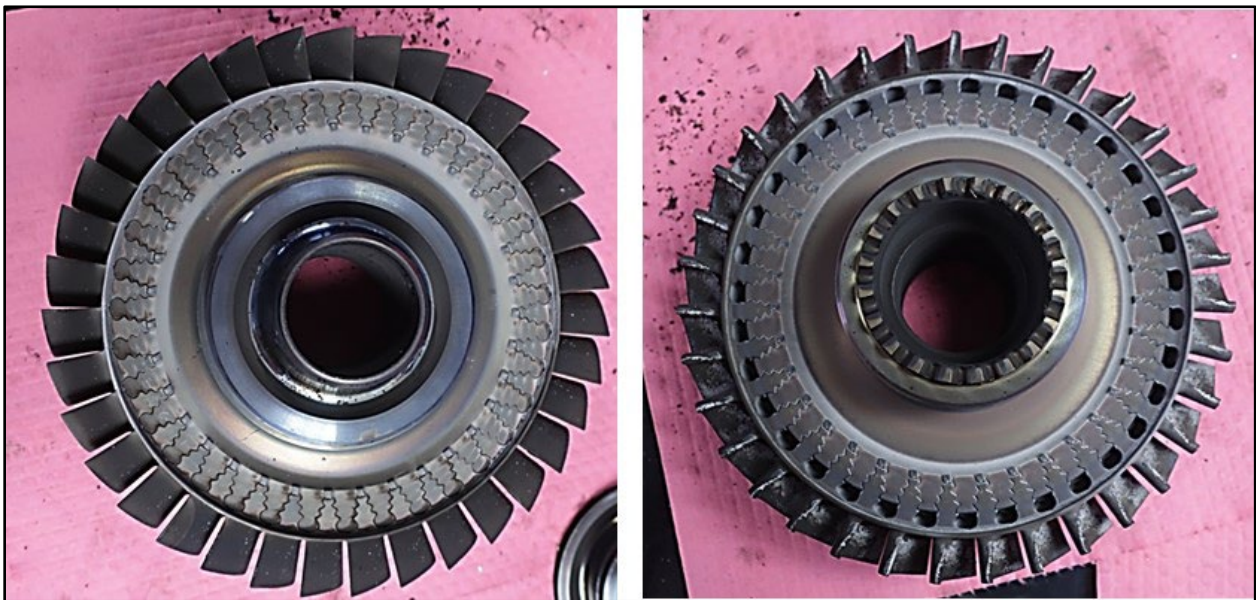
**Figure 48.** Gas Generator Turbine Disk/Blades - Trailing Edge (L), Leading Edge (R)

The gas generator turbine disk blades appeared intact with no evidence of damage (Figure 48) and exhibited a white discoloration and a flaking appearance on the leading edge surfaces near the blade root. The airfoils of gas generator turbine disk blades also exhibited a white discoloration on the concave (pressure) side. All gas generator turbine disk posts and blade fir trees appeared undamaged and all the blade locks were present. The gas generator turbine shroud segments were all present and unremarkable.

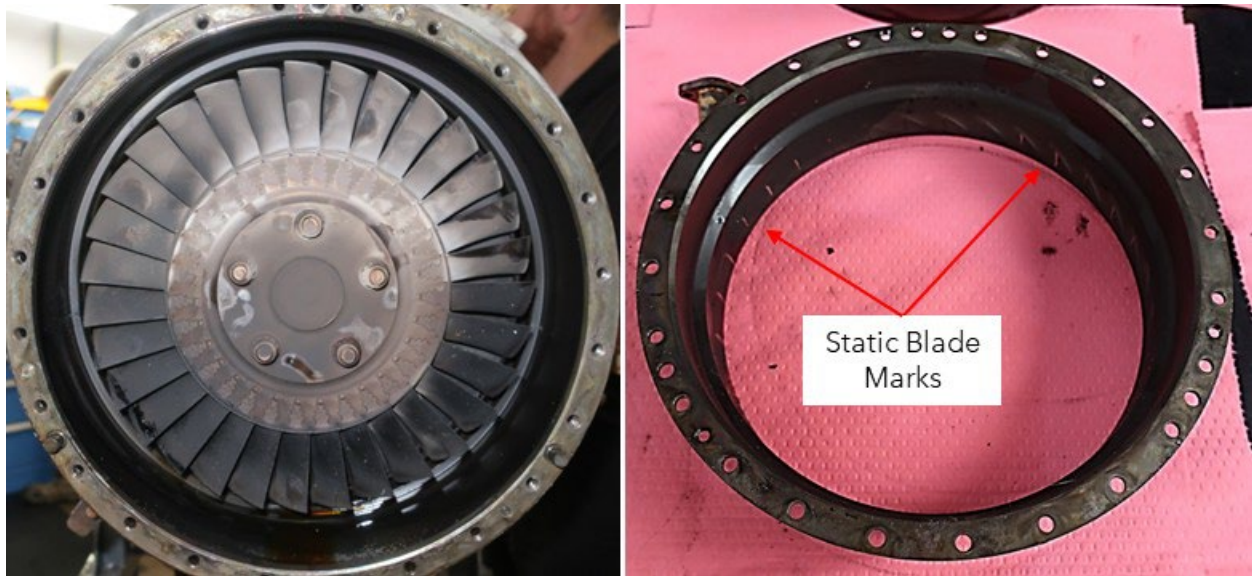
**Figure 50.** PT Disk/Blades Installed (L), PT Inner Shroud (R)

All PT disk blades were intact and complete with no evidence of damage (Figure 50 and Figure 51). The PT inner shroud was removed, revealing static blade contact marks resulting from the radial sliding action and contact between the PT disk blade tips and the PT inner shroud (Figure 50). With the removal of the PT inner shroud, the PT disk freely rotated with corresponding rotation of the power drive shaft through the reduction gearbox.

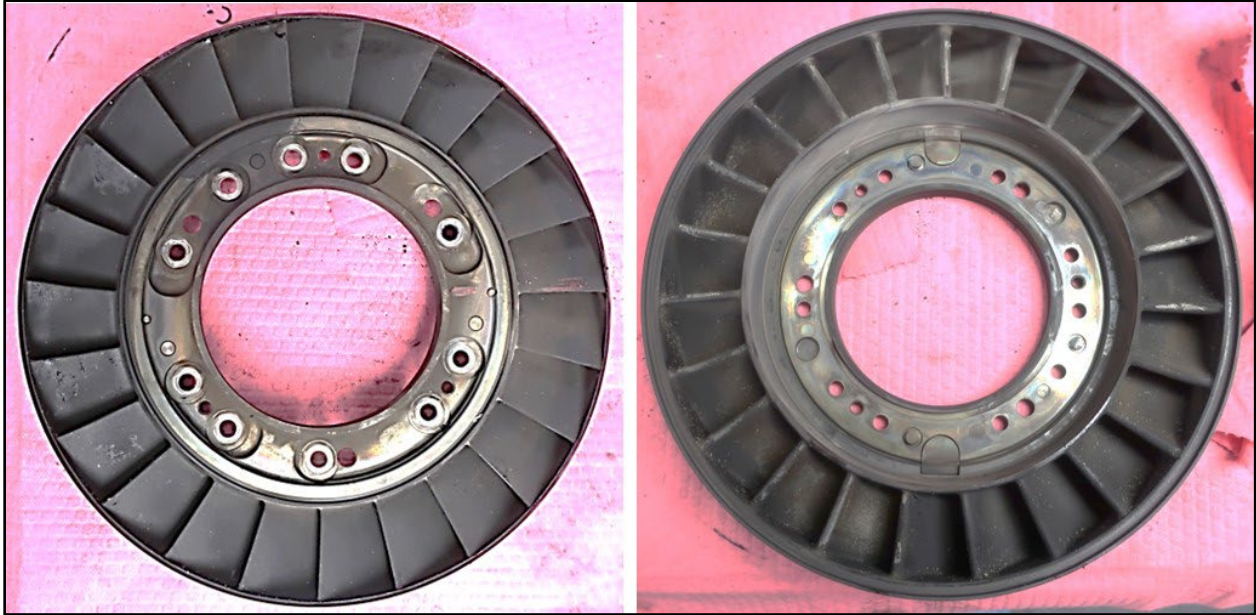
**Figure 52.** PT NGVs - Trailing Edge Side (L), Trailing Edge Side (R)

The PT NGVs had dark discoloration and residue adhered to all vanes but was otherwise unremarkable (Figure 52).

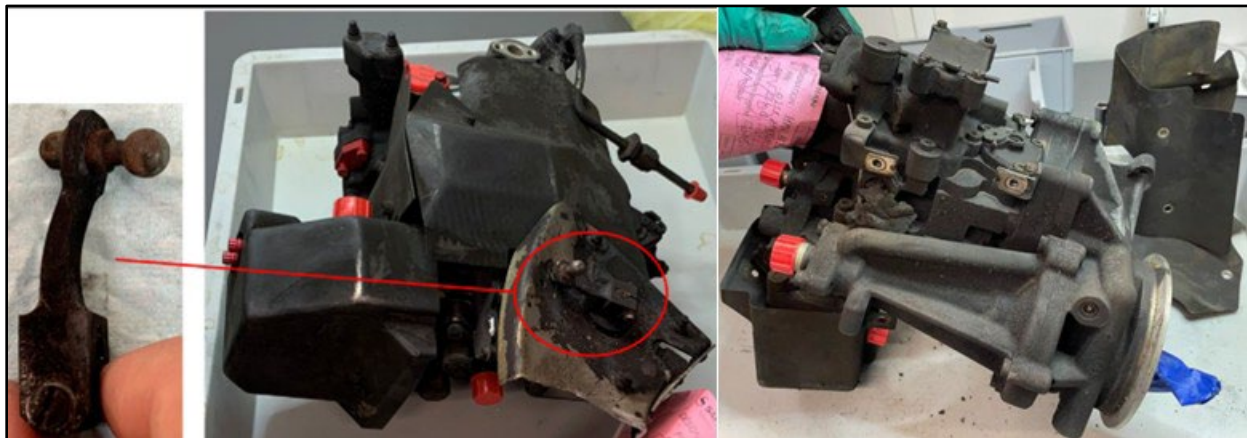
**Figure 55.** No. 1 Engine HMU - As Received (R), Bent Mode Control Lever (L)  
(Figure Courtesy of SafranHE)

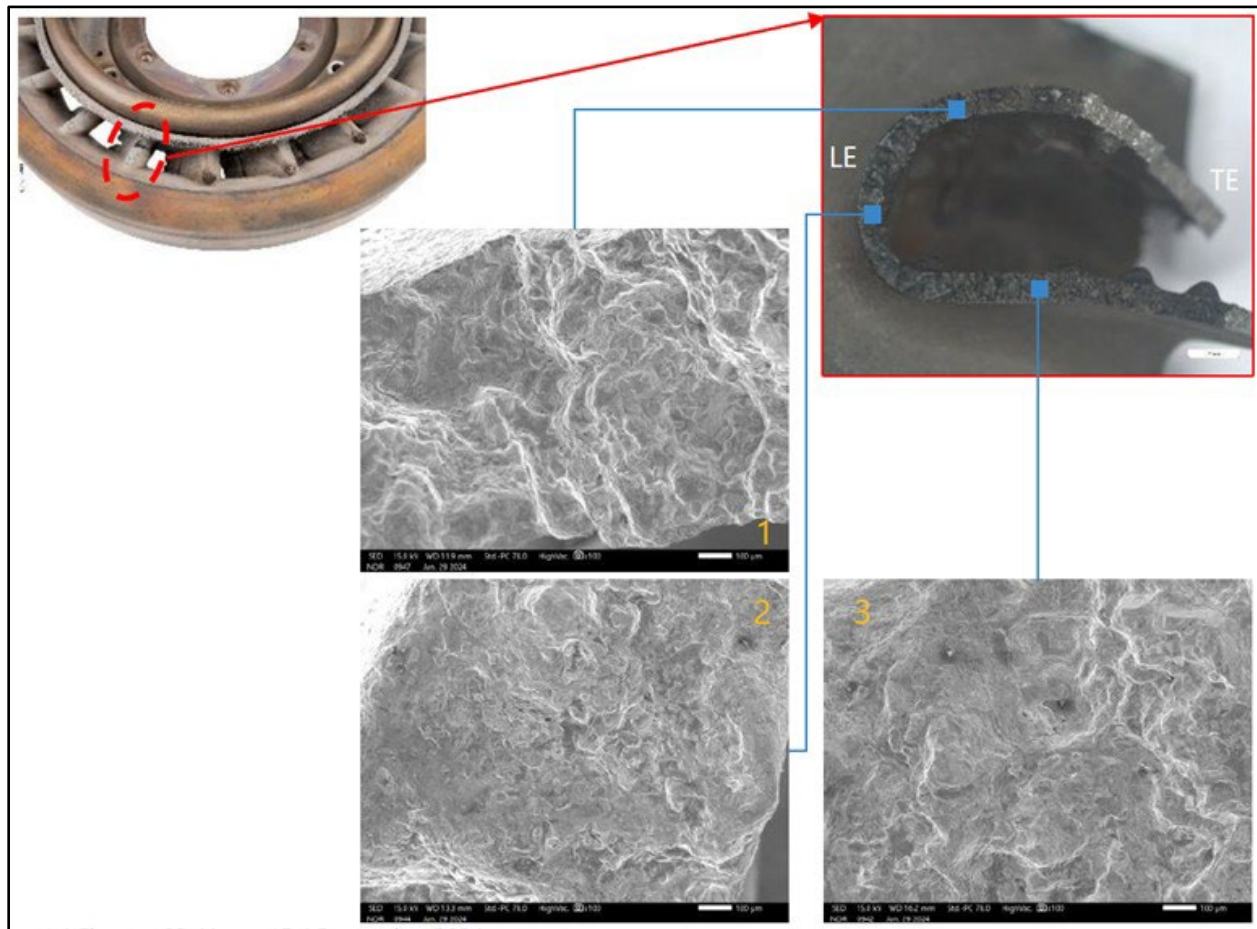
**Figure 78.** Gas Generator Turbine NGV Metallography - Cracked Vane  
(Figure Courtesy of SafranHE, Etchant copper sulfate reagent)

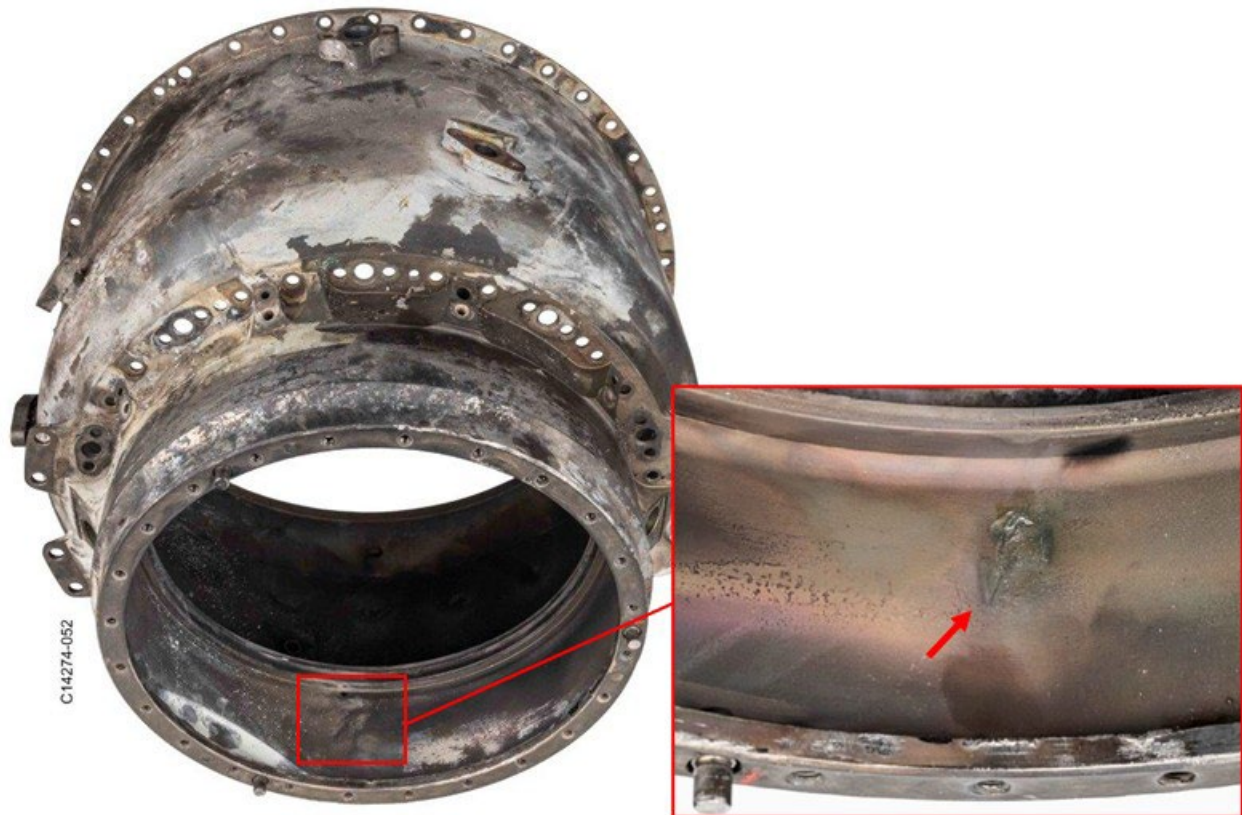
**Figure 82.** Turbine Case (L), Impact Mark at PT Containment Ring (R)  
(Figure Courtesy of SafranHE)

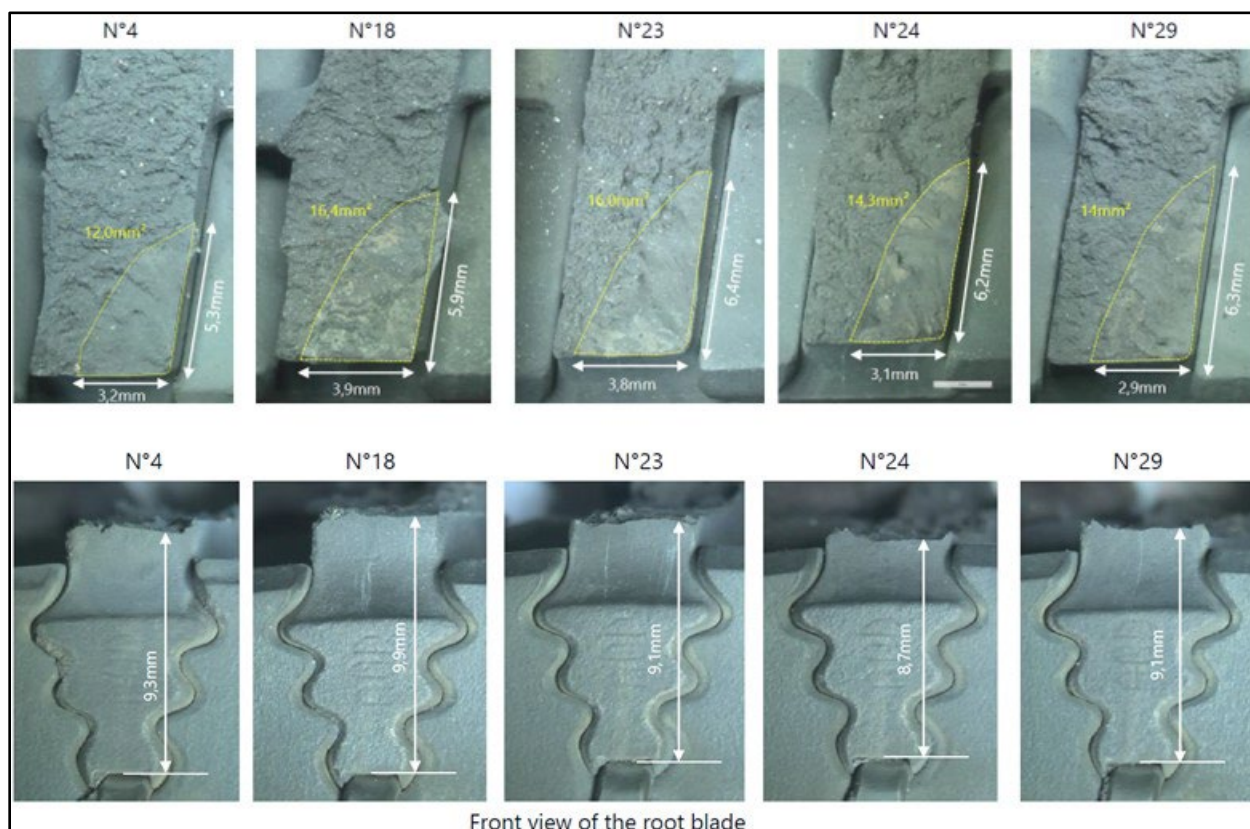
**Figure 88.** Fractured PT Blades

The Safran laboratory performed fractography and metallography on the five fractured power turbine blades. All presented a similarly shaped area of crack initiation/propagation with characteristics consistent with fatigue, initiation occurred below platform in the blade shank at the corner of the leading-edge side and the pressure side, no material anomalies were found at the initiation sites.
