ERA23FA352

## **POWERPLANTS**

## Engine Control Units examination

Document ID: **BEA2023-0379\_tec01**  
Registration number: **N109BC**  
Aircraft type: EUROCOPTER - EC135 - T1  
Date of occurrence: 28th August 2023  
Place of occurrence: Pompano Beach (Florida)  
Equipment examined:

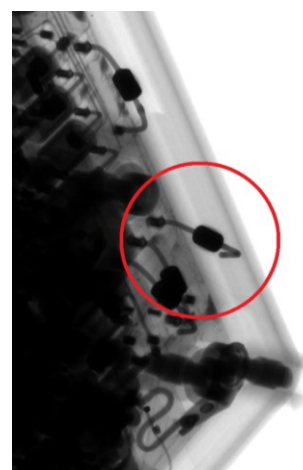
The ECU was visually examined. Evidence of thermal damages were observed on the external casing. The connectors and their pins were in good condition. A small bump was observed on the upper part of the casing.

The lower part of the casing was opened. The visible parts of the electronics boards were in good condition. No trace of heat was found. To prevent any additional damage on the ECU, only the CPU board (which contains the memory component) was removed from the computer for visual examination under magnification. The board and its components were in good condition. As it was not possible to dismantle all the boards without risking damaging the computer, an X ray examination was performed. It was noticed that two components were partially unsoldered from one of the electronic boards.

**Figure 1** : Partially unsoldered components on ECU\_1

As the decoding of the memory dump of ECU\_2 was consistent, the BEA suggests proceeding with a chip-off data recovery process on the ECU\_1. This would prevent any risk of data corruption while trying to power-up the ECU with damages on the electronic boards.
