# National Transportation Safety Board

ERA23FA352

## VIDEO STUDY

Description: Helicopter in-flight fire and impact with apartment building  
Location: Pompano Beach, Florida  
Date: August 28, 2023  
Time: 0844 Eastern Daylight Time (EDT)  
Aircraft: Eurocopter Deutschland GMBH EC135T1, N109BC  
Operator: Broward County Sheriff's Office

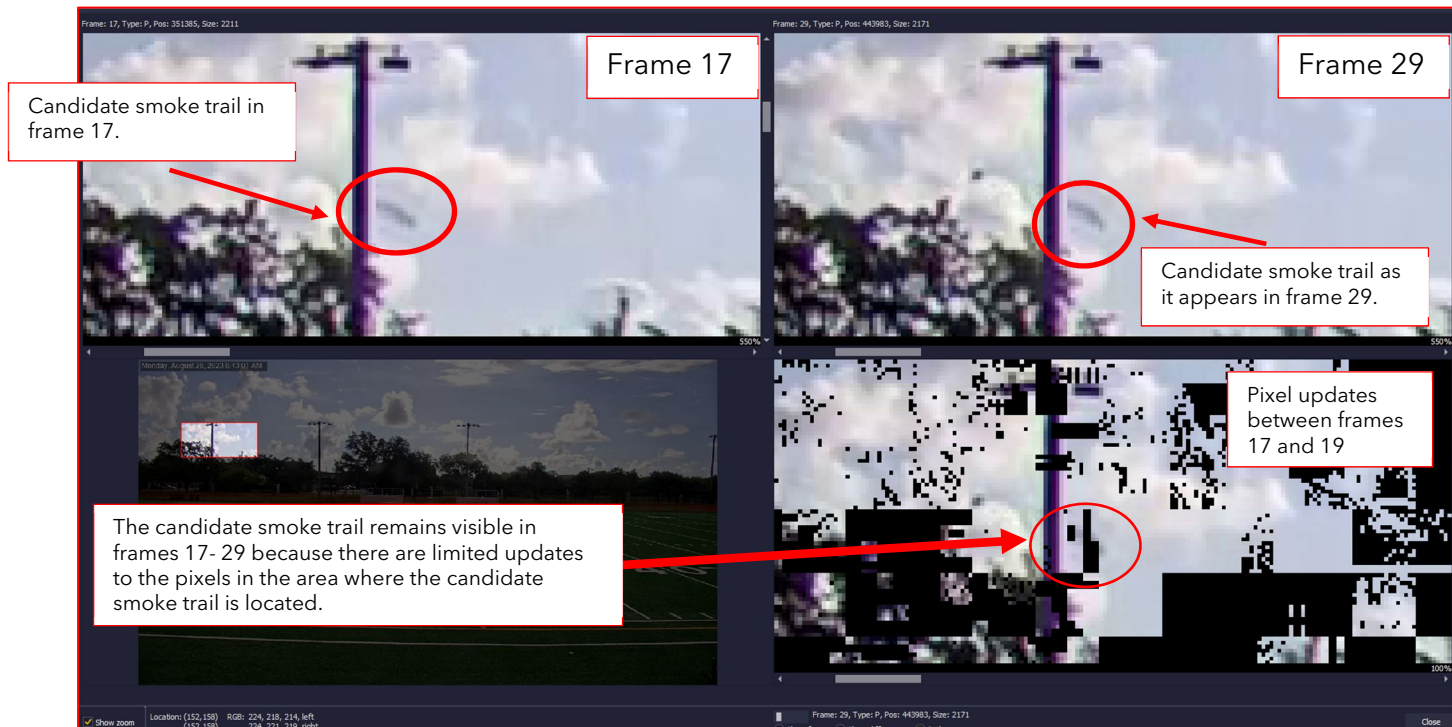
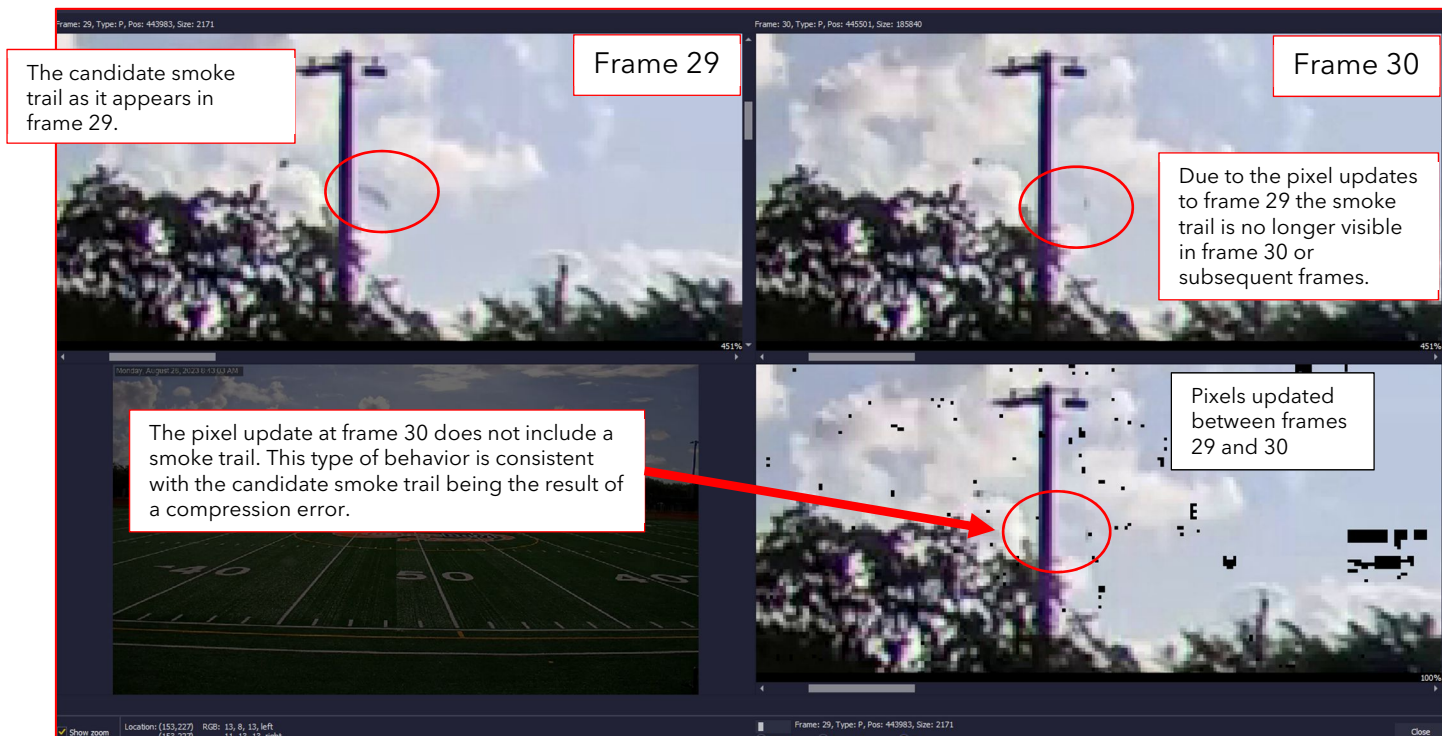
The ball field video camera captured portions of the N109BC westbound and eastbound flight segments. Cropped and scaled images extracted from the ball field video camera recording are presented in sequential order in Attachment 1. The westbound flight segment documented by frames 0 through 35 (of 550 total frames) depicts N109BC traveling west, transitioning from no smoke trail (frames 0-9) to a "possible but discontinuous smoke trail" (frames 10-29) to abrupt, follow-on frame content updates showing no smoke trail (frames 30-35). The candidate smoke trail pixel content in frames 10 through 29 is likely an image compression artifact because it lacks the commonly observed periodic, continuous, descending, dissipating, and/or wind drift features of airborne smoke trails (see exemplar smoke trail in frames 256-494). The composite image in Figure 1 shows that the smoke trail artifact visible in frames 11-29 is no longer present after the pixels in frame 30 are updated. This behavior is consistent with the candidate smoke trail being the result of video compression effects rather than a real object in the video. Similarly, the disjoint helicopter fuselage position content in frames 92-119 (repeated and/or skipped fuselage content) appears to be due to image compression effects.

Figure 1. This composite image shows that the candidate smoke trail content suddenly disappears from the video when the pixels in the location of the candidate smoke trail are updated.

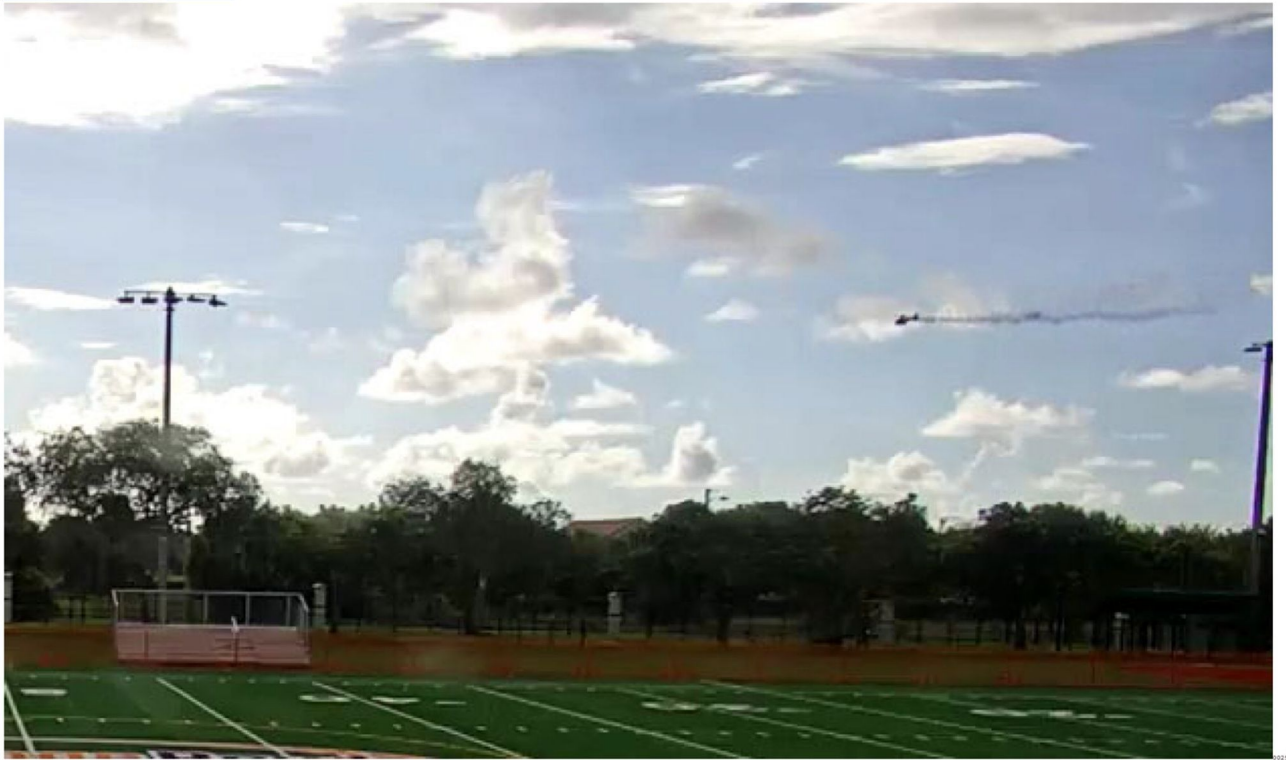
Preceding the emergence of N109BC eastbound, ball field video camera frames 75 through 115 (of 1,355 total frames) illustrate stale, static positions of a bird in flight (content that appears to be splitting due to pixels not updating). However, frames 256-494 illustrate that N109BC generated genuine, commonly observed smoke trail features during the flight segment that preceded the

helicopter partial tail boom separation, spin, and impact. An exemplar smoke trail frame is presented in Figure 2. There is also evidence of a flock of birds flying in the general area between frames 619 and 672 (of 1,355 total frames).

Figure 2: Exemplar N109BC smoke trail documented by ball field camera frame 295.

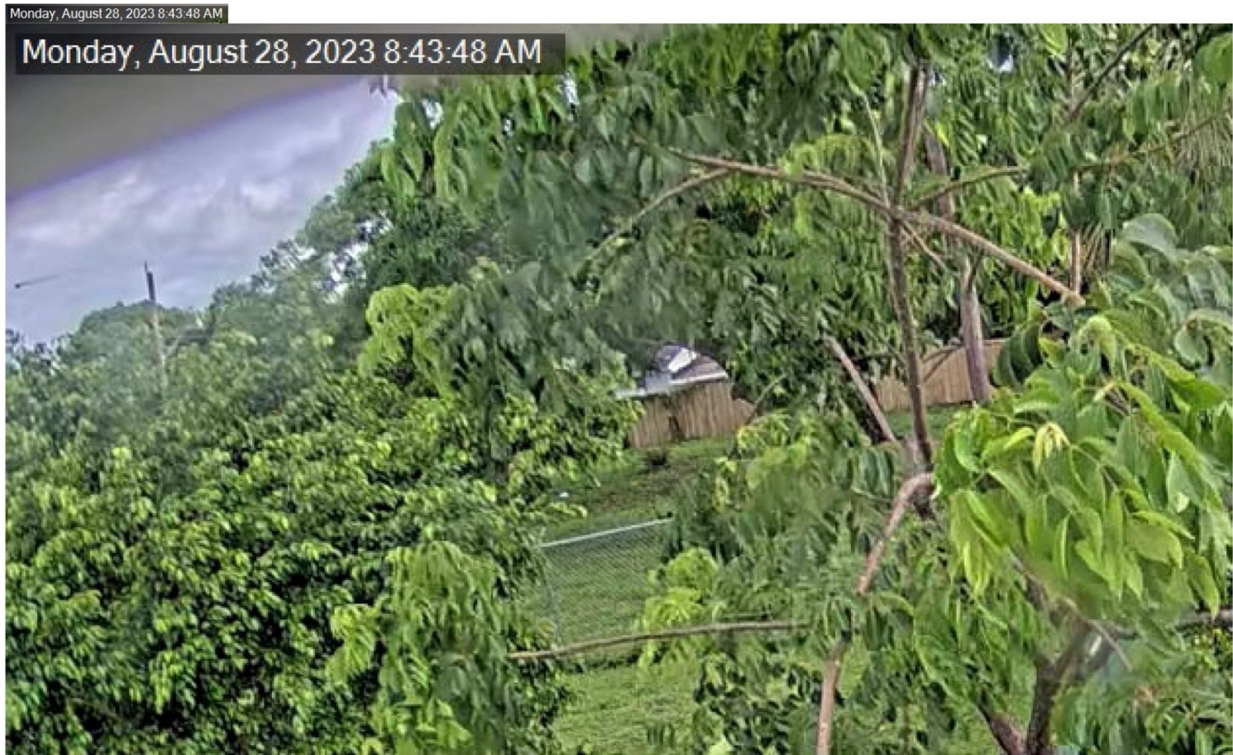
The content in westbound frames 461 through 490 (of 499 total frames) indicates that N109BC generated genuine, commonly observed continuous, descending, dissipating, and/or wind drift features of airborne smoke trails. An exemplar smoke trail frame is presented in Figure 3.

Figure 3: Exemplar N109BC smoke trail documented by Annie Gillis Park camera frame 479.
