# National Transportation Safety Board

ERA23FA357

**EXAM**

Location: Kingston, New Jersey  
Date: August 31, 2023  
Time: 1520  
1920 (UTC)  
Airplane: Robinson R-22 Beta N2356M

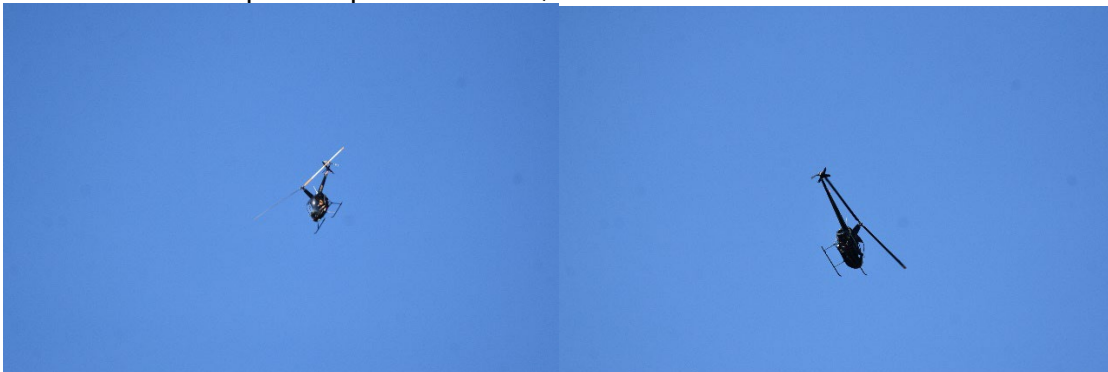
Shortly after departure from Princeton, NJ Airport (39N) while operating at about 1,000 feet mean sea level (800 agl) witnesses reported the helicopter flying erratically; it was climbing, descending, and spinning. During the erratic flying, the helicopter suffered a catastrophic failure; the main rotor blade(s) contacted the tail boom, severing the tail rotor assembly and causing a loss of control and subsequent impact with trees, terrain and water.

**Figure 1 Photographs of helicopter taken by witness preceding crash.**

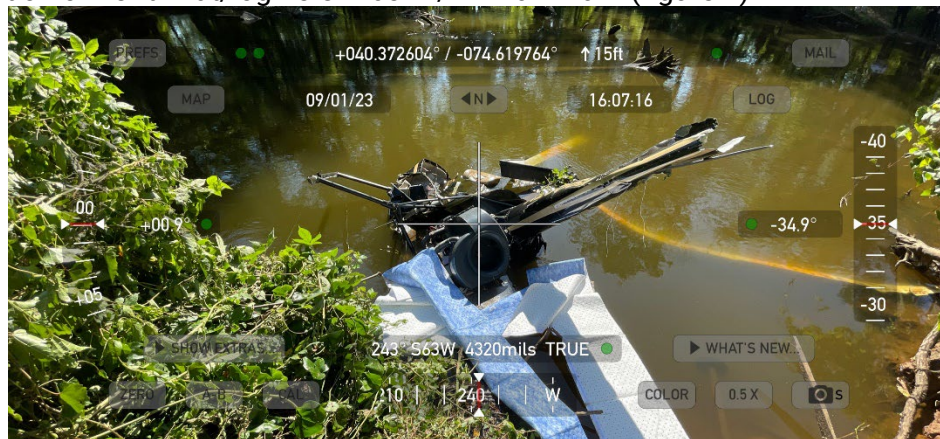
Princeton Airport (39N) Princeton/Rocky Hill, New Jersey, USA was about 2 miles west of the accident site. The helicopter came to rest inverted in about 3 feet of water on the shoreline of a tributary; the site contained thick brush, trees and swamp. The main wreckage consisting of the main rotor blades, engine fuselage and about 8 feet of the tail boom came to rest at an elevation of 15 ft. Lat/log 40.372604° / -74.619764° (figure 1)

**Figure 2 Accident site with location/ direction details**

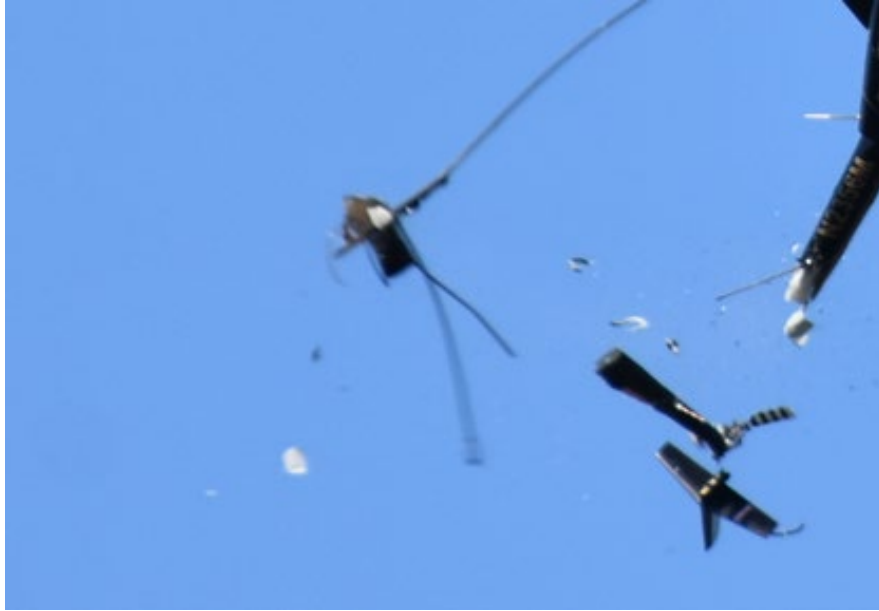
The forward fuselage was buckled and crumpled. The lower portion where the rudder pedals were located was crushed upwards into the occupiable space in the cockpit indicating that the helicopter struck the terrain nose low. The tail rotor assembly was severed aft of the N numbers. Photographic evidence showed that the tail came off in three separate pieces.

All control rods/tubes remained intact although damaged by impact forces. No anomalies or other irregularities were discovered. Tail Rotor pedals and their associated control rods showed no signs of anomalous damage or other irregularity. Continuity was established up through the fuselage to the remaining tail boom.

**Figure 3 Tail boom severing showing 3 large pieces including the rotor blades and shaft.**

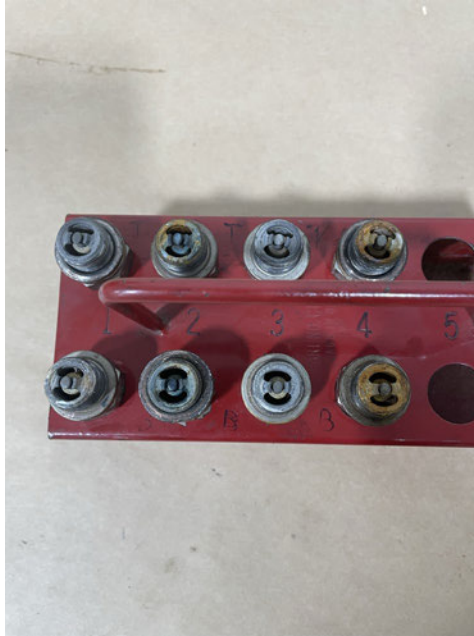
The Nos 2 and 3 (Top & Bottom) spark plugs displayed unusual blue coloration with normal electrodes as compared to the Champion Aerospace AV-27 Check-A-Plug chart. Blue thick substance found on spark plug and in the induction system. Sent the induction pipe(s) to the NTSB Materials lab for analysis.

**Figure 4 Spark Plugs and blue tint**

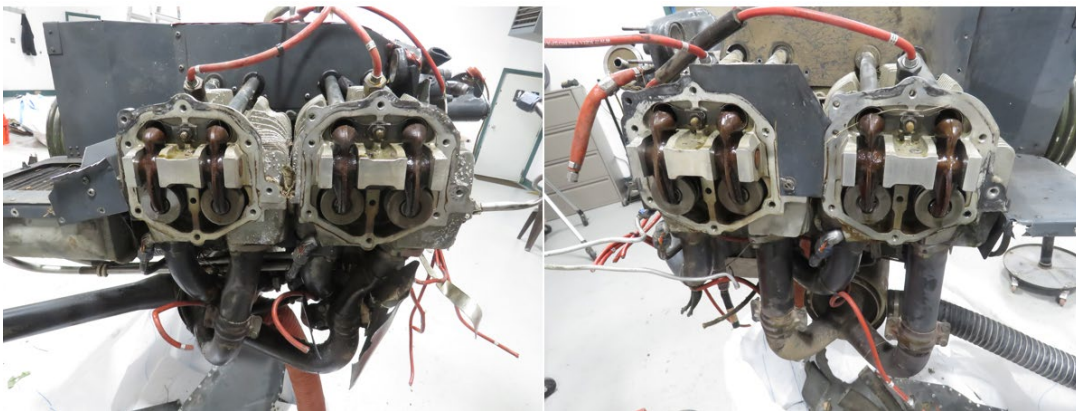
**Figure 5 View of left and right side of engine prior to examination.**

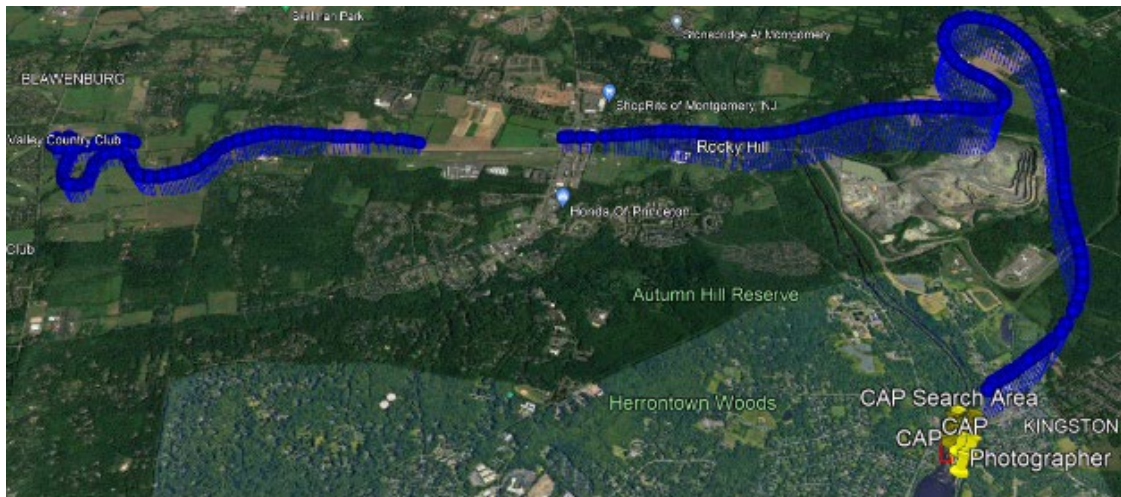
**Figure 6 ADS-B Flight track. Instructor stated that he was supposed to do regular airport pattern work. This was unusual and he doesn't know why the pilot deviated from his instruction.**

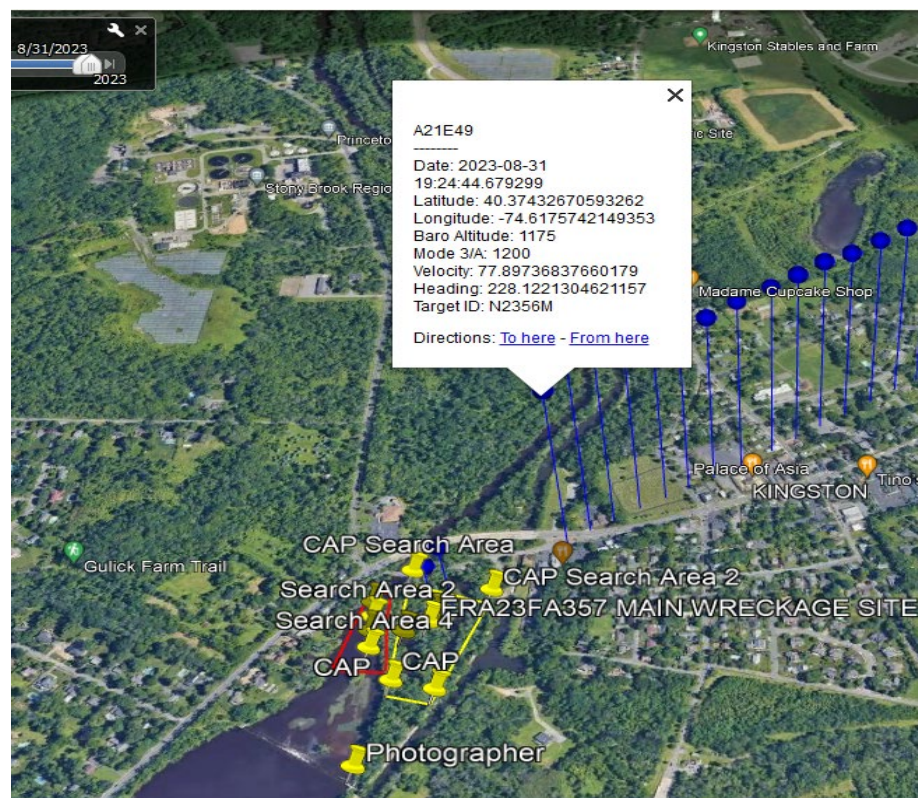
**Figure 7 Last flight target prior to loss of control and impact. Note search grids and location of photographer.**
