ERA23FA357

## INVESTIGATION PHOTOGRAPHS

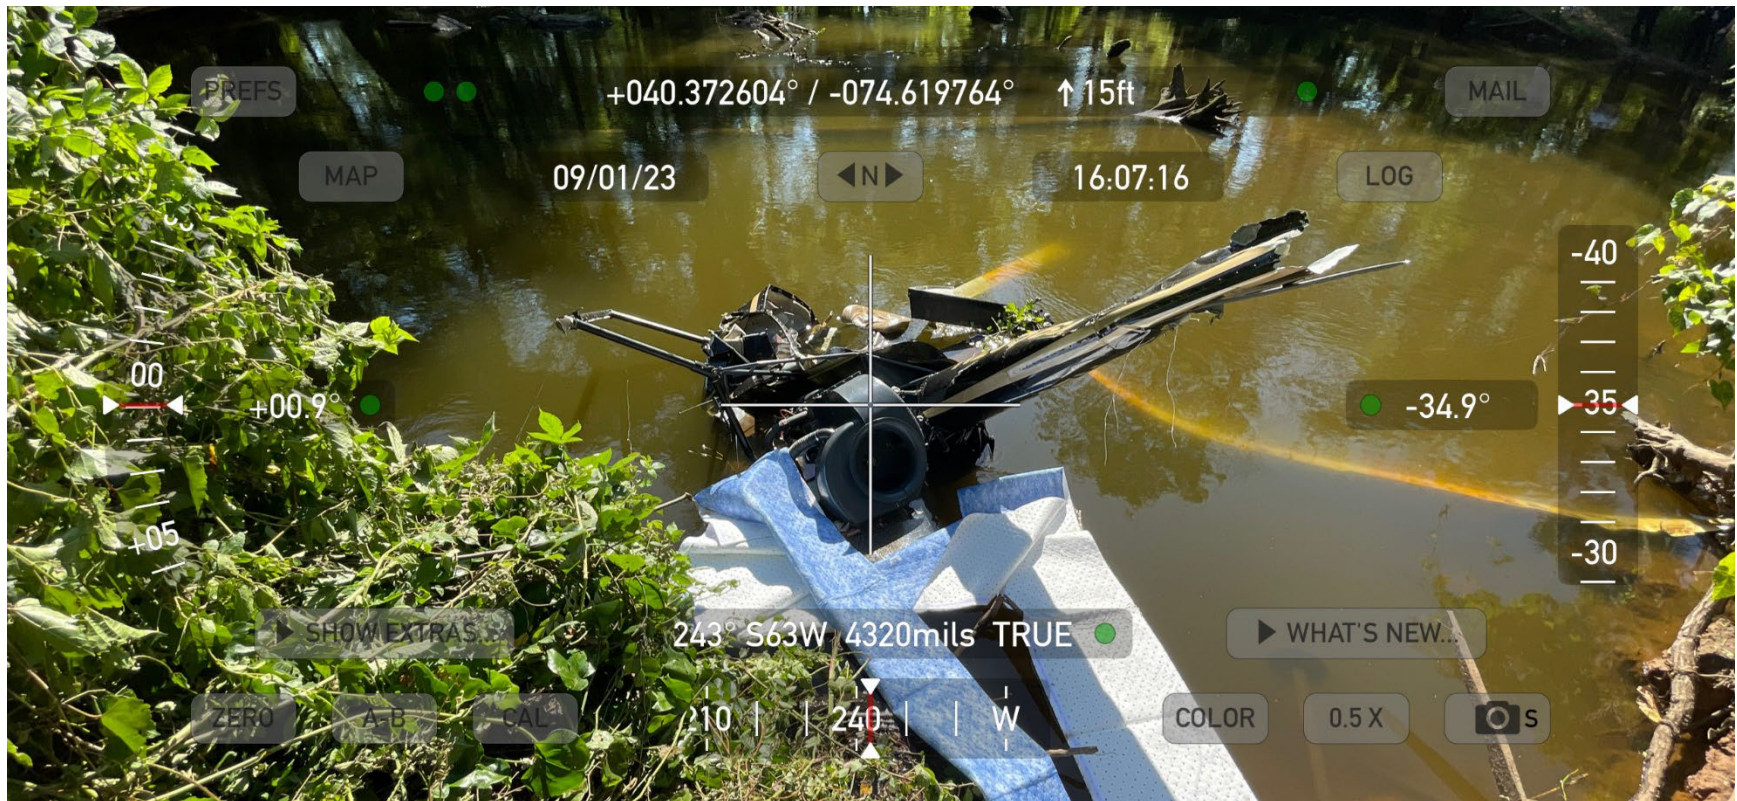
**Photograph 1 - View of wreckage resting in water with location details. Note oil mats to prevent fuel and oil from escaping into waterway. (NTSB IIC)**

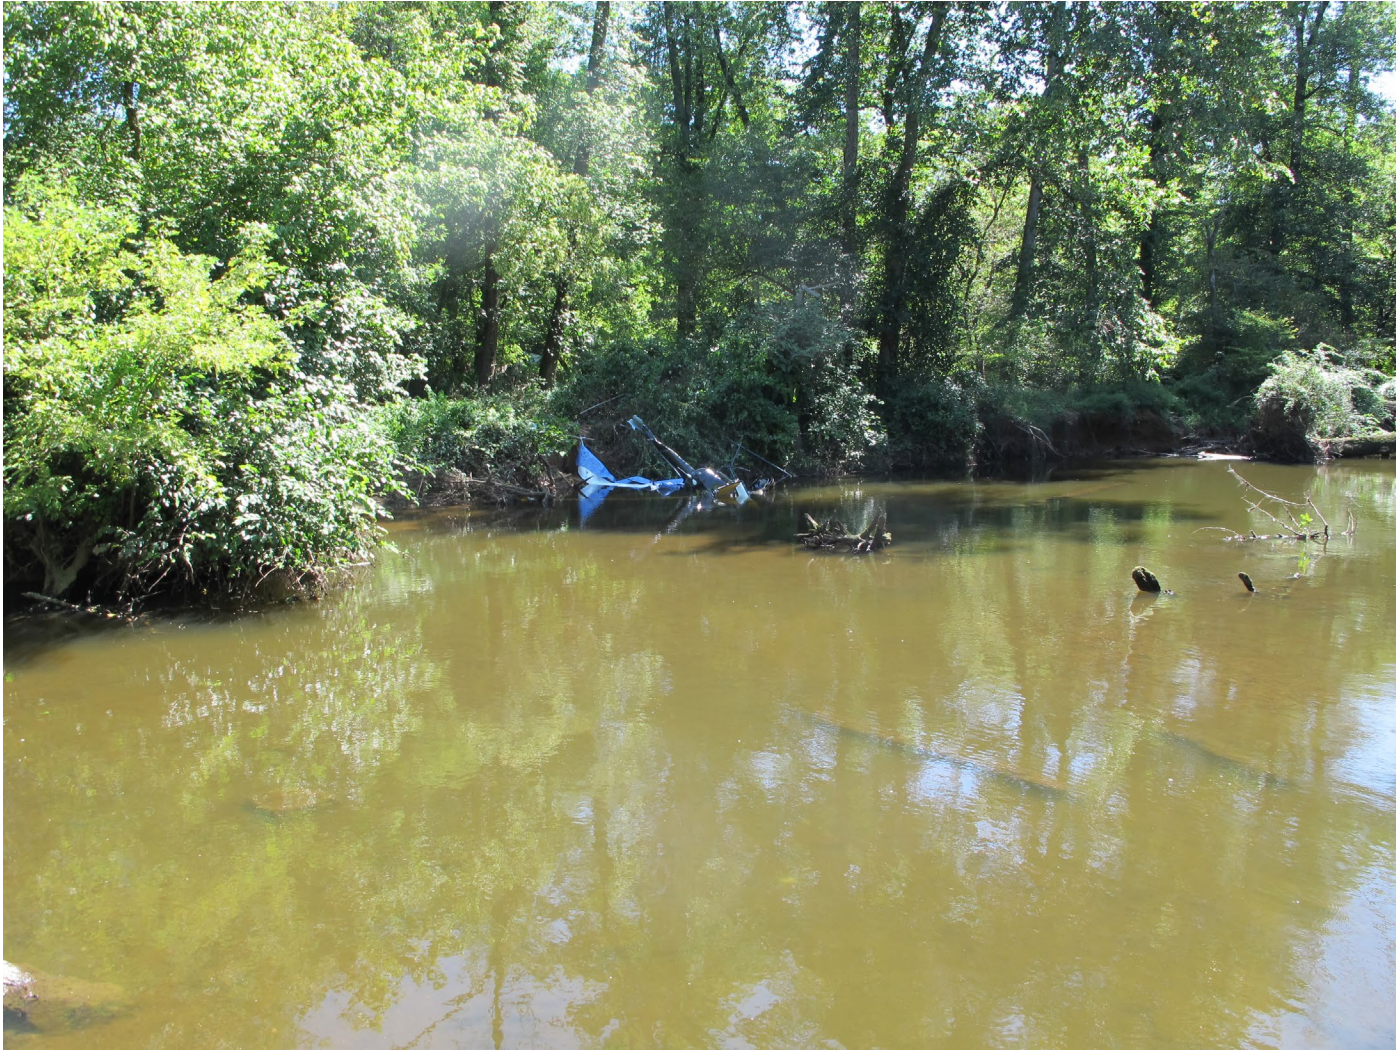
**Photograph 2 - View of wreckage from opposing tributary bank. (Courtesy of Robinson)**

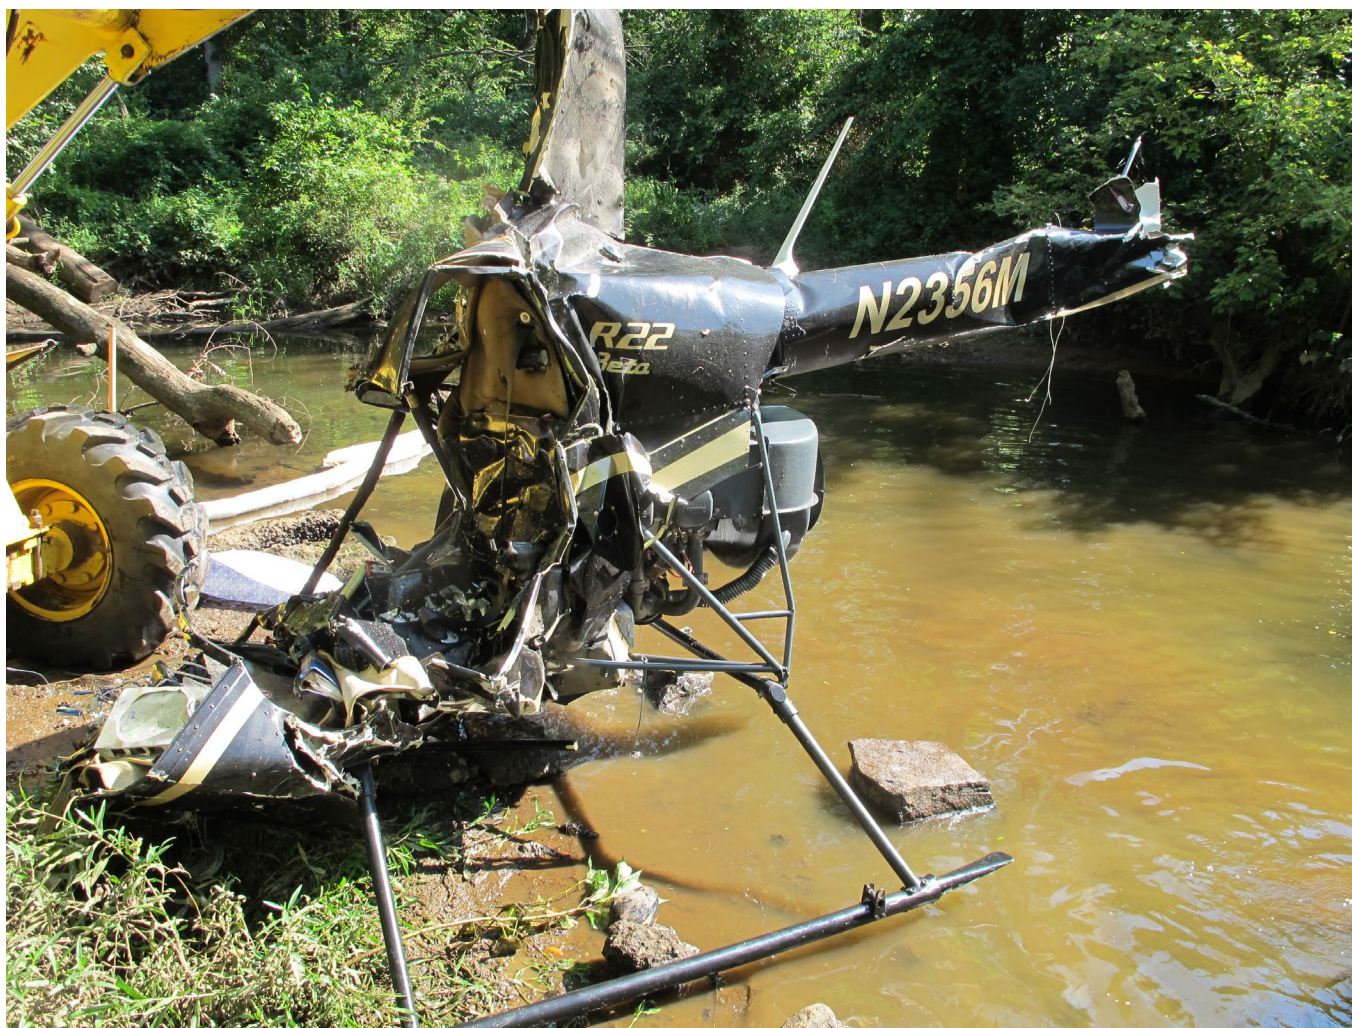
**Photograph 3 - View of wreckage during recovery from water. (NTSB IIC)**

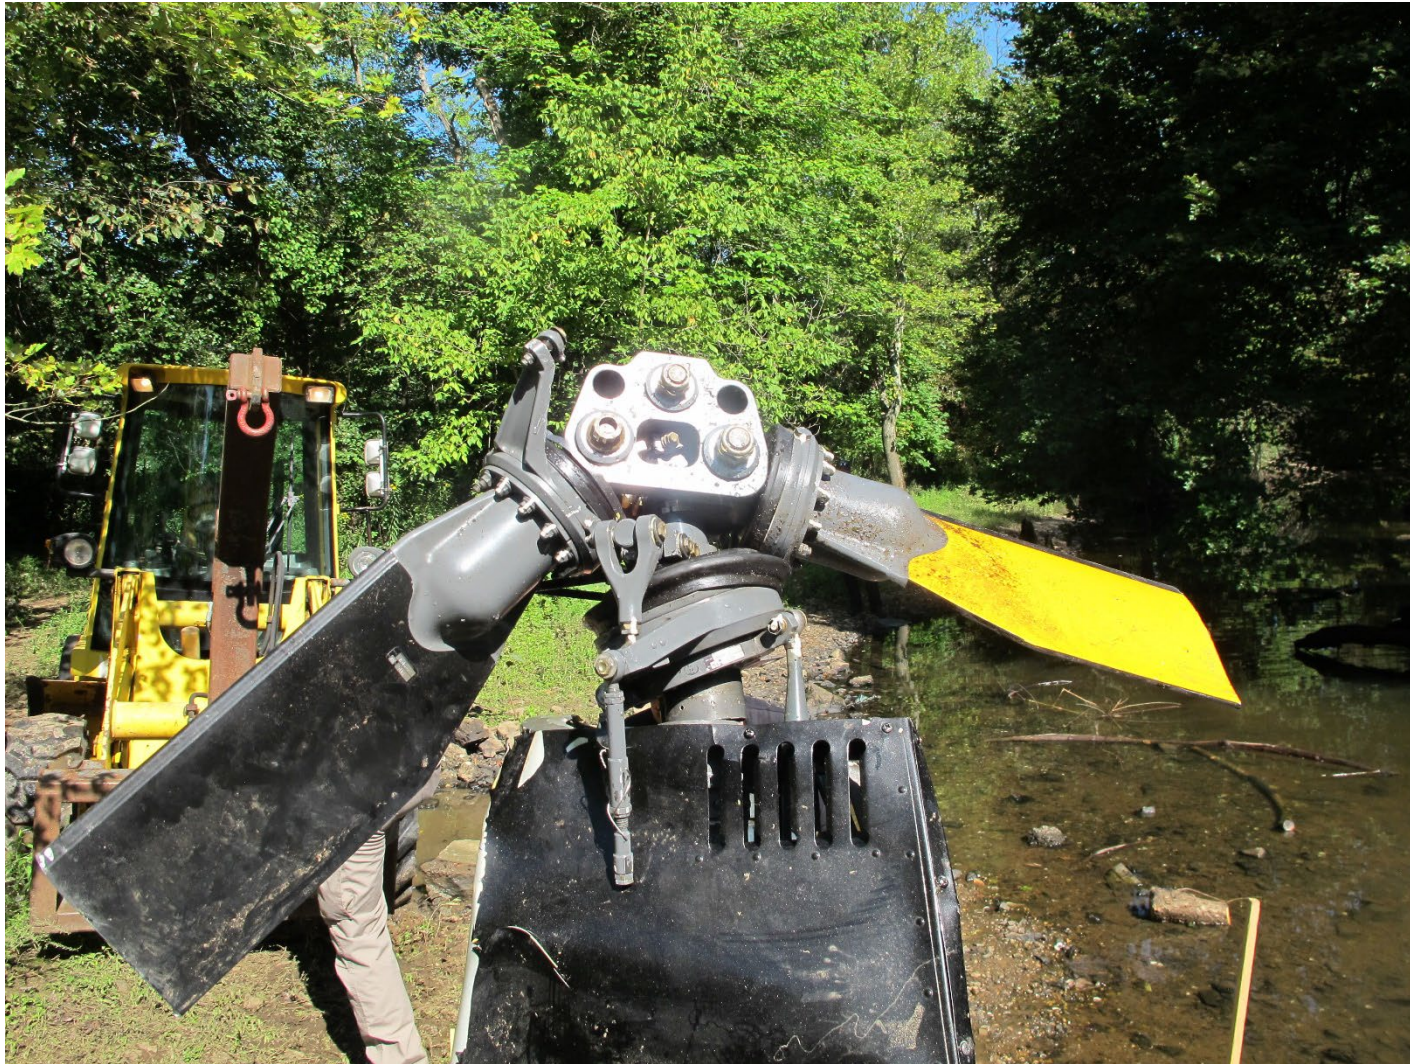
**Photograph 4 - View of rotor head and blades. Note, blades were cut off to facilitate recovery.  
(Courtesy of Robinson)**

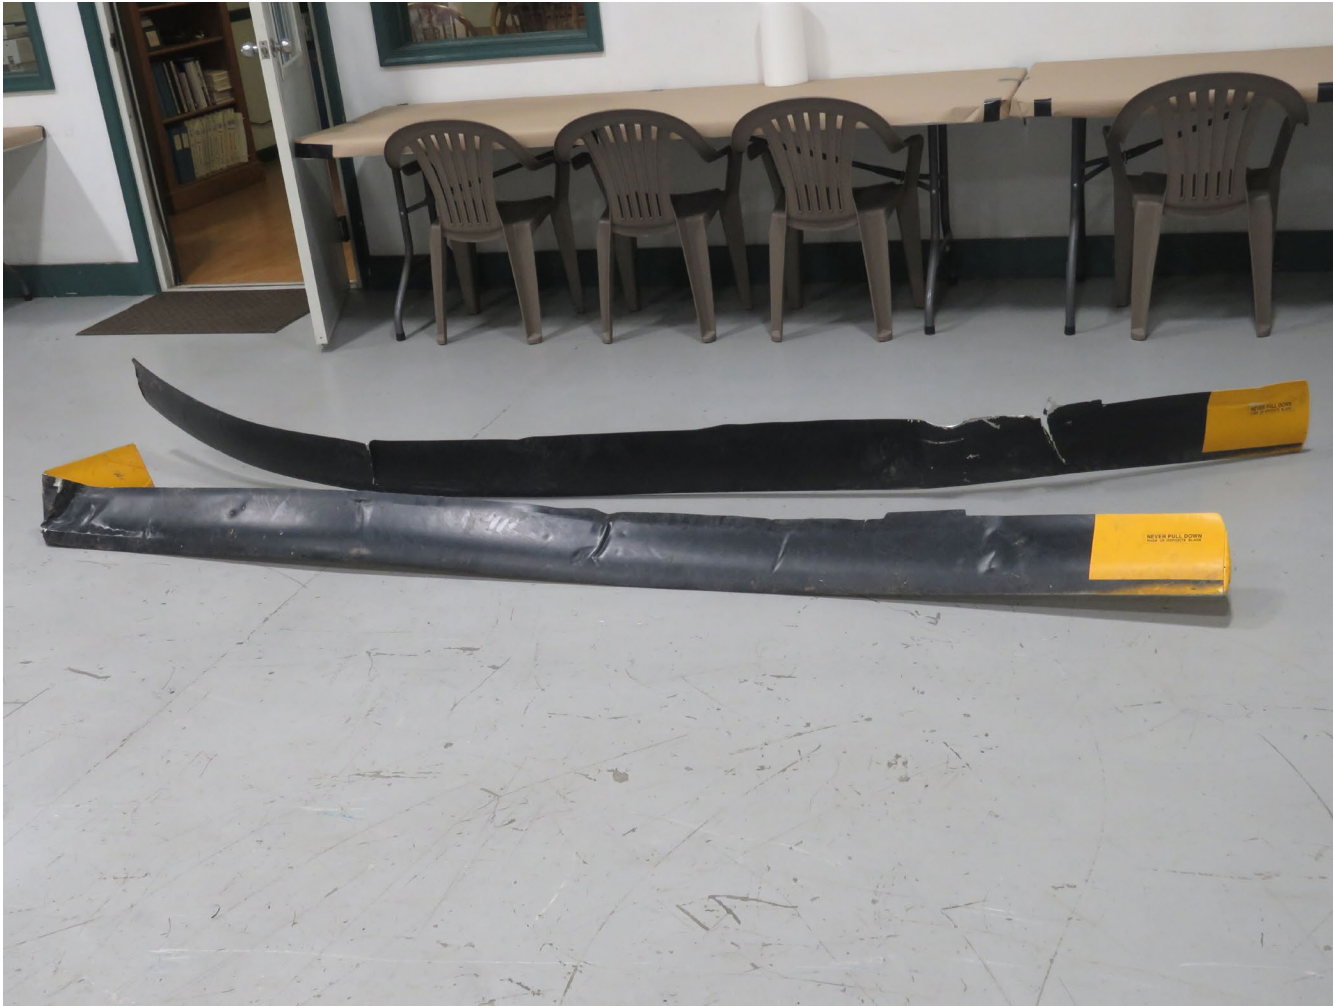
**Photograph 5 - View of rotor blades on hanger floor. (NTSB IIC)**

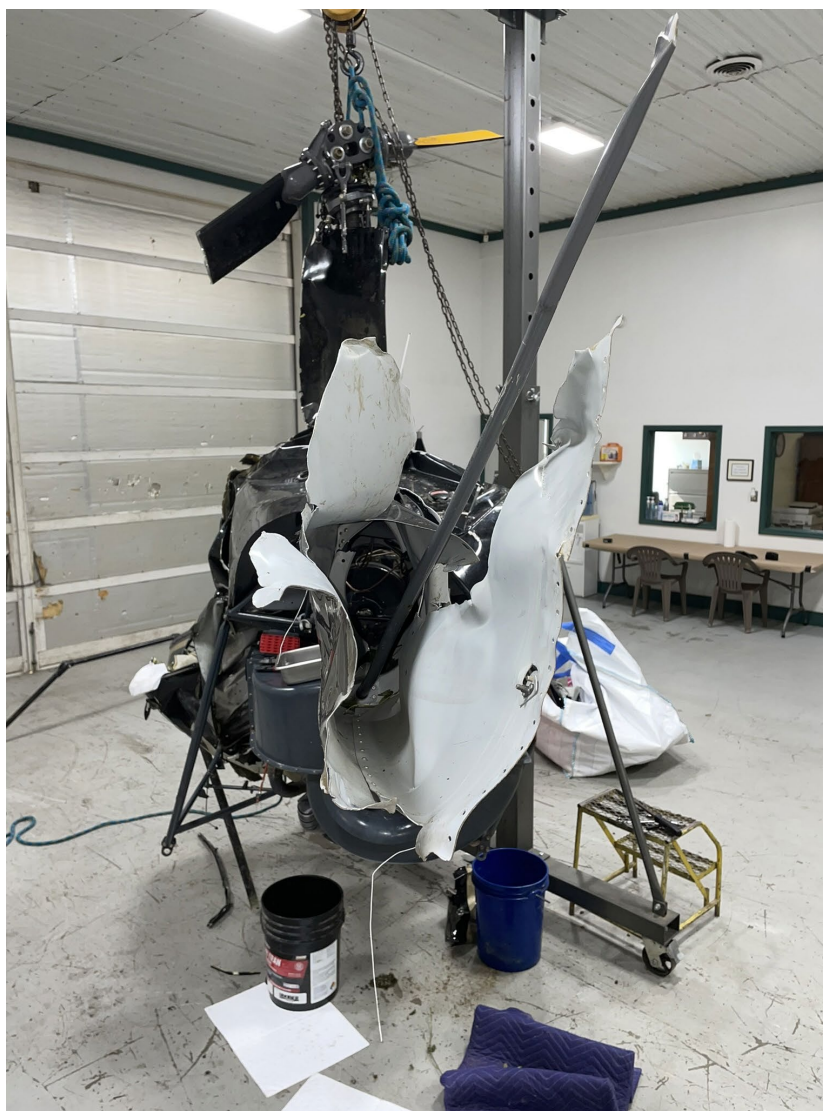
**Photograph 6 - View looking forward of severed tail boom and control rod. (NTSB IIC)**

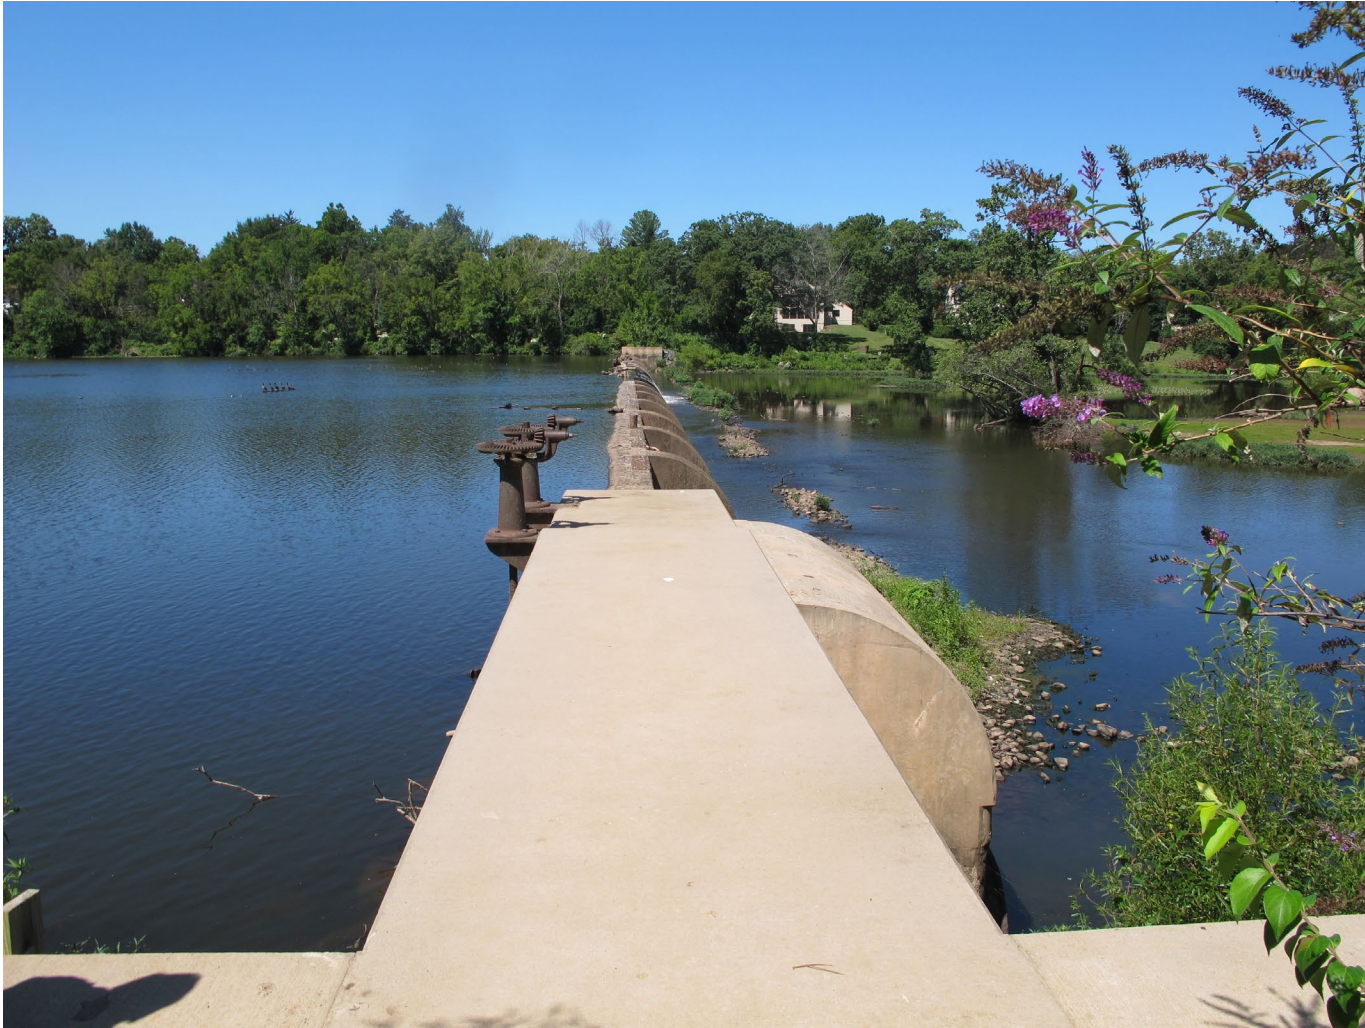
**Photograph 7 - View of dam and river where the photographer was standing. (NTSB IIC)**
