# ERA23FA357 N2356M, Kingston NJ

August 31, 2023

Eyewitness Photographs

# 17 Sequential Photographs

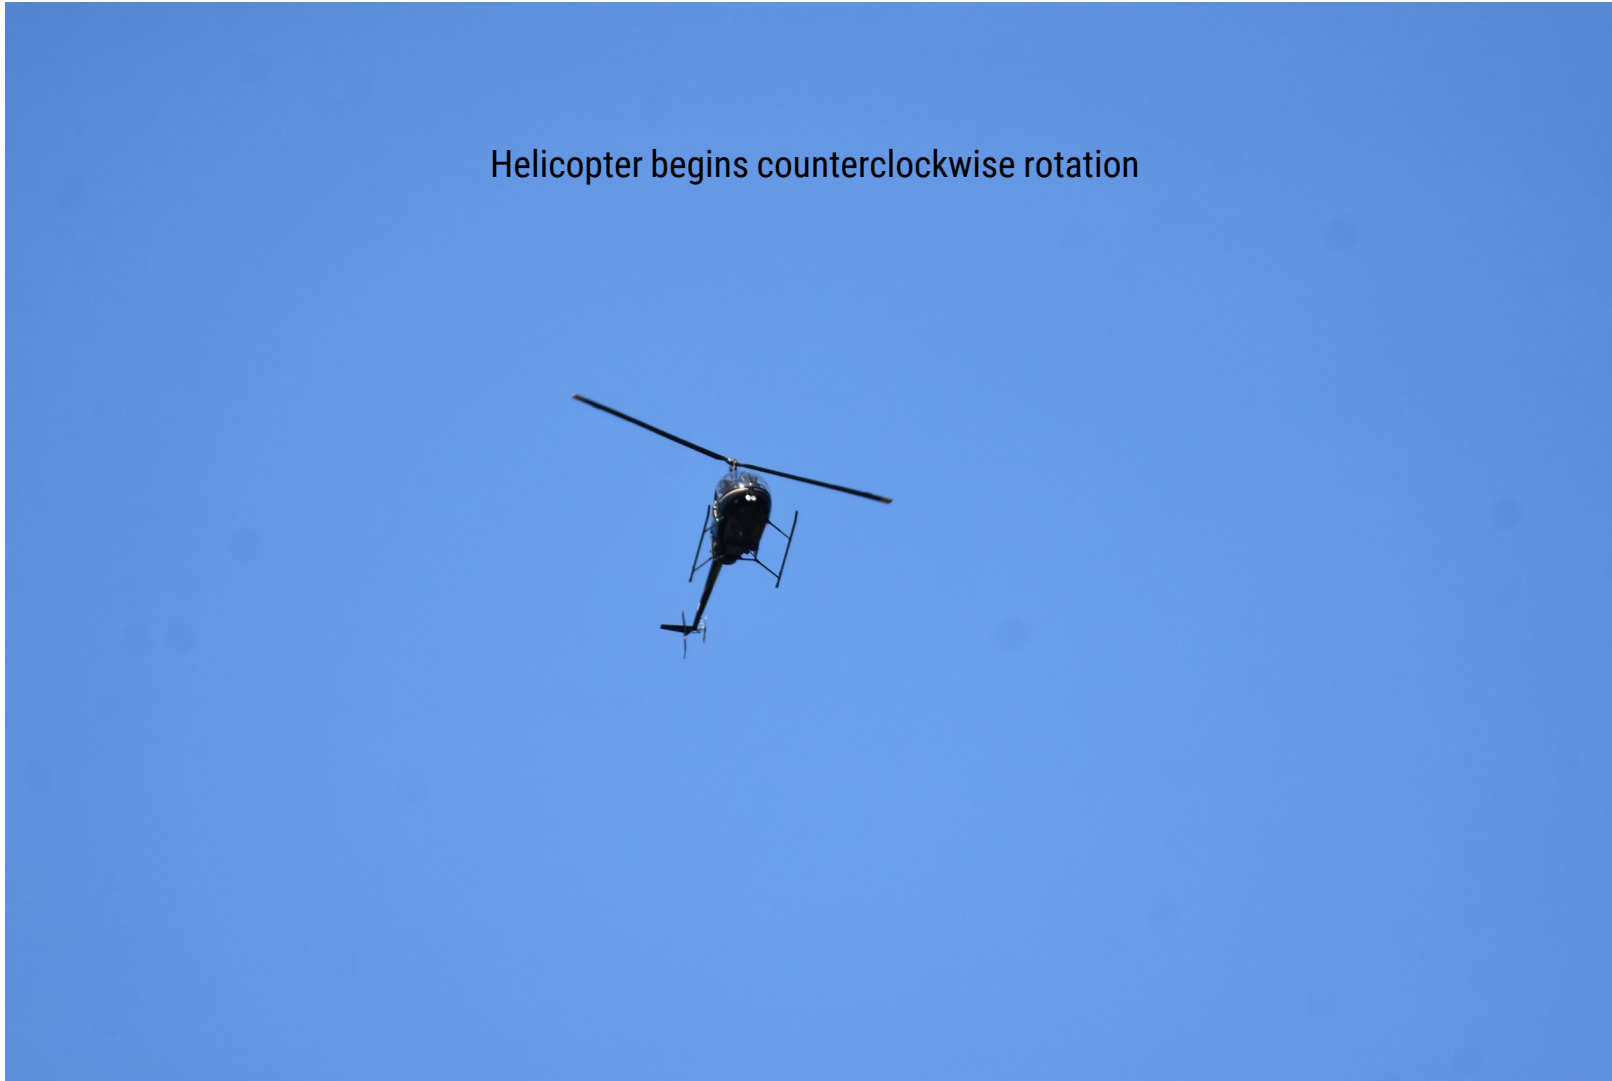
## Photograph No. 4 (0381)

Helicopter begins counterclockwise rotation

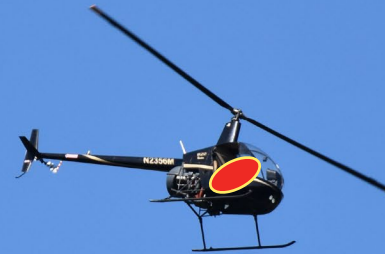
## Photograph No. 6 (0383)

Counterclockwise rotation. Pilot bent significantly forward. Cannot determine if right hand is on the cyclic. Headset is off his right ear and resting on his neck. Right foot does not appear to be on the pedals. The pilot is redacted by red oval.

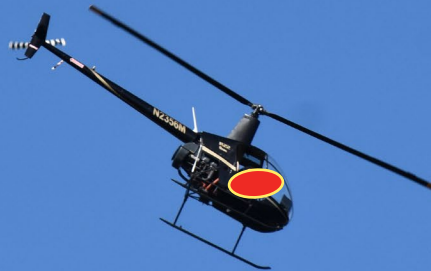
## Photograph No. 7 (0384)

Counterclockwise rotation continues. Pilot bent significantly forward. Cannot determine hand and feet position. The pilot is redacted by red oval.

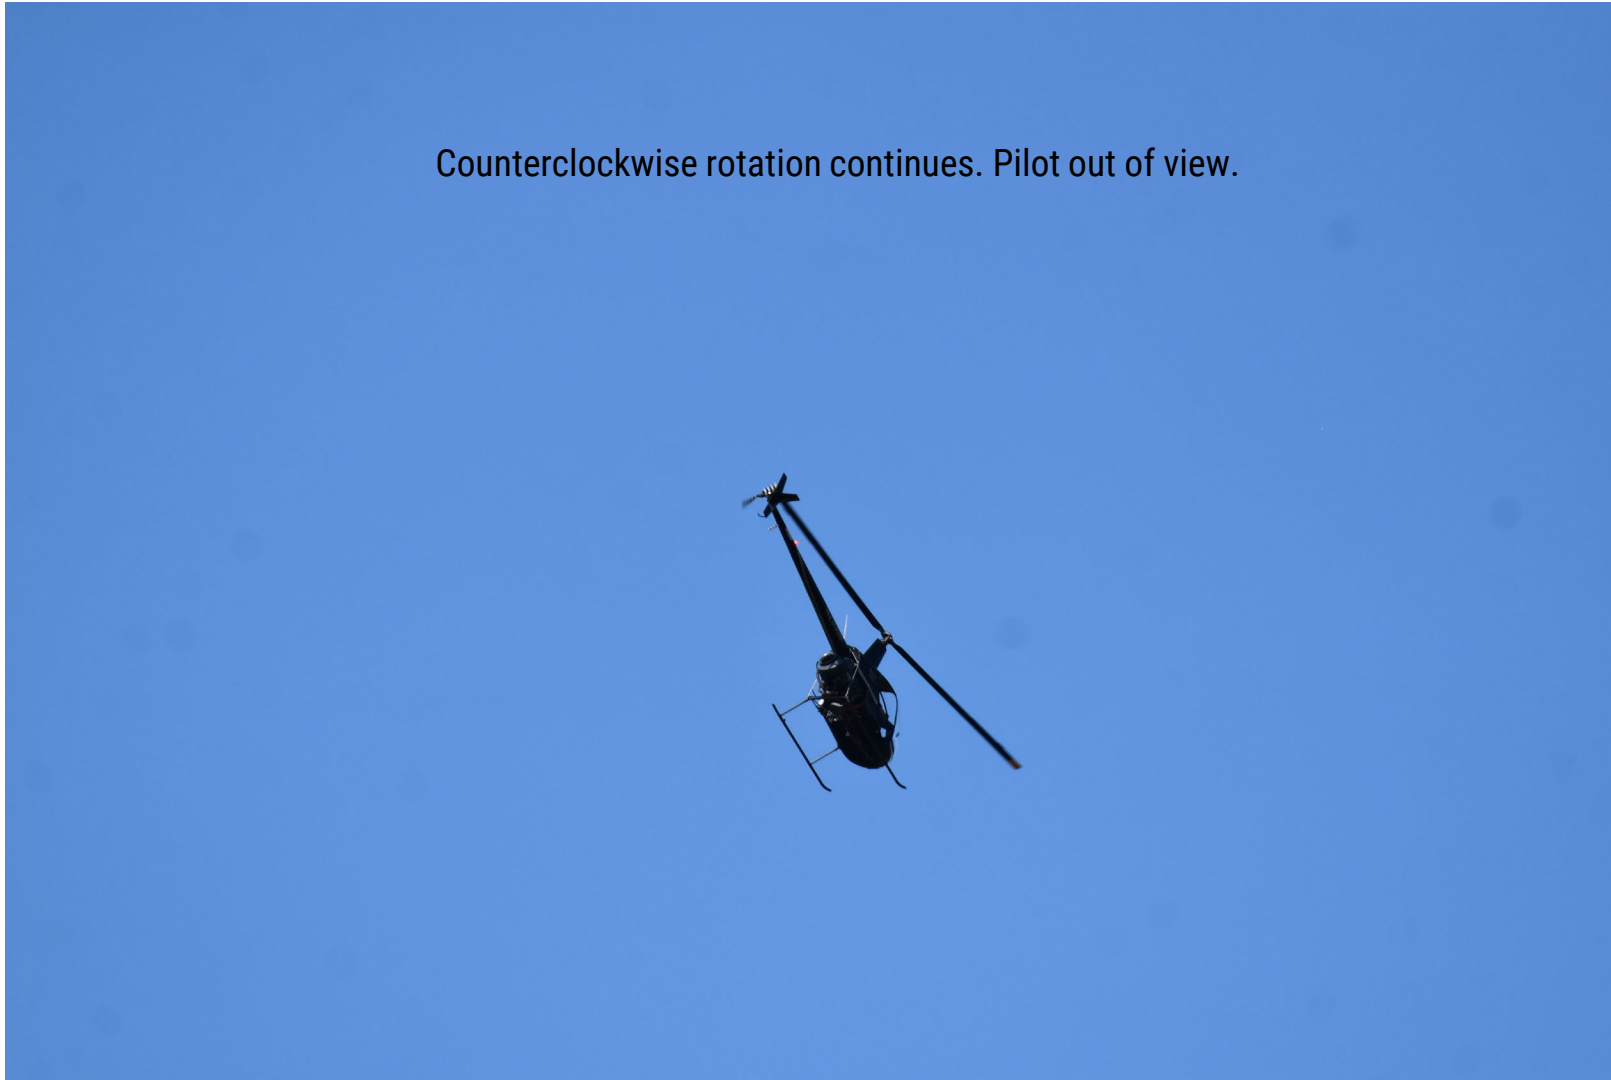
## Photograph No. 8 (0385)

Counterclockwise rotation continues. Pilot out of view.

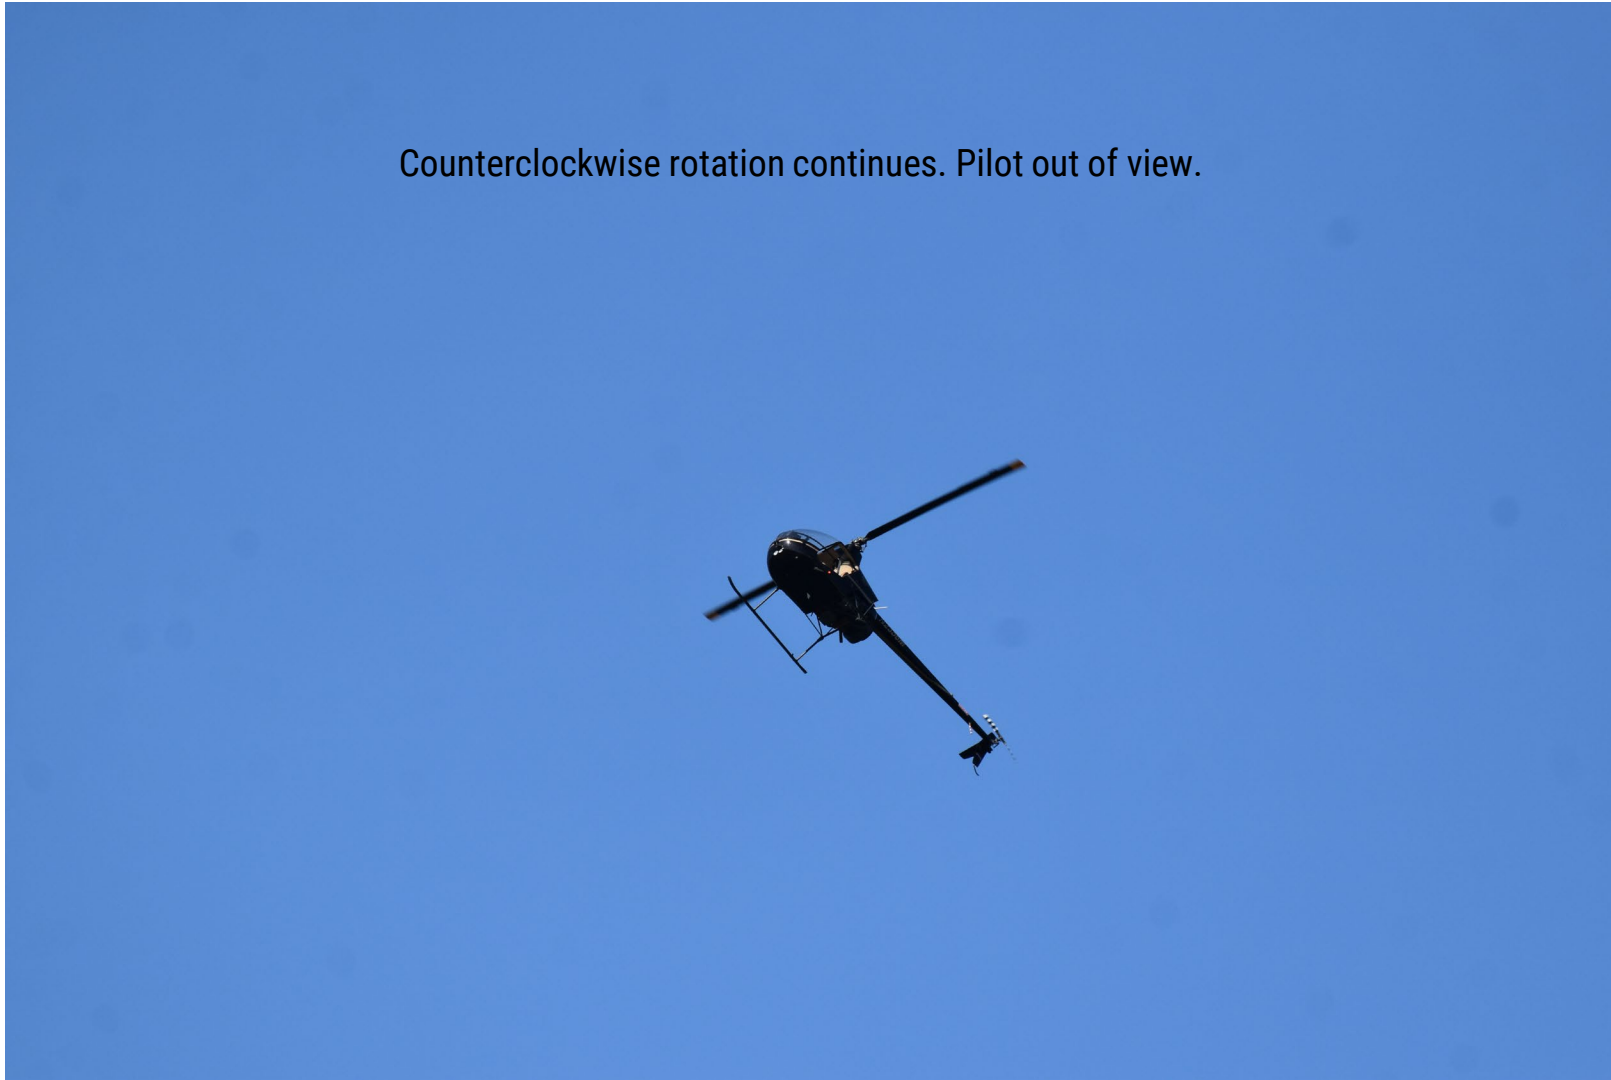
## Photograph No. 10 (0387)

Counterclockwise rotation continues. Pilot out of view.

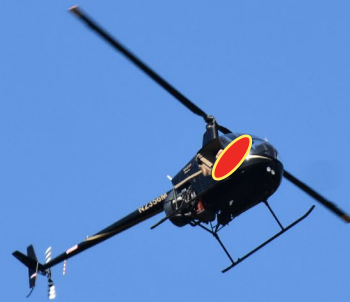
## Photograph No. 11 (0388)

Counterclockwise rotation continues. Pilot bent fully forward with head nearly on the windscreen and right arm pulled back towards his chest. Both sides of headset earpieces are around his neck. Pilot is redacted with red oval.

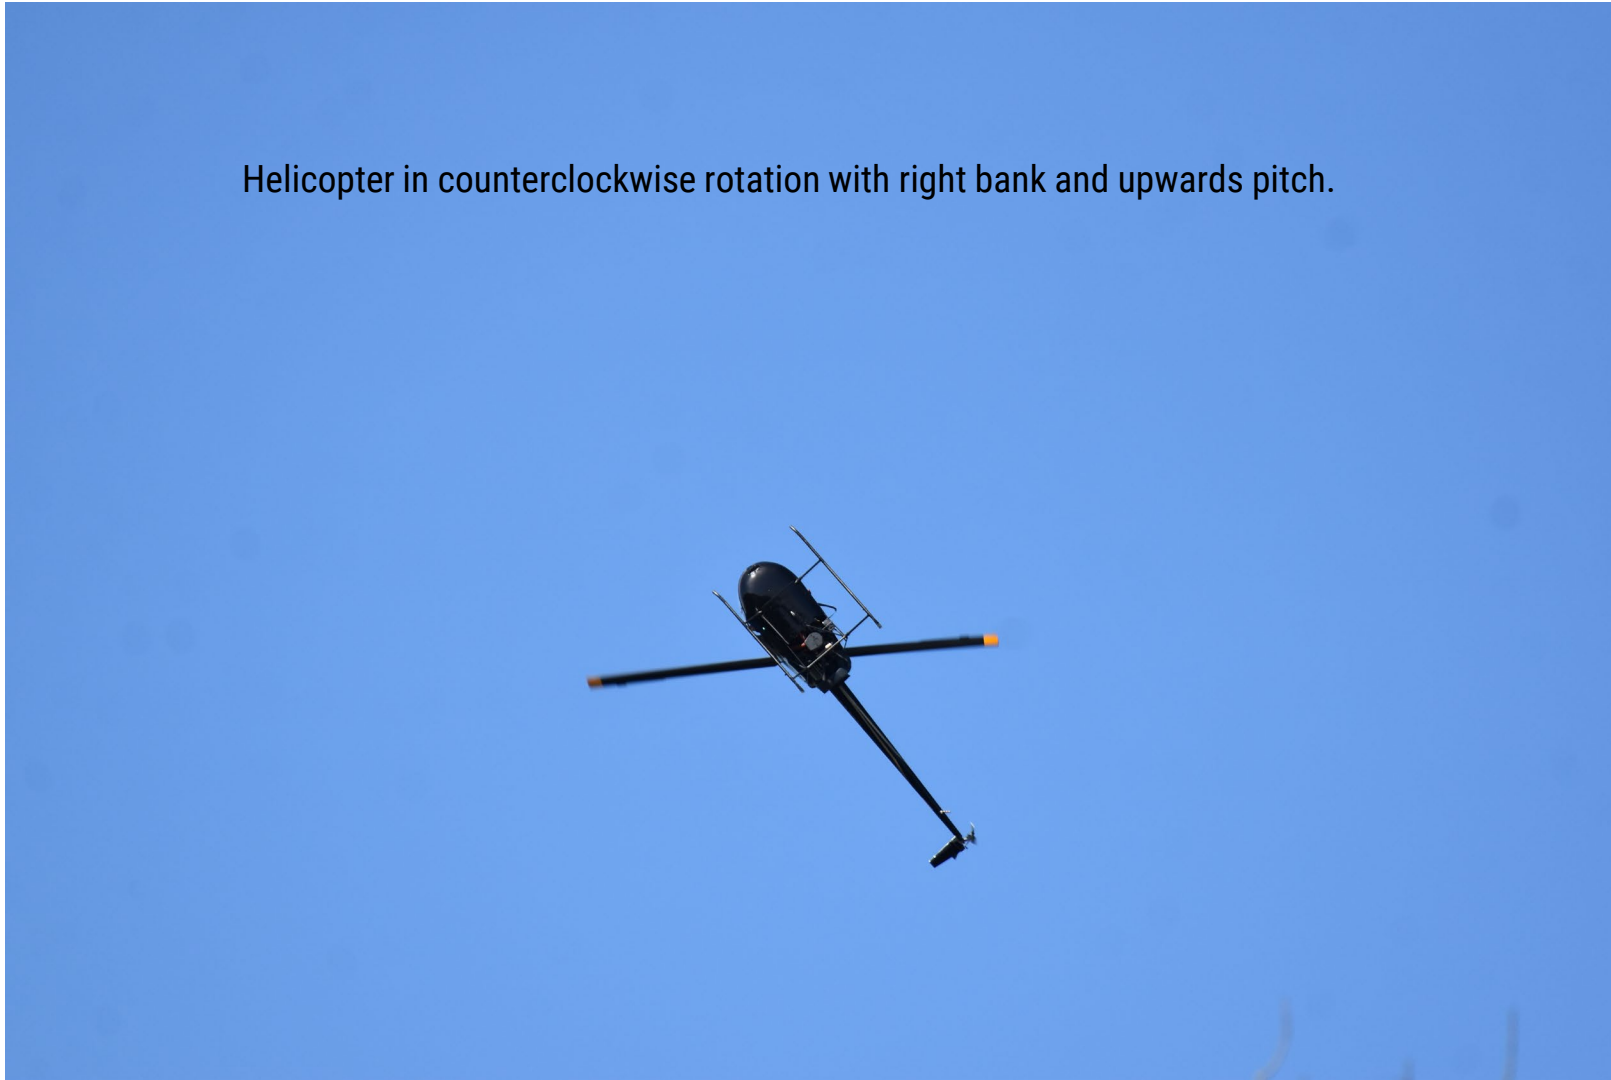
## Photograph No. 14 (0391)

Helicopter in counterclockwise rotation with right bank and upwards pitch.

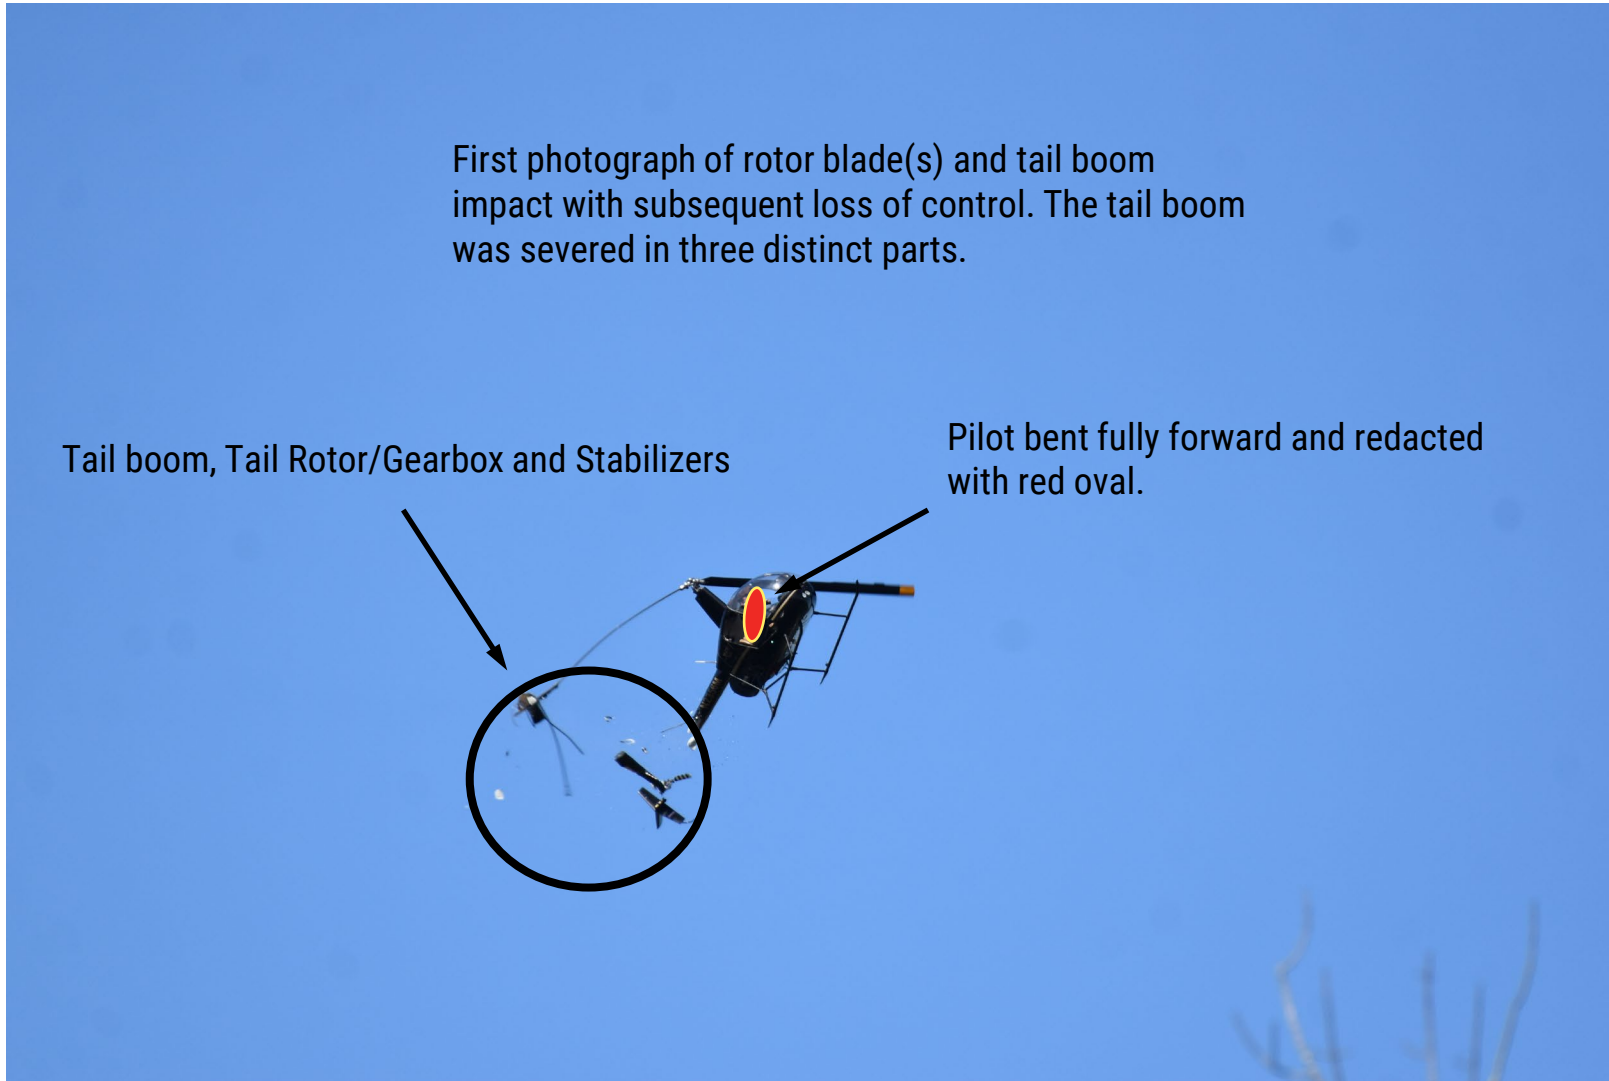
## Photograph No. 15 (0392)

First photograph of rotor blade(s) and tail boom impact with subsequent loss of control. The tail boom was severed in three distinct parts.

Tail boom, Tail Rotor/Gearbox and Stabilizers

Pilot bent fully forward and redacted with red oval.
