# National Transportation Safety Board

ERA23FA370

## **MAINTENANCE, WRECKAGE AND ENGINE EXAMINATION SUMMARY**

Location: Fitzgerald, Georgia  
Date: September 13, 2023  
Time: 1654 EDT  
2054 coordinated universal time (UTC)  
Airplane: N2796H, Engineering and Research Corp. 415-C

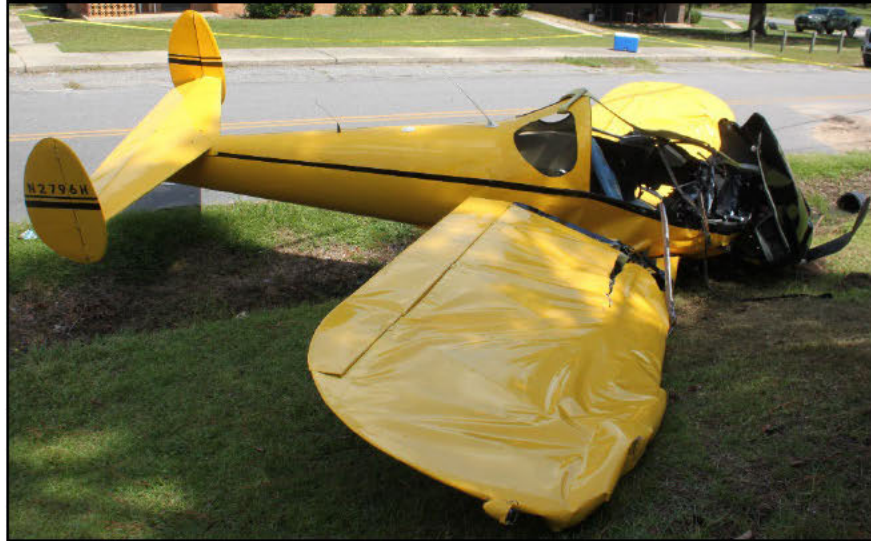
**Figure 8 Right Side View of the Wreckage At the Accident Site**

The airplane crashed in a residential area. The main wreckage was resting over a shallow ditch in front of a house while a portion of the aft empennage was located over the edge of the road (Figure 8). The main wreckage was located at 31.719532° North latitude and -083.244536° West longitude. That location when plotted was about 2.24 nautical miles and 038° from the approach end of runway 20. The airplane was oriented on a magnetic heading of 131°. There was no evidence of fire on any components. Fuel blight was noted to grass forward of the resting position of the ruptured right wing fuel tank. No fuel blight was noted to grass forward of the resting position of the left wing fuel tank.

The aft empennage was displaced and rotated to the right.

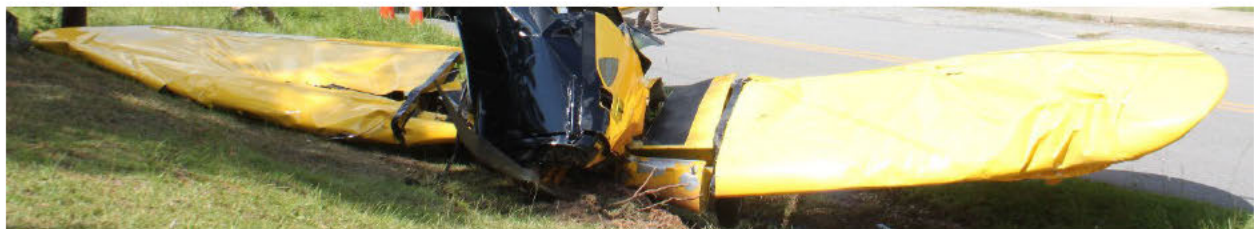
**Figure 9 View of the Left and Right Wings**

Both wings exhibited extensive impact damage (Figure 9).

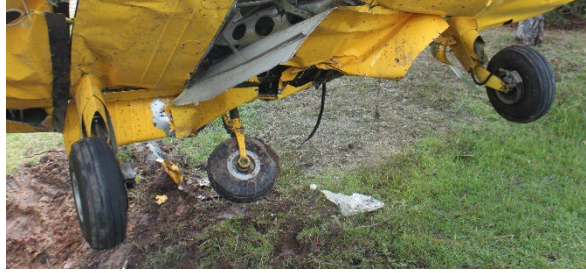
**Figure 10 View of the Landing Gears**

The nose landing gear was displaced aft while the main landing gears were in their relative positions (Figure 10).

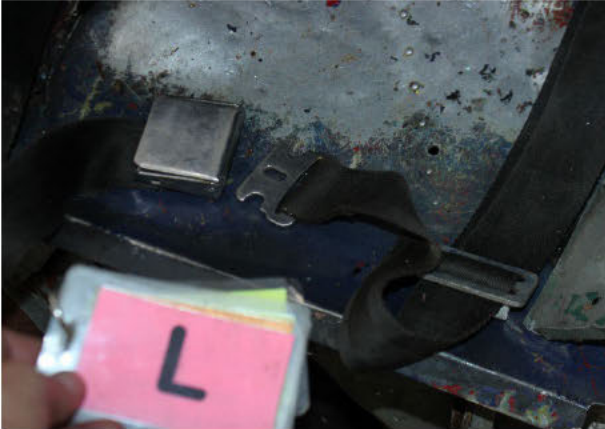
**Figure 11 Left Seat Lapbelt Assembly**

The airplane was equipped with only lapbelts (Figures 11 and 12). Inspection of both restraints revealed both were unlatched as first observed. The lift portion of the male buckle of the passenger seat exhibited a dent on top. There was no evidence of stretching of the webbing of either lapbelt consistent with non-use. Both buckles were tested and released easily.

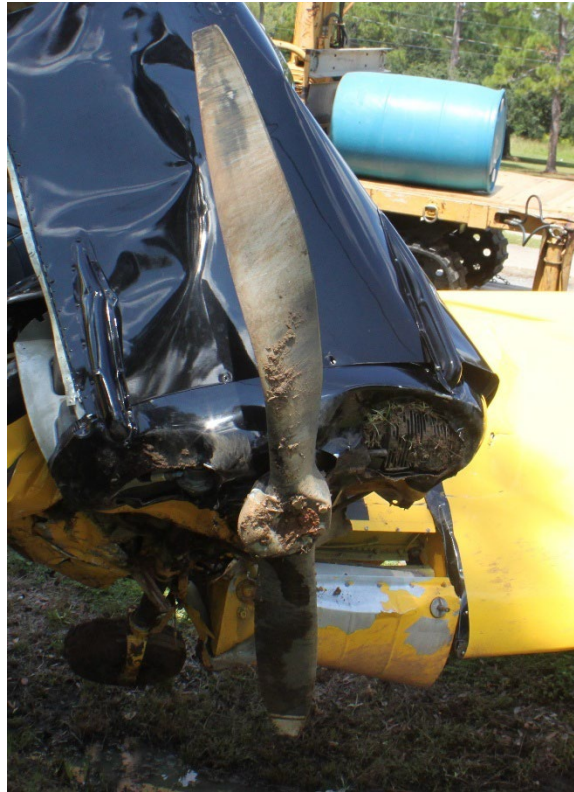
**Figure 13 View of the Propeller**

Examination of the propeller (Figure 13) revealed one blade exhibited a slight aft bend and full-span chordwise scratches on the cambered side of the blade. The other blade was bent aft about 45° and also exhibited full-span chordwise scratches on the cambered side of the blade. Nicks were noted on the leading edges of both blades.
