# National Transportation Safety Board

ERA23FA380

## **AIRFRAME AND ENGINE EXAMINATION**

N3079M, Piper PA-28-161

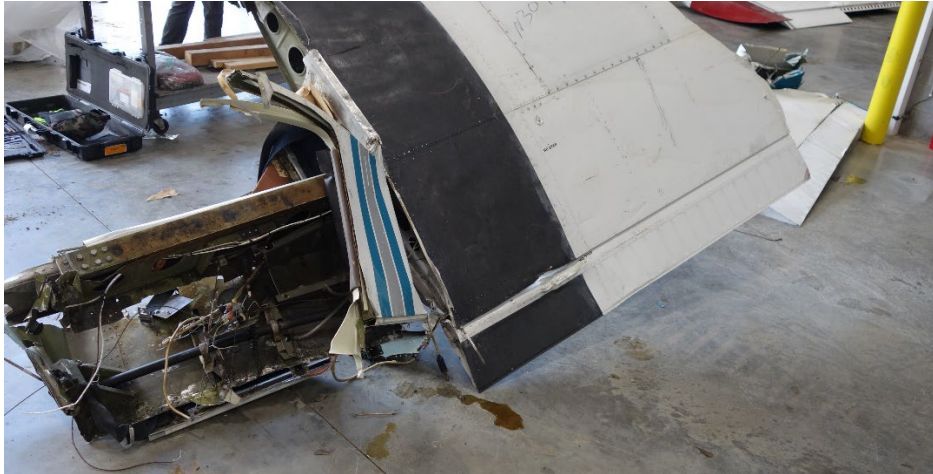
The right wing was cut for recovery. The aileron and flap remained attached to the wing by their hinges. The aileron cables were continuous to the wing root. The aileron cables remained attached to the bellcrank and the bellcrank remained attached to the wing.

**Photo 1 - View of inboard right wing (cut for recovery) and main spar. (Photo courtesy of Piper Aircraft)**

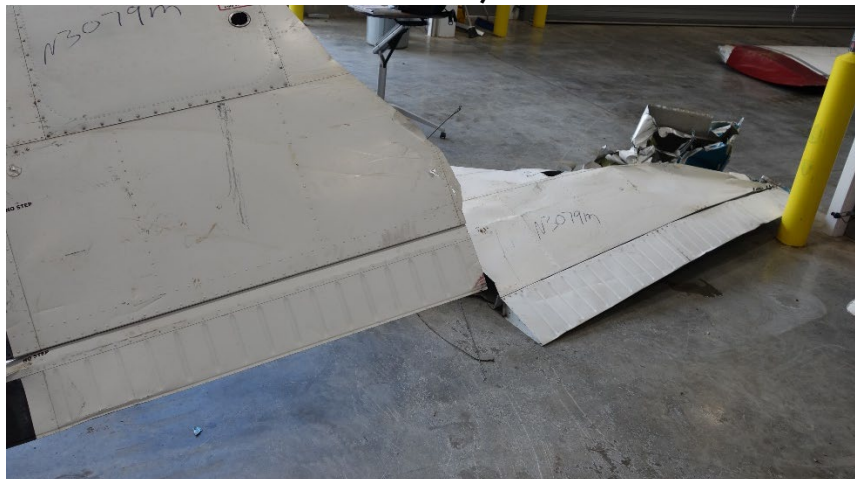
**Photo 2 - View of outboard right wing (cut for recovery). (Photo courtesy of Piper Aircraft)**

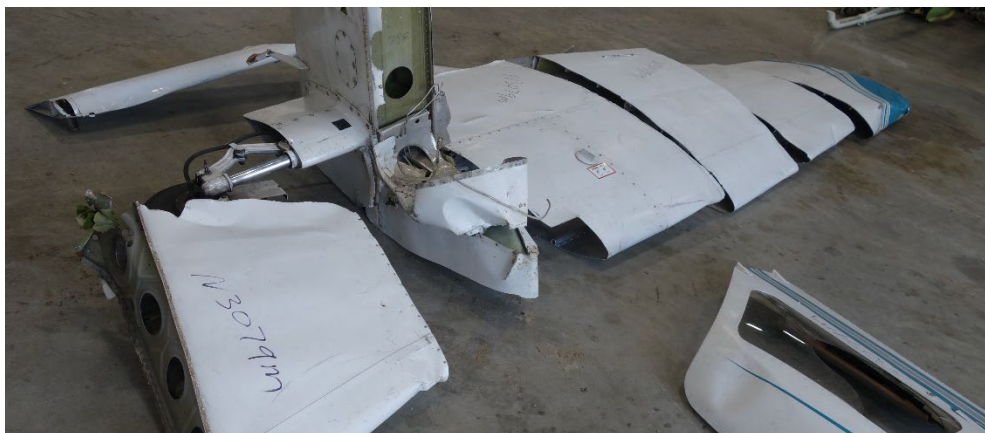
The left wing was cut for recovery. The aileron remained attached to the wing by its hinges and the flap was separated from the wing. The interior wing ribs exhibited signatures consistent with the aileron bellcrank having been pulled from its mount and drawn through the wing to the inboard end. The aileron bellcrank was broken with the balance cable arm remaining attached to the balance cable. The balance cable was continuous to the right wing. The remainder of the bellcrank was not located. The pitot mast and lift detector remained attached to their respective mounts.

**Photo 3 - View of left wing and cockpit door (cut for recovery). (Photo courtesy of Piper Aircraft)**

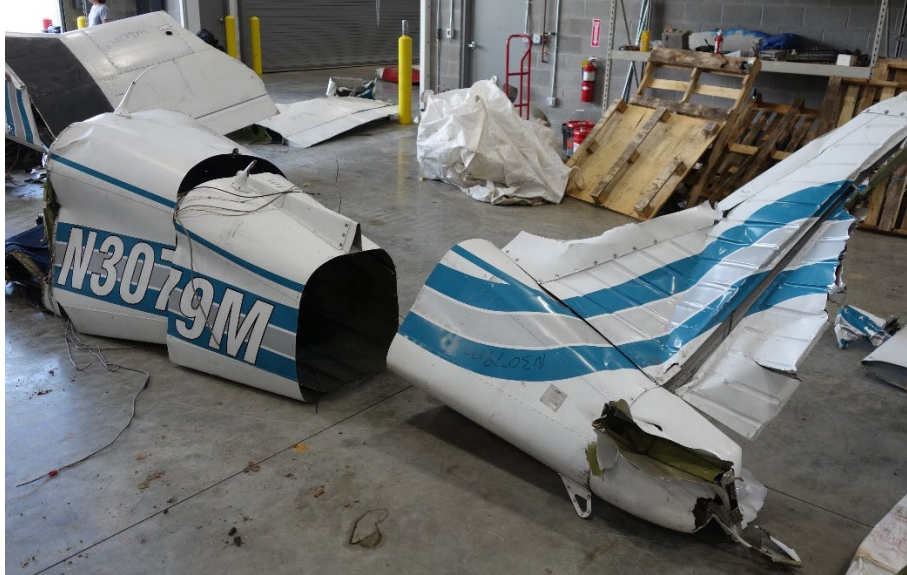
The vertical stabilizer remained attached to the tailcone. The rudder was impact damaged and torn diagonally from top to bottom with the lower portion of remaining attached to the vertical stabilizer and the upper portion separated.

**Photo 4 - View of aft fuselage and empennage. (Photo courtesy of Piper Aircraft)**

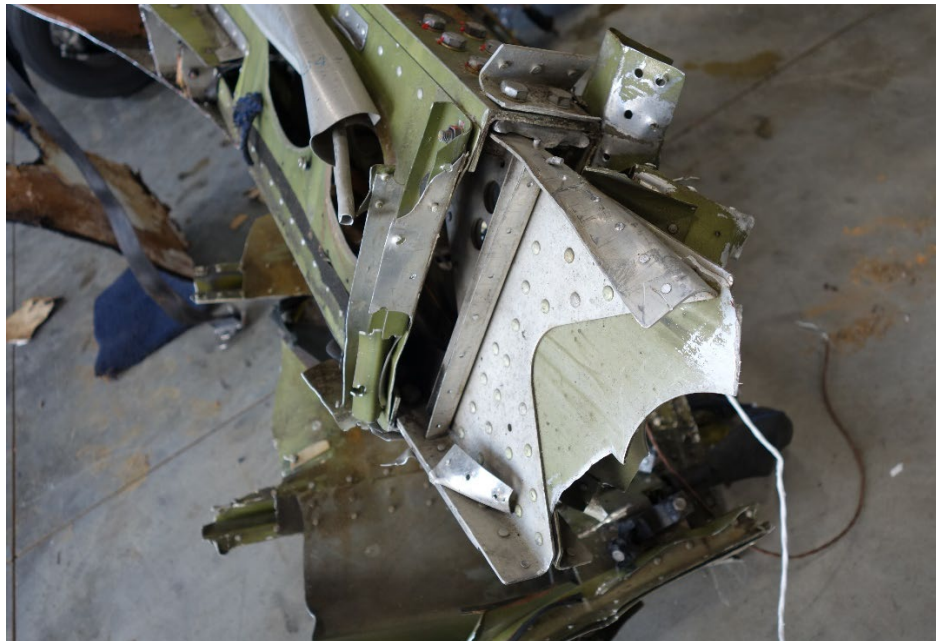
**Photo 5 - View of fractured main wing spar. (Photo courtesy of Piper Aircraft)**

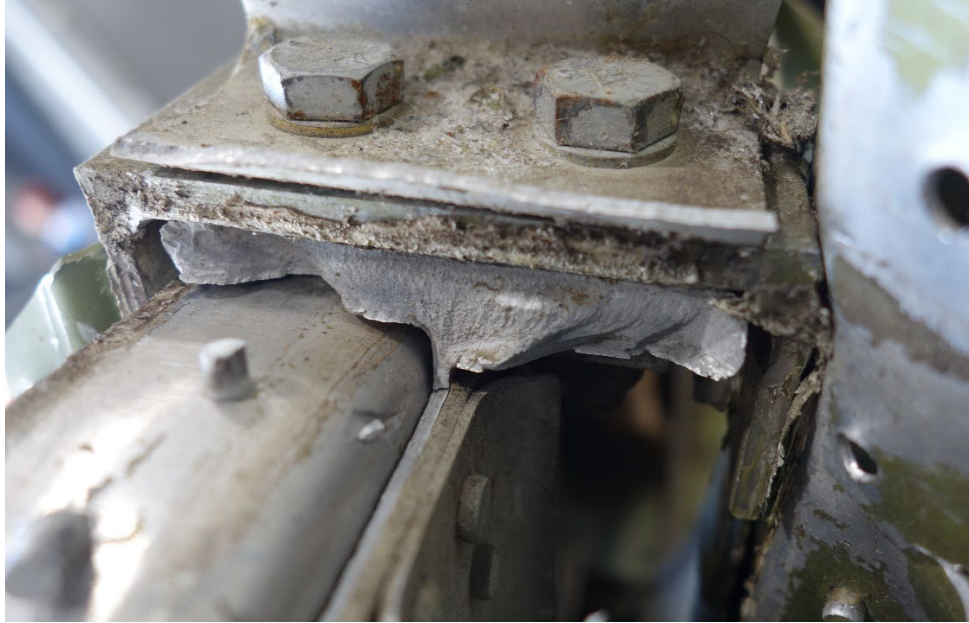
**Photo 6 - Close-up view of fractured wing spar. (Photo courtesy of Piper Aircraft)**

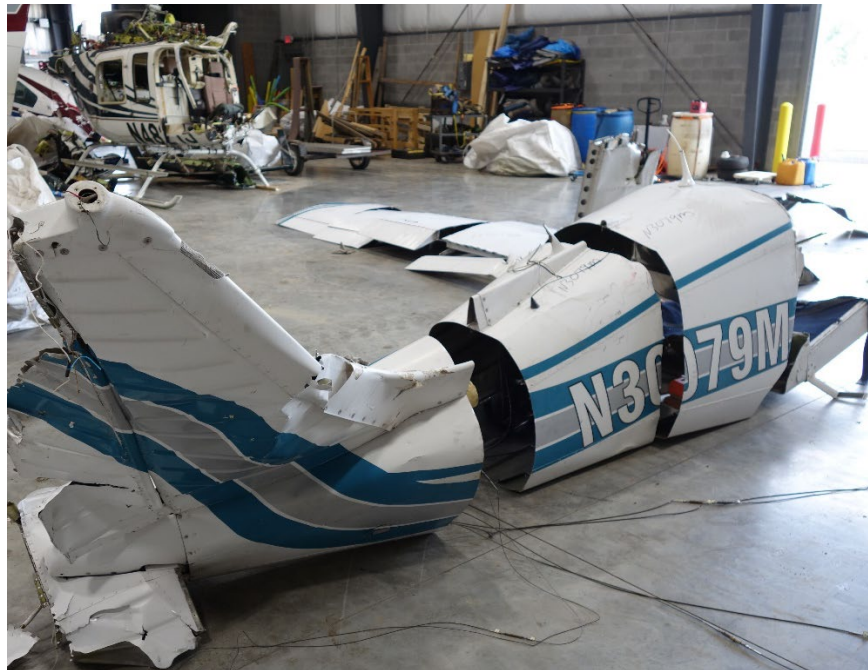
**Photo 7 - View of empennage and aft fuselage (cut for recovery). (Photo courtesy of Piper Aircraft)**

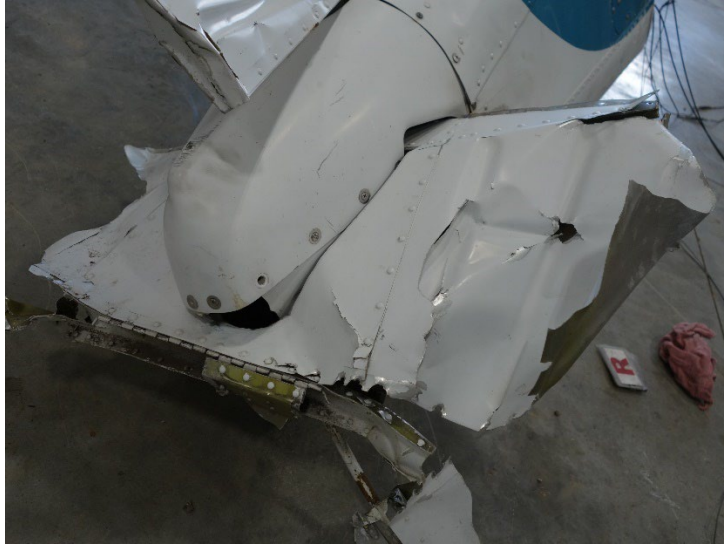
The stabilator was torn chordwise just outboard of the hinges. The left side of the stabilator was not located.

**Photo 8 - View of fractured stabilator on tail cone. (Photo courtesy of Piper Aircraft)**

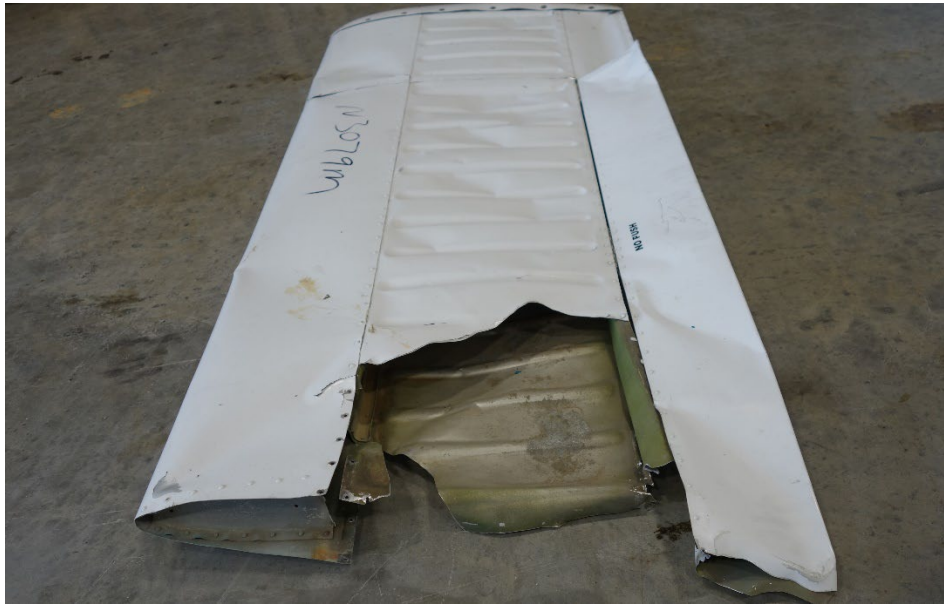
**Photo 9 - View of right side of fractured stabilator. (Photo courtesy of Piper Aircraft)**

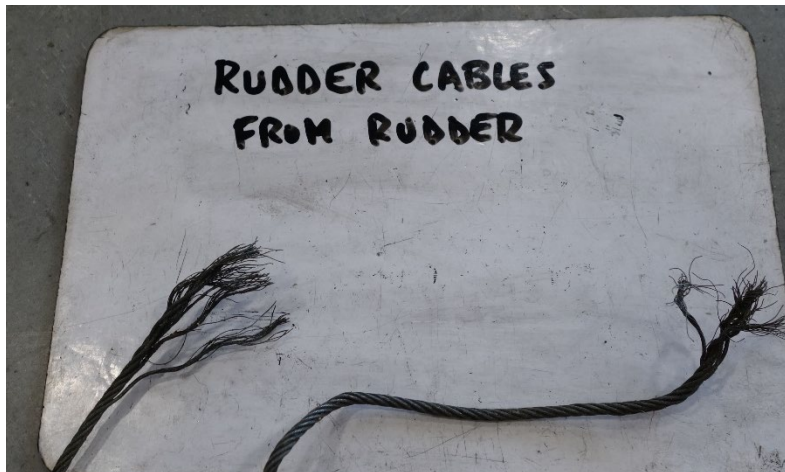
**Photo 10 - View of broom-strawed rudder cables. (Photo courtesy of Piper Aircraft)**

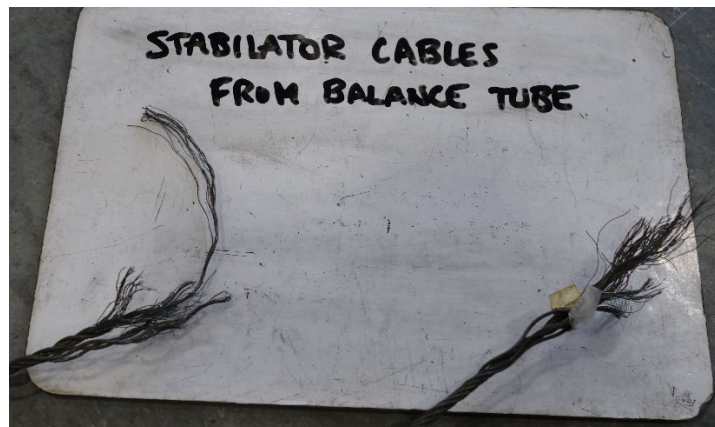
**Photo 11- View of broom-strawed stabilator cables from balance tube. (Phot Courtesy of Piper Aircraft)**

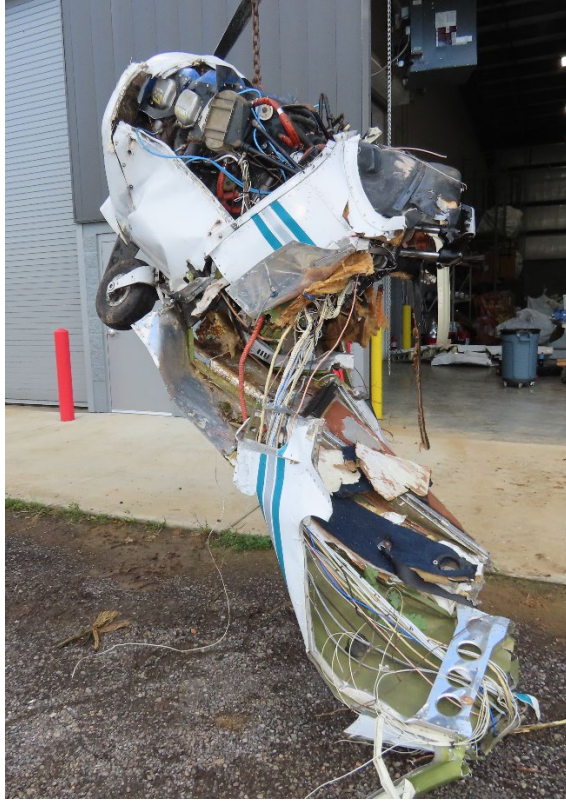
**Photo 12 - View of hoisted engine section with forward cockpit and lower fuselage. (Photo courtesy of Lycoming Engines)**

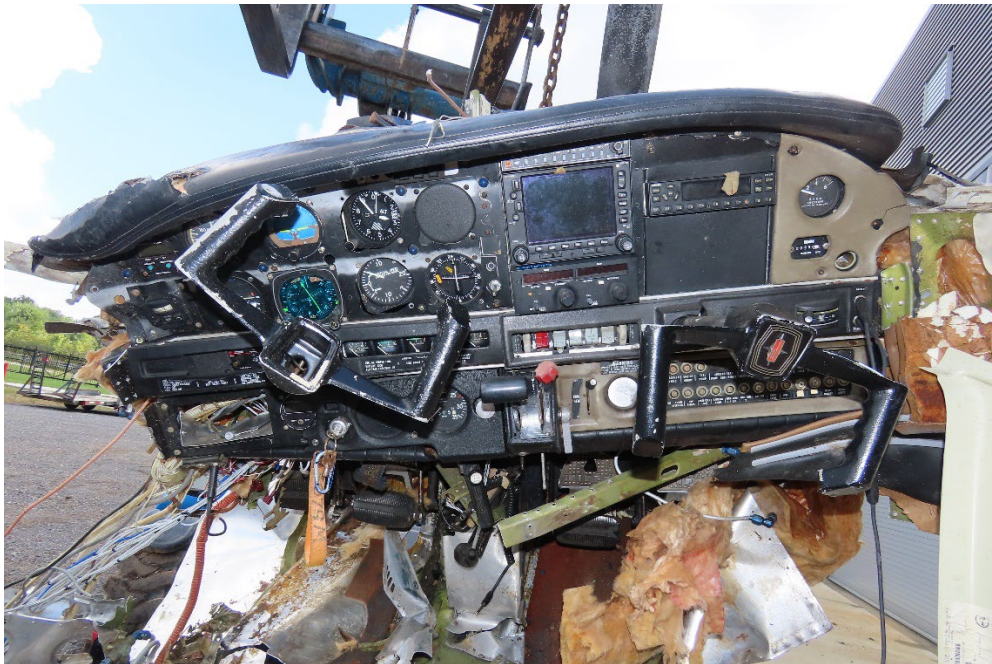
**Photo 13 - View of hoisted engine and attached cockpit panel. (Photo courtesy of Lycoming Engines)**

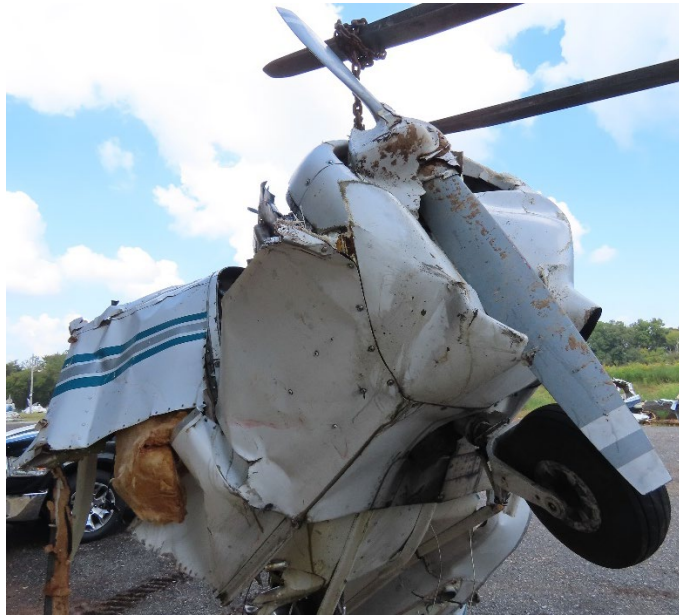
The engine was impact bent to the right with corresponding bends to the engine mount. The engine was cut from the fuselage section and engine mount to conduct an engine examination.

**Photo 14 - View of hoisted engine and propeller before examination. (Photo courtesy of Lycoming Engines)**

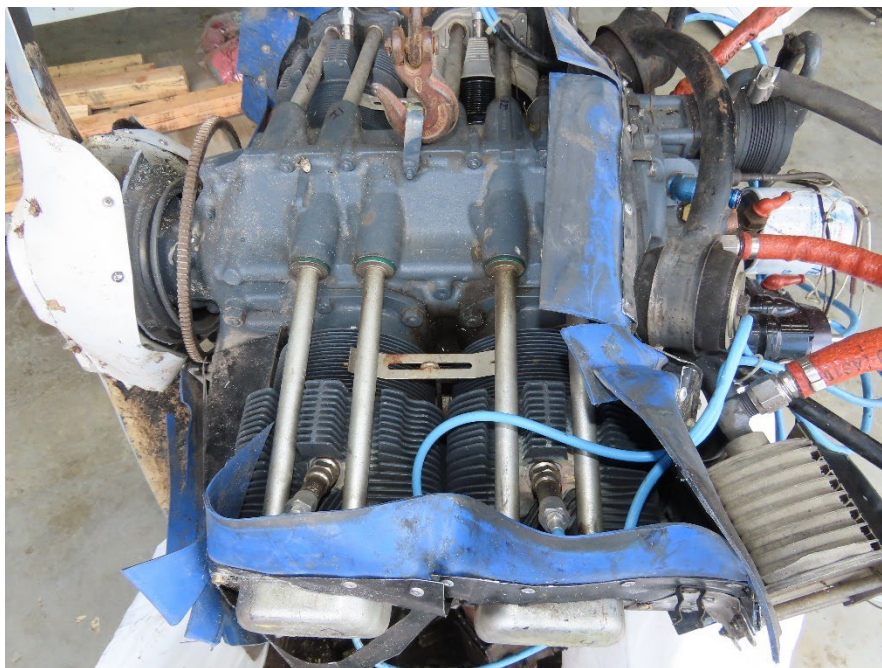
**Photo 15 - Engine as viewed from above. (Photo courtesy of Lycoming Engines)**

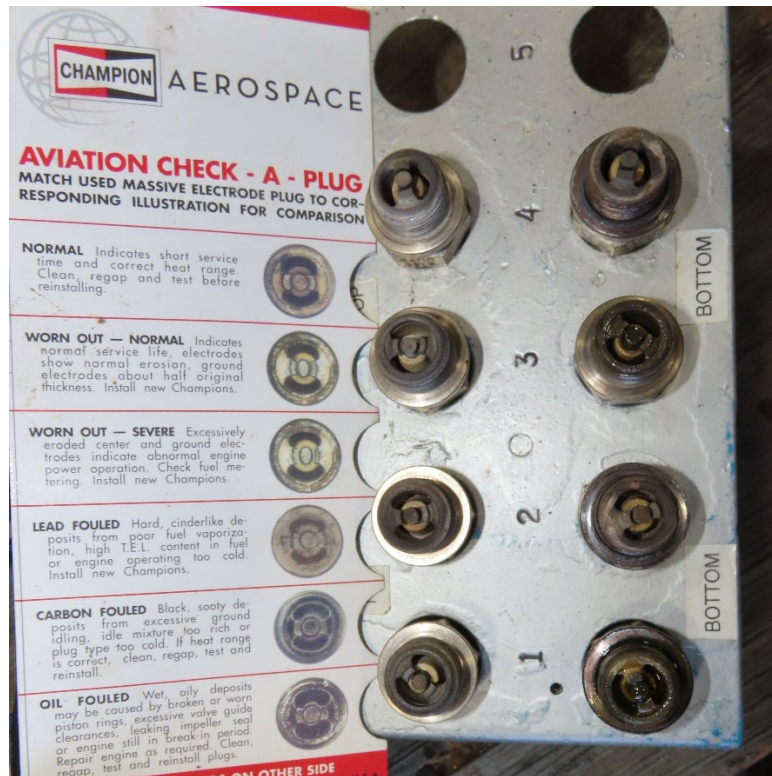
No oil was observed leaking from the engine and no holes or fractures to the engine case were observed. All valve covers were present and tightly installed on each cylinder. All sparkplugs were present and undamaged on each cylinder. The plugs showed normal coloration and wear patters when compared to a Champion Check-A-Plug chart.

**Photo 16 - Spark plugs (Photo courtesy of Lycoming Engines)**

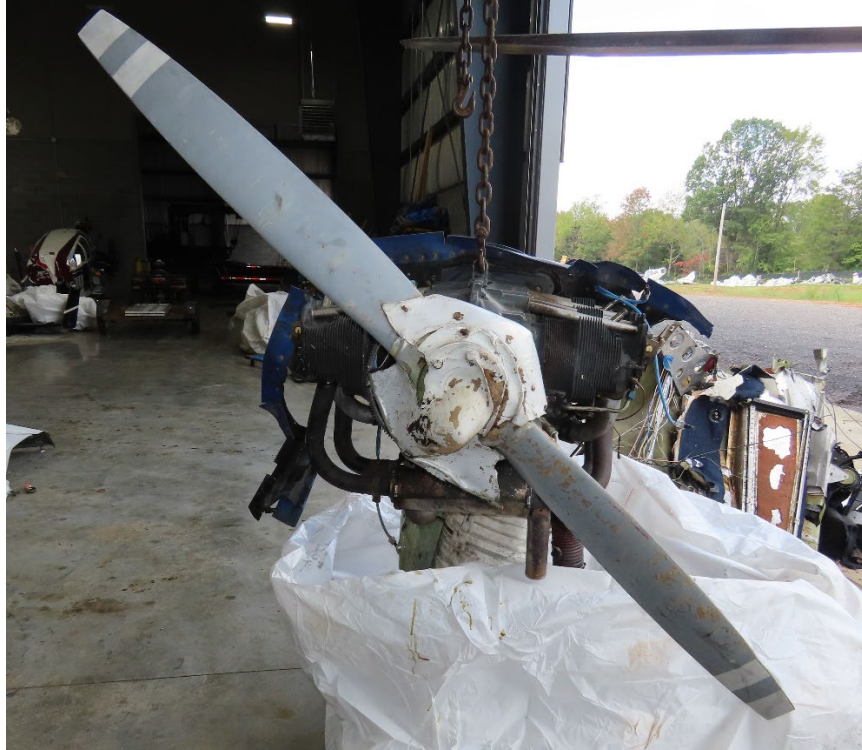
The 2-blade fixed pitch Sensenich propeller remained attached to the crankshaft flange and the two blades remained attached to the hub. The propeller spinner was impact molded around the propeller hub, showing impact molding of the bolts and safety wire underneath through the aluminum. Blade A showed wear to the leading edge towards the tip of the blade; however, no other damage noted to either side of the blade. Blade B showed minor rearward bending of the entire blade consistent with ground impact.

**Photo 17 - View of the propeller. (Photo courtesy of Lycoming Engines)**
