# National Transportation Safety Board

ERA23FA382

Location: Cullman, Alabama  
Date: September 29, 2023  
Time: 1200

Airplane: Smith Cozy Mark IV, N95SF

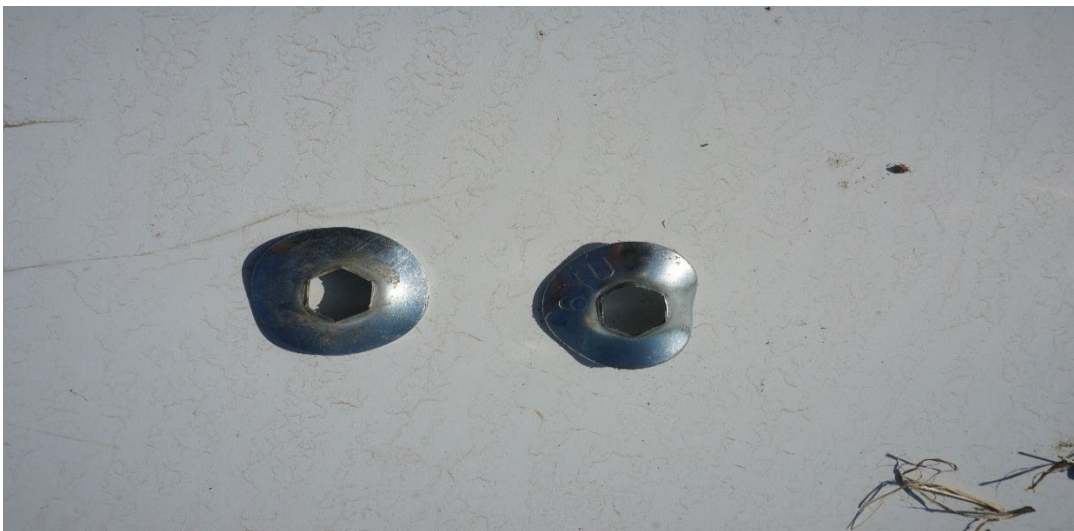
All four engine mount bolts and nuts were present and tight; however, the required bushings and large-area washers on the engine side of the mount were missing. Both upper engine vibration isolator bolts (truss mount to engine case) lacked the required washers beneath the nuts. The two lower bolts were severely bent and exhibited thin, non-aircraft grade washers with hex-shaped extrusion marks. These marks were consistent with the nuts bearing against the washers under load. Two of the non-standard washers were recovered within the engine cowling near the lower attachment points. (see photos)

Non-standard washers

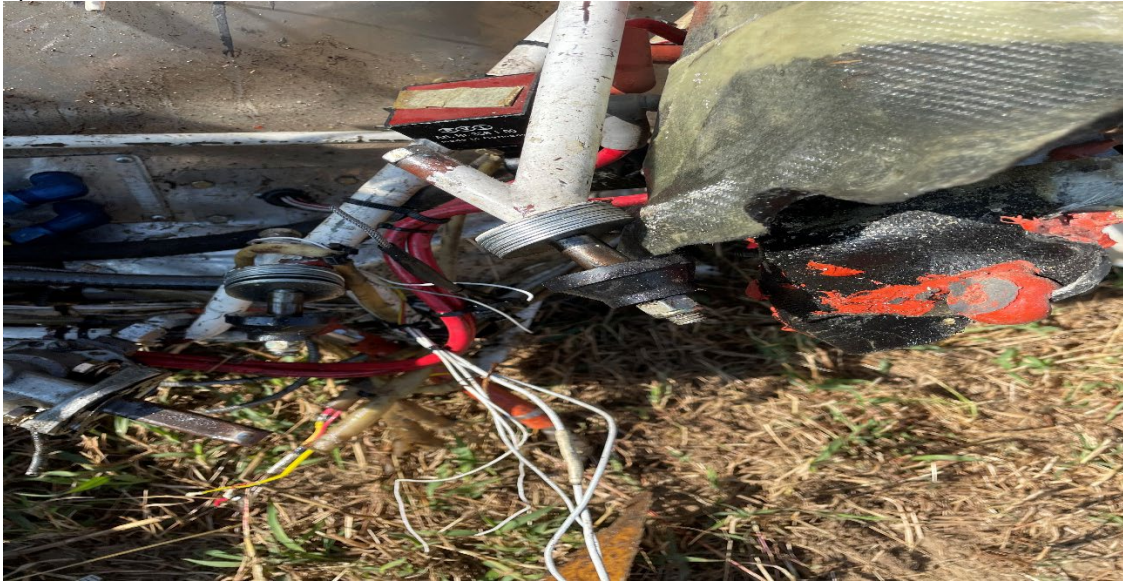
Engine Mount

The pusher configuration of the aft-mounted engine allowed all four engine mount bolts to remain in place. However, the upper two bolt/nut assemblies appeared to have pulled through their respective rubber vibration isolators. According to Lycoming, the hardware used for the engine mounting was not correct for this application. Several washers of varying sizes were located in the pilot's hangar, including one that appeared consistent with the correct type specified for the installation.
