ERA23FA382

## INVESTIGATION PHOTOGRAPHS

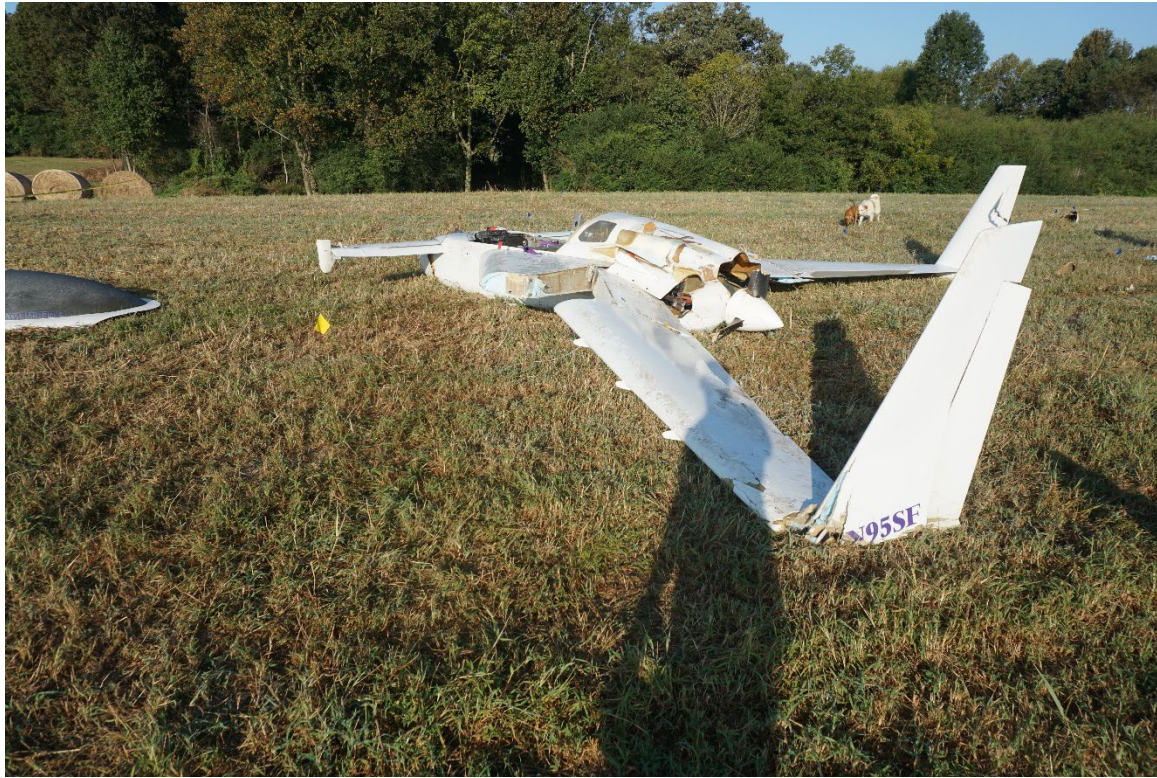
**Photograph 1 - Left side view of wreckage  
(Courtesy of NTSB)**

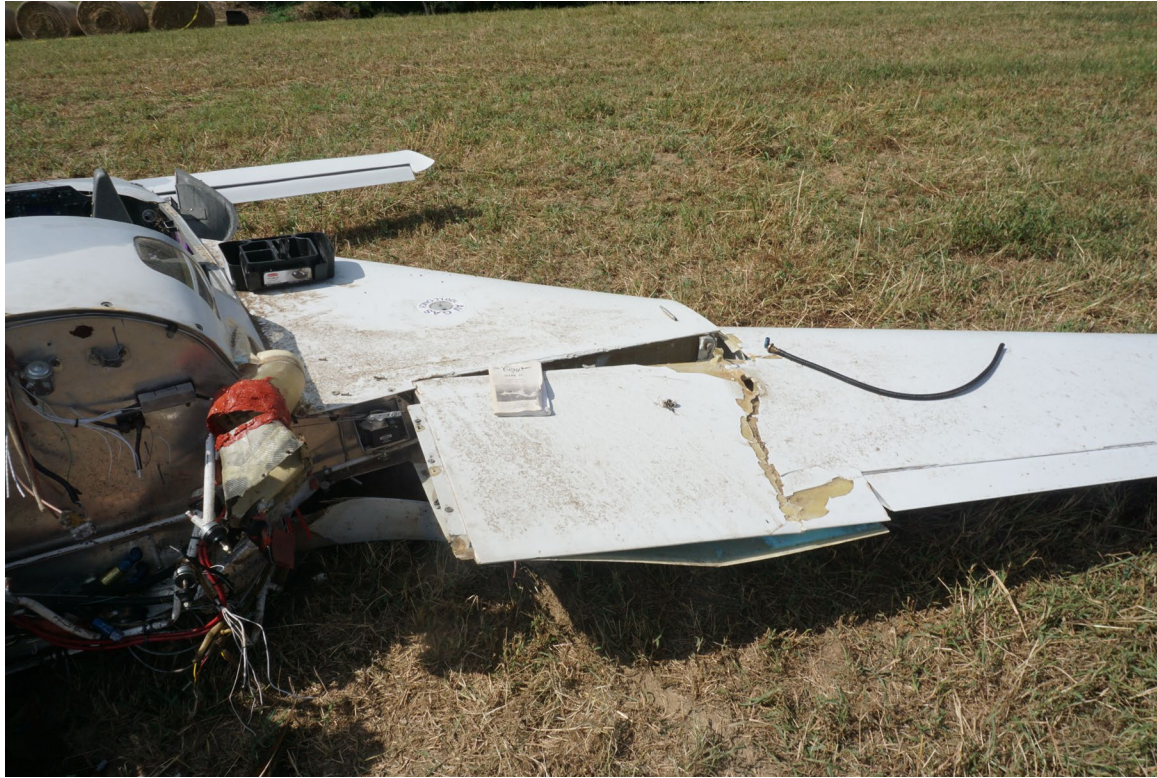
**Photograph 3 -Right side airplane wreckage  
(Courtesy of NTSB)**

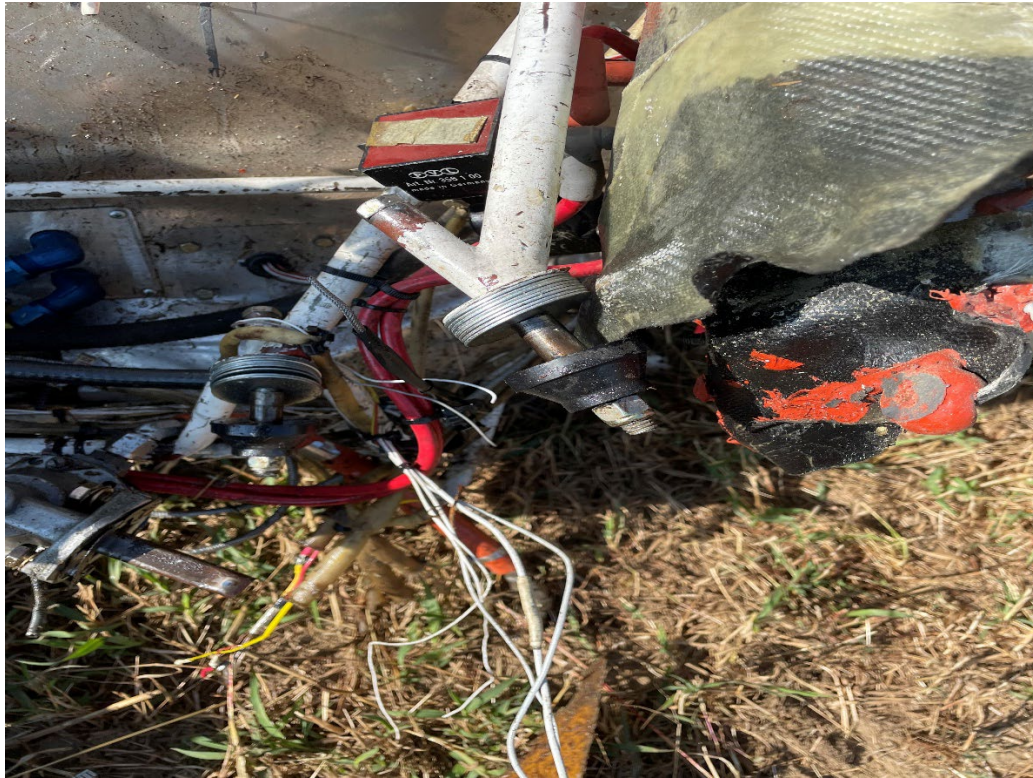
**Photograph 4 - Engine mounts with non-standard washers  
(Courtesy of NTSB)**

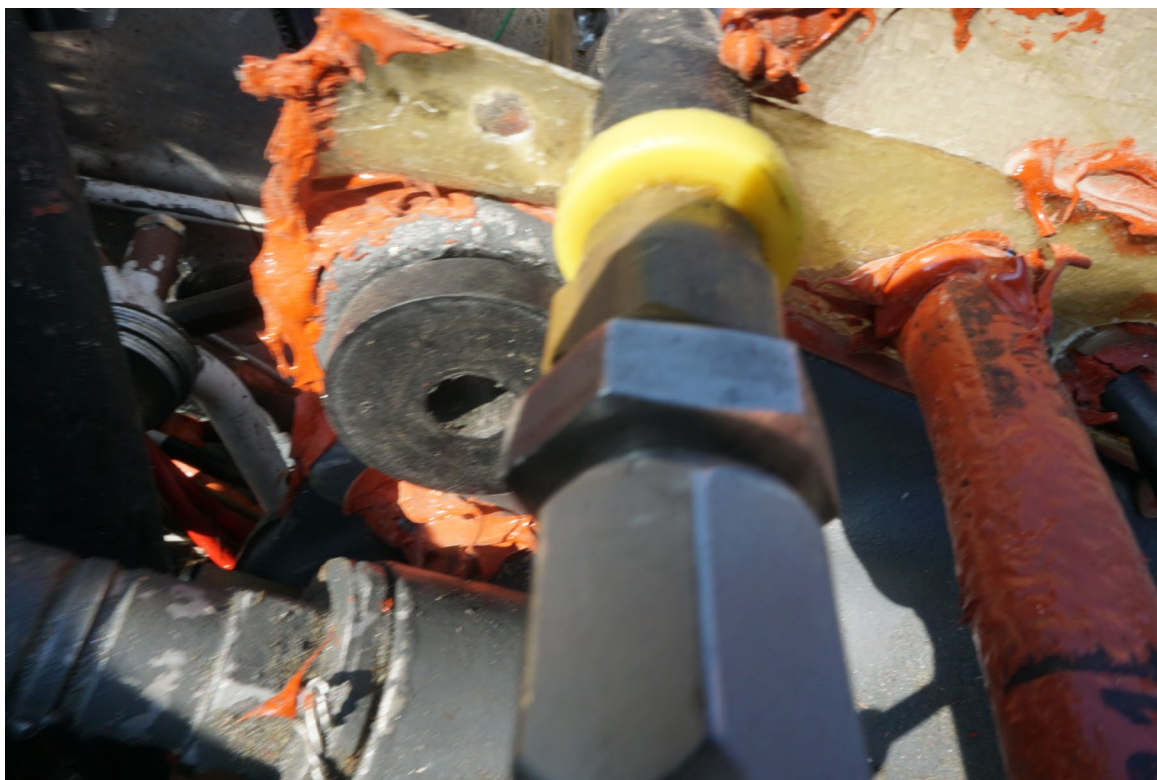
**Photograph 5 -Left engine upper bushing  
(Courtesy of NTSB)**

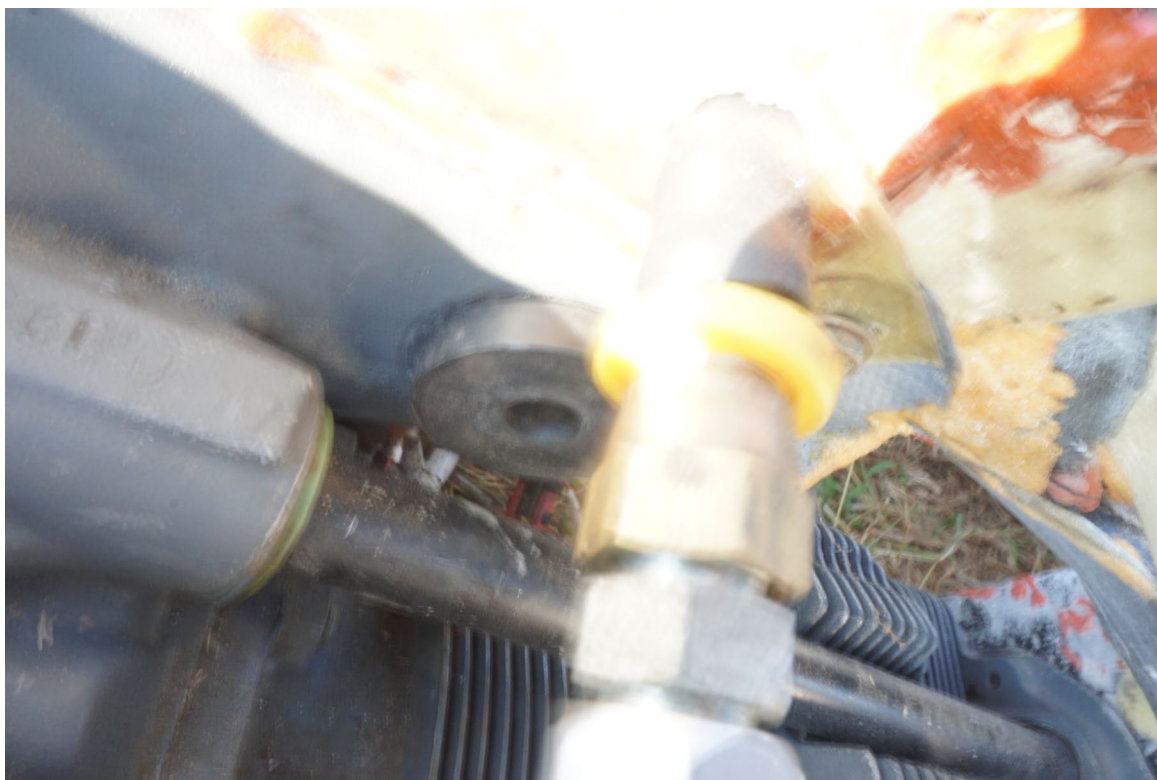
**Photograph 6 - Right engine upper bushing  
(Courtesy of NTSB)**

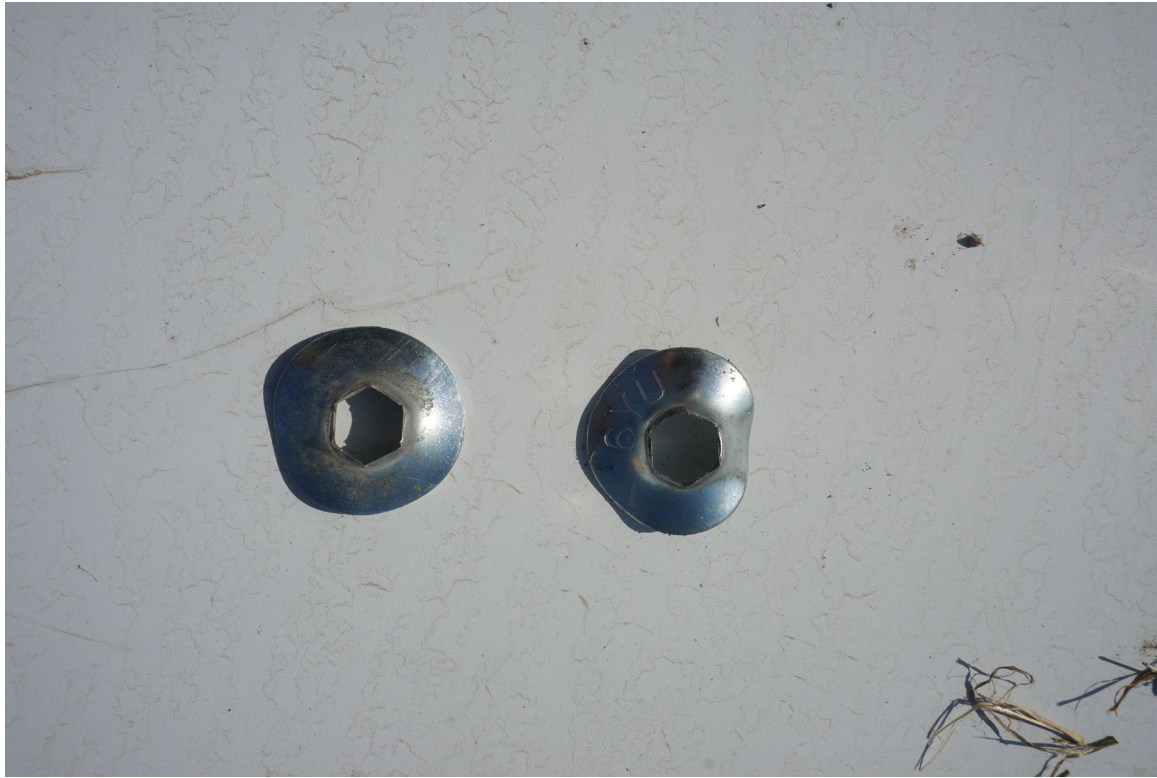
**Photograph 7 - Nonstandard upper engine mount washers  
(Courtesy of NTSB)**
