# National Transportation Safety Board

ERA23LA009

## ENGINE EXAMINATION SUMMARY

Location: Greensboro, North Carolina  
Date: October 6, 2022  
Time: 1621 EDT  
2021 coordinated universal time (UTC)  
Airplane: N655WP, Fisher Celebrity

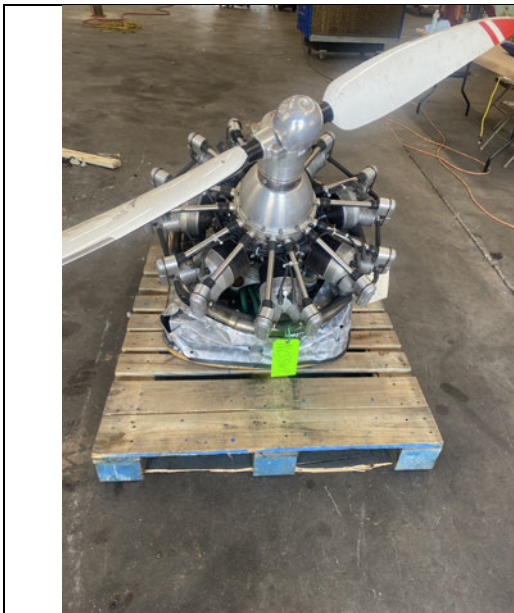
At the start of the examination the Rotec Aerosport R2800 (7 cylinder radial) engine with attached two-bladed Sensenich ground adjustable, carbon fiber propeller was on a pallet (Figure 3). The engine, which did not have a lifting eye was positioned normally and secured to a forklift for examination (Figure 4).

**Figure 3: Engine and Propeller**

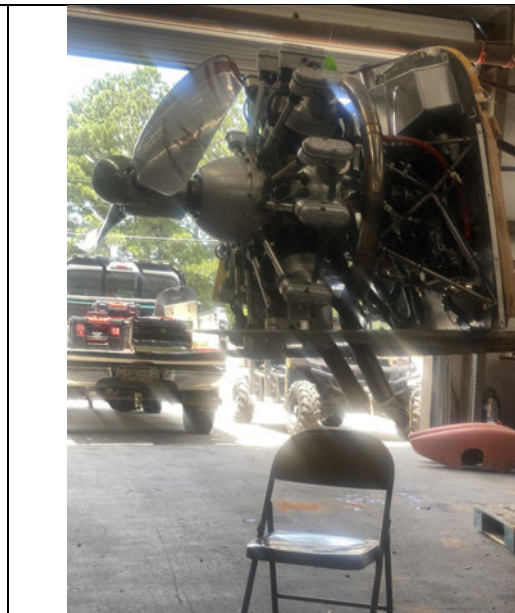
**Figure 4: Engine Assembly For Examination and Testing.**

The rocker box covers were removed and then 1 spark plug in each cylinder were removed. The propeller was rotated by hand and crankshaft and valve train continuity was confirmed. No compression was noted in the No. 5 cylinder. A compression gauge was installed into one spark plug hole of every cylinder and during hand rotation of the propeller the following readings were noted-

No. 5 - 0 psi. Air leakage was noted out the intake valve. The piston was moving. Valve train continuity was confirmed.

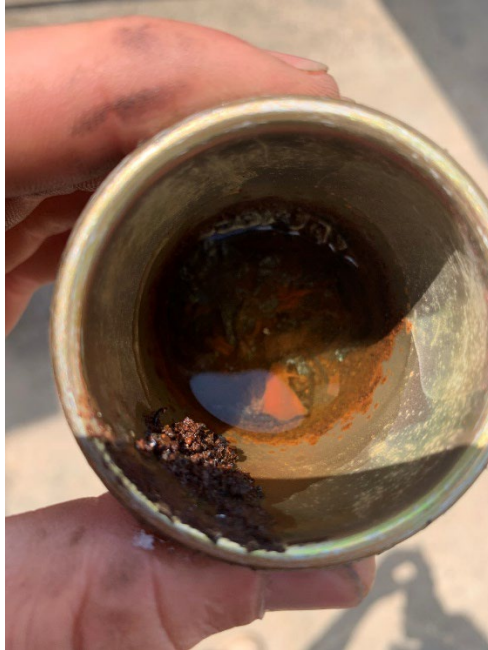
The engine-driven fuel pump was impact damaged from the engine, and the inlet and outlet hoses were also impact fractured. Examination of the inlet hose to the airframe fuel strainer revealed the hose was tightly secured at the strainer. The b-nut was carefully wiped down and the hose was drained into a clean container and found to contain about 1/4 ounce of fuel. The airframe fuel strainer contained rust (Figure 5). About 1 ounce of fuel was drained from the fuel strainer that was rusty/muddy in appearance. The screen was clean, and the fuel smelled like "old gas." The fuel shutoff valve which was closed, operationally checked satisfactory. The electrically operated fuel pump was electrically checked and operationally checked good. The fuel hose from the fuel strainer to the electric boost pump contained only a few drops of fuel. The inlet hose to the fuel pressure regulator was tight, and maybe 3 drops of fuel drained from the removed hose. The outlet hose of the fuel pressure regulator to the TBI was disconnected at the outlet of the fuel pressure regulator and no fuel came from the fuel hose. The inlet hose at the TBI was tight and the hose was removed and no fuel was present. The TBI inlet was clean, and the throttle and mixture control cables were connected at the TBI but were removed for the inspection. The fuel inlet screen at the TBI was examined and it contained some debris in the screen, but there was no evidence of red silicone. There was no fuel in the TBI. It should be noted that the last place fuel was present was the fuel strainer.

**Figure 5: Airframe Fuel Strainer**

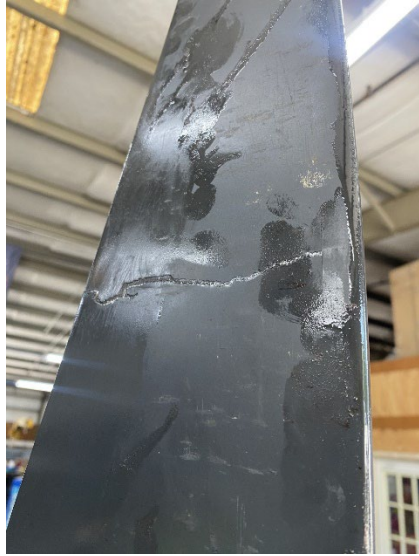
Examination of the propeller revealed nicks and dents on the leading edge of 1 blade, and the other blade had a chordwise tear (Figure 6).

**Figure 6: View of Chordwise Crack in One Propeller Blade.**
