# National Transportation Safety Board

ERA23LA009

## WRECKAGE EXAMINATION SUMMARY

Location: Greensboro, North Carolina  
Date: October 6, 2022  
Time: 1621 EDT  
2021 coordinated universal time (UTC)  
Airplane: N655WP, Fisher Celebrity

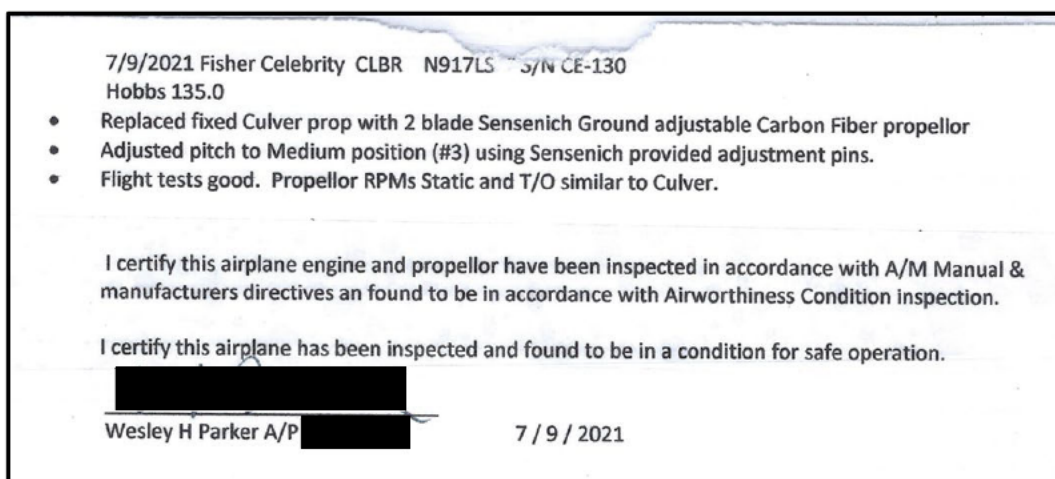
**Figure 2: Propeller Installation Entry.**

A review of the maintenance records revealed that on July 9, 2021, at hour meter reading 135.0<sup>3</sup>, the Culver Fixed Pitch propeller was removed and a Sensenich Ground-Adjustable Carbon Fiber propeller was installed by the pilot/owner/airframe and powerplant mechanic. The entry also indicated that the propeller pitch was adjusted to "...Medium position (#3) using Sensenich provided adjustment pins. Flight tests good. Propeller RPMs Static and T/O similar to Culver", Figure 2.

- Replaced fixed Culver prop with 2 blade Sensenich Ground adjustable Carbon Fiber propellor
- Adjusted pitch to Medium position (#3) using Sensenich provided adjustment pins.
- Flight tests good. Propellor RPMs Static and T/O similar to Culver.

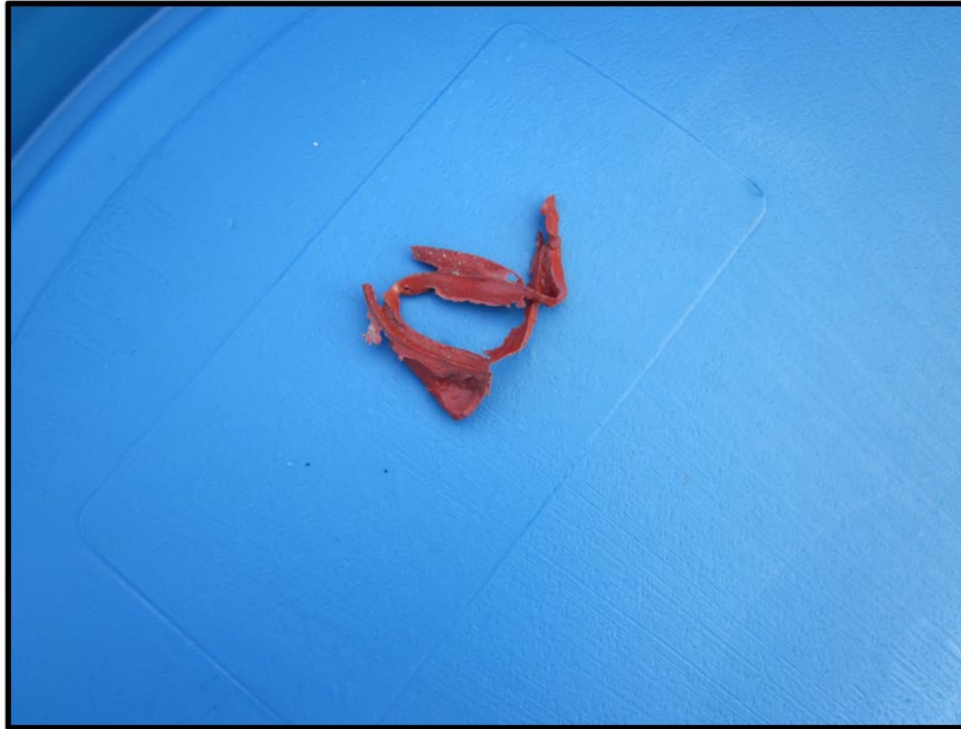
**Figure 3: View of Foreign Object Removed From Header Fuel Tank.**

FAA inspector Sarah Allen who was on-scene when the header fuel tank was removed and drained reported the fuel had a chemical smell, like "...lacquer thinner." She later asked the pilot whether he added any additives to the fuel and he reported to the inspector that he had used Marvel Mystery Oil® to the fuel but had not done that in "quite some time." During the header tank removal and draining process, visual inspection of the tank interior revealed a red/orange colored foreign object (Figure 3).

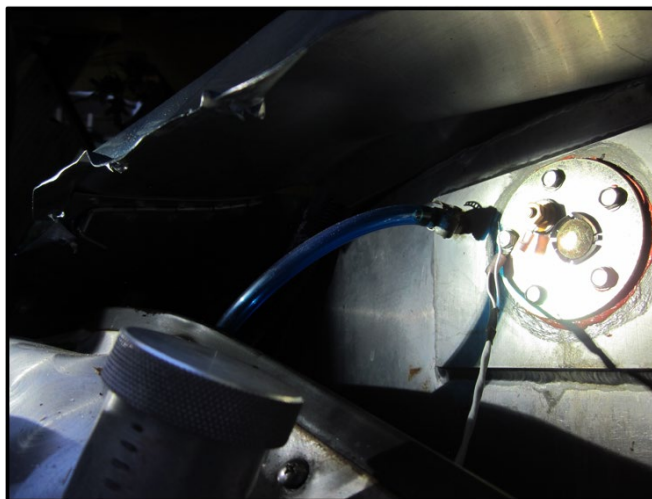
**Figure 4: View of the Fuel Sender Unit.**

Examination of the header fuel tank fuel sender revealed it was in-place and secured. The sender remained secured by all five bolts and partially electrically secured but one electrical wire was pulled from the terminal fitting (Figure 4). Red/orange colored sealant was noted extruded from the base on the sending unit.

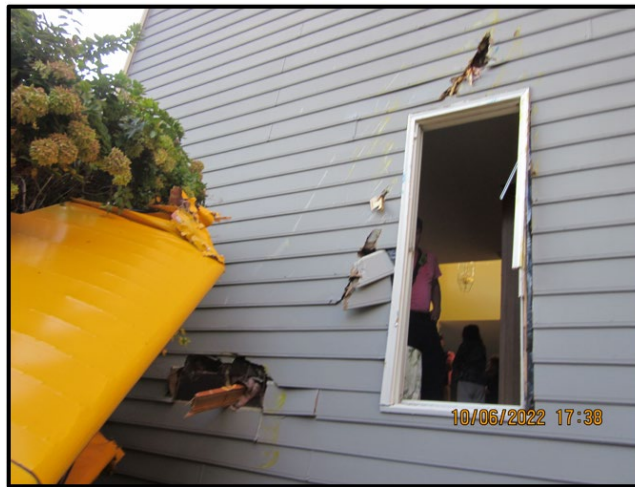
**Figure 5: View Showing Damage to House.**

Examination of the accident site (house in a residential area) was performed by an airworthiness inspector on October 6<sup>th</sup> and 7<sup>th</sup>, 2022. Initial examination of the impacted house revealed damage to one window and several areas of structure adjacent to the window (Figure 5). Additional damage to a portion of a fence, and air conditioner was noted. The left wings of the airplane were adjacent to the house with portions of wing spar embedded into the house (Figure 6).

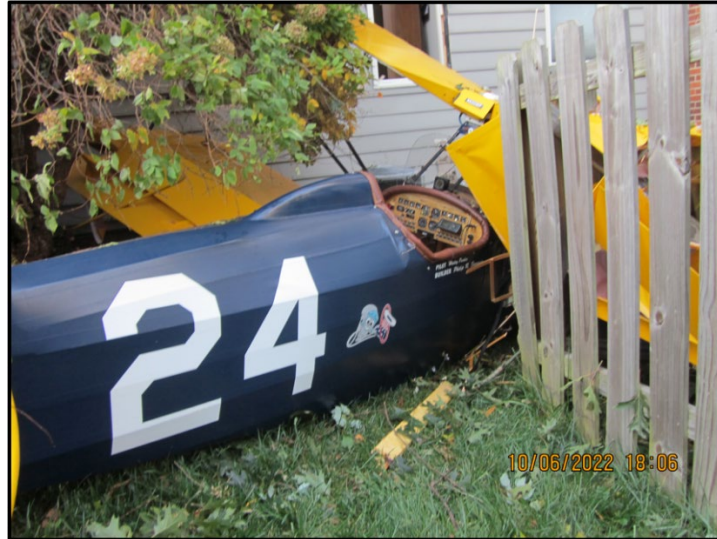
**Figure 7: Right Side View of Fuselage and Rear Cockpit.**

Examination of the fuselage in the rear seat cockpit area revealed minimal deformation (Figure 7).

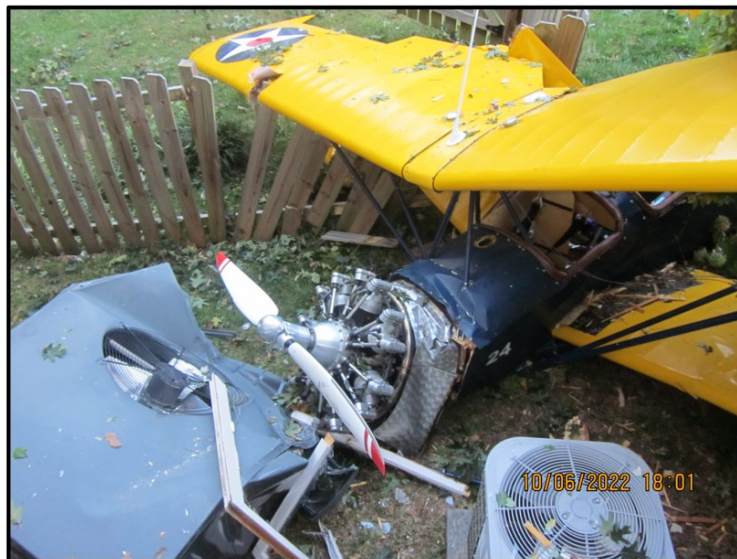
**Figure 8: Displaced Engine with Attached Propeller.**

Examination of the engine with attached propeller revealed displacement of the engine relative to their normal orientation (Figure 8).

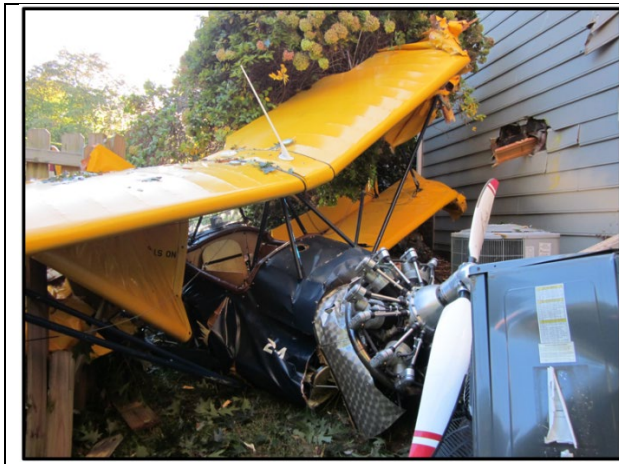
**Figure 9: Left Wings**

Both upper and lower wings associated with the left wing and both upper and lower wings associated with the right wing sustained structural damage (Figures 9 and 10).

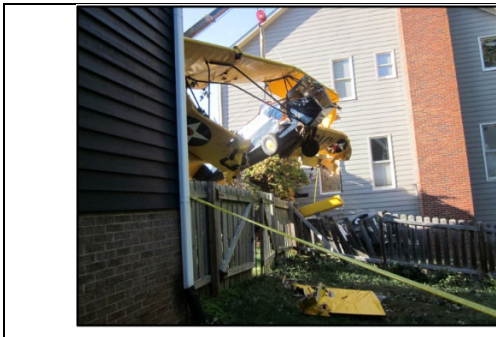
**Figure 11: Both Main Landing Gears**

Both main landing gears were displaced aft (Figure 11) while the tailwheel appeared undamaged (Figure 12).
