# National Transportation Safety Board

ERA23LA011

## **COCKPIT DISPLAY**

Location: Fort Myers, FL  
Date: October 8, 2022  
Time: 18:00 eastern daylight time (EDT)  
Helicopter: Bell Textron Canada LTD 505, N5DF

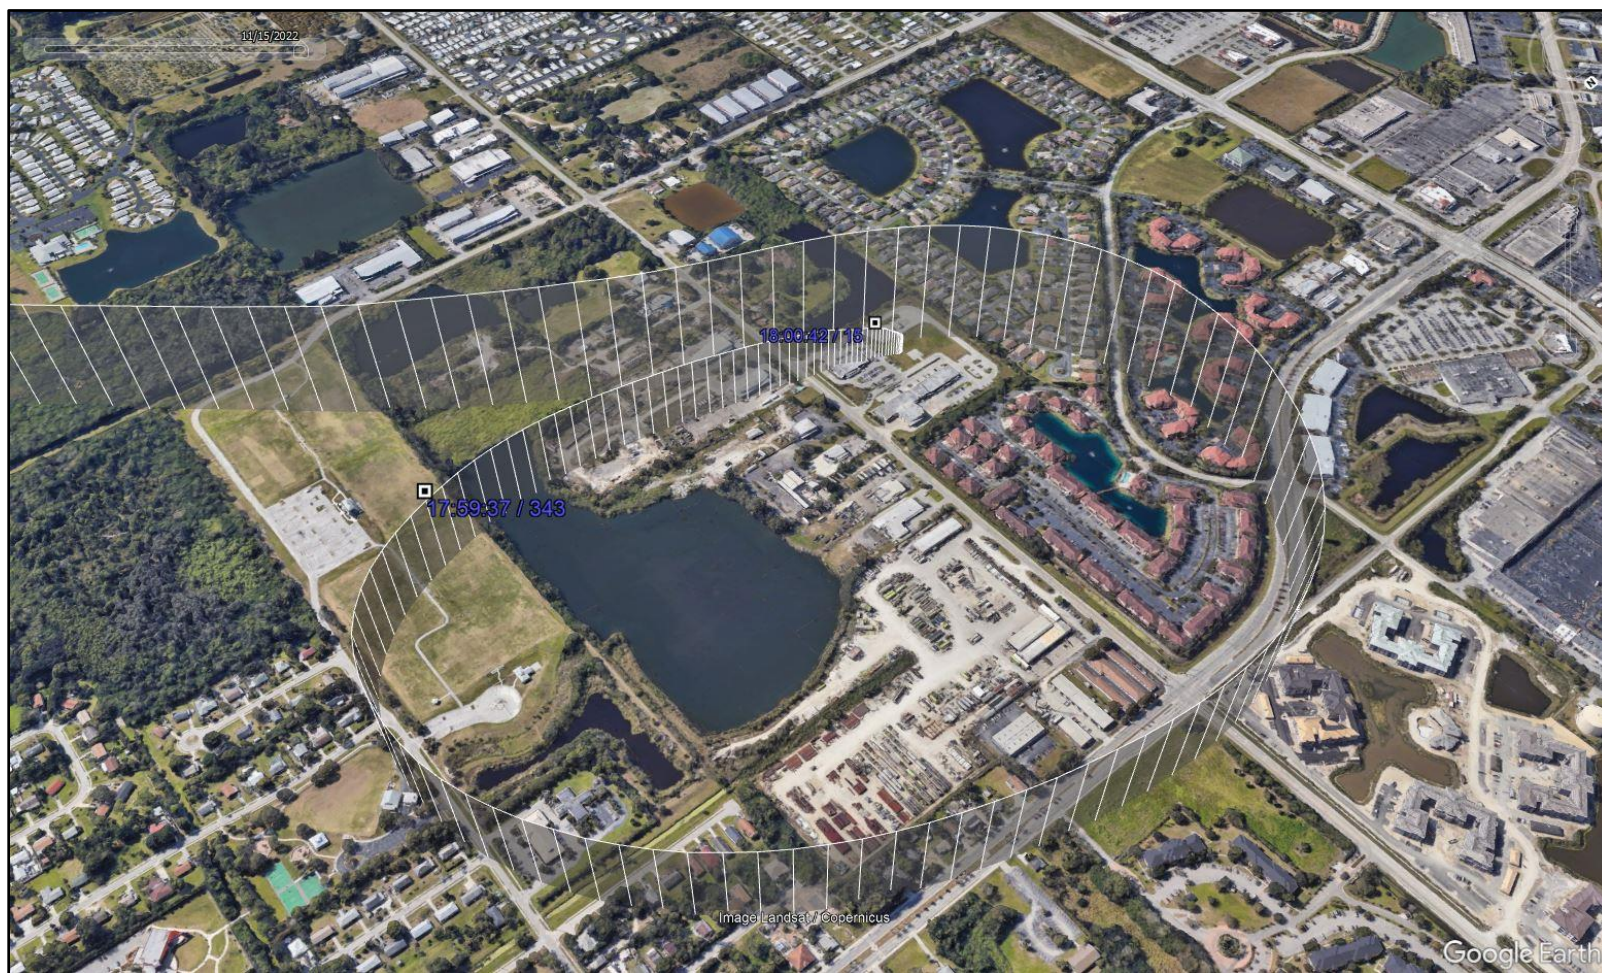
Figure 3 is a graphical overlay using Google Earth for the final portion of the accident flight. The GPS tracklog is shown in the vicinity of the immediate accident site. The helicopter circled the municipal building and then took a 282 degree heading toward the accident site. The last portion of the tracklog shows a rapid descent and a transit of the equipment toward a nearby pond.

**Figure 3.** Google Earth overlay for the helicopter's approach and descent prior to the accident. Note that the orientation of the plot is not north up.

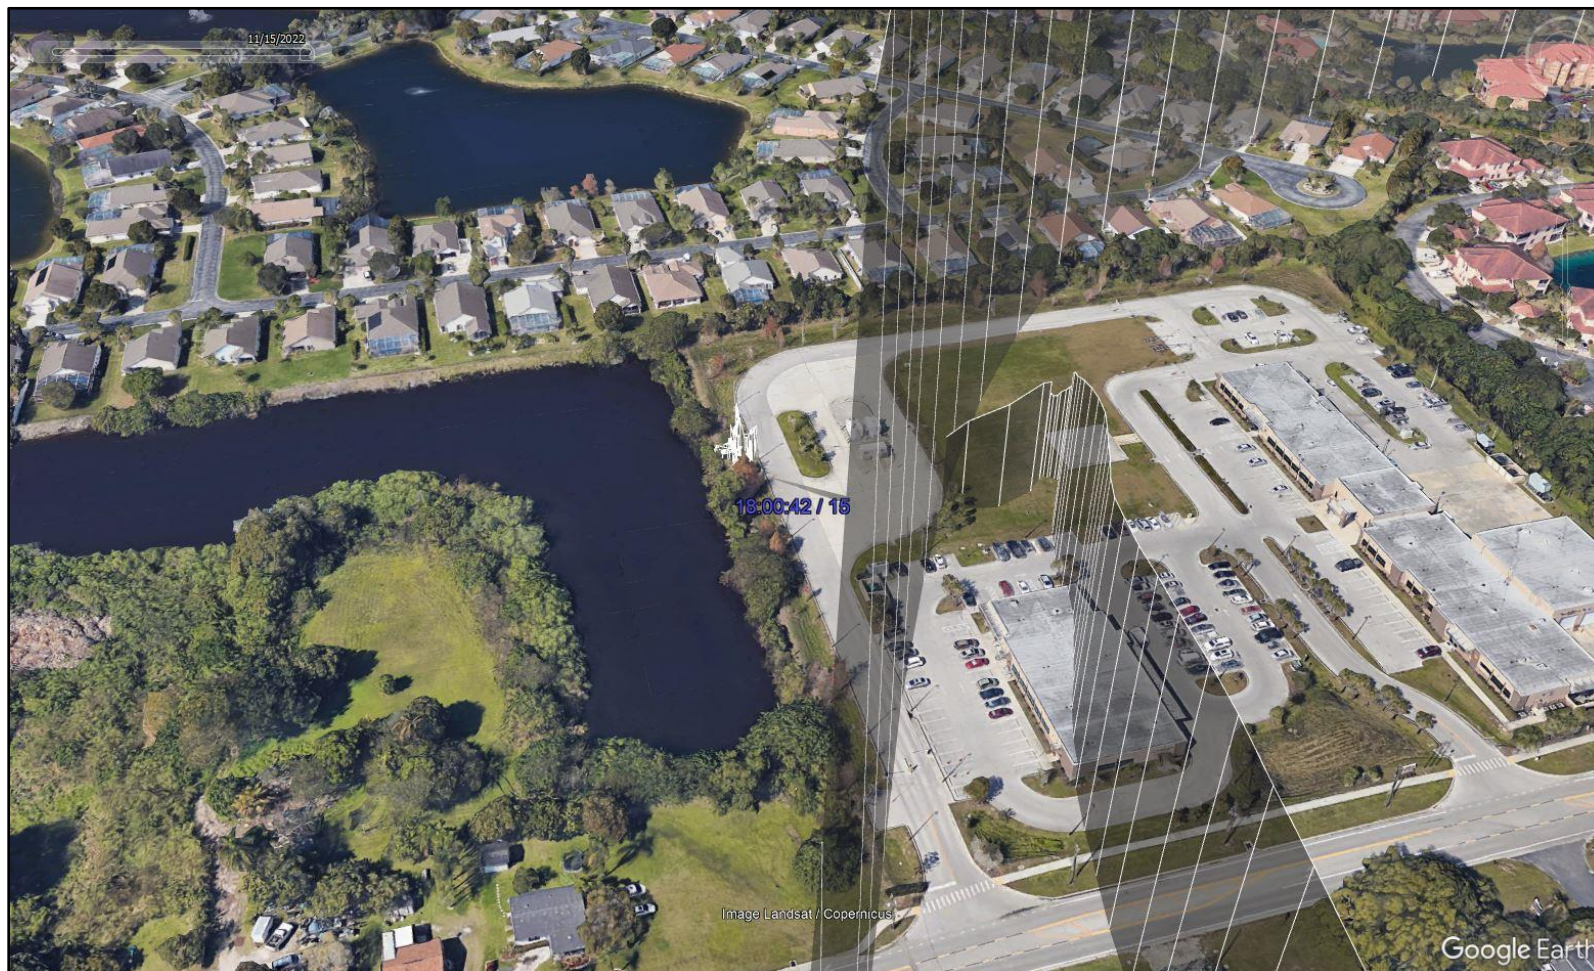
Figure 4 is a close in Google Earth overlay of the immediate accident site.

**Figure 4.** Google Earth overlay for the accident portion of the flight. Note that the orientation of the plot is not north up.

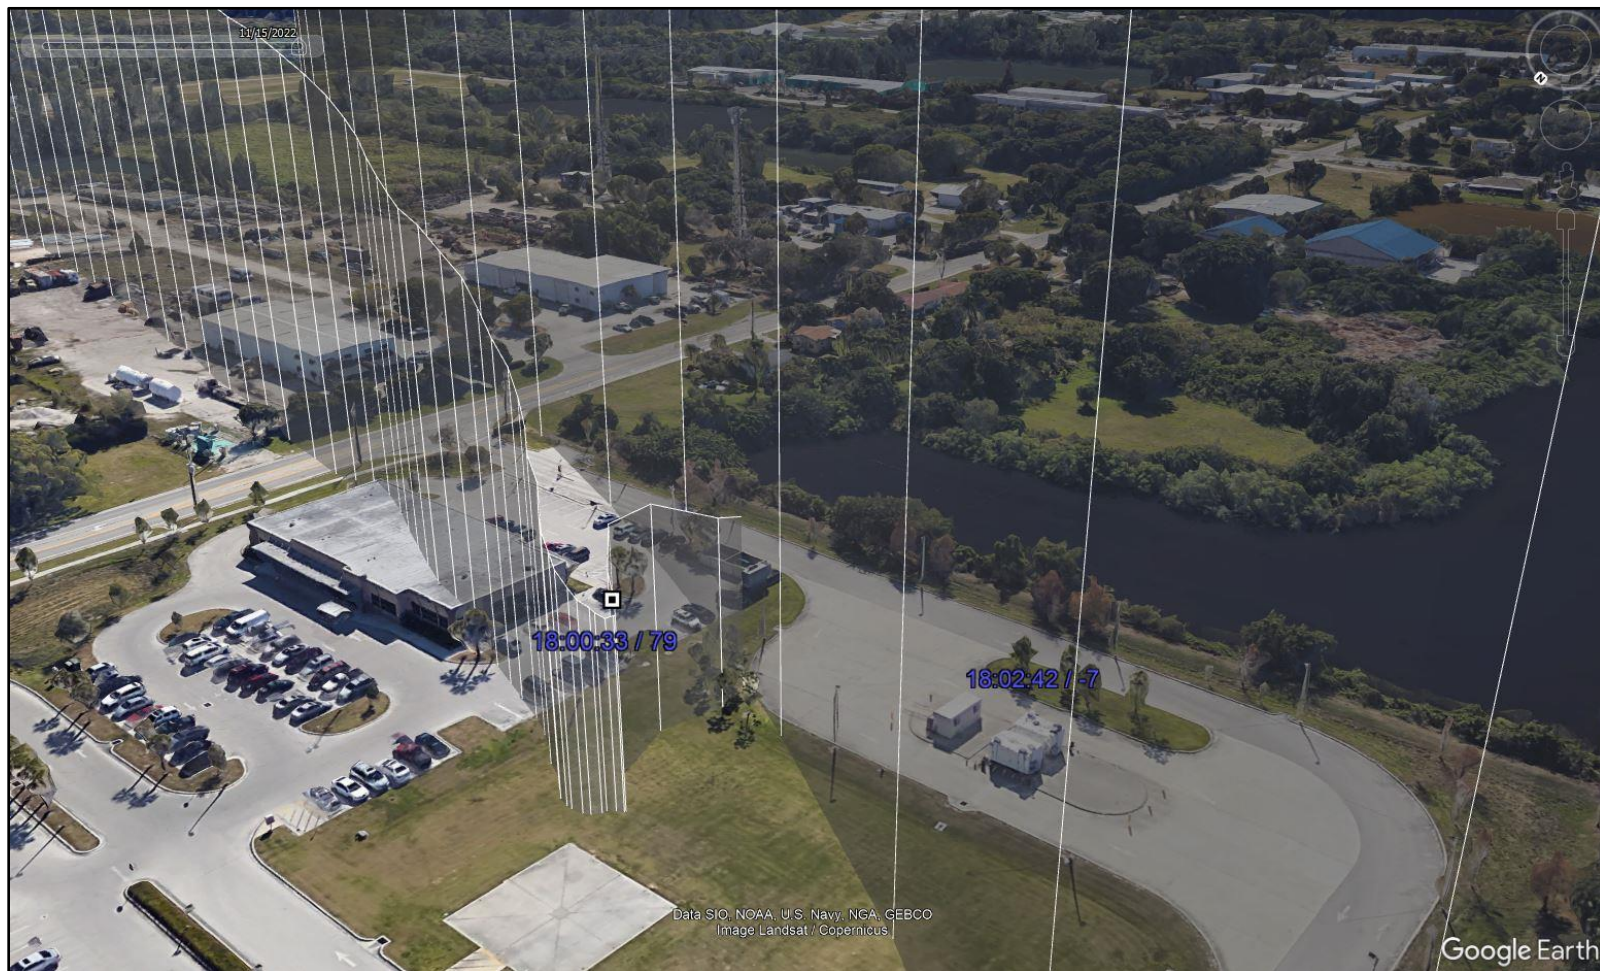
Figure 5 is a close in Google Earth overlay of the immediate accident site from an alternate viewpoint.

**Figure 5.** Google Earth overlay for the accident portion of the flight from an alternate view point. Note that the orientation of the plot is not north up.

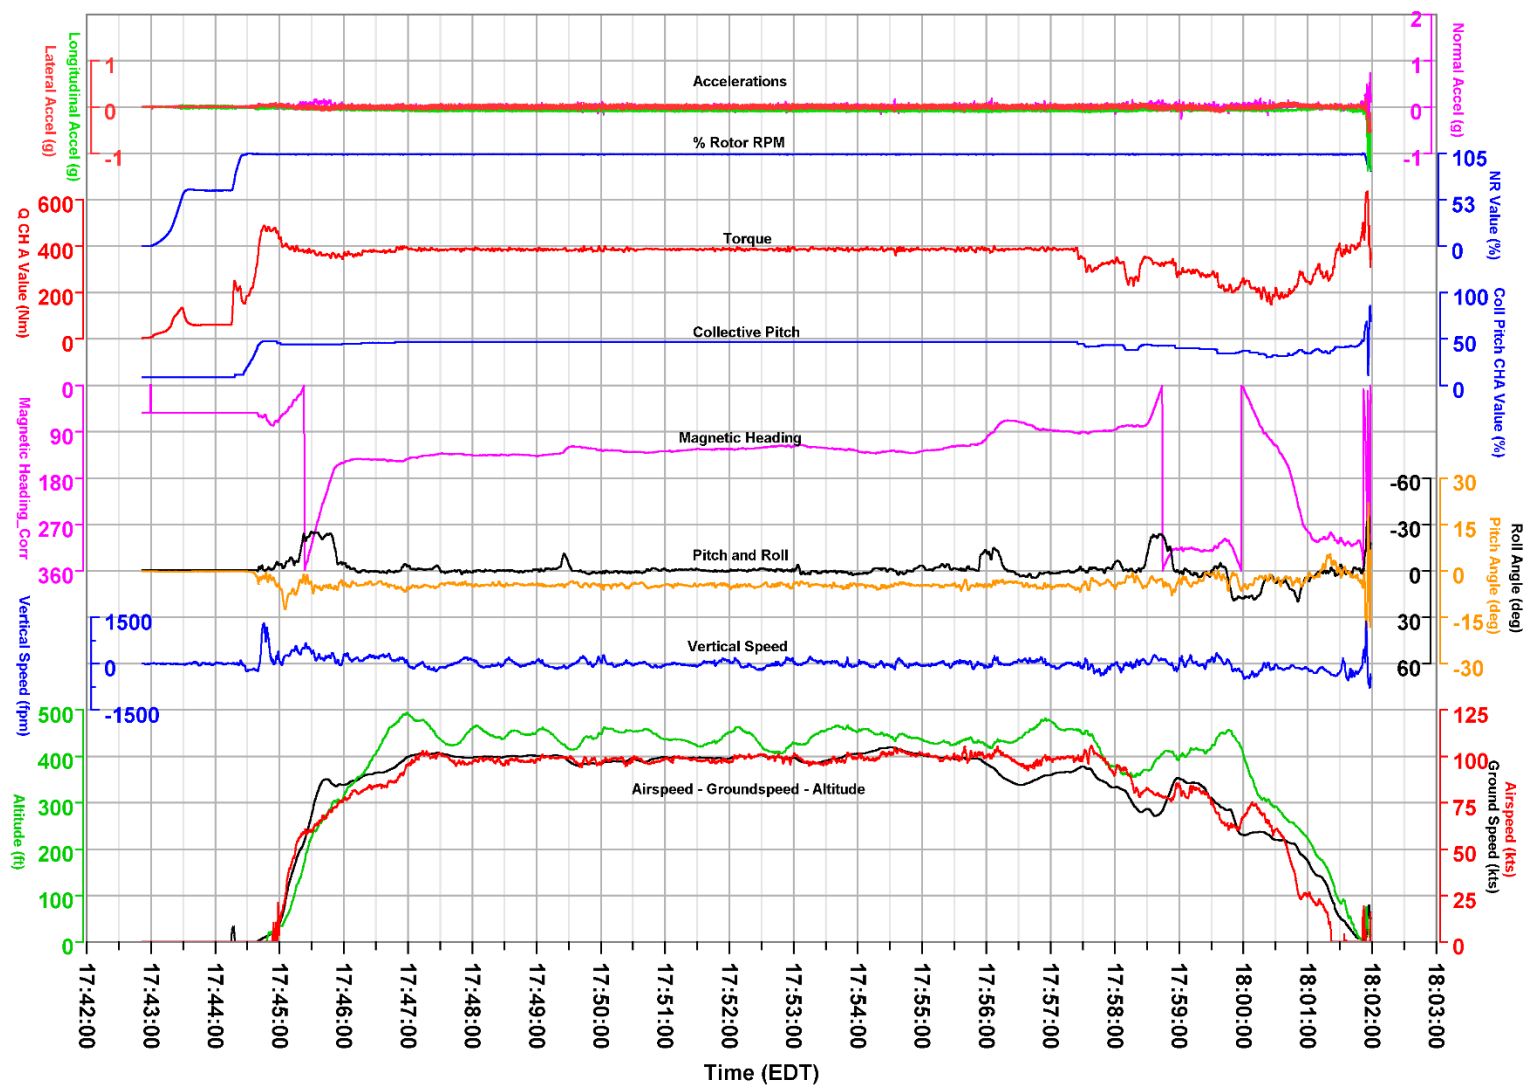
Figure 6 is a plot of basic engine, air and flight control data for the entire flight. The time range displayed is from 17:42:00 to 18:03:00 EDT.

**Figure 6.** A plot of basic engine, air and flight control data for the entire flight.

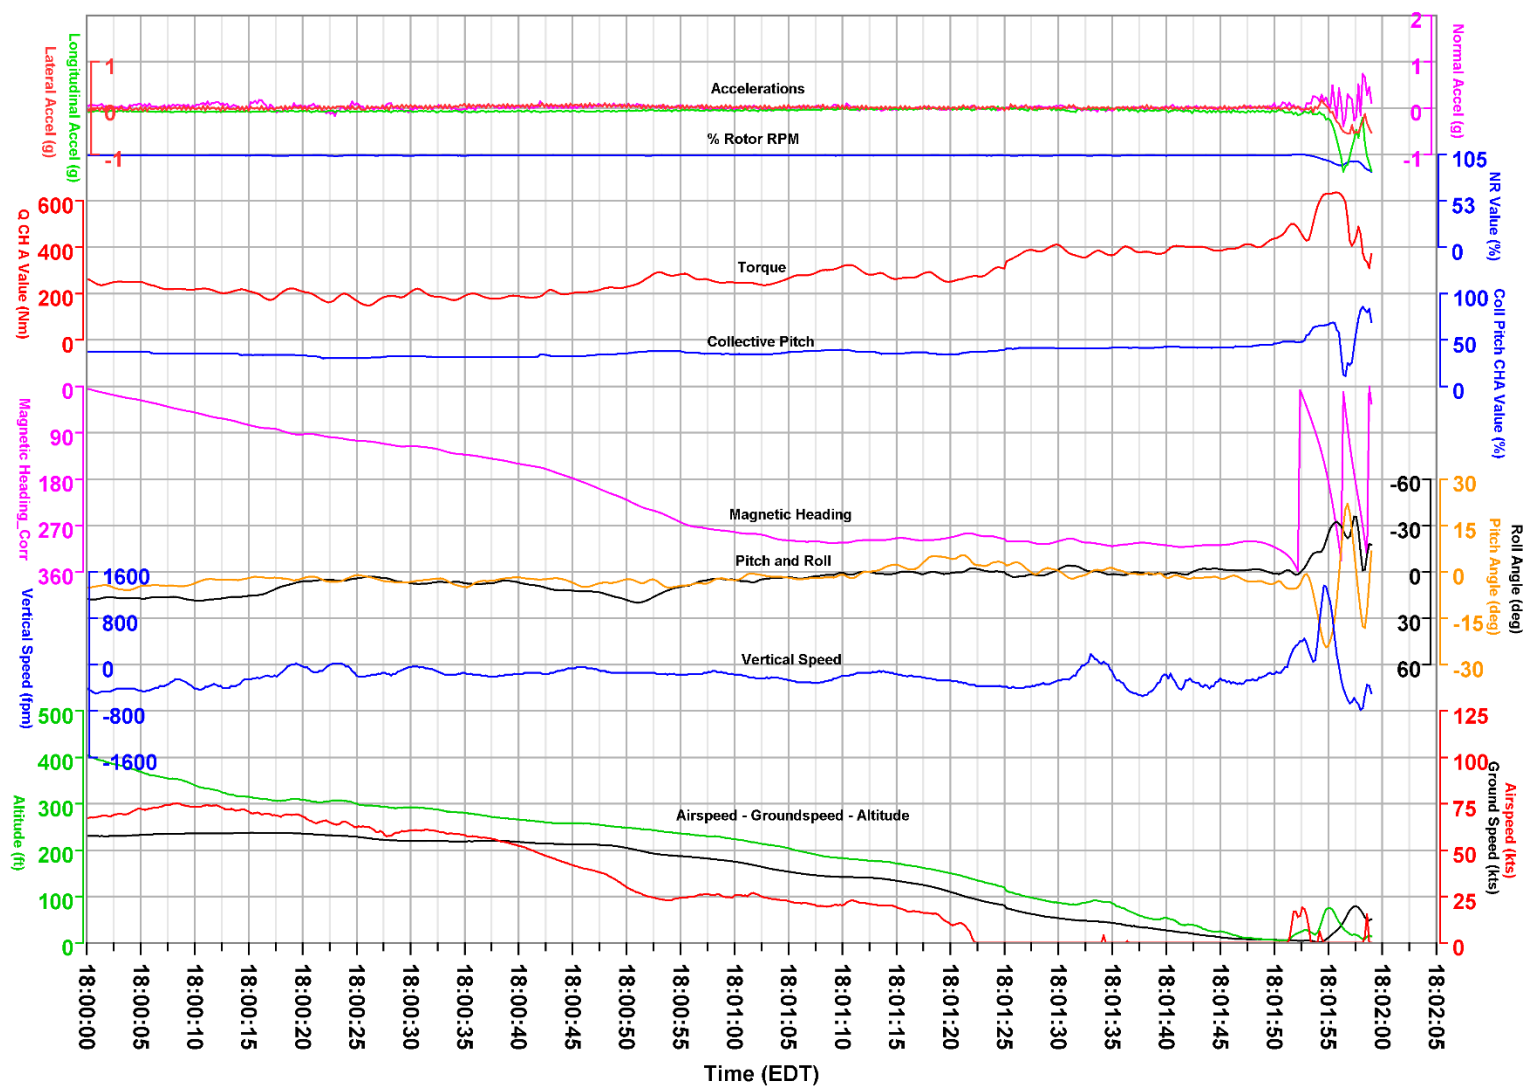
Figure 7 is a plot of basic engine, air and flight control data for a portion of the flight covering the helicopter's descent. The time range displayed is from 18:00:00 to 18:02:05 EDT.

The data plots show the helicopter had made a circling descending approach to the accident site starting around 18:00:00. The helicopter circled to the right while

descending, its indicated airspeed and corresponding groundspeed were decreasing at this time. By approximately 18:01:05, the helicopter was tracking approximately 282 degrees toward the accident site at an altitude of around 300 feet MSL. Around 18:01:52, the helicopter began a rapid yaw to the right. The data in this area is fluctuating, however, the data show the helicopter yawing and descending, indicated airspeed had decreased to around 0 knots at this time (just prior to the yaw onset).

**Figure 7.** A plot of basic engine, air and flight control data for the descent portion of flight.

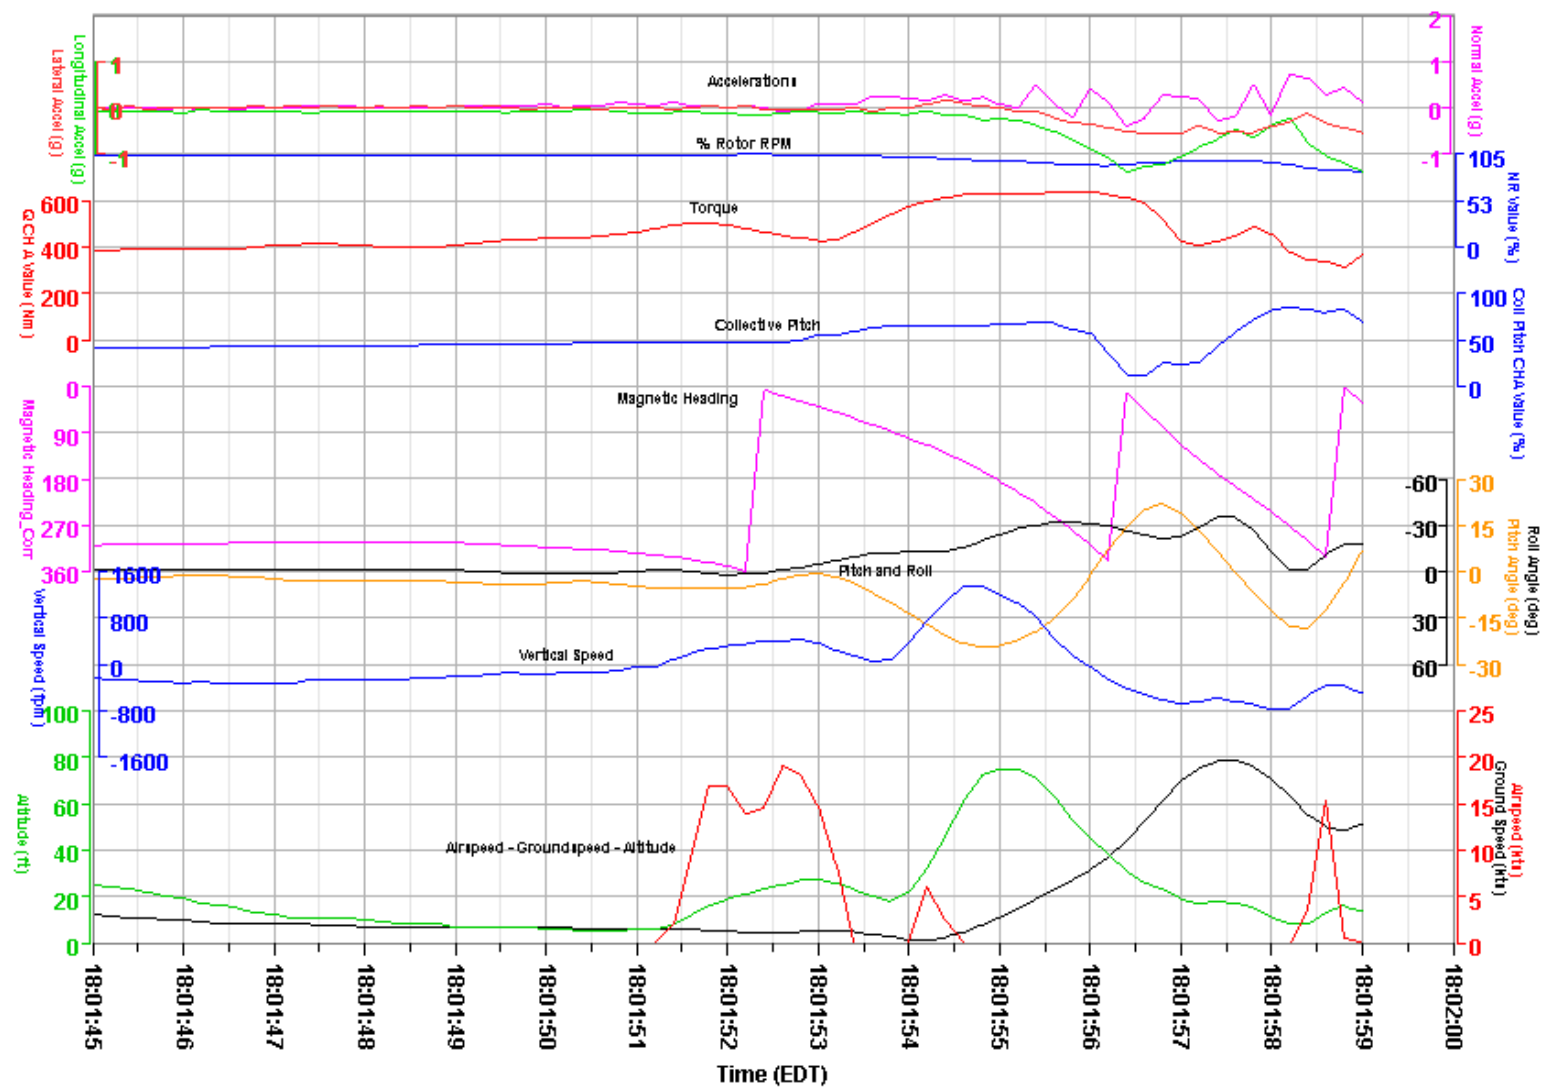
Figure 8 is a plot of basic engine, air and flight control data for the final portion of the accident flight. The time range displayed is from 18:01:45 to 18:02:00 EDT.

During the accident sequence, review of the engine data show the helicopter's components operating normally. During the rapid descent, the data show the collective position was raised<sup>3</sup> and corresponding parameters, such as torque and Nr (rotor RPM) changed correspondingly in an expected response.

**Figure 8.** A plot of basic engine, air and flight control data for the final portion of flight.

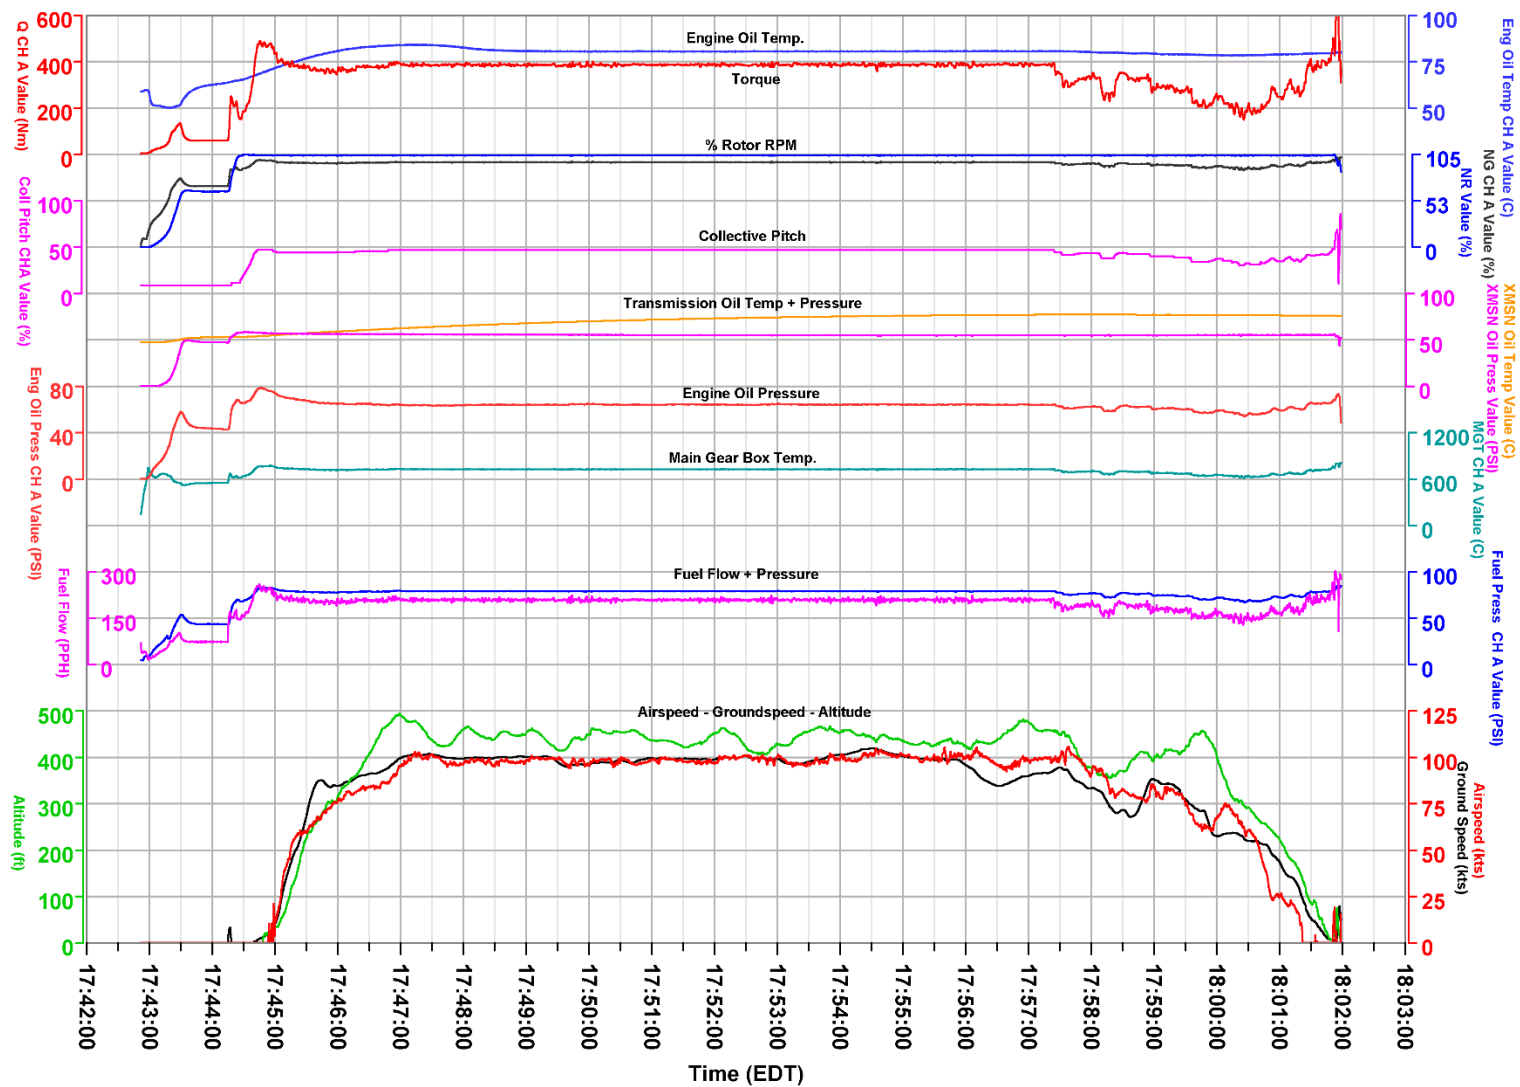
Figure 9 is a plot of expanded engine parameters and basic air data for the entire flight. The time range displayed is from 17:42:00 to 18:03:00 EDT.

**Figure 9.** A plot of expanded engine parameters for the entire flight.

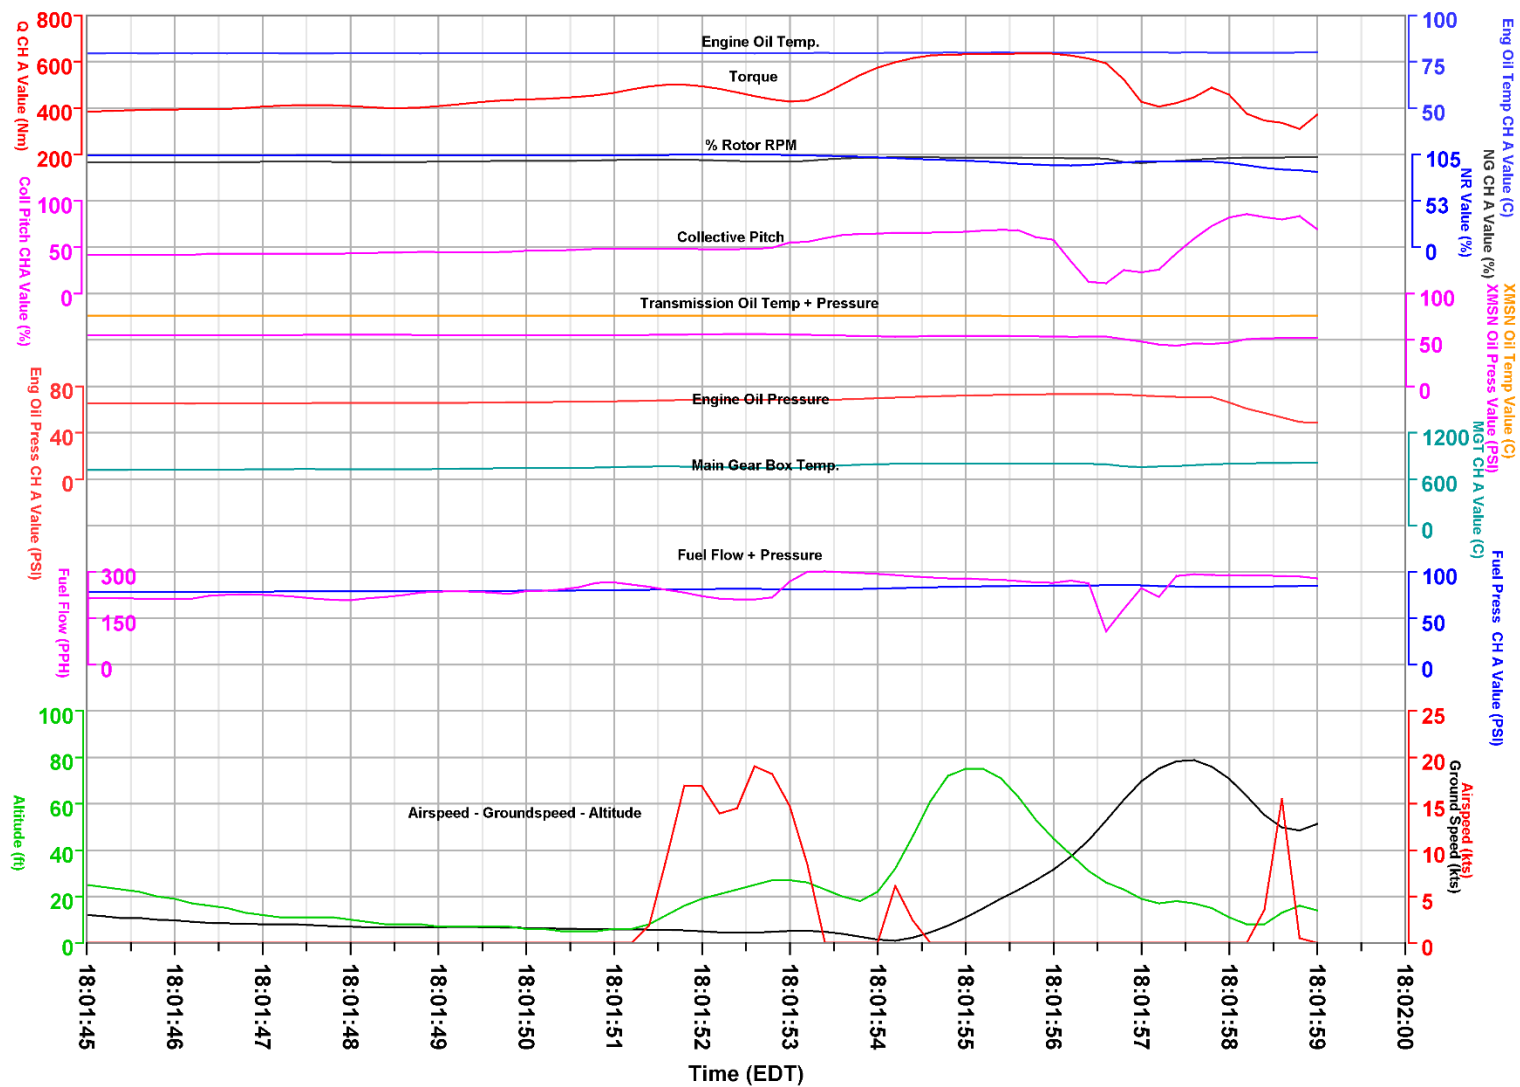
Figure 11 is a plot of expanded engine parameters and basic air data for the final portion of the accident flight. The time range displayed is from 18:01:45 to 18:02:00 EDT.

**Figure 11.** A plot of expanded engine parameters for the final portion of the flight.
