# National Transportation Safety Board

ERA23LA011

## **SURVIVAL FACTORS**

Group Chair's Factual Report

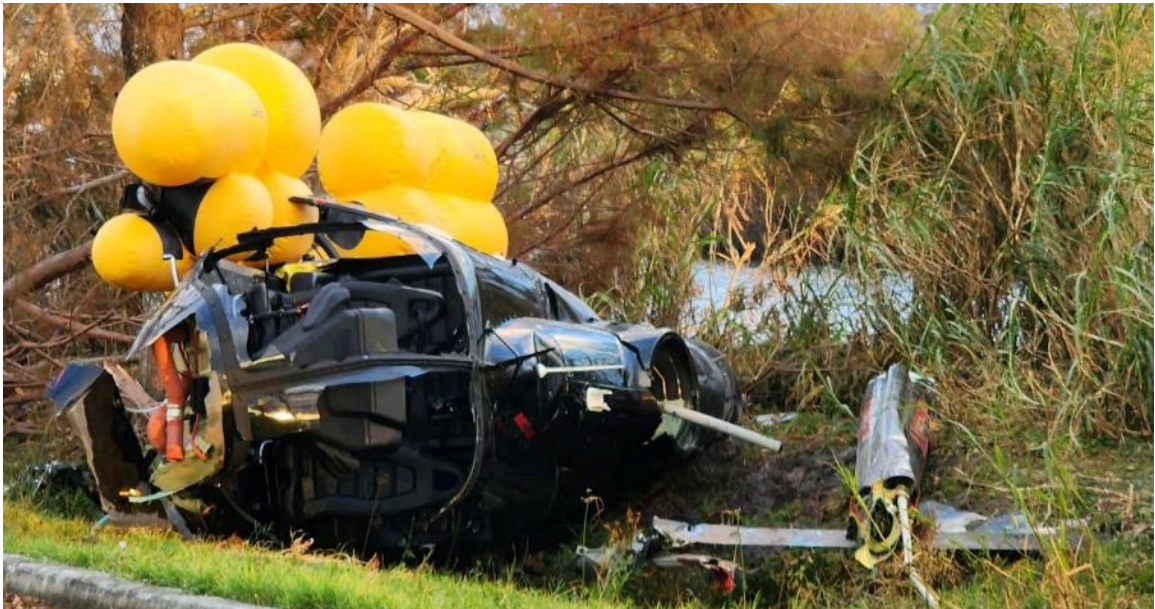
**Figure 3.** N5DF at the accident site after firefighters had extricated all occupants. [Source: FAA]

The helicopter was found resting on its left side by the FAA inspectors. The main transmission and engine remained attached to the airframe. The tail boom, main rotor hub and blades had separated, and there was damage to the front of the helicopter (see figure 3). The left side skid broke off during the accident sequence and was located across a small road. The floats on the right-side skid were deployed. The mid fuselage composite skin panel surrounding the fuel bladder was partially fractured and delaminated on its left-hand side and on its belly. First responders reported a fire around the engine area which was put out with a fire extinguisher.

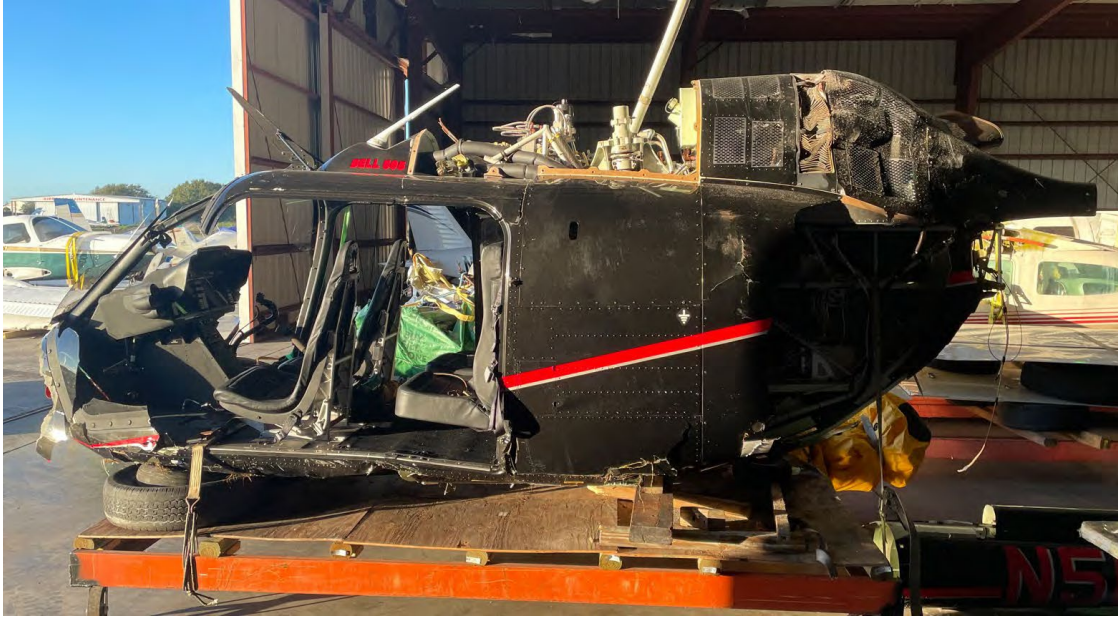
**Figure 4.** Left side view of N5DF during post-accident inspection.

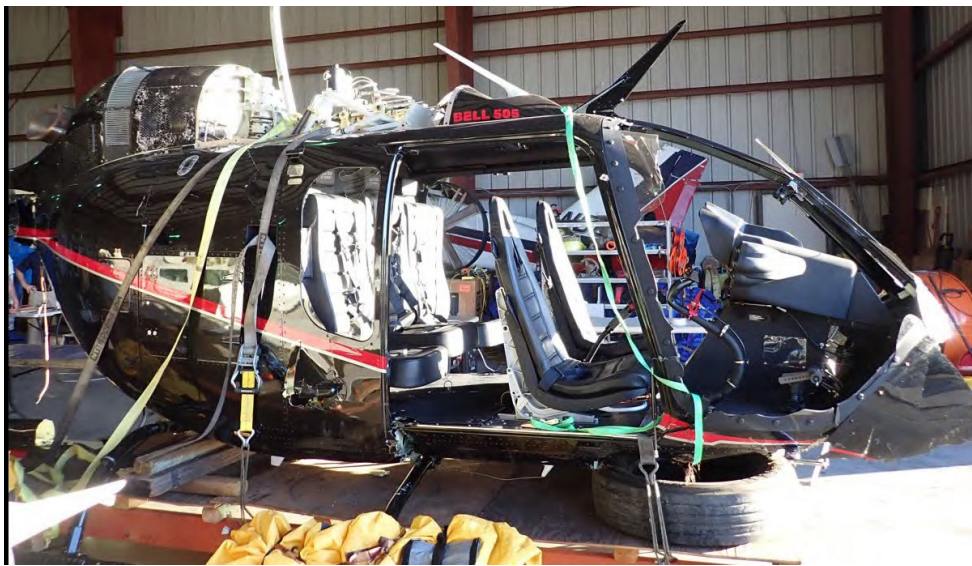
**Figure 5.** Right side view of N5DF during post-accident inspection.

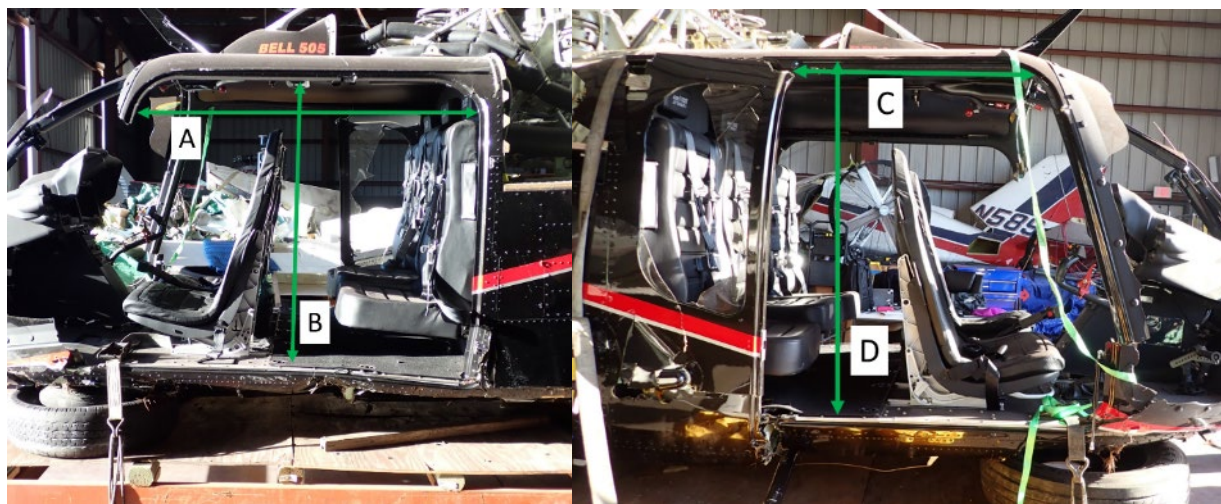
The helicopter was missing the front left pillar. Measurements were taken from the floor to the bottom of the door trim on both the right and left side of the accident helicopter, and in an exemplar helicopter<sup>1</sup>. Additionally, the cabin was measured across at the center of the aisle for the rear passengers. The measurement locations are shown in figure 6, and measurements in figure 7.

**Figure 6.** Door measurement locations of N45DF.

| Measurements (inches) | Exemplar Helicopter | Accident Helicopter |
| Width of left door opening (A) | 49.0 | 51.0 |
| Height of left door opening (B) | 48.0 | 44.8 |
| Width of right door opening (C) | 32.0 | 32.5 |
| Height of right door opening (D) | 48.0 | 46.1 |
| Width at the center of the rear aisle | 56.4 | 52.0 |

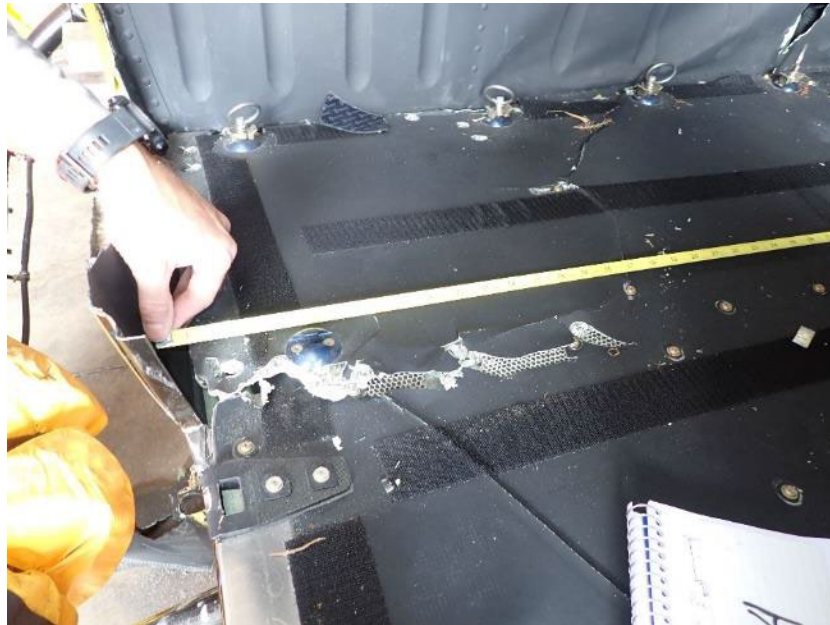
After the carpet and three rear bulkhead mounted seats were removed, it was noted that there was floor disruption beneath the rear seats. There was an approximately 16-inch crack extending from the right edge of the floor inward, and 20 inches from the bulkhead forward (see figure 8). The distance from the top to

**Figure 8.** Floor crack beneath passenger seat two.

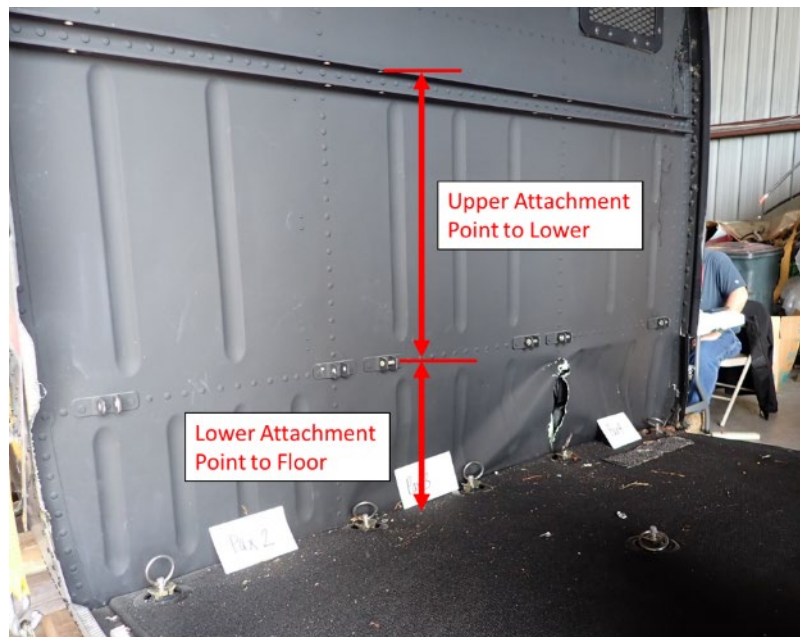
bottom attachment points, and bottom attachment points to floor were measured (see figure 9 and 10).

**Figure 9.** Bulkhead measurements.

| Seat Place | Top seat attachment point to lower seat attachment point | | Lower seat attachment point to floor | |
| Pass 2 | 19.2 | 19.2 | 11.60 | 11.40 |
| Pass 3 | 19.2 | 19.2 | 10.90 | 11.45 |
| Pass 4 | 19.2 | 19.0 | 11.25 | 10.80 |

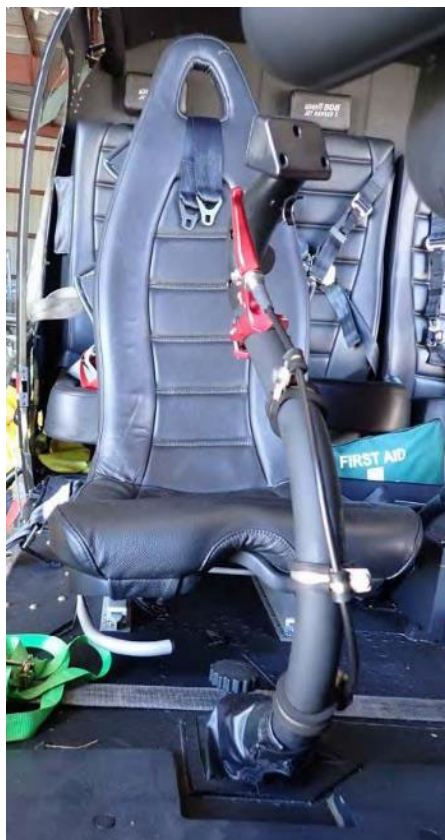
The pilot was located on the right side of the helicopter (see figure 13). The seat was found stroked downward (see section 4.1.3). The seat bucket was structurally undamaged but a scratch on the seat bucket was noted just above marks on the floor (see figure 14). There was an impact mark on the right seat leg directly below the EA attachment bolt (see figure 15). There was fretting noted between the right-hand seat leg and the EA device (see figure 16). The Bose headset kit electrical wire under the seat bucket was bent. The seat was in the forward and locked position for flight. The anti-torque pedals were set to the farthest forward position. The unlocking handle for fore/aft adjustment did not function when tested.

**Figure 13.** Pilot seat at the salvage facility.

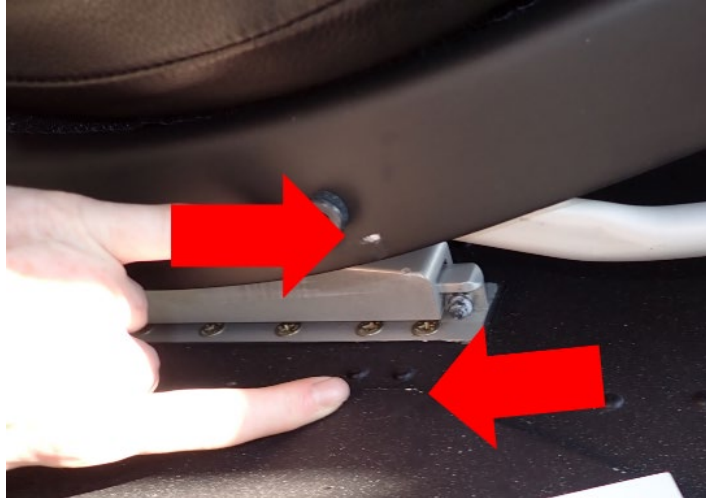
**Figure 14.** Marks on the seat and the floor.

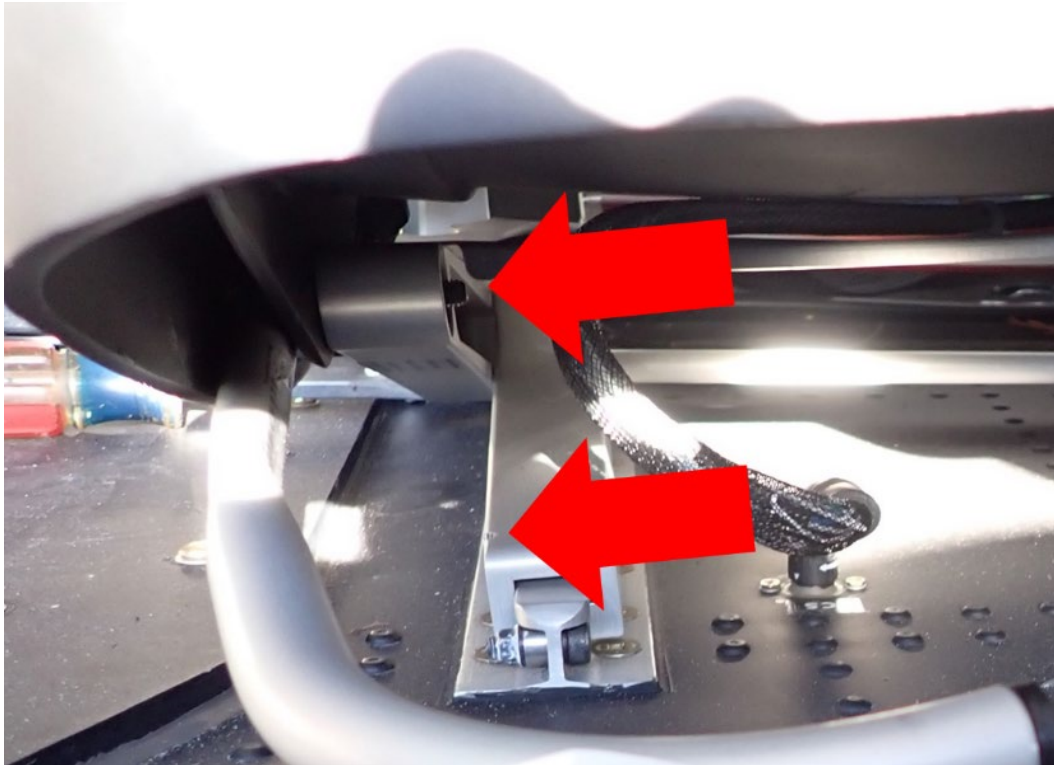
**Figure 15.** EA device attachment bolt, directly above marks on the pilot seat leg.

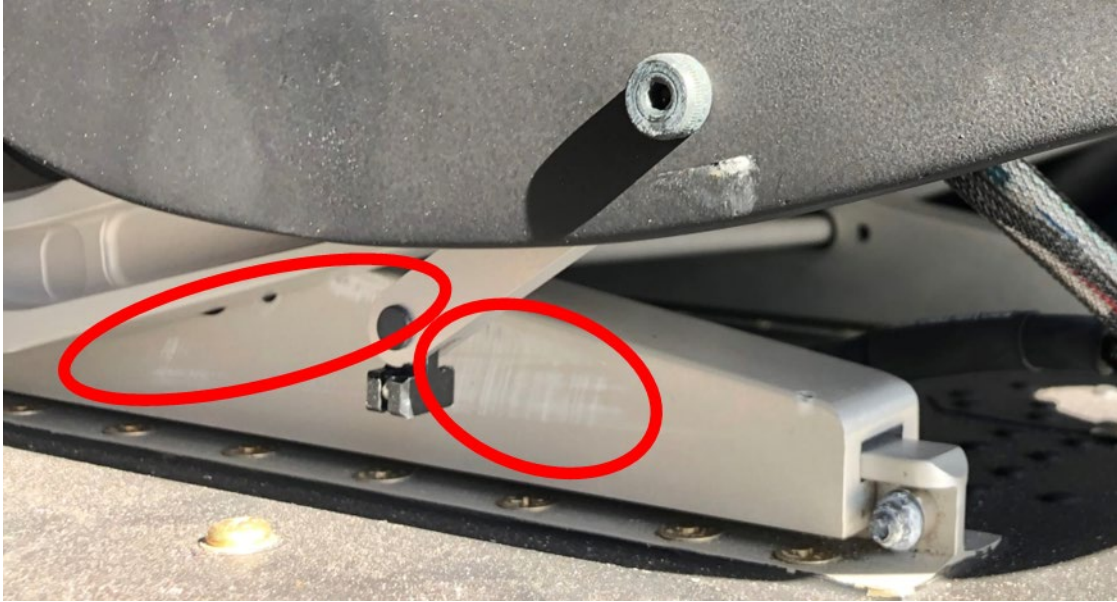
**Figure 16.** Fretting marks between the pilot right hand seat leg and EA device.

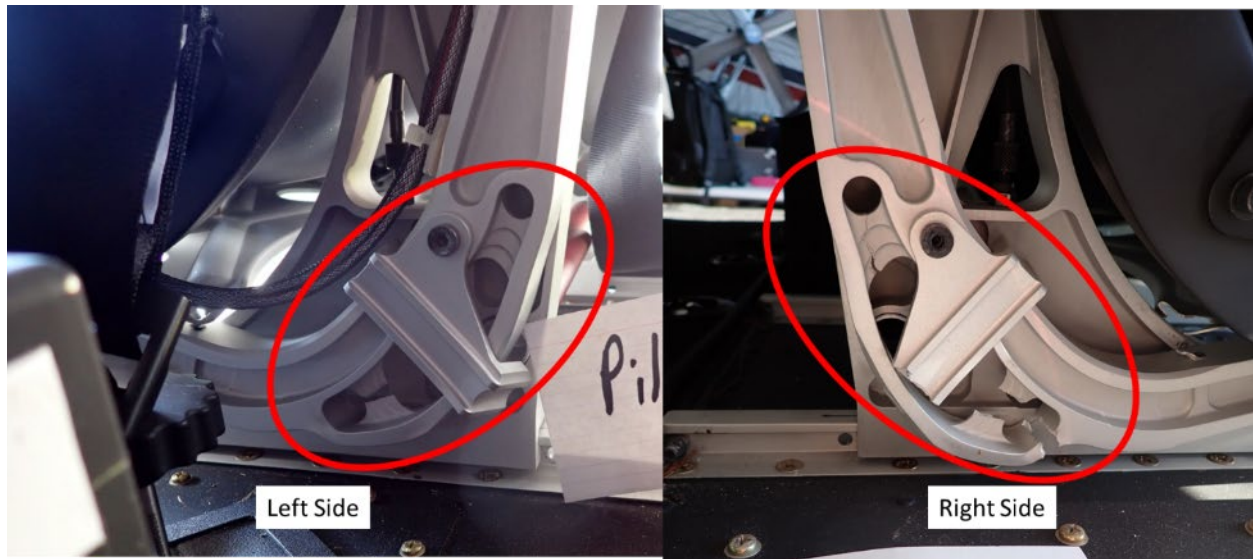
The absorption devices in both sides were deformed (see figure 17). The clamp along the right-side absorber had fractured and the broken piece was found near the seat at the salvage facility. The clamp on the left side had bent but not fractured. The seat bucket sliding mechanism slot was widened on both sides.

**Figure 17.** Pilot seat bottom absorption devices left and right sides.

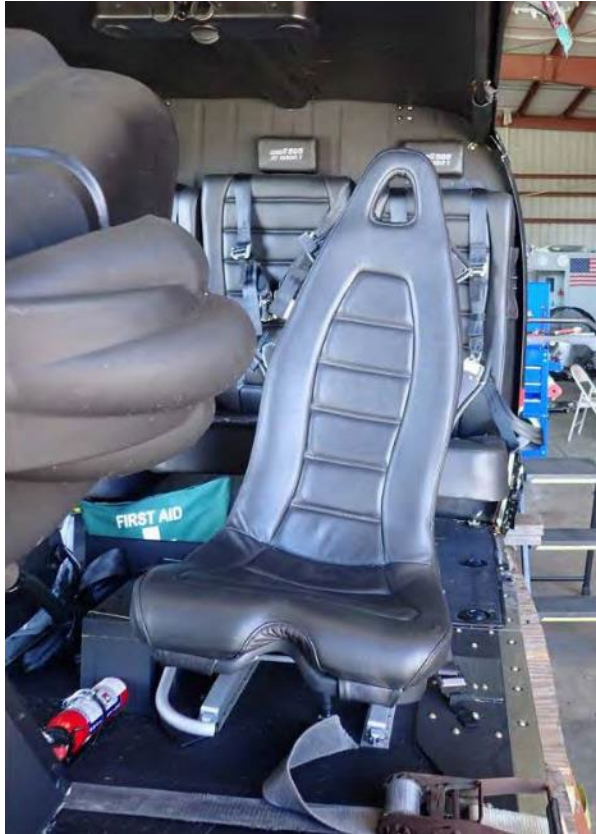
While the seat was a crew seat, there were no controls installed in front of it (see figure 18). The seat was found stroked downward. The seat bucket was structurally undamaged. The seat was in the forward and locked position for flight. The unlocking handle for the fore/aft adjustment was functional.

**Figure 18.** Passenger seat 1 at the salvage facility.

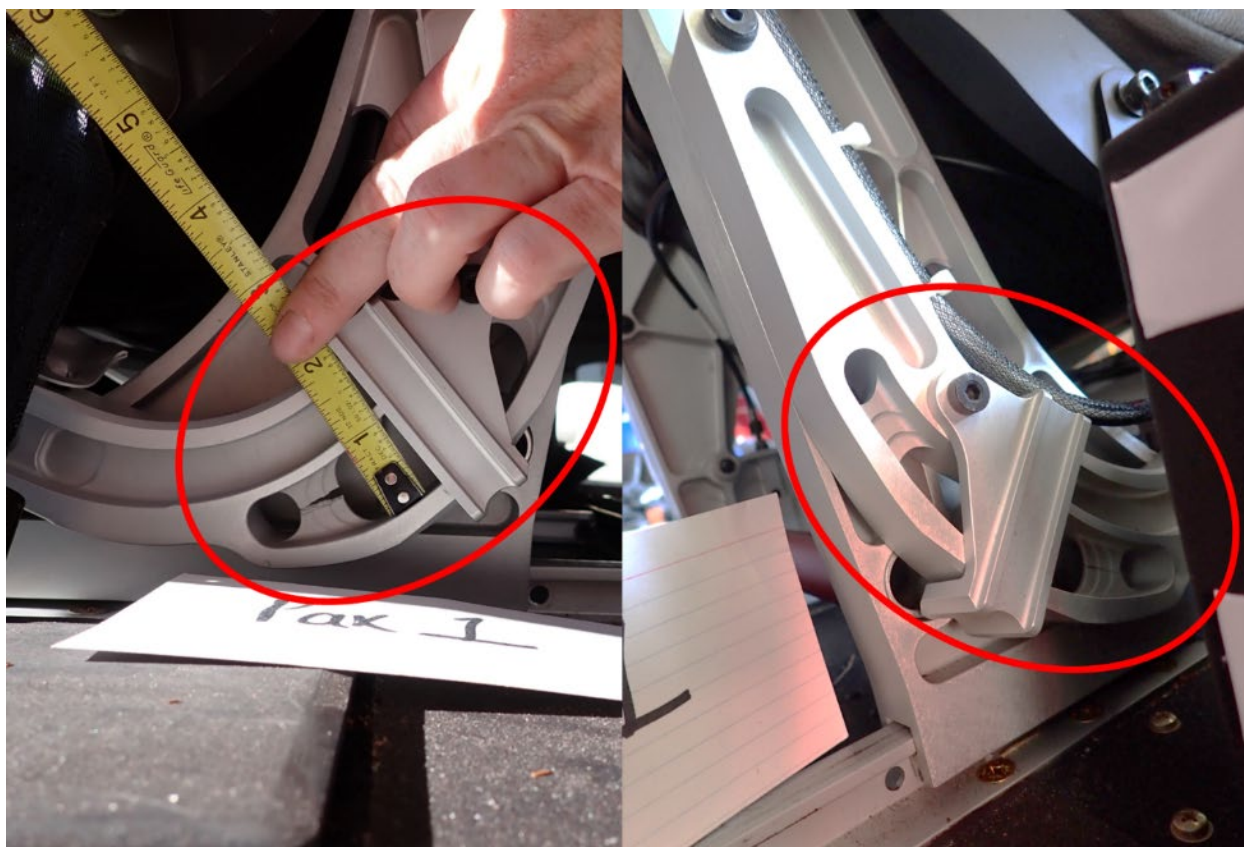
The absorption device on the left and right were activated (see figure 19). Neither of the clamps on the absorption devices had fractured. The sliding mechanism slot was widened on both sides.

**Figure 19.** Passenger seat 1 seat bottom absorption devices left and right.

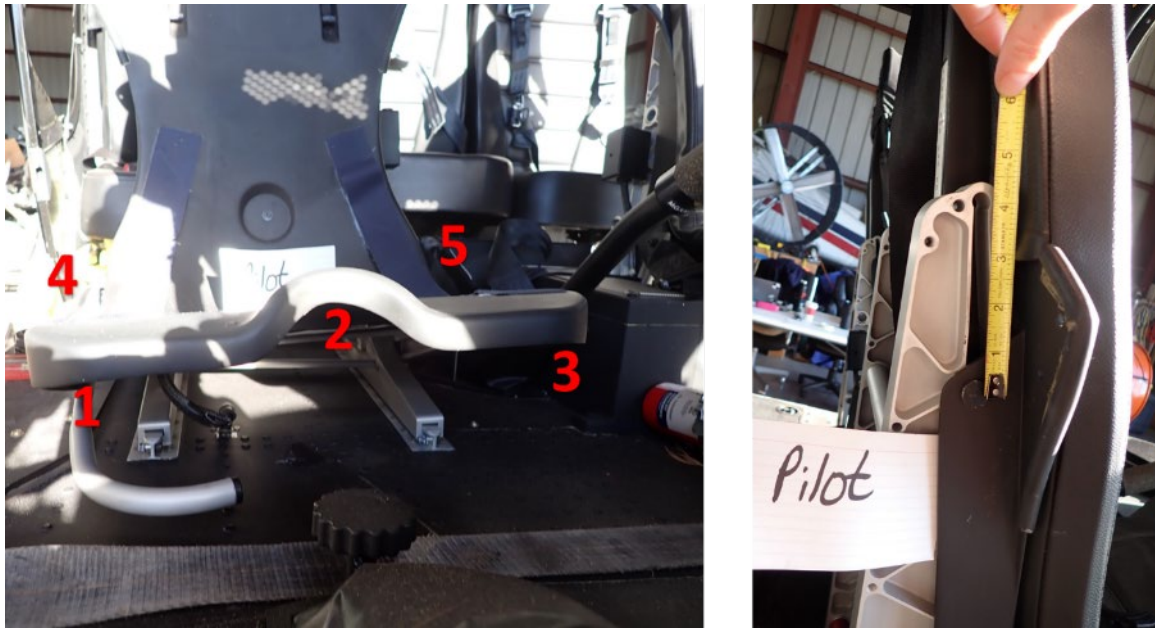
To document the seat downward permanent displacement of the seat during the accident, measurements were taken at locations on the bottom and side of the seat: the bucket along the front (points 1-3), the belt anchor at the back (points 4 and 5), and from the center of the seat bucket guide pin to the arc at the top of the slot above it. Additionally, there were also angle measurements taken at the floor and across the seat pan (see figure 20 and 21). With a positive angle being clockwise and negative being counterclockwise.

**Figure 20.** Five points measured on the seat bucket bottom and vertical displacement of seat bucket guide pins.

| Seat | 1<br>(in) | 2<br>(in) | 3<br>(in) | 4<br>(in) | 5<br>(in) | Floor angle<br>(deg) | Seat pan<br>angle (deg) | Left vert<br>disp (in) | Right vert<br>disp (in) |
|---|---|---|---|---|---|---|---|---|---|
| <b>Pilot</b> | 4.7 | 6.3 | 5.5 | 4.9 | 5.9 | -1 | 4 | 3.4 | 4.2 |
| <b>Pass 1</b> | 7.5 | 8.4 | 6.9 | 7.6 | 5.9 | -1 | -7 | 2.7 | 1.7 |

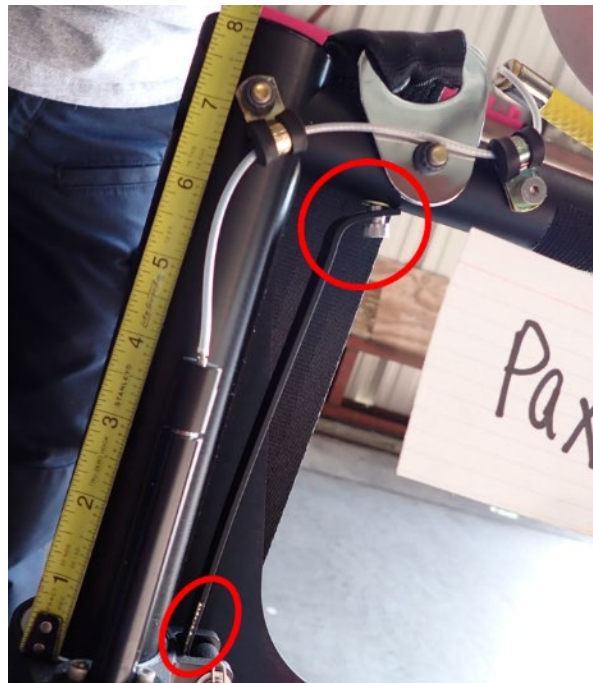
Both the left and right-hand EA devices were activated. Fretting marks on left-hand side EA device strip and bending of its flange at the upper connection were observed (see figure 24). There was deformation in multiple places on the seat pan tubular frame. The frame was fractured on both sides forward of the bottom reinforcing frame at the seat back bottom interface (see figures 25 and 26). The lower right seat frame hook was no longer attached to the pin that secured it to the bulkhead (see figure 27). Fretting marks were observed on the lower right-hand hook seat attachment fitting.

**Figure 24.** EA device strip showing flange bending at the top and fretting marks towards the bottom.

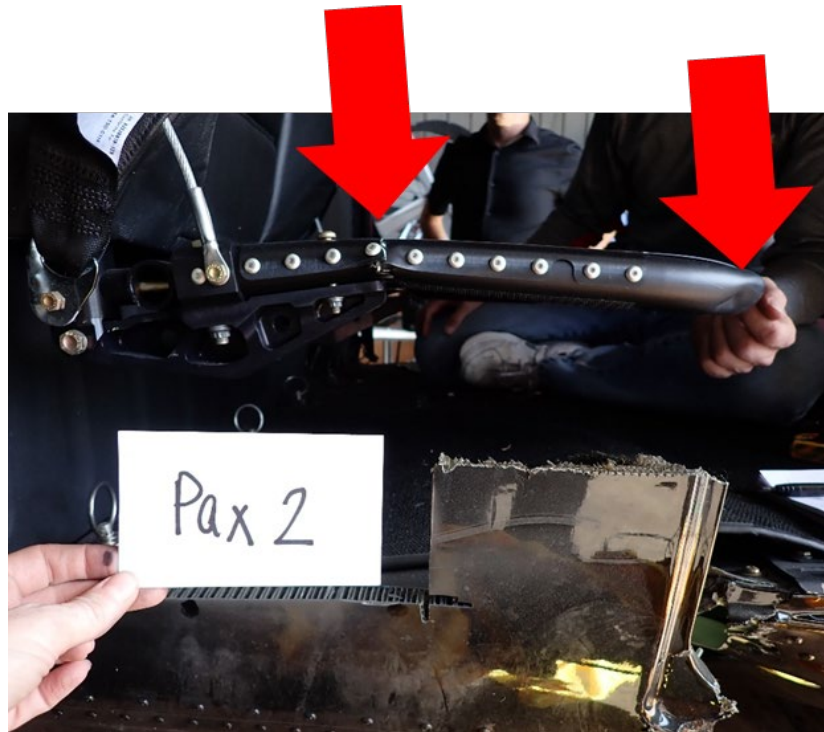
**Figure 25.** Side view of the passenger 2 seat frame.

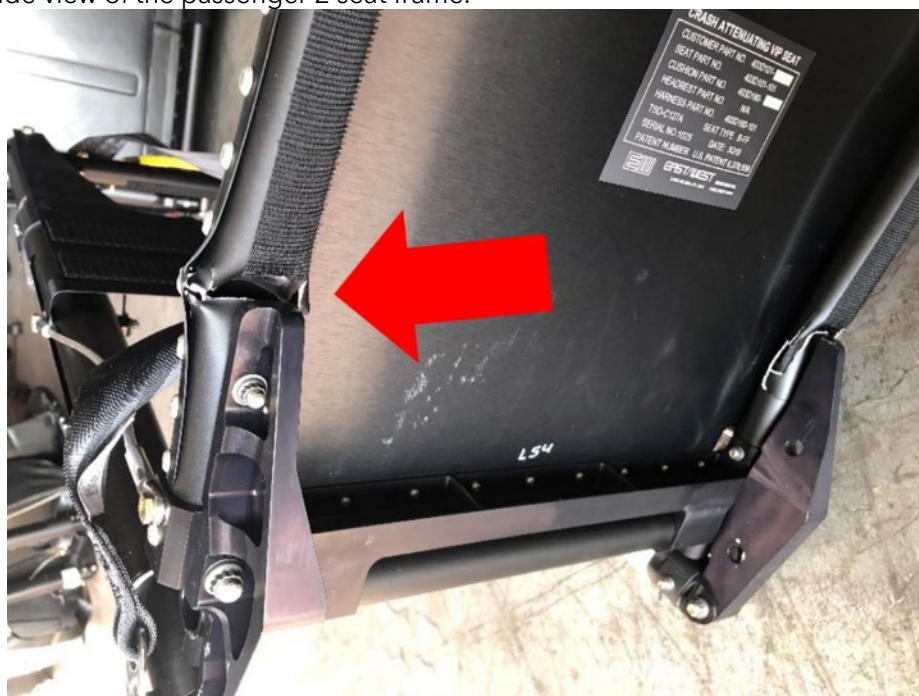
**Figure 26.** Bottom of passenger seat 2 showing tubular fractures forward of the reinforcing structure.

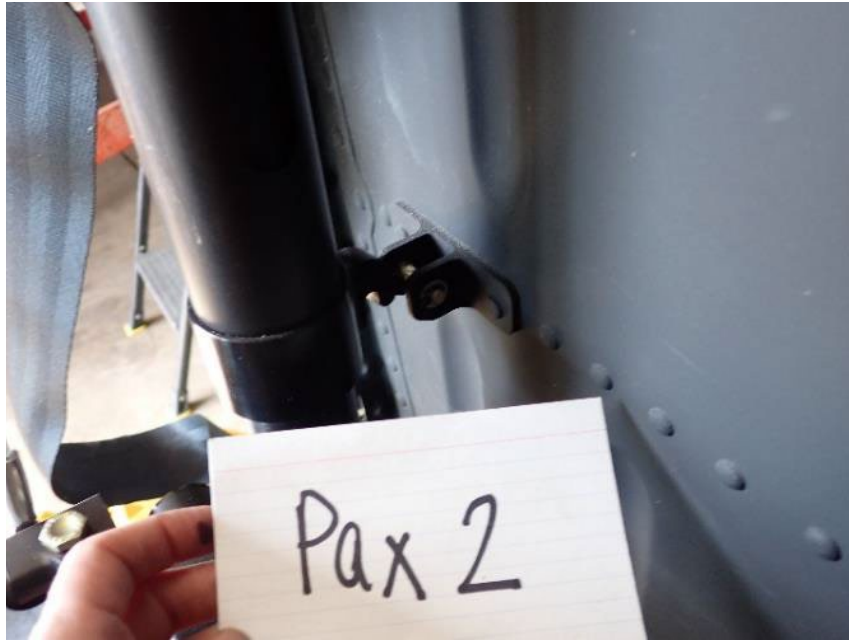
**Figure 27.** Passenger seat lower right seat frame hook off its pin.

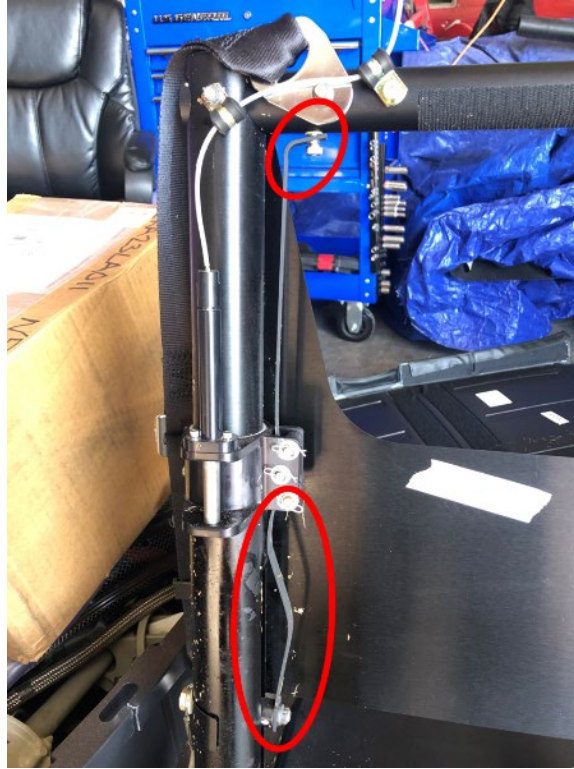
The seat was stroked downward. Both the right-hand and left-hand EA devices were activated. The LHS EA Device strip was found bent at its upper connection and its lower portion was found buckled (see figure 28). The seat pan was undamaged. The seat pan to overhead structure measured 38.8 inches. The right lap belt was adjusted to measure 24.7 inches and the right shoulder belt was 22.9 inches. The left lap belt was adjusted to measure 20.2 inches and the left shoulder belt was 23.4 inches. According to the written statement of passenger 4, which included photographs from his phone, his body rotated outboard after the first impact with the ground as the helicopter rebounded into the air. For additional information see the written statement in the NTSB docket.

**Figure 28.** EA Device strip flange bending at the top and buckling below the rollers.

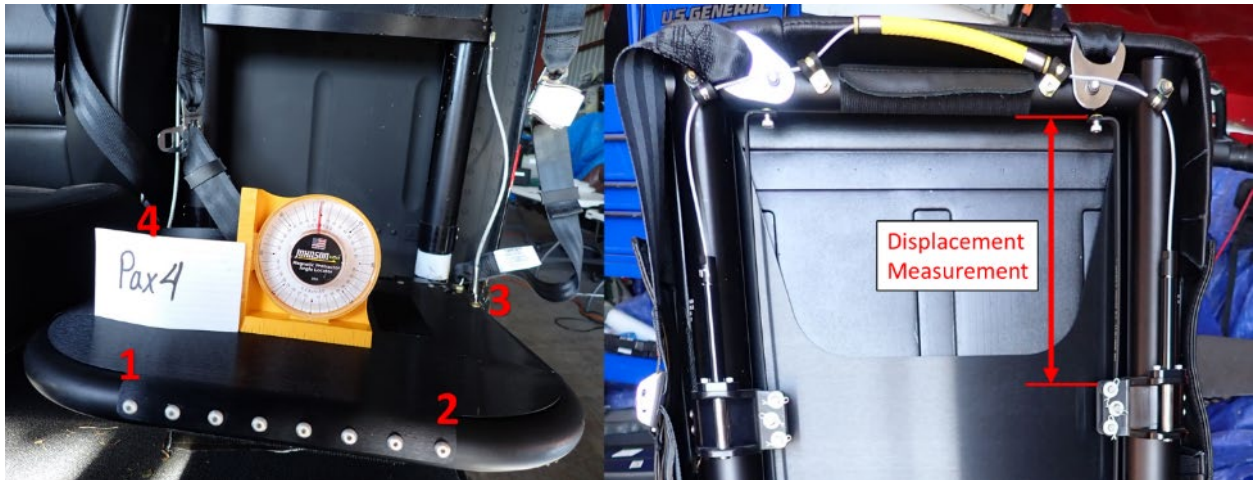
To document the seat downward permanent displacement during the accident, measurements were taken at locations on the bottom and side of the seat: the seat pan along the front (points 1 and 2), the belt anchor at the back (points 3 and 4). To measure the stroking of each of the energy attenuating mechanisms, a measurement was taken from the top of the upper roller to the bottom of the top rail of the seat frame on the left and right side of the seat. Additionally, there were also angle measurements taken at the floor and across the seat pan (see figure 29 and 30). With a positive angle being clockwise and negative being counterclockwise.

| Seat | 1<br>(in) | 2<br>(in) | 3<br>(in) | 4<br>(in) | Left<br>Displacement<br>(in) | Right<br>Displacement<br>(in) | Floor<br>angle<br>(deg) | Seat pan<br>angle<br>(deg) |
|---|---|---|---|---|---|---|---|---|
| Pass 2 <sup>2</sup> | 6.1 | 6.3 | 7.5 | 6.9 | 6.70 | 6.95 | -1 | 0 fwd/ -4 aft |
| Pass 3 <sup>3</sup> | 8.6 | 9.0 | 8.4 | 9.0 | 8.50 | 8.50 | -2 | 0 |
| Pass 4 | 7.9 | 7.9 | 7.6 | 7.7 | 7.00 | 7.20 | -2 | -2 |

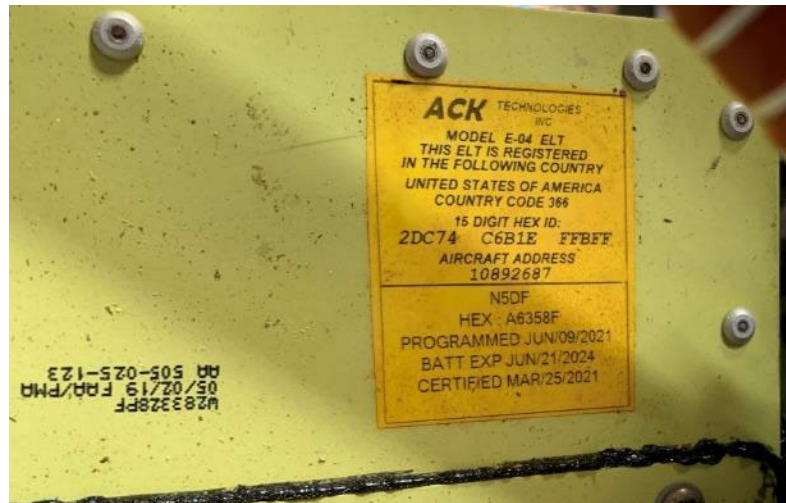
A fully charged fire extinguisher was secured in its cradle to the floor between the front seats. An ACK Technologies 406 MHz Emergency Locator Transmitter (ELT) was still secured in its cradle in the aft fuselage section of the helicopter (see figure 31). The battery had an expiration date of June 21, 2024. The ELT's switch position could not be determined due to significant structural damage in the area.

**Figure 31.** The ACK Technologies 406 MHz ELT.
