# National Transportation Safety Board

ERA23LA011

## **WRECKAGE EXAMINATION SUMMARY**

Location: Fort Myers, Florida  
Date: October 8, 2022  
Time: 1800 EST  
2200 UTC  
Helicopter: N5DF, Bell 505

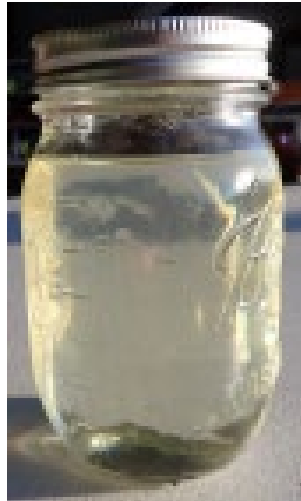
Examination revealed fuel was present in the fuel cells and no pre-existing fuel leaks were observed. Fuel was clear with no abnormal odor (Photo 1). No fuel system issues were suspected or reported by the pilot.

Photo 1: Fuel Sample (Courtesy Bell Helicopter Textron)

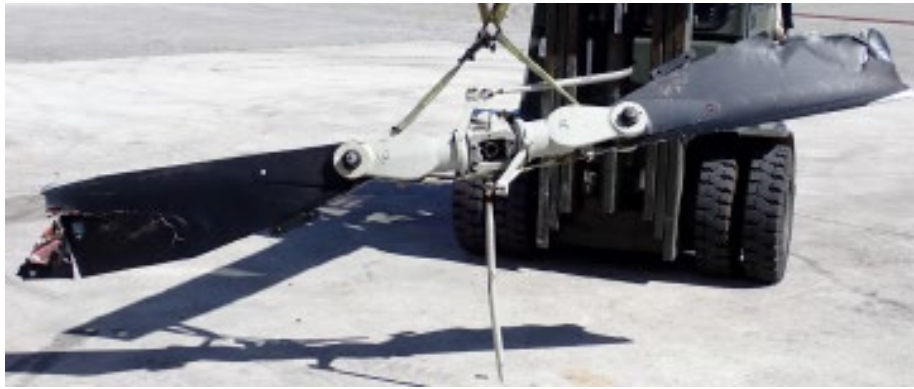
No pre-impact anomalies were observed with the main rotor. The mast nut and flap restraint assembly were present along with all associated hardware (Photo 2). The main rotor hub and blade assembly was observed to be separated from the main rotor mast. Additionally, the swashplate and support assembly had separated from the mast. Both pitch links exhibited mechanical overload fracturing which is consistent with the main rotor departing. Both main rotor blades fractured at the end of the doublers which is consistent with a sudden stoppage and/or ground contact (Photo 2).

Photo 2: Main Rotor Blades (Courtesy Bell Helicopter Textron)

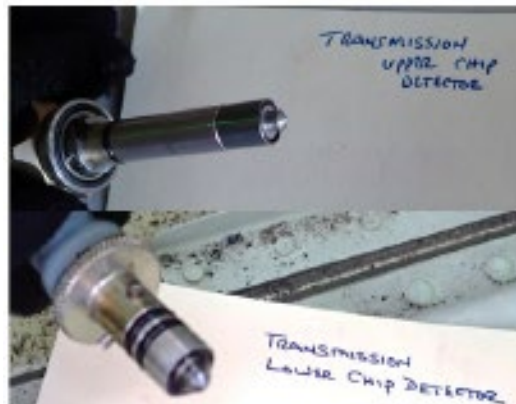
No pre-impact anomalies were observed with the main rotor drive system. The mast was bent due to impact forces. Main rotor continuity was confirmed by rotating the KAflex® (main rotor driveshaft) drive shaft by hand. Movement was confirmed from the drive shaft through the transmission to the mast. No abnormal sounds or binding were noted with rotation of the main transmission. The transmission was visually inspected, and no pre-impact anomalies observed. Oil was present within the main transmission and exhibited a normal color. Both chip detectors were removed and visually inspected with no particulate matter observed (Photo 3).

Photo 3: Transmission Chip Detectors (Courtesy Bell Helicopter Textron)

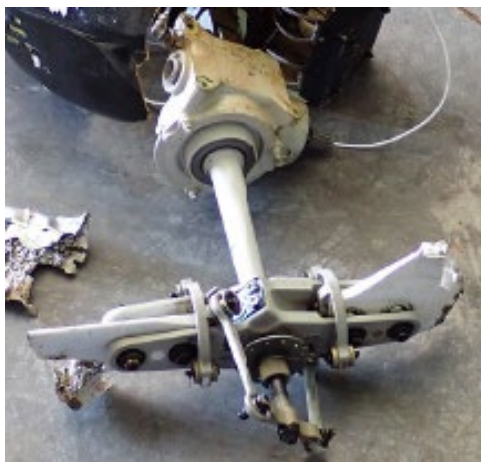
The crosshead, pitch links, pitch horns, and yoke assembly were unremarkable. Both tail rotor blades had fractured in the near the yoke attachment bolts. The tail rotor flap stops exhibited evidence of contact with the yoke assembly. Only one fractured blade section was recovered (Photo 4).

Photo 4: Tail Rotor (Courtesy Bell Helicopter Textron)

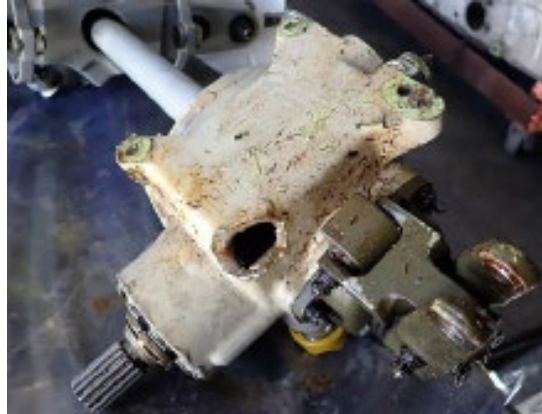
No pre-impact anomalies were observed with the tail rotor drive system. All tail rotor drive shaft segments were recovered. A continuity check was performed on the tail rotor drive system from the forward driveshaft (under the engine) to the fan shaft assembly. The aft driveshaft was pulled from the splined adapter of the fan shaft assembly. The aft end of the number 5 drive shaft segment was disconnected from splined adaptor of the tail rotor gear box. All hanger bearings had been fractured and the disc packs suffered various degrees of damage. The tail rotor gearbox had separated from the mount. All bolts had sheared, and the front left corner of the case had fractured (Photo 5). The tail rotor gearbox was visually inspected, and no pre-impact anomalies observed. The chip detector was removed and visually inspected with no particulate matter observed (Photo 6). A trace amount of oil was present within the tail rotor gearbox. The tail rotor was able to be rotated by hand in both directions with no binding or abnormal sounds coming from the tail rotor gearbox. Continuity could only be demonstrated from the tail rotor through the tail rotor gear box.

Photo 5: Tail Rotor Gearbox (Courtesy Bell Helicopter Textron)

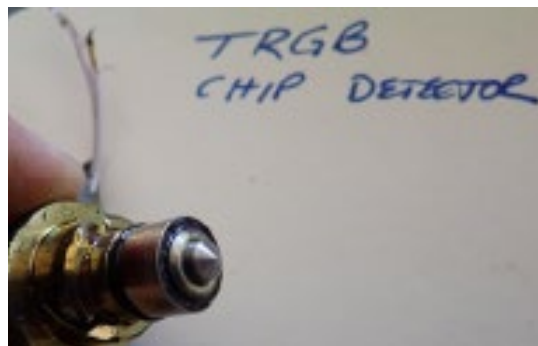
Photo 6: Tail Rotor Gearbox Chip Detector (Courtesy Bell Helicopter Textron)
