# National Transportation Safety Board

ERA23LA011

## **POWERPLANT EXAMINATION SUMMARY**

Location: Fort Myers, Florida  
Date: October 8, 2022  
Time: 1800 EST  
2200 UTC  
Helicopter: N5DF, Bell 505

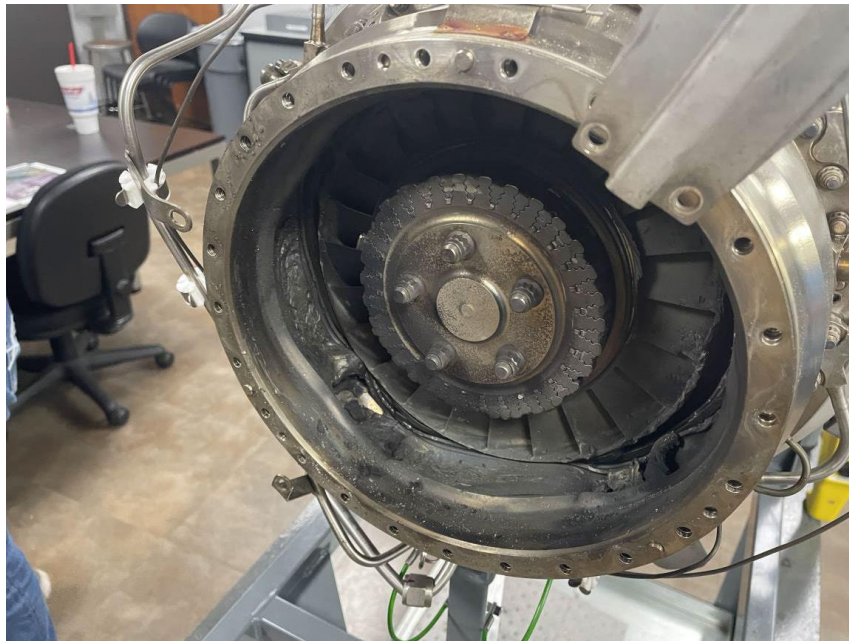
The module 2 (gas generator) was disassembled down to the high pressure turbine. The free turbine blades had shed during overspeed protection and were contained by the shroud and protection ring. This blade shedding is by engine design to prevent the free turbine disk from bursting in the event of an overspeed as was the case in this event when the main rotor mast was sheared. The free turbine nozzle guide vane sustained damage during the blade shedding (Photo 1). The disk could still be rotated by hand. The rotating assembly of the gas generator could not be rotated by hand. The thermocouples were removed and all exhibited thermal damage. The high pressure turbine blades all exhibited extreme thermal damage and were partially consumed.

Photo 1: Free Turbine Blade Shedding (Overspeed Protection)

At 20:12:77 the NFFREQ (N2) was at 124.2205% consistent with the physical evidence of the power turbine overspeed protection blade shedding. This was most likely when the main rotor impacted the light pole and the main rotor mast was sheared.

As a result of the blade shedding the gas generator T4 exceeds its limits resulting in thermal damage to the HP turbine.
