# National Transportation Safety Board

ERA23LA011

## ONBOARD IMAGE RECORDER

Location: Fort Myers, FL  
Date: October 8, 2022  
Time: 18:00 eastern daylight time (EDT)  
Helicopter: Bell Textron Canada LTD 505, N5DF

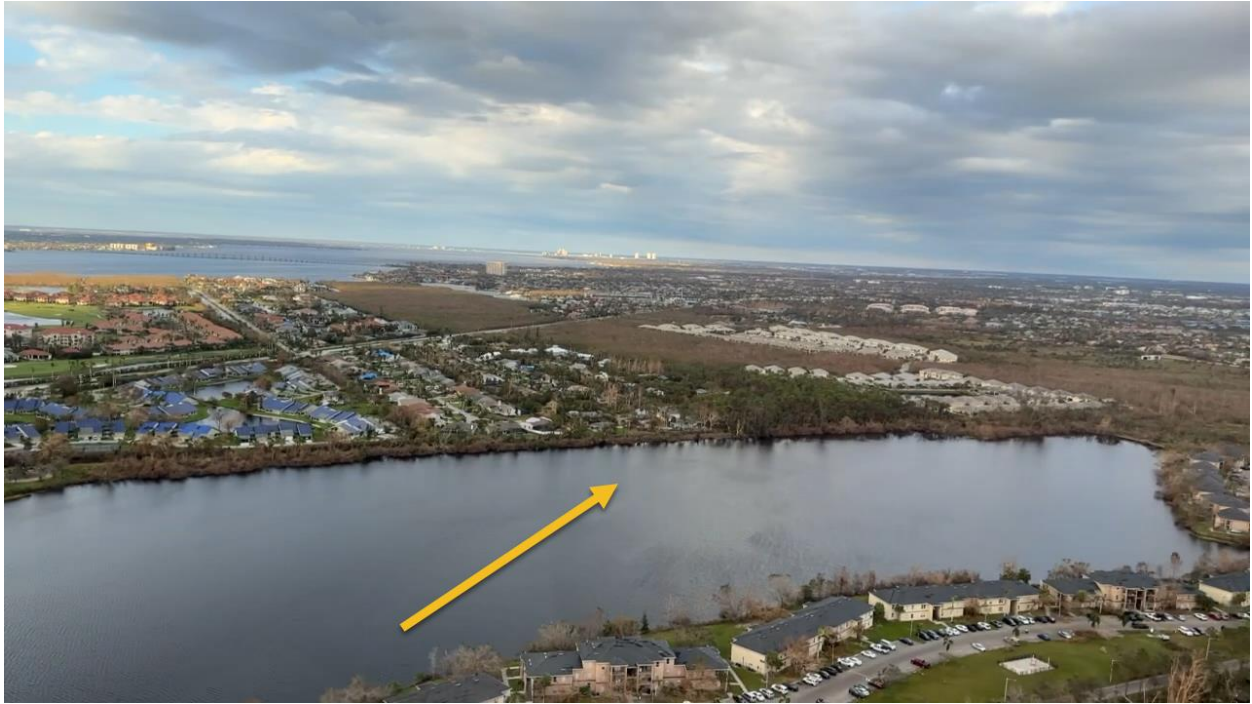
At 00:17:00, the helicopter passed over a pond near Gladiolus Drive, Iona, Florida. Figure 1 is a screenshot of the recording at this time. The screenshot has been annotated to show the direction of the wind across the pond with yellow arrows. The arrowhead points toward the direction the wind was blowing.

**Figure 1.** A screenshot of the recording near Gladiolus Drive, Iona, FL. The yellow arrows indicate the direction of the wind across the pond.

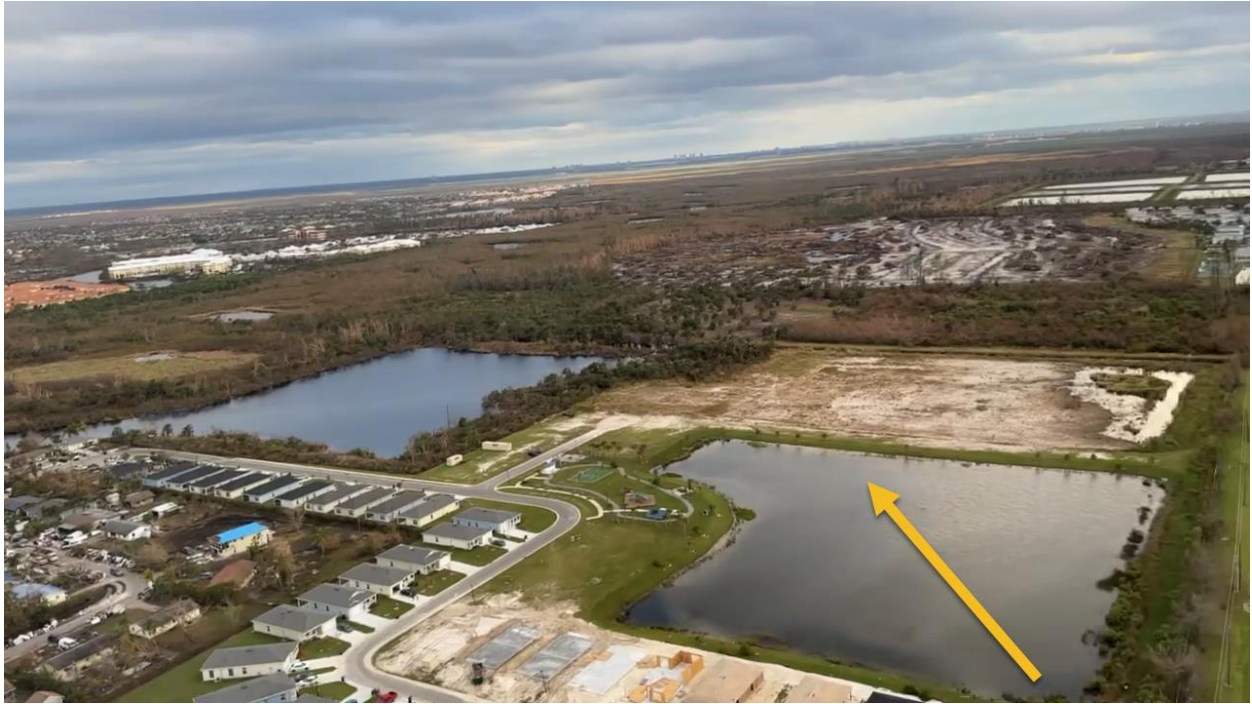
At 00:43:00, the helicopter passed over another pond near Hagie Drive & Kelly Road Soccer Complex. Figure 2 is a screenshot of the pond, shown at this time. The screenshot has been annotated to show the direction of the wind across the pond. The arrowhead points toward the direction the wind was blowing. The wind was roughly out of the northeast blowing toward the southwest.

**Figure 2.** A screenshot of the recording near Hagie Drive and Kelly Road Soccer Complex. The yellow arrows indicate the direction of the wind across the pond.

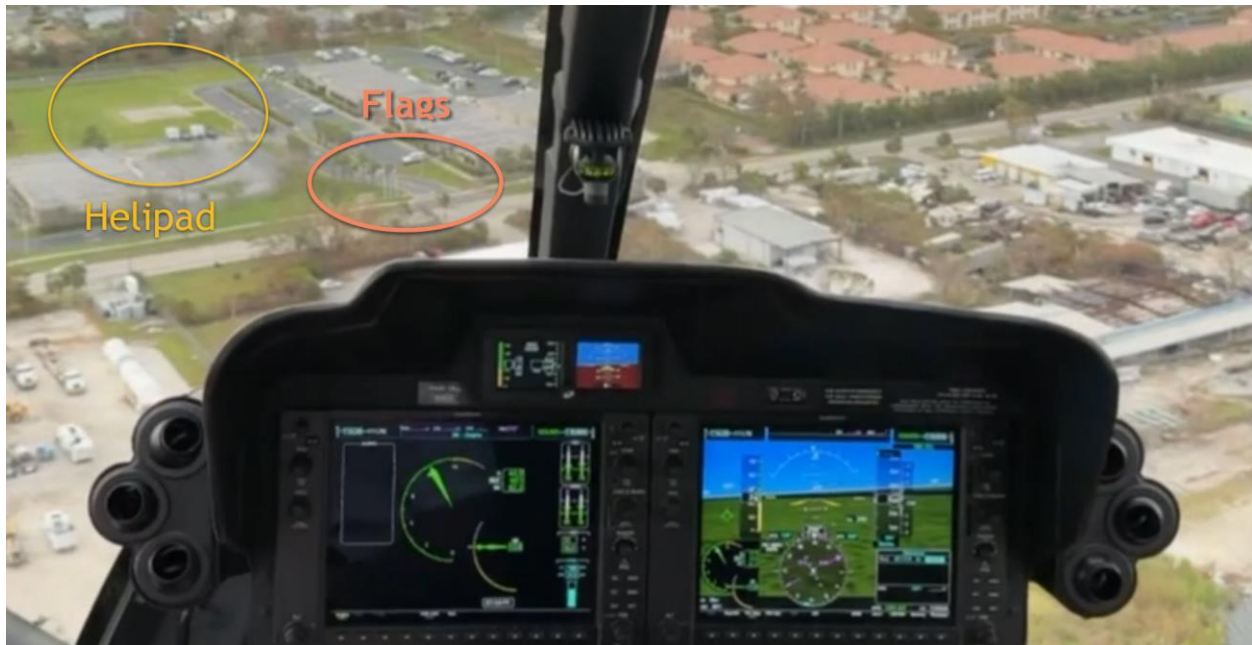
Around 00:57:00, the camera view panned inside the helicopter and captured the instrument panel. The instrument panel appeared nominal, there were no caution or warning lights, or CAS messages. The instrument panel showed the following:

- The Power Situation Indicator was just above "8"
- The rotor RPM was at 104% (nominal)
- The fuel status appeared to be approximately 3/4 full.
- The attitude indicator suggested the helicopter was nearly level at this time in pitch and roll.

The accident site (Iona Tax Assessor's Office and helipad) is visible ahead of the helicopter. There were two flagpoles ahead of the helicopter annotated in figure 3. The helicopter's heading at this time was WNW. The flags on the flagpole are erect and indicated the wind was blowing from NNE.

**Figure 3.** A screenshot of the instrument panel at this time. An area of flags are circled. The helipad is annotated.

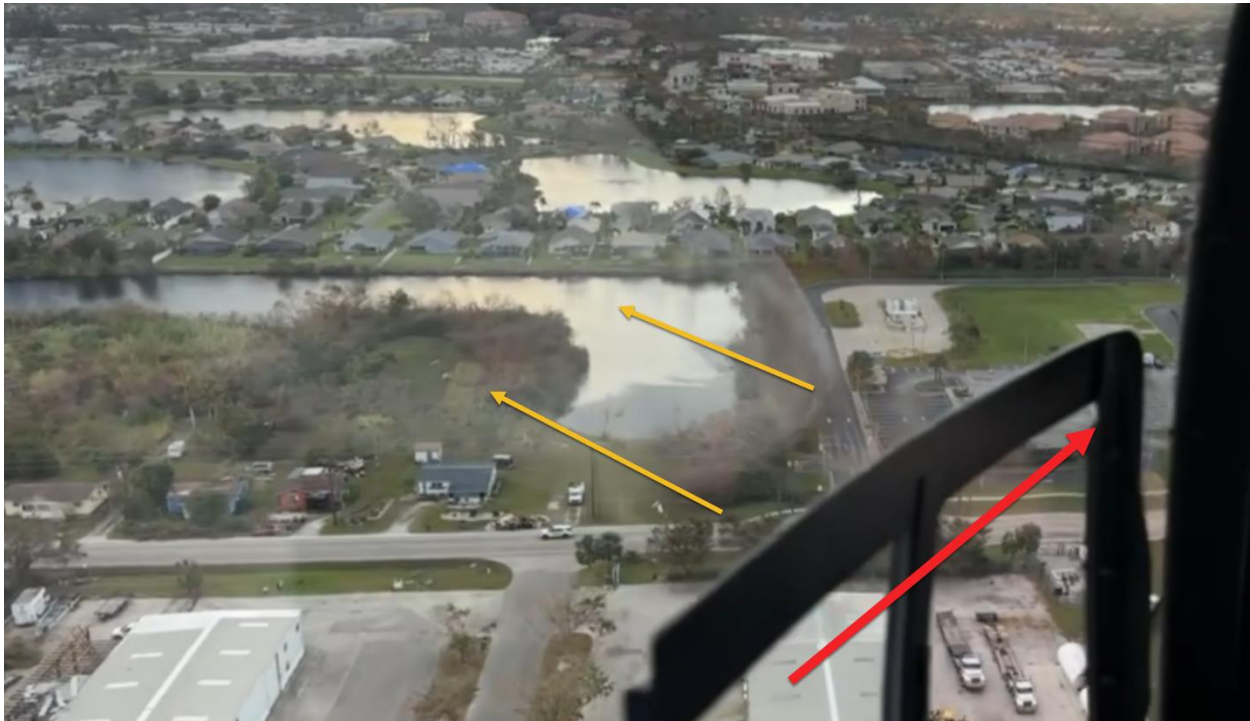
Figure 5 is a cropped screenshot showing the camera's view at 01:02:00 as it headed toward the accident site. The image was cropped to remove occupants from the image. A pond ahead and to the left shows the wind was blowing from the NNE. The screenshot has been annotated to show the direction of the wind across the pond with yellow arrows. The arrowhead points toward the direction the wind was blowing. The direction of the helicopter's motion is depicted with a red arrow.

**Figure 5.** A cropped screenshot at 01:02:00. The wind direction across the pond has been annotated. The direction of the helicopter is in red.

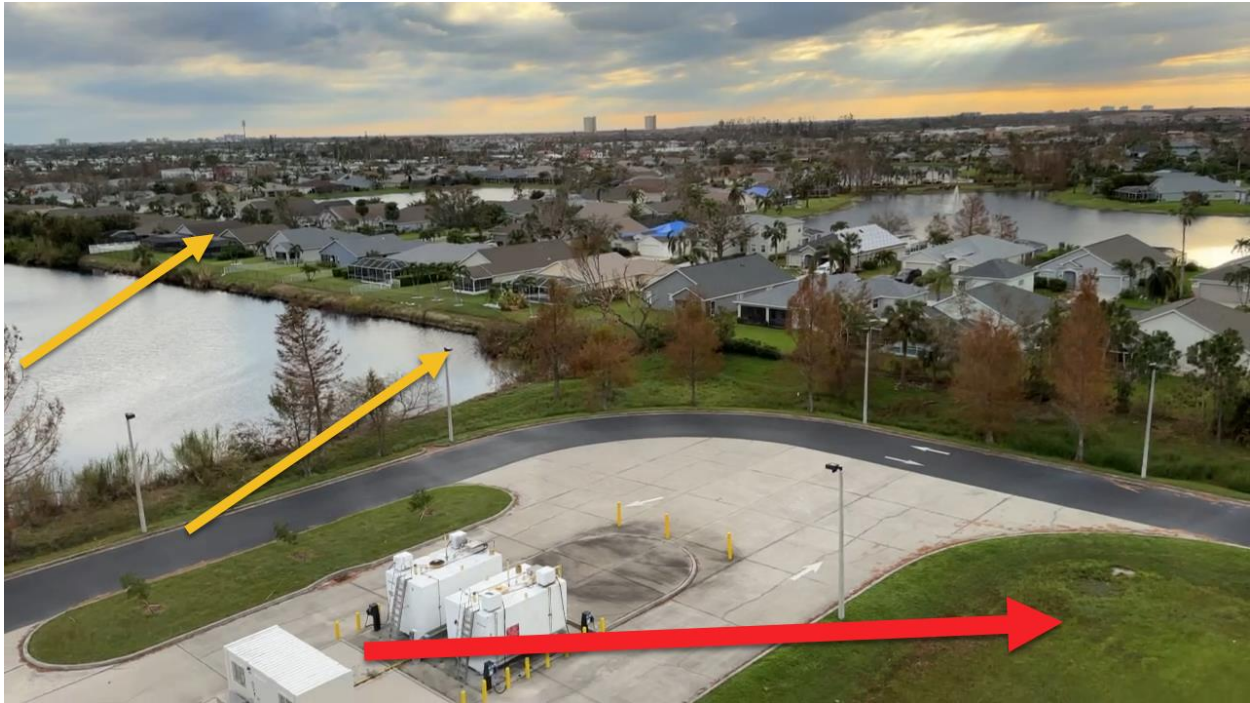
Moments later at 01:41:00, the camera captured a pond to the left of the helicopter. The helicopter had nearly zero forward airspeed. Figure 6 is a screenshot at this time. The wind was blowing across the pond from the NNE. The screenshot has been annotated to show the direction of the wind across the pond with yellow arrows. The arrowhead points toward the direction the wind was blowing. The approximate direction of the helicopter's nose is annotated with a red arrow.

**Figure 6. A screenshot at 01:41:00. The wind direction is annotated in yellow, the direction the helicopter's nose was pointed is in red.**
